# AERIAL PHOTOGRAPHY ANALYSIS OF COASTAL EROSION ON THE ISLANDS OF KAUAI, MOLOKAI, LANAI, MAUI AND HAWAII

JUNE, 1991

**PREPARED BY:**  
**MAKAI OCEAN ENGINEERING, INC**  
**and**  
**SEA ENGINEERING, INC.**  
**Honolulu, Hawaii**

**PREPARED FOR:**  
**STATE OF HAWAII**  
**OFFICE OF STATE PLANNING**  
**COASTAL ZONE MANAGEMENT**  
**PROGRAM**

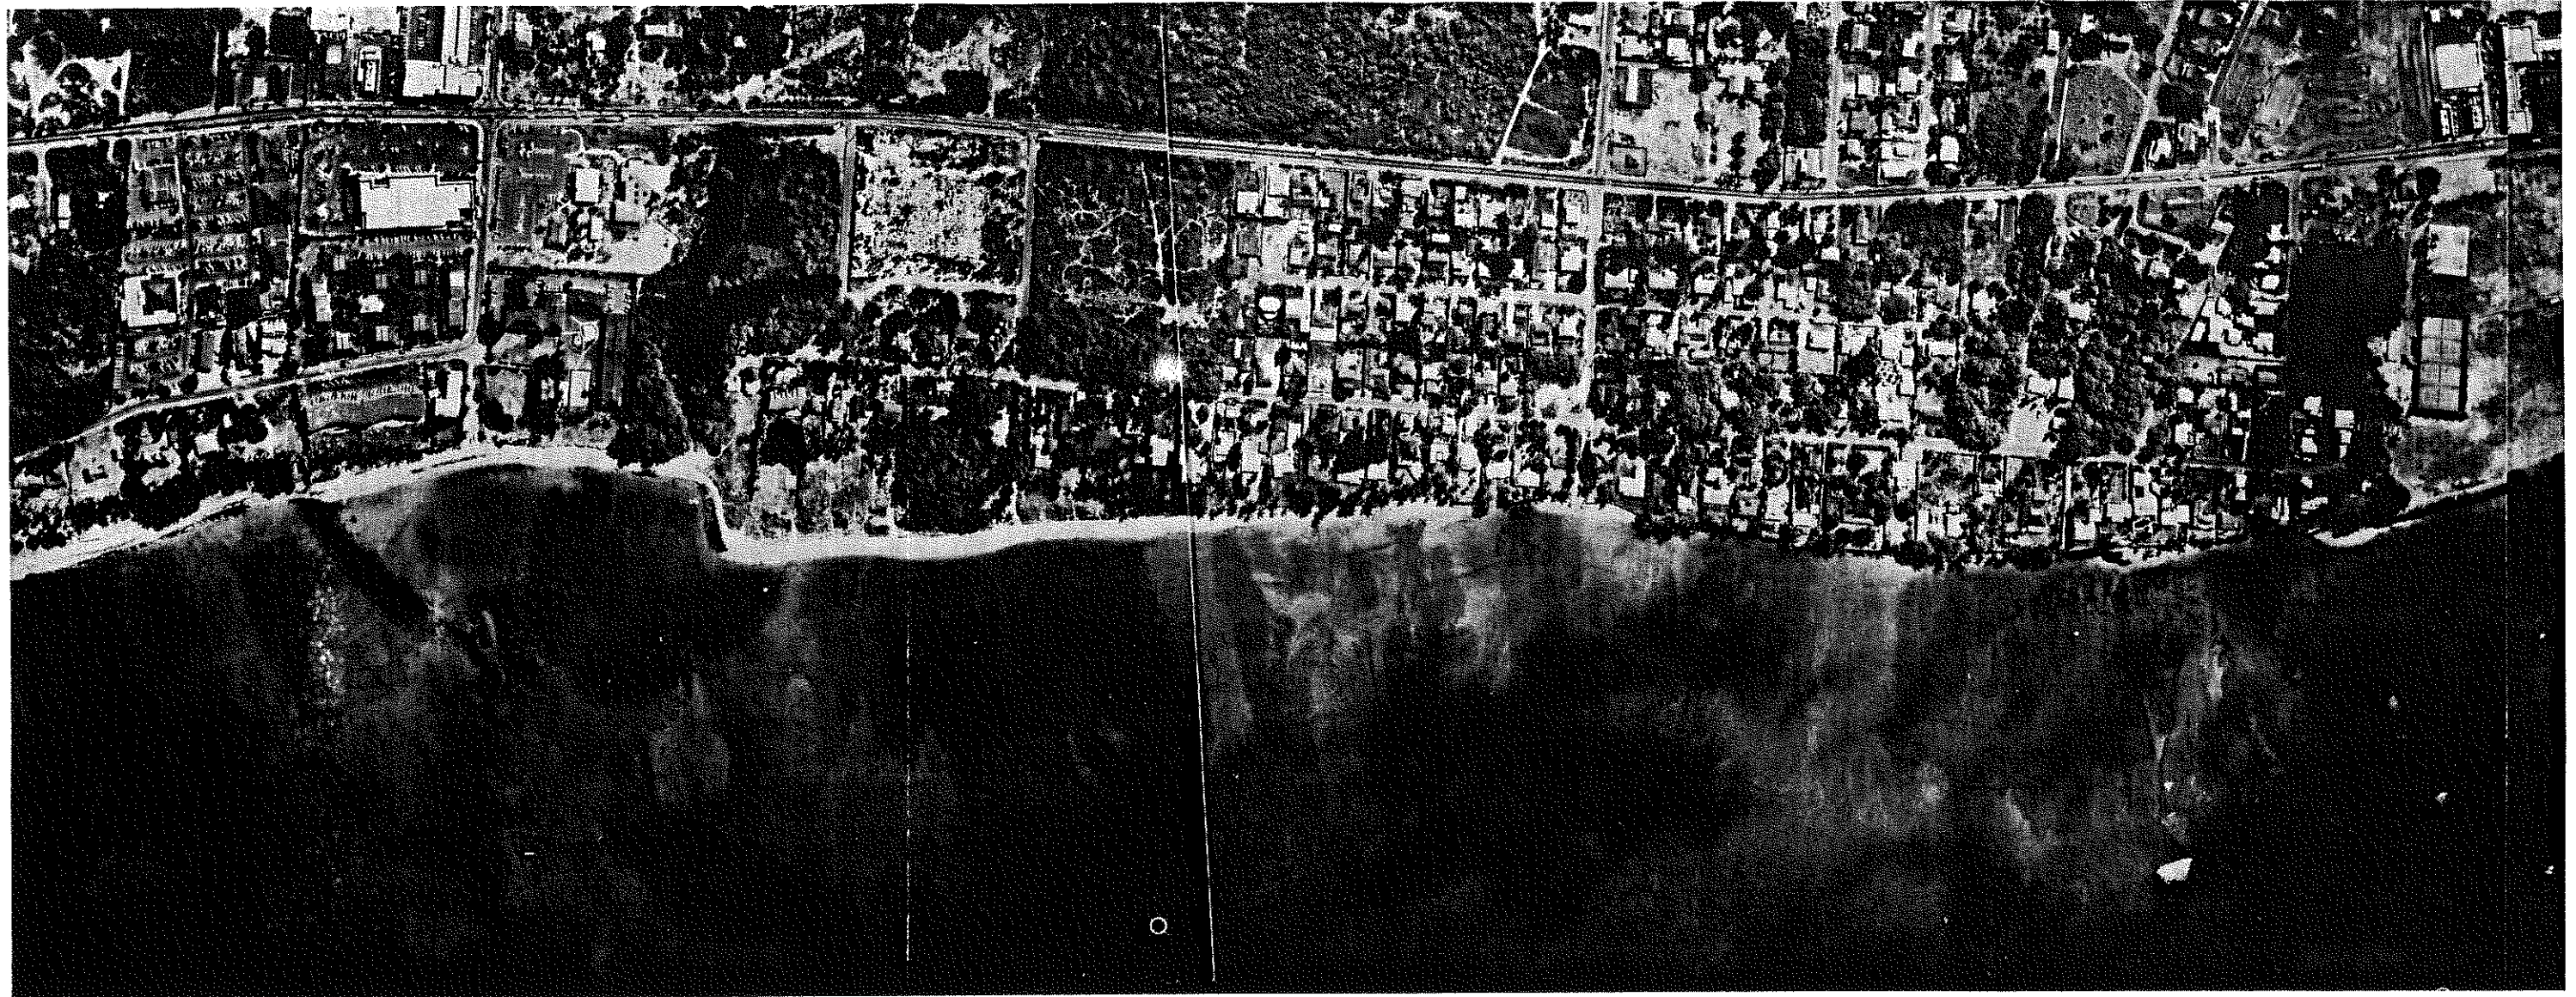
FIGURE MB-7

- The beach changes in this subsector are the direct result of man-made coastal structures.
- The construction of a groin within the fishpond ruins has caused beach accretion in Region 19, and beach erosion in Region 18.
- Seawalls and revetments protecting property in the southern half of the subsector have resulted in loss of the beach in this area, and severe erosion along the shore to the north of the structures.
- More recently, a groin has been constructed to halt the erosion around Region 20, north of the shore protection.

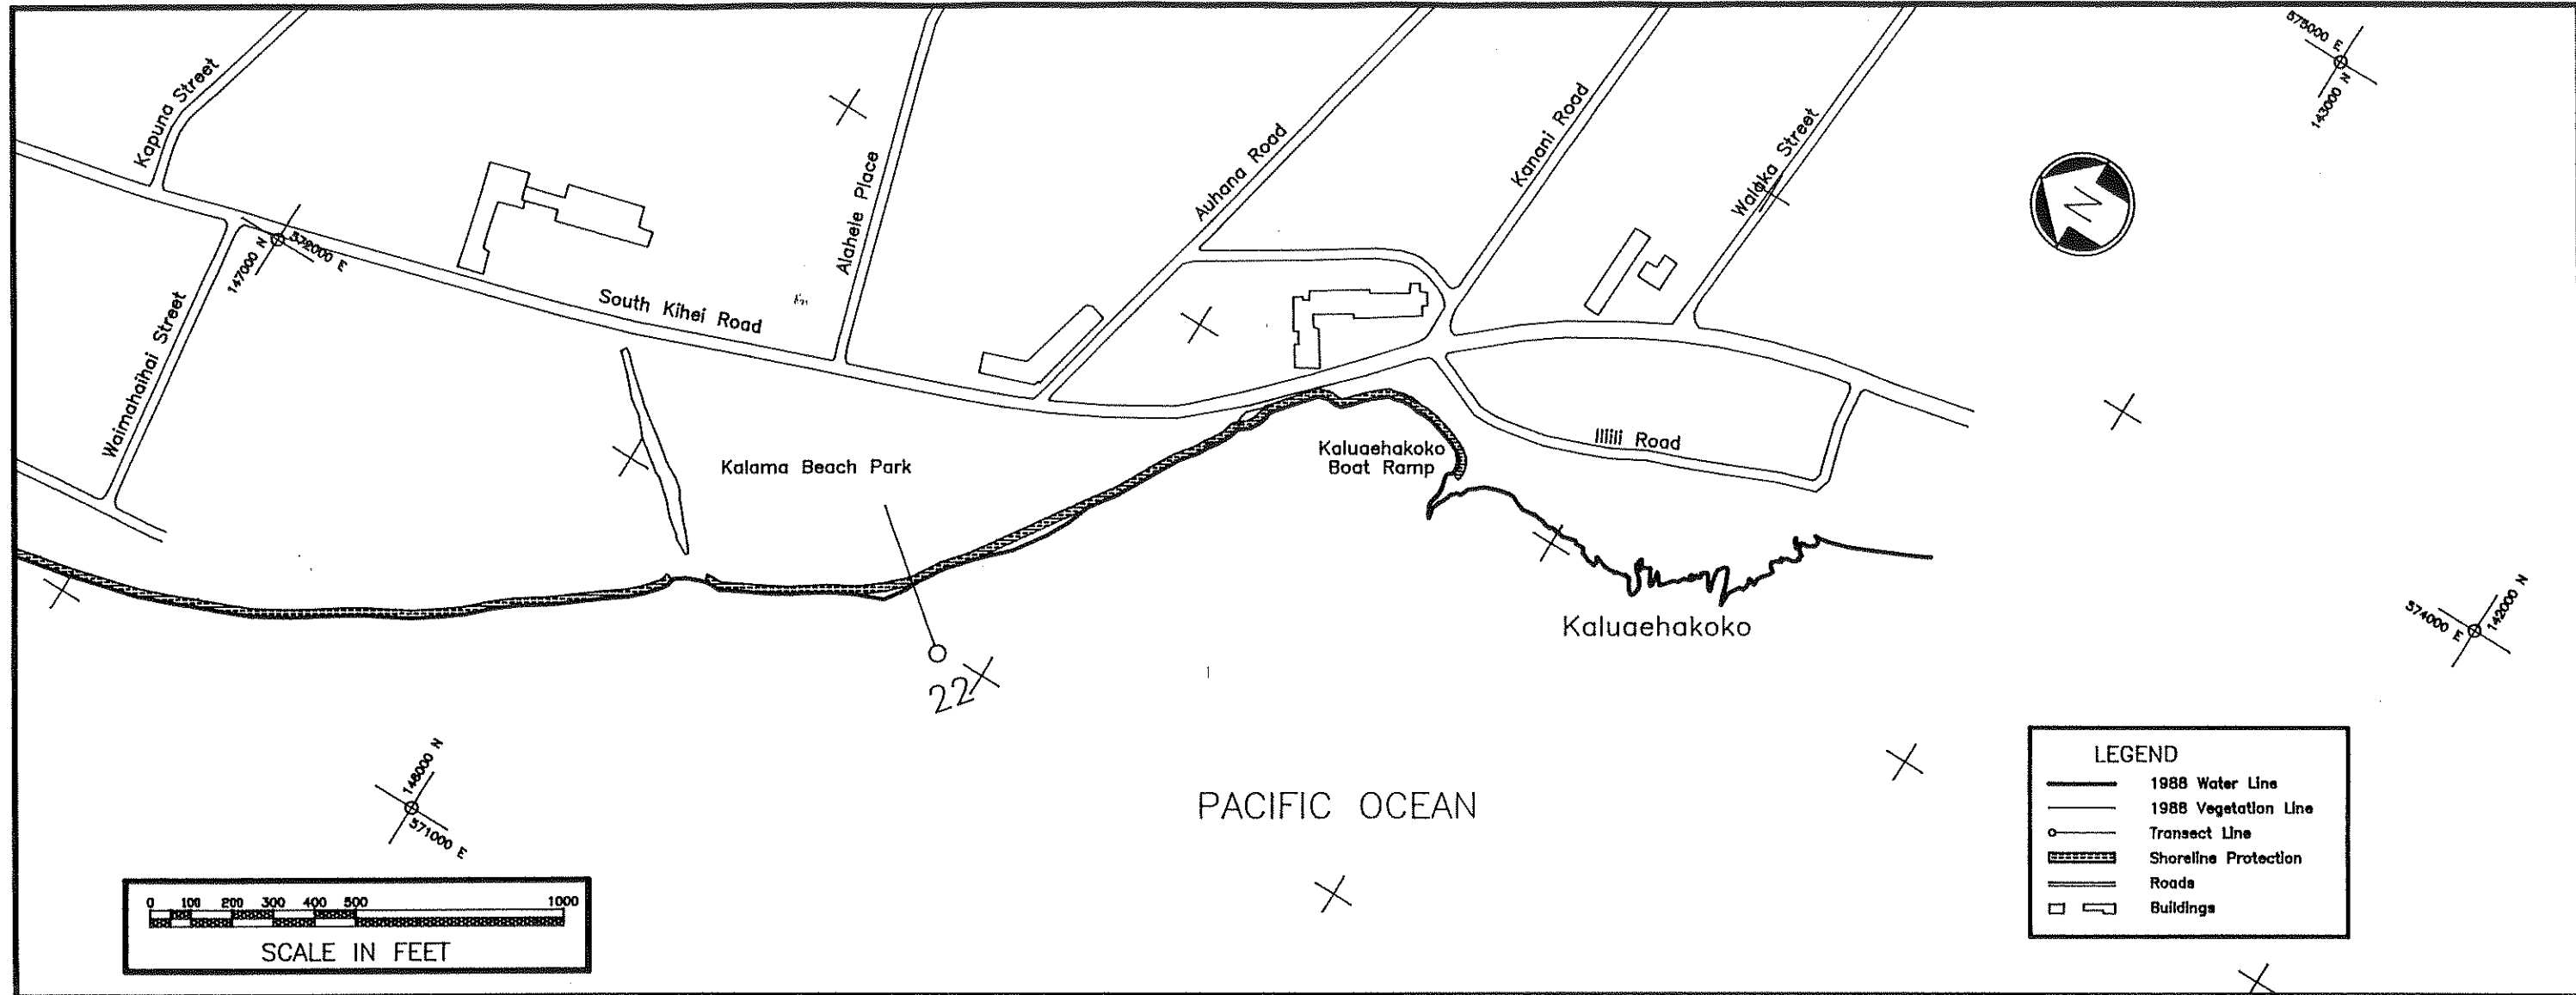
FIGURE MB-8

- There is no beach in this subsector. A 3000 foot long revetment was built in the early 1970's to protect land from further erosion. The revetment has resulted in loss of the beach in the subsector, and continuing erosion problems further to the north.

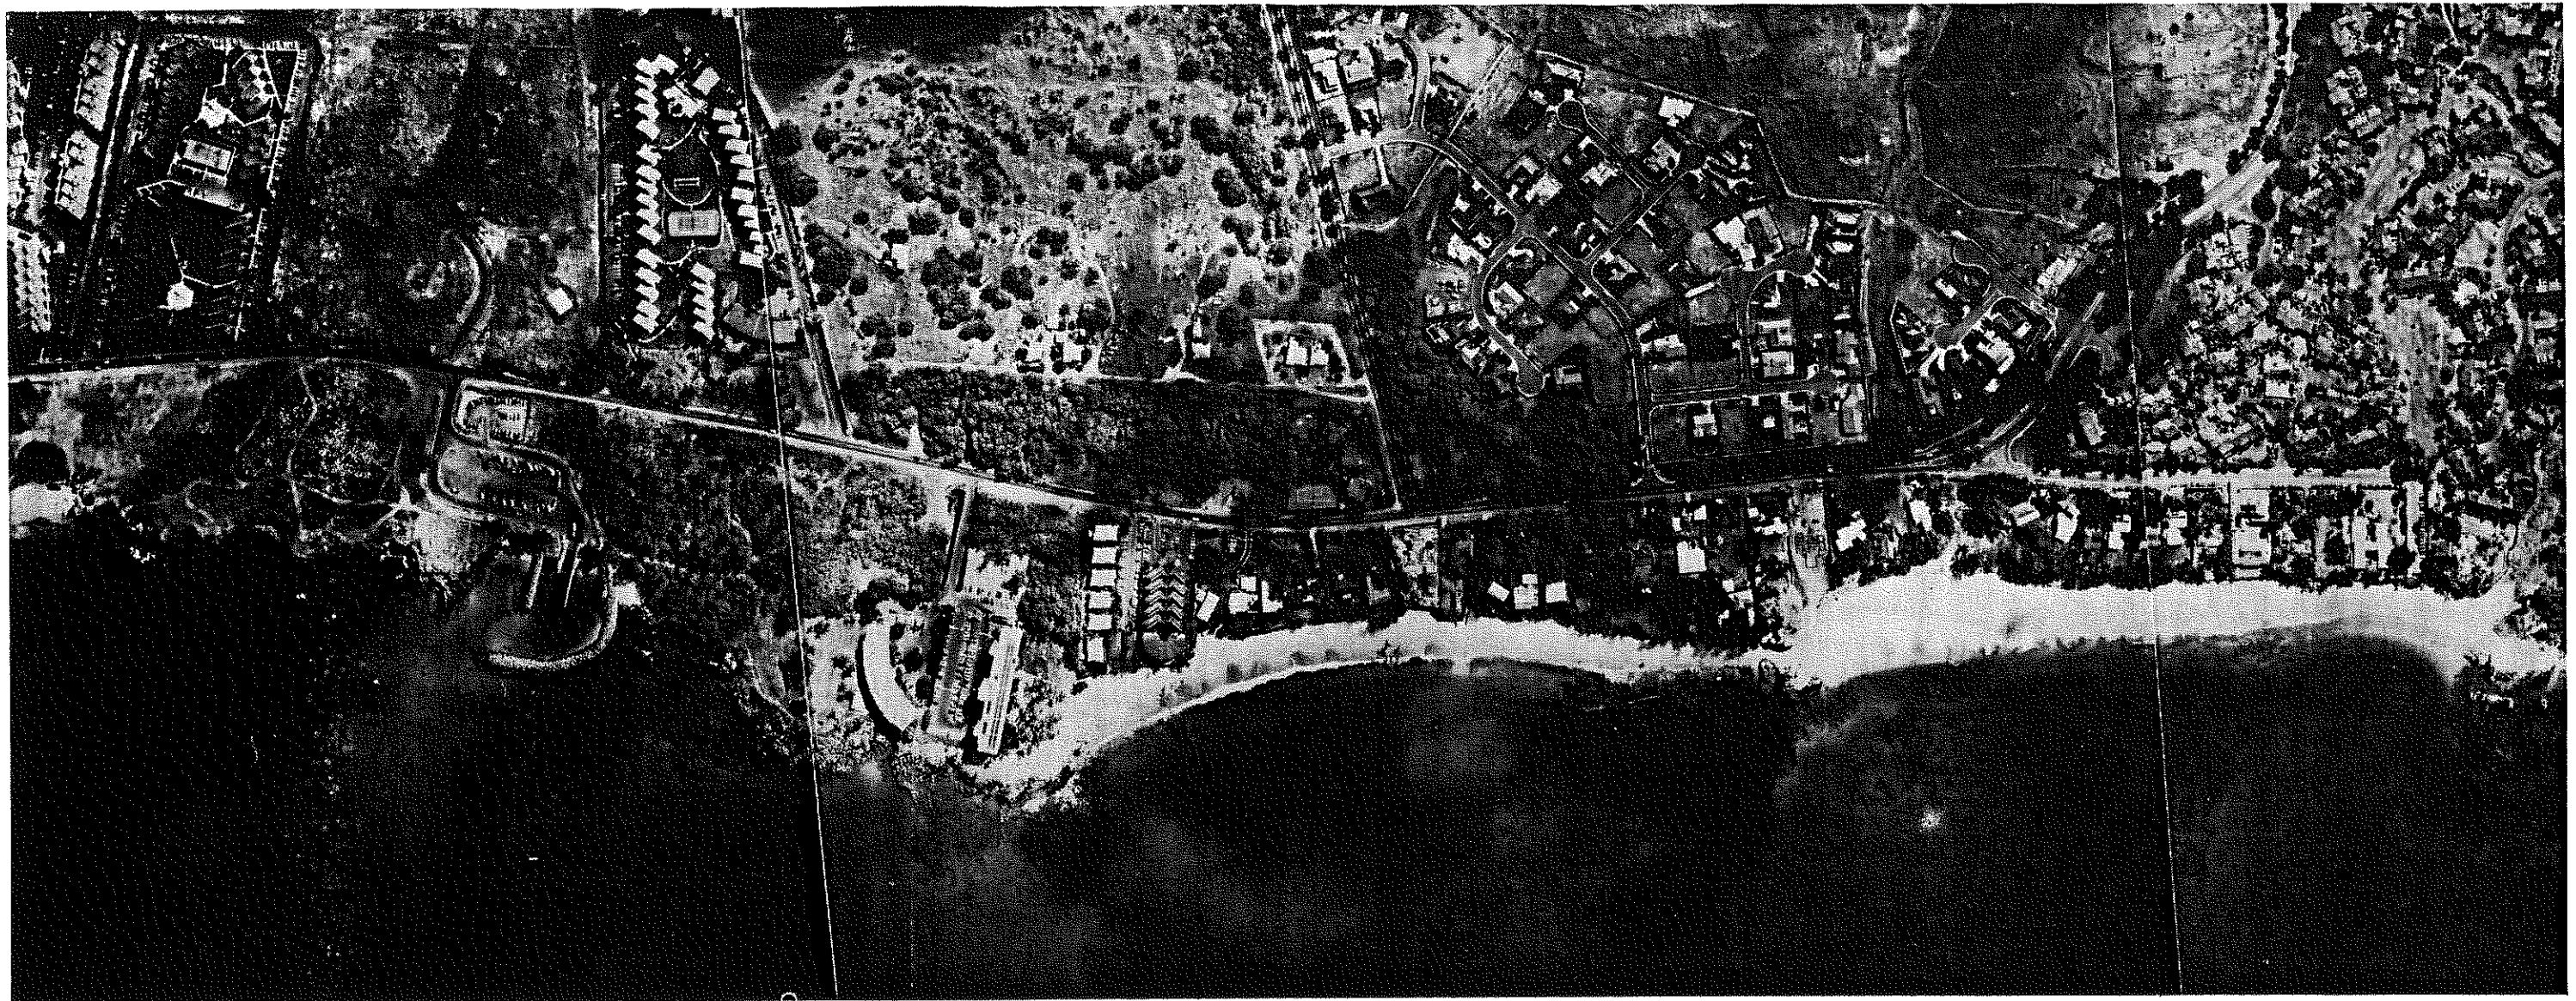
FIGURE MC-2

- Keawakapu Beach is an unprotected, dynamic beach subject to severe storm erosion.
- Storms in 1959 and the winter of 1963 caused severe erosion, and left beach rock exposed along the entire length of beach.
- The beach then accreted through 1975.
- Storms in 1980 and 1982 again caused severe erosion along the beach, as is shown by the 1988 vegetation line.

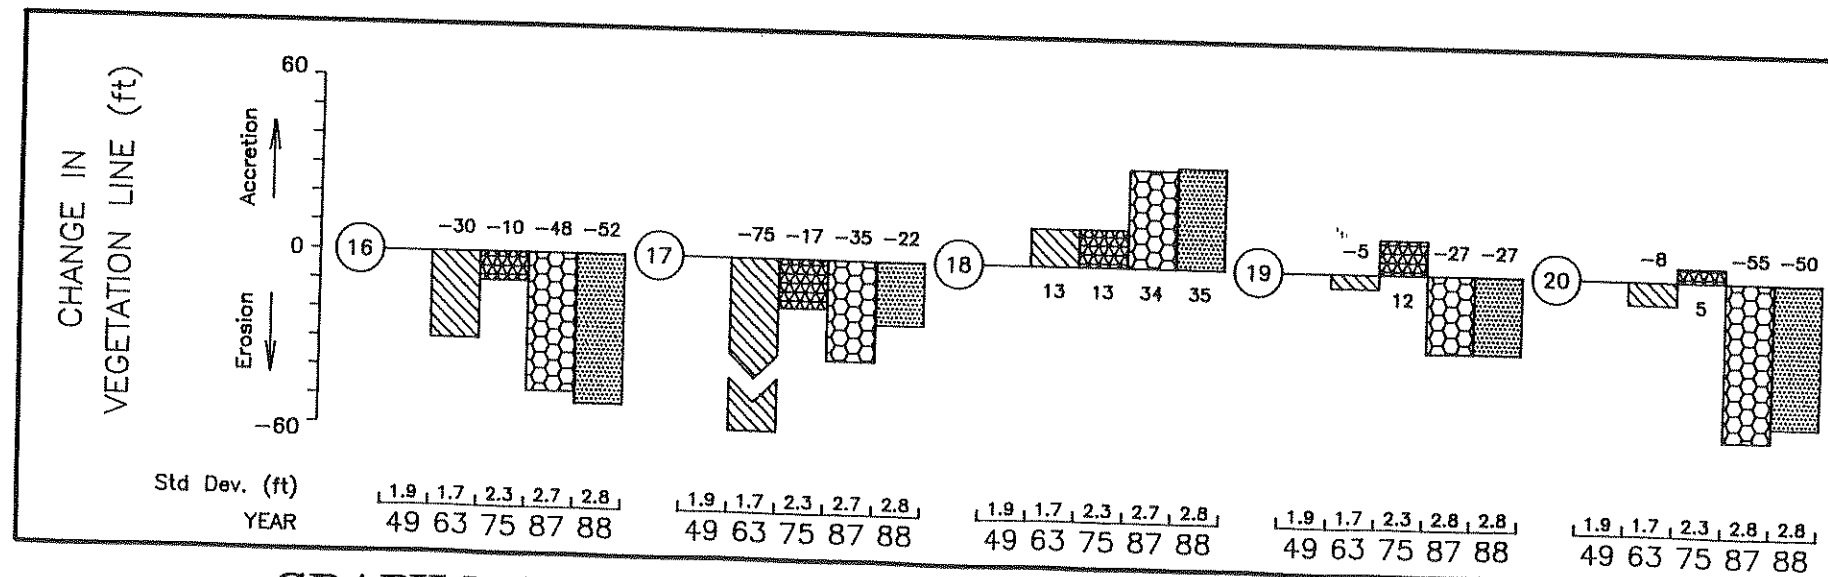
**FIGURE MC-4**

damage in 1963 was significantly greater than indicated by this vegetation line. Vegetation appears to have been destroyed and sand eroded as much as 150 feet behind this vegetation line.

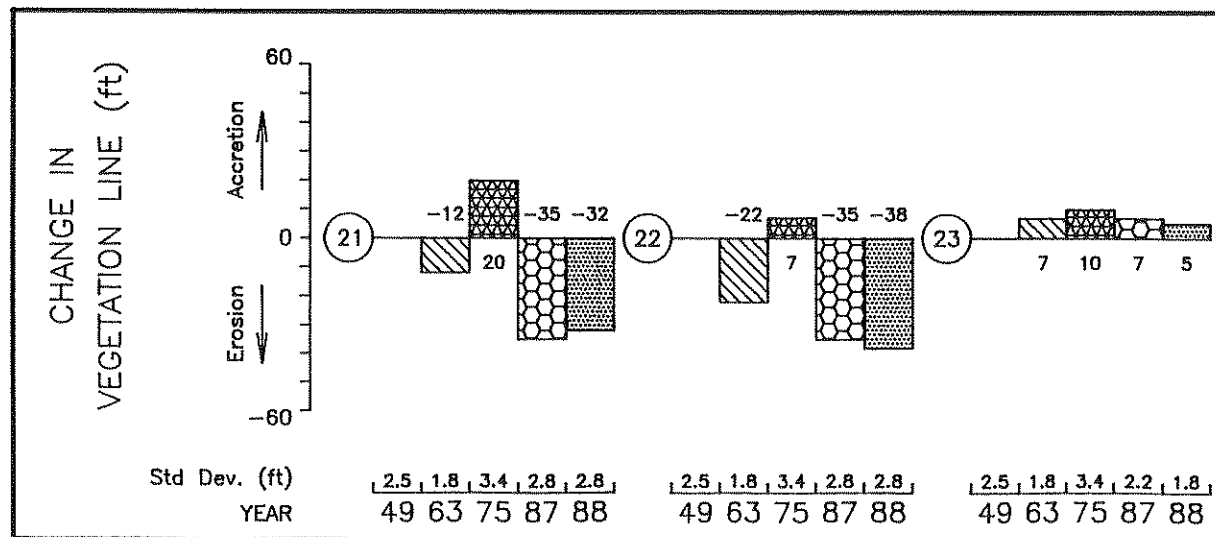
FIGURE MC-5

- Poolenalena Beach is dynamic, although it has not undergone the extreme erosion indicated on the other beaches of the sector.
- Net erosion ranged from 32 to 38 feet in Regions 21 and 22.
- The shorelines are relatively stable behind the rock outcrops along the beach.

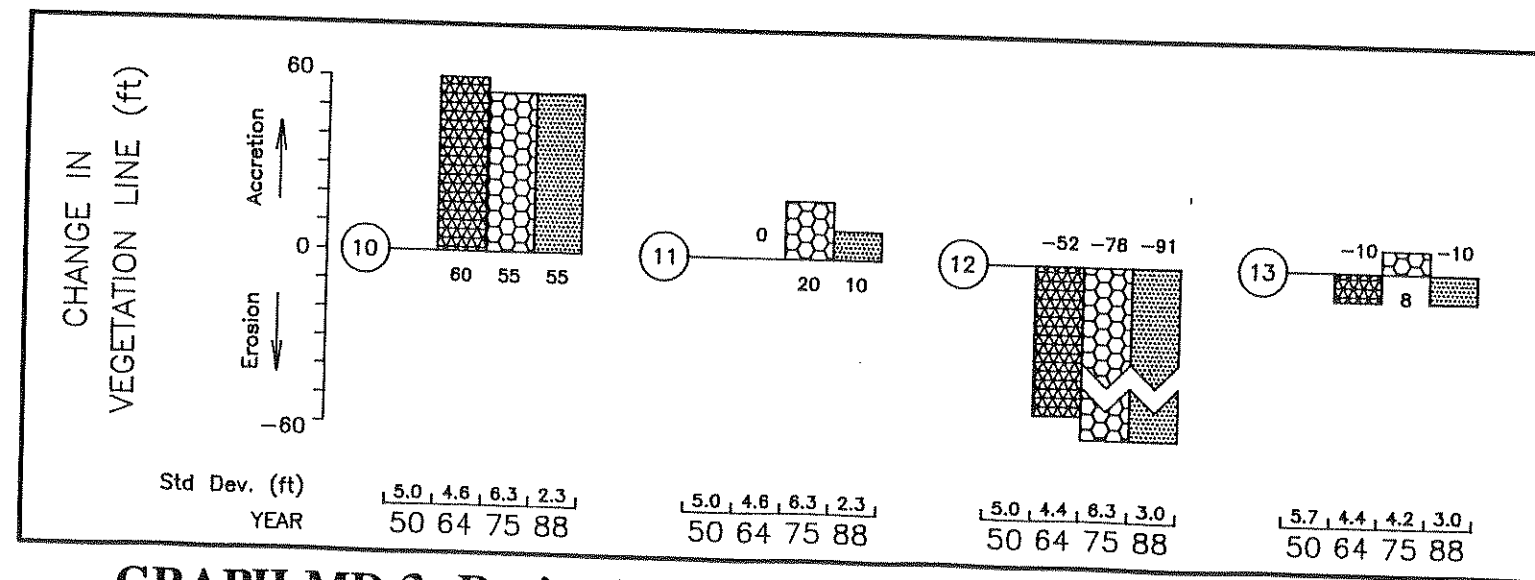
**FIGURE MD-3**

- Region 11 shows the same trend, although the accretion is less significant and occurred between 1964 and 1975. It was probably caused by the series of small groins located to the west.
- Region 12 shows significant erosion both in the historical record and in the oblique photos. A coral bench is located to the east and a revetment to the west. The revetment was built to stabilize the shoreline and is not the cause of the erosion. The coral bench helps stabilize the waterline. It is unclear why such pronounced erosion is occurring here.

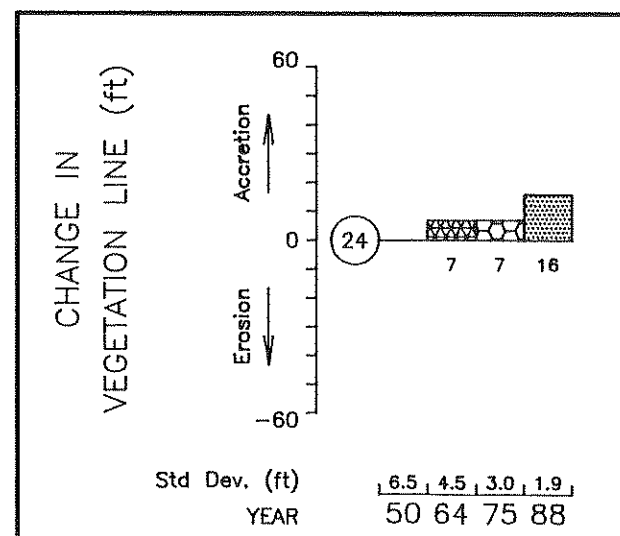
**FIGURE MD-7**

- There is some indication of wave cut erosion at the rocky points.
- The sandy areas are, in general, stable.

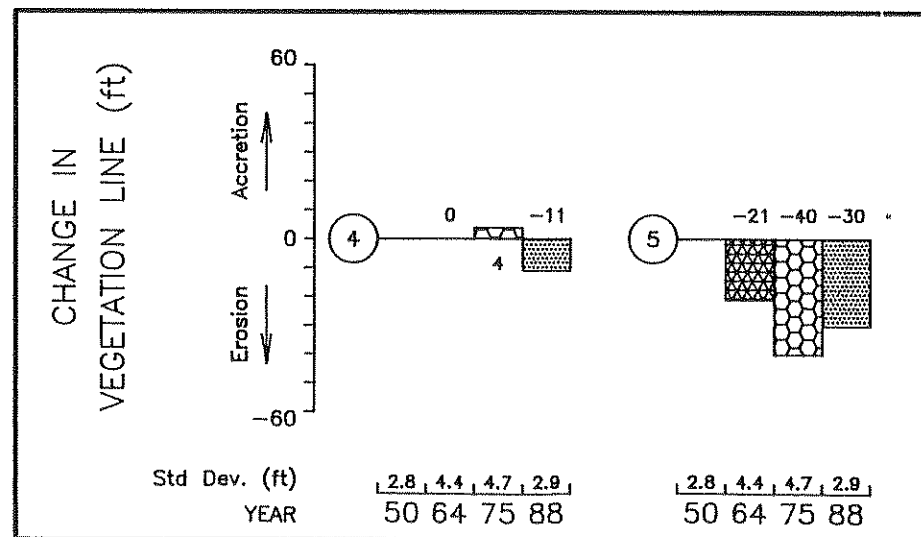
**FIGURE HA-3**

- Few definitive conclusions can be drawn about the beach fronting the Mauna Lani Resort. Beach fill as well as shore protection structures have been placed to help stabilize the beach. The vegetation line has also been altered.
- The beach between the Mauna Lani Bay Hotel and the Ritz-Carlton Mauna Lani is, however, definitely eroding. The oblique photos show the bases of palm trees being undercut and many trees falling over. A site visit verified this conclusion.

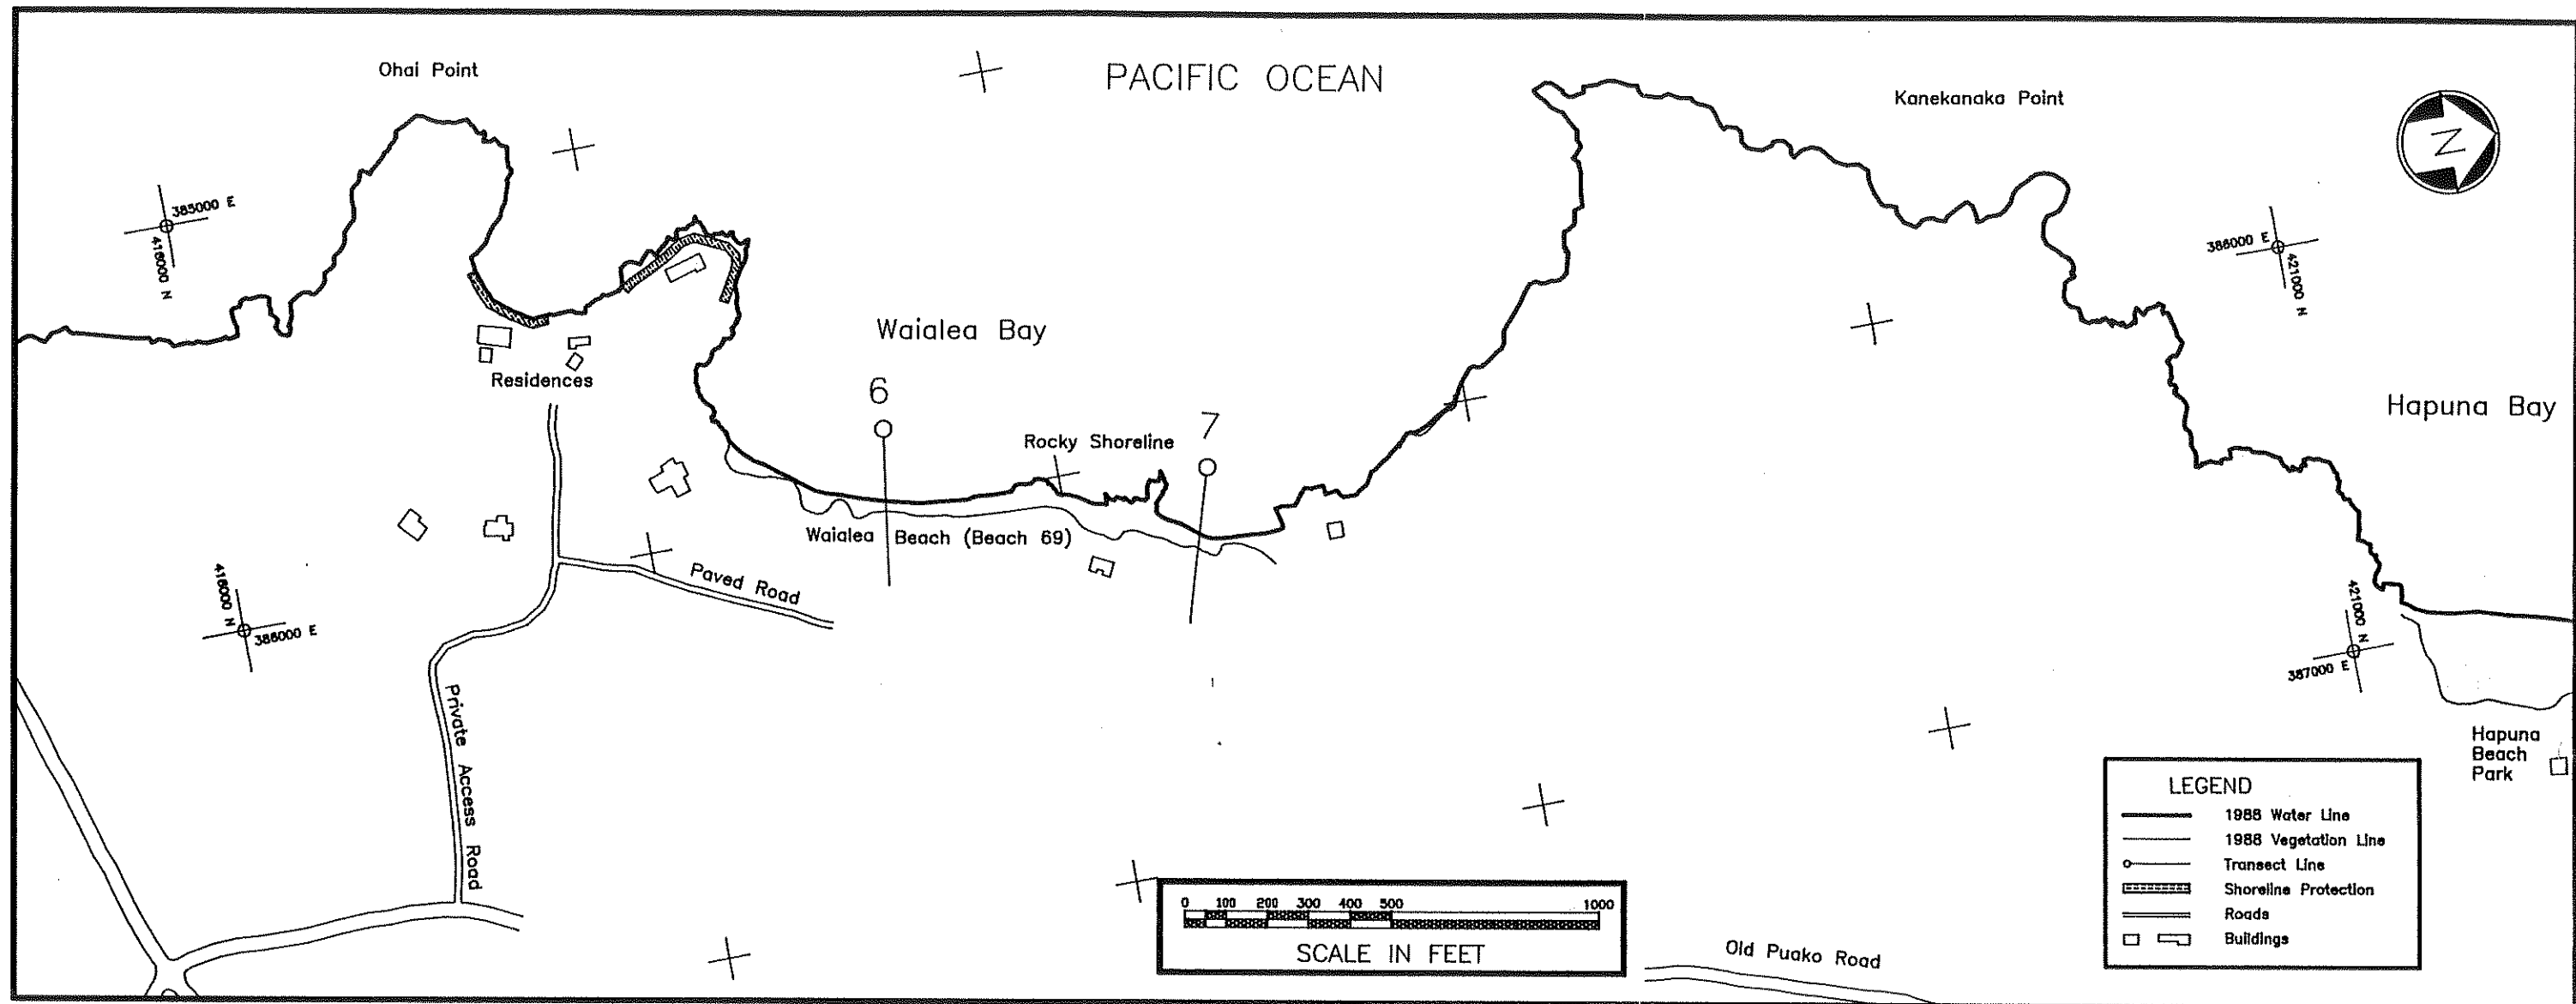
**FIGURE HA-5**

- Waialea Beach is a dynamic beach with seasonal changes in the shoreline. There was a net transport of sand to the south that resulted in erosion in Region 7 and accretion in Region 6.

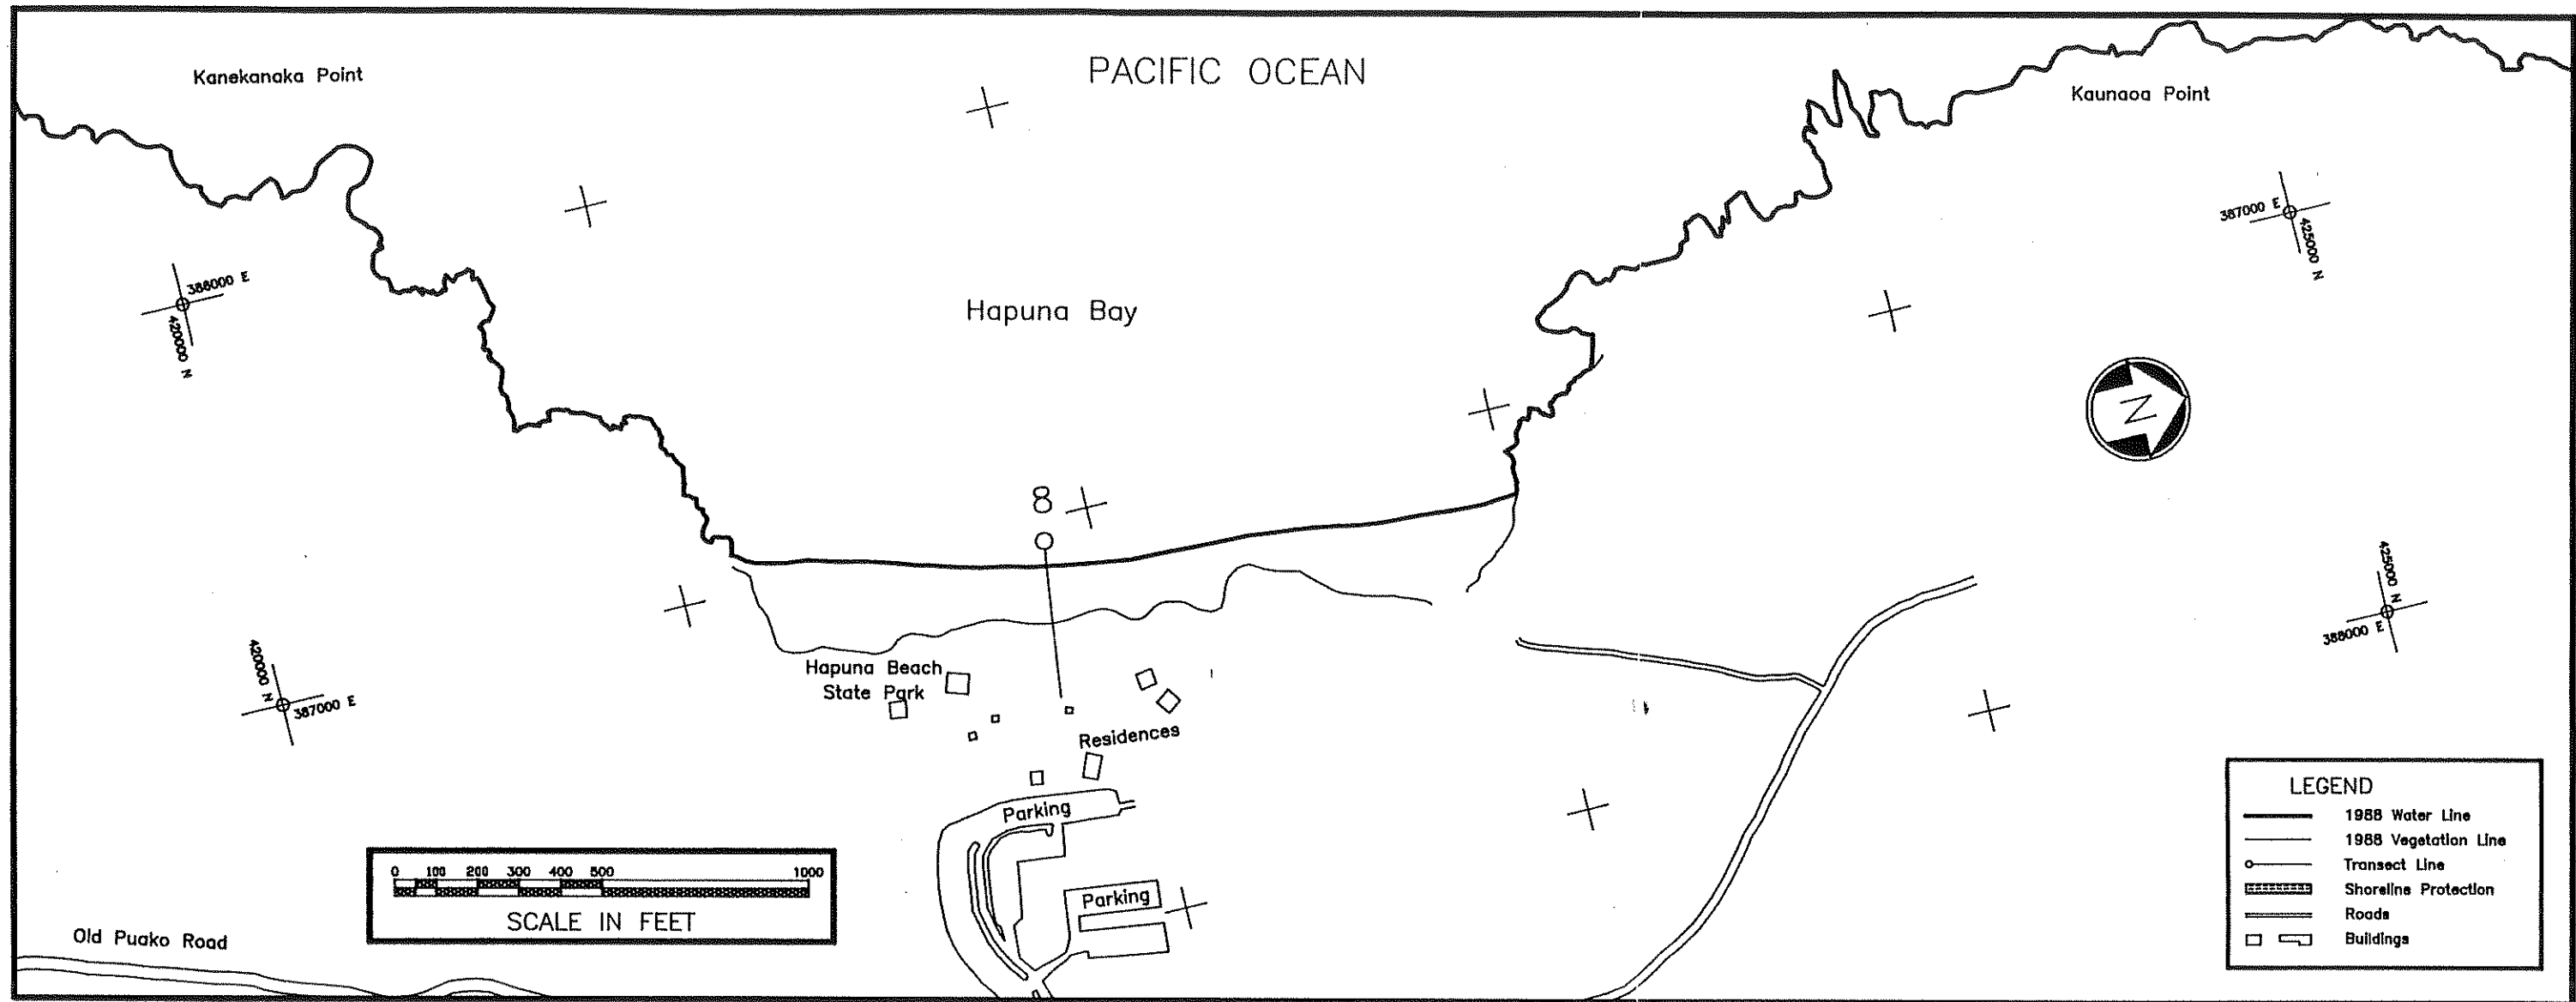
**FIGURE HA-6**

- The beach is directly exposed to large winter waves, and is not protected by an offshore reef.
- Hapuna Beach is a closed littoral cell with sand moving offshore during the winter, and then moving back onshore during the summer months. There has been significant erosion along the beach, with a probable net loss of sand offshore.

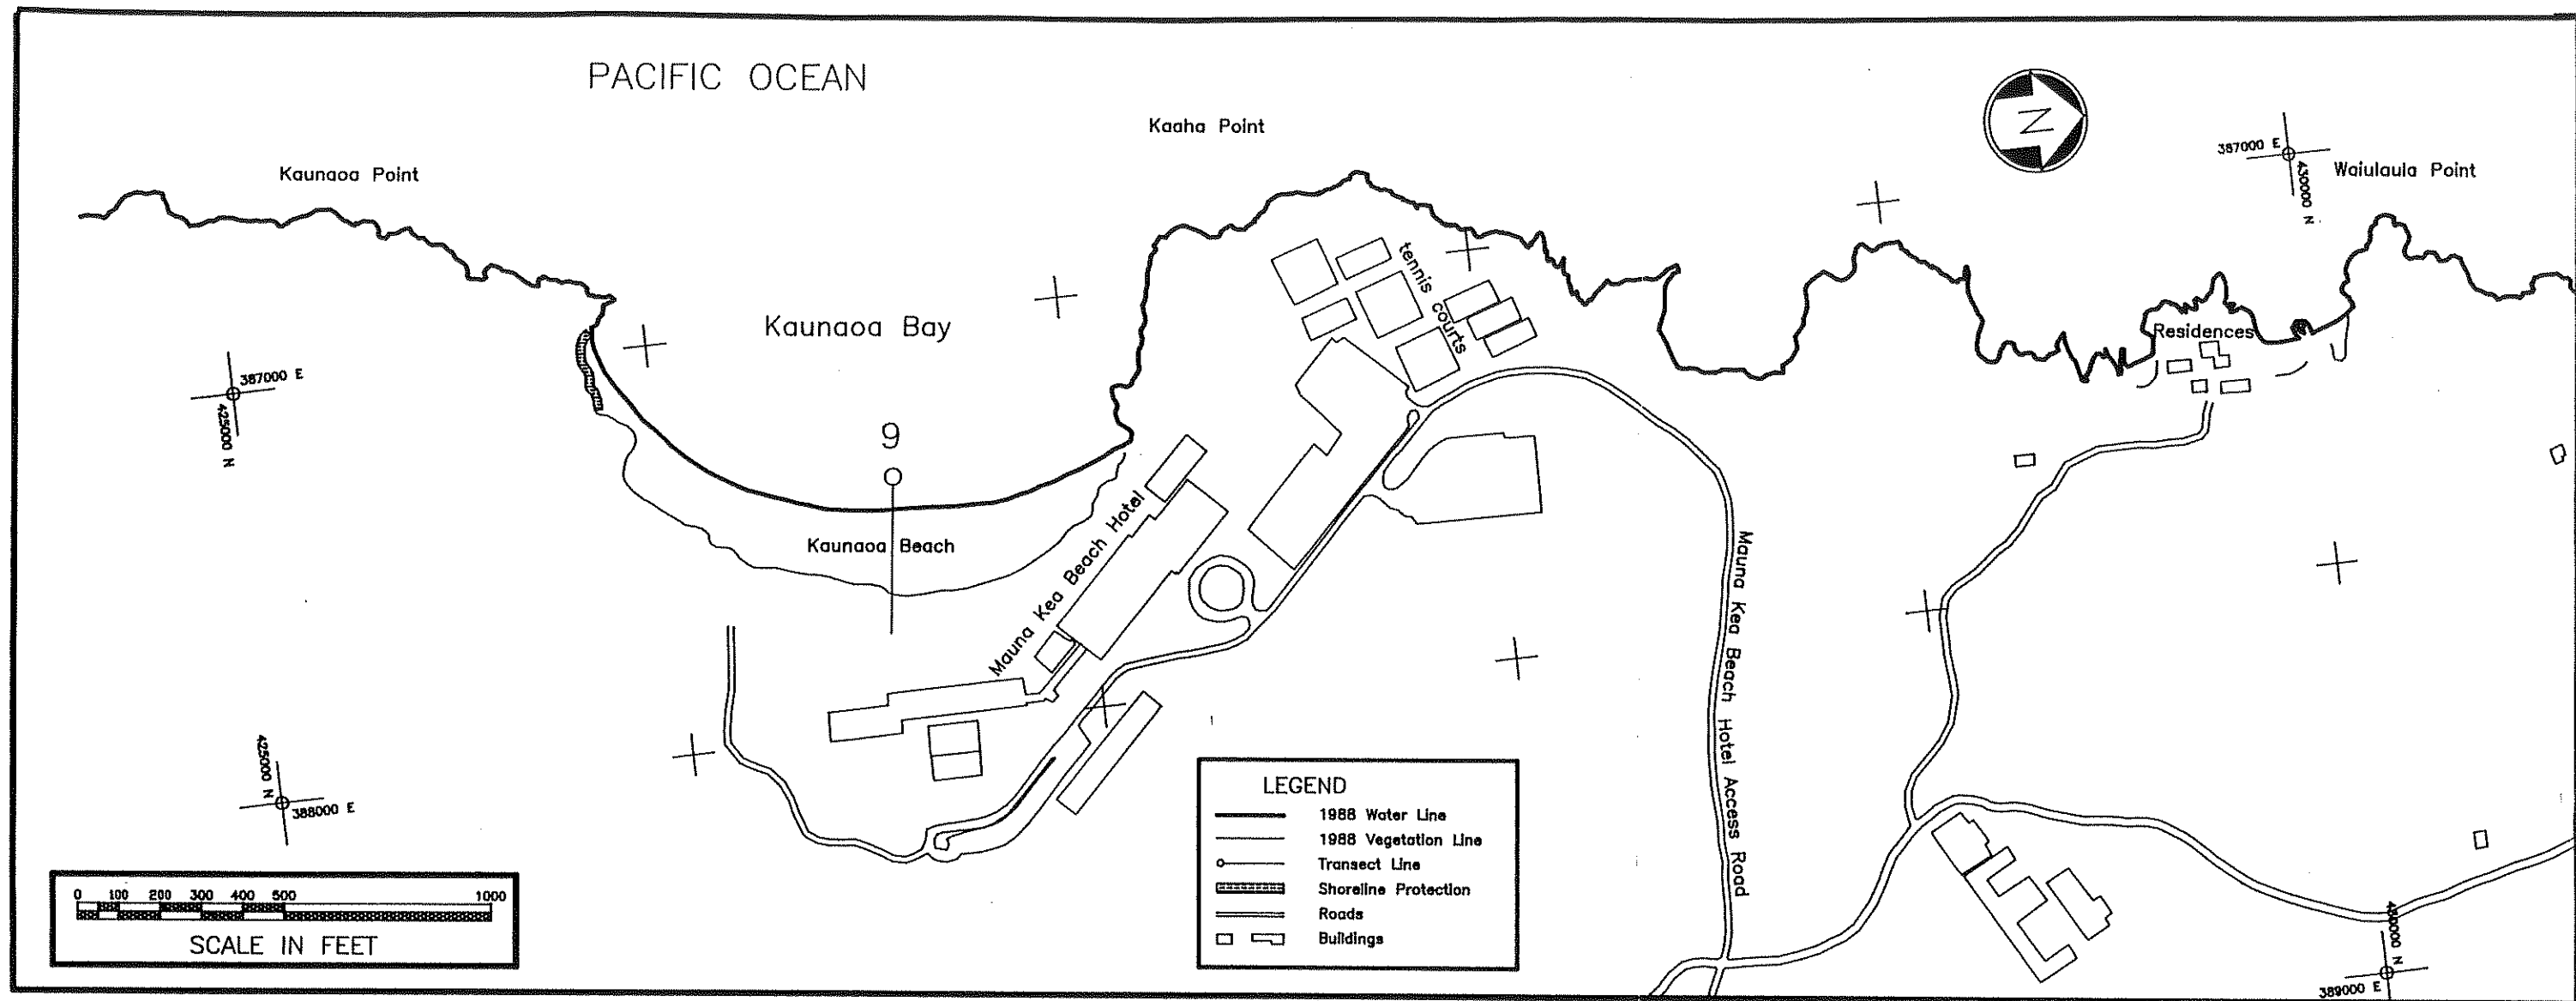
FIGURE HA-7

- The Mauna Kea Beach Hotel has significantly altered and maintained the vegetation line.

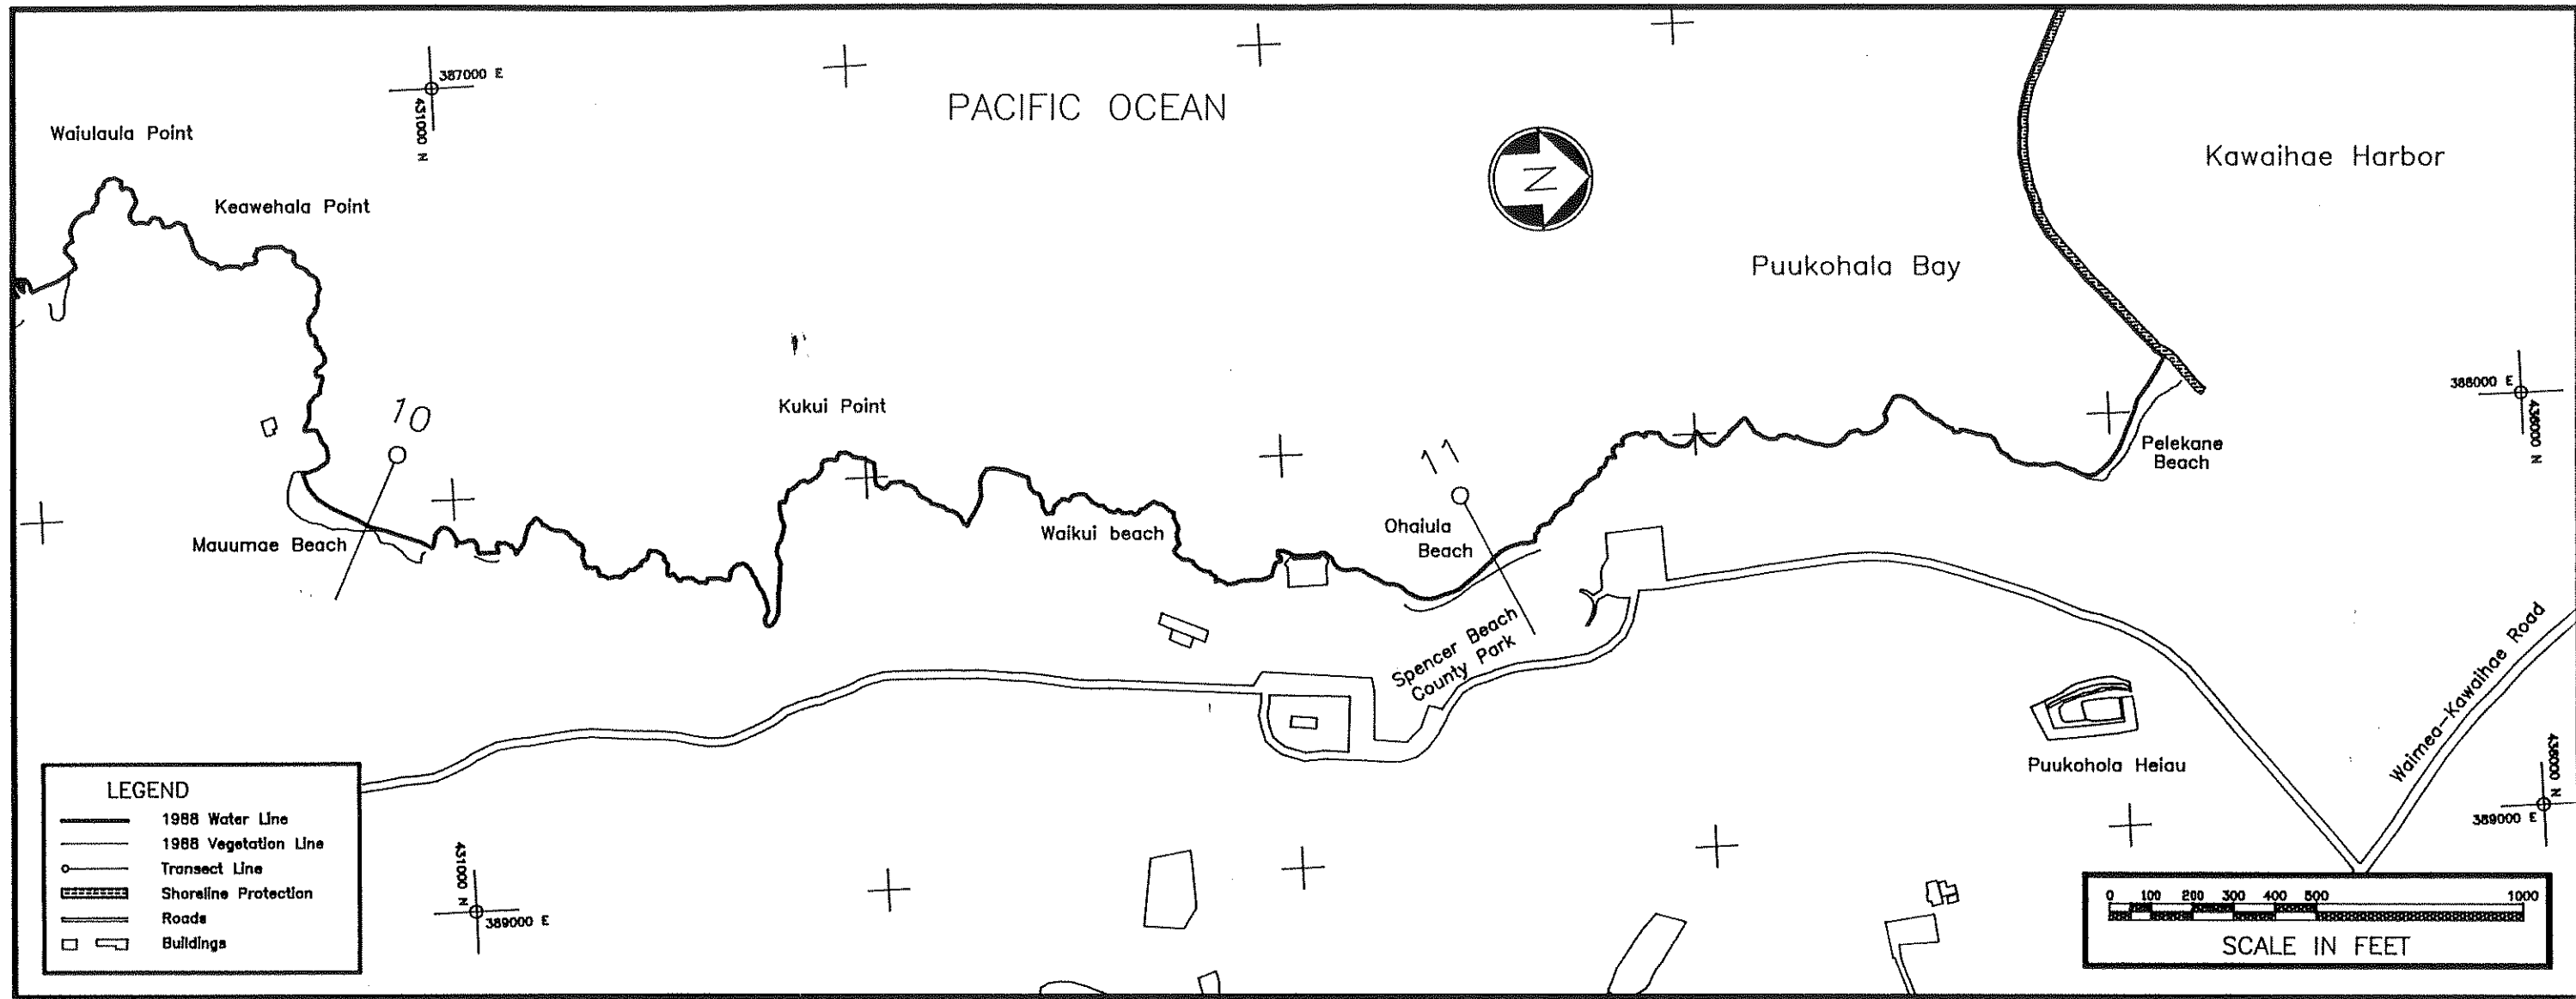
**FIGURE HA-8**

- Both Mauumae and Ohaiula Beach are stable with only minor cyclic changes in the vegetation lines.
