# AERIAL PHOTOGRAPHY ANALYSIS OF COASTAL EROSION ON THE ISLANDS OF KAUAI, MOLOKAI, LANAI, MAUI AND HAWAII

JUNE, 1991

**PREPARED BY:**  
**MAKAI OCEAN ENGINEERING, INC**  
**and**  
**SEA ENGINEERING, INC.**  
**Honolulu, Hawaii**

**PREPARED FOR:**  
**STATE OF HAWAII**  
**OFFICE OF STATE PLANNING**  
**COASTAL ZONE MANAGEMENT**  
**PROGRAM**

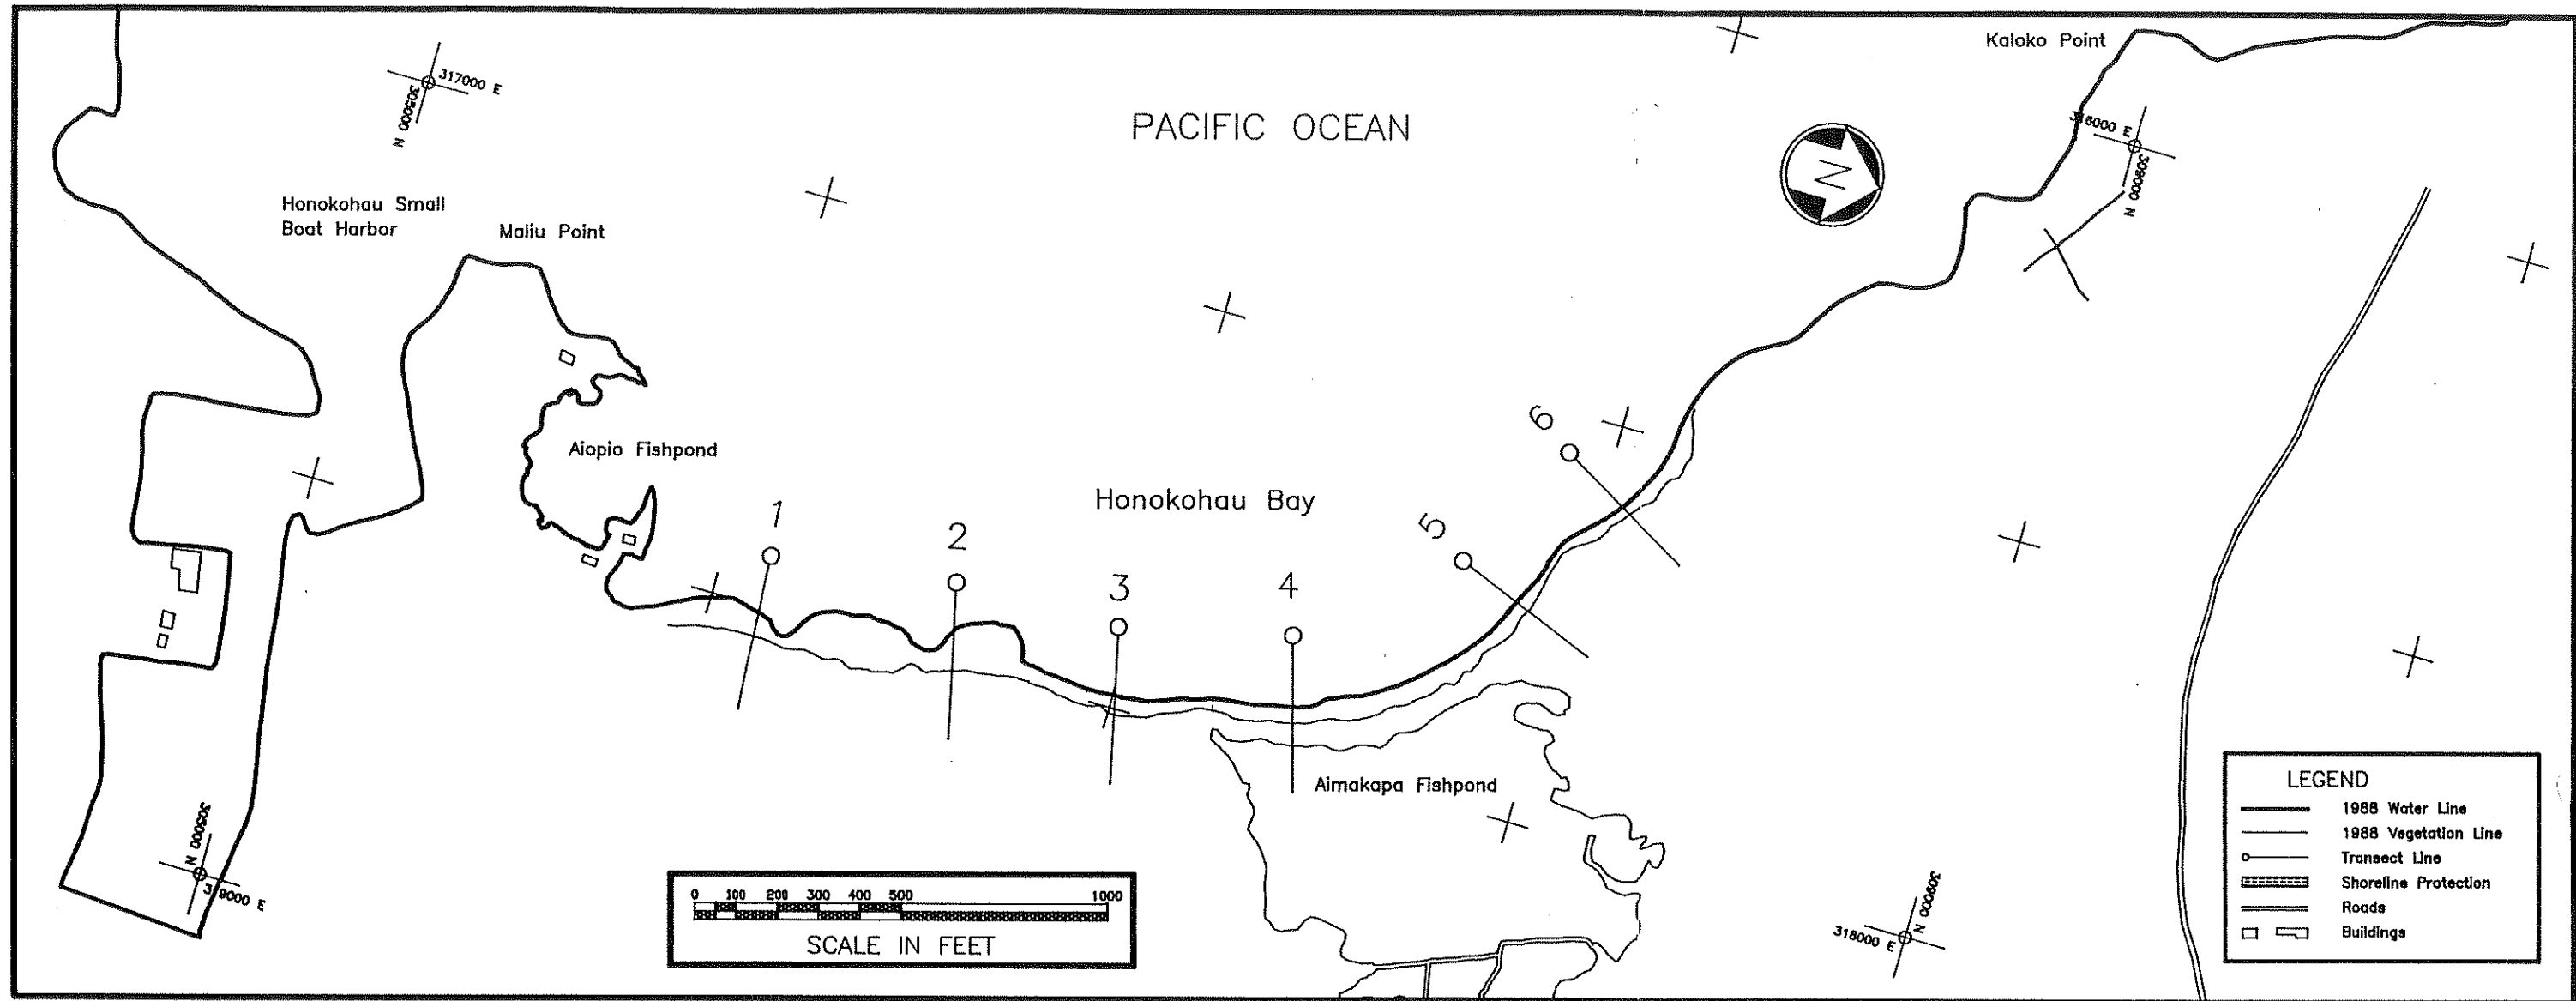
**FIGURE HB-1**

- Honokohau Beach shows signs of a net transport of sand from the widest portion of the beach, located in front of and to the south of Aimakapa Fishpond, to the north and to the south. This point is known as a nodal point and should show evidence of erosion.
- The construction of Honokohau Small Boat Harbor in the 1970's appears to have had no influence on Honokohau Beach. Aiopio Fishpond, located just north, limited the impact the harbor had on the beach.
- The vegetation line was clear and easily identifiable in all years. The standard deviation was also low, making the results very accurate.

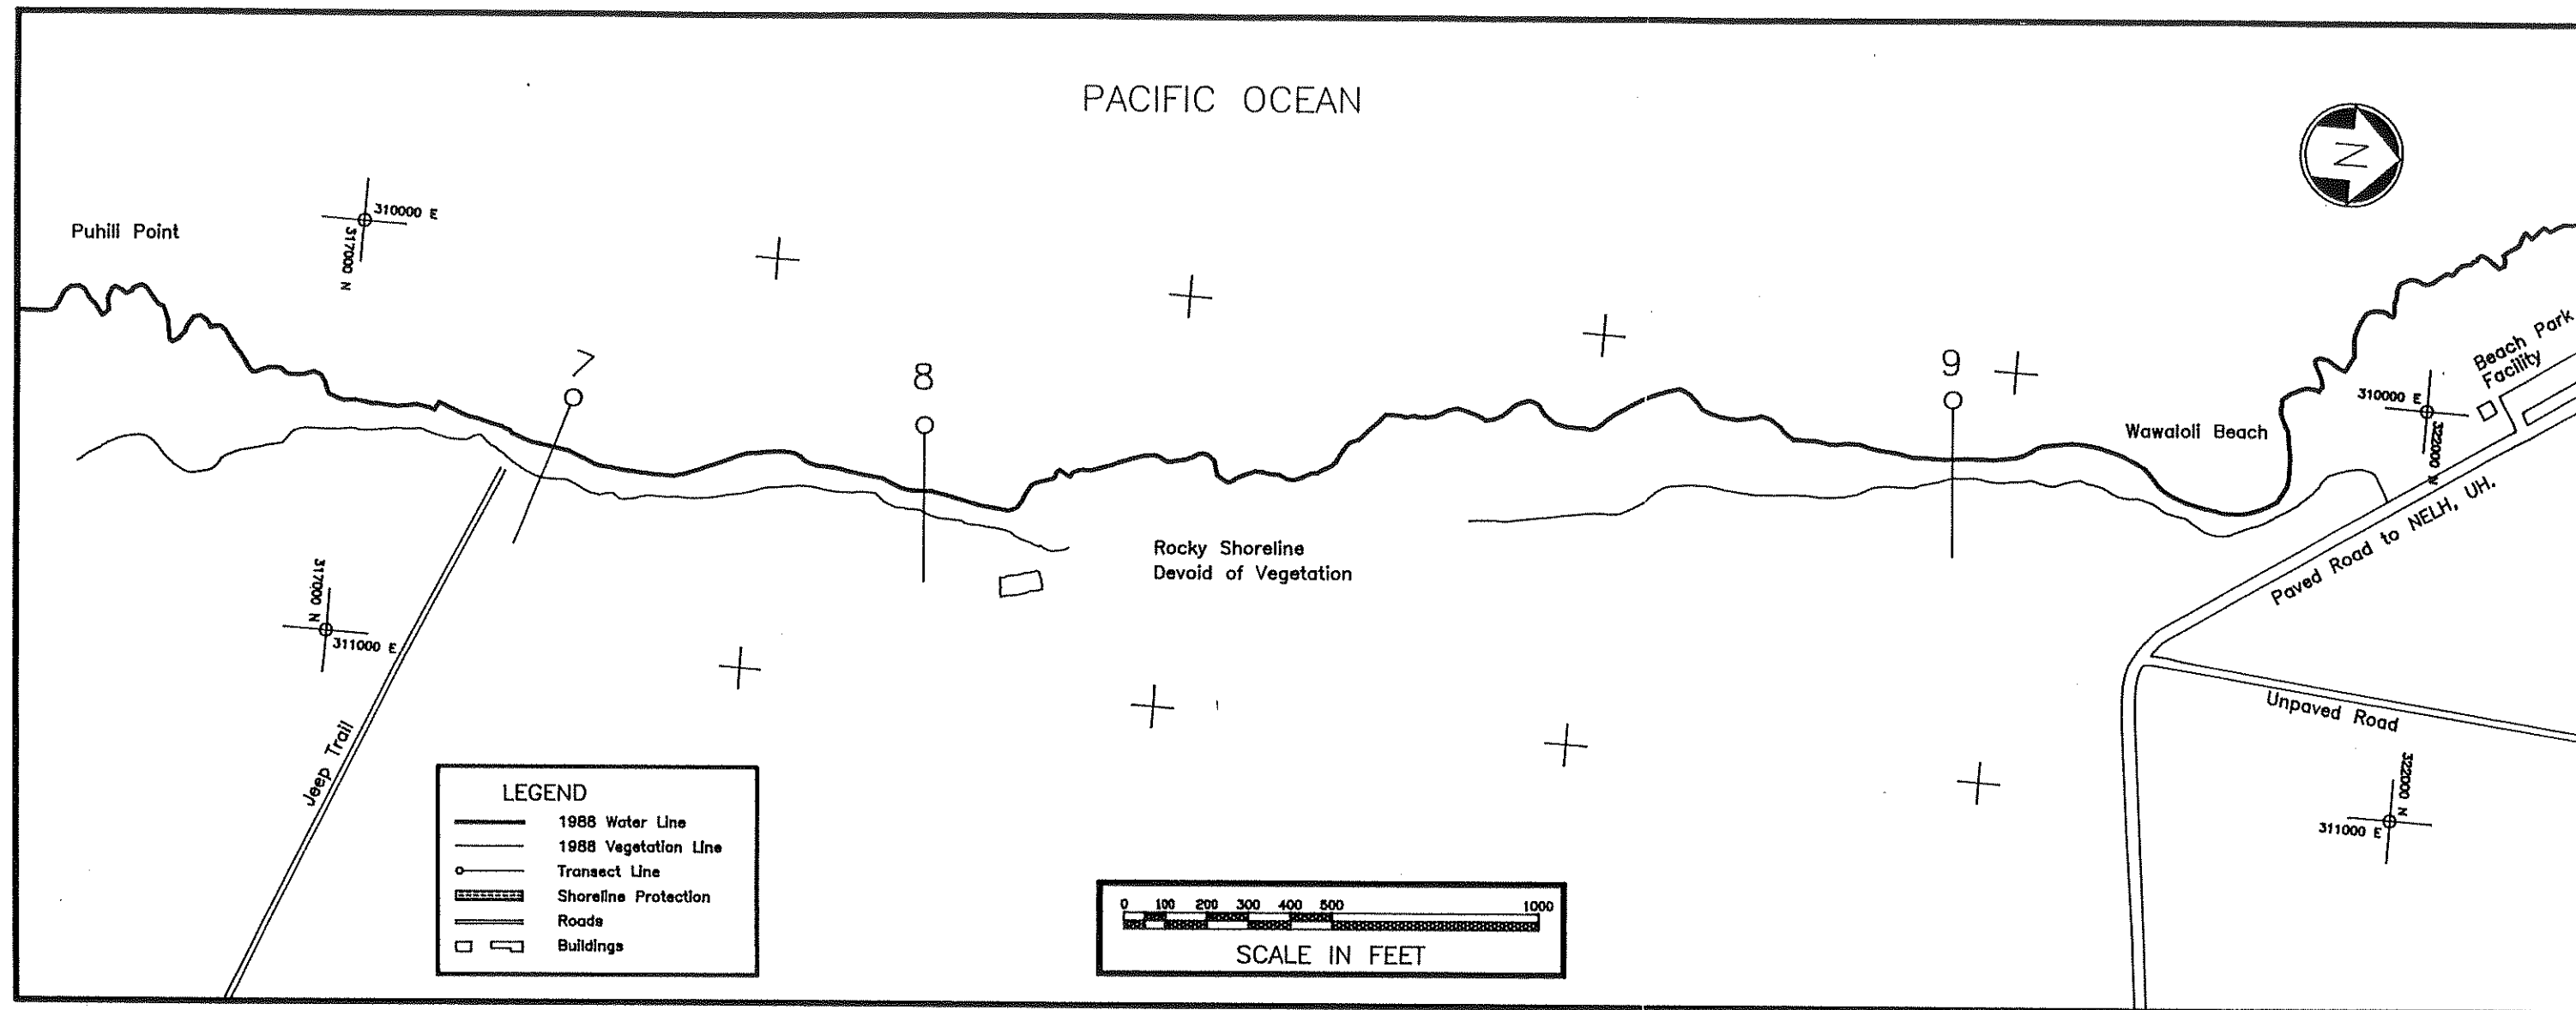
FIGURE HB-2

- Region 9 shows no significant change.
- The vegetation line in front of Wawaloli Beach has moved approximately 120 feet landward since 1950. This change appears to have been caused by the formation of a small tidal pond after 1961. Thus, the changes in the vegetation line are man-made and not caused by littoral processes.

- Almost the entire subsector can be classified as a perched beach. The rock shelf eliminates the day to day changes in the sandy shoreline and stabilizes the location of the waterline.
- The beach shows sign of generally accreting.

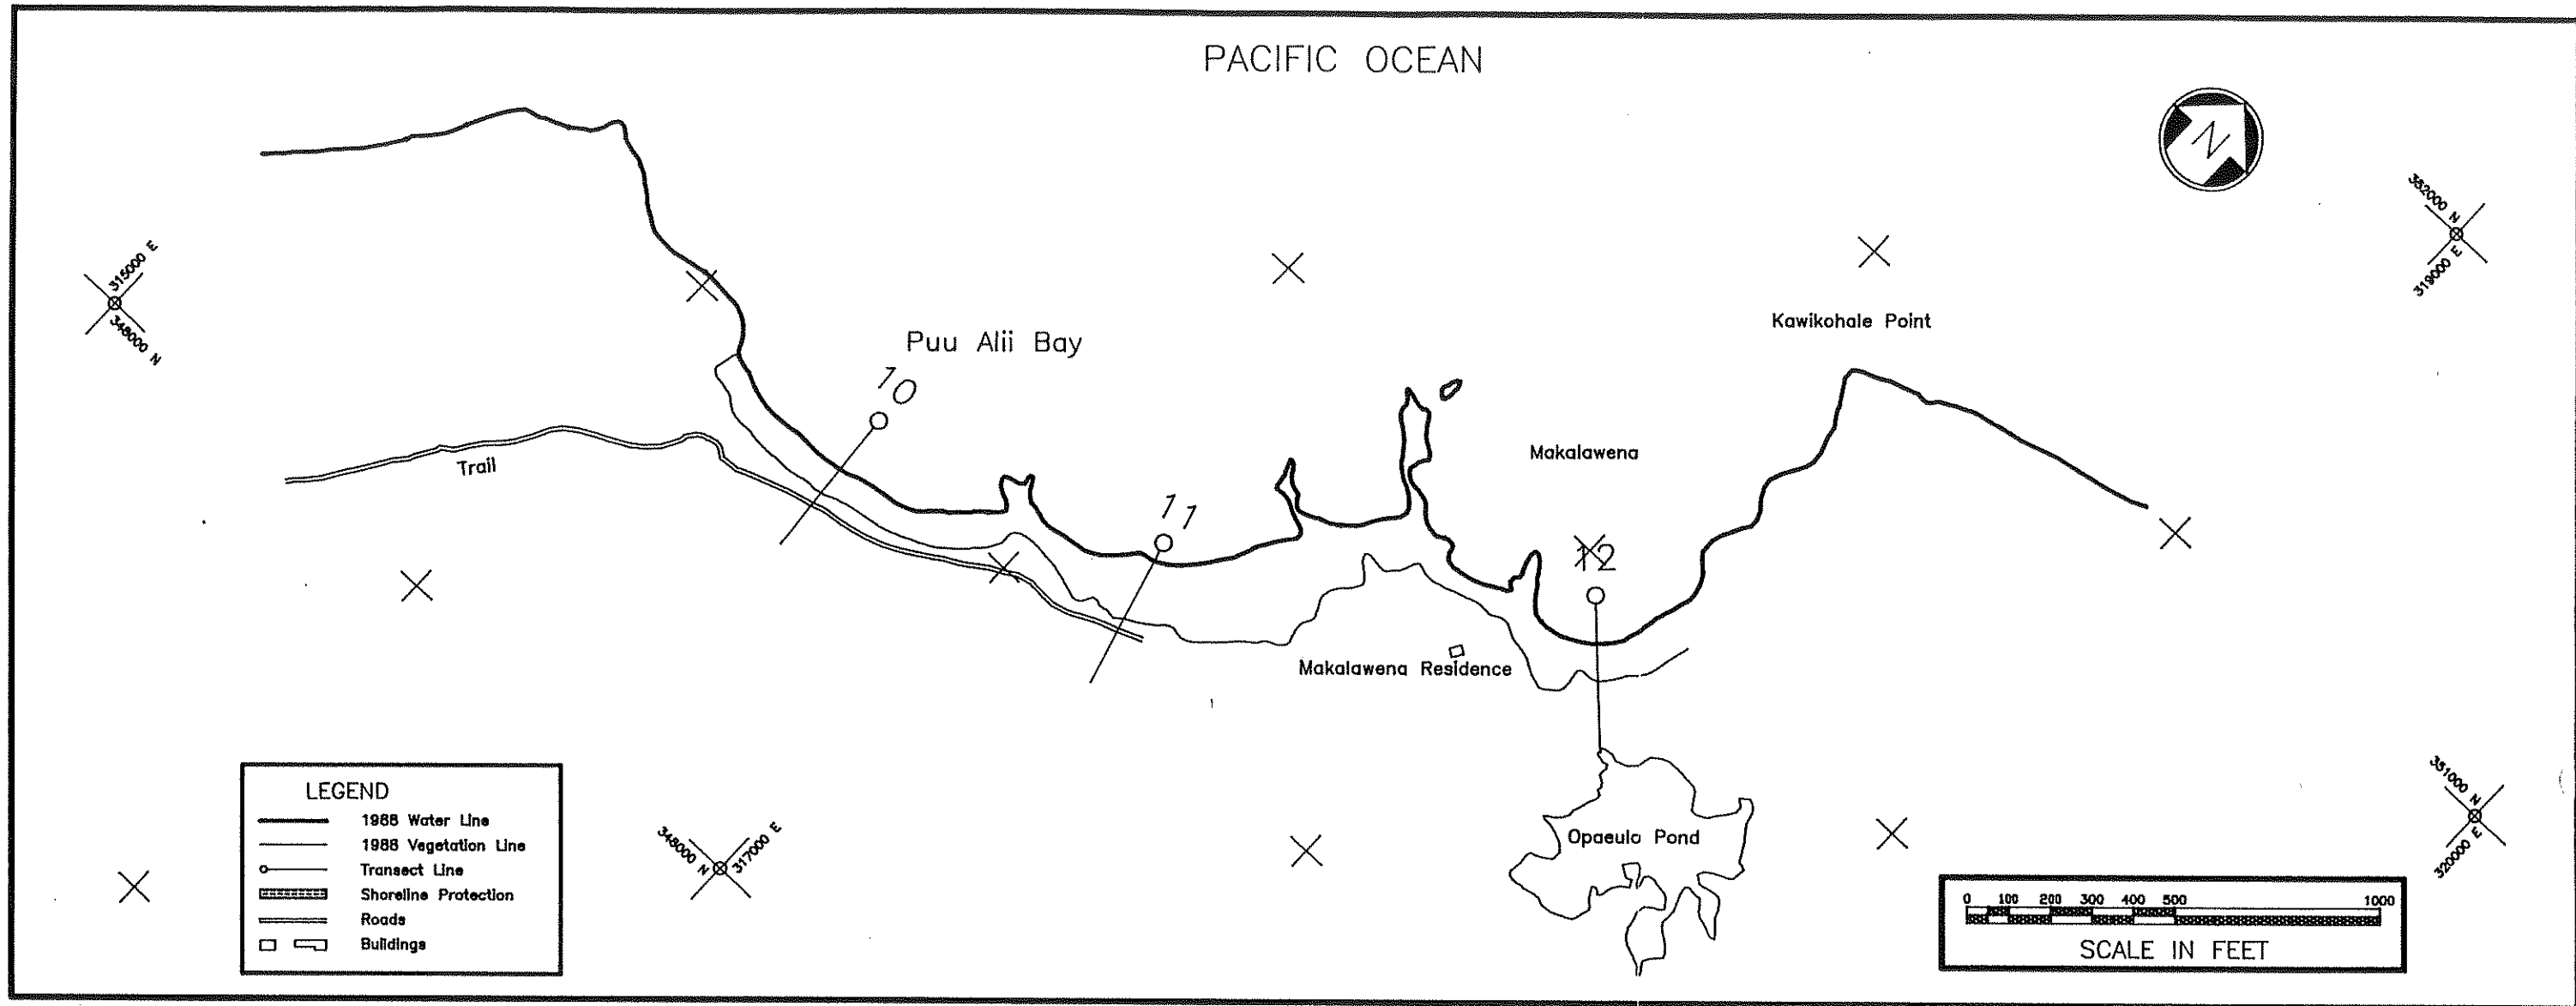
FIGURE HB-3

- There is no indication of a predominate alongshore transport adjacent to the rocky lava points along this subsector.
- There is an overall trend of accretion from 1950 to 1960, followed by erosion of the beach from 1960 onward.
- There are small reaches which are accreting, but these are not significant relative to the general trend in the subsector.
- This subsector has a fairly large supply of sand as is evident by the sand dunes present at the south end of the site.

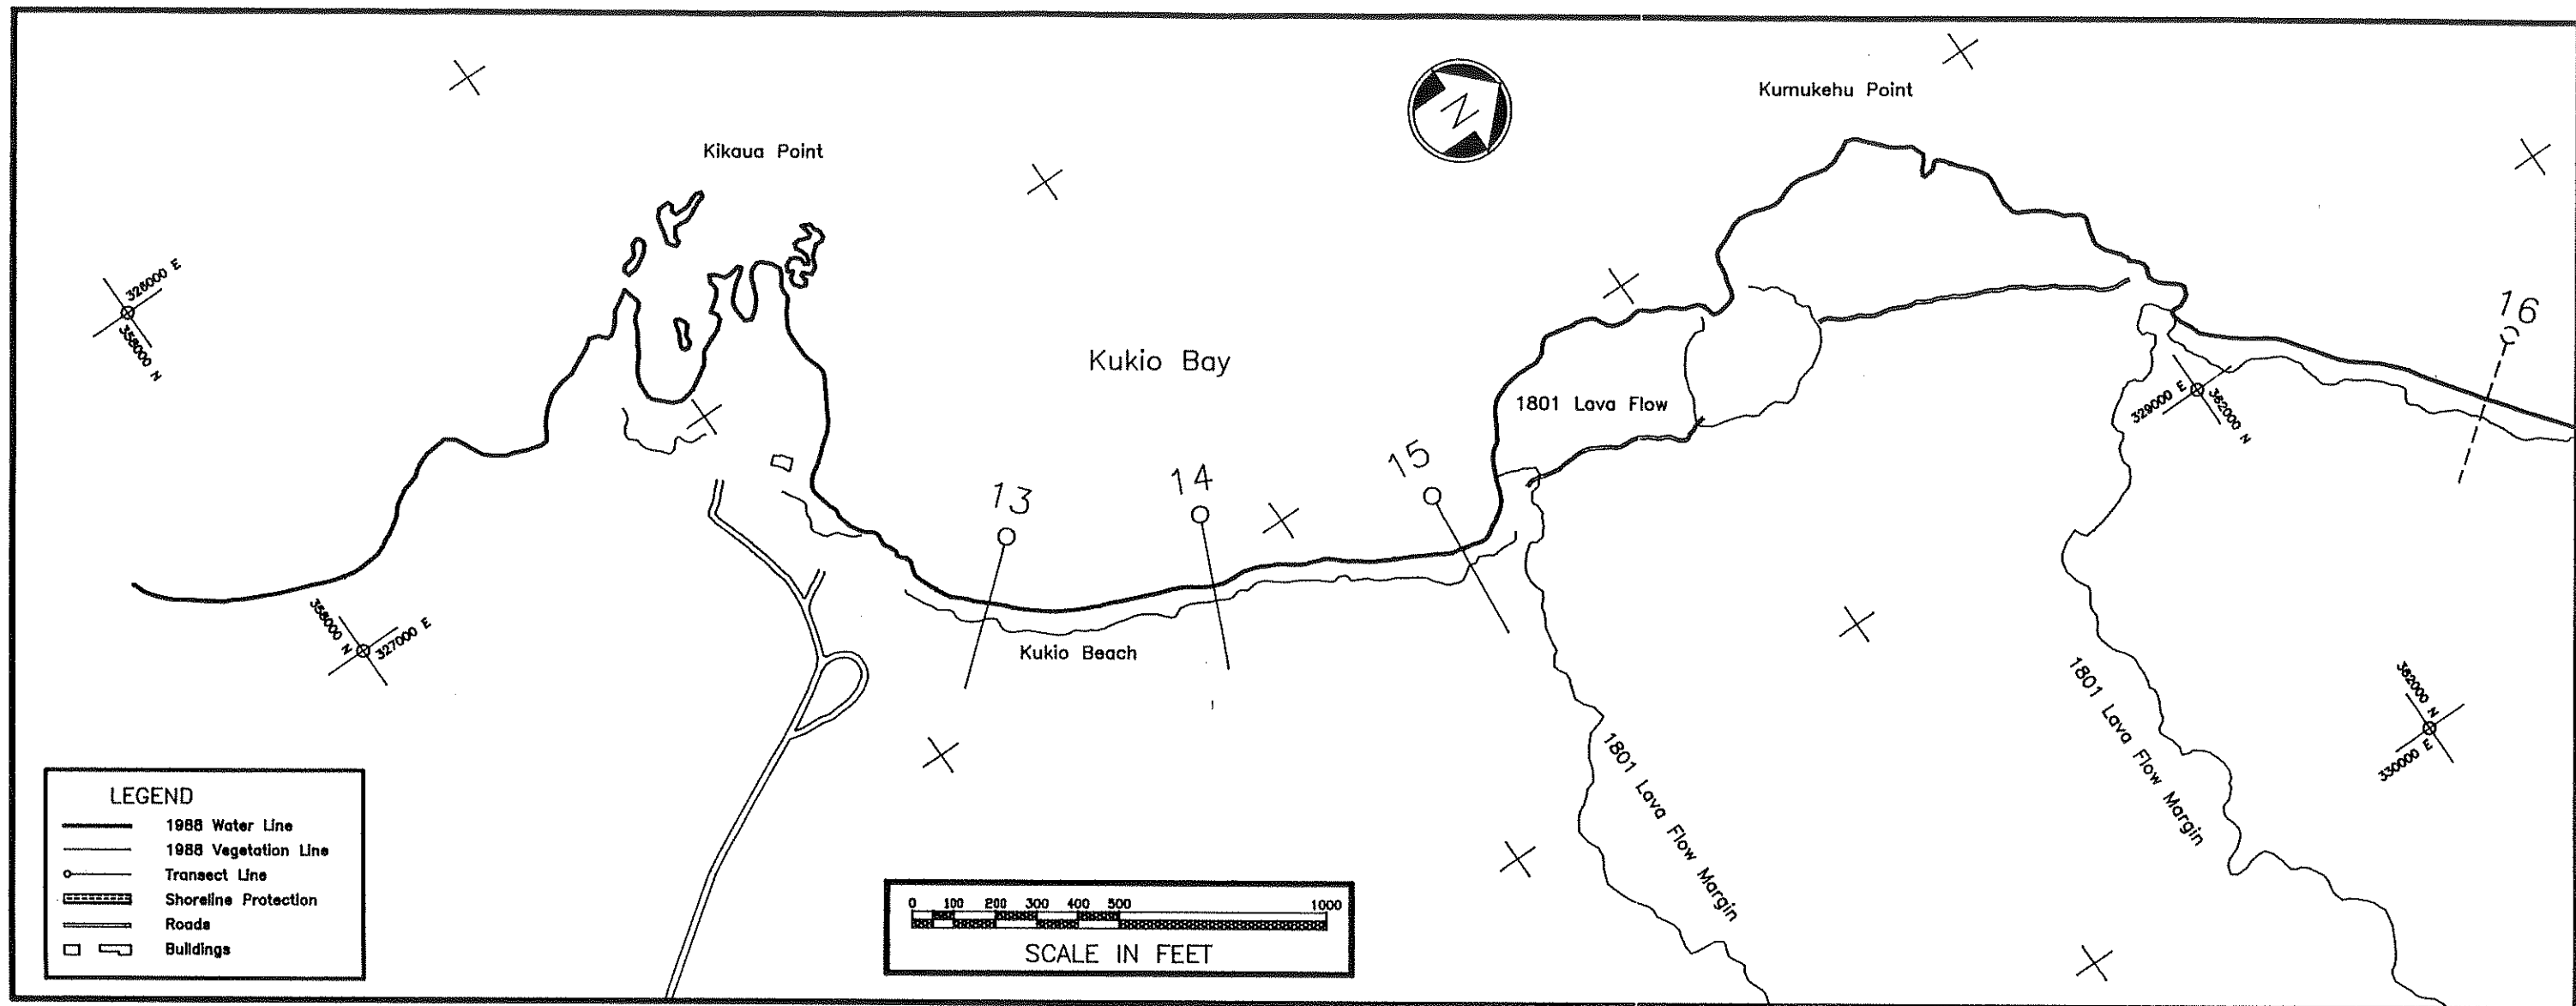
**FIGURE HB-4**

- This subsector shows evidence of alongshore sediment transport and corresponding changes in the vegetation line. The rock bench limits the wave energy reaching the shoreline, but there appears to be a net sediment transport to the north. Region 15 is accreting, and Region 13 is eroding.

- The limestone bench present along the shoreline stabilizes the location of the waterline. Unlike an unprotected sandy shoreline, a landward migration of the vegetation line does not necessarily indicate erosion. On a sandy shoreline erosion of the vegetation line is usually preceded by a net landward movement of the waterline. Widening of the sandy area located landward of the rocky bench is indicative of either more sand being tossed onto the beach or recent storm damage. Changes in the vegetation line could also be indicative of stressed vegetation. Lack of rainfall is one condition that could cause a change in the vegetation line.

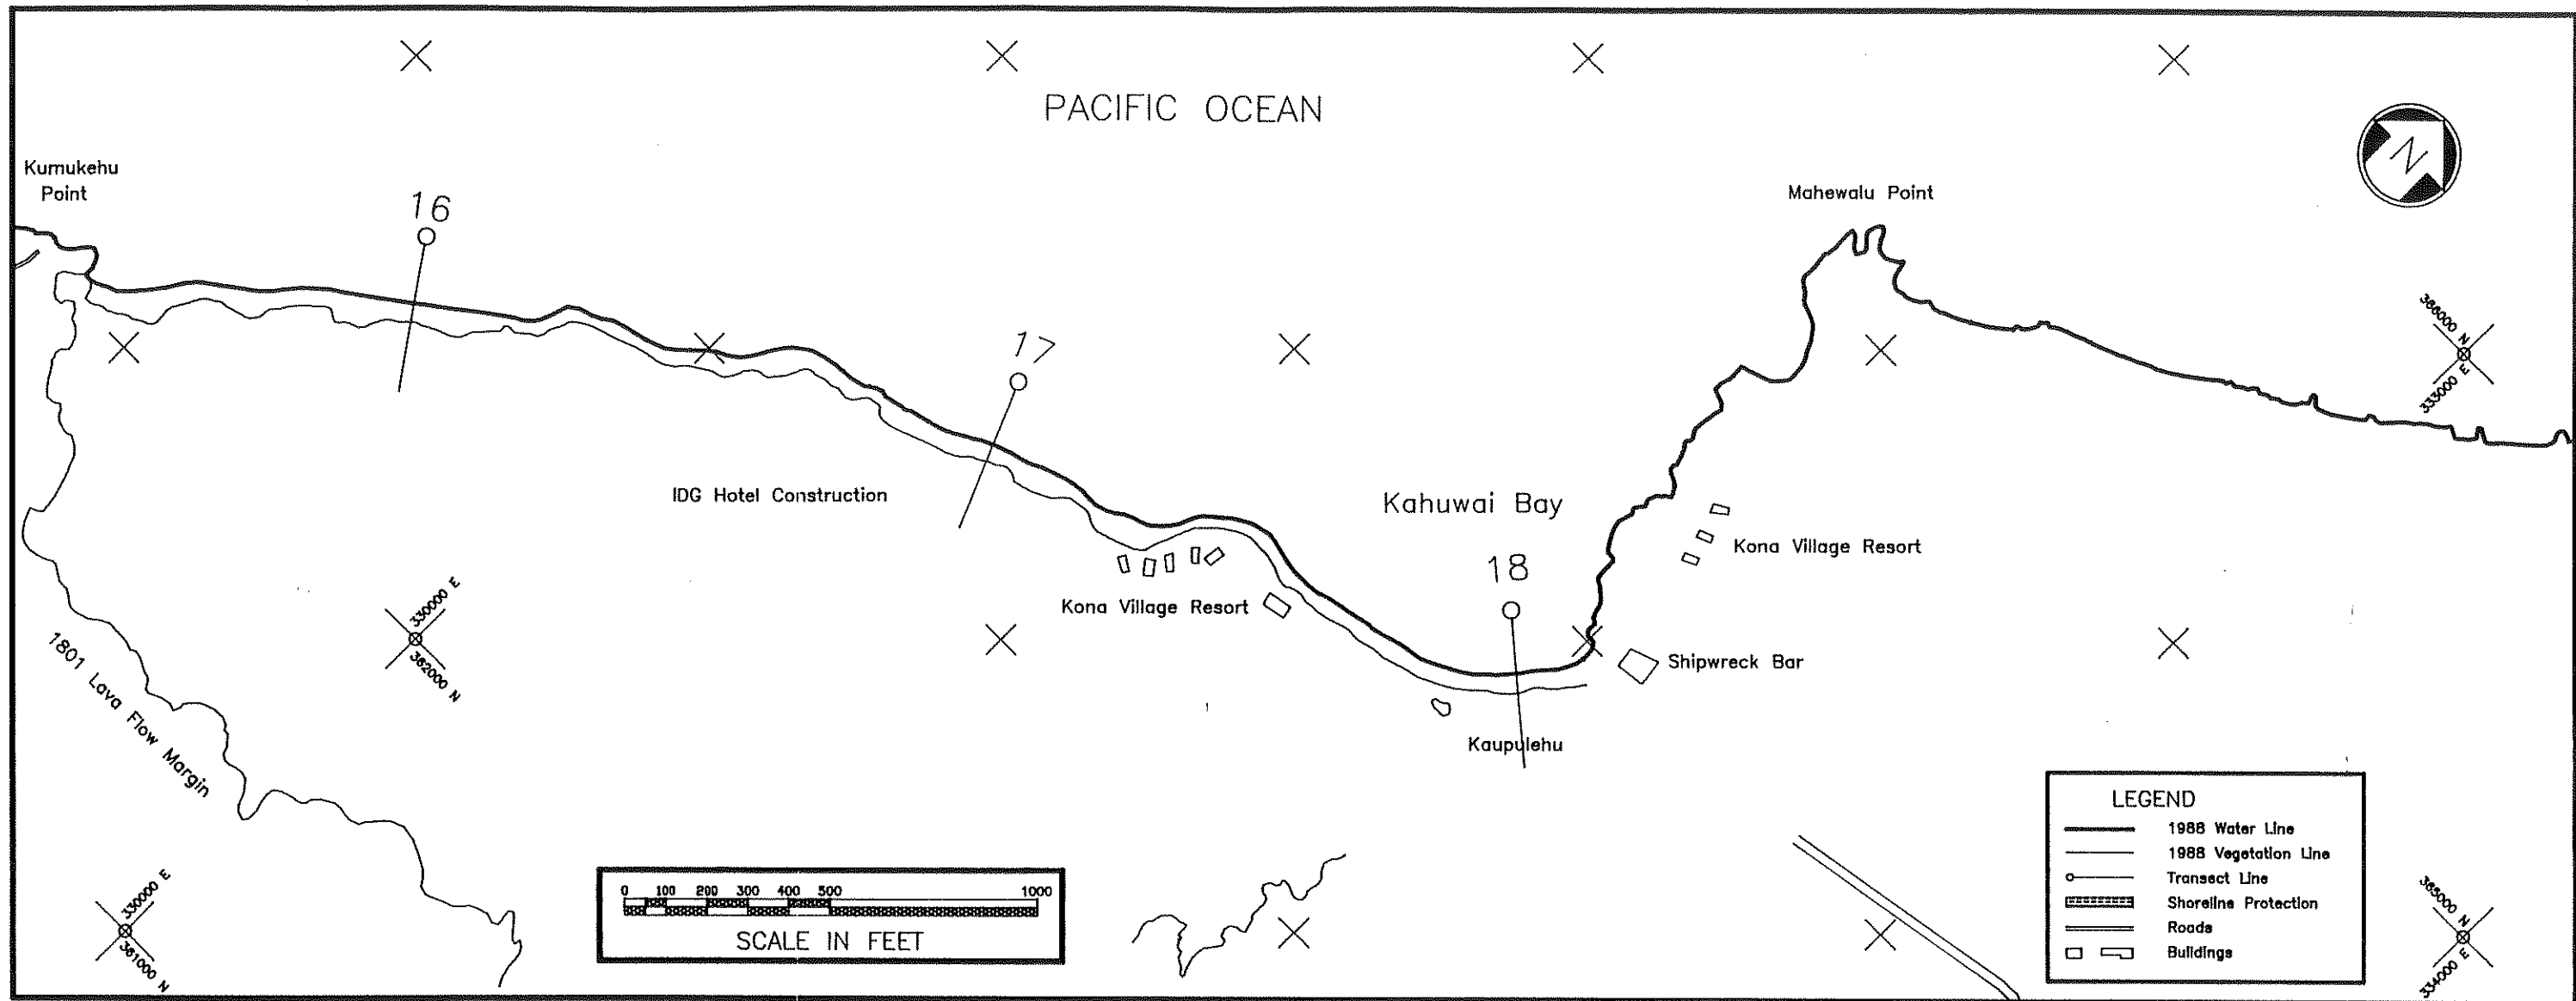
**FIGURE HB-5**

- Kaupulehu Beach can be divided into three categories. The beach located at the south end of the subsector is characterized by a 50 foot wide beach subject to typical littoral processes with a submerged rock bench offshore. This area shows both erosion and accretion in certain areas, but tends towards a slightly eroding beach.
- The rock bench is more pronounced at the center of the subsector and shelters the sandy beach from day to day littoral processes. This is a perched beach with a stable waterline and a vegetation line that is moving landward, causing a widening of the beach.
- The sandy areas in front of Kahuwai Bay makes up the third category. It is an unprotected beach that has accreted slightly since 1967.
