# Update on Water Resources in the Lahaina Aquifer Sector Area

## Agenda Item B-2

### a. Wells in the Fire-Impacted Area

## Wells Inspected on CWRM Site Visit on October 17, 2023

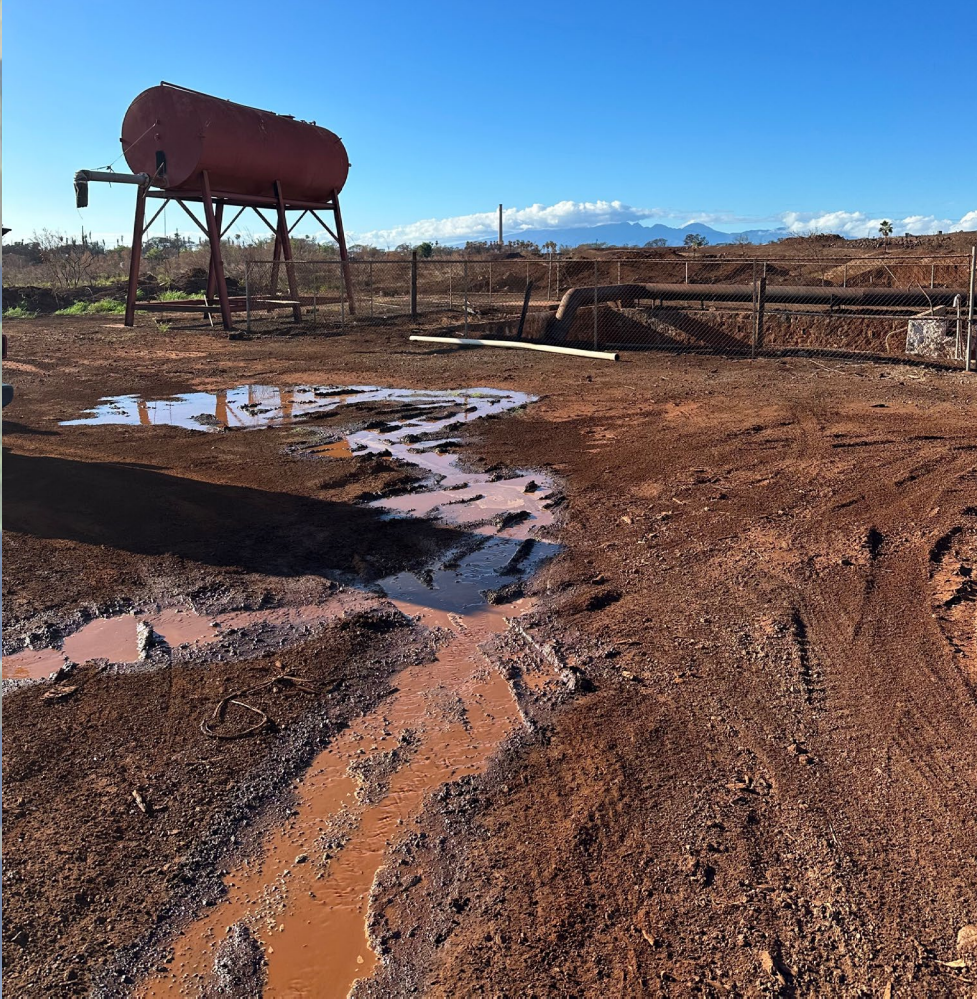
## Lahaina Shaft A&B

1. While the potential for a storm event of sufficient intensity to produce sheet flow is low, the open vaults are vulnerable to sheet runoff potentially transporting surface debris and contamination into the vault, and into direct contact with ground water.
2. Low soil berms should be placed on the mauka, north, and south sides of both vaults to direct runoff away from the vaults.
