Assessment Report

State of Hawai'i, Department of Land & Natural Resources, Land Division

Assess Banyan Drive Properties

Prepared by Erskine Architects, Inc.

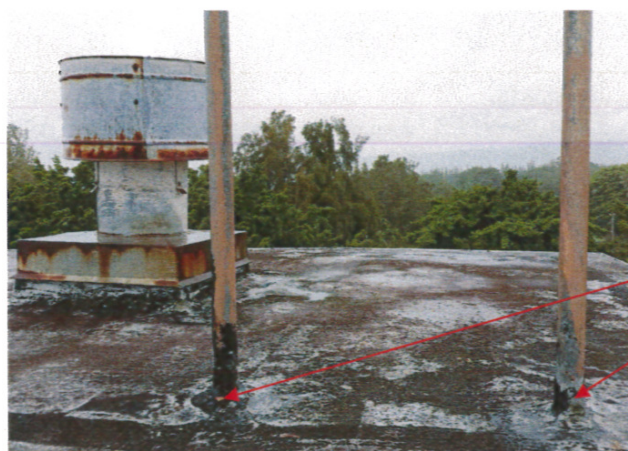
Photograph 1: Roof, Black Sealant around Metal Handrail

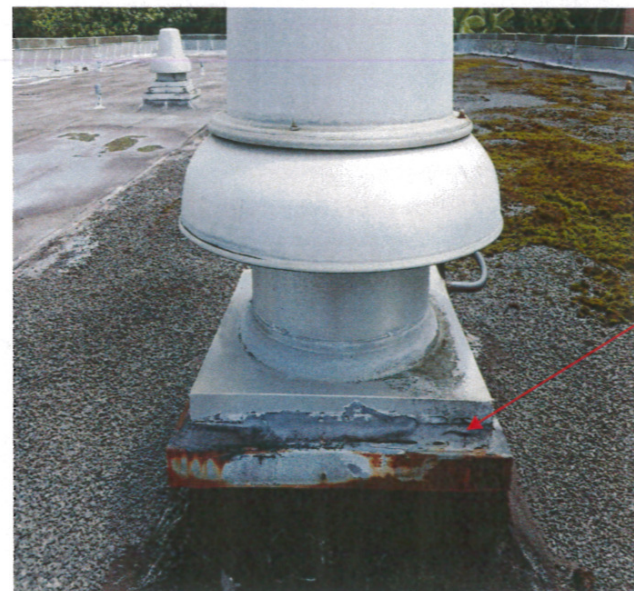
Photograph 19: Gray Exhaust Vent Caulking
