STATE OF HAWAII
DEPARTMENT OF LAND AND NATURAL RESOURCES
COMMISSION ON WATER RESOURCE MANAGEMENT
 Stream Protection and Management Branch

FIELD INVESTIGATION REPORT

FI2008102703 (East Maui, Honopou Haiku Ditch, restore)

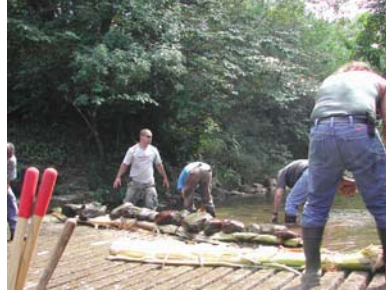
20081027013.JPG

Image Listing:	(Attach PDF of image contact sheet)		
File Name:	Brief Description:		
20081027013	EMI staff building a berm wall at Haiku Ditch on Honopou Stream by first placing banana leaves on the ditch grating structure.		
20081027015	EMI staff building a berm wall at Haiku Ditch on Honopou Stream.		
20081027017	EMI staff building a berm wall at Haiku Ditch on Honopou Stream.		
20081027018	EMI staff building a berm wall at Haiku Ditch on Honopou Stream.		
20081027020	Sanford Kekahuna helping EMI staff to gather boulders for building a berm wall at Haiku Ditch on Honopou Stream.		
20081027021	EMI staff building a berm wall at Haiku Ditch on Honopou Stream.		
20081027025	EMI staff building a berm wall at Haiku Ditch on Honopou Stream.		
20081027031	Completed berm wall at Haiku Ditch on Honopou Stream.		
20081027033	Completed berm wall at Haiku Ditch on Honopou Stream.		
20081027035	Completed berm wall at Haiku Ditch on Honopou Stream, near the three 4-inch bypass pipes.

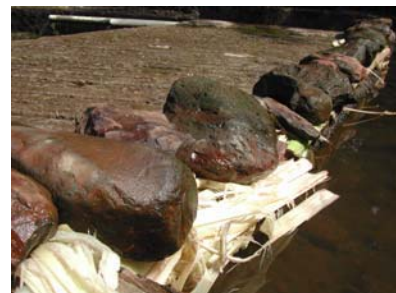
20081027038.JPG

20081027038	Completed berm wall at Haiku Ditch on Honopou Stream.		
20081027039	Completed berm wall at Haiku Ditch on Honopou Stream.		
20081027040	Completed berm wall at Haiku Ditch on Honopou Stream.

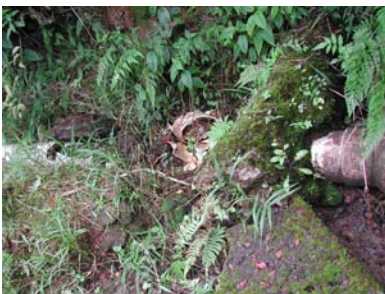
20081209041.JPG

20081209041	Minor diversion on a tributary of Waiokamilo Stream (K-22a). This section of the 6-inch aluminum PVC pipe is broken sever diversion of water from the stream.
20081209042	Minor diversion on a tributary of Waiokamilo Stream (K-22a). A 6-inch aluminum PVC pipe diverts water to a tributary of East Waiokamilo Stream, formerly known as Kualani Stream.
20081209043	Tributary of East Waiokamilo Stream upstream of the Koolau Ditch major diversion #10 intake (K-22).
20081209045	Koolau Ditch major diversion (K-22, #10 intake) on a tributary of East Waiokamilo Stream. Metal grate on the left streambank has been sealed with concrete.
20081209046	Koolau Ditch major diversion (K-22, #10 intake) on a tributary of East Waiokamilo Stream.
20081209047	Koolau Ditch major diversion (K-22, #10 intake) on a tributary of East Waiokamilo Stream.
20081209049	Koolau Ditch major diversion (K-22, #10 intake) on a tributary of East Waiokamilo Stream.

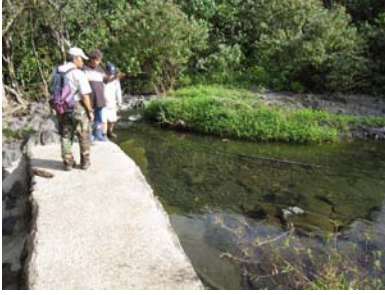
20090210069.jpg

File Name:	Brief Description:
20090210069	Dam 3 on Waiokamilo Stream.
20090210071	Waiokamilo Stream upstream of Dam 3.
20090210072	USGS gaging station gage pool at dam 3 on Waiokamilo Stream.
20090210073	Losing section upstream from Dam 3 on Waiokamilo Stream.
20090210074	Where the stream leaks into the losing section upstream from Dam 3 on Waiokamilo Stream.
20090210083	Waiokamilo Stream upstream of the losing section upstream from Dam 3 on Waiokamilo Stream.
20090210085	Large pond about 400 feet upstream of Dam 3 on Waiokamilo Stream.
20090210090	Location where the large pond (see image 2009021085) flows into two branches of Waiokamilo Stream.
20090210092	Location where the large pond (see image 2009021085) flows into two branches of Waiokamilo Stream.

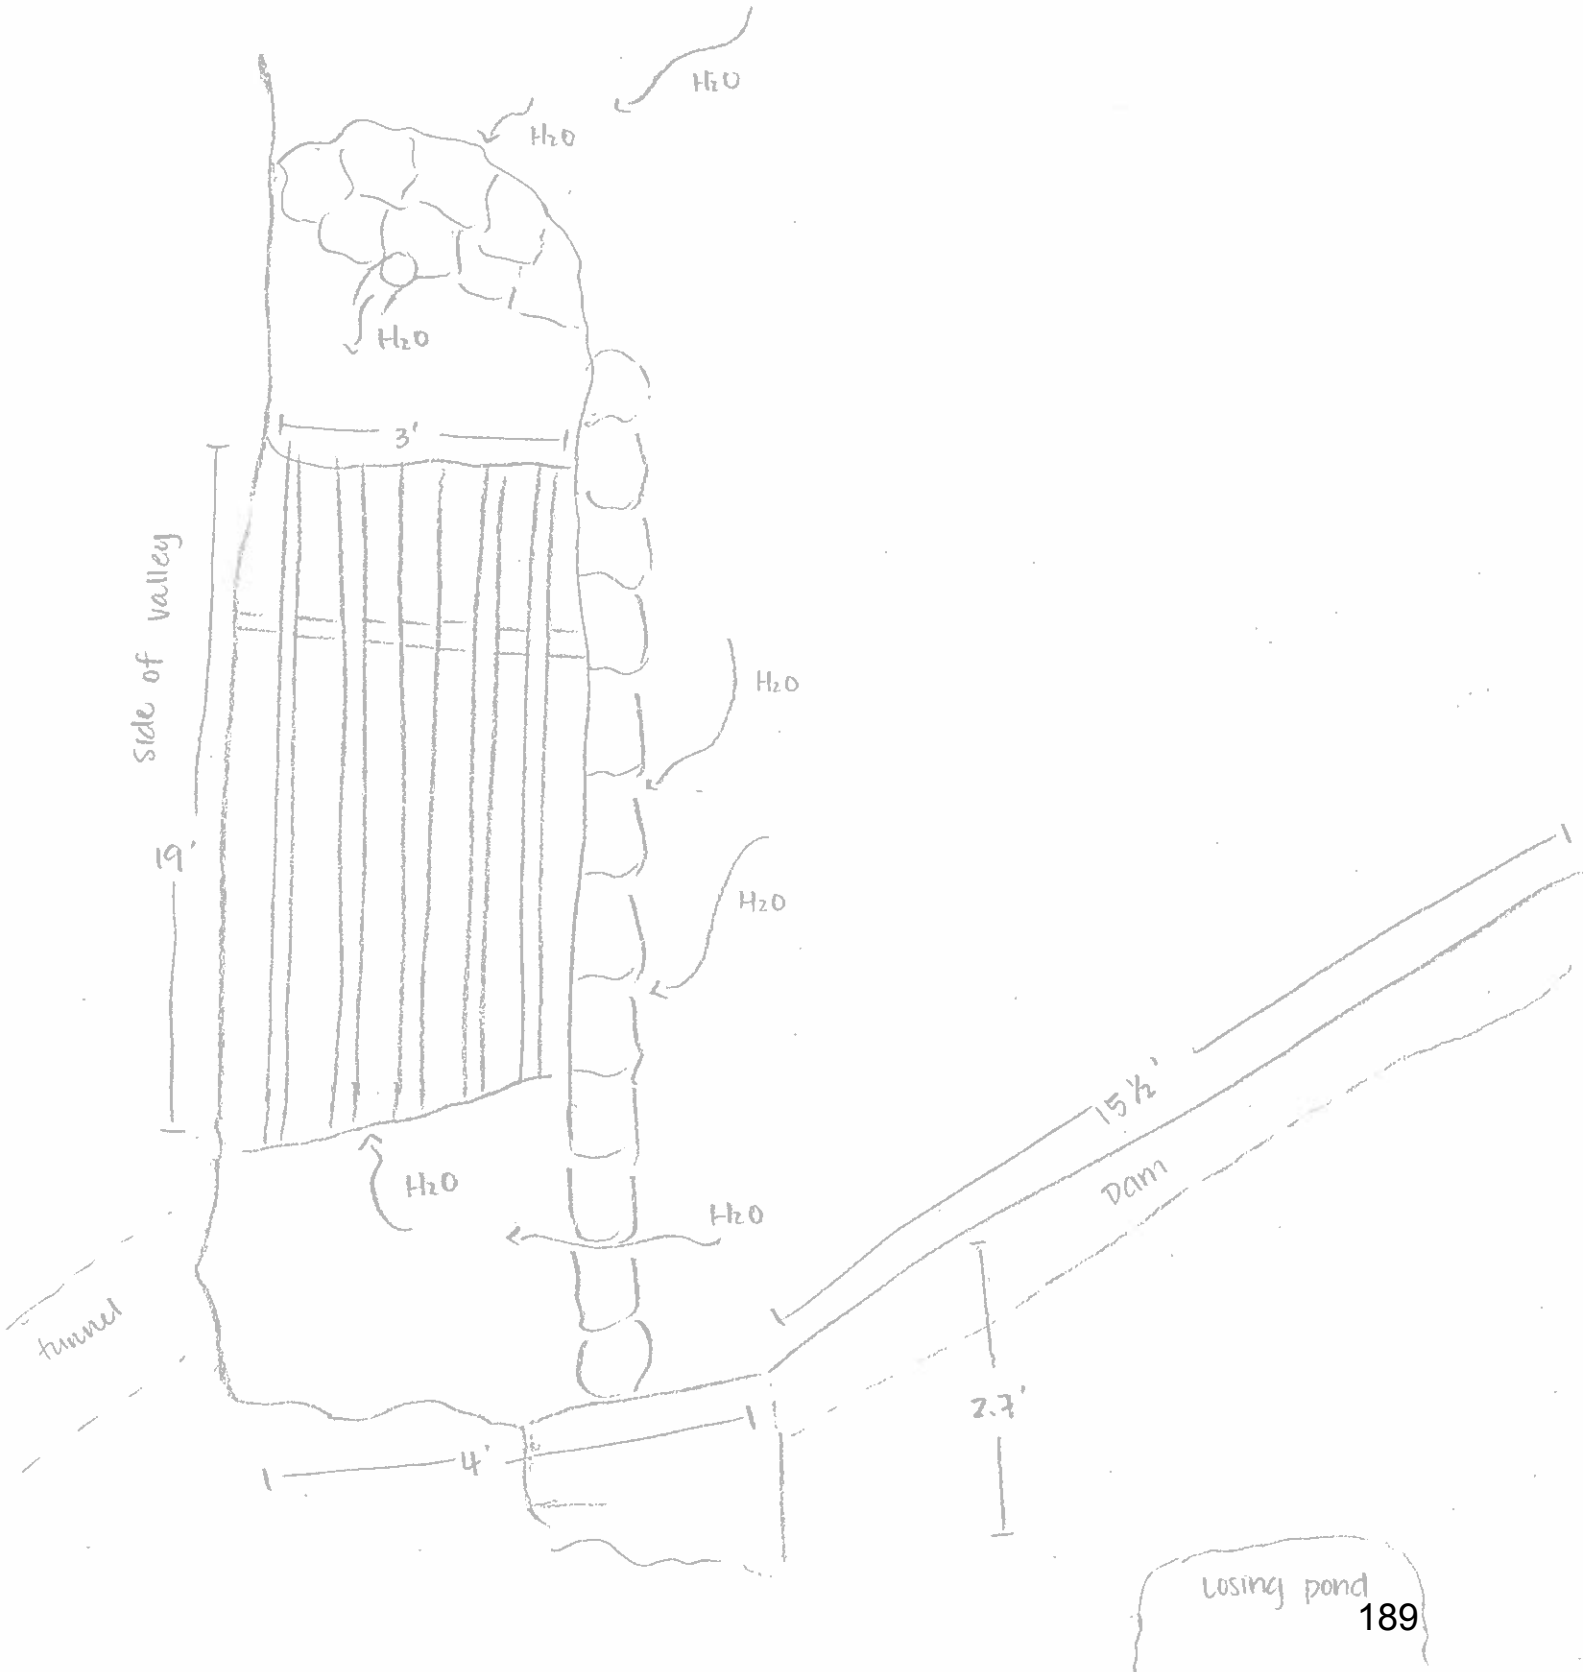
cascading falls (small)

losing pond

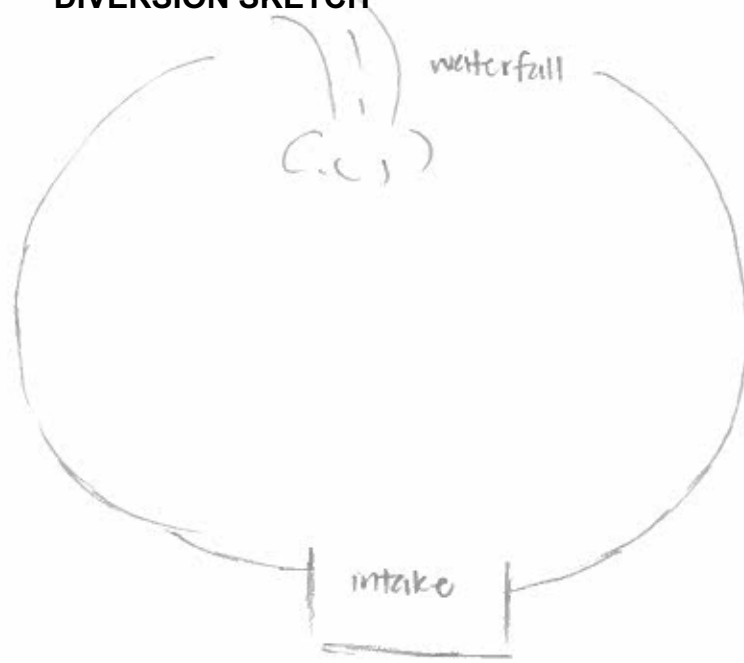
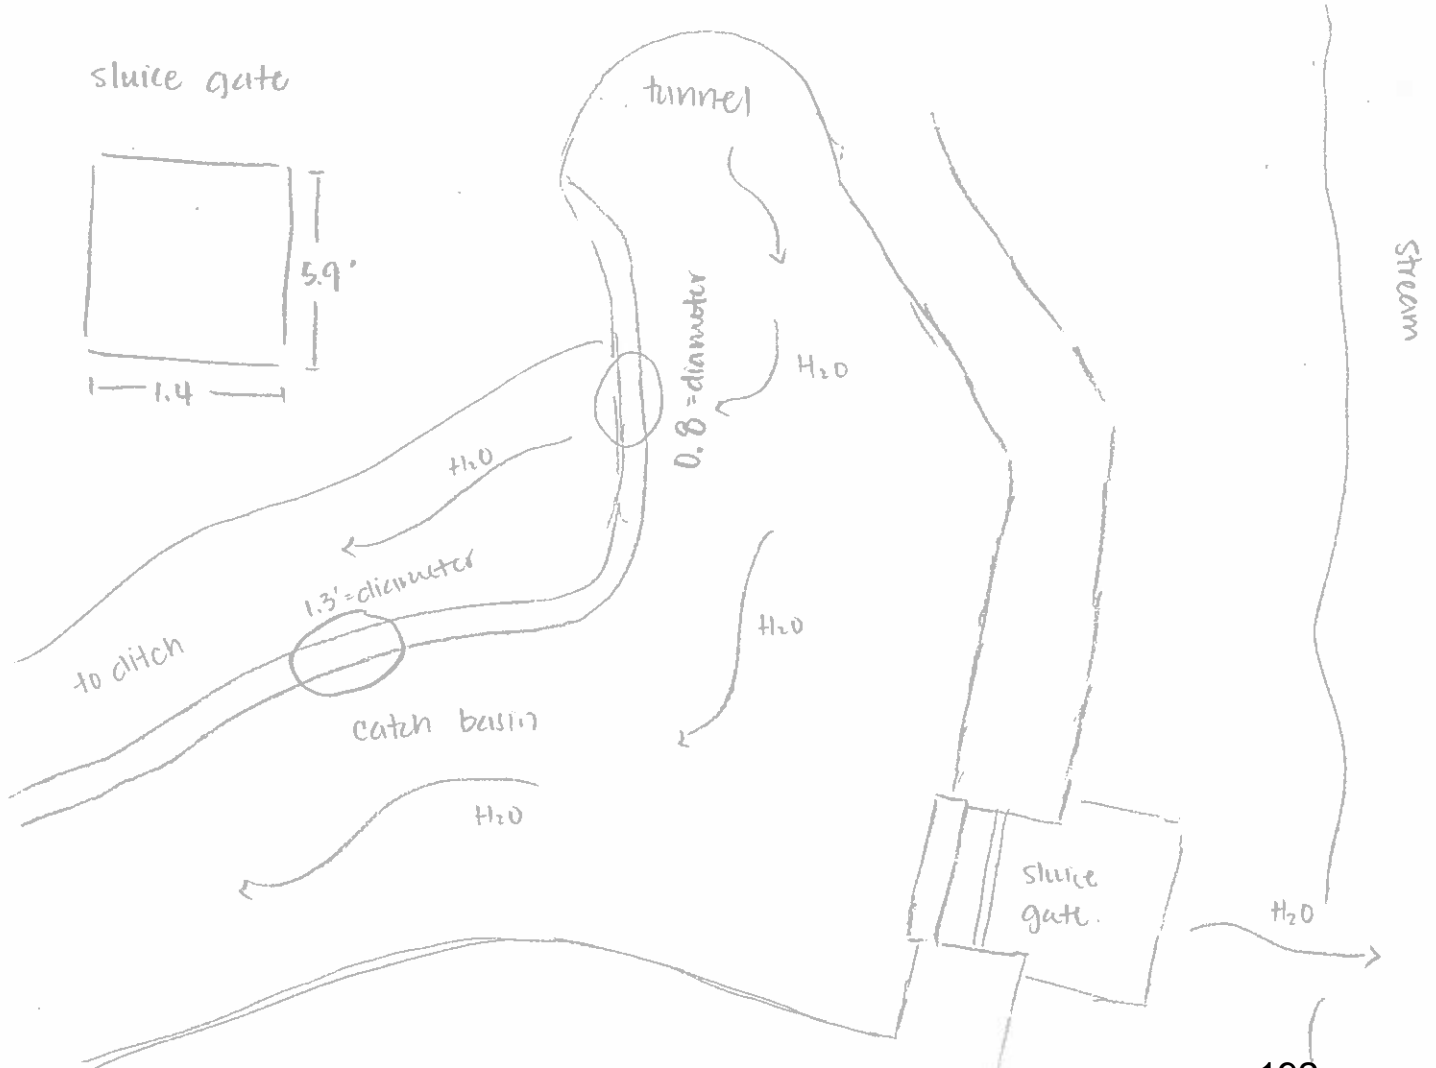
WAIOHUE

intake grate

x tunnel

sluice gate

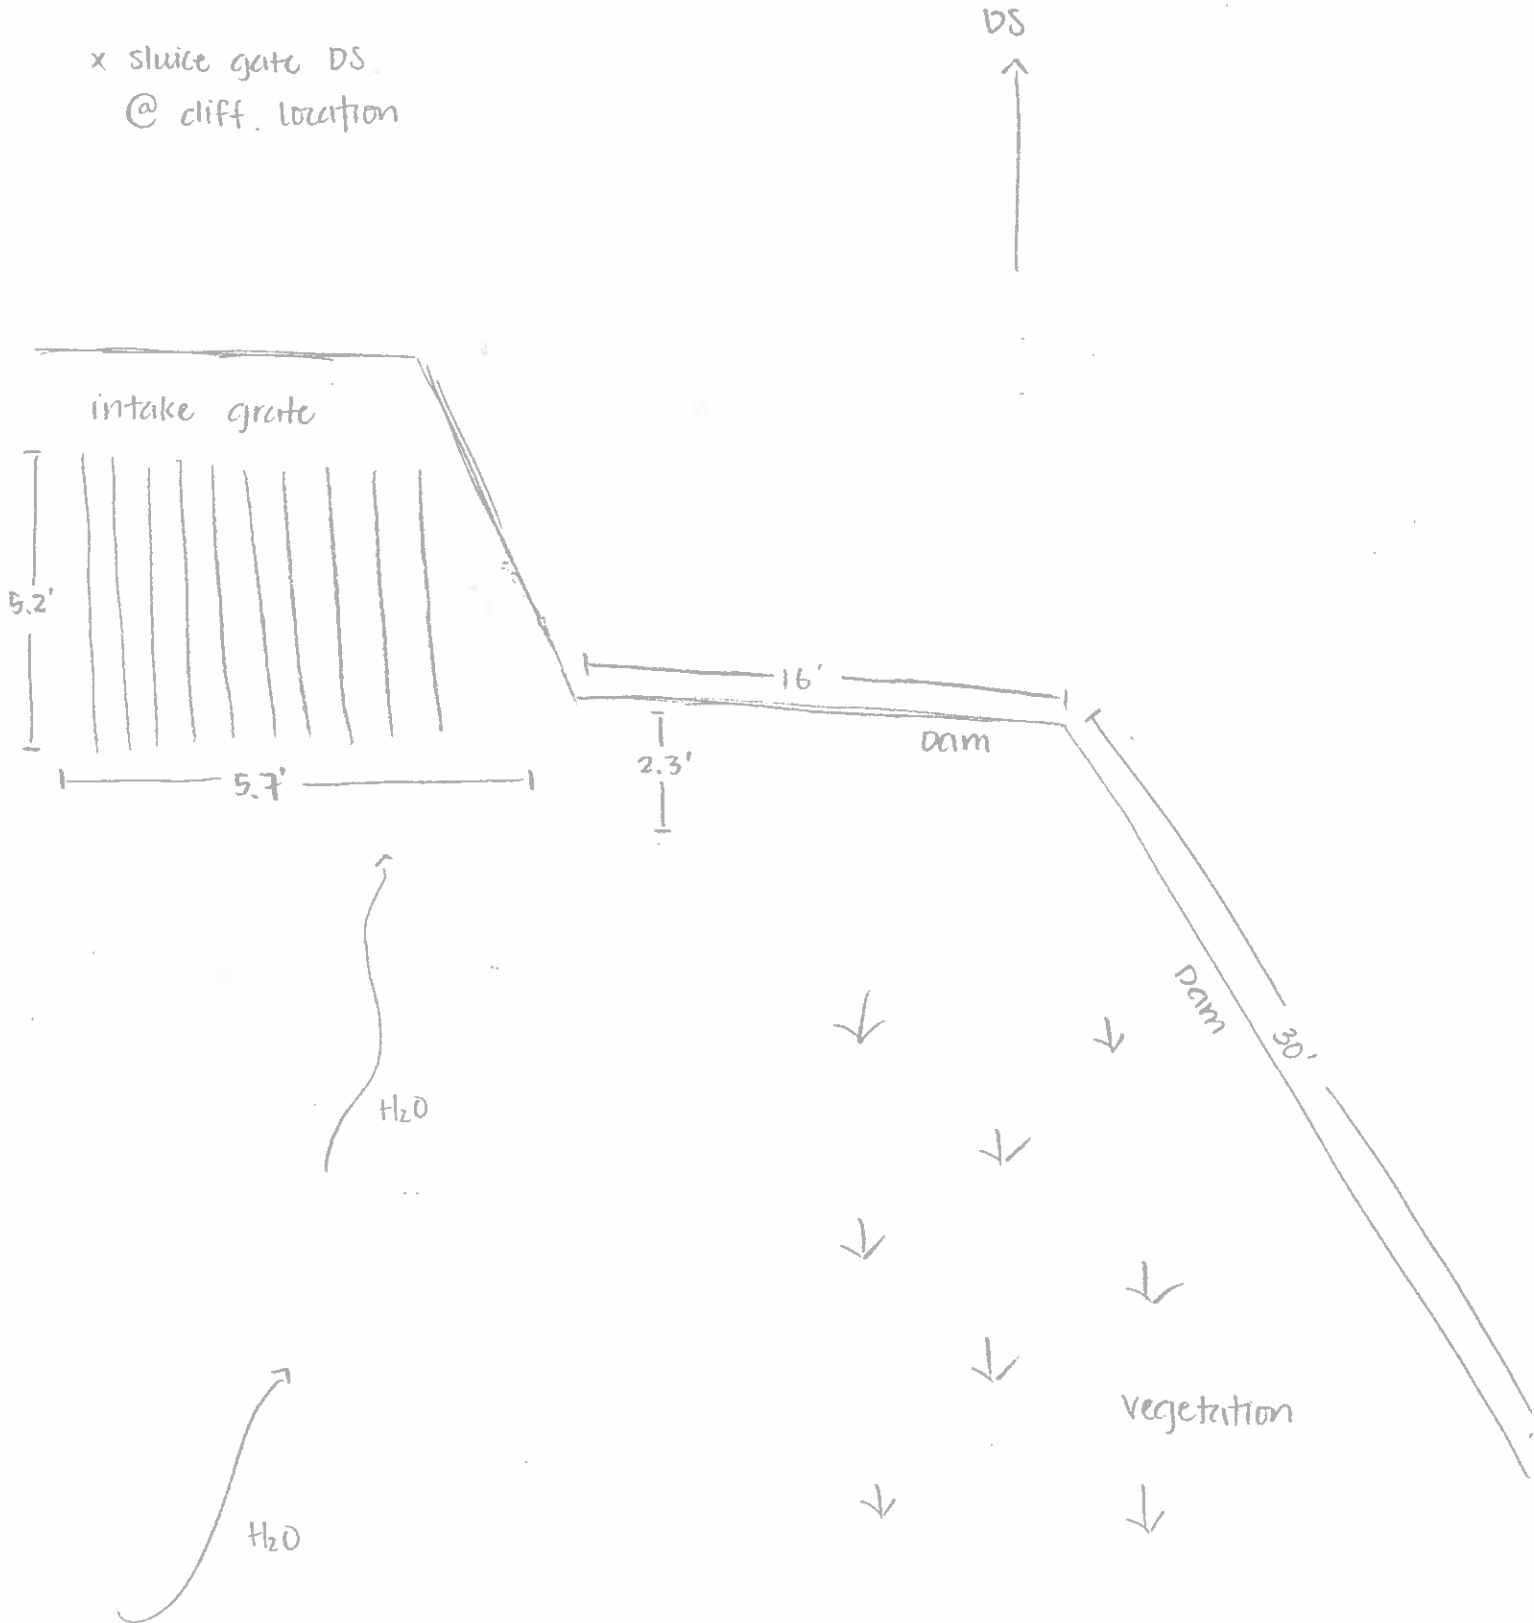
PUAKAA

x sluice gate DS.
@ cliff location

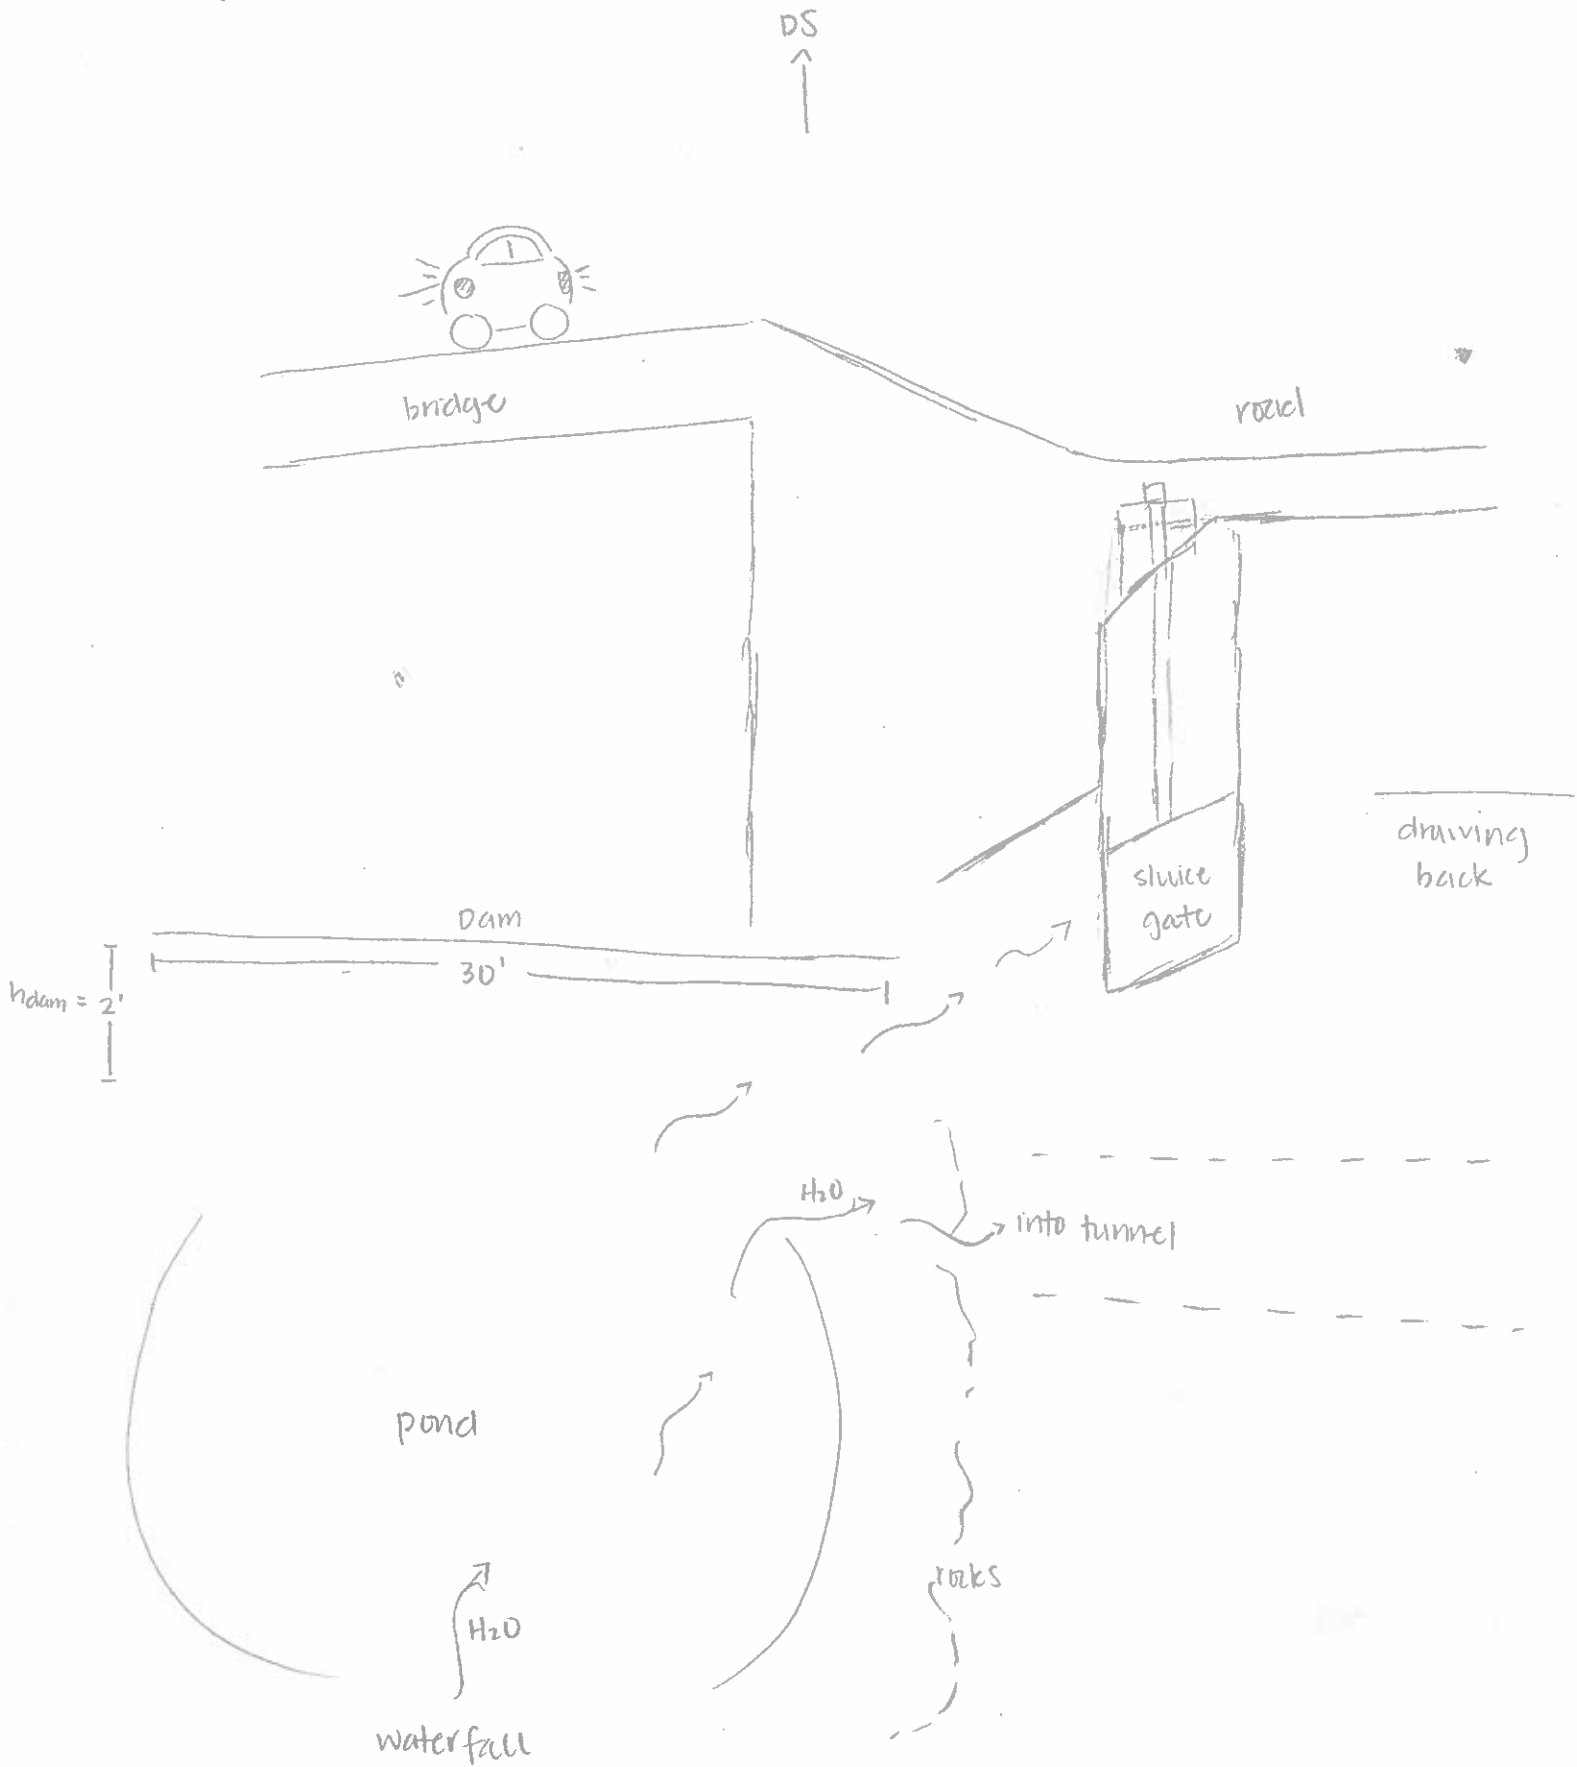
WEST WAILUAIKI

x waterfall downstream of bridge.

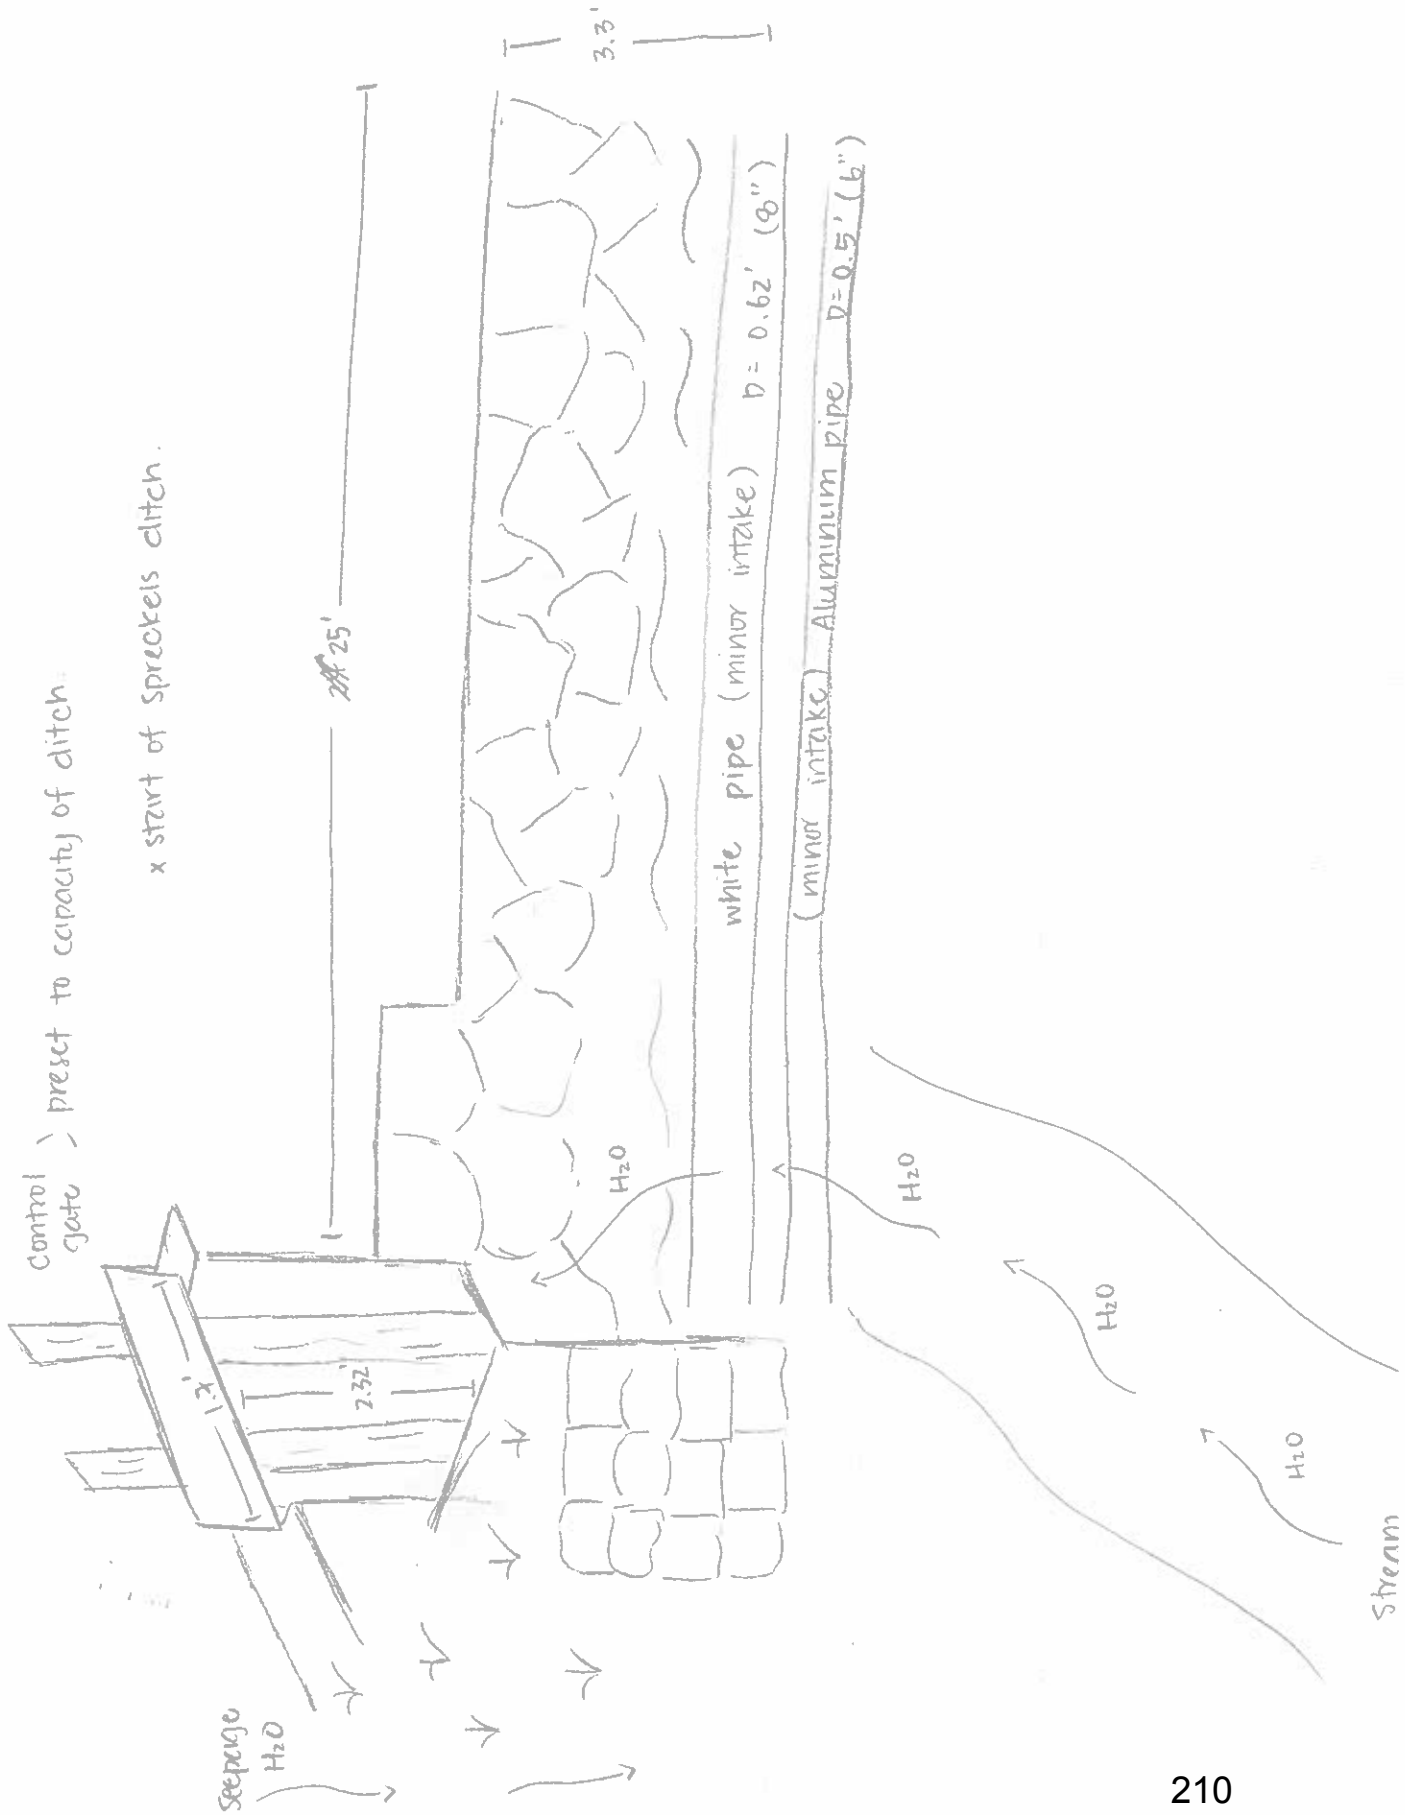
NUAAILUA (spreckels Ditch)

HONOMANU (Banana Intake) x top view

x sluice gate behind me

x intake behind me.

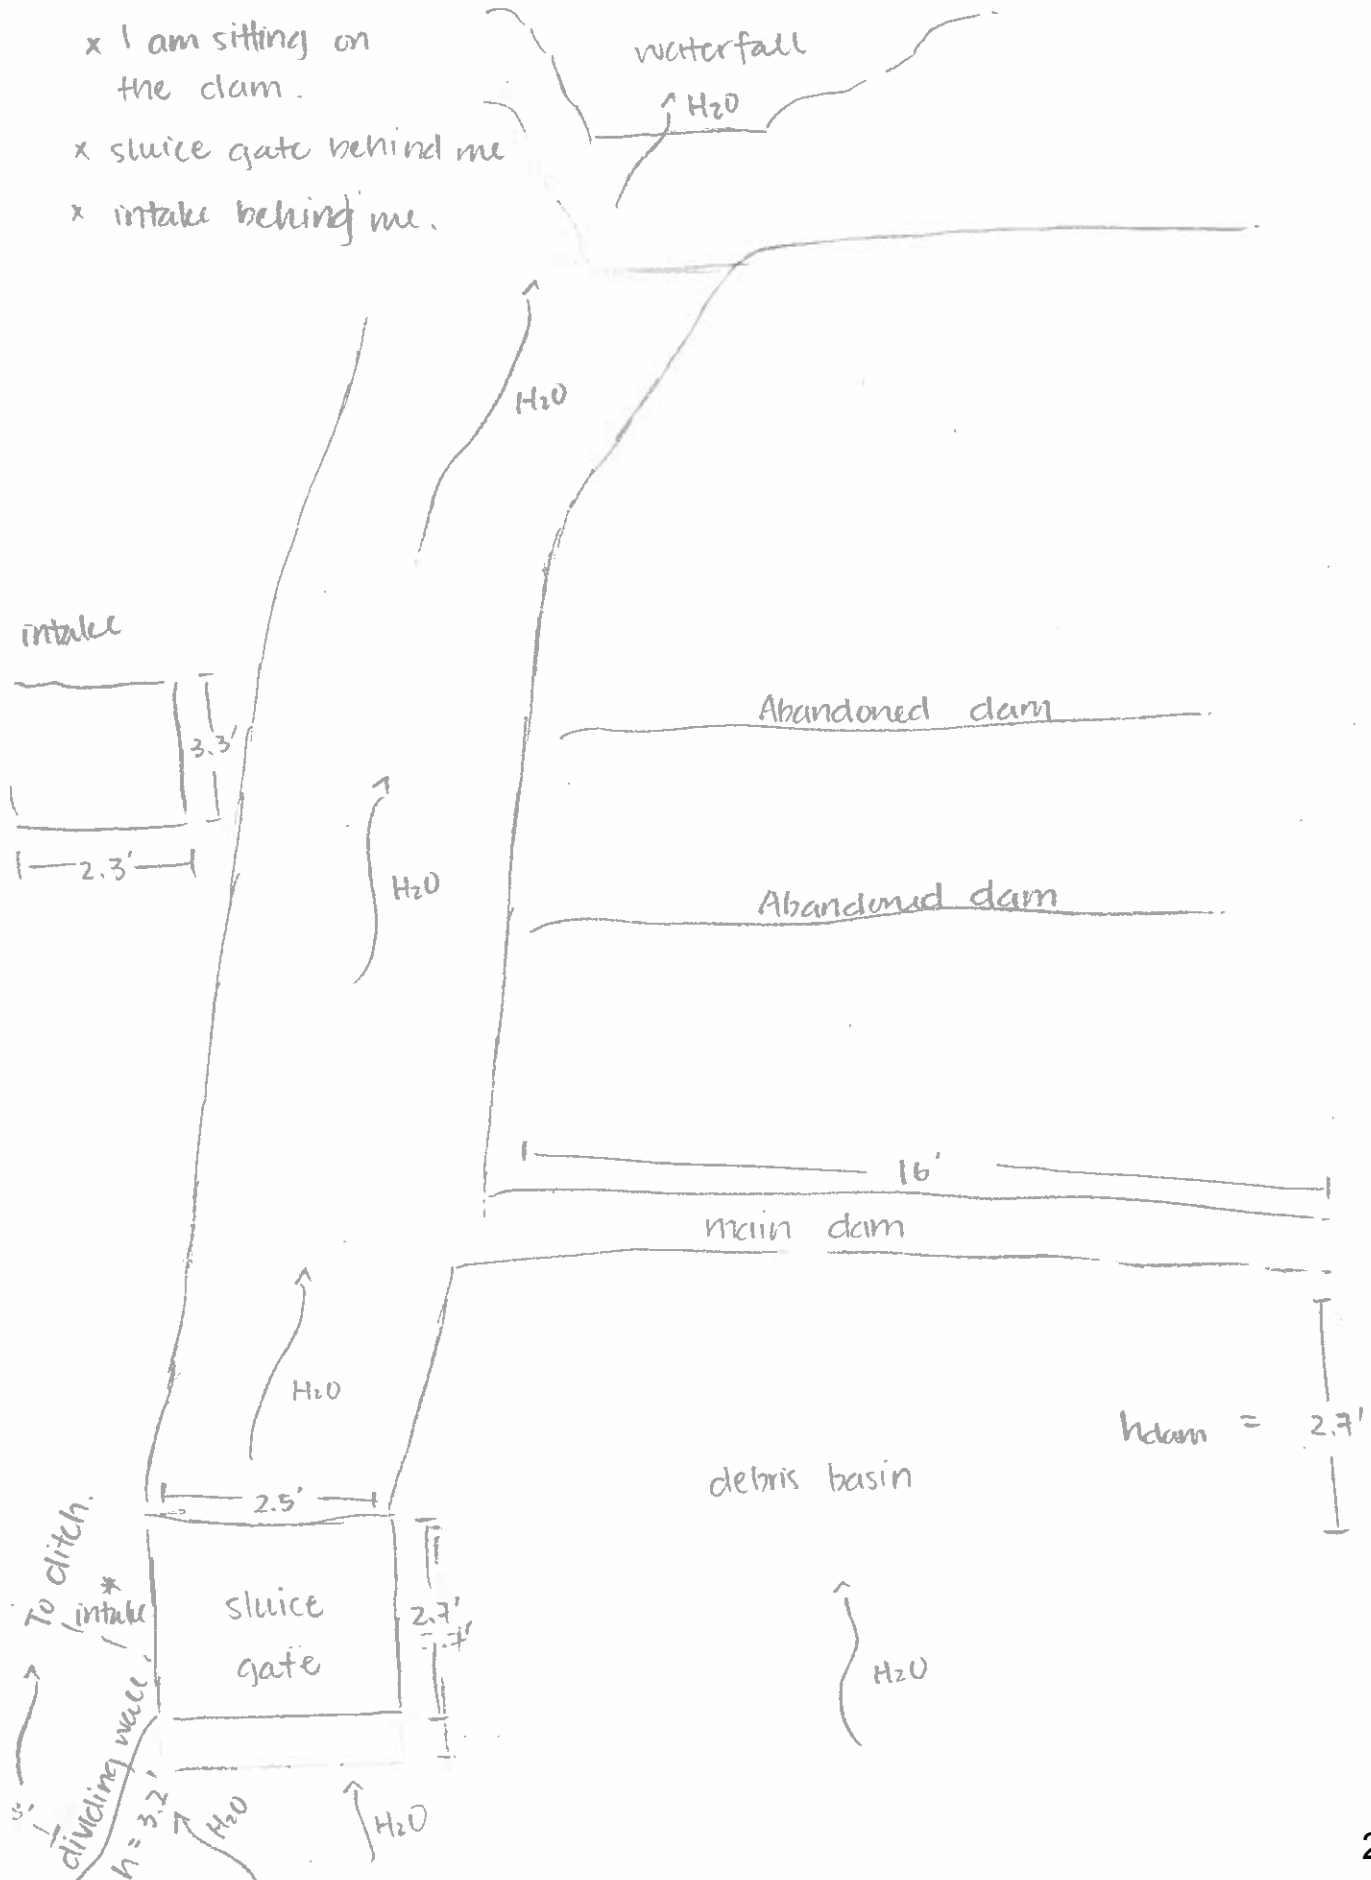
HONOMANU (Center Honomanu intake) S-3?

x Spreckels Ditch.

x dry DS.

x waterfall DS.

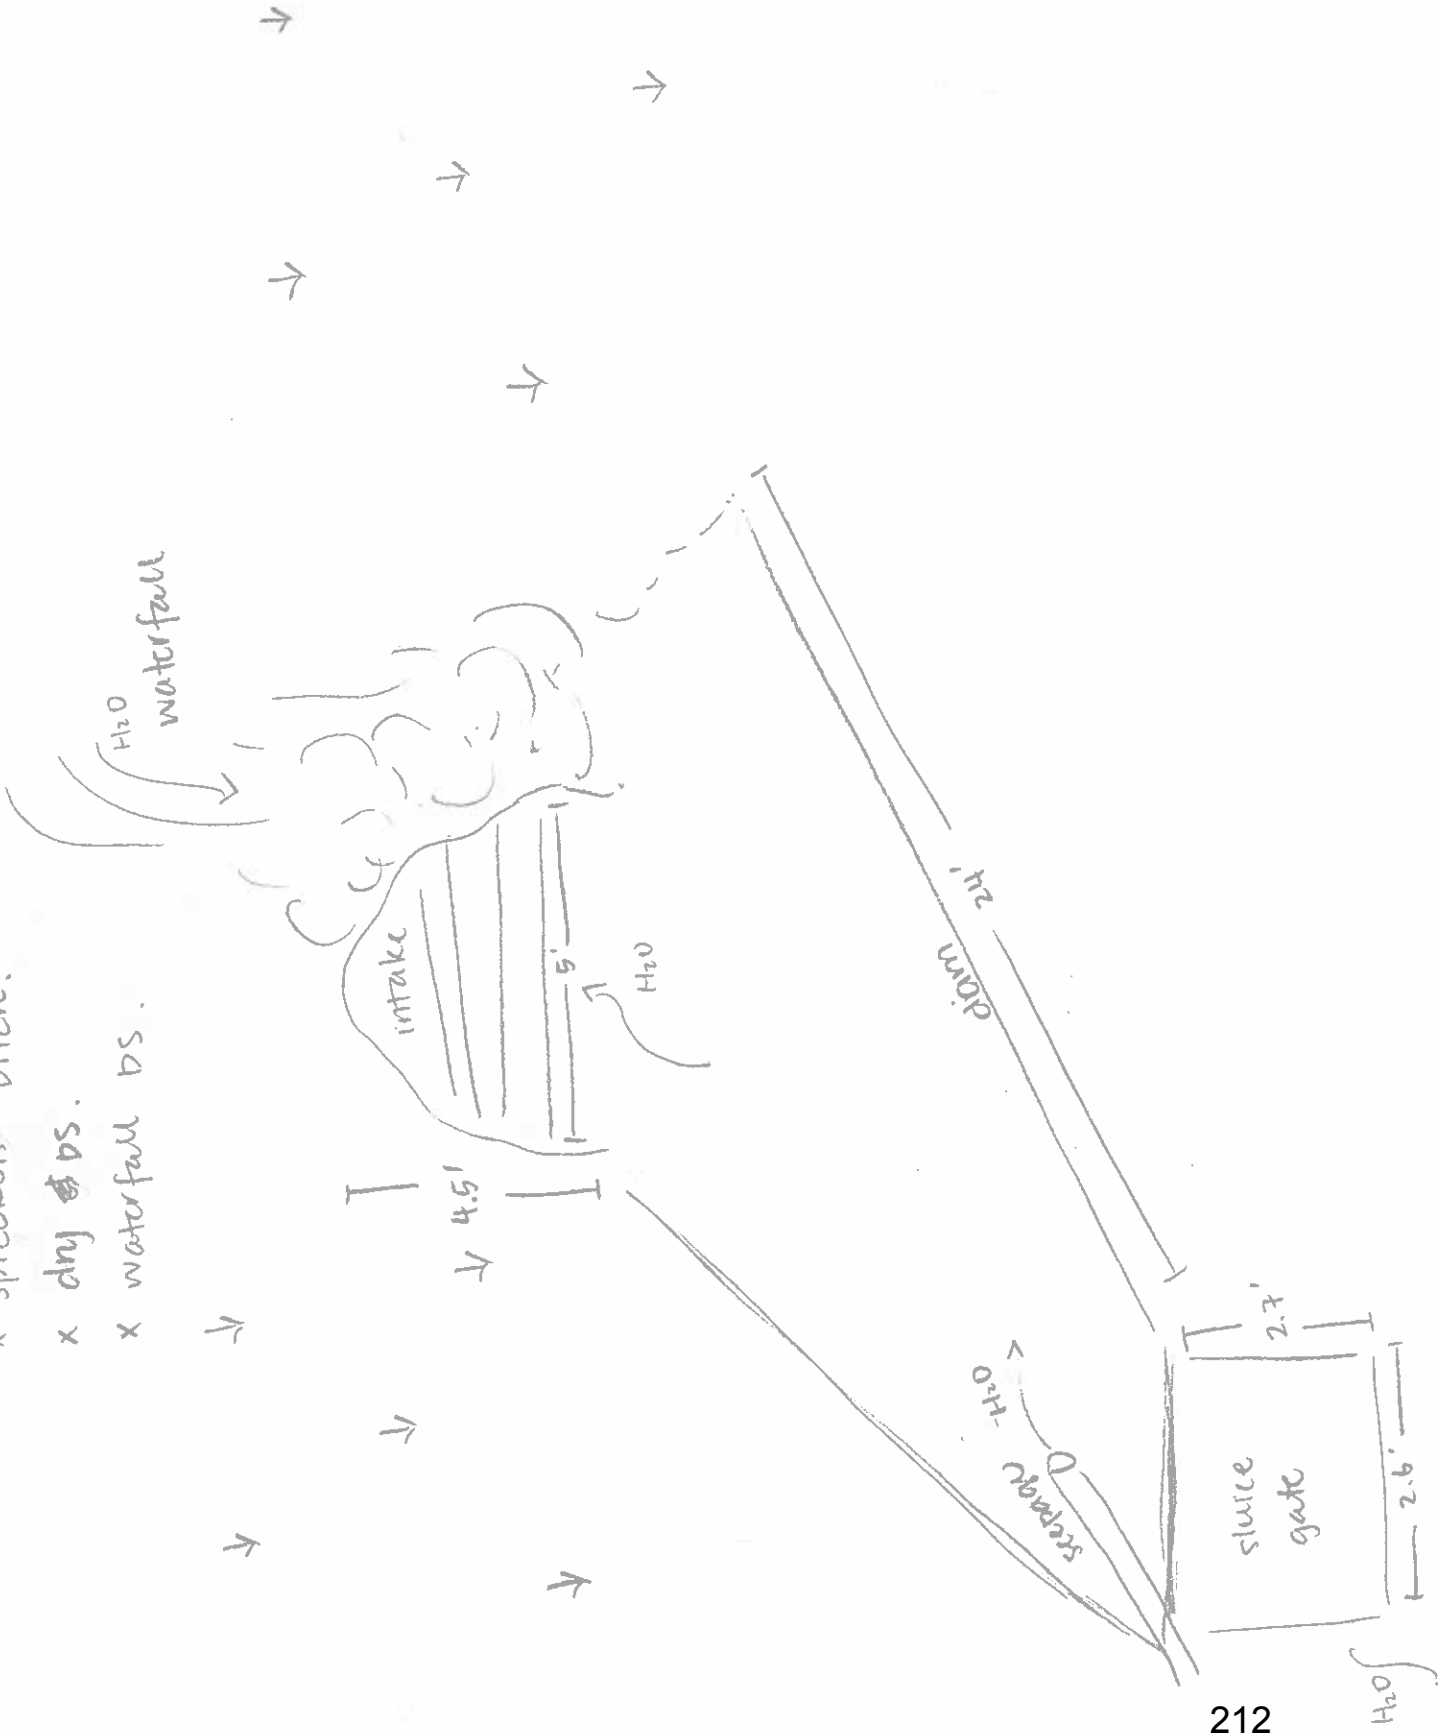
HONOMANU (main intake)

x spreckels ditch.

x ~~etc~~ benefit from continuous flow

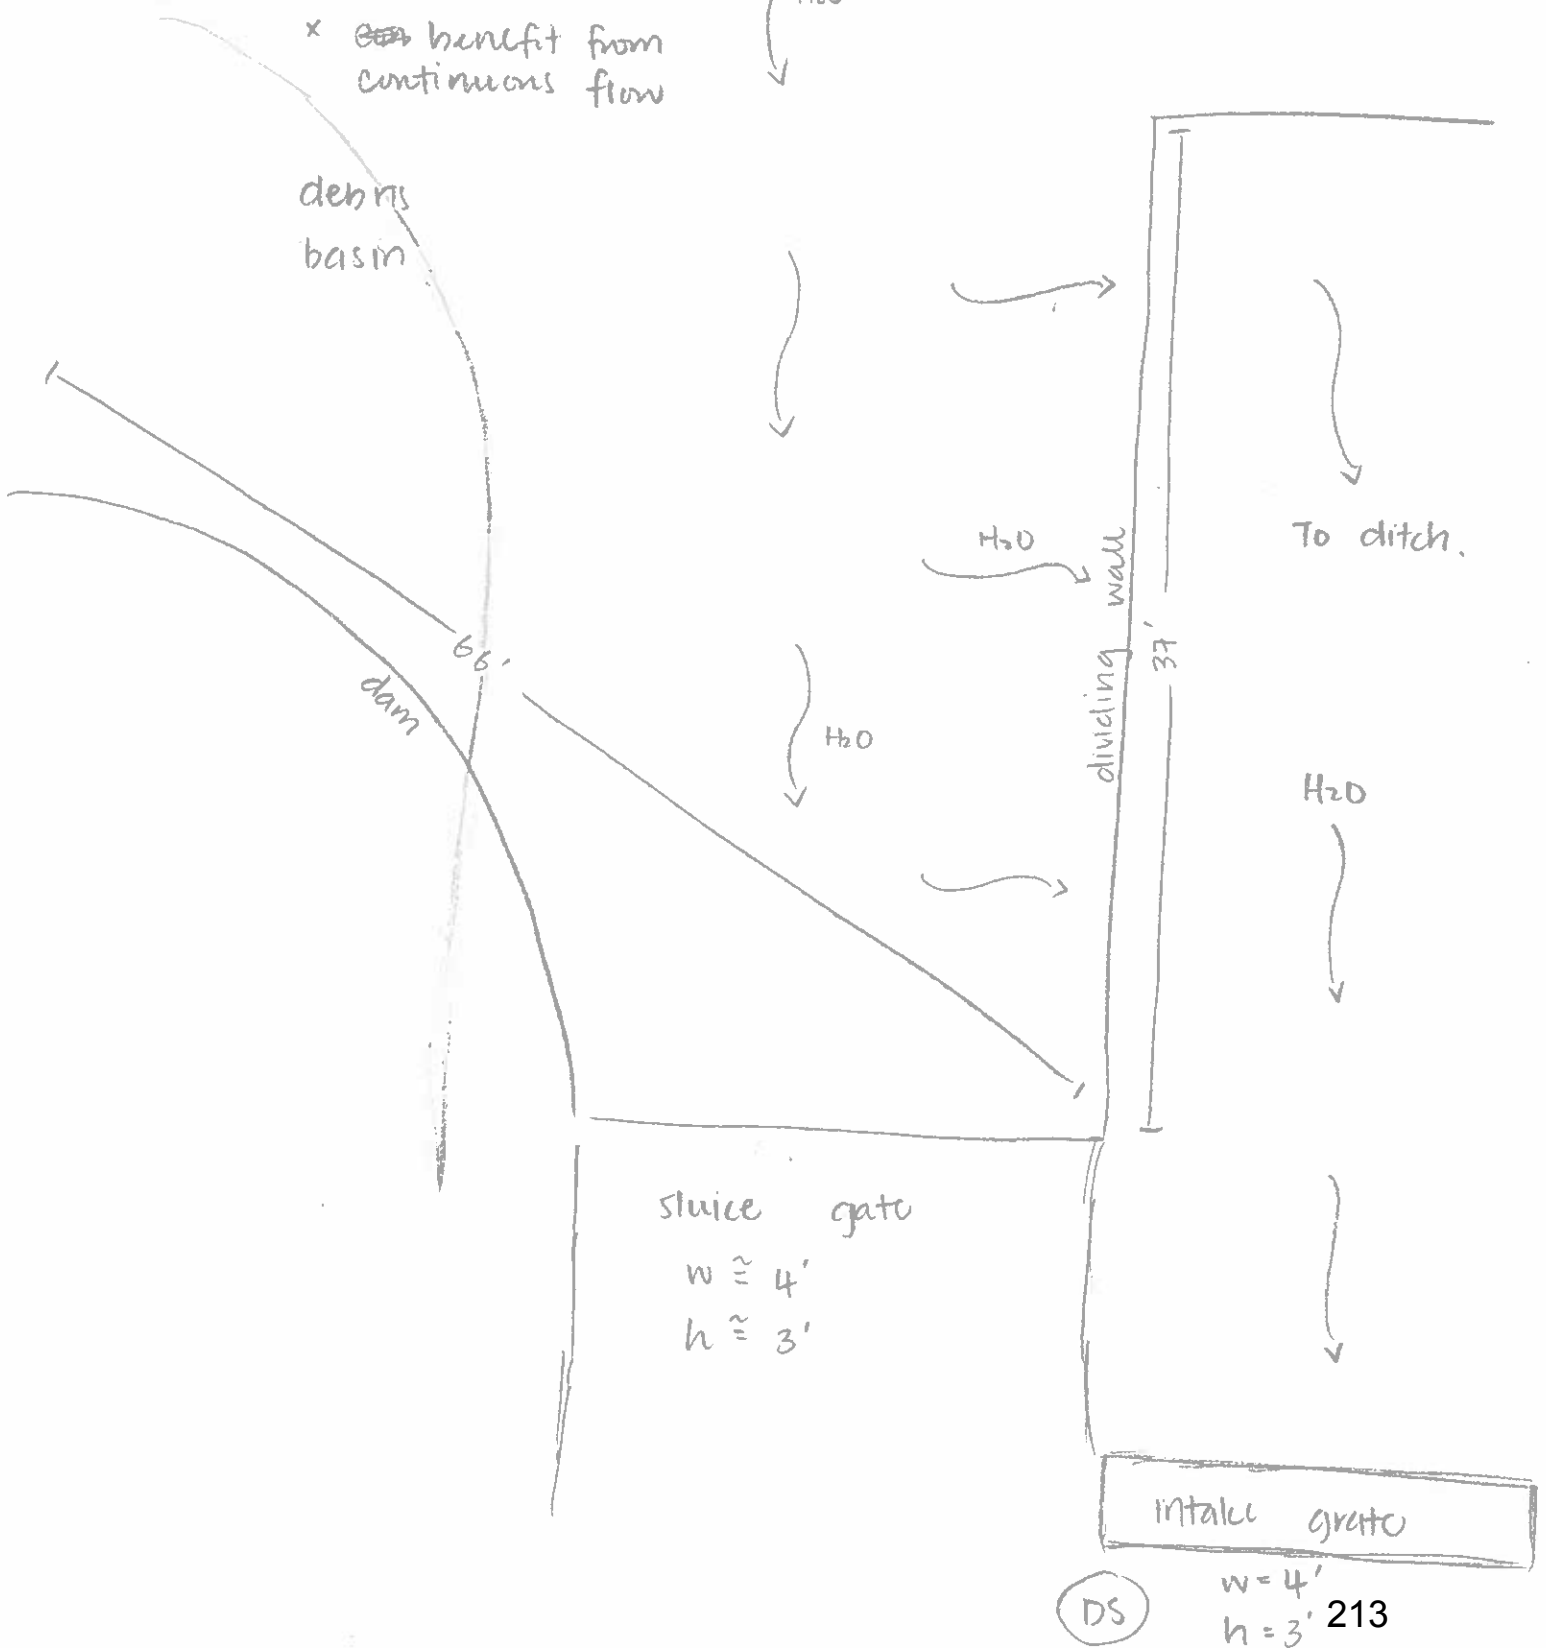
HONOMANU (High Falls)

- x spreckels ditch
- x seepage DS
- x waterfall DS
