STATE OF HAWAII
DEPARTMENT OF LAND AND NATURAL RESOURCES
COMMISSION ON WATER RESOURCE MANAGEMENT
 Stream Protection and Management Branch

FIELD INVESTIGATION REPORT

FI2008102703 (East Maui, Honopou Haiku Ditch, restore)

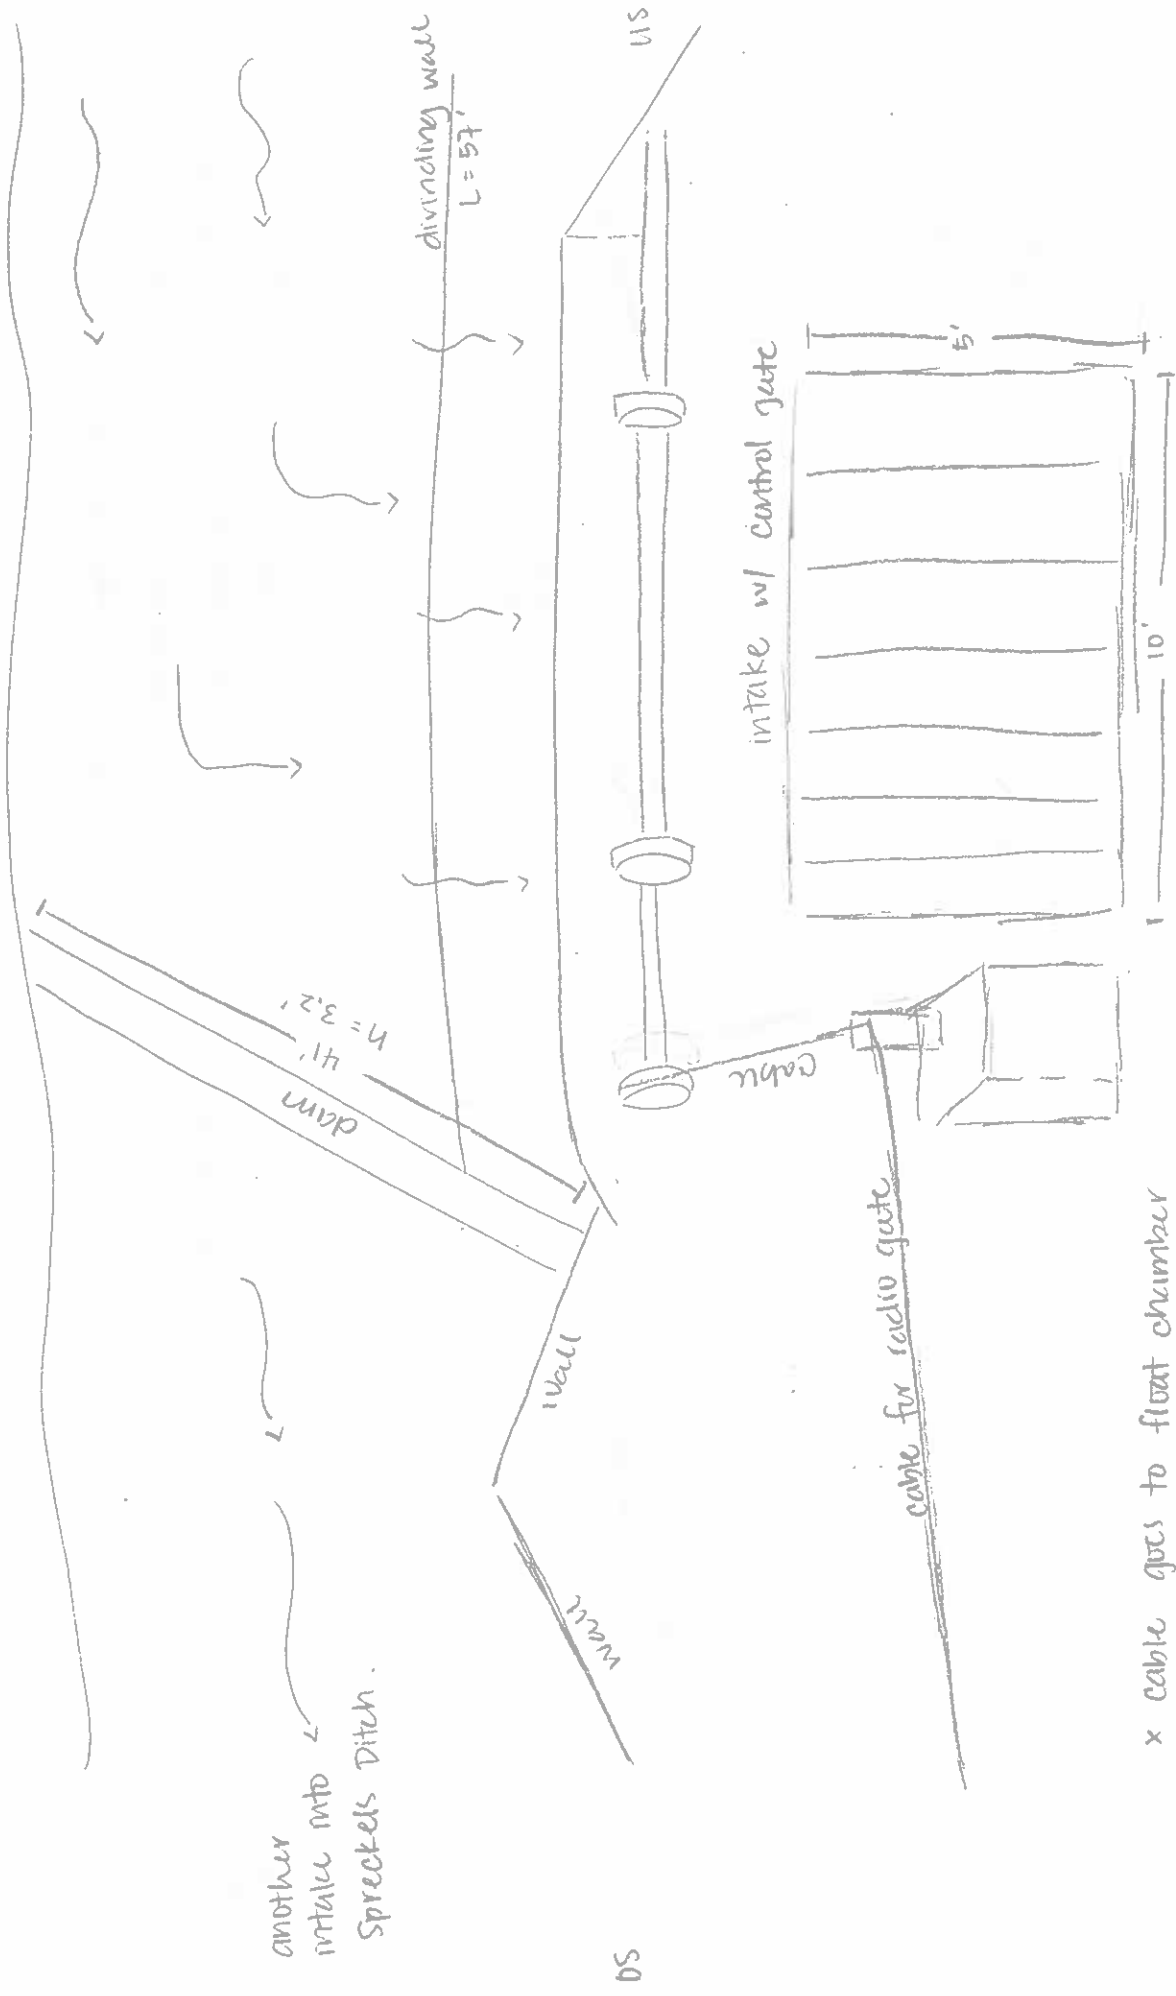
PUOHOKAMDA (Koolau Ditch)

x cable goes to float chamber in Koolau Ditch. when float goes up, control gate shuts and water flows in stream to the next intake - Spreckels.

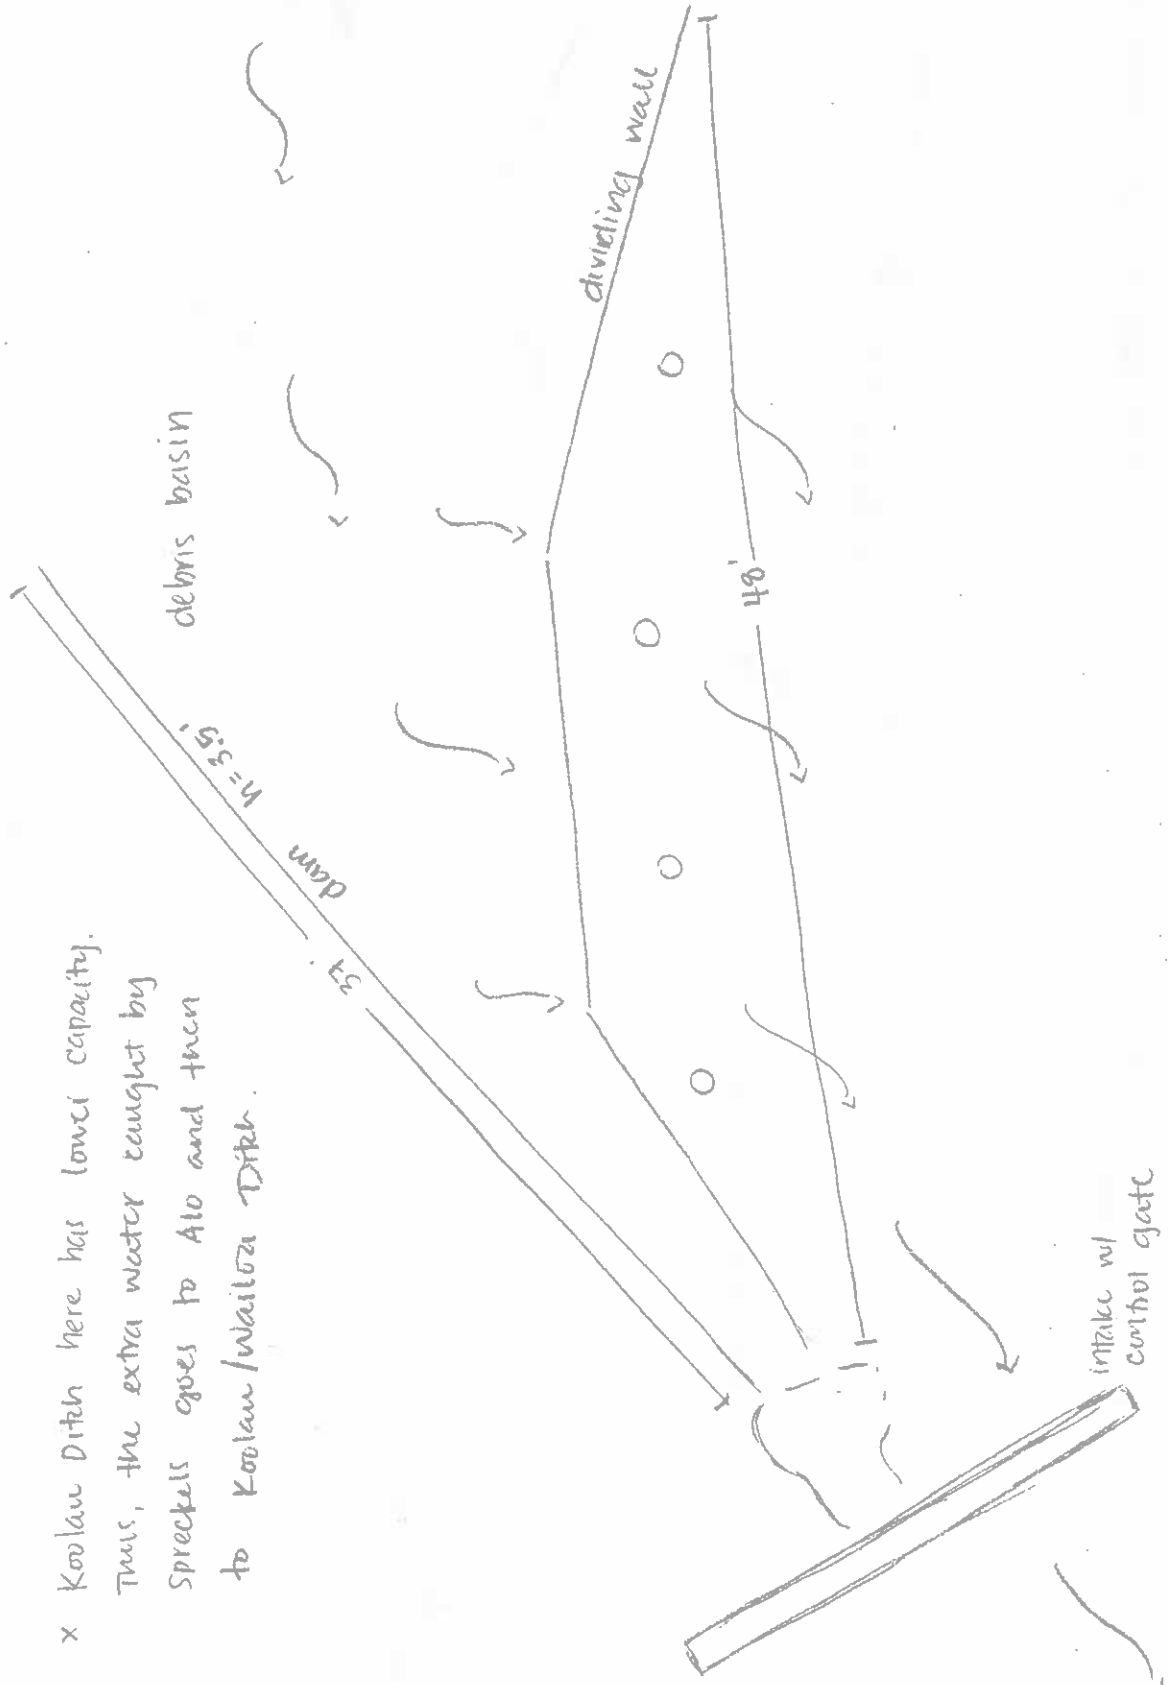
PUDHOKAIMOA (Spreckels ditch)

x Koolau Ditch here has lower capacity. Thus, the extra water caught by Spreckels goes to Alo and then to Koolau/Wailoia Ditch.

intake w/ control gate
w = 4'
h = 2'

Goes to Alo Stream.

x has sluice gate

x dry DS

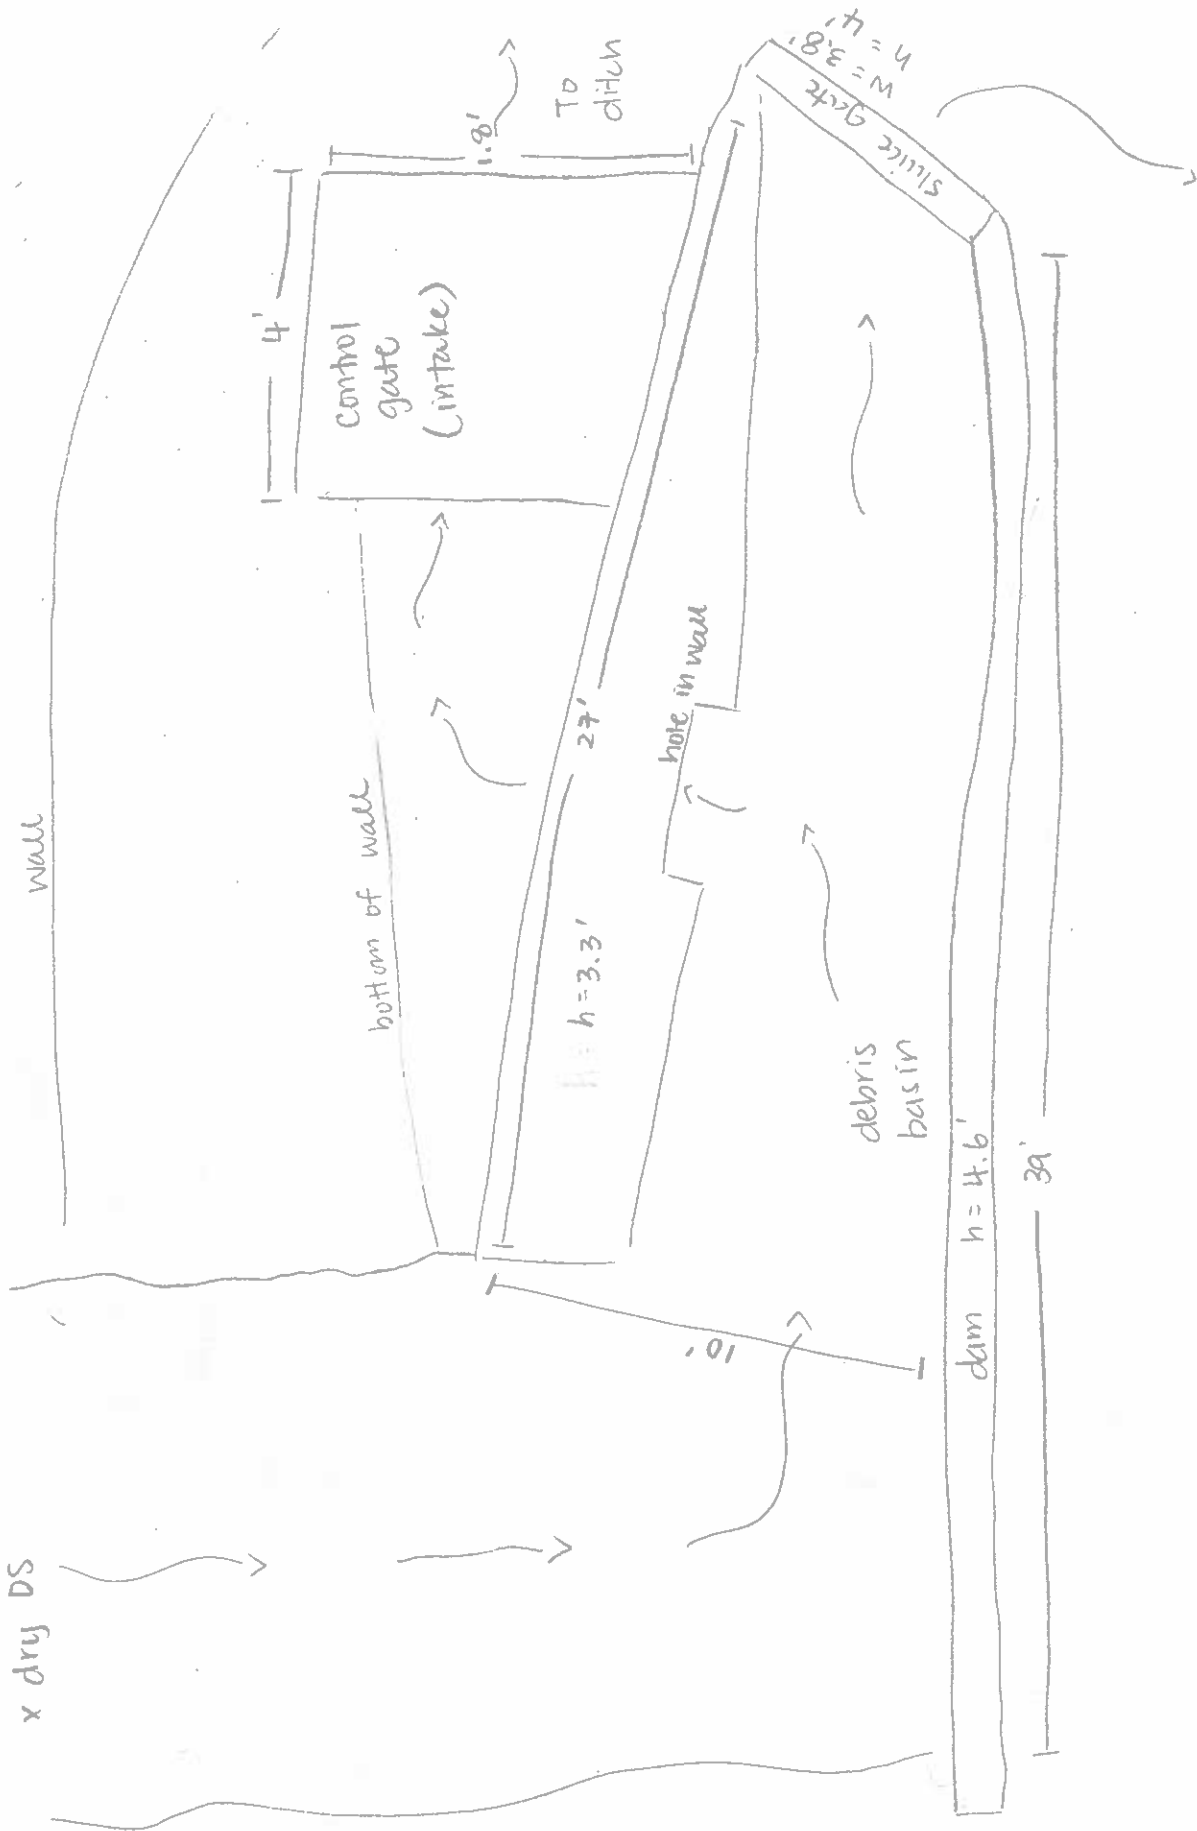
HAI PUAENA (Mauuel Luis Ditch)

- x water from Haihuacena
- x goes into Manuel Luis Ditch
- x no sluice gate.
- x dry DS

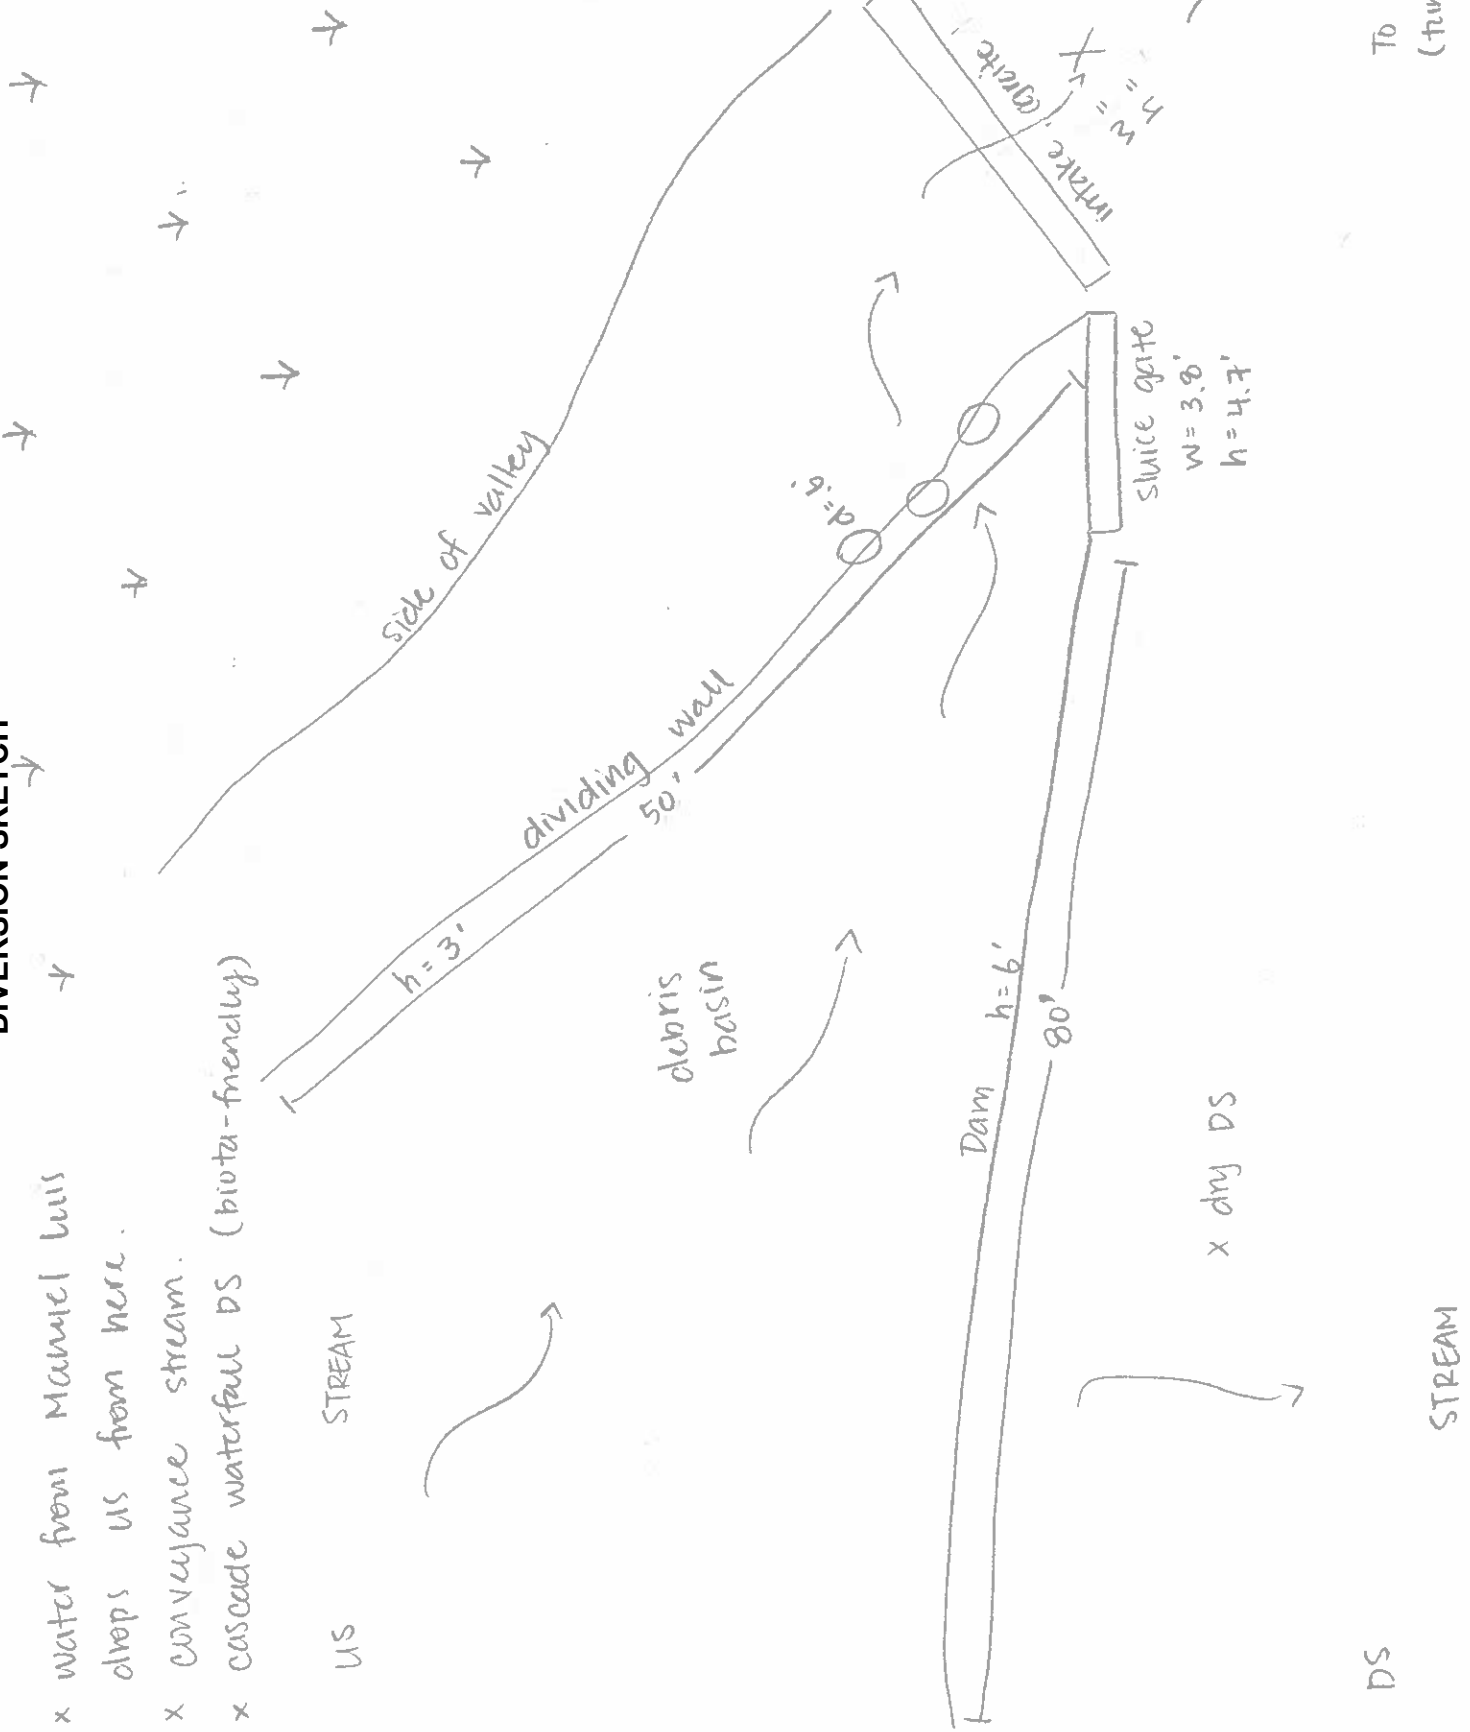
WAIKAMOI (C-1, Center Ditch)

- x water from Manuel built drops US from here.
- x conveyance stream.
- x cascade waterfall DS (biota-friendly)

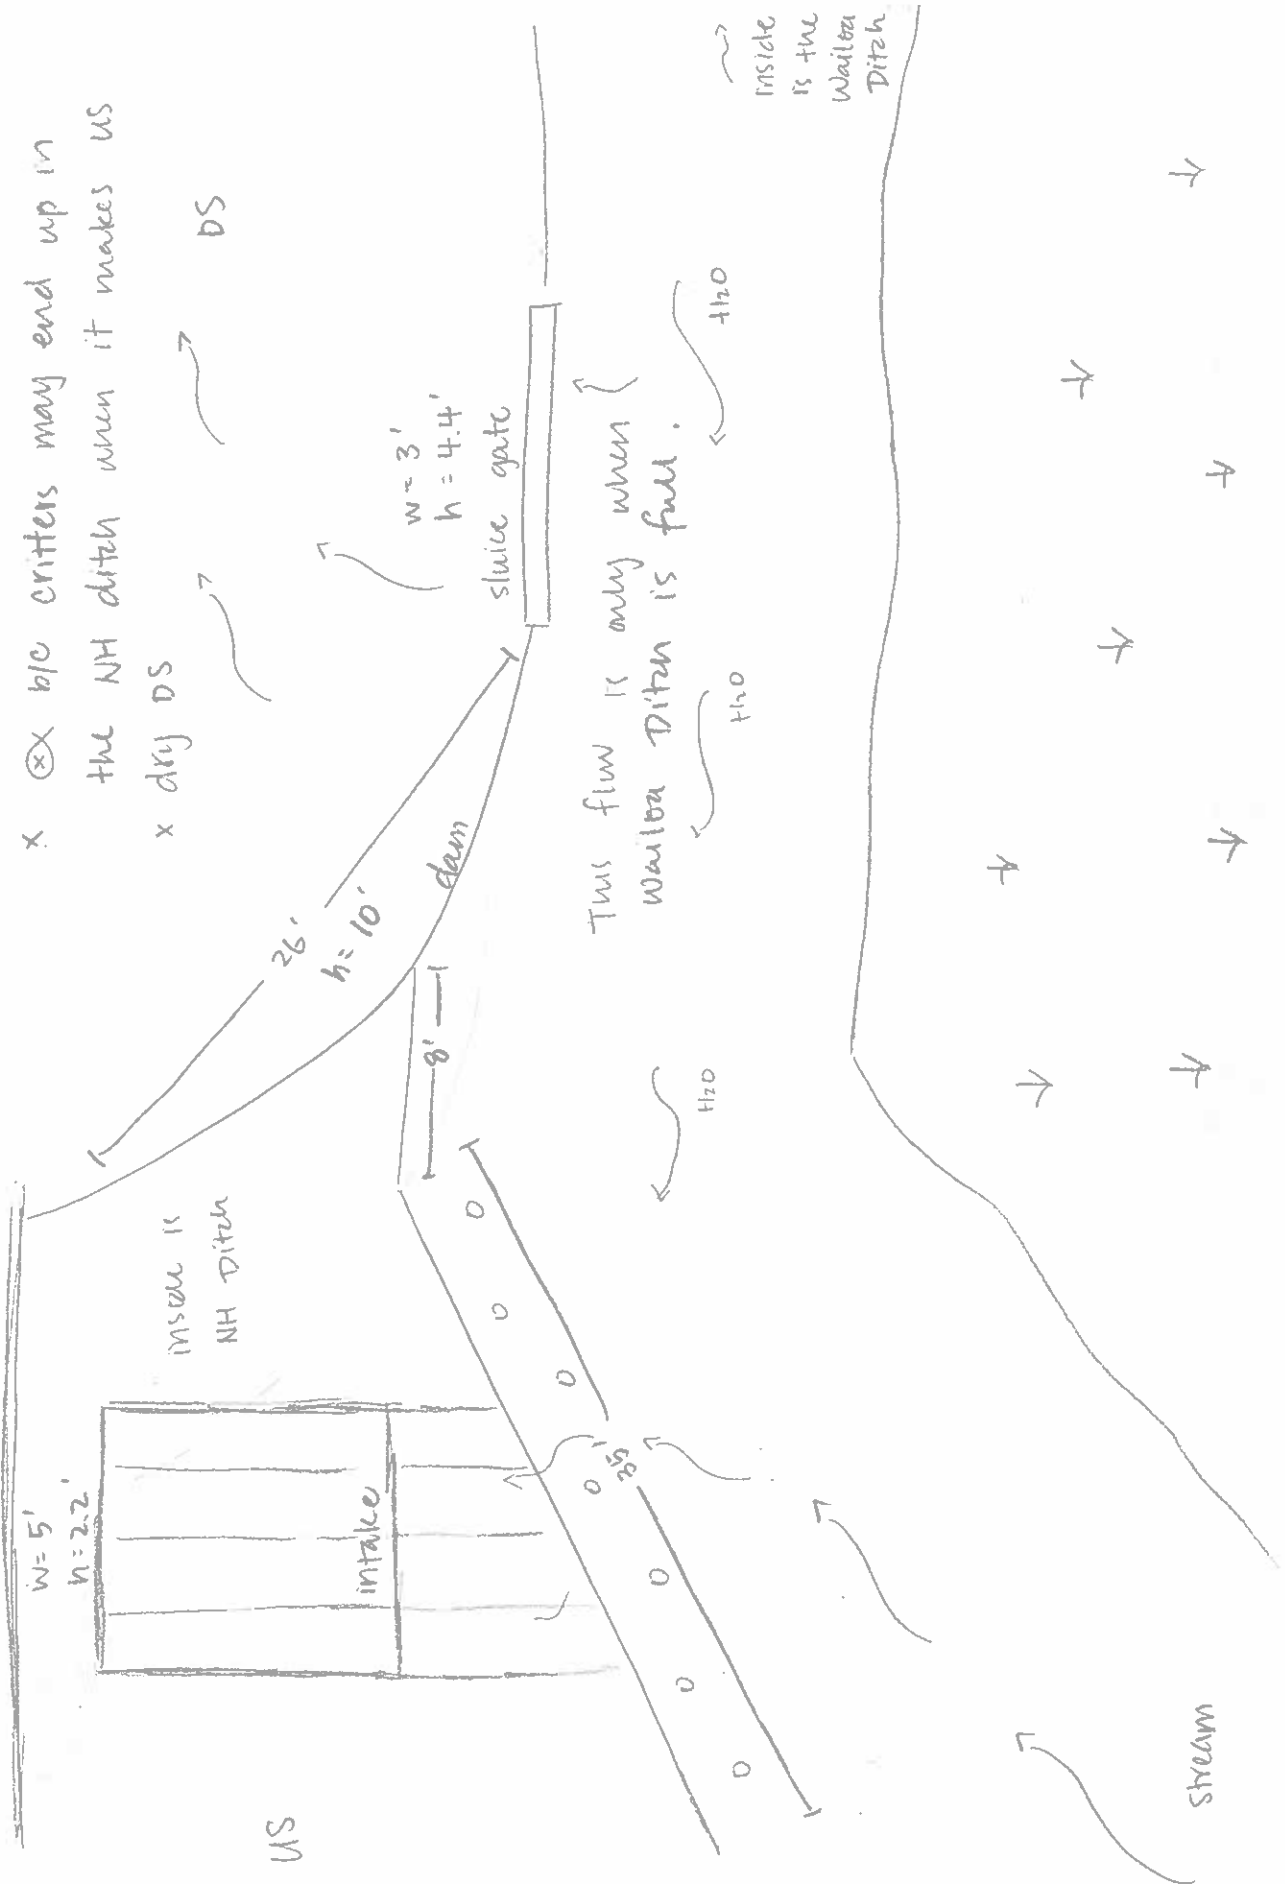
ALO (Koolau/Wailoa Ditch)

- x waterfall carries water from **DIVERSION SKETCH**.
- x 2 sluice gates.
- x water makes a u-turn before going to sluice gate.
- x Here, Wailoa Ditch has higher capacity

x ~~xx~~ b/c critters may end up in the NH ditch when it makes US

x dry DS → DS

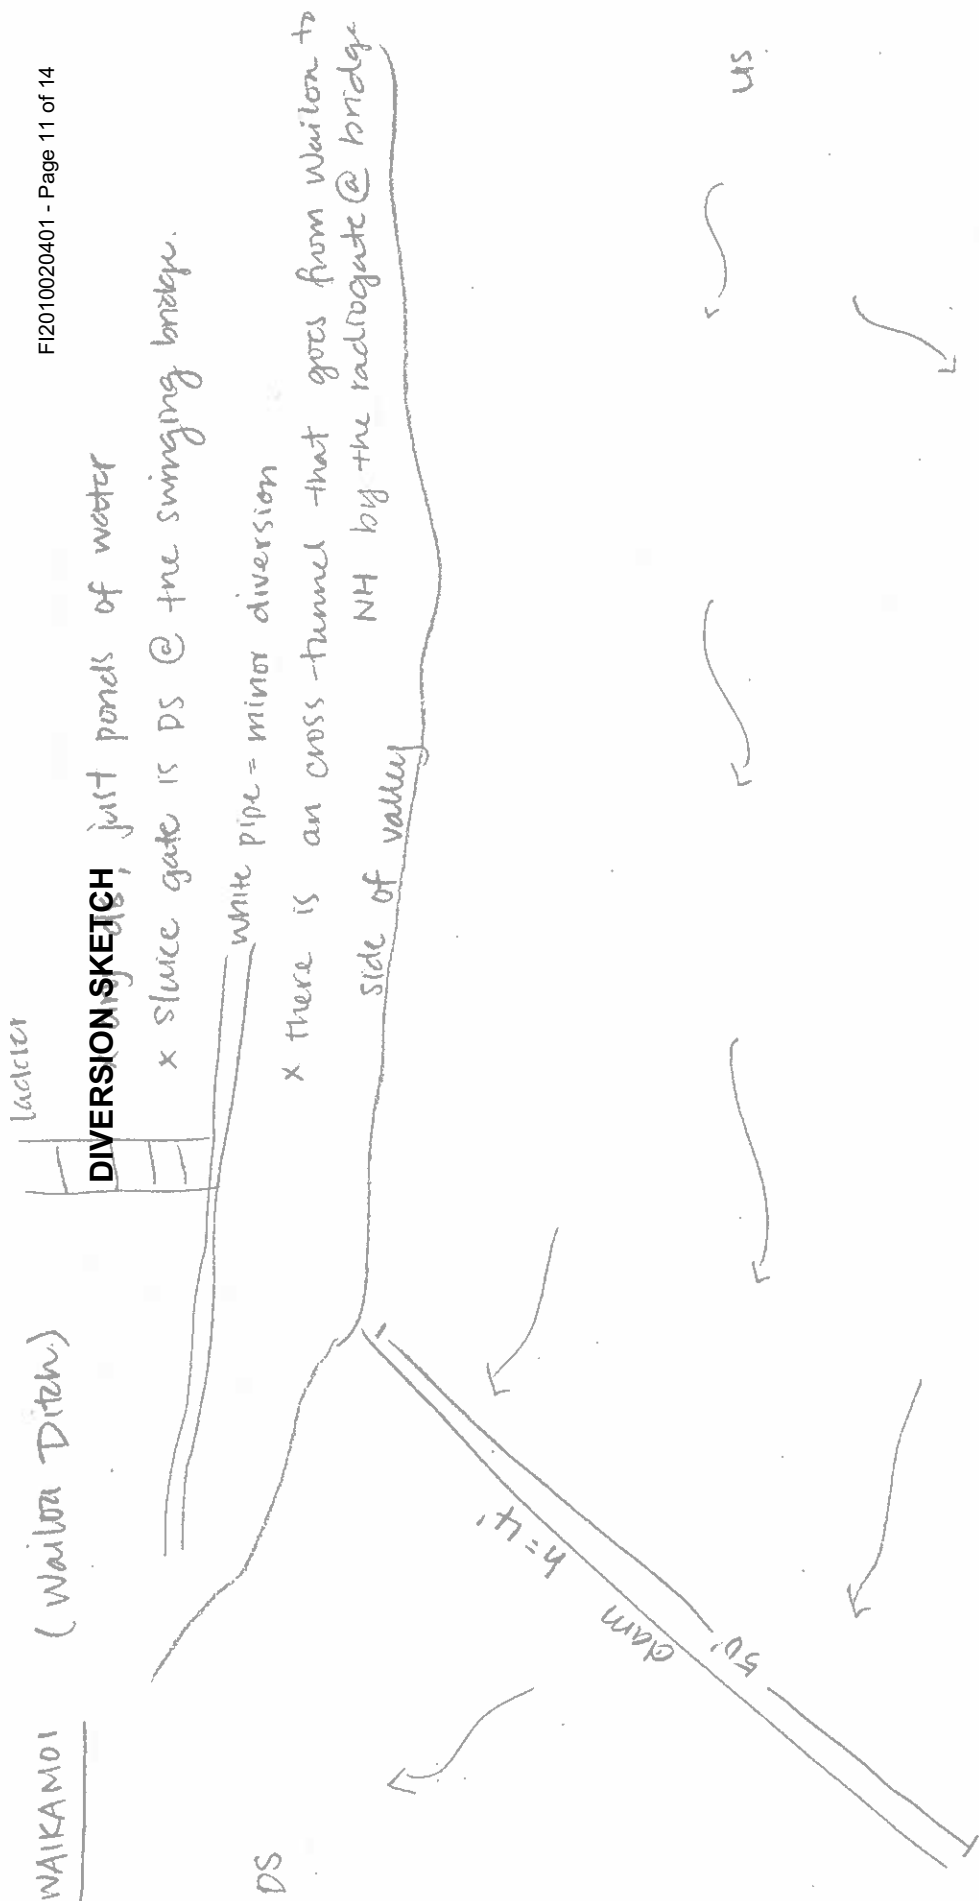
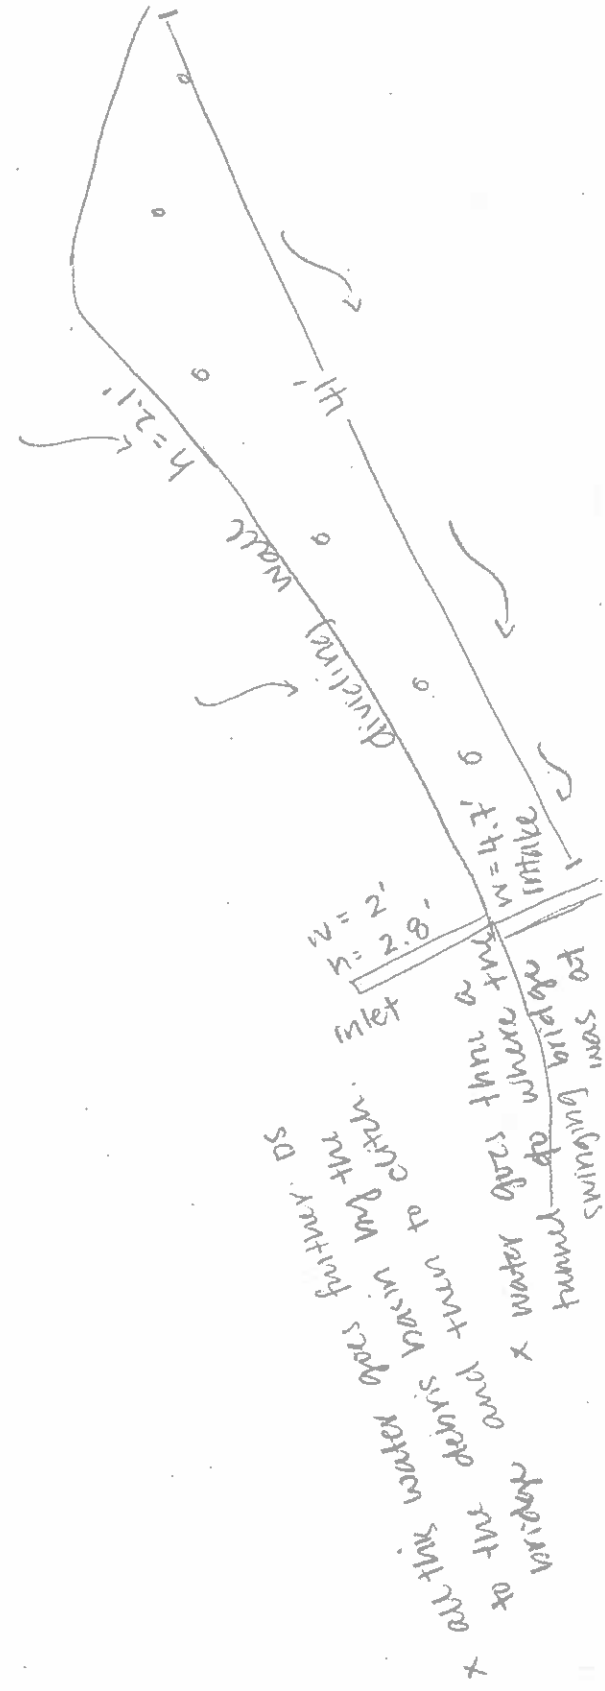
WAIKAMOI (Waikona Ditch)

DIVERSION SKETCH, just ponds of water

white pipe = minor diversion

x there is an cross-tunnel that goes from Waikona to NH by the radiogate @ bridge.

x all this water gets further DS
 at Mt. Waikona
 and turn to creek
 x water gets thru a tunnel do where swinging bridge was at
 x water gets thru a tunnel do where swinging bridge was at

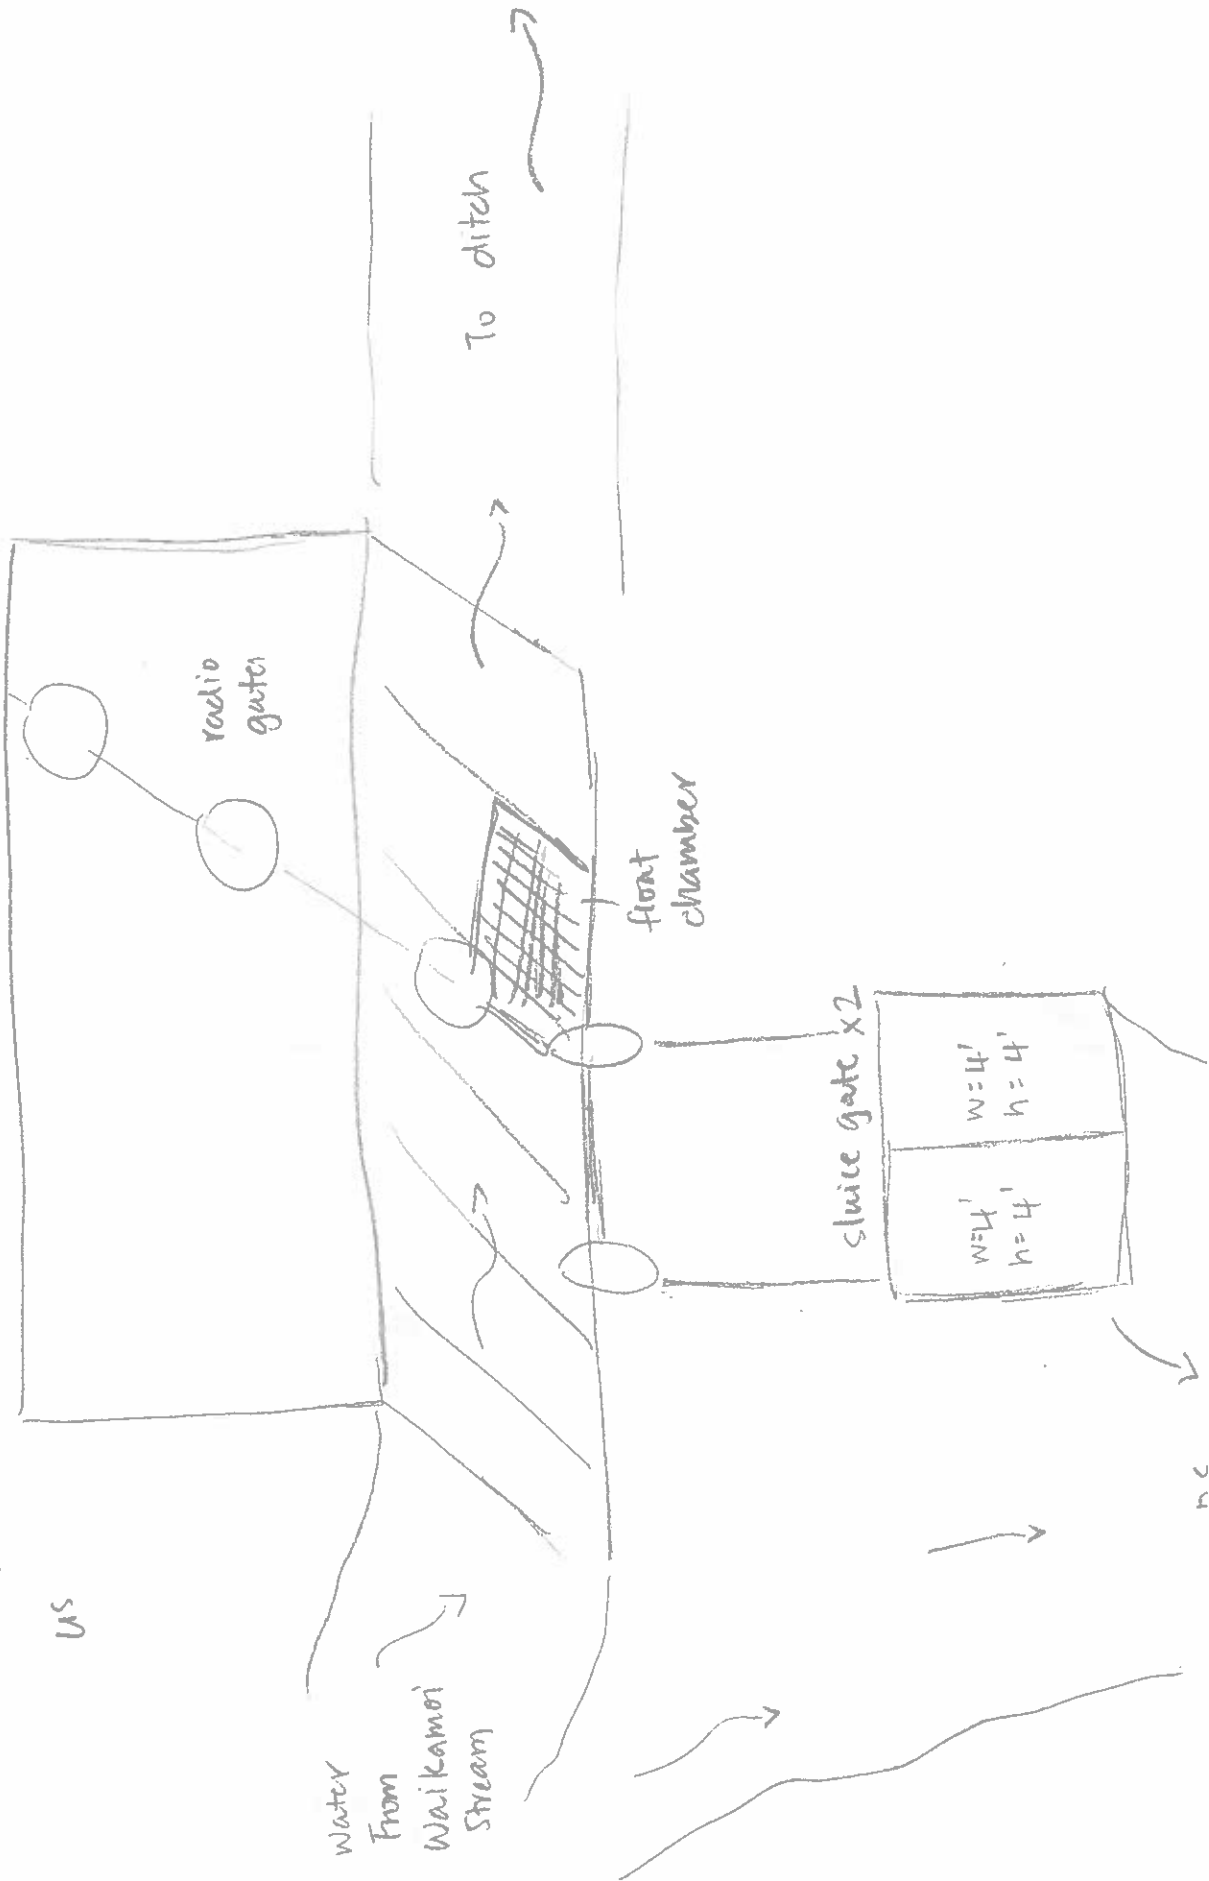
WAIKAMOI (Waikamoi Ditch continued) **DIVERSION SKETCH**

- x this is the sluice gate further DS.
- x also where the water goes into the ditch.
- x \otimes biota goes into the ditch; however, can make up str if the section between the intake & sluice gate have water.

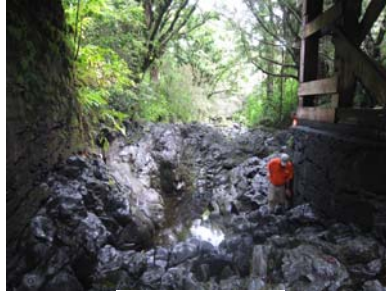
20100624002.jpg

Image Listing:	(Attach PDF of image contact sheet)		
File Name:	Brief Description:		
20100624001	Makapipi Stream upstream from the bridge on Lower Nahiku Road.		
20100624002	Makapipi Stream at the bridge on Lower Nahiku Road.		
20100624008	Potential site for the second staff gage on Makapipi Stream immediately downstream from the bridge on Lower Nahiku Road.		
20100624011	Very flow in Makapipi Stream downstream from the bridge on Lower Nahiku Road.		
20100624013	Potential site for the second staff gage on Makapipi Stream viewed from the bridge on Lower Nahiku Road.		
GPS Listing:			
Shapefiles:	(List file names of all shapefiles created and a brief description of each)		
File Name:	Brief Description:		
Waypoints:	(List all waypoints in decimal degrees and provide a brief description of each)		
WP No.	Latitude	Longitude	Brief Description:
Attachments:			
Brief Description:	1. Image Contact Sheet		
Recommendations:

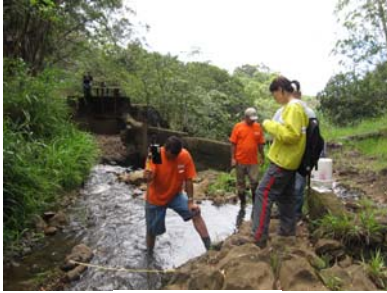
20100624056.jpg

Image Listing:	(Attach PDF of image contact sheet)		
File Name:	Brief Description:		
20100624056	USGS staff conducting flow measurement on Honopou Stream upstream from Lowrie Ditch intake.		
GPS Listing:			
Shapefiles:	(List file names of all shapefiles created and a brief description of each)		
File Name:	Brief Description:		
Waypoints:	(List all waypoints in decimal degrees and provide a brief description of each)		
WP No.	Latitude	Longitude	Brief Description:
Attachments:			
Brief Description:	1. Image Contact Sheet 2. Discharge Summary		
Recommendations:

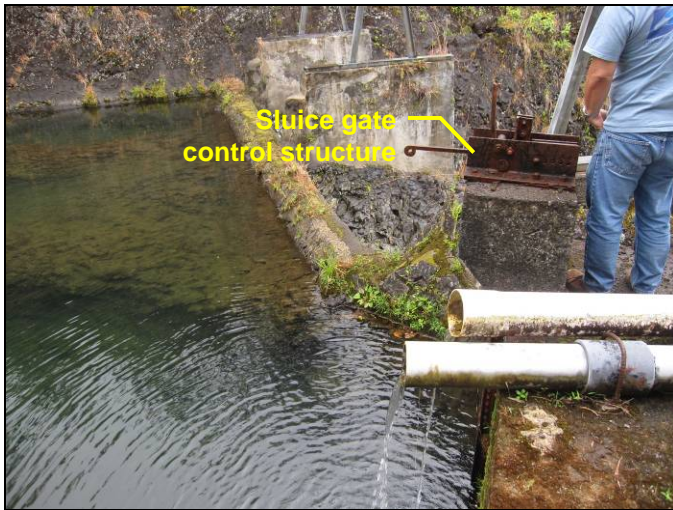
Diversion dam with minor diversion pipes in the foreground.

- There are currently two 6 in. PVC pipes on the right bank of the diversion structure which convey water from other (i.e., spring/seep) sources. These sources are considered minor diversions not directly from Hanawi Stream. EMI plans to extend one of the existing pipes with elbows and short sections of pipe and secured along the sluice gate structure to drop water onto the top of the diversion dam.

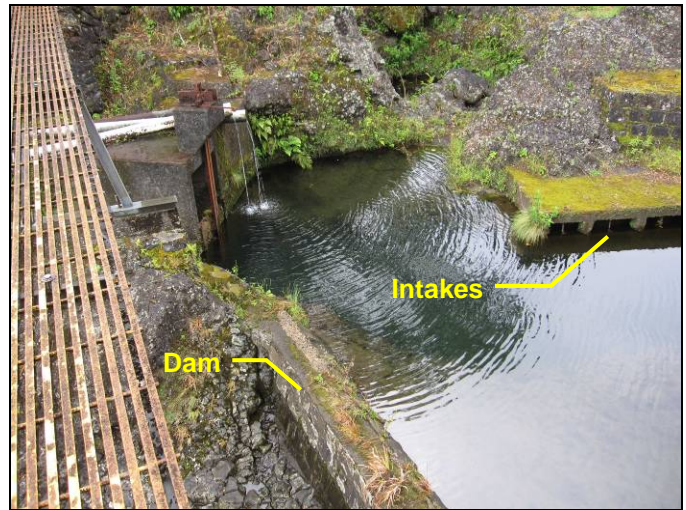
View from the opposite (left) bank of Hanawi Stream.

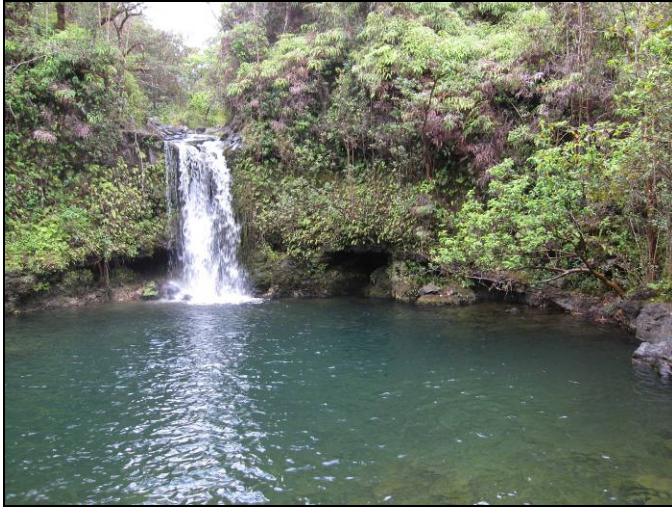
Waterfall and pool upstream of the Waiohue Stream diversion intake.

- At the time of this site visit, the level of the water was approximately 3 ft. below the concrete dam structure.
- EMI also intends to construct a pipe along one of the stream banks starting from atop the waterfall to drop water onto the top of the diversion dam. The pipe installation initially discussed in the field was the right bank; however, EMI will scout trails to the top of the waterfall to determine the best route to convey the pipe.

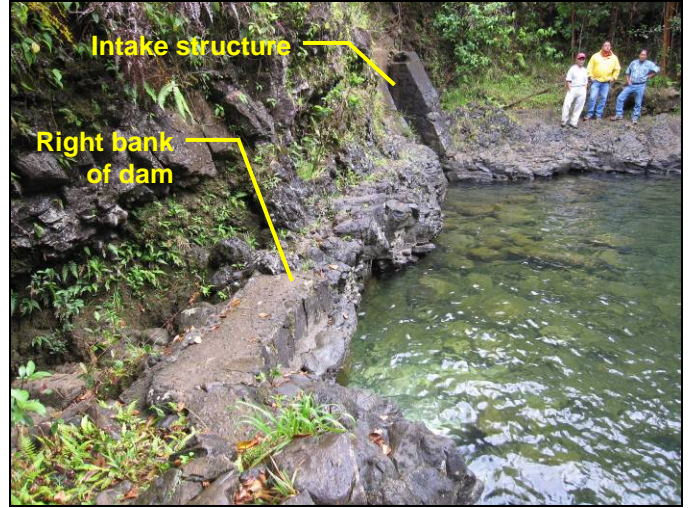
Diversion intake and dam structure on Waiohue Stream.

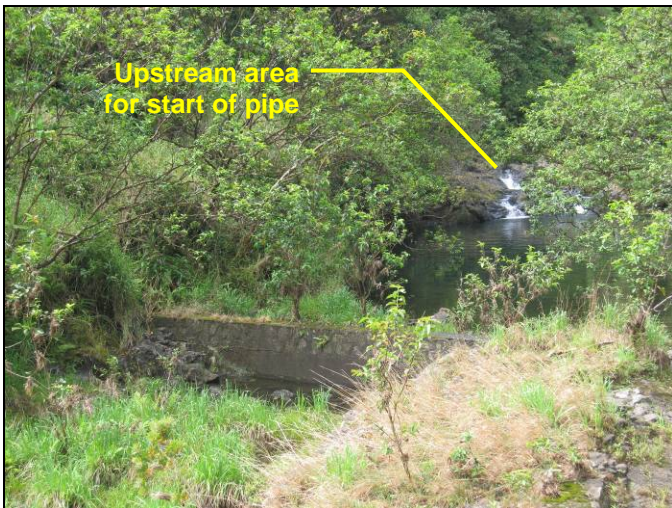
Diversion dam on the right bank of East Wailuaiki Stream.

- EMI plans to install a pipe along the right bank of East Wailuaiki Stream starting from a section of stream higher in elevation than the height of the diversion dam. Water from the pipe will be dropped onto the top of the diversion dam approximately 5 ft. from the right bank of the stream.

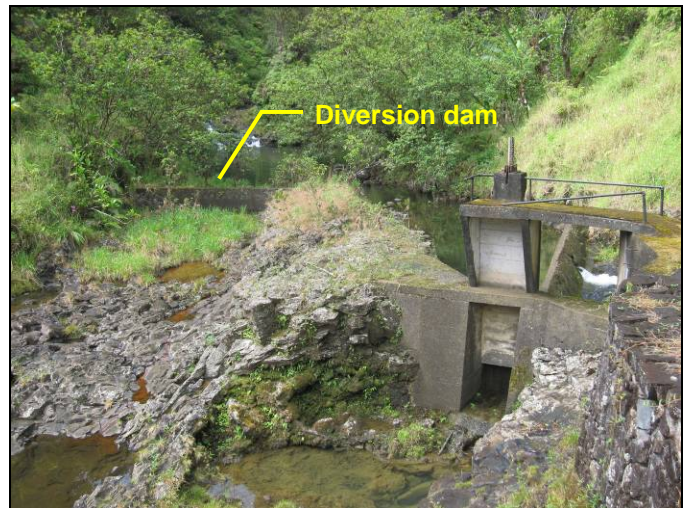
Upstream view of dam (left) and sluice gate/intake structure (right).

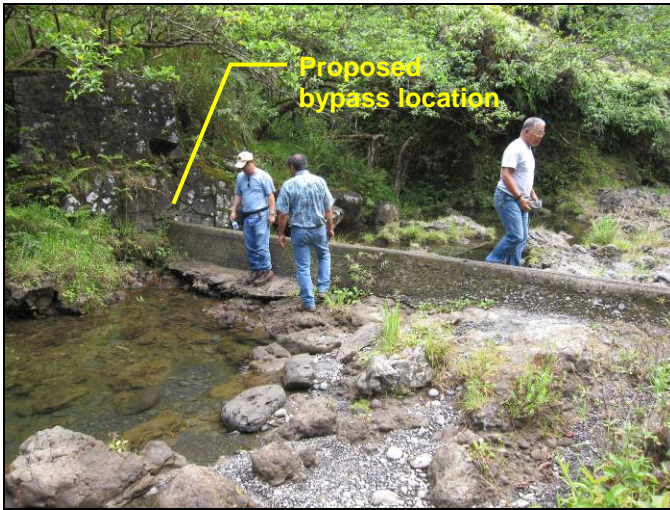
Diversion dam facing the left bank of West Wailuaiki Stream.

- EMI plans to install a pipe along the left bank of West Wailuaiki Stream from atop the waterfall and drop water onto the top of the diversion dam nearest the left bank. EMI will scout trails to the top of the waterfall to determine the best route to convey the pipe. This site may require “trial-and-error” due to high flow events and the stability of the installation.

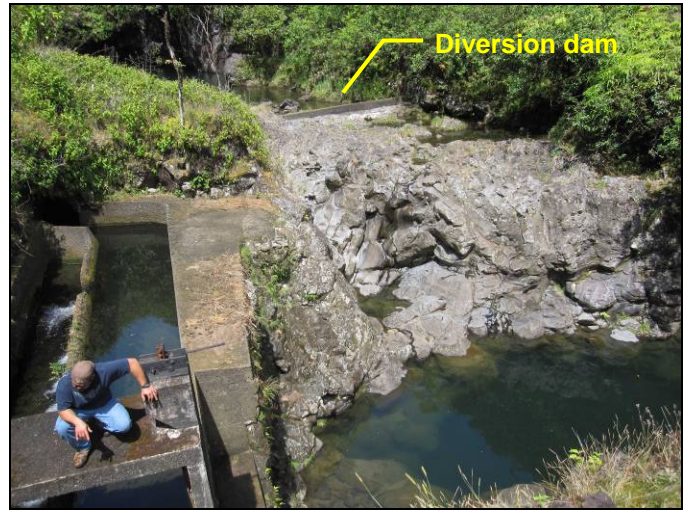
Upstream view of sluice gate/intake structure (left) and dam (center).

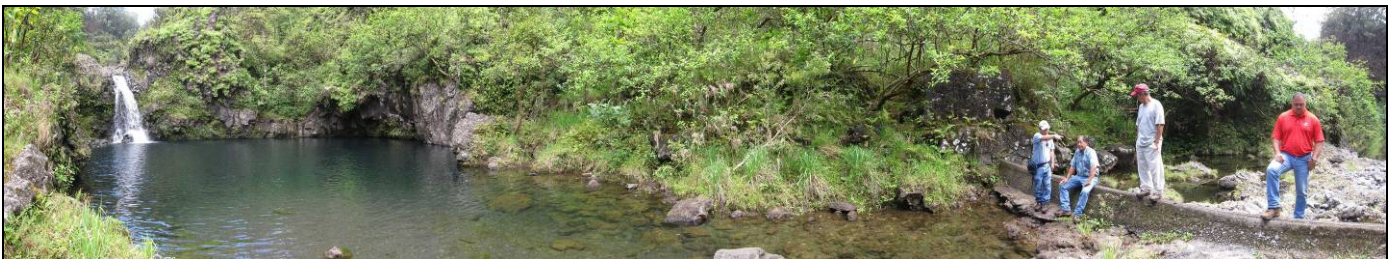
Panoramic view of left bank of West Wailuaiki Stream with waterfall and diversion dam (right), and possible location for bypass pipe installation.

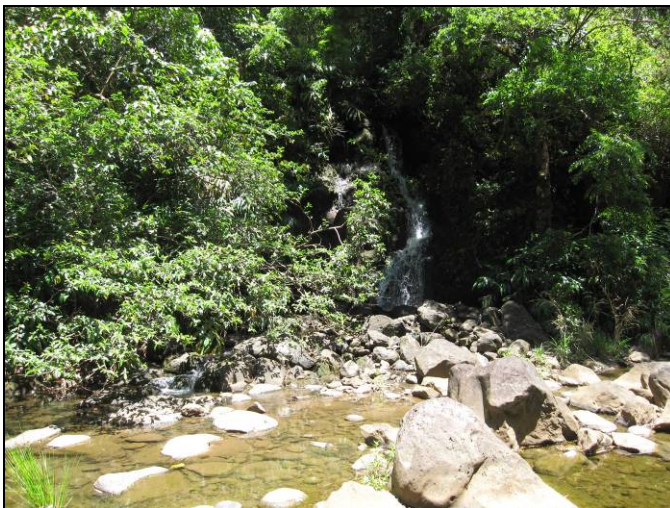
- No action is proposed for this stream, since the dry season interim instream flow standard is 0 cfs.

Manual Luis Ditch drops water into Waikamoi Stream on the right bank.

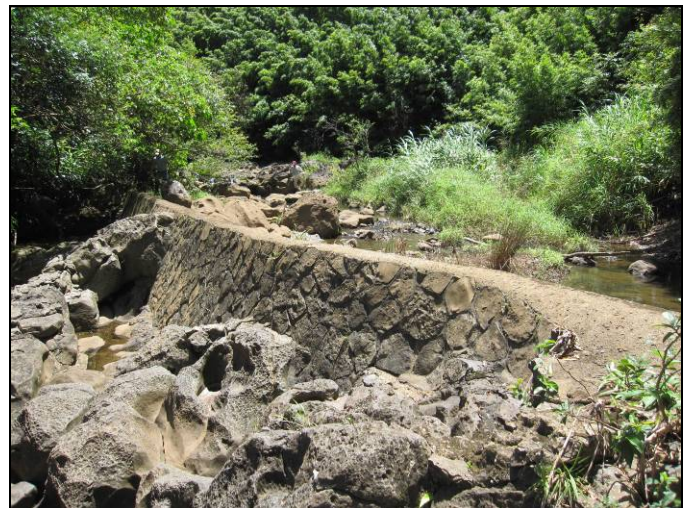
Upstream view of Waikamoi Stream and diversion dam from left bank.

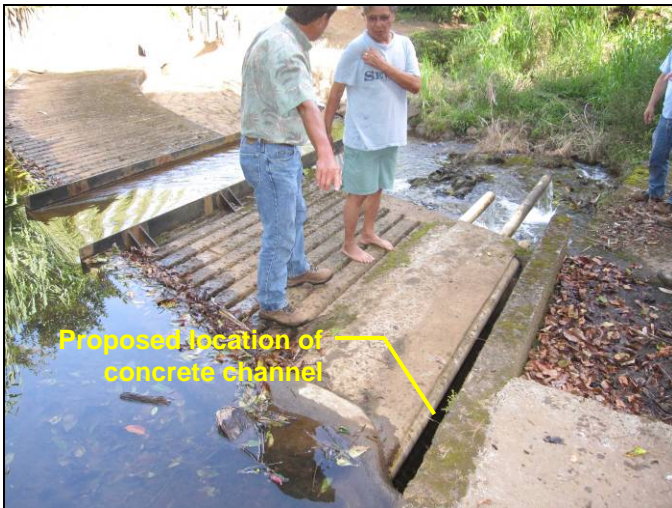
Right bank of the Haiku Ditch diversion intake on Honopou Stream.

- EMI intends to use cement to construct a small channel in the diversion intake structure where there is currently an opening nearest the right bank of the stream. The concrete berm on the upstream end of the channel will also be chipped away to allow water to flow downstream in the channel. The channel should be kept fairly rough (i.e., not smooth).
- EMI will also construct a small concrete berm near at the base of the water drop from the low-flow bypass channel to prevent water from flowing back into the Haiku Ditch.
