STATE OF HAWAII
DEPARTMENT OF LAND AND NATURAL RESOURCES
COMMISSION ON WATER RESOURCE MANAGEMENT
 Stream Protection and Management Branch

FIELD INVESTIGATION REPORT

FI2008102703 (East Maui, Honopou Haiku Ditch, restore)

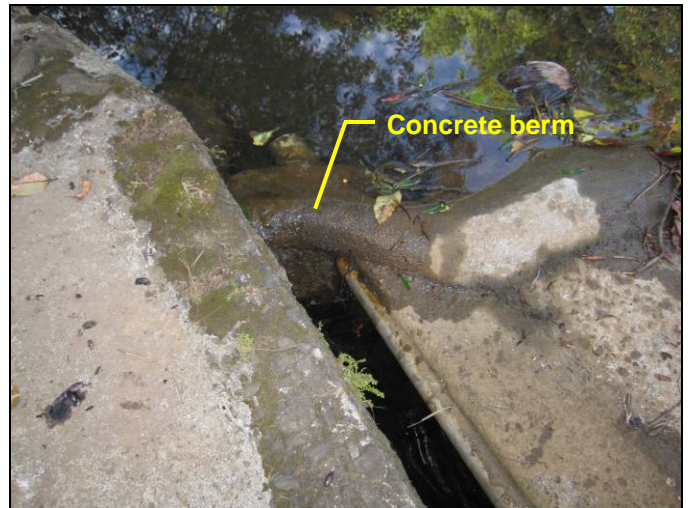
Concrete berm proposed for modification.

- EMI intends to use cement to construct a small channel in the diversion intake structure where there is currently an opening nearest the right bank of the stream. The concrete berm on the upstream end of the channel will also be chipped away to allow water to flow downstream in the channel. The channel should be kept fairly rough (i.e., not smooth).
- EMI will also construct a small concrete berm near at the base of the water drop from the low-flow bypass channel to prevent water from flowing back into the Haiku Ditch.

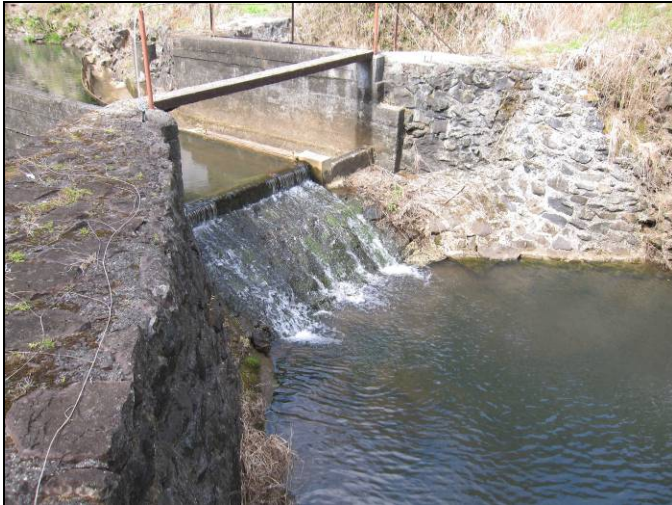
- No actions are proposed for this site since bypass provides flow downstream.

Overflow bypass from the New Hamakua Ditch diversion intake.

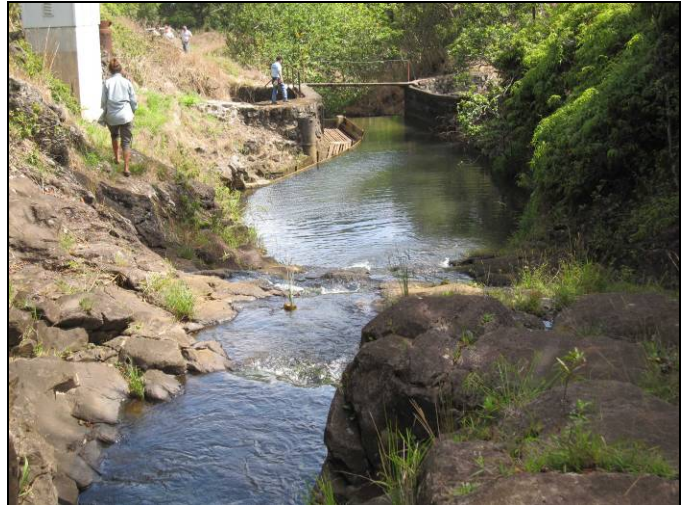
Downstream view from above the New Hamakua Ditch intake bypass.

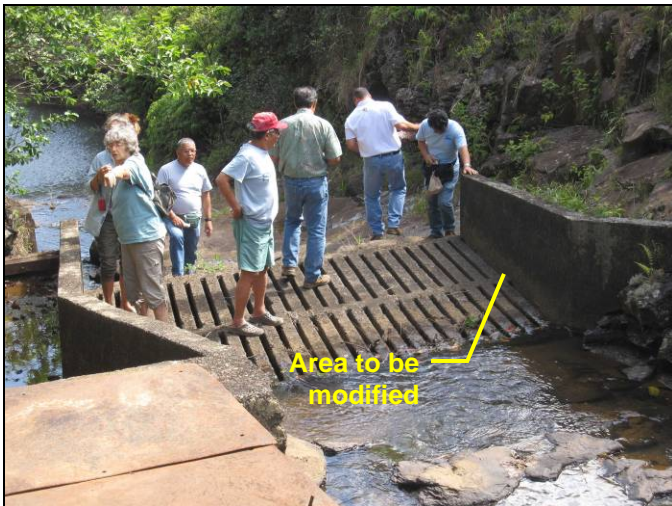
Downstream view of the Wailoa Ditch diversion intake.

Note: At the time of the site visit, the sluice gate bypassing water from the Wailoa Ditch intake was wide open. EMI indicated that they had not opened the gate more than the height which had been agreed to at a previous visit.

- One option discussed was to place an iron 'H' beam on the right bank edge of the diversion intake grates, and bolted into the wing wall.
- The preferred option is to fill the first intake grate section (from the right bank) with cement, and leave the concrete slightly depressed to allow the section to fill with water and pool. Upon filling, the section would be expected to overflow down the intake apron to provide a wetted face for connectivity.

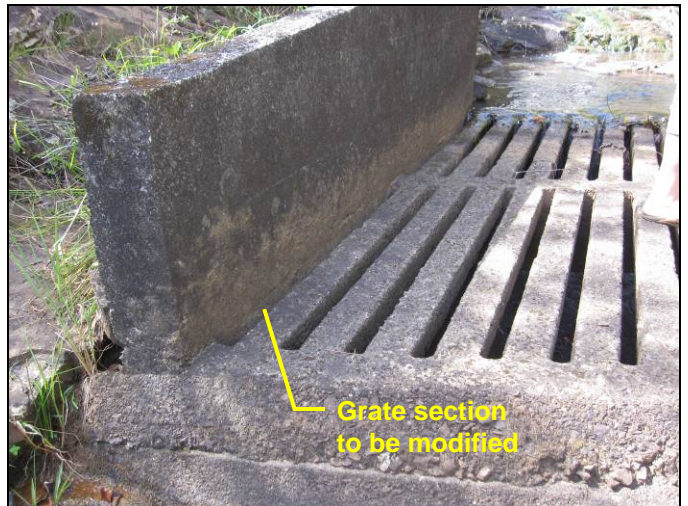
Close-up of the right bank of the Wailoa Ditch intake grate.
