**Final
Addendum to an
Archaeological Inventory Survey
of Approximately 1339-Acres of Castle and Cooke Lands
Waipi‘o and Waiawa Ahupua‘a,
‘Ewa District, O‘ahu Island**

**TMK: [1] 9-4-006:001 por., 002 por., 029 por.;
9-5-003: 001 por.; and 9-6-004:021 por.**

**Cultural Surveys Hawai‘i, Inc.
Kailua, Hawai‘i
(Job Code: WAPIO 9)**

September 2009

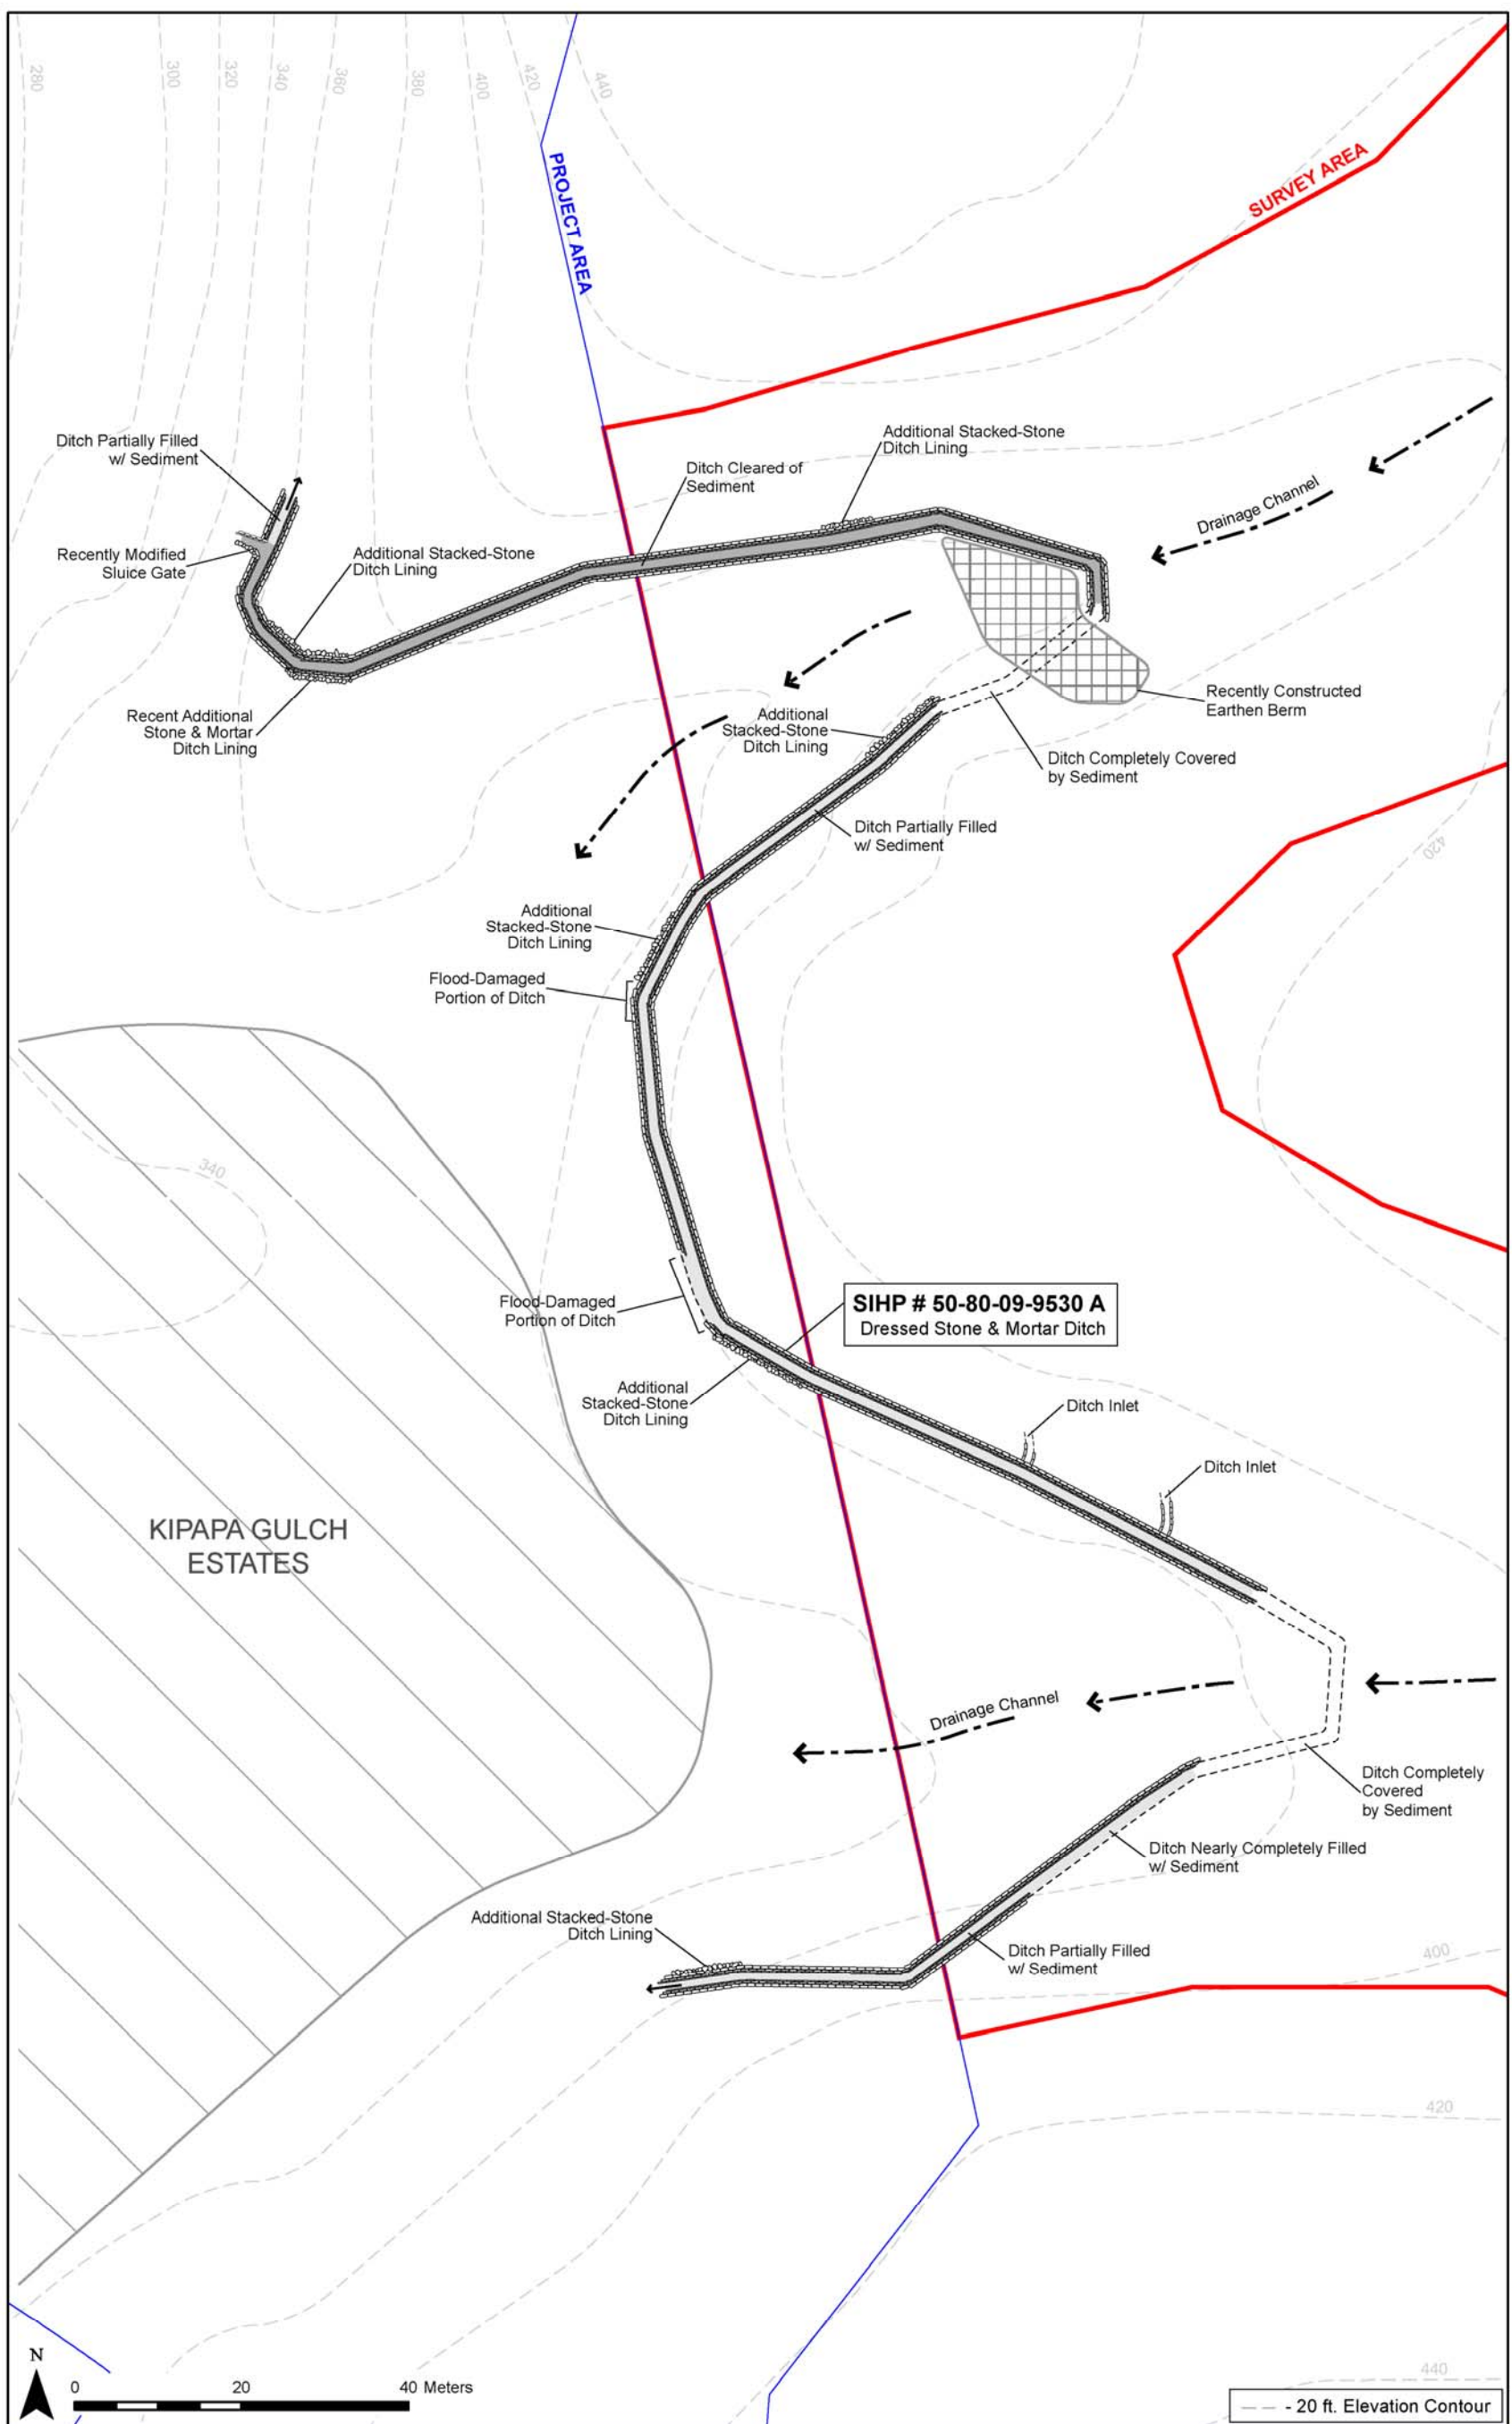
Figure 22. Plan-view diagram of SIHP # 50-80-09-9530 Feature A within Survey Area A

An approximately 330 m long portion of the SIHP # 50-80-09-9530 Feature A irrigation ditch was documented within Survey Area A (Figure 22). The Feature A ditch is constructed along the contour of the eastern slope of Kīpapa Gulch, and extends north and south beyond the survey area. The ditch is generally U-shaped, with a flat bottom and sloping side walls, measuring 1.2-1.8 m wide at the base and 2.2-2.8 m wide at the top surface, with depths of 1.3-1.6 m. The interior of the ditch is lined with cut (“dressed”) and mortared basalt blocks, each measuring approximately 30 by 30 cm, 4-5 courses high along the side walls of the ditch (Figure 23). The base of the ditch is lined with cement. Portions of the ditch walls are reinforced with the addition of stacked basalt boulder and cobble retaining walls, 2-4 courses high, constructed above the top of the mortared basalt blocks (Figure 24). The additional stacked-stone retaining walls are generally located along the upslope wall of the ditch in areas where the ditch is heavily cut into the hillside, and along the downslope wall in areas where the ditch makes sharp curves.

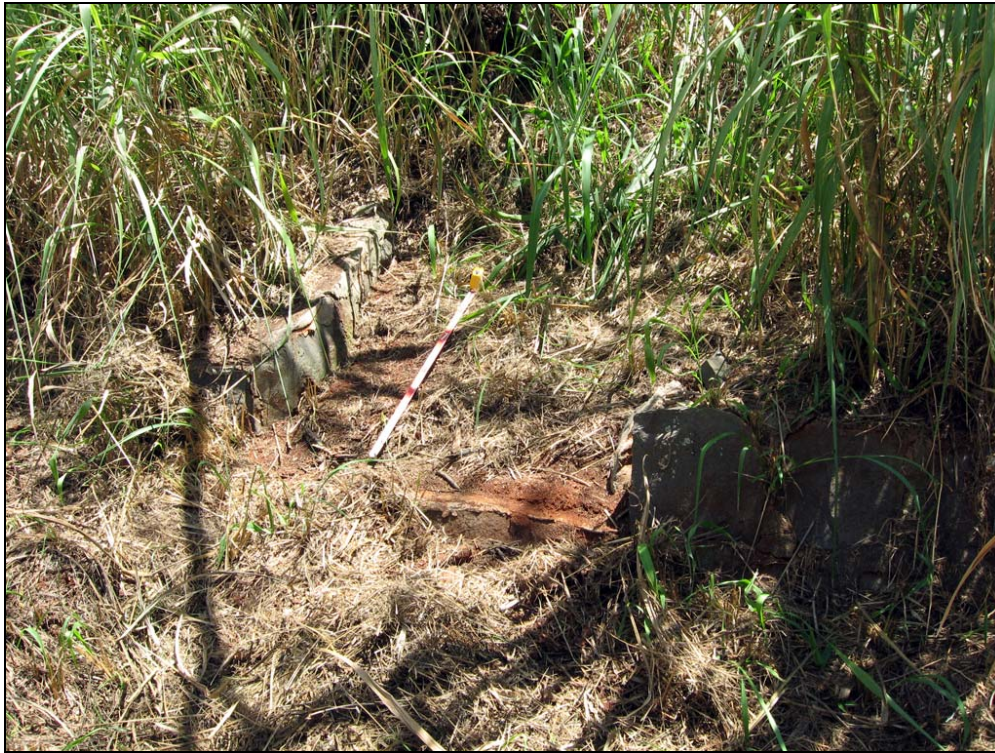
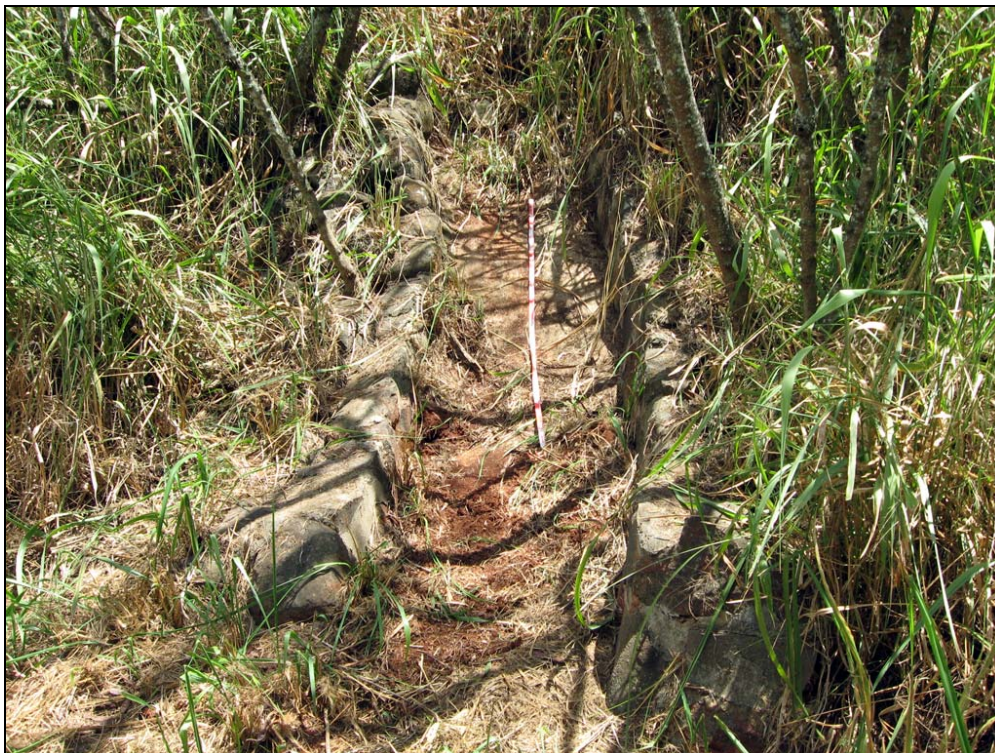
Figure 26. SIHP # 50-80-09-9530 Feature A irrigation ditch, showing ditch inlets adjacent to the upslope ditch wall (views to north)

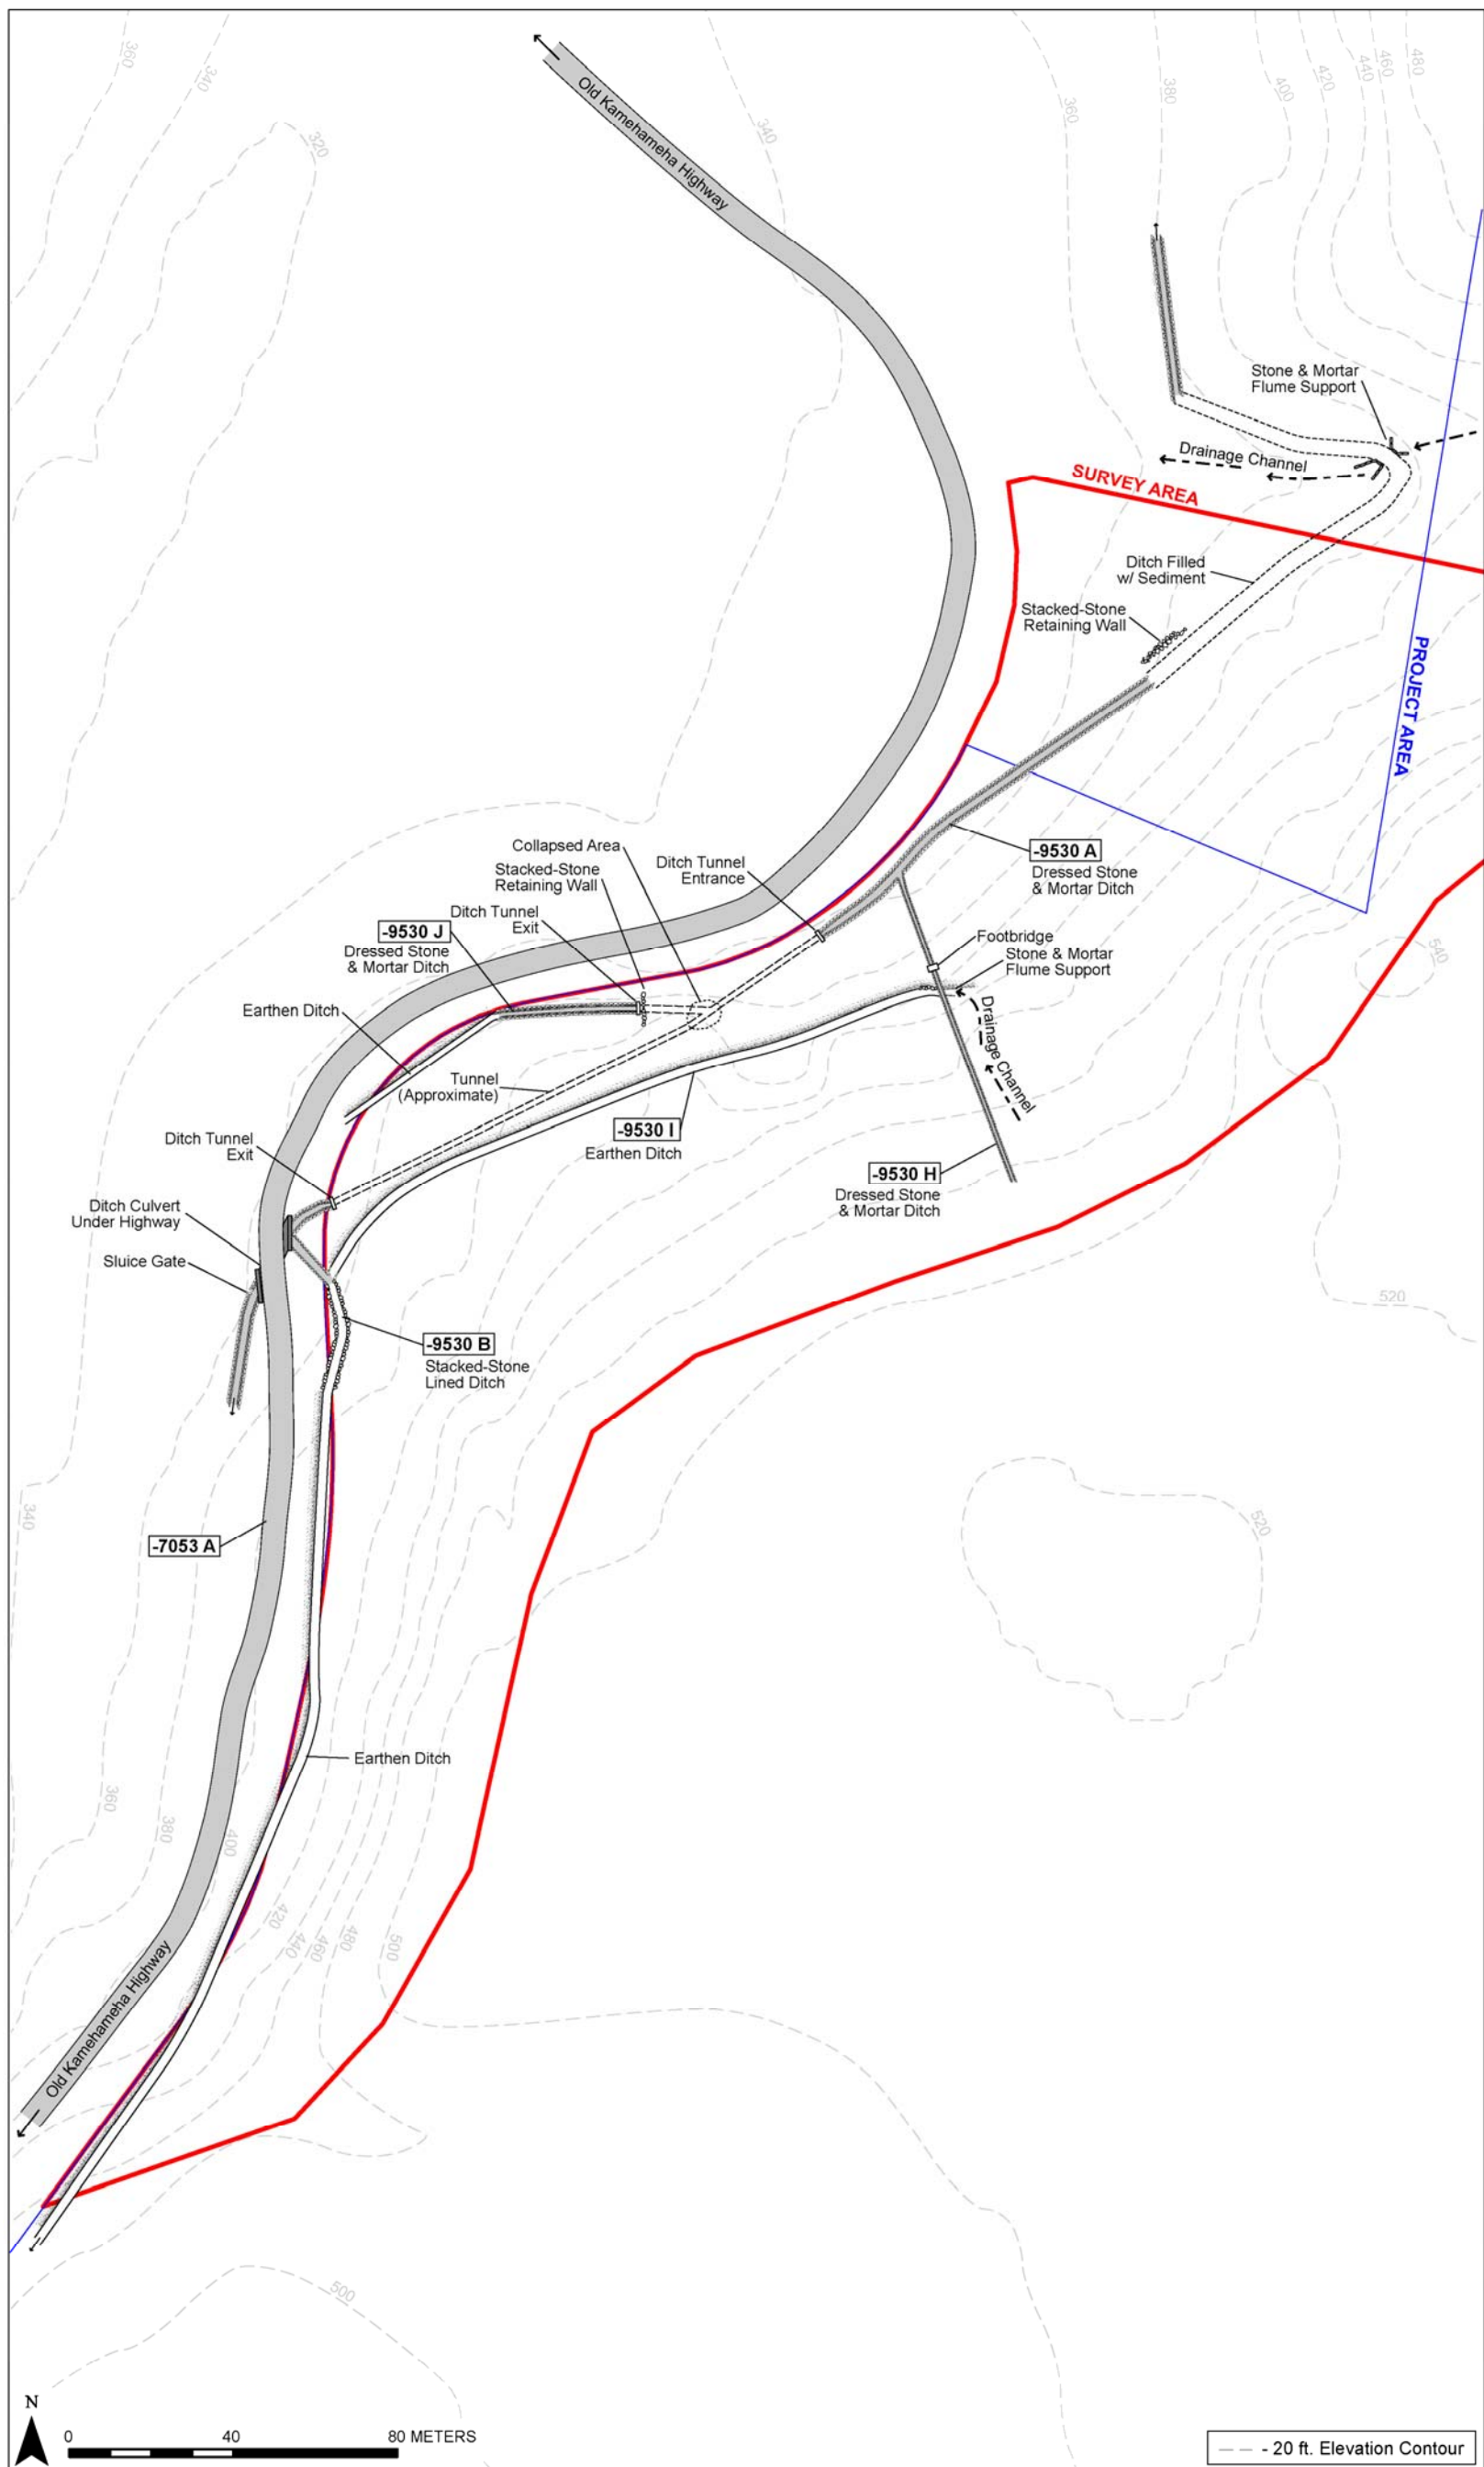
Figure 29. Plan-view diagram of SIHP # 50-80-09-9530 within Survey Area B

Five component features of SIHP # 50-80-09-9530 were identified within Survey Area B (Figure 29). An approximately 300 m long portion of the Feature A irrigation ditch is constructed along the contour of the steep gulch slope. Portions of the Feature A ditch immediately north and south of Survey Area B were documented in detail by Tulchin et al. (2009). Within Survey Area B, much of the Feature A ditch is partially or completely filled with sediment eroding from upslope areas. Based on observations of the exposed portions of the ditch, the general construction of the ditch appears to be fairly uniform throughout its length, with dimensions equivalent to those observed in the recently excavated portions of the Feature A ditch in Survey Area A.

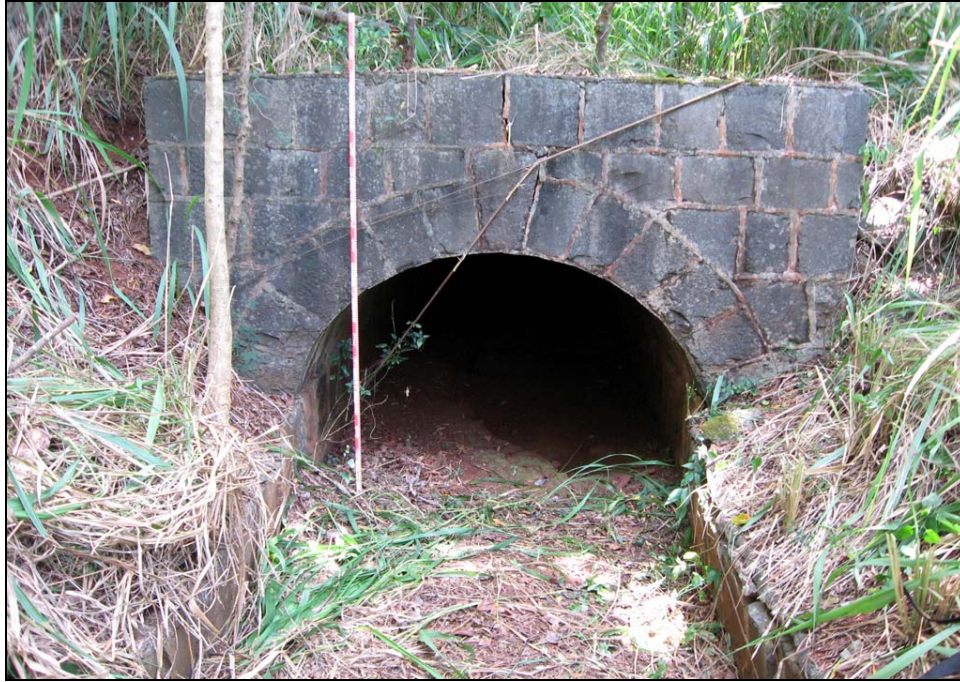
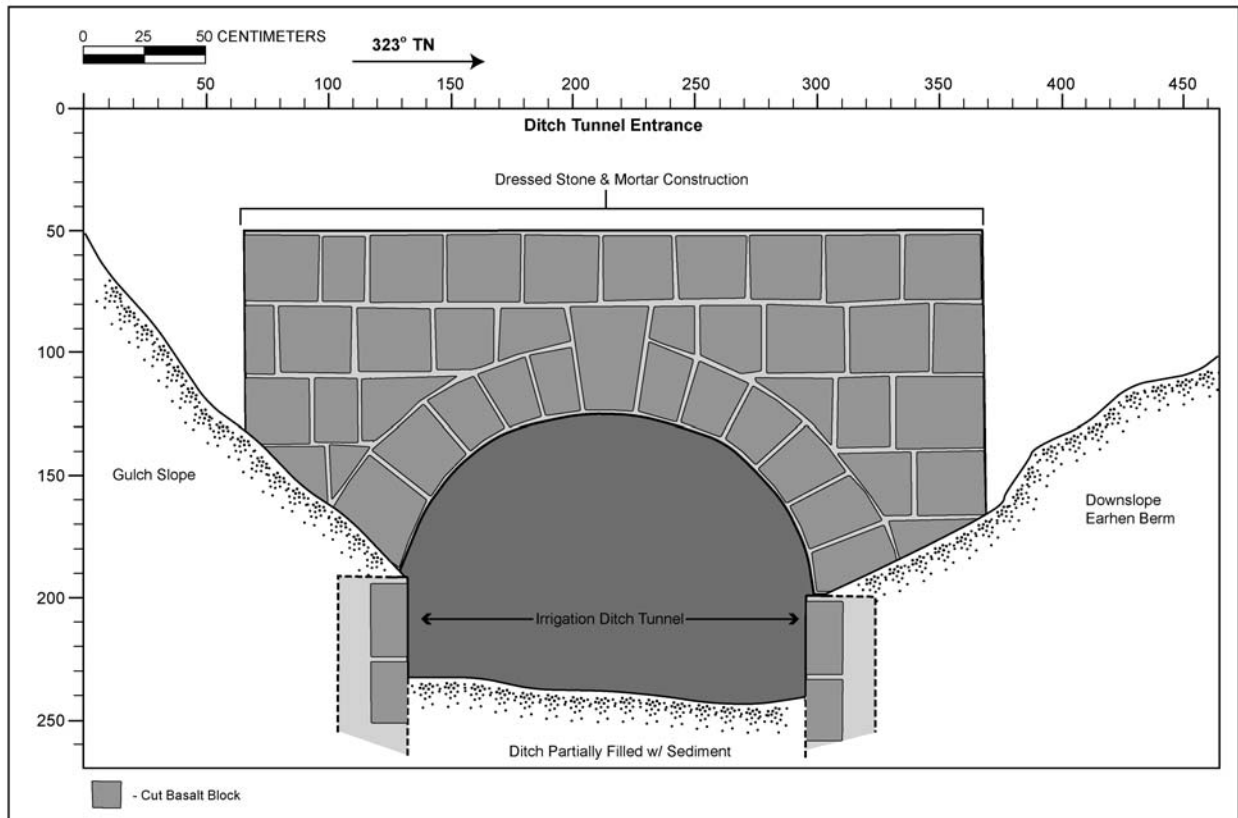
In the central portion of Survey Area B, the Feature A ditch enters an approximately 135 m long ditch tunnel. Prior to entering the tunnel, the Feature A ditch narrows from 3.1 to 1.7 m in width. The ditch tunnel entrance is constructed of cut (“dressed”) and mortared basalt blocks, measuring 3.0 m wide and 1.5 m high above the sidewall of ditch (Figure 30). The ceiling of the ditch tunnel is arched, with a height of 65 cm above the ditch sidewall (Figure 31). A portion of the ditch tunnel has collapsed, revealing the tunnel construction (Figure 32). The tunnel was apparently excavated through loose soil as well as solid rock, with the ceiling of the tunnel reinforced with an approximately 15 cm thick cement lining. The Feature A ditch exits the tunnel near the western boundary of Survey Area B. The ditch tunnel exit is of similar construction as the ditch entrance, measuring 3.3 m wide and 1.6 m high above the sidewall of ditch (Figure 33). A date plaque of “1931” is carved into the basalt block above the tunnel arch. The Feature A ditch continues south, beyond Survey Area B, where it crosses beneath the Old Kamehameha Highway alignment (SIHP # 50-80-09-7053) via a culvert. The ditch culvert was documented in detail by Tulchin et al. (2009).

Figure 30. Photograph (above, view to southwest) and profile diagram (below) of the SIHP # 50-80-09-9530 Feature A ditch tunnel entrance

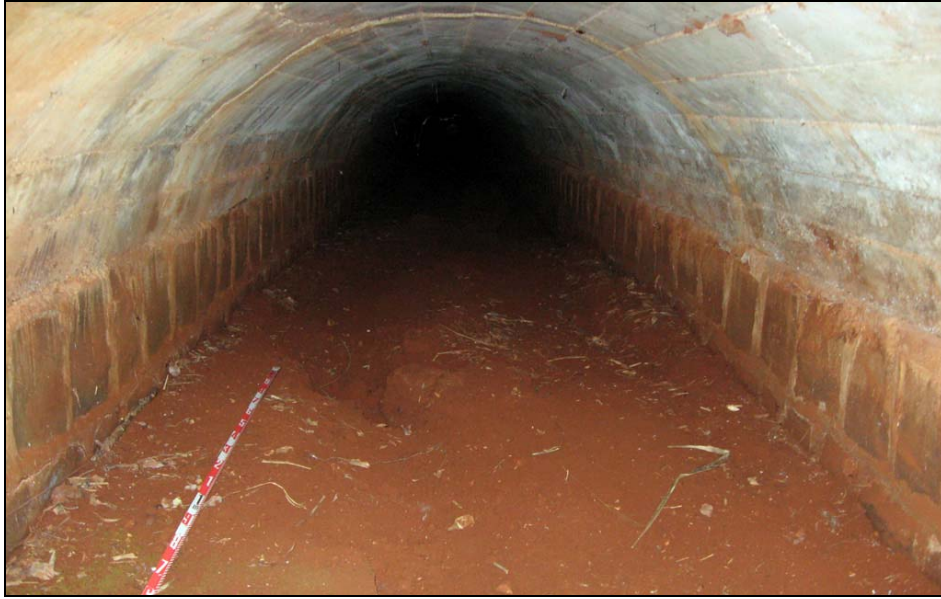
Figure 31. Photograph of the interior of the SIHP # # 50-80-09-9530 Feature A ditch tunnel

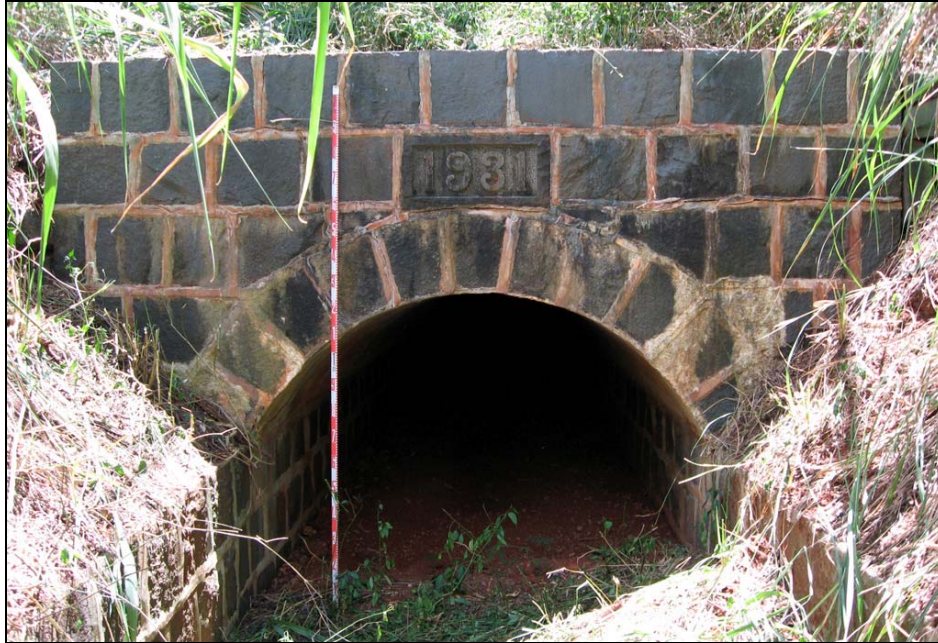
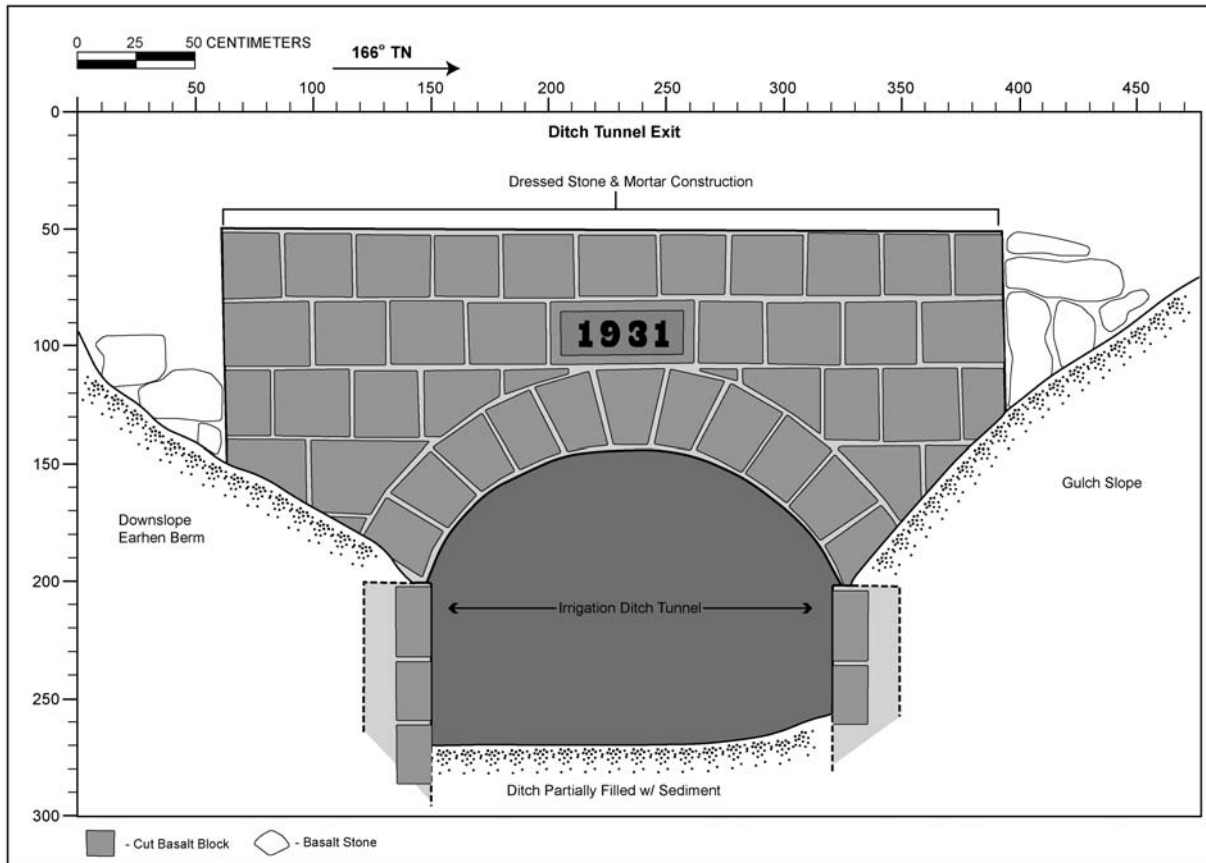
Figure 33. Photograph (above, view to northeast) and profile diagram (below) of the SIHP # 50-80-09-9530 Feature A ditch tunnel exit

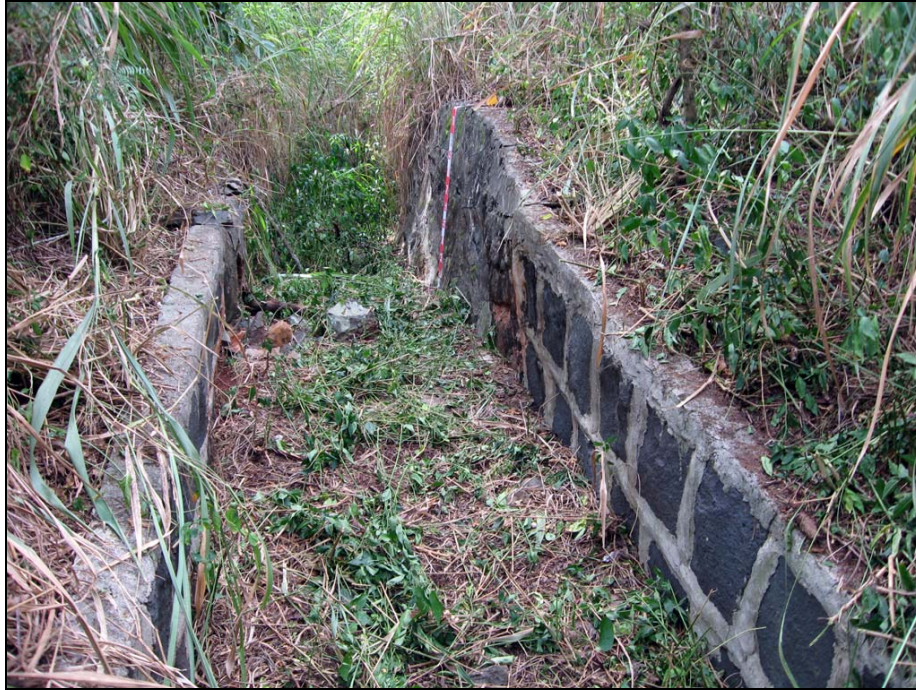
Figure 34. Photograph of SIHP # 50-80-09-9530 Feature B ditch, showing cut (“dressed”) stone and mortar construction transitioning to natural stone and mortar construction, view to southeast

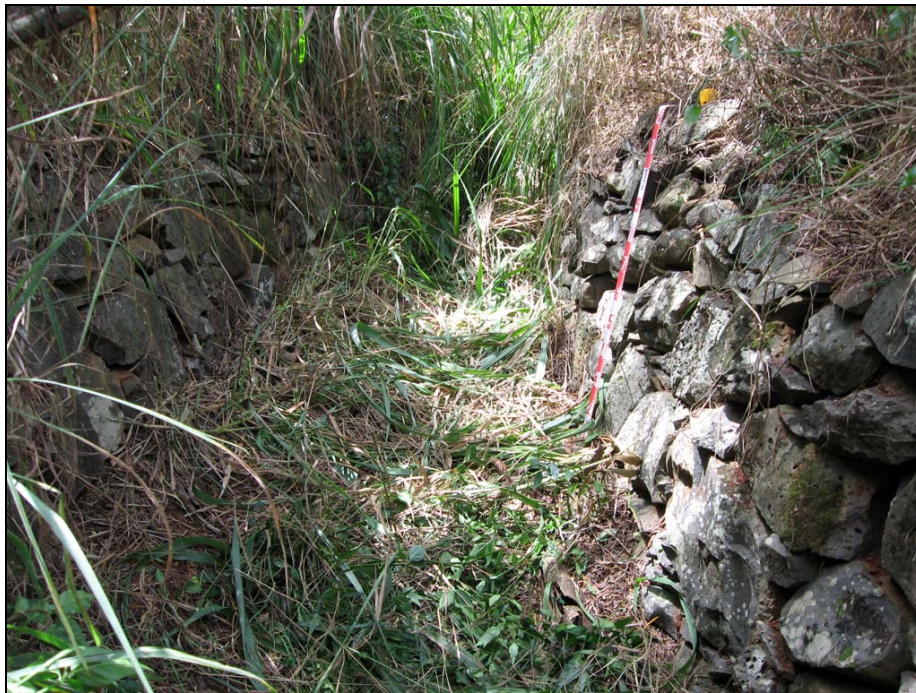
Figure 35. Photograph of SIHP # 50-80-09-9530 Feature B ditch, showing stacked-stone construction, view to south

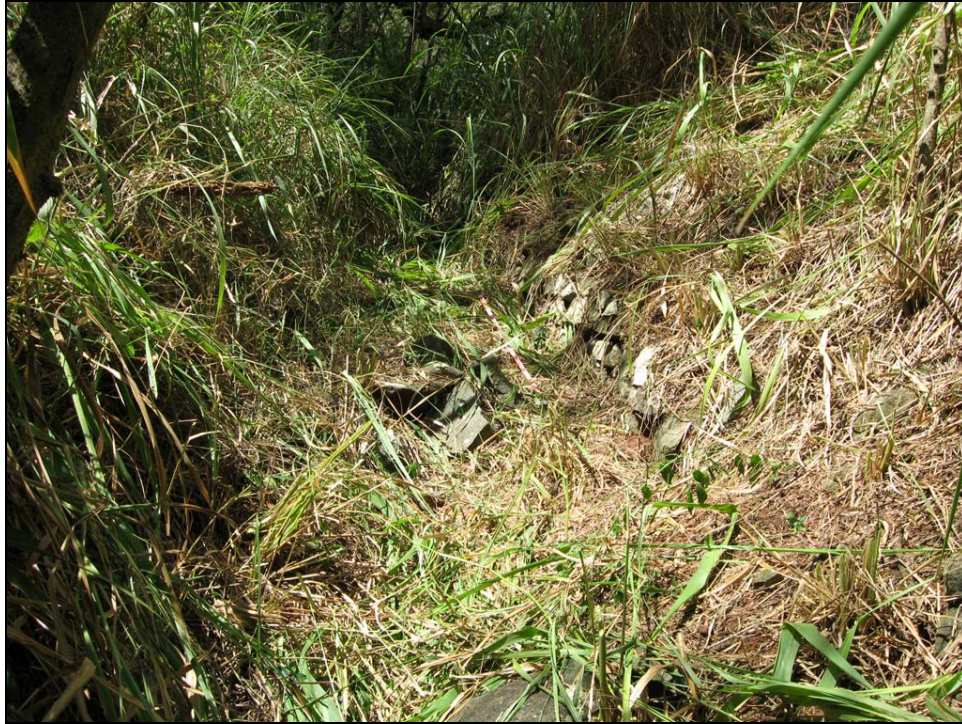
measuring 1.5-2.5 m wide and 0.5-1.5 m deep, with an earthen berm along the downslope edge (Figure 36). Feature B continues to parallel the Old Kamehameha Highway alignment to the south, beyond Survey Area B. Feature B likely functioned as a water diversion / drainage feature. The ditch collects storm water draining from the eastern gulch slope, upslope of the Old Kamehameha Highway alignment. The water is collected along the length of the Feature B ditch and is then directed into the Feature A irrigation ditch and beneath the highway via the aforementioned ditch culvert, thereby preventing flooding of the Old Kamehameha Highway alignment.

Figure 36. Photograph of SIHP # 50-80-09-9530 Feature B ditch, showing primarily earthen ditch construction with limited stacked-stone lining, view to south

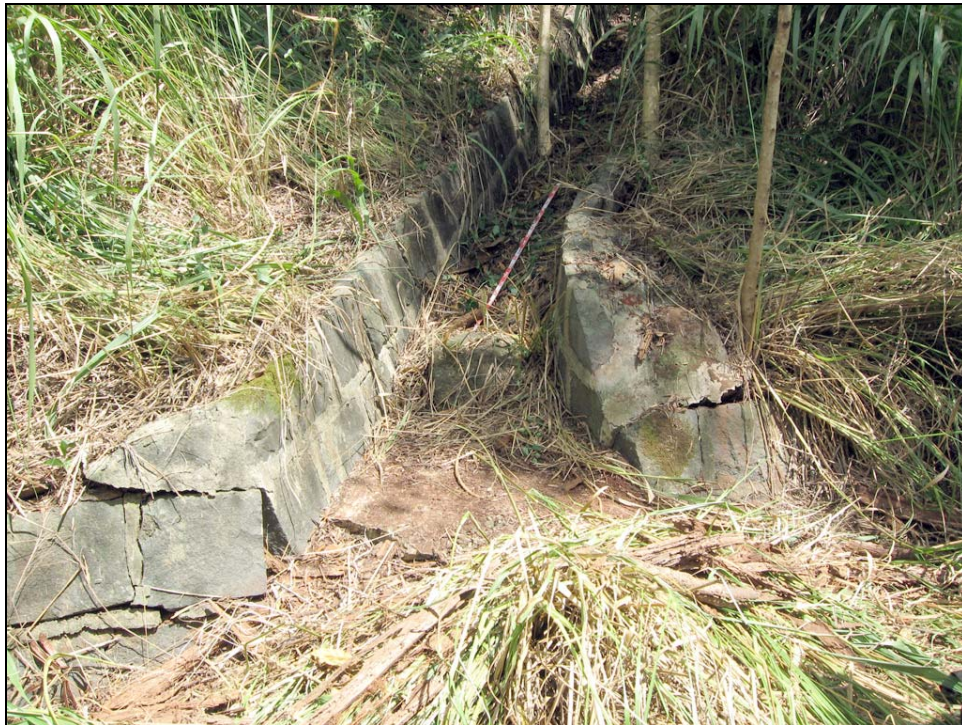
Feature H is an irrigation ditch that connects to the Feature A ditch approximately 20 m north of the ditch tunnel entrance. The Feature H ditch is of similar construction as Feature A, including a lining of mortared basalt blocks, and measures 0.8 m wide and 0.3 m deep (Figure 37). The Feature H ditch is oriented *mauka-makai* (upslope-downslope), extending upslope from the Feature A ditch to the edge of the tablelands, where it has been disturbed by modern agricultural activities. The Feature H ditch likely connected to the plantation irrigation system along the tablelands upslope of Survey Area B, allowing excess irrigation water from the plantation fields to be recovered by the Feature A ditch and transported to fields further south. Approximately 20 m upslope of the intersection with the Feature A ditch, is a well-constructed bridge over the Feature H ditch (Figure 38). The bridge measures 2.0 by 1.2 m wide, with a height of 1.3 m above the sidewall of the ditch. The bridge rests on a mortared basalt block foundation, with the bridge constructed from a base layer of iron railroad tracks, followed by a layer of sheet metal, 3 courses of stacked basalt boulders and cobbles, and a top layer of sheet-metal. The bridge appears to function as a footbridge, likely associated with maintenance of the plantation ditch system.

Figure 37. Photograph of SIHP # 50-80-09-9530 Feature H ditch, view to south

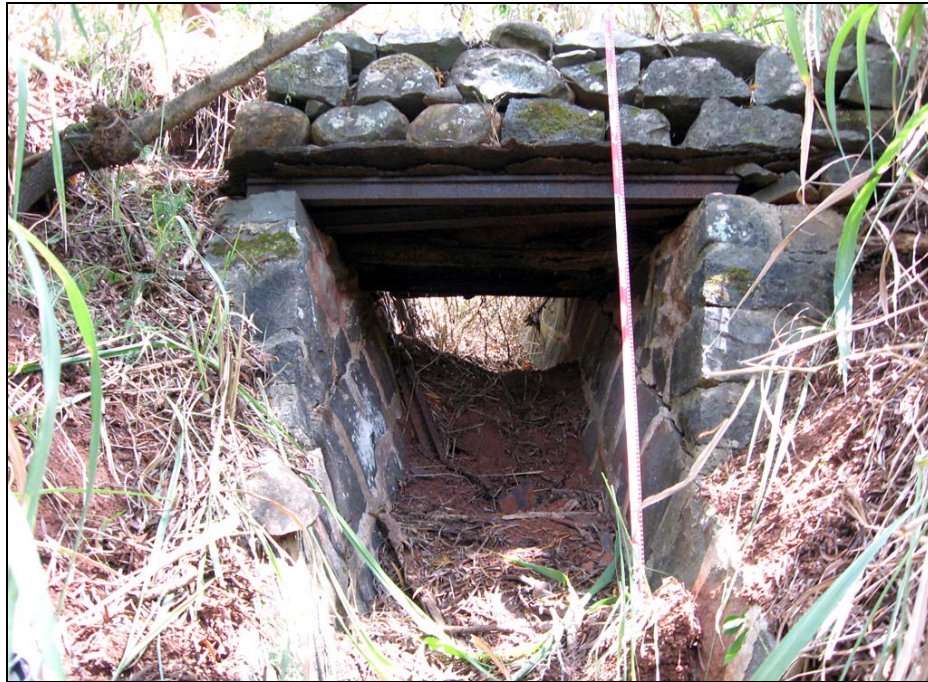
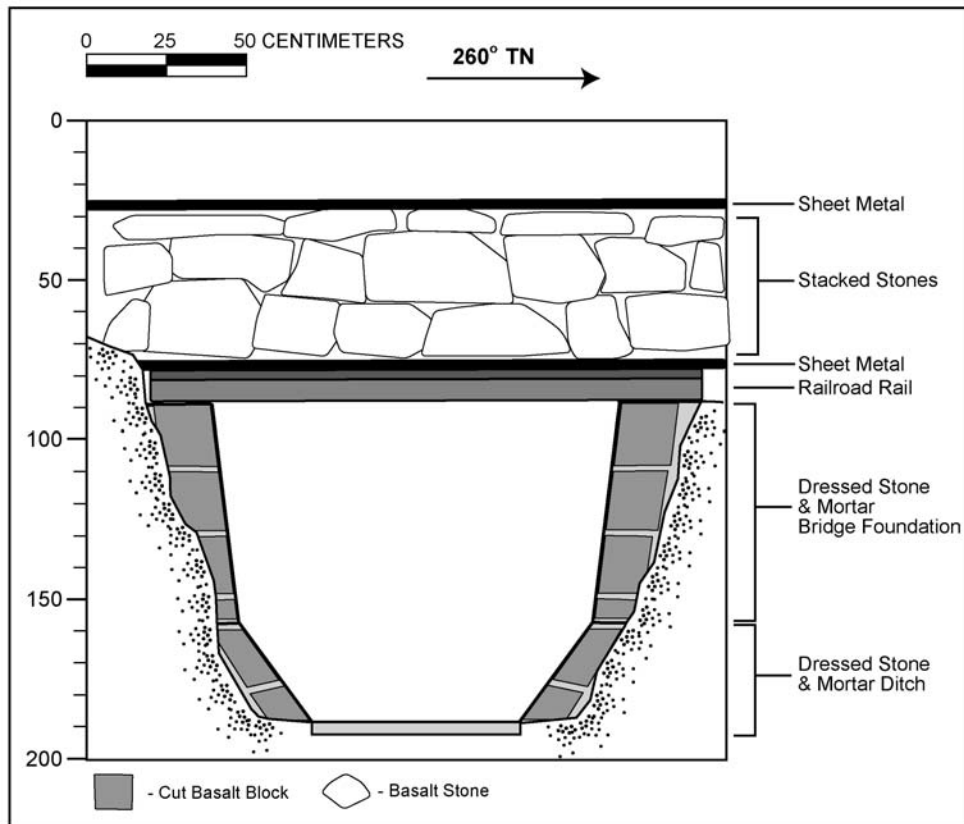
Figure 38. Photograph (above, view to southeast) and profile diagram (below) of the SIHP # 50-80-09-9530 Feature H footbridge

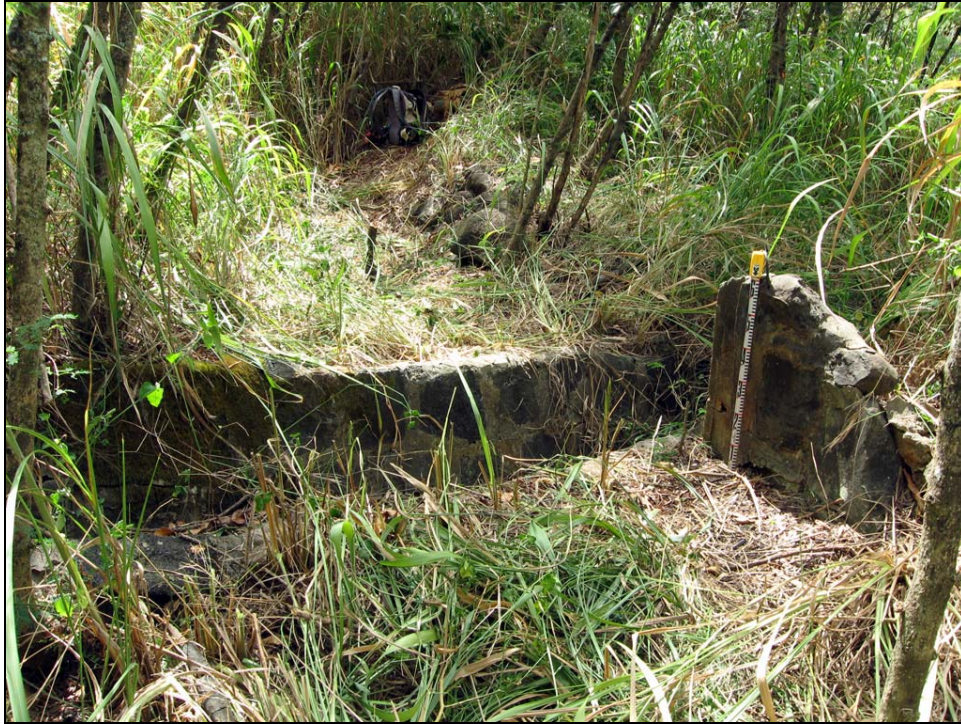
Feature I is a ditch that extends along the eastern slope of Kīpapa Gulch, upslope from and generally parallel to the Feature A ditch. The Feature I ditch originates at an intersection of a natural drainage channel with the Feature H ditch. At the intersection, an earthen berm lined with stone and mortar wall segments diverts the water flow from the natural drainage over the Feature H ditch and into the Feature I ditch (Figure 39). The stone and mortar walls have notches that likely functioned as the foundation for a wooden or metal flume over the Feature H ditch. The Feature I ditch is primarily an earthen ditch, measuring 1.5-2.5 m wide and 0.5-1.0 m deep, with an earthen berm along the downslope edge. The downslope wall of the ditch is lined with stacked stones near intersection with the Feature H ditch. The Feature I ditch progresses cross-slope for approximately 170 m, upslope of the Feature A ditch tunnel, until connecting with the Feature B ditch. Feature I likely functioned as a water diversion / drainage feature. The ditch collects storm water from a natural drainage channel, as well as water draining from the eastern gulch slope, upslope of the Feature A ditch tunnel. The water is collected along the length of the Feature I ditch, directed into the Feature B ditch, and then into the Feature A ditch, beyond the ditch tunnel. The Feature I ditch thereby prevents flooding of the Feature A ditch tunnel and erosion of land above the ditch tunnel. A portion of the Feature I ditch has been breached by flood waters, allowing storm water to now flow over the Feature A ditch tunnel. Erosion caused by the flood waters likely caused the aforementioned collapse of a portion of the Feature A ditch tunnel.

Figure 39. Photograph of the origin of SIHP # 50-80-09-9530 Feature I ditch at the intersection with Feature H ditch, view to northwest

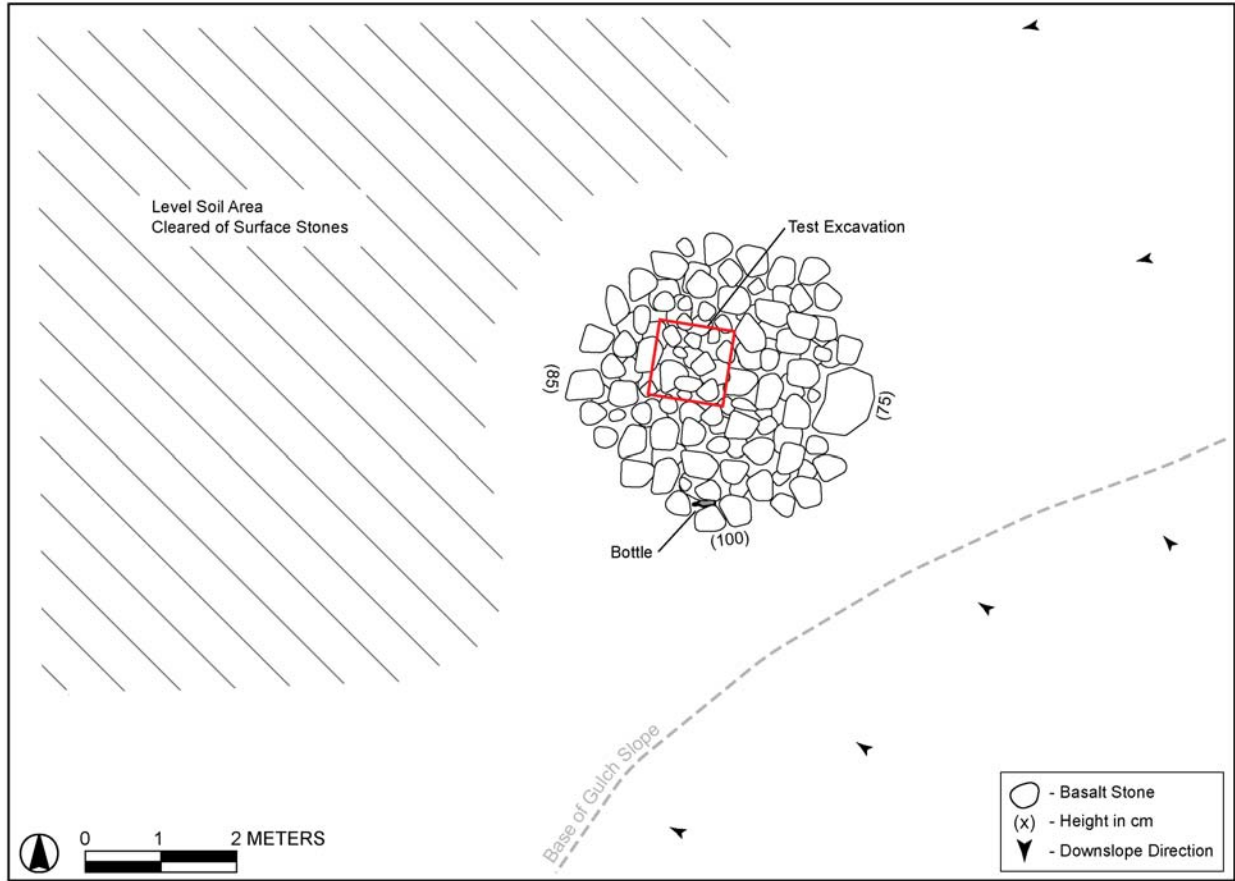
Figure 41. Plan-view diagram of SIHP # 50-80-09-7080 mound

SIHP # 50-80-09-7080 is a rock mound located in the central portion of Survey Area C (see Figure 14 and Figure 15). The mound is situated on the relatively wide and gently sloping base of a tributary gully, near the base of the southern gully slope. The mound is oval-shaped, measuring 4.2 m by 3.9 m in diameter, with a maximum height of 1.0 m (Figure 41). The mound is constructed of loosely piled basalt boulders and cobbles, 1-3 courses high, with large gaps between the stones (Figure 42). The perimeter of the mound is not faced, and the top surface of the mound is sloping and uneven. A particularly large boulder is located at the east edge of the mound. The base of the gully in the vicinity of the mound appears to have been cleared of surface stones.

SIHP # 50-80-09-7080 is likely a clearing mound, constructed during land clearing efforts associated with agricultural cultivation in the early 1900s. SIHP # 50-80-09-7080 is in good condition, with limited disturbance due to erosion and vegetation growth. SIHP # 50-80-09-7080 is assessed as significant under Criterion D (have yielded, or may be likely to yield information important in prehistory or history) of the National and Hawai'i Registers of Historic Places evaluation criteria.

A 1 m by 1 m test excavation was made within the central portion of the SIHP # 50-80-09-7080 mound (see Figure 41) to better determine the function, age, and method of construction of the feature. The test excavation was located in a relatively well-constructed portion of the mound, thought to have the highest likelihood of encountering intact cultural material. The uneven surface of the test excavation consisted of piled basalt boulders and cobbles, covered with a layer of leaf litter and humus (Figure 45). Excavation of the mound revealed that the stones were loosely piled with an accumulation of soil amongst the stone matrix extending to the base of excavation (Figure 46). The stones comprising the mound structure were unsorted, with cobbles and boulders distributed throughout the construction. Several massive boulders were also incorporated into the mound construction.
