**SUBJECT: Rainstorm Events, MSW Cell E-6 Damage Repairs, and Construction of
the Western Drainage System Inspection
Waimanalo Gulch Sanitary Landfill (WGLF)**

INSPECTION REPORT

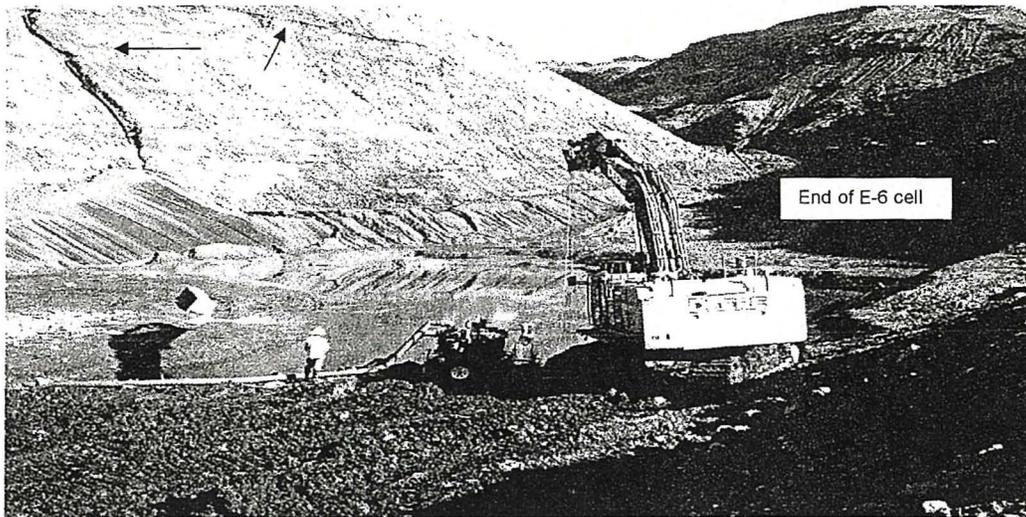
Photograph 1

Location: 92-460 Farrington Highway
 Date taken: December 23, 2010
 Photographer: JRuiz
 Description: Northwestern view of MSW Cell E-6 filled with contaminated storm water from recent rainstorm and contractor pumping the liquid into the southern end of the same cell within the leachate sump area. The red line indicates the north end of Cell E-6, the blue line arrow indicates up canyon area of the landfill and the black arrows indicate the recently installed drainage system for storm water run-on under construction.

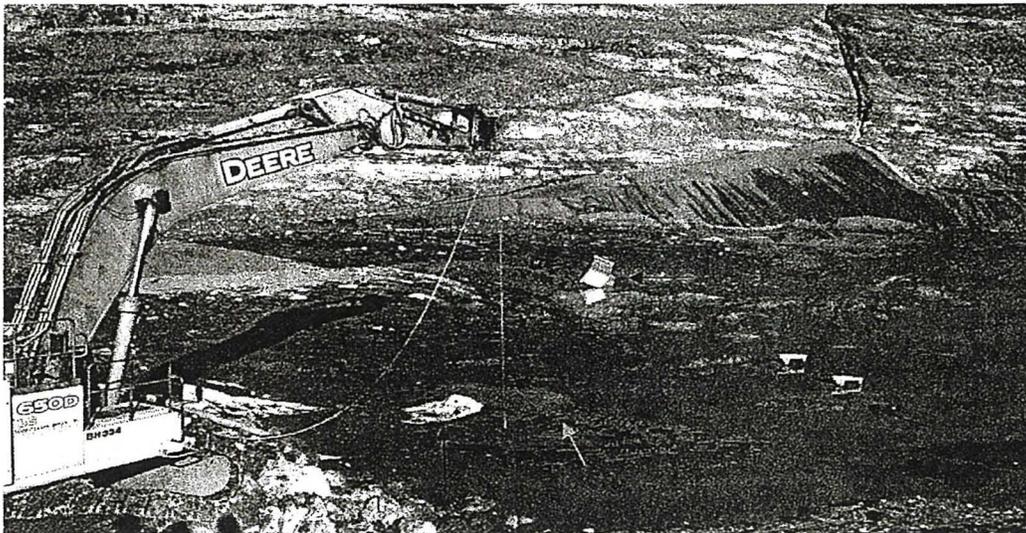
Photograph 2

Site Name: Waimanalo Gulch Landfill
 Location: 92-460 Farrington Highway
 Date taken: December 23, 2010
 Photographer: JRuiz
 Description: Western view of MSW Cell E-6 with submerged tarpomatic machine and tarp cover used for alternative daily cover (red arrows), a porta-potty on its side (black arrow), and a green hose (green arrow) pumping contaminated storm water into the southern portion of cell E-6.

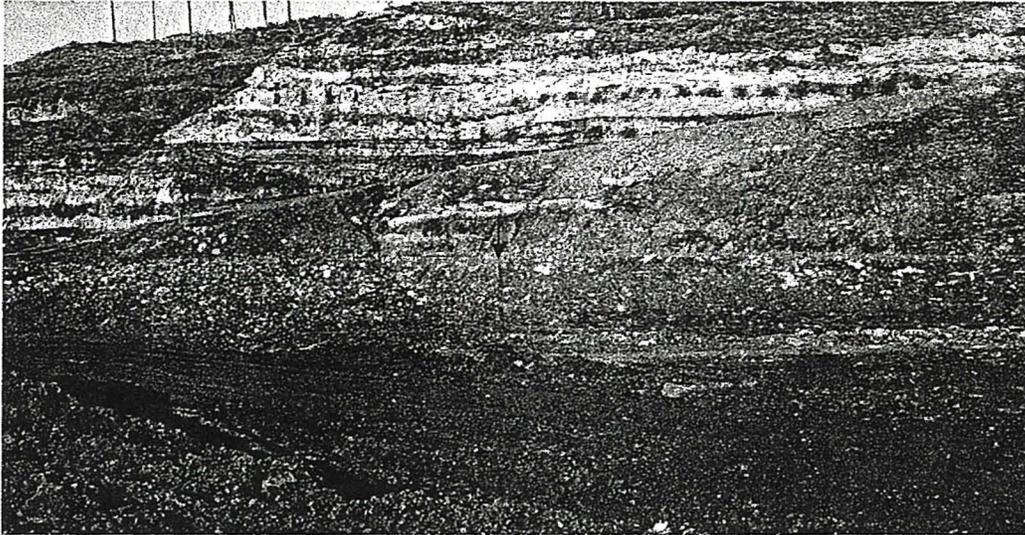
Photograph 3

Site Name: Waimanalo Gulch Landfill
Location: 92-460 Farrington Highway
Date taken: December 23, 2010
Photographer: JRuiz
Description: High-level mark from contaminated storm water on the western side of cell E-6 (red arrow). The high-level mark was estimated at 25 to 30 feet from the top level of the contaminated storm water. The side slope of the cell also shows trash and hospital waste bags (blue) below the high-level mark.

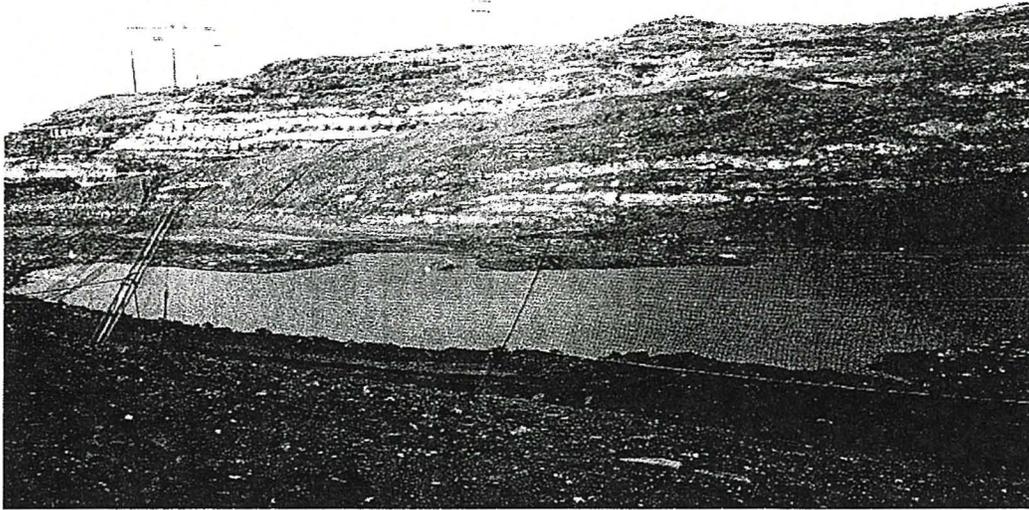
PHOTOGRAPH 1

Site name: Waimanalo Gulch Landfill
Location: 94-460 Farrington Highway
Date taken: December 30, 2010
Photographer: JRuiz
Description: Western view of MSW Cell E-6 inundated with water run-on from up canyon.

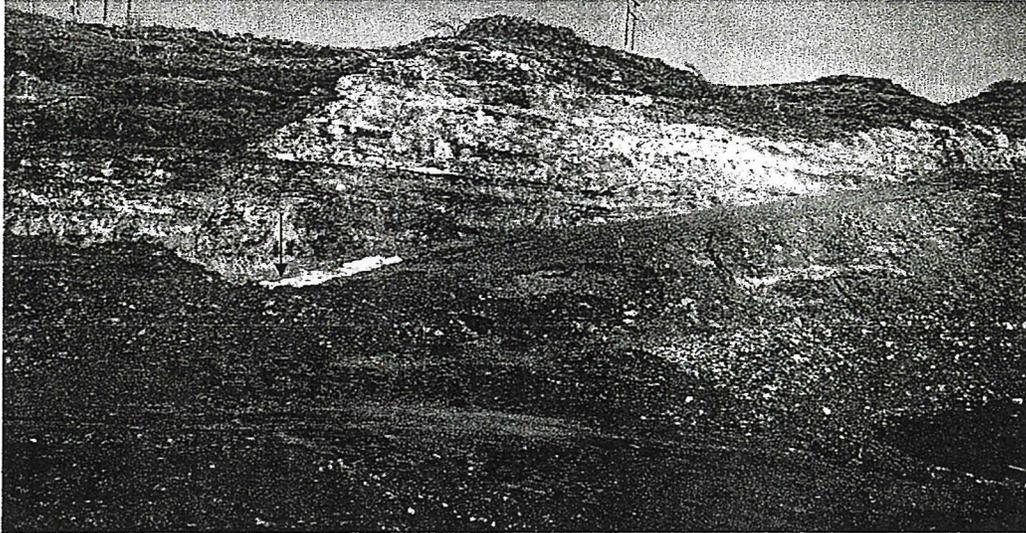
PHOTOGRAPH 3

Site name: Waimanalo Gulch Landfill
Location: 94-460 Farrington Highway
Date taken: January 6, 2011
Photographer: JRuiz
Description: The blue arrow shows the location of the 36-inch manhole that connect to the Hobas pipe (storm water system) and the red arrow shows a 36-inch pipe that penetrates the temporary berm adjacent to the lower pond of Cell E-6.

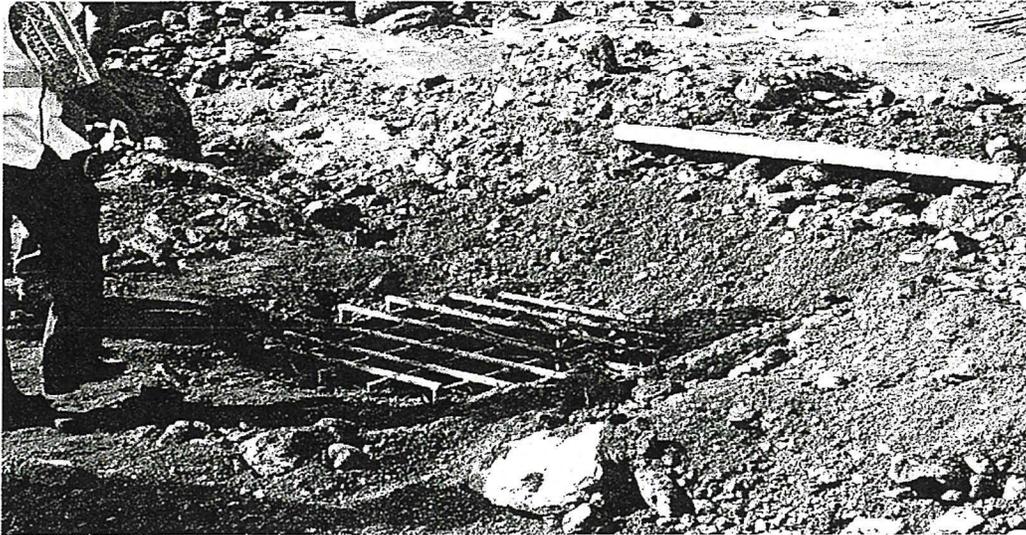
PHOTOGRAPH 5

Site name: Waimanalo Gulch Landfill
Location: 94-460 Farrington Highway
Date taken: January 6, 2011
Photographer: JRuiz
Description: View of the storm water intake to the 48-inch drain inlet for the 36-inch subsurface drainage line located in MSW Cell E-7. The intake was being cleared of soil and rock from the recent storm.

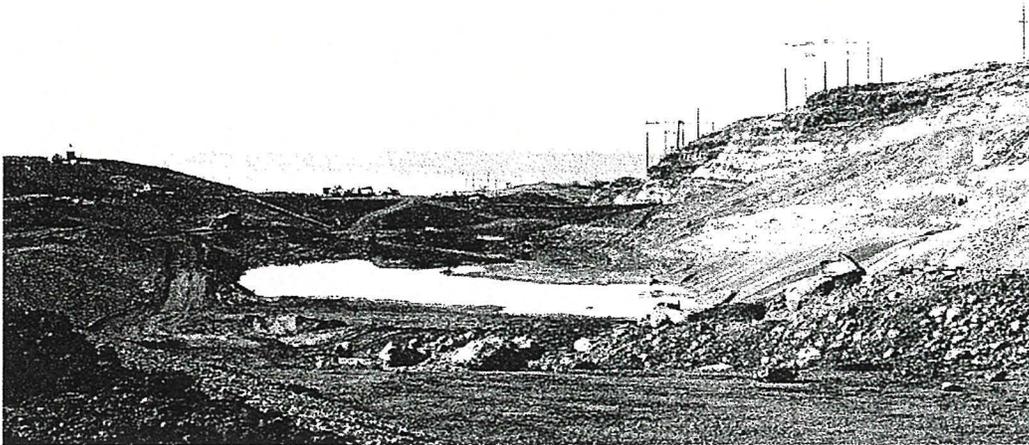
PHOTOGRAPH 6

Site name: Waimanalo Gulch Landfill
Location: 94-460 Farrington Highway
Date taken: January 6, 2011
Photographer: JRuiz
Description: View facing south of MSW Cell E-6

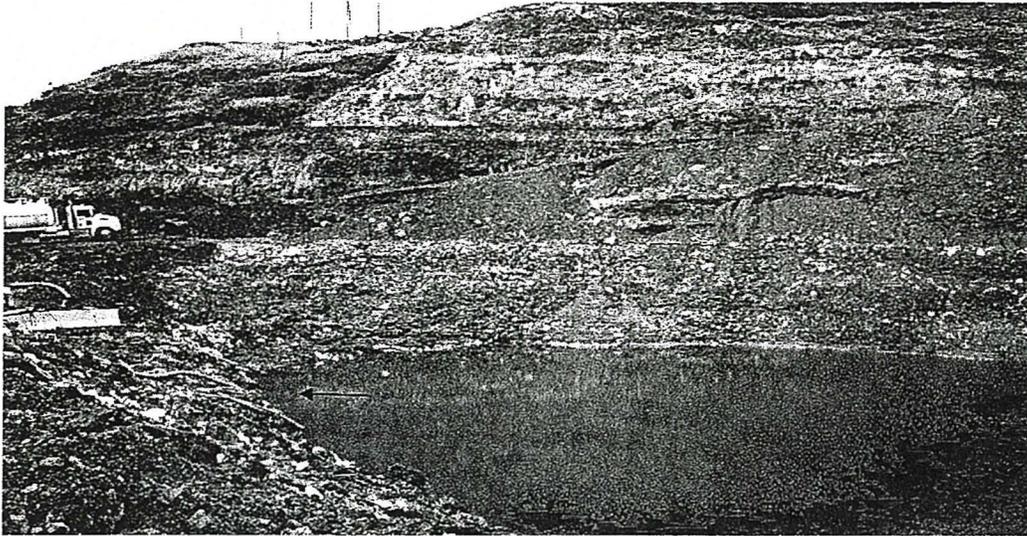
PHOTOGRAPH 1

Site name: Waimanalo Gulch Landfill
Location: 94-460 Farrington Highway
Date taken: January 10, 2011
Photographer: JRuiz
Description: Southwestern view of MSW Cell E-6 (lower pond) being pumped with hoses (black arrow) into the truck at the background and liquids transported to Waianae Waste Water Treatment Plant (WWTP).

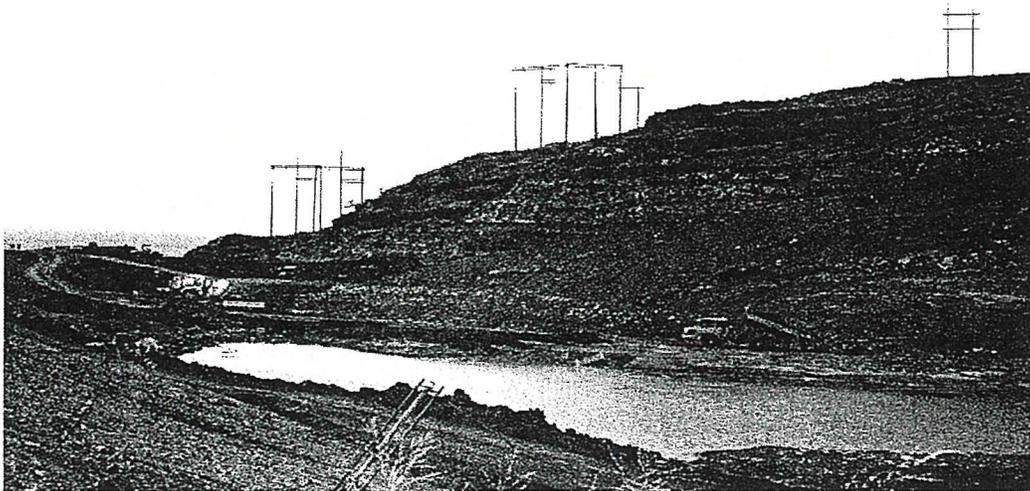
PHOTOGRAPH 6

Site name: Waimanalo Gulch Landfill
Location: 94-460 Farrington Highway
Date taken: January 10, 2011
Description: Southwestern view of MSW Cell E-6 lower pond being pumped by water truck (red arrow) and heavy equipment placing soil cover at the upper pond to cover exposed waste and fill soft spots on the cell.

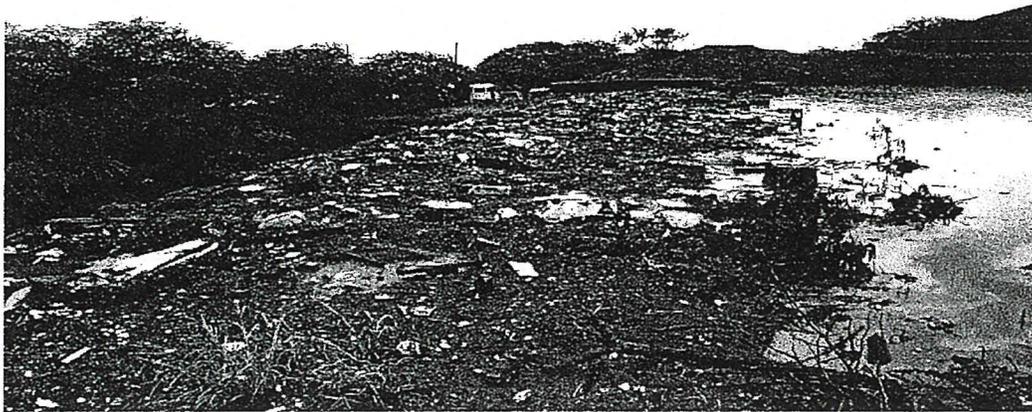
PHOTOGRAPH 2

Site name: Waimanalo Gulch Landfill
Location: 94-460 Farrington Highway
Date taken: January 13, 2011
Photographer: JRuiz
Description: Western view of the sedimentation basin overflow spillway area, overtopped with large amount of trash and debris.

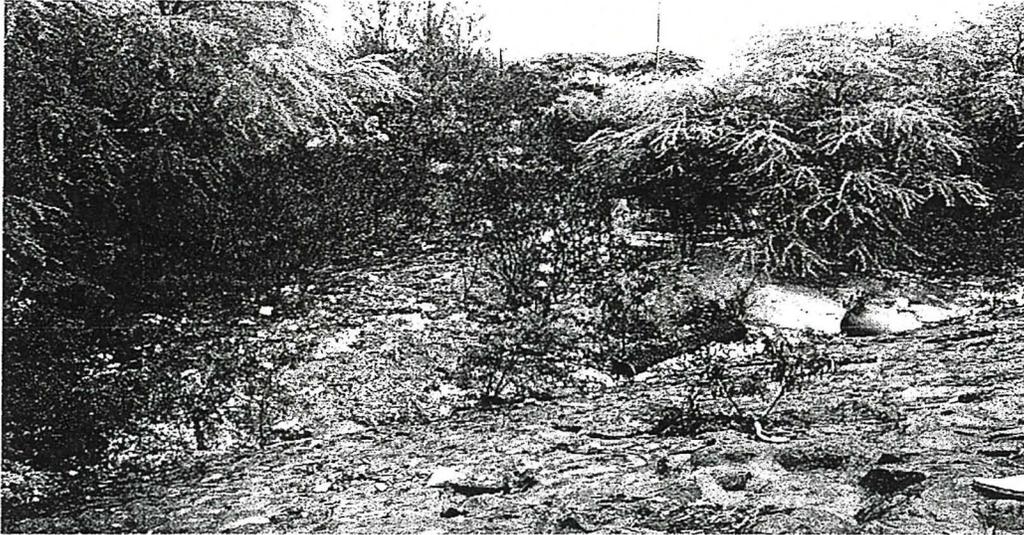
PHOTOGRAPH 3

Site name: Waimanalo Gulch Landfill
Location: 94-460 Farrington Highway
Date taken: January 13, 2011
Photographer: JRuiz
Description: Southern view of trash including medical waste that appeared to have overtopped the sedimentation basin overflow spillway area.

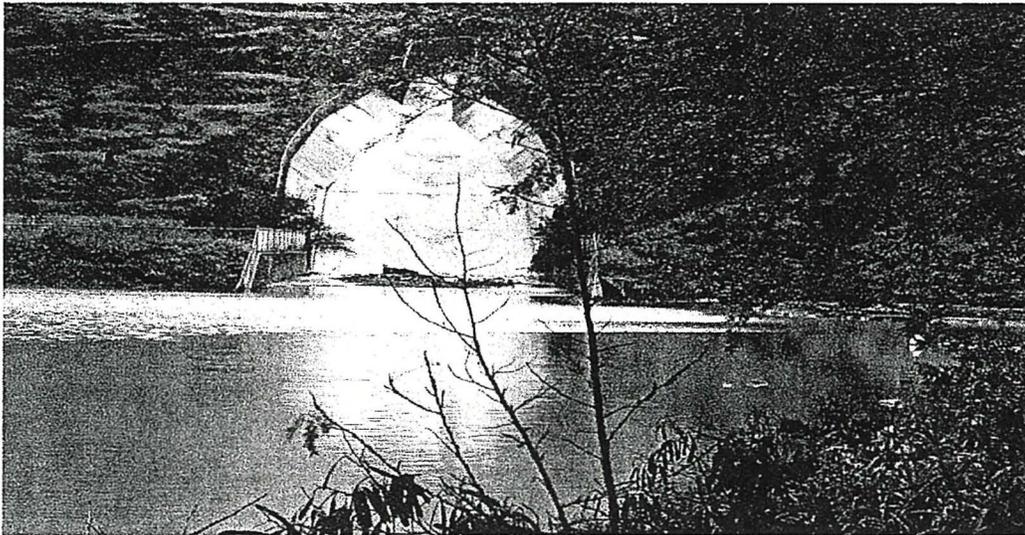
PHOTOGRAPH 4

Site name: Waimanalo Gulch Landfill
Location: 94-460 Farrington Highway
Date taken: January 13, 2011
Photographer: JRuiz
Description: Northern view of the concrete storm water channel with a heavy flow of stormwater discharging into the sedimentation basin.

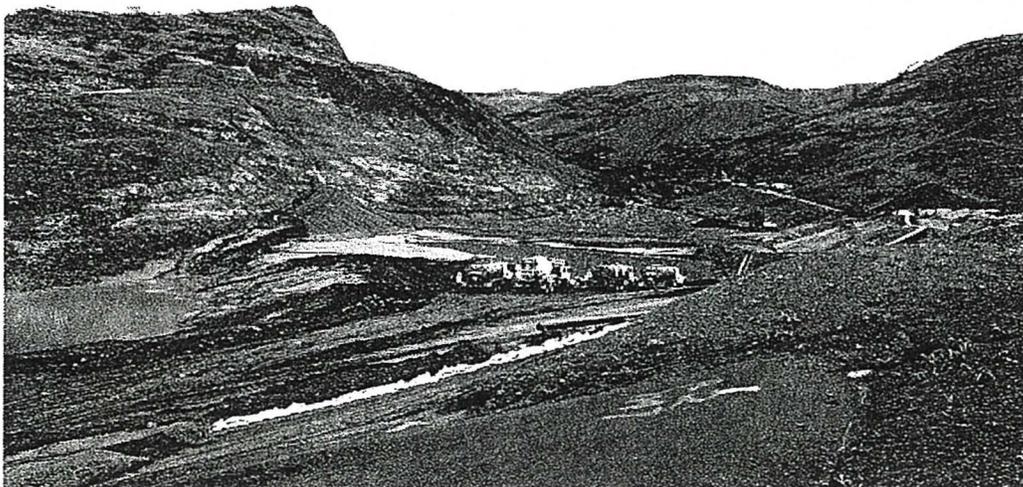
PHOTOGRAPH 4

Site Name: Waimanalo Gulch Landfill
Location: 92-460 Farrington Highway
Date Taken: January 18, 2011
Photographer: JRuiz
Description: Northern view of MSW Cell E-6 with vacuum trucks pumping liquids from the upper pond.

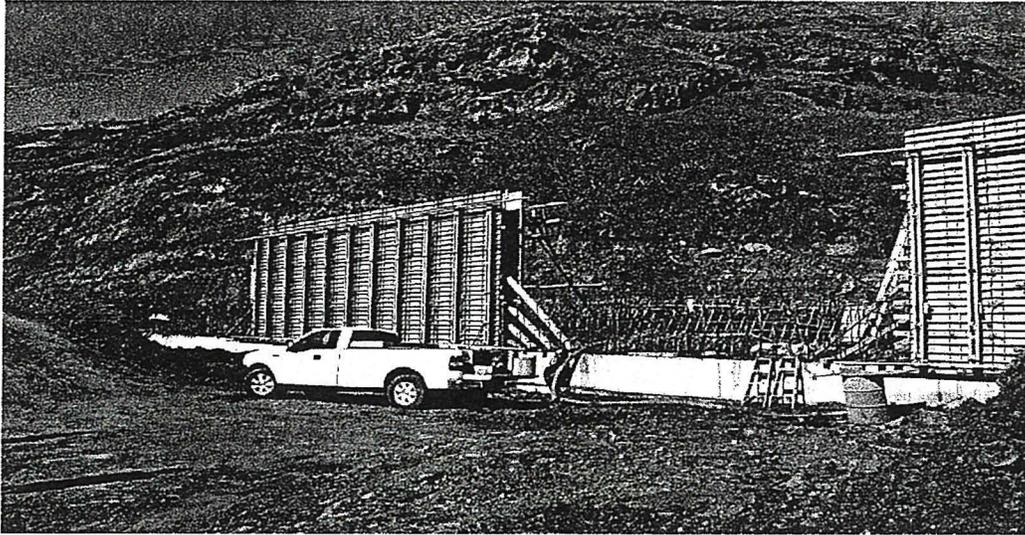
PHOTOGRAPH 3

Site name: Waimanalo Gulch Landfill
Location: 94-460 Farrington Highway
Date taken: January 20, 2011
Photographer: JRuiz
Description: Northern view of the on-going construction for the western surface water drainage system located on the upper canyon of the landfill and just above the future MSW Cell E-9.

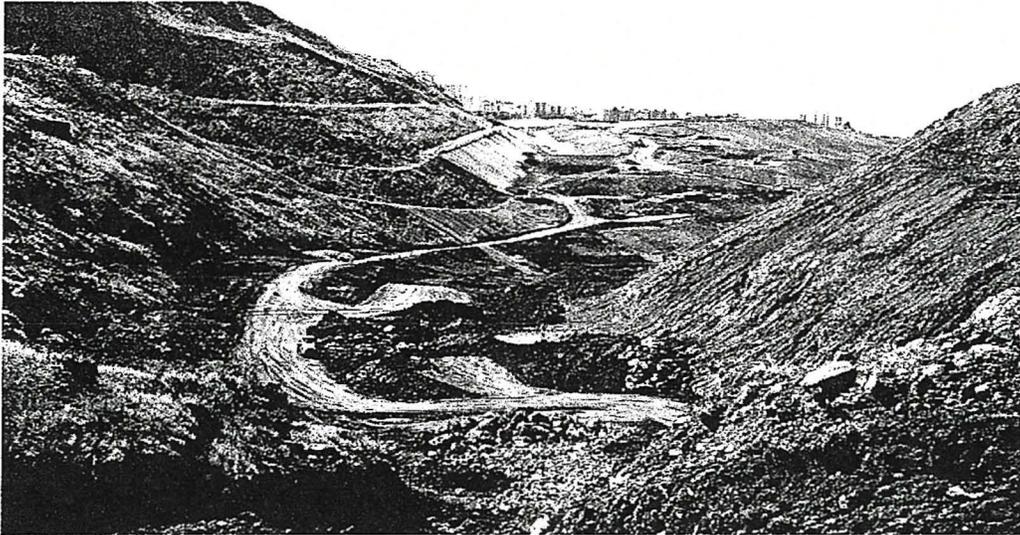
PHOTOGRAPH 5

Site name: Waimanalo Gulch Landfill
Location: 94-460 Farrington Highway
Date taken: January 20, 2011
Photographer: JRuiz
Description: Southern view of the eastern part of landfill from the upper canyon, overlooking MSW E-cells and MSW Cells 3, 4A, C, and 9 to 11.

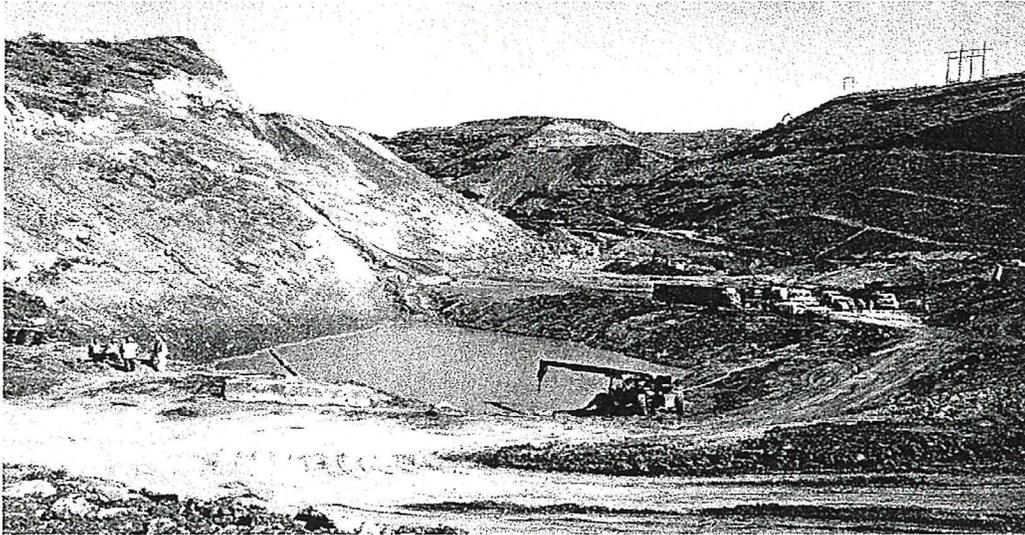
PHOTOGRAPH 7

Site name: Waimanalo Gulch Landfill
Location: 94-460 Farrington Highway
Date taken: January 20, 2011
Photographer: JRuiz
Description: Northern view of MSW Cell E-6 lower pond being pumped into the PCS frac container and C&C water trucks pumping liquid from the upper pond and transporting the liquid to Waianae WWTP for disposal.

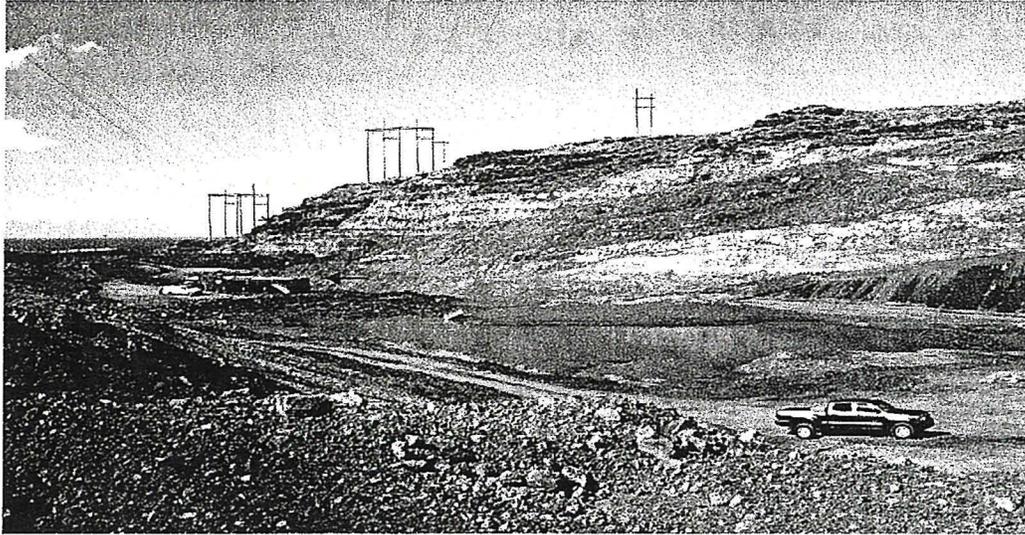
PHOTOGRAPH 1

- Pacific Commercial Services (PCS), WMH's contractor, was observed pumping liquid and mud from MSW Cell E-6's upper pond into a 20,000-gallon frac tank (see photograph 1). PCS then removes most of the liquid from the frac tank and transports in a tanker truck for disposal at Waianae Waste Water Treatment Plant (Waianae WWTP). The mud is then pumped from the frac tank and placed on the top deck of the northeastern cells to dry for later use as daily cover material.

Site name: Waimanalo Gulch Landfill
Location: 94-460 Farrington Highway
Date taken: January 24, 2011
Photographer: JRuiz
Description: PCS continues to pump liquids and silt into a 20,000-gallon frac tank (red arrow) from MSW Cell E-6.

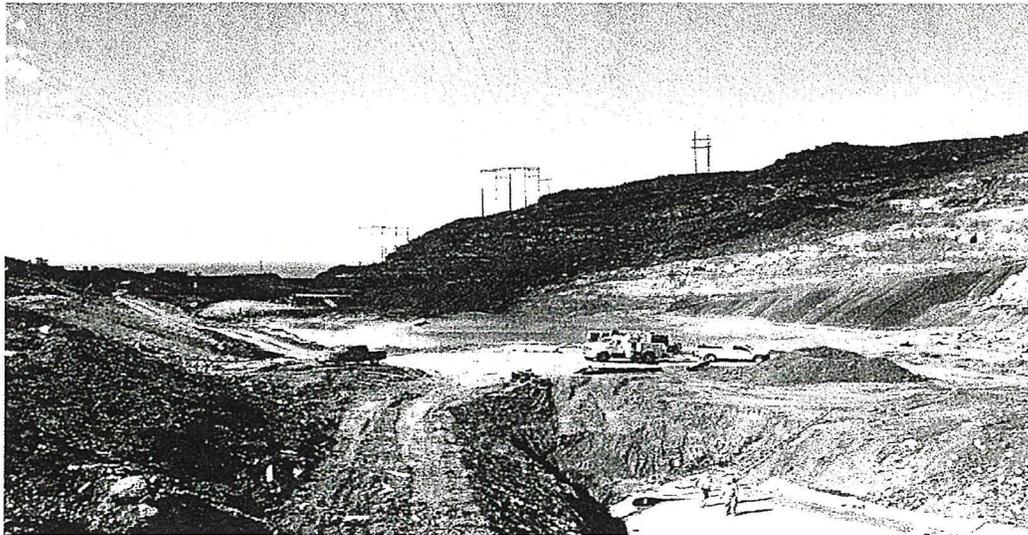
PHOTOGRAPH 6

Site name: Waimanalo Gulch Landfill
Location: 94-460 Farrington Highway
Date taken: January 24, 2011
Photographer: JRuiz
Description: View of the damaged liner area facing southwest of MSW Cell E-6

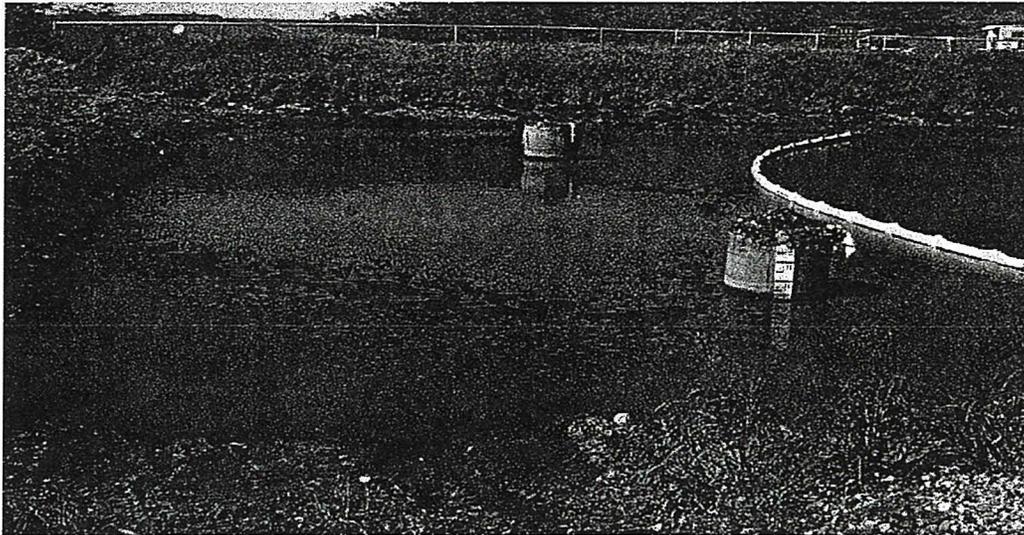
PHOTOGRAPH 1

Site name: Waimanalo Gulch Landfill
Location: 94-460 Farrington Highway
Date taken: January 25, 2011
Photographer: JRuiz
Description: Liquid level within the siltation basin at 9 feet and WMH contractor continues to pump the basin.

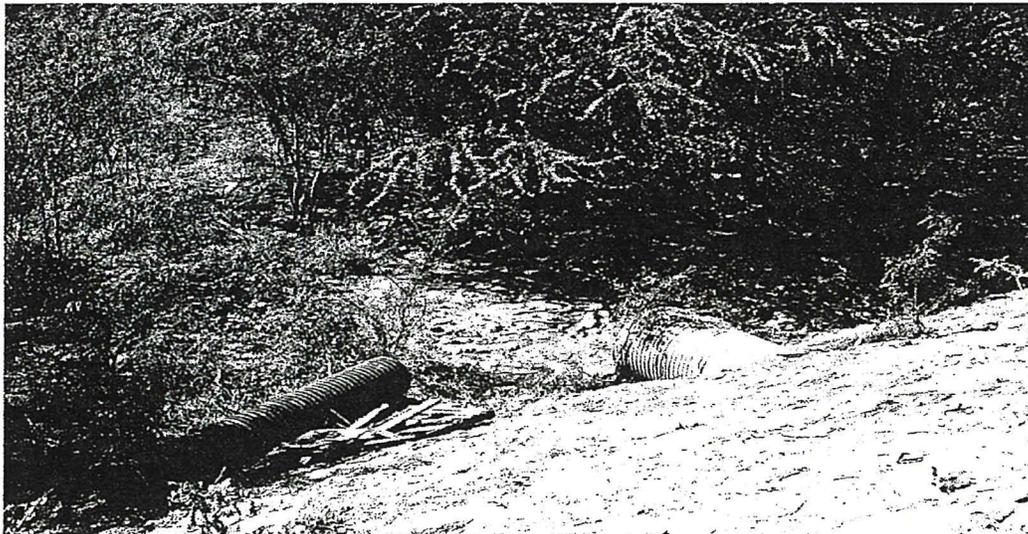
PHOTOGRAPH 2

transported to Waianae (WWTP) for disposal. No storm water was observed from the horizontal discharge pipes of the siltation basin (see photograph 2).

Site name: Waimanalo Gulch Landfill
Location: 94-460 Farrington Highway
Date taken: January 25, 2011
Photographer: JRuiz
Description: No water was observed coming out of the horizontal discharge pipes from the siltation basin.

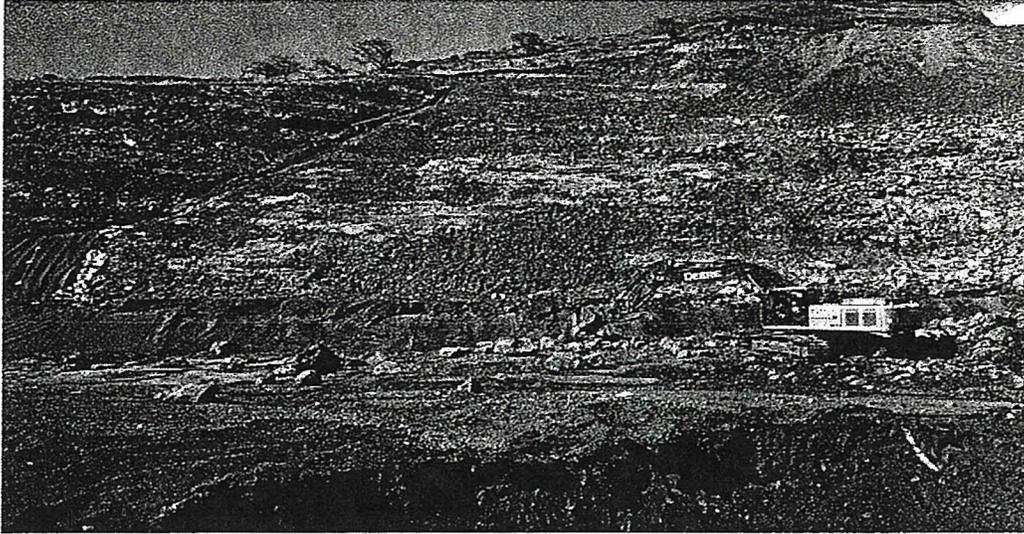
PHOTOGRAPH 3

- Construction of the western storm water diversion channel along the upper canyon continues.
- GBI was observed removing boulders from the western area of MSW Cell E-6, to determine the extent of liner damage caused by the construction of the upper west side of Cell E-6 (see photograph 3)
- Landfill continues to be closed for the acceptance of any type of waste.

Site name: Waimanalo Gulch Landfill
Location: 94-460 Farrington Highway
Date taken: January 25, 2011
Photographer: JRuiz
Description: Contractor removing boulders from the western area of MSW Cell E-6 to determine the extent of damage to the liner.

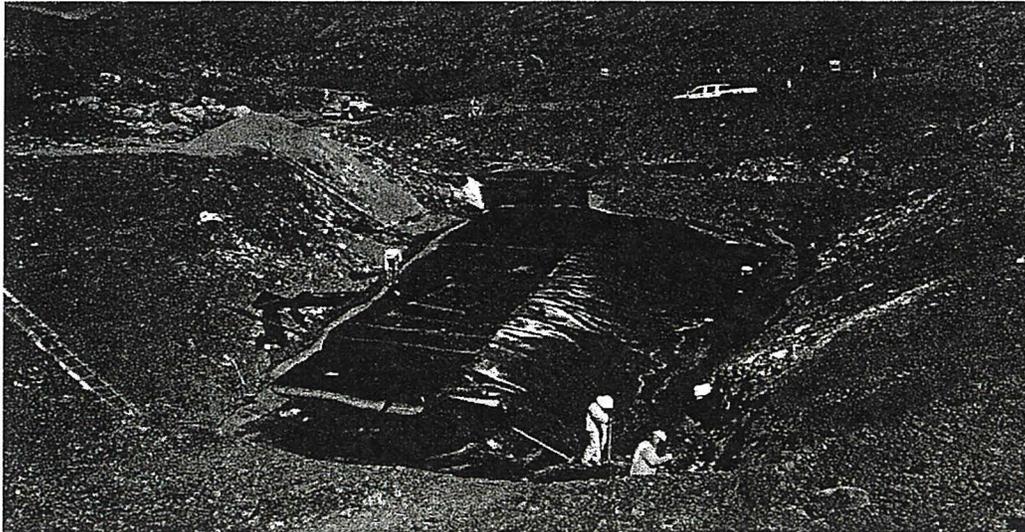
PHOTOGRAPH 4

Site name: Waimanalo Gulch Landfill
Location: 94-460 Farrington Highway
Date taken: January 25, 2011
Photographer: JRuiz
Description: Contractor has replaced the damaged liner on the northeastern portion of MSW Cell E-6, where it joins E-4.

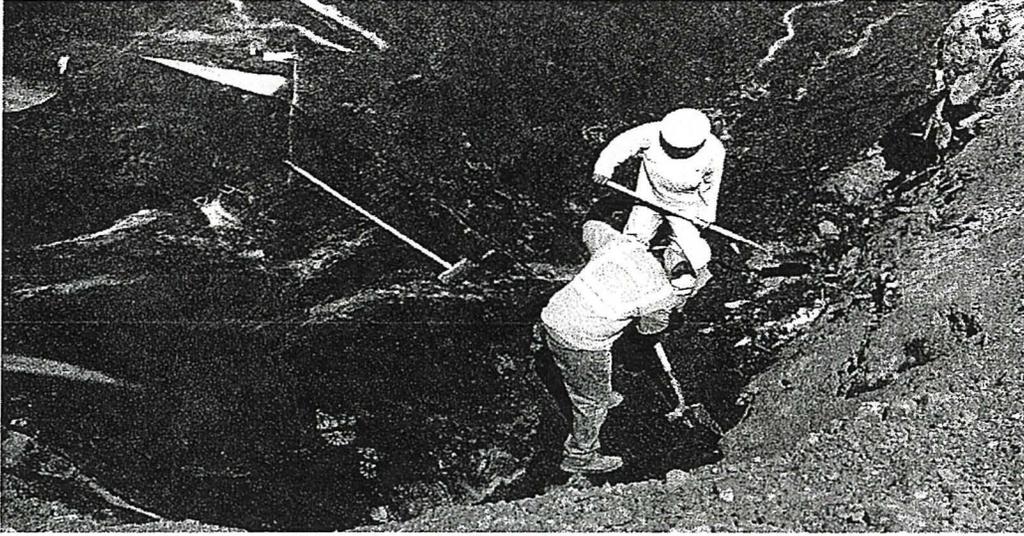
PHOTOGRAPH 5

Site name: Waimanalo Gulch Landfill
Location: 94-460 Farrington Highway
Date taken: January 25, 2011
Photographer: JRuiz
Description: Contractor exposing liner at MSW Cell E-4

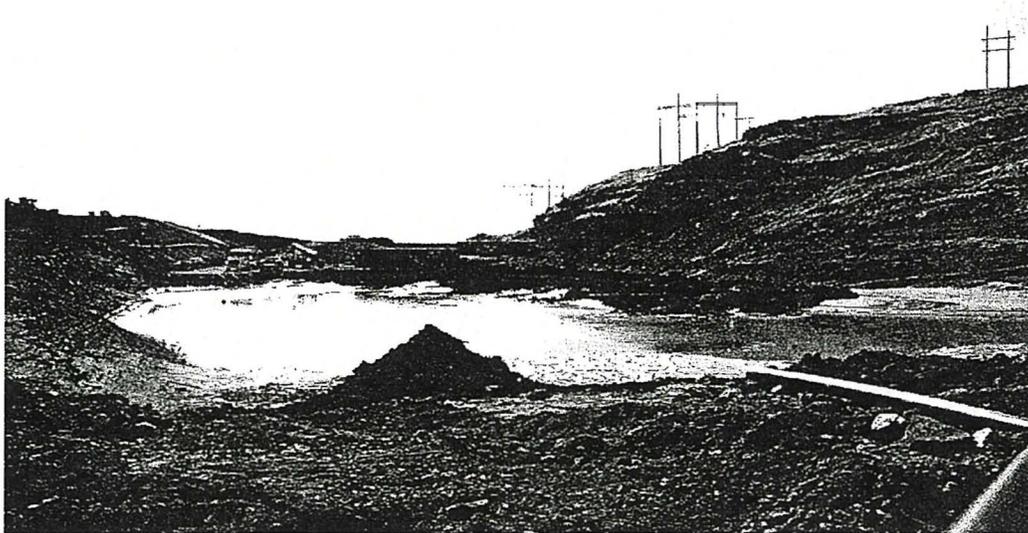
PHOTOGRAPH 6

Site name: Waimanalo Gulch Landfill
Location: 94-460 Farrington Highway
Date taken: January 25, 2011
Photographer: JRuiz
Description: View of MSW Cell E-6, upper pond, with remaining muddy water. Contractor continues to pump the area.

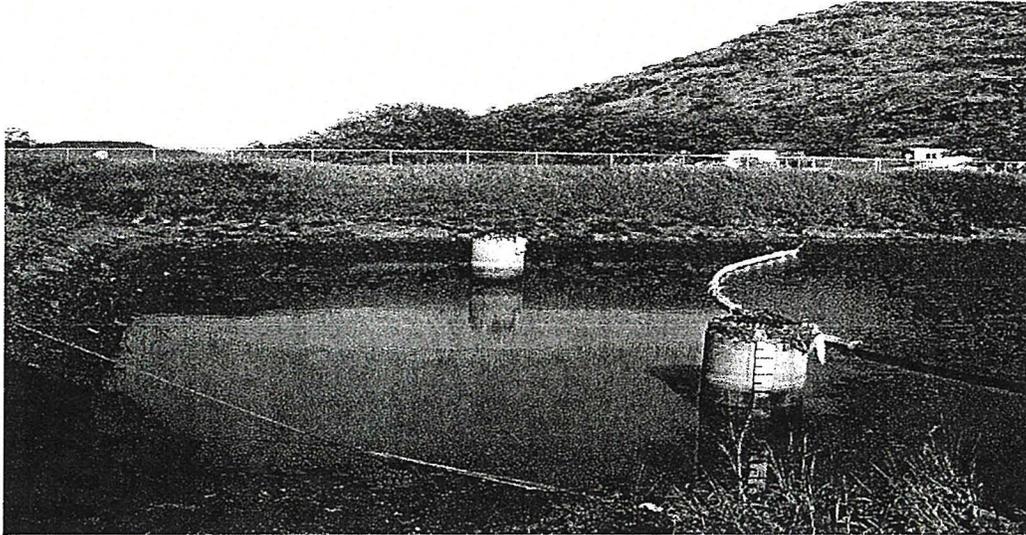
PHOTOGRAPH 1

Site name: Waimanalo Gulch Landfill
Location: 94-460 Farrington Highway
Date taken: February 1, 2011
Photographer: JRuiz
Description: Sedimentation basin with 7 ½ feet of liquid still remaining. WMH continues to pump and transport the liquid to Waianae WWTP.

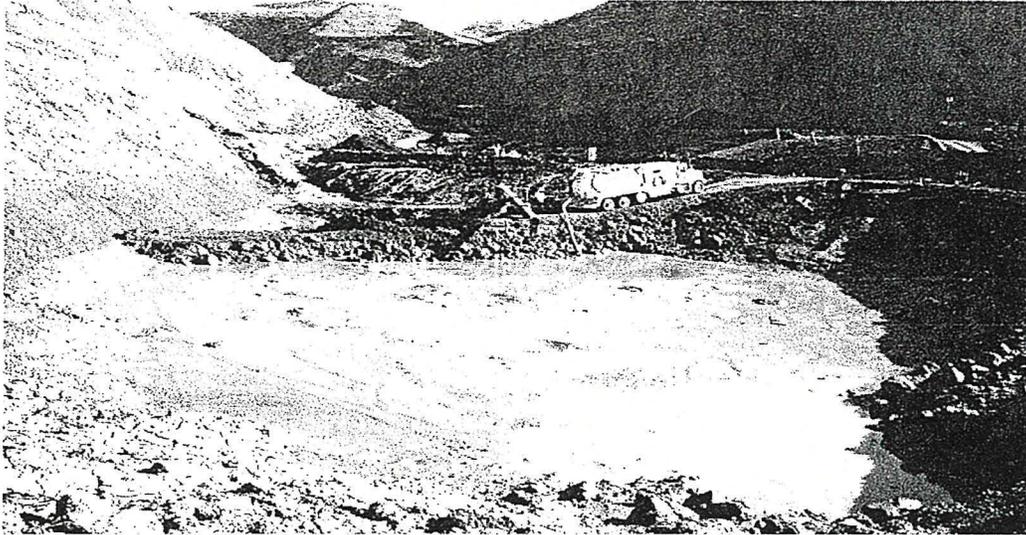
PHOTOGRAPH 3

Site name: Waimanalo Gulch Landfill
Location: 94-460 Farrington Highway
Date taken: February 1, 2011
Photographer: JRuiz
Description: View of the lower pond in MSW Cell E-6, which continues to be pumped by PCS. The contents appear to be mostly mud.

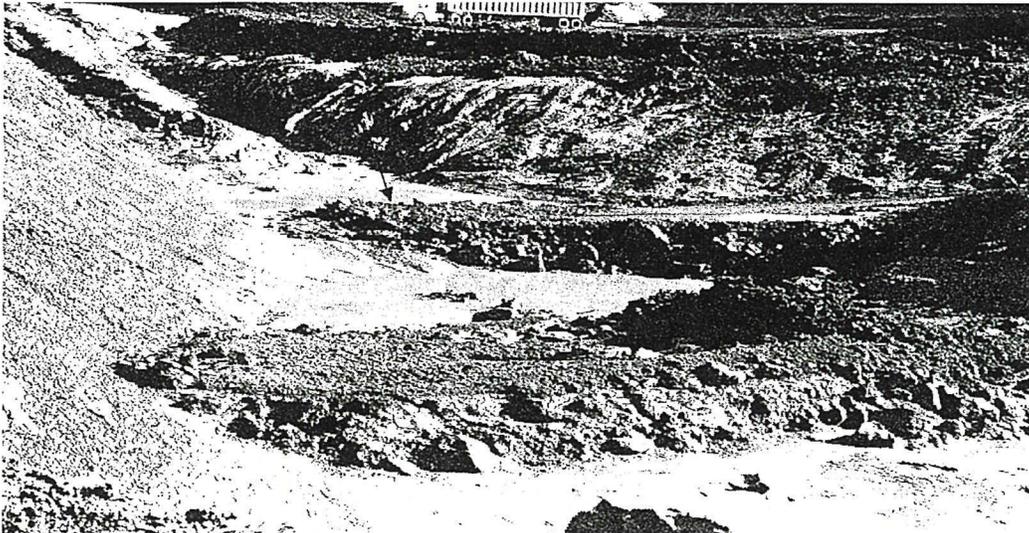
PHOTOGRAPH 4

Site name: Waimanalo Gulch Landfill
Location: 94-460 Farrington Highway
Date taken: February 1, 2011
Photographer: JRuiz
Description: Leachate riser in MSW Cell E-6 continues to be under mud and WMH plans to have the mud and water pumped, and to place the leachate system back in operation. Red arrow indicates approximate location of leachate riser

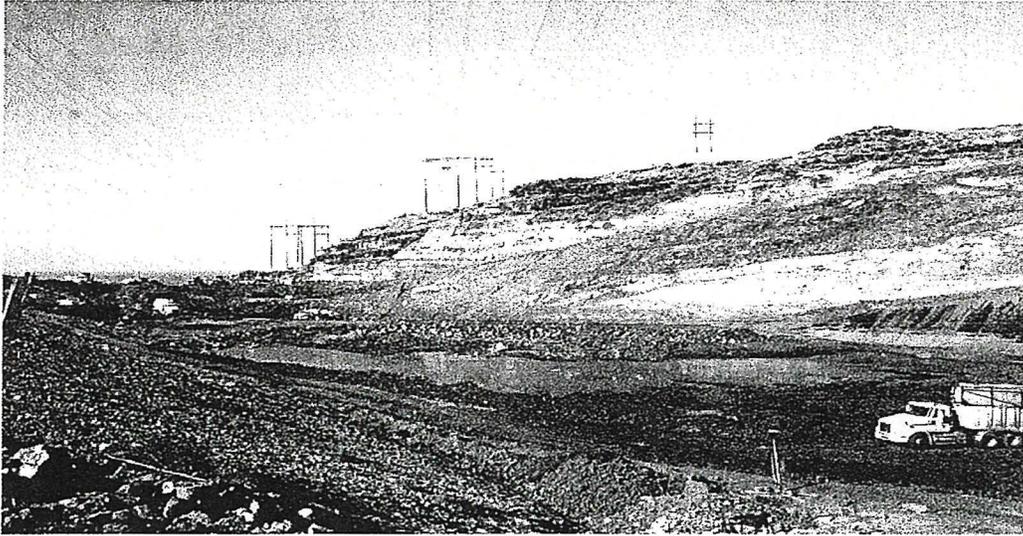
PHOTOGRAPH 5

Site name: Waimanalo Gulch Landfill
Location: 94-460 Farrington Highway
Date taken: February 1, 2011
Photographer: JRuiz
Description: View of the entire MSW Cell E-6 from top of MSW Cell E-4

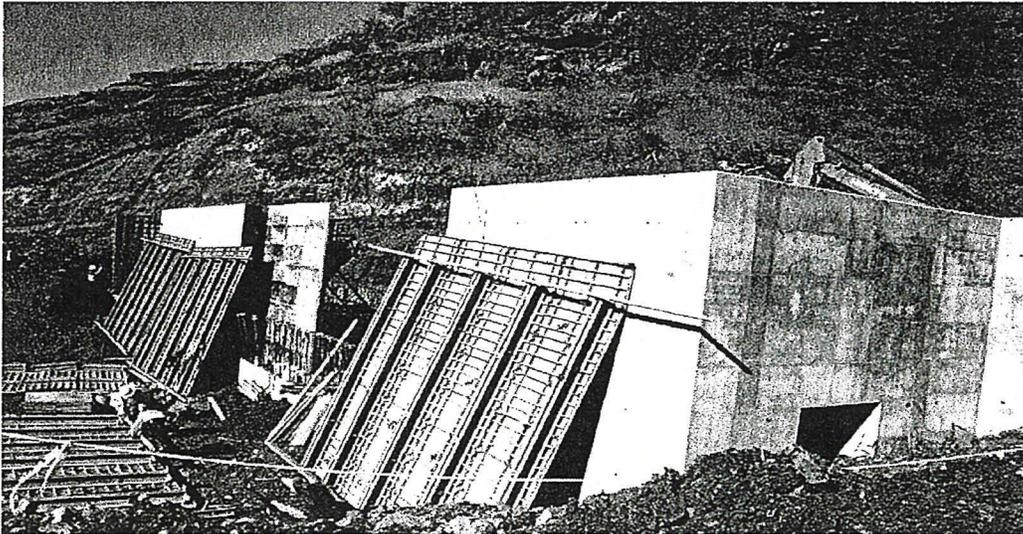
PHOTOGRAPH 6

Site name: Waimanalo Gulch Landfill
Location: 94-460 Farrington Highway
Date taken: February 1, 2011
Photographer: JRuiz
Description: Contractor working on forms to construct the western surface water drainage structure.

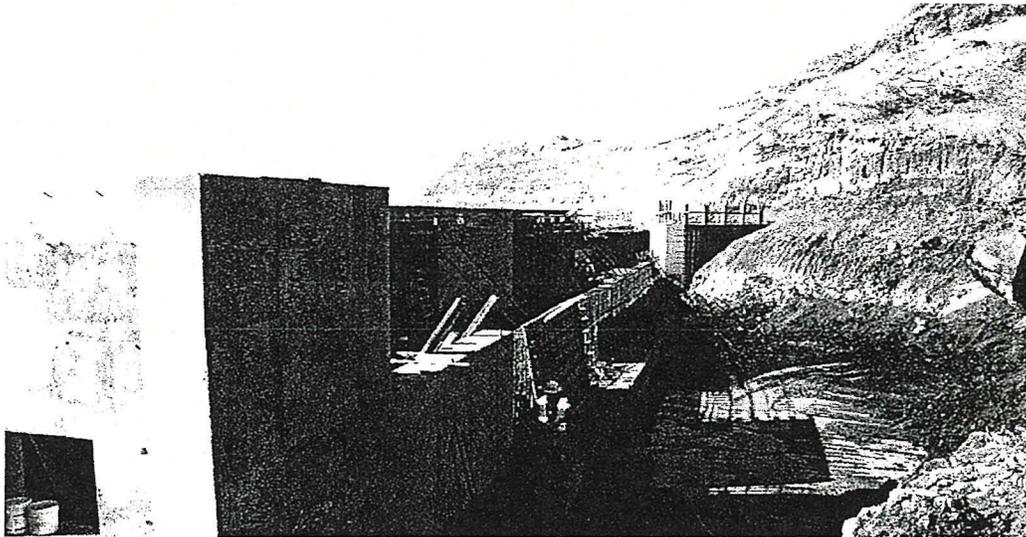
PHOTOGRAPH 7

Site name: Waimanalo Gulch Landfill
Location: 94-460 Farrington Highway
Date taken: February 1, 2011
Photographer: JRuiz
Description: Contractor working the weir portion of the storm water structure, looking from the northwest.

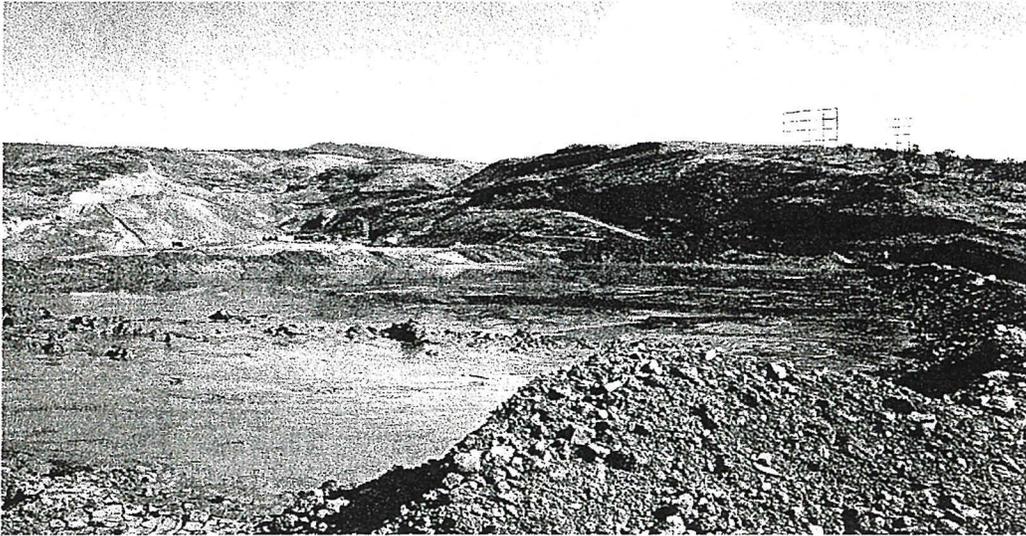
PHOTOGRAPH 8

Site name: Waimanalo Gulch Landfill
Location: 94-460 Farrington Highway
Date taken: February 1, 2011
Photographer: JRuiz
Description: View of the slurry mud removed from MSW Cell E-6, located on top of the landfill within MSW Cells 4-A and 4-C. A berm was constructed to prevent run-off.

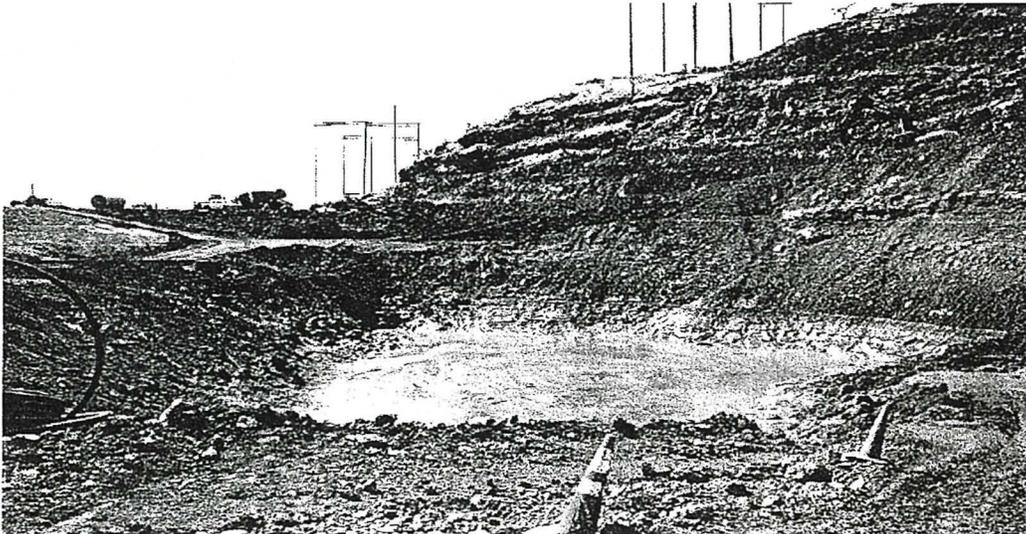
PHOTOGRAPH 1

Site name: Waimanalo Gulch Landfill
Location: 94-460 Farrington Highway
Date taken: February 3, 2011
Photographer: JRuiz
Description: Liquid level within sedimentation basin was at 6-1/2 feet. WMH continues to pump and transport the liquid to Waianae WWTP.

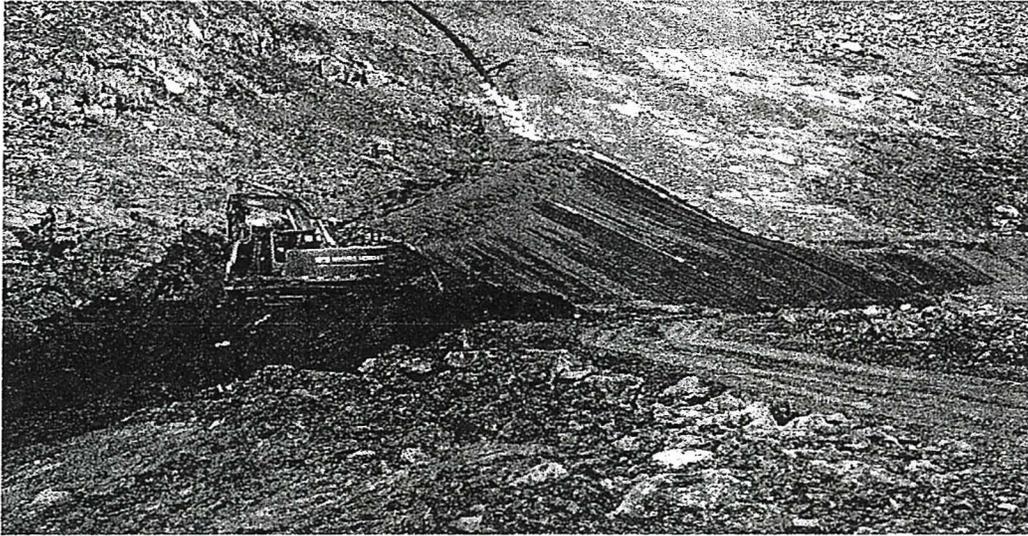
PHOTOGRAPH 2

Site name: Waimanalo Gulch Landfill
Location: 94-460 Farrington Highway
Date taken: February 3, 2011
Photographer: JRuiz
Description: View of MSW Cell E-6 lower pond with mud remaining. Contractor expects to reach and clear the leachate riser within the next few days.

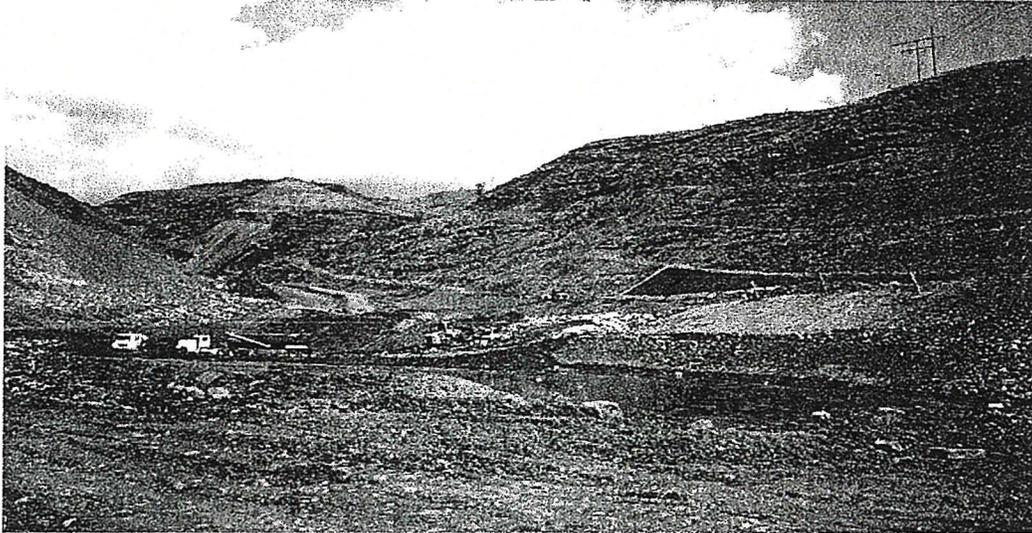
PHOTOGRAPH 4

Site name: Waimanalo Gulch Landfill
Location: 94-460 Farrington Highway
Date taken: February 3, 2011
Photographer: JRuiz
Description: Red arrow shows the estimated area where the leachate riser is located and remains under mud.

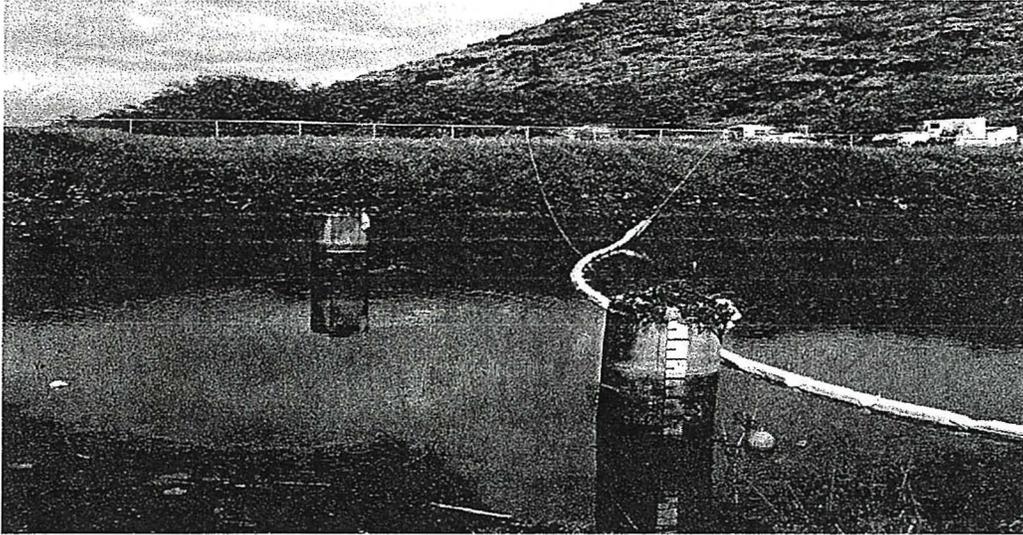
PHOTOGRAPH 7

Site name: Waimanalo Gulch Landfill
Location: 94-460 Farrington Highway
Date taken: February 3, 2011
Photographer: JRuiz
Description: View of upper pond within MSW Cell E-6, which continues to be pumped of mud. WMH continues to fill the area with soil cover in preparation of solid waste acceptance (see red arrow).

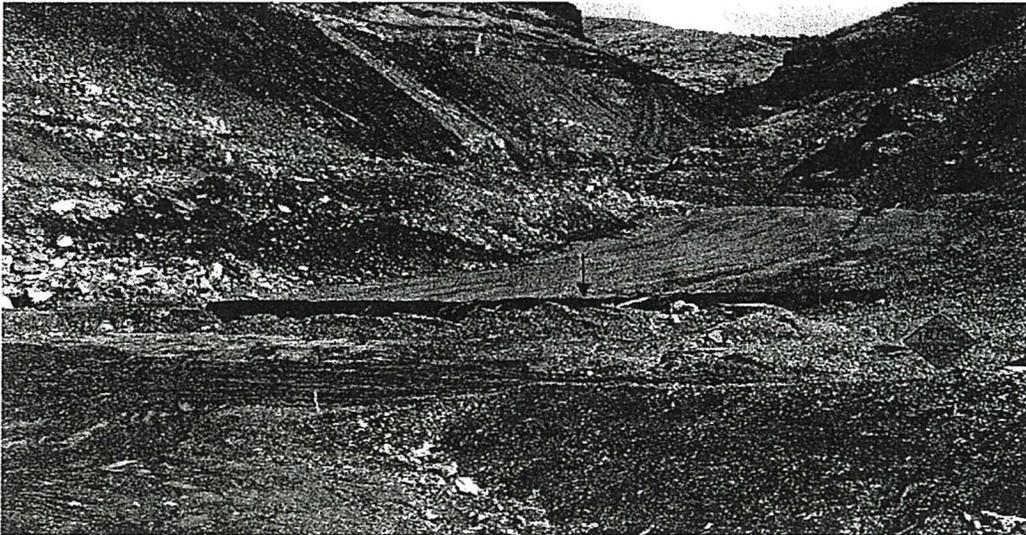
PHOTOGRAPH 1

Site name: Waimanalo Gulch Landfill
Location: 94-460 Farrington Highway
Date taken: February 7, 2011
Photographer: JRuiz
Description: View of the sedimentation basin with 6 feet of liquid still remaining
