**SUBJECT: Rainstorm Events, MSW Cell E-6 Damage Repairs, and Construction of
the Western Drainage System Inspection
Waimanalo Gulch Sanitary Landfill (WGLF)**

INSPECTION REPORT

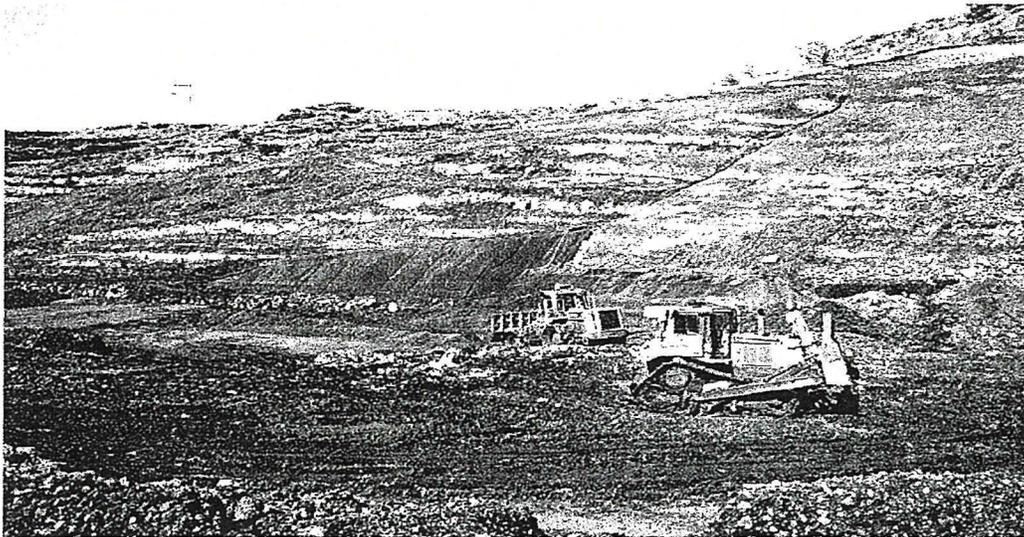
PHOTOGRAPH 2

Site name: Waimanalo Gulch Landfill
Location: 94-460 Farrington Highway
Date taken: February 7, 2011
Photographer: JRuiz
Description: View of the upper MSW Cell E-6 with a soil berm and sacrificial liner (red arrow) to prevent water from entering the active cell area.

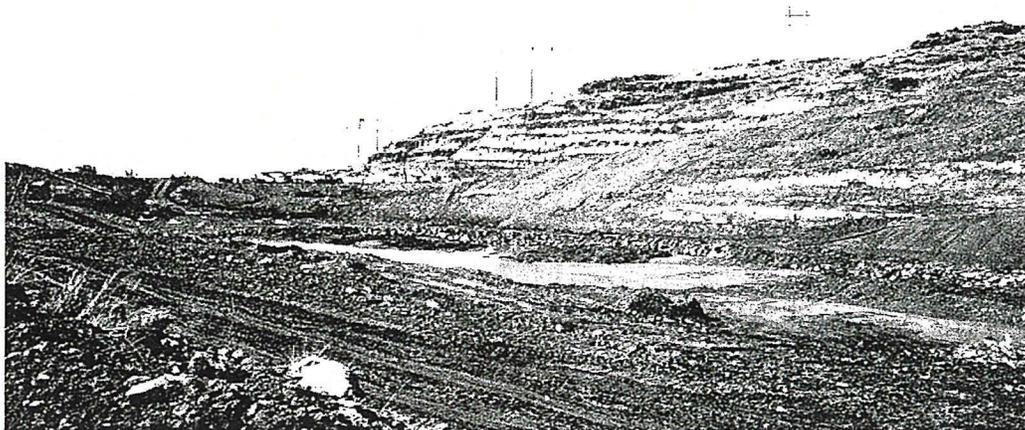
PHOTOGRAPH 3

Site name: Waimanalo Gulch Landfill
Location: 94-460 Farrington Highway
Date taken: February 7, 2011
Photographer: JRuiz
Description: Upper MSW Cell E-6 workforce with limited acceptance of waste

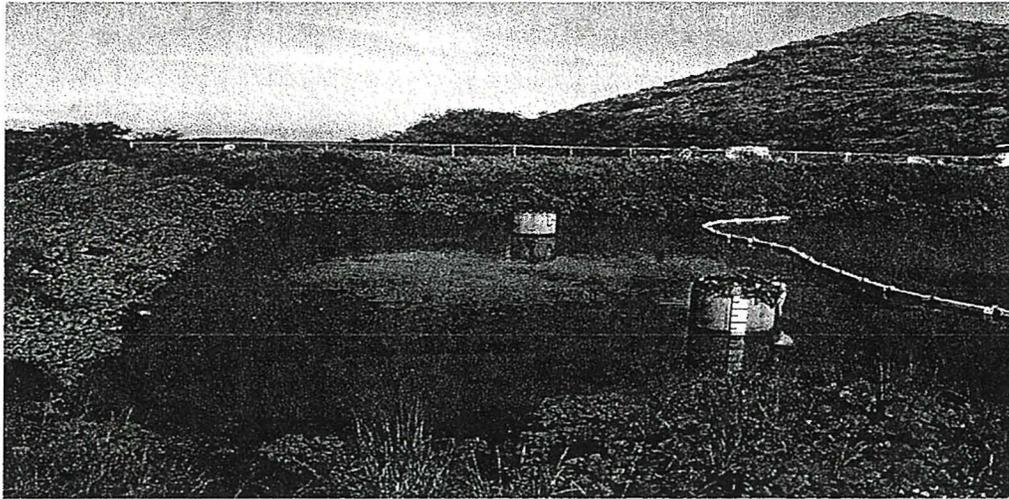
Photograph 1

- SWS inspector observed the liquid levels within the sedimentation basin at 9 feet high (see photograph 1) and the discharge pipe from the sedimentation basin berm (see photograph 2) into Farrington Highway did not have water flowing from it.

Site Name: Waimanalo Gulch Sanitary Landfill
Location: 92-460 Farrington Highway, Kapolei
DateTaken: February 25, 2011
Photographer: JRuiz
Description: View of the sedimentation basin with nine (9) feet of stormwater.

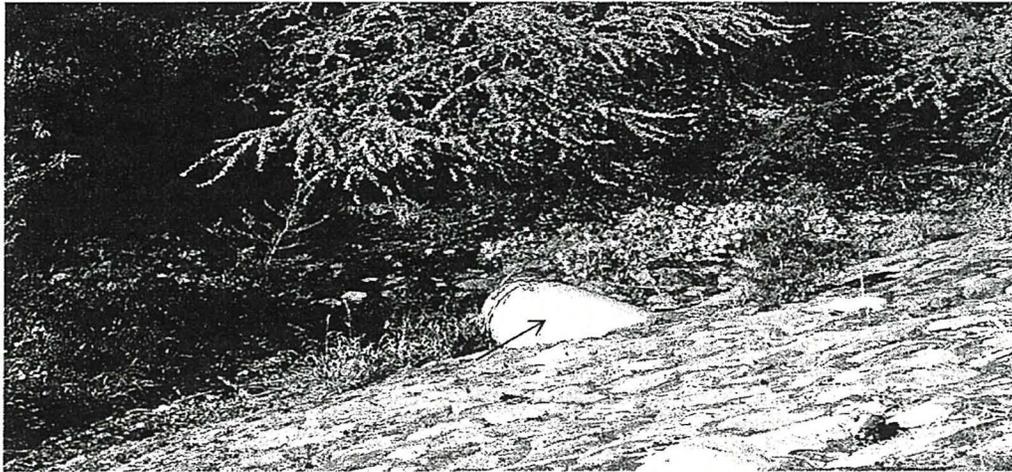
Photograph 2

Site Name: Waimanalo Gulch Sanitary Landfill
Location: 92-460 Farrington Highway, Kapolei
DateTaken: February 25, 2011
Photographer: JRuiz
Description: No water observed flowing out of drainage line (red arrow) from sedimentation pond

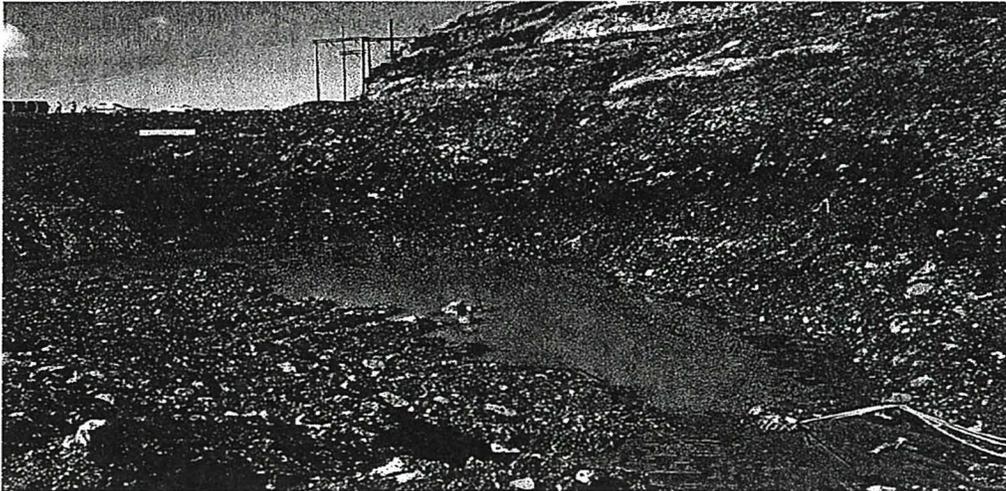
Photograph 4

Site Name: Waimanalo Gulch Sanitary Landfill
Location: 92-460 Farrington Highway, Kapolei
Date Taken: February 25, 2011
Photographer: JRuiz
Description: MSW Cell E-6 lower pond with leachate riser at the water surface (red arrow).

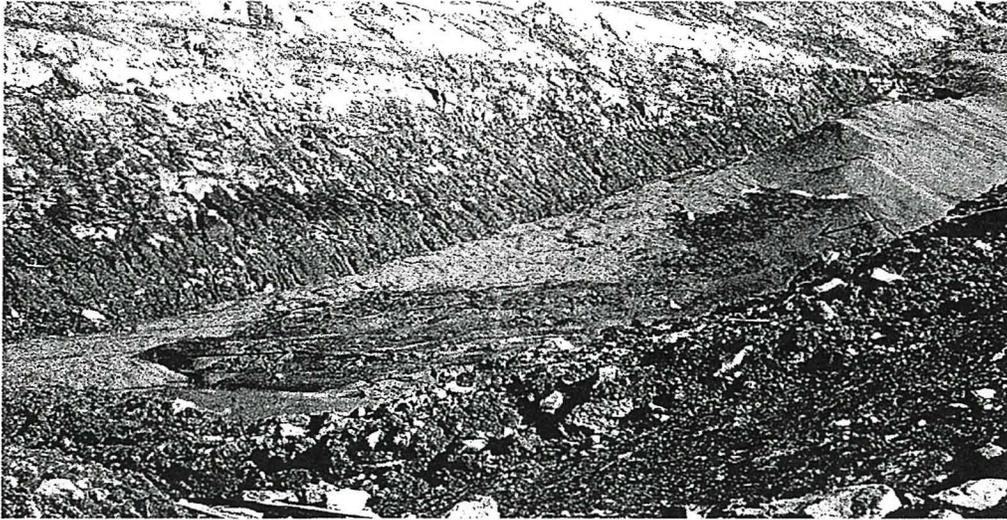
Photograph 5

- At the upper western side of MSW Cell E-6, the SWS staff observed the damaged liner caused by the rainstorm and from cell construction (see photograph 5).

Site Name: Waimanalo Gulch Sanitary Landfill
Location: 92-460 Farrington Highway, Kapolei
Date Taken: February 25, 2011
Photographer: JRuiz
Description: Damaged liner (red arrow) caused by the rainstorm and from cell construction at the upper western side of MSW Cell E-6.

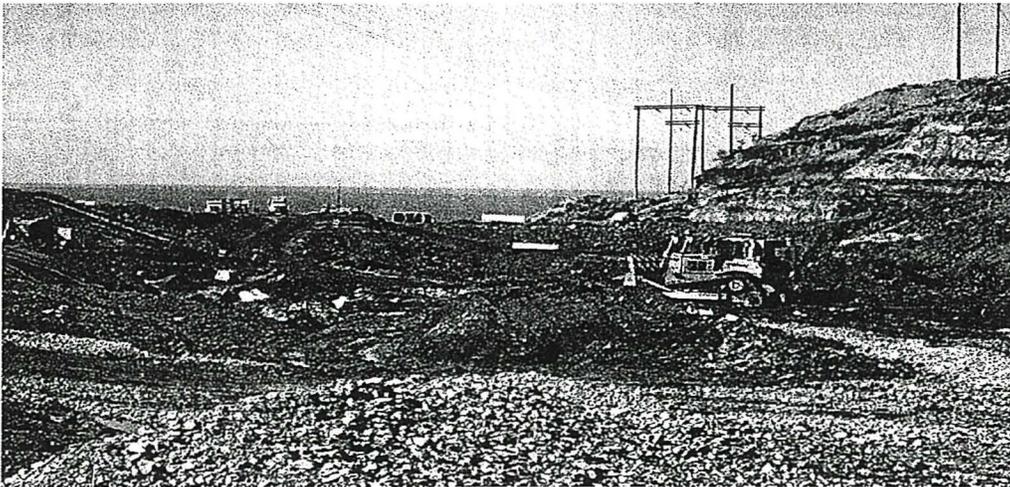
Photograph 6

- The contractor was observed placing wet weather material (gravel) at the upper area of MSW Cell E-6 due to muddy road and workface conditions (see photographs 6 & 7).

Site Name: Waimanalo Gulch Sanitary Landfill
Location: 92-460 Farrington Highway, Kapolei
Date Taken: February 25, 2011
Photographer: JRuiz
Description: Due to rain showers for the past few days, MSW Cell E-6 cell became muddy. Wet weather material (gravel) had to be placed on the cell for the movement of heavy equipment and refuse trucks within MSW workforce.

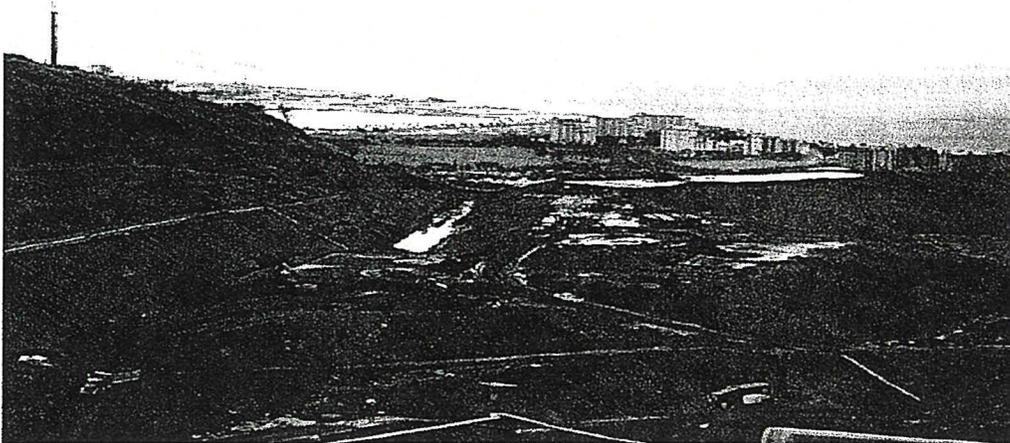
Photograph 10

Site Name: Waimanalo Gulch Sanitary Landfill
Location: 92-460 Farrington Highway, Kapolei
Date Taken: February 25, 2011
Photographer: JRuiz
Description: View from the top canyon of the landfill looking south with visible mud ponds at the top deck of various MSW Cells.

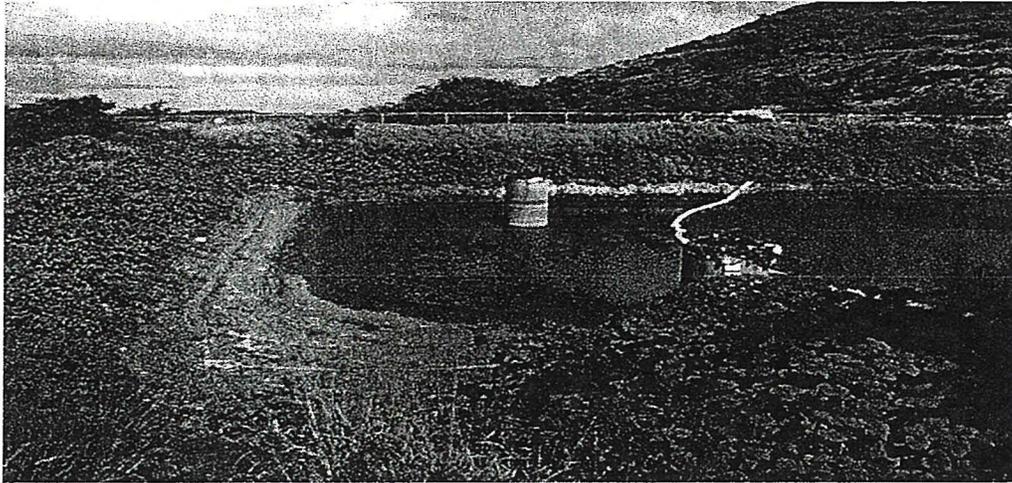
Photograph 1

Site Name: Waimanalo Gulch Sanitary Landfill
Location: 92-460 Farrington Highway, Kapolei
DateTaken: March 23, 2011
Photographer: JRuiz
Description: View of the sedimentation basin with 4 ½ to 5 feet of stormwater and silt remaining

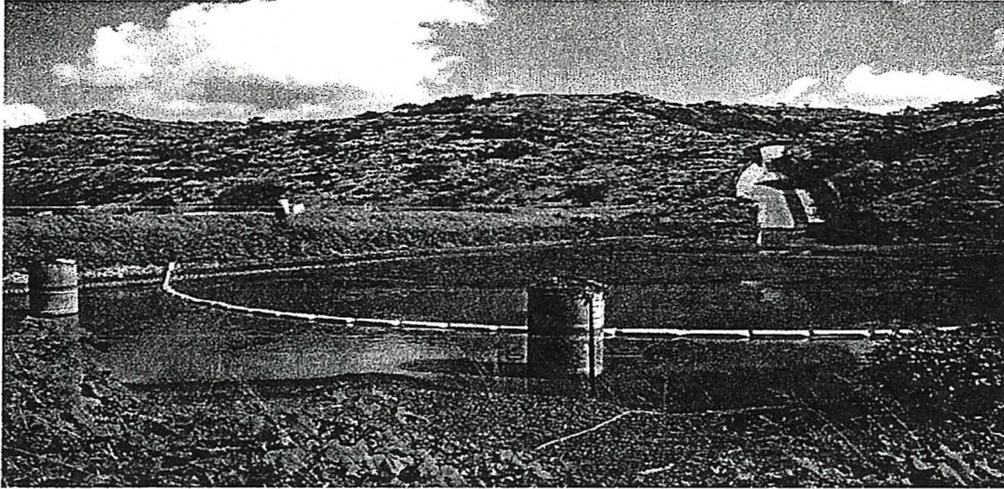
Photograph 1

- SWS inspector observed liquid levels within the sedimentation basin at 4 to 4 ½ with a large volume of mud within the sedimentation basin (see photograph 1) and the discharge pipe from the sedimentation basin into Farrington Highway remains plugged.

Site name: Waimanalo Gulch MSWLF
Location: 92-460 Farrington Highway, Kapolei
Date Taken: March 30, 2011
Photographer: JRuiz
Description: Sedimentation basin with 4 to 4-1/2 feet of stormwater and mud.

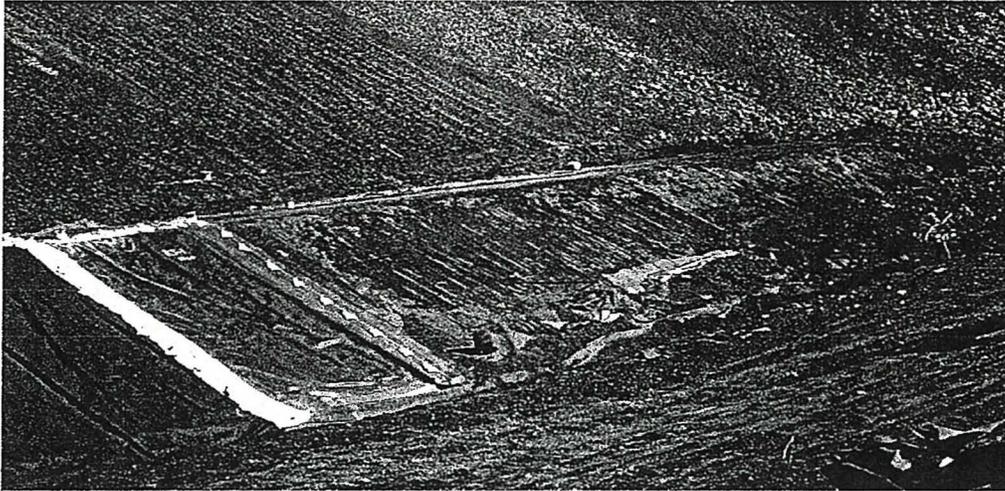
Photograph 5

- SWS inspector and engineer visited the landfill were driven around the landfill by Joseph Whelan, Operations Manager. At Cell E-6, the inspector noted that workers had removed part of the damaged liner located on the upper northwest of MSW Cell E-6 (see photographs 5 & 6).

Site name: Waimanalo Gulch MSWLF
Location: 92-460 Farrington Highway, Kapolei
Date Taken: March 30, 2011
Photographer: JRuiz
Description: Contractor removed part of the damaged liner (red arrow) and was installing new liner (blue arrow) on the northwestern edge of MSW Cell E-6.

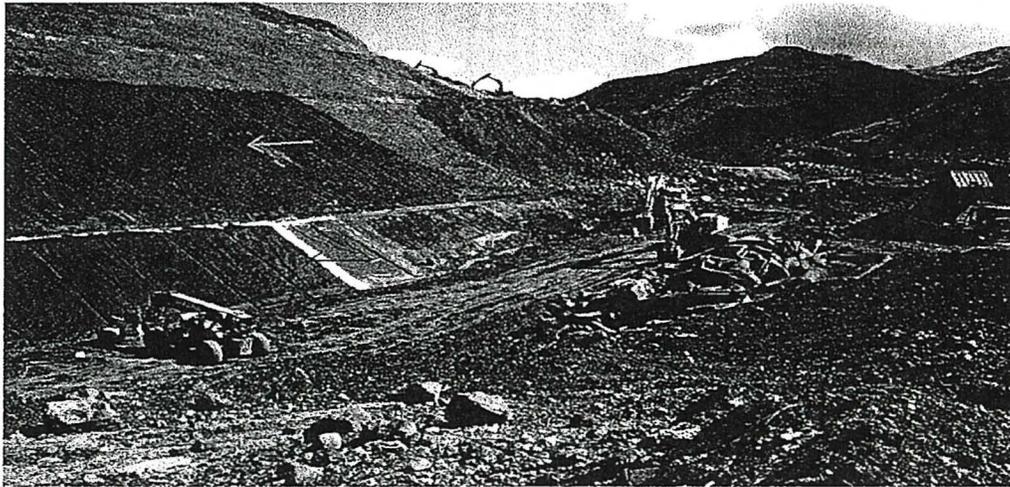
Photograph 6

Site name: Waimanalo Gulch MSWLF
Location: 92-460 Farrington Highway, Kapolei
Date Taken: March 30, 2011
Photographer: JRuiz
Description: View of the damaged liner replaced in MSW Cell E-6 (red arrow), new liner (blue arrow) and the on-going construction of the upper cell for MSW Cell E-6 (green).

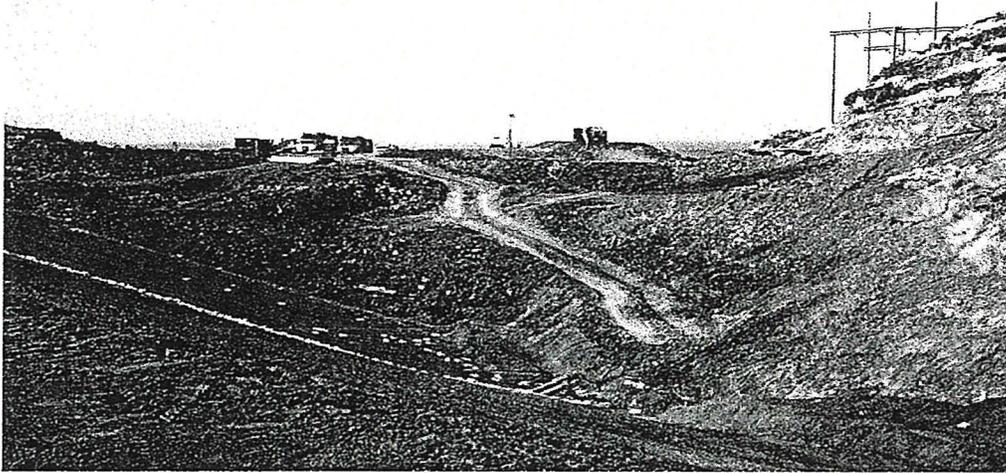
Photograph 7

Site name: Waimanalo Gulch MSWLF
Location: 92-460 Farrington Highway, Kapolei
Date Taken: March 30, 2011
Photographer: JRuiz
Description: View of the leachate riser (red arrow) for MSW Cell E-6, soon to be extended to the upper road (blue arrow).

In addition, the inspector observed the contractor anchoring the geosynthetic clay liner (GCL) layer of the cover liner for the portion of MSW Cell E-6 over which the extended West Berm will be constructed (see photograph 8). According to Mr. Whelan, the contractor also plans to complete the cover liner installation within the week (see photograph 4) and continue with the construction of the west berm by placing compacted rock fill over the cover liner. The contractor also plans to have the leachate risers extended to the upper west road, and the West

Berm (see photograph 7) will then be constructed so as not to damage the risers.

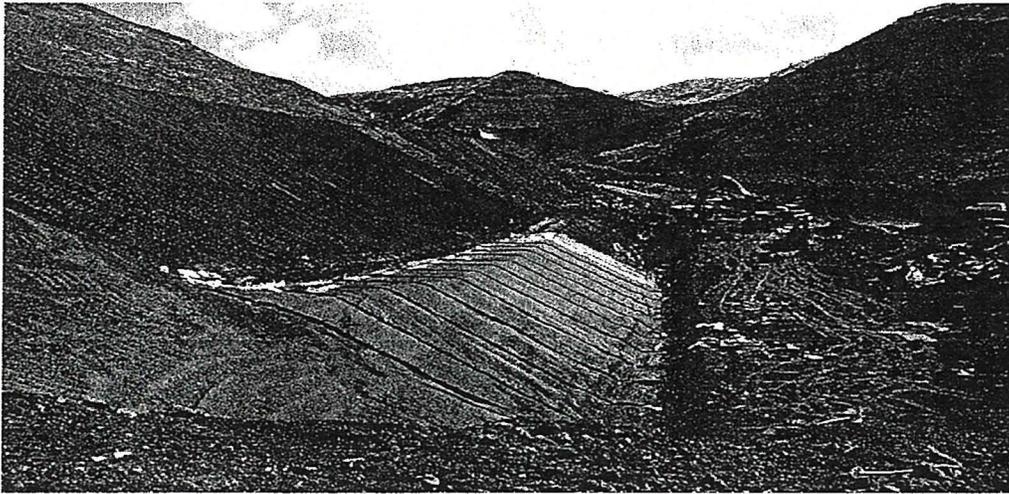
Photograph 9

- The inspector also observed part of the upper western side slope for MSW Cell E-6 already prepared and ready for the installation of the new liner (see photograph 9).

Site name: Waimanalo Gulch MSWLF
Location: 92-460 Farrington Highway, Kapolei
Date Taken: March 30, 2011
Photographer: JRuiz
Description: Contractor continues to replace damage liner at the northwestern edge of MSW Cell E-6.
