STAFF SUBMITTAL

COMMISSION ON WATER RESOURCE MANAGEMENT

September 27, 2011
Honolulu, Hawaii

Mediation or Binding Arbitration for Complaint/Dispute Resolution (CDR.2769.8)
Application for After-the-Fact Stream Channel Alteration Permit,
Stream Diversion Works Permit and Petition to Amend Instream Flow Standard (SCAP.2898.8)
Ainako Branch Stream, Hilo, Hawaii
TMKs: (3) 2-5-025:005, 014 and 006, 2-5-024:028, 029 and 045

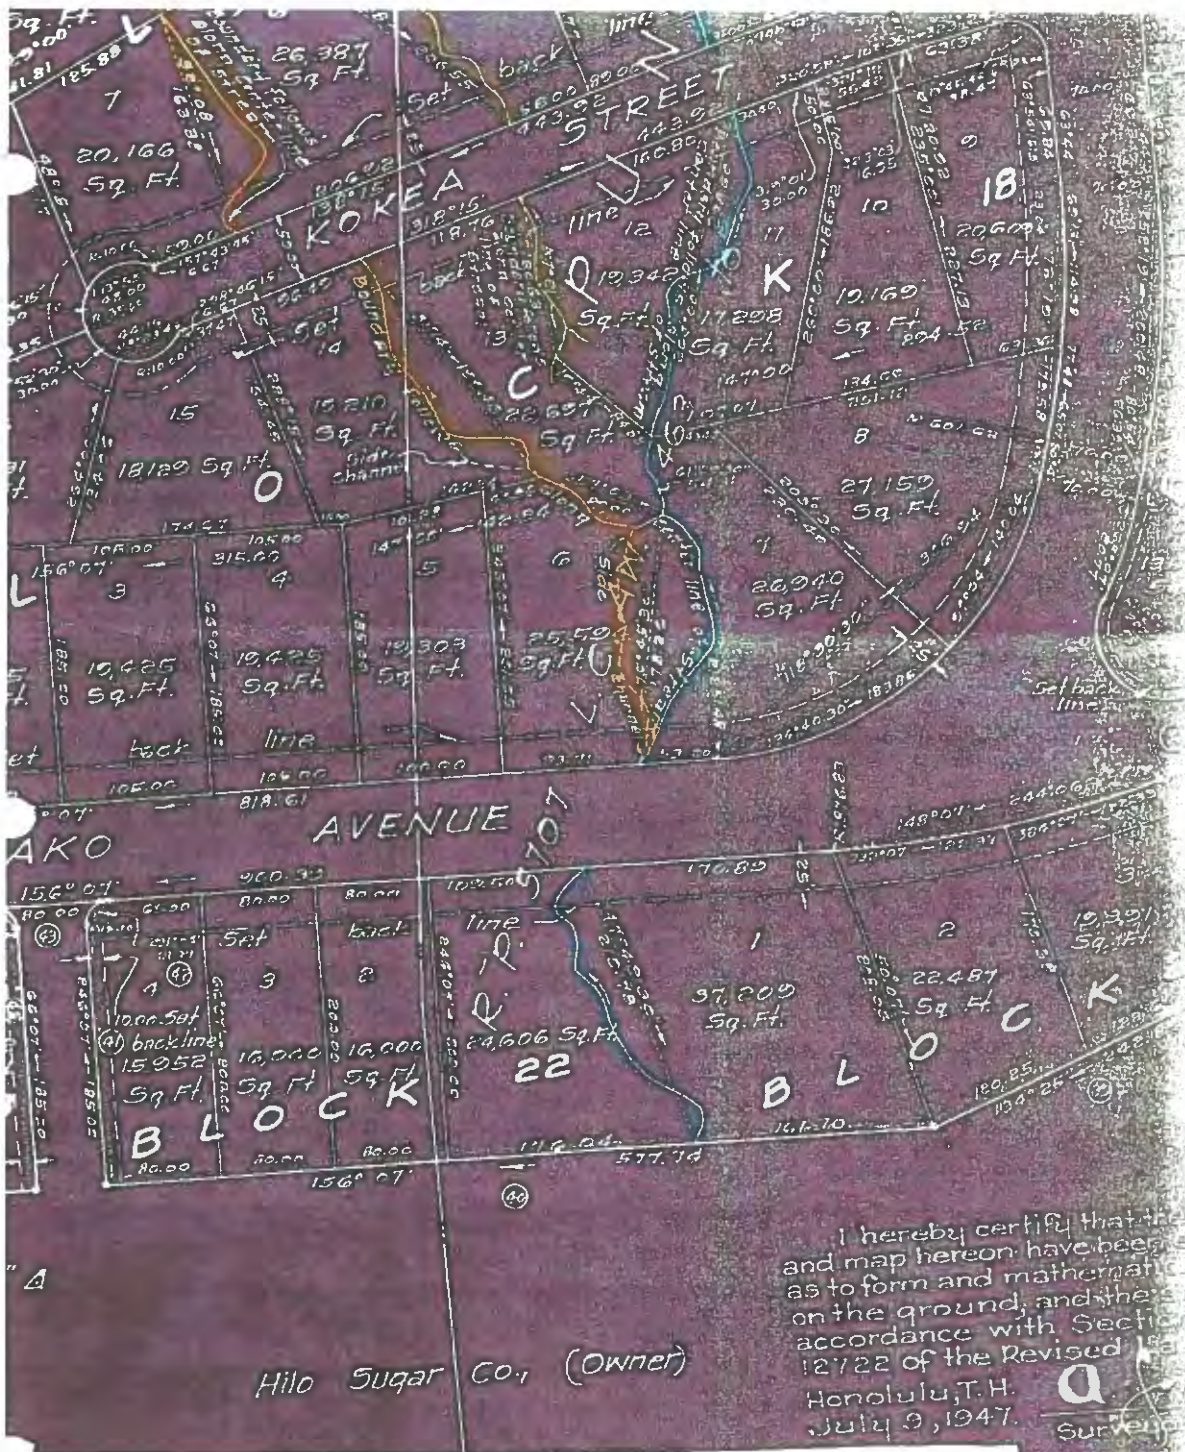
Figure A-3. Territory of Hawaii TMK, July 1947, showing route of Ainako Stream (blue) and Branch Stream (orange).

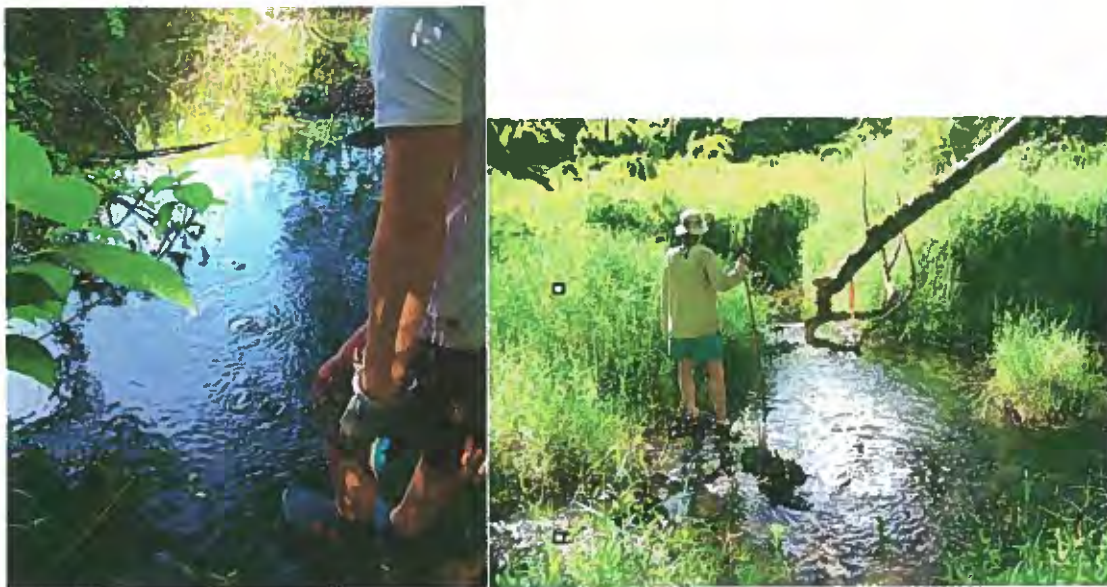
Figure 1. Typical springs at Ainako stream origin area (approximate location N 19 42 26.4, W155 07 56.1, 250 meter elevation).

Ainako stream originates at about 820-foot elevation about 0.4 mile upslope from the 1000 Ainako Avenue bridge. The origin area is roughly a half-mile square of boggy scrub forest and grasslands immediately below Akolea Road. Numerous springs arise from the origin area (Figure 1) and converge on the stream channel via a network of ill-defined meandering routes. Substrate over the entire length of Ainako stream is dominated by pahoehoe lava flows dating to 5,000 to 10,000 years of age. This same substrate dominates slopes extending more than five miles above the stream origin. The pahoehoe flows are very porous, and lava blisters, tumuli and lava tubes are common. Less than a half-mile to the south of the stream origin area, an extensive lava tube system contains underground streams that flow most of the year. Similar subterranean systems likely feed the Ainako stream springs.

Figure 1. Typical springs at Ainako stream origin area (approximate location N 19 42 26.4, W155 07 56.1, 250 meter elevation).

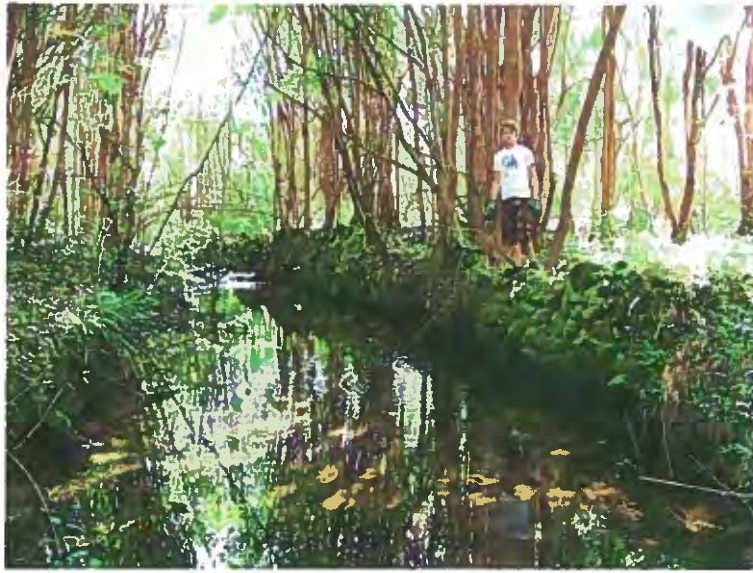
Figure 2. Ainako stream in lower portion of origin area. The rock embankments were possibly built by Hilo Sugar Plantation Company.

In a few locations, stacked rock lines the borders of the stream (Figure 2), possibly put in place by Hilo Sugar Plantation Company for flood control or water diversion purposes. Below the origin area, the stream flows over gentle relief through forest composed of strawberry guava, tibuchina, ferns, ginger and tall grasses (Figure 3).

Figure 2. Ainako stream in lower portion of origin area. The rock embankments were possibly built by Hilo Sugar Plantation Company.

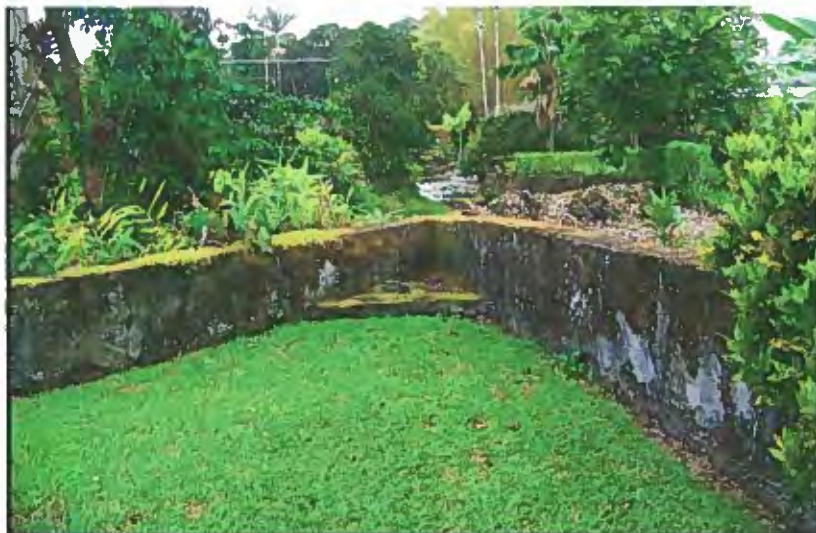
Figure 4. Flood levee along Ainako stream on upstream border of Marsh property. Built circa 1956-58 soon after damaging flood of 1956.

By the time that the Henderson family moved to 51 Kokea Street in August 1958, substantial flood control levees of mortared rock and solid concrete had been built along several flood-prone sections of Ainako stream between Ainako Avenue and Koula Street (a distance of 0.2 mile). Those levees are generally 2 to 5 feet high and 0.5 to 1.5 foot thick (Figures 4 & 5). The levees were likely built by the Hilo Sugar Plantation Company (developer of the Ainako subdivision) and individual landowners in the subdivision. During a major flood in 1964, water level in the Ainako stream rose to within a few inches of the top of the levee in back of the Henderson's house.

Figure 4. Flood levee along Ainako stream on upstream border of Marsh property. Built circa 1956-58 soon after damaging flood of 1956.

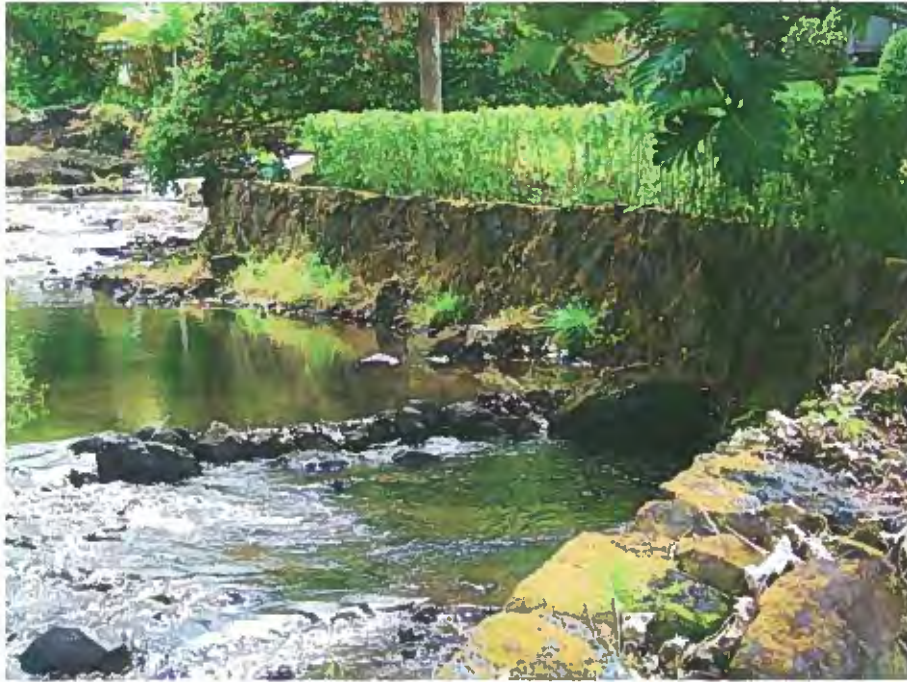
Figure 5. Levee embankments along the Ainako stream Weight property margin.

Figure 5. Levee embankments along the Ainako stream Weight property margin.

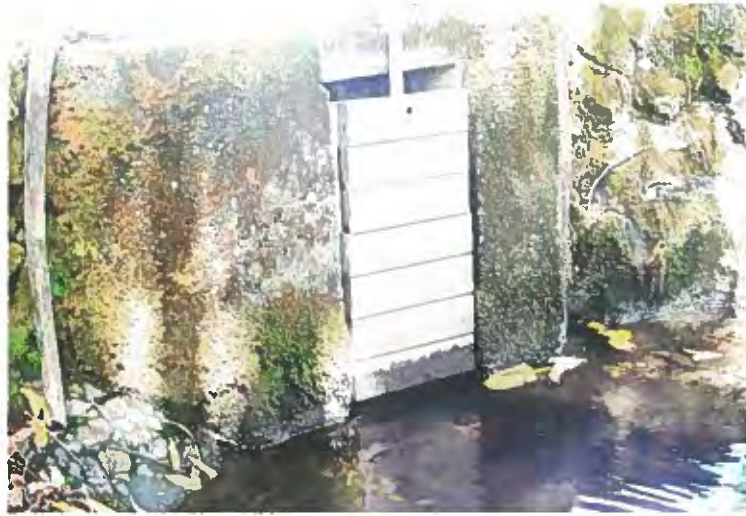
Figure 6. Flood control gate that buffers water flow into the branch stream. In back of the gate is a 14-inch ID diameter four-foot section of concrete culvert. Historic (2 to 4 decade) setting of the gate opening gap (3 ½ -4 inches) provides steady day-to-day water supply while keeping storm flow to non-damaging levels on downstream properties. The present gate, built of plastic wood, replaces the pre-existing steel gate and is set at the historical gap. Station 1 in Figure 11.

It appears that the concrete culvert piece had been placed onto an unaltered pahoehoe lava surface in a natural low spot through which water would have flowed. Primary function of the flood gate over the last three decades has been to prevent very high levels of water from flowing into the branch stream during storm flow.

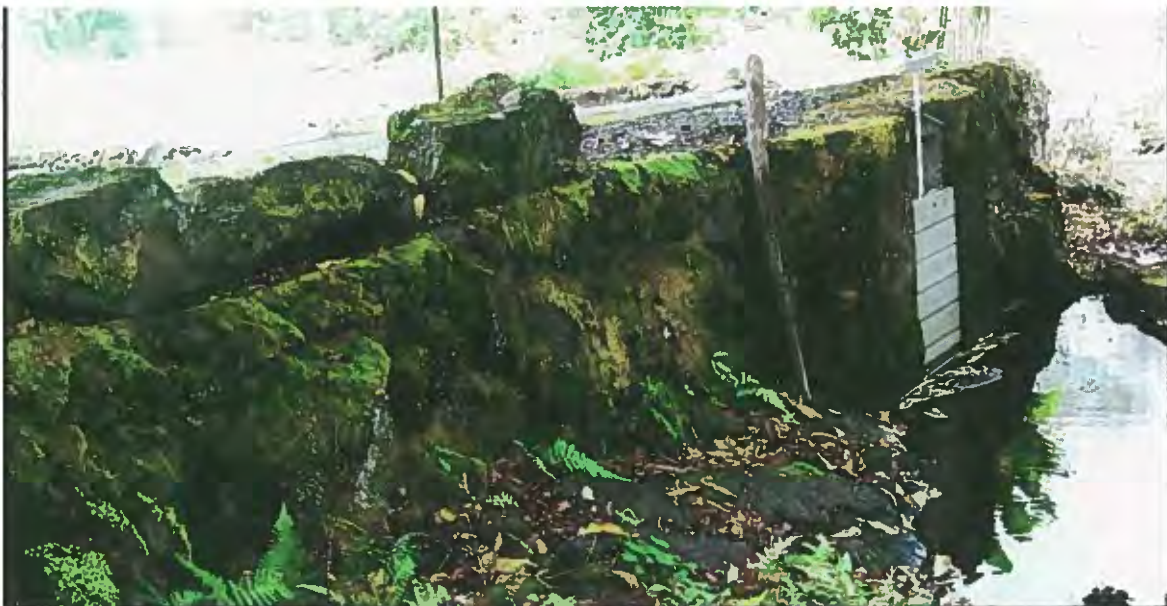
Figure 7. Flood control gate and reinforced embankment at origin of branch stream.

Figure 7. Flood control gate and reinforced embankment at origin of branch stream.

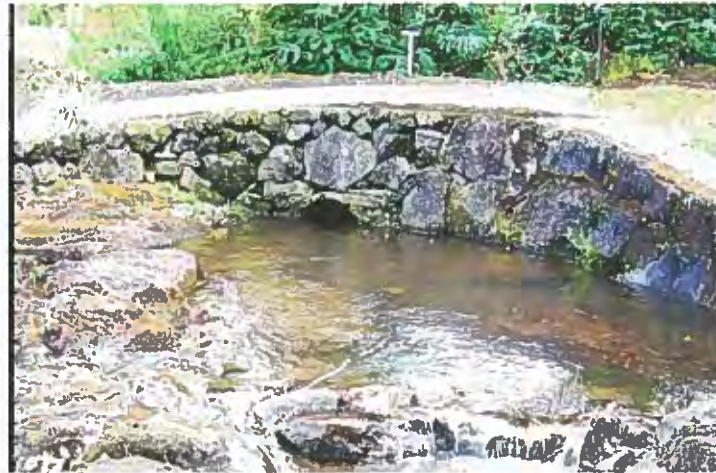
Figure 8. Culvert that supplies flow to branch stream from Ainako stream. View from branch stream side. Station 1 in Figure 11.

The Weights purchased their first Ainako property, that included Lot 6, sometime in 1954-55. At that time the property was covered with tall grass and ferns and the branch stream ran through the property along the same general route that it follows today. The Weights moved onto the Ainako property in 1956. In the 1950s, or possibly earlier, a small flood gate was installed at the junction of the main stream and Ainako stream, most likely by the Sugar Company or Dr. Weight. The gate structure appears to be integral with the 3-foot-high retaining wall that runs along the entire Ainako stream boundary of the Weight property (Figures 5, 6 & 7). A steel plate of 14-inch width and 36-inch height slid vertically within grooves in the sides of the gate structure (Figures 6 & 7). For two or three decades, the steel plate had been jammed in a position that was about 3 ½ inches above the bottom of the gate. Water flows from Ainako stream, through the gate, into a 4-foot section of 14-inch ID concrete culvert (that passes under a sidewalk), and then into the branch stream (Figure 8).

Figure 8. Culvert that supplies flow to branch stream from Ainako stream. View from branch stream side. Station 1 in Figure 11.

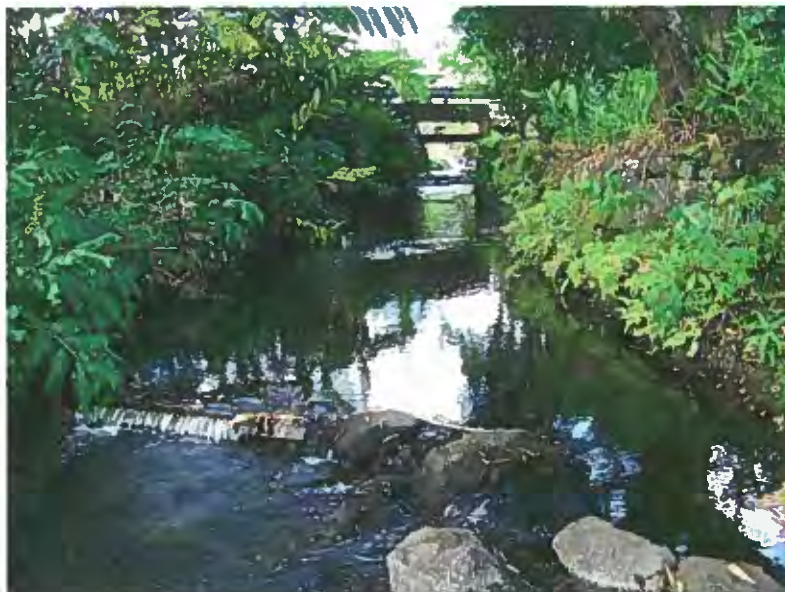
Figure 9. Diversion dam (in left foreground) that raises Ainako stream level to divert water into the branch stream culvert. Ainako Avenue bridge is seen in background.

To ensure that the water level of Ainako stream is maintained at a level that will provide ample flow of water into the branch stream, a diversion dam was built across half the width of Ainako stream (Figures 9 & 10). The diversion dam is made of loose-stacked rock and is topped by a length of railroad track. Landside end of the track piece is buried in soil. It is not known who first built the diversion dam, but it was likely either the Sugar Company or Dr. Weight. Over the years, Dr. Weight periodically repaired storm flow damage to the dam by recovering loose rocks in the stream and placing them back on the dam face.

Figure 9. Diversion dam (in left foreground) that raises Ainako stream level to divert water into the branch stream culvert. Ainako Avenue bridge is seen in background.

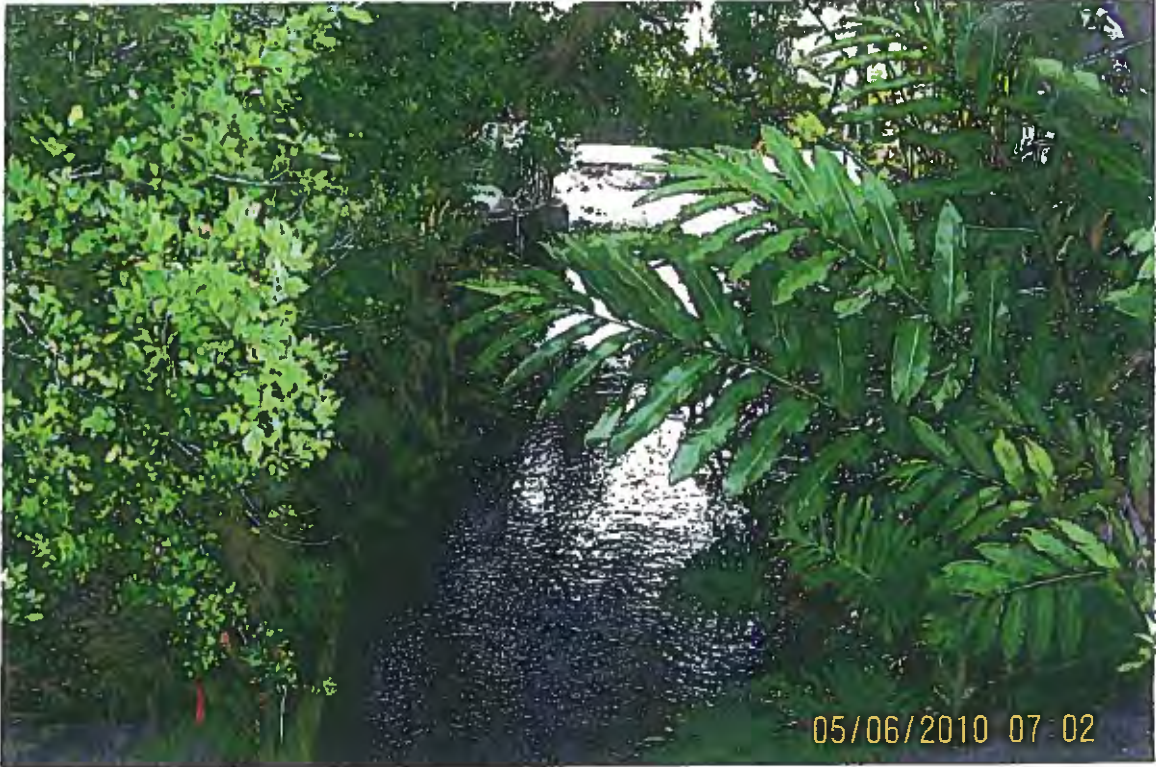
PHOTOGRAPH 1

The mouth of this stream coming off the main stream has been modified since 1990 by first Dr. Weight and then by his daughter Ms. Aina Weight. The mouth has been narrowed to allow the gate to be placed. It has been elevated off the main stream floor and angled differently.

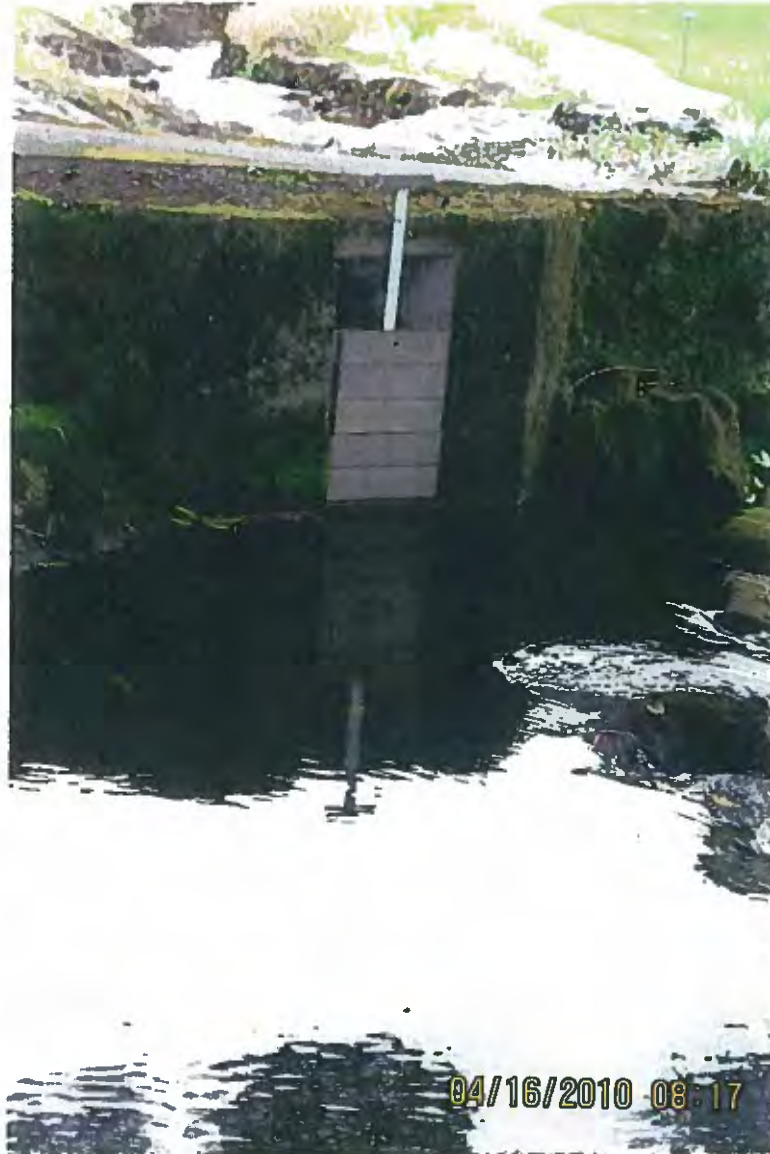
PHOTOGRAPH 2

Consequently, a small dam has been placed by Mr. Scott Henderson in the main stream back to the mouth of smaller stream. Otherwise when the main stream runs low not enough water will enter the mouth of the small stream.

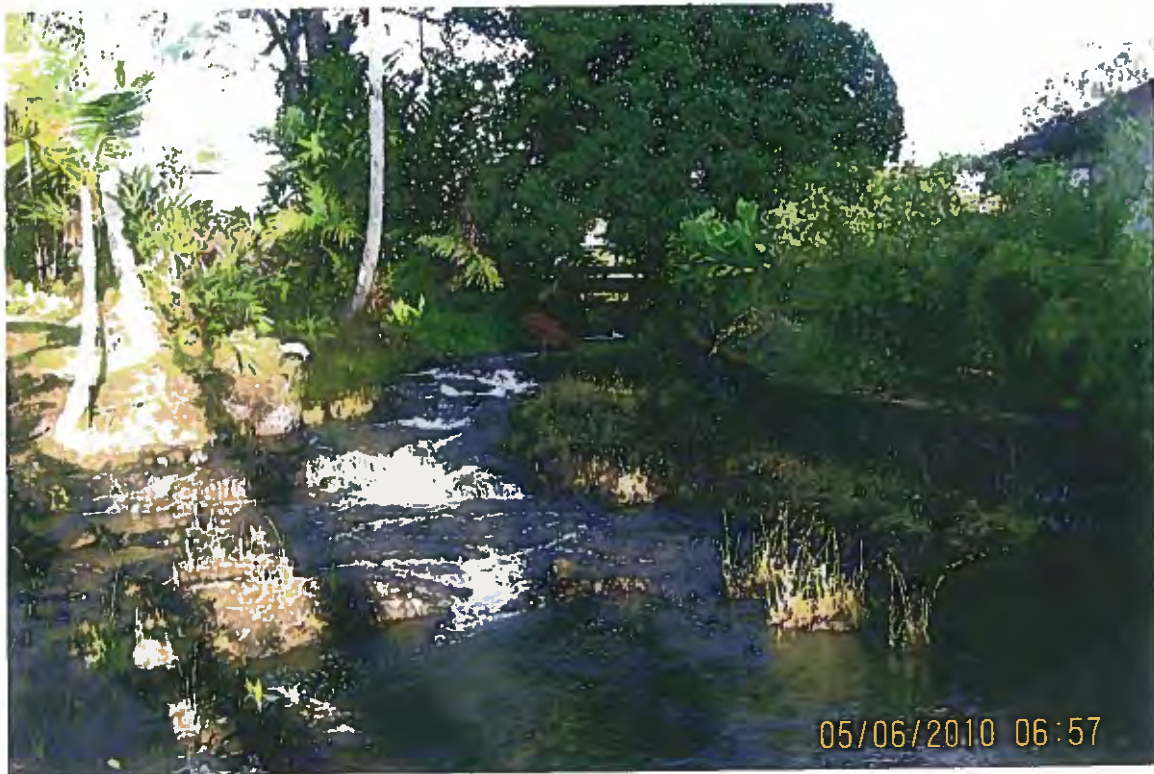
PHOTOGRAPH 4

Main stream as it is kept in bounds by wall. Behind the wall is the Weight property.

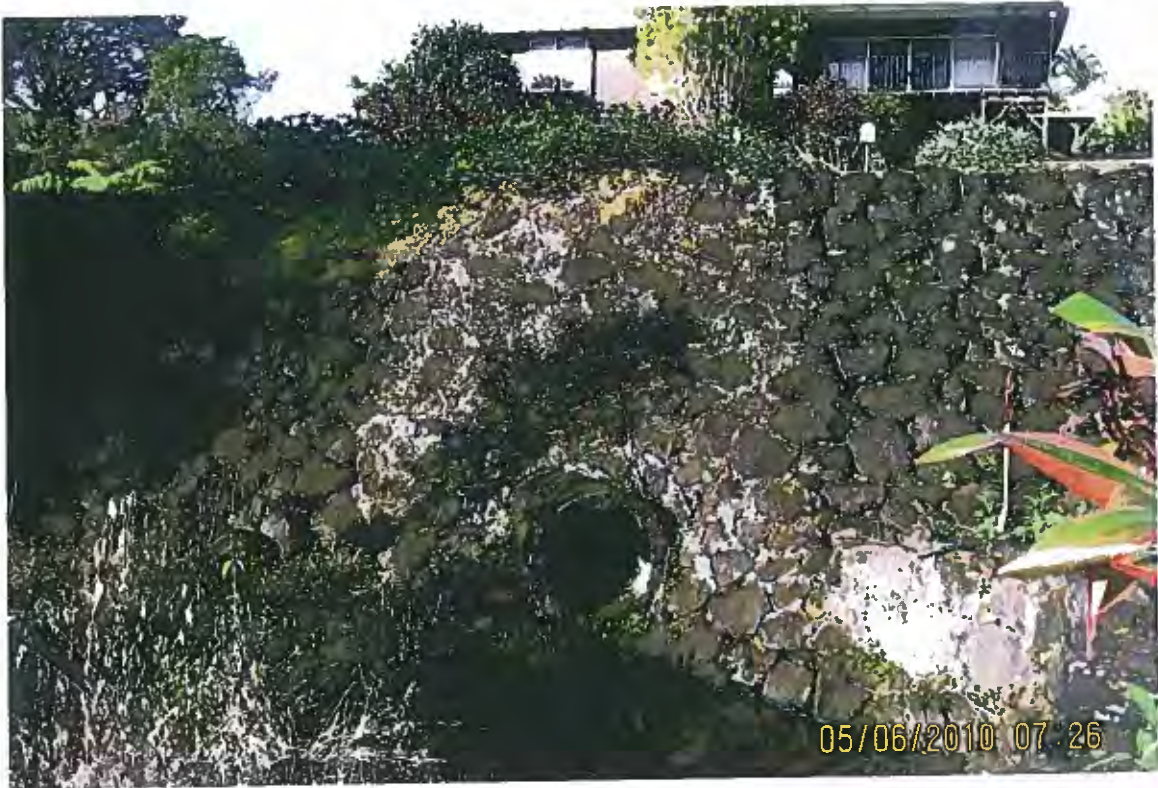
This results in drastic reduction of water flow below the Henderson property. This shows no water as the stream crosses under Kokea Street and enters the Okazaki residence.

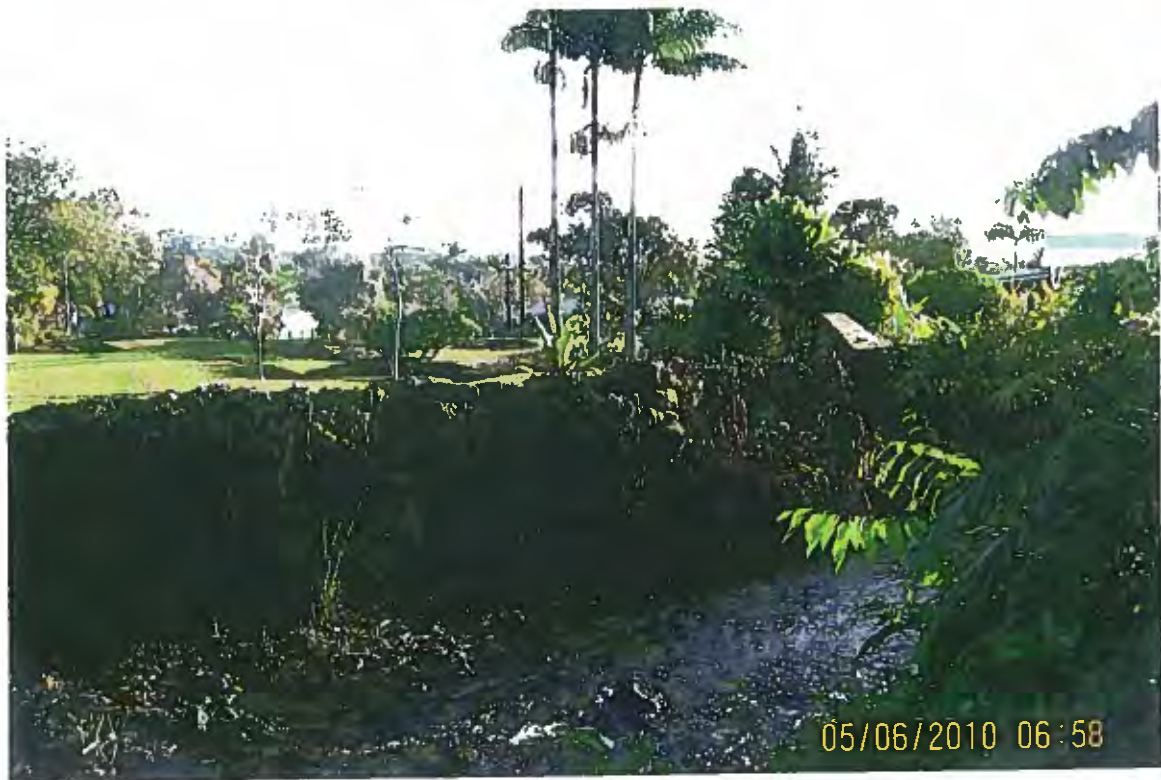
Beyond the wall to the right, this wall protects the Weight/Henderson (Marsh) properties from flooding from the main stream. However, a stream marked on the title deed has also been blocked. This stream marks the property boundary between the Weight and present day Marsh (formerly Dr. Henderson) properties.

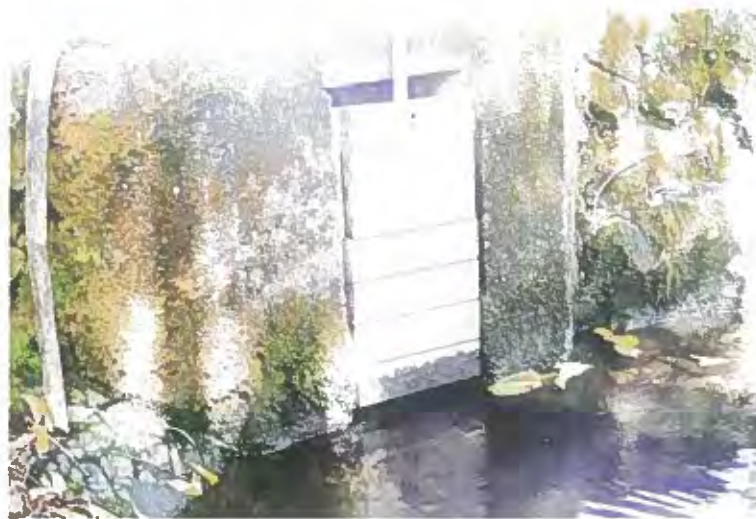
Figure 6. Flood control gate that buffers water flow into the branch stream. In back of the gate is a 14-inch ID diameter four-foot section of concrete culvert. Historic (2 to 4 decade) setting of the gate opening gap (3 ½ -4 inches) provides steady day-to-day water supply while keeping storm flow to non-damaging levels on downstream properties. The present gate, built of plastic wood, replaces the pre-existing steel gate and is set at the historical gap. Station1 in Figure 11.

9. I recently replaced the gate on the flood control gate at the origin of the Branch Stream. I used a sledgehammer and bottle jack to free up the steel gate that had been frozen by rust in the slider channels.

10. I replaced the old gate with a new plastic wood gate. The new gate has the same configuration and size as the old gate. I placed the new gate in the same slider channels and positioned it to provide the same 3.5 inch

11. For the last 50 years, storm flow from the Main stream into the Branch Stream has been controlled by the flood control gate. Based on my observations of storm flow in the Ainako and Branch Streams, I believe the flood control gate is necessary to prevent flood damage to the 1000 Ainako Street and 99 Kokea Street properties.

It appears that the concrete culvert piece had been placed onto an unaltered pahoehoe lava surface in a natural low spot through which water would have flowed. Primary function of the flood gate over the last three decades has been to prevent very high levels of water from flowing into the branch stream during storm flow.

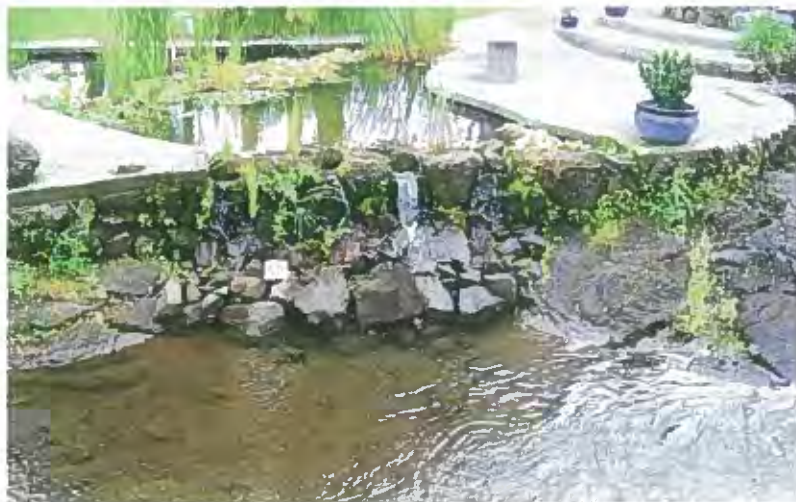
Figure 18. Station 8 of branch stream looking across stream to pond overflow.

Figure 18. Station 8 of branch stream looking across stream to pond overflow.

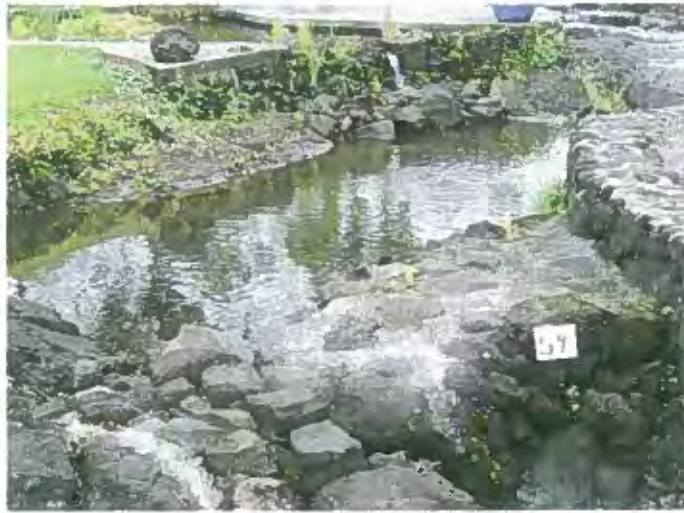
Figure 19. Station 9 of branch stream looking upstream.

Figure 11. Ainako branch stream route & features. Triangular symbols = GPS-located photo stations. More data on the stations are provided in Table 1 (next page). Photos taken at the stations are shown in Figures 6, 8 and 13 through 26.

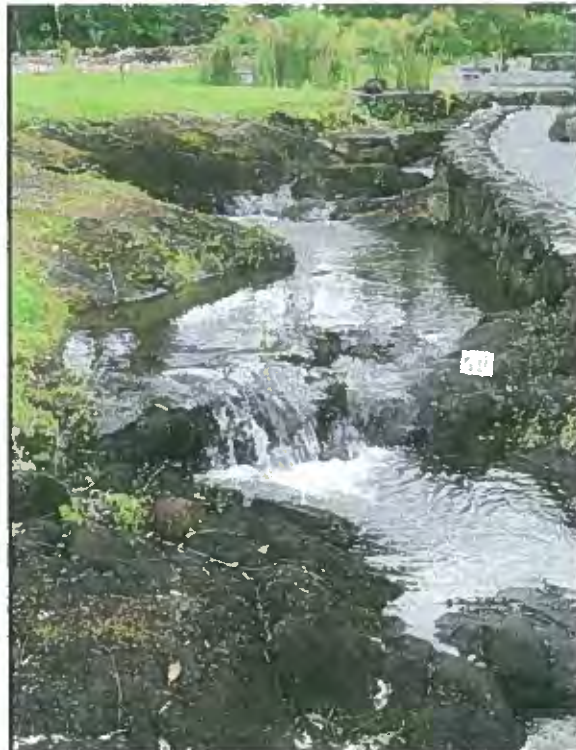
Figure 20. Station 10 of branch stream looking upstream.

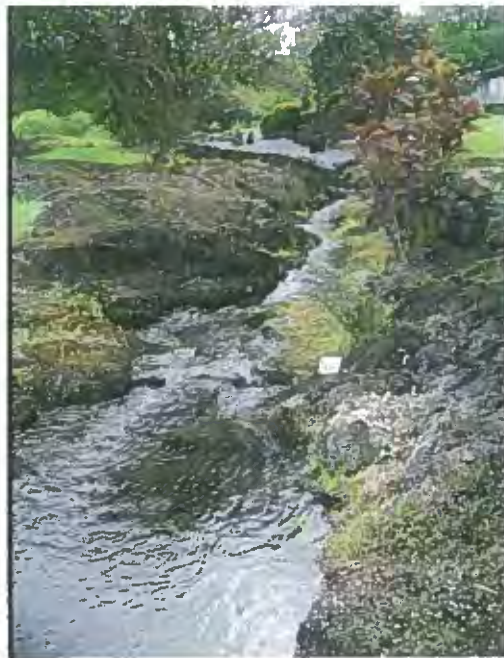
Figure 22. Station 12 of branch stream looking upstream.

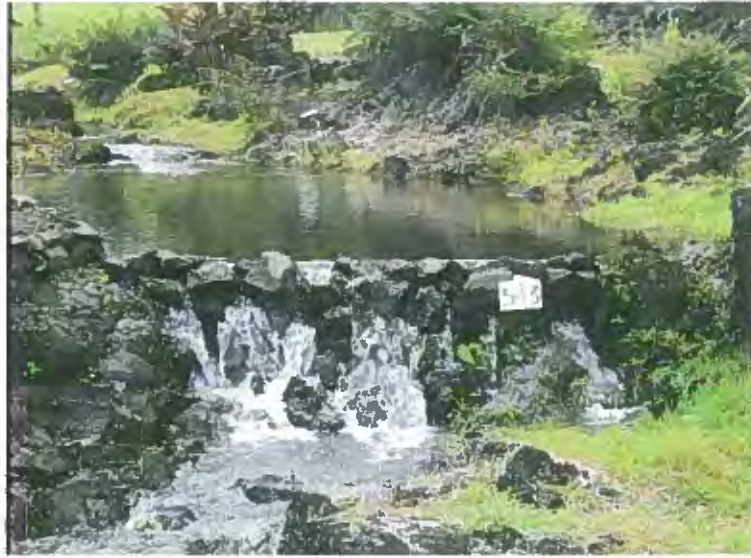
Figure 23. Station 13 of branch stream looking upstream.

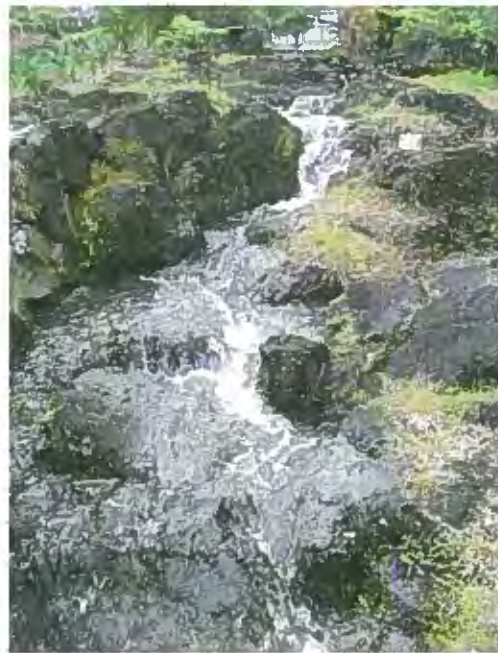
Figure 24. Station 14 of branch stream looking upstream.

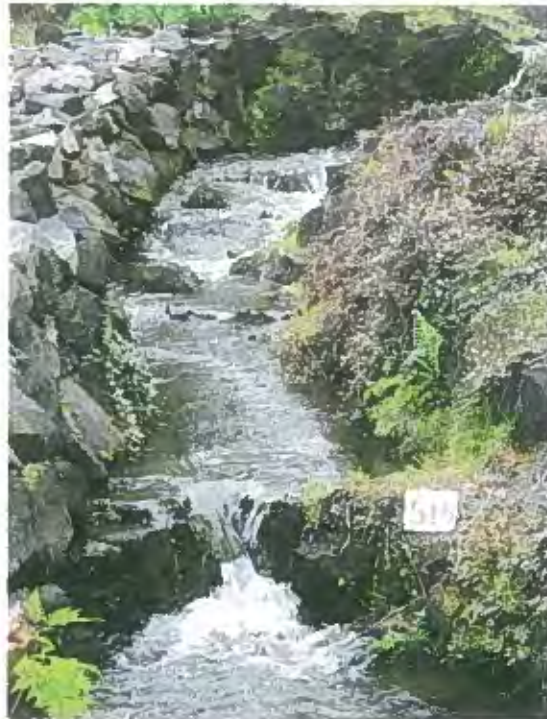
Figure 25. Station 15 of branch stream looking upstream.

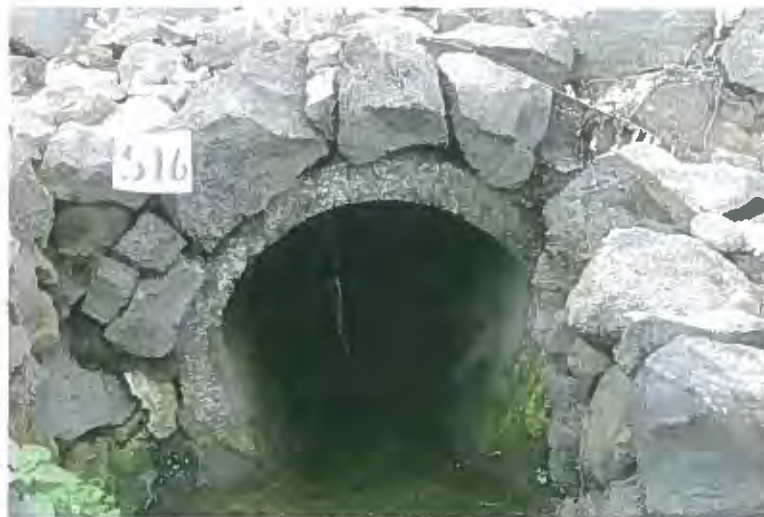
Figure 26. Station 16 of branch stream looking downstream at culvert that passes under Kokea Street.

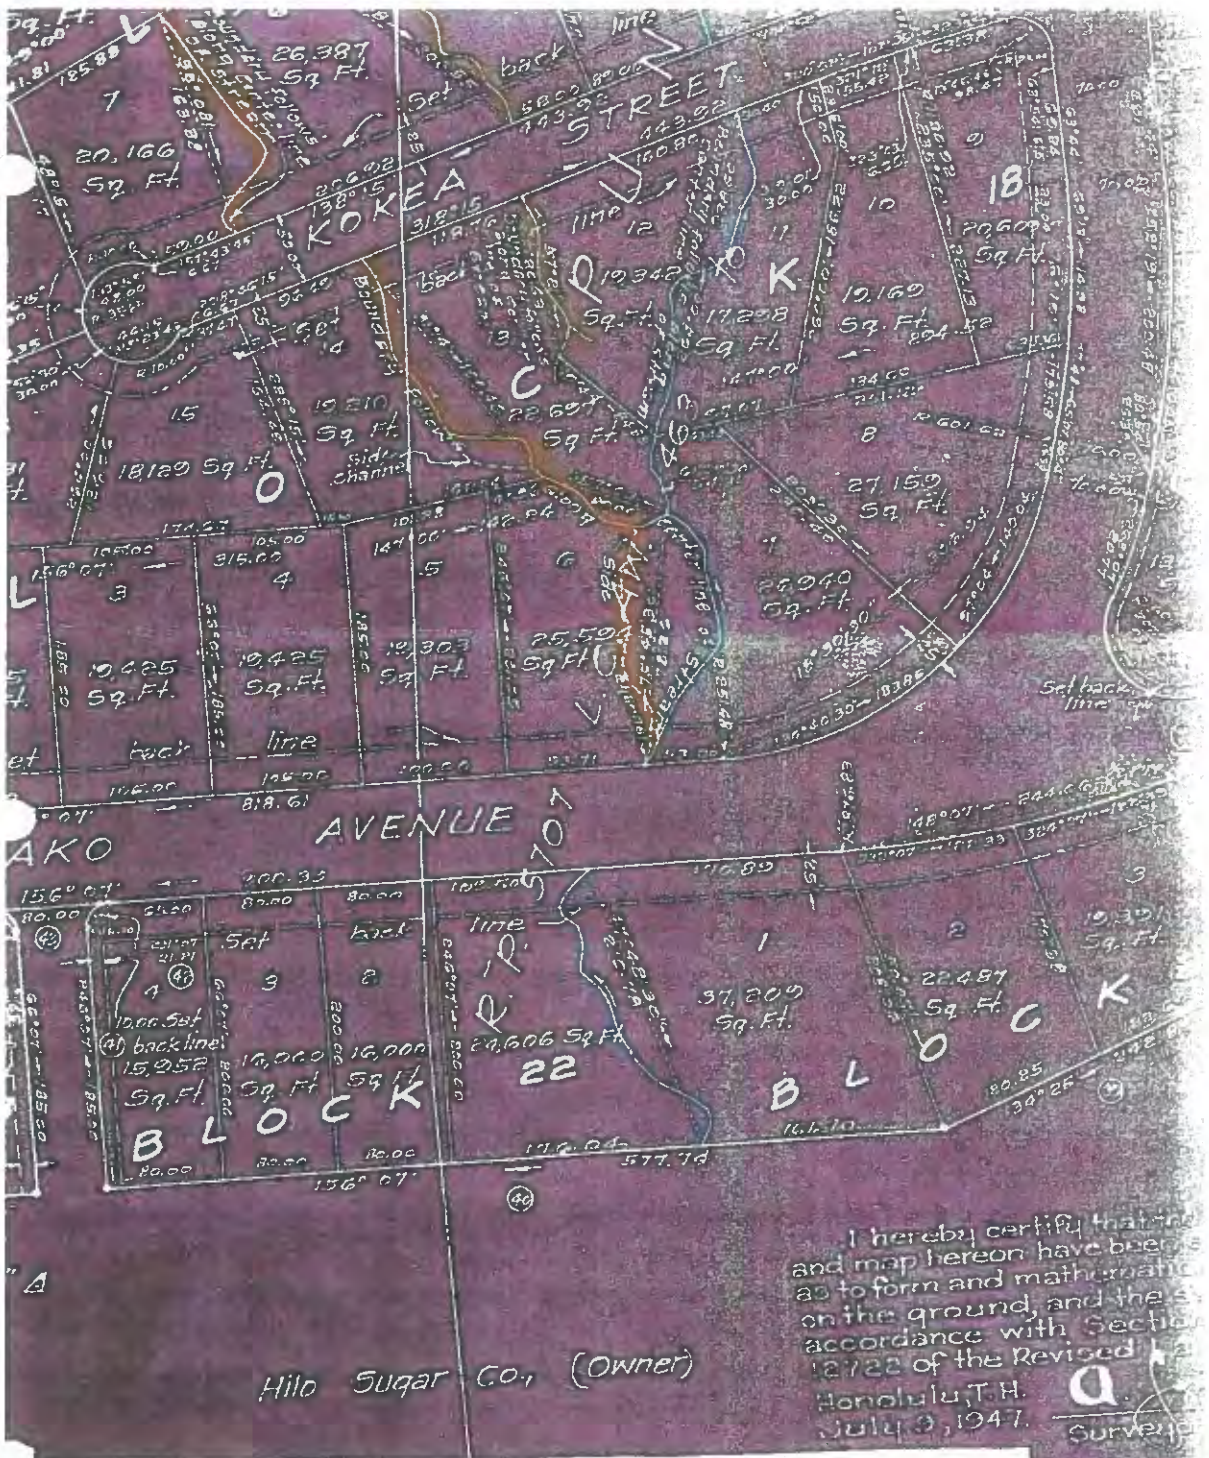
Figure A-3. Territory of Hawaii TMK, July 1947, showing route of Ainako Stream (blue) and Branch Stream (orange).

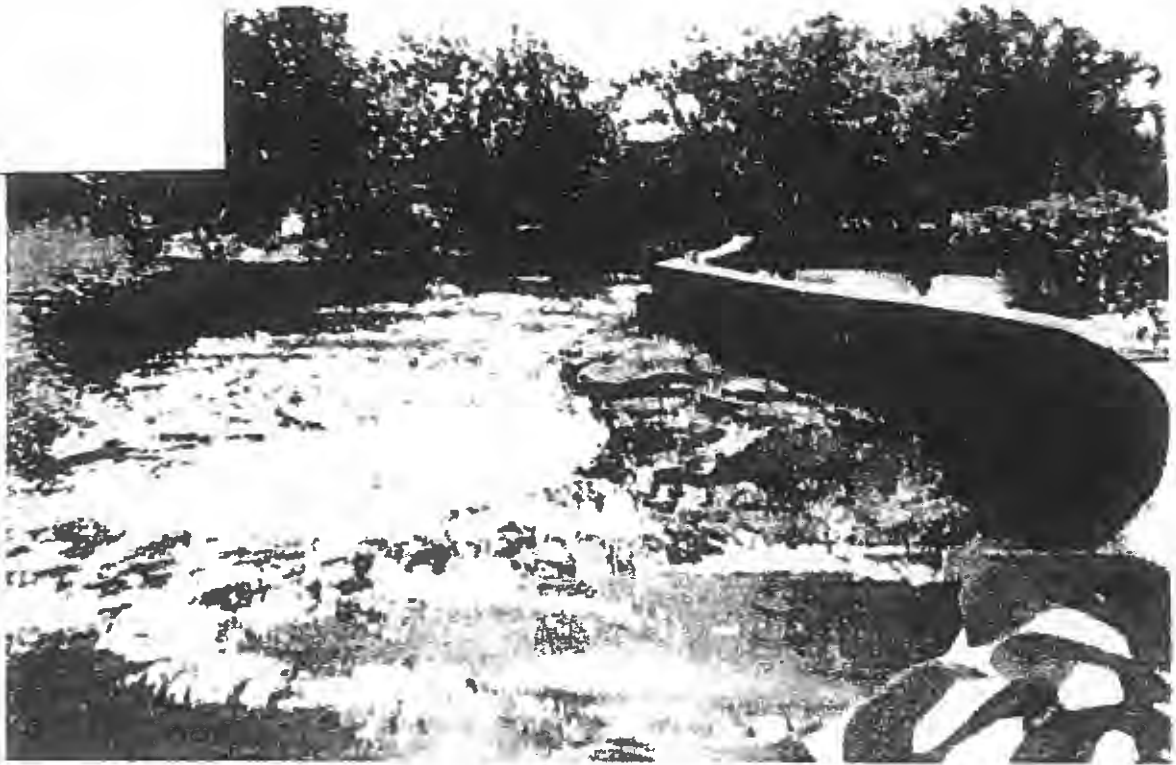
Figure A-4. View of Ainako stream looking upstream from S side of TMK 2-5-25-4 property. Above photo taken in August 1960 . Below photo taken in May 2010.

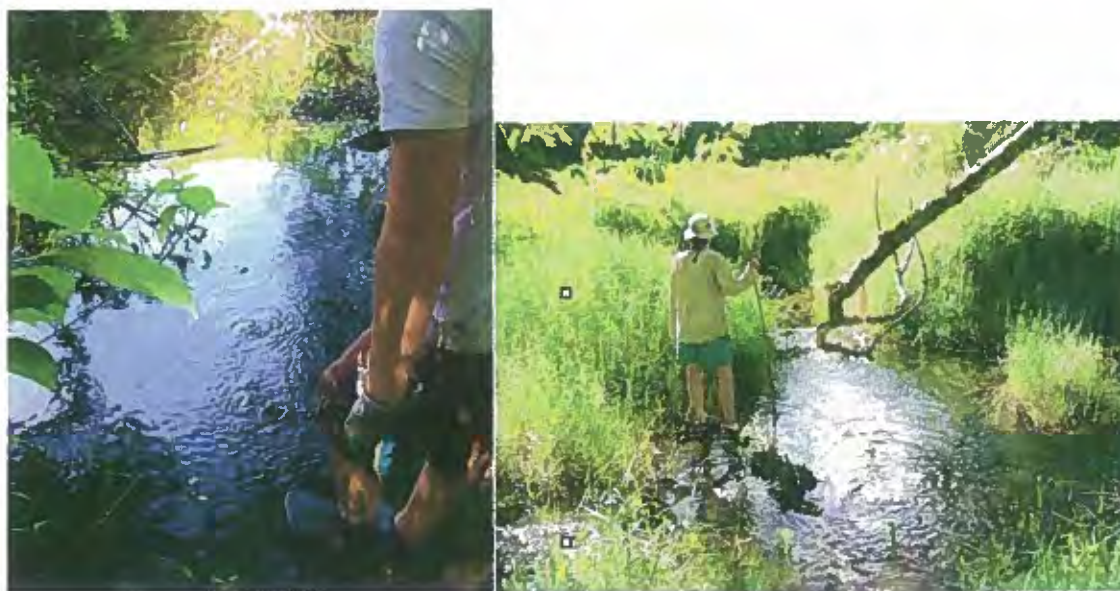
Figure 1. Typical springs at Ainako stream origin area (approximate location N 19 42 26.4, W155 07 56.1, 250 meter elevation).

Ainako stream originates at about 820-foot elevation about 0.4 mile upslope from the 1000 Ainako Avenue bridge. The origin area is roughly a half-mile square of boggy scrub forest and grasslands immediately below Akolea Road. Numerous springs arise from the origin area (Figure 1) and converge on the stream channel via a network of ill-defined meandering routes. Substrate over the entire length of Ainako stream is dominated by pahoehoe lava flows dating to 5,000 to 10,000 years of age. This same substrate dominates slopes extending more than five miles above the stream origin. The pahoehoe flows are very porous, and lava blisters, tumuli and lava tubes are common. Less than a half-mile to the south of the stream origin area, an extensive lava tube system contains underground streams that flow most of the year. Similar subterranean systems likely feed the Ainako stream springs.

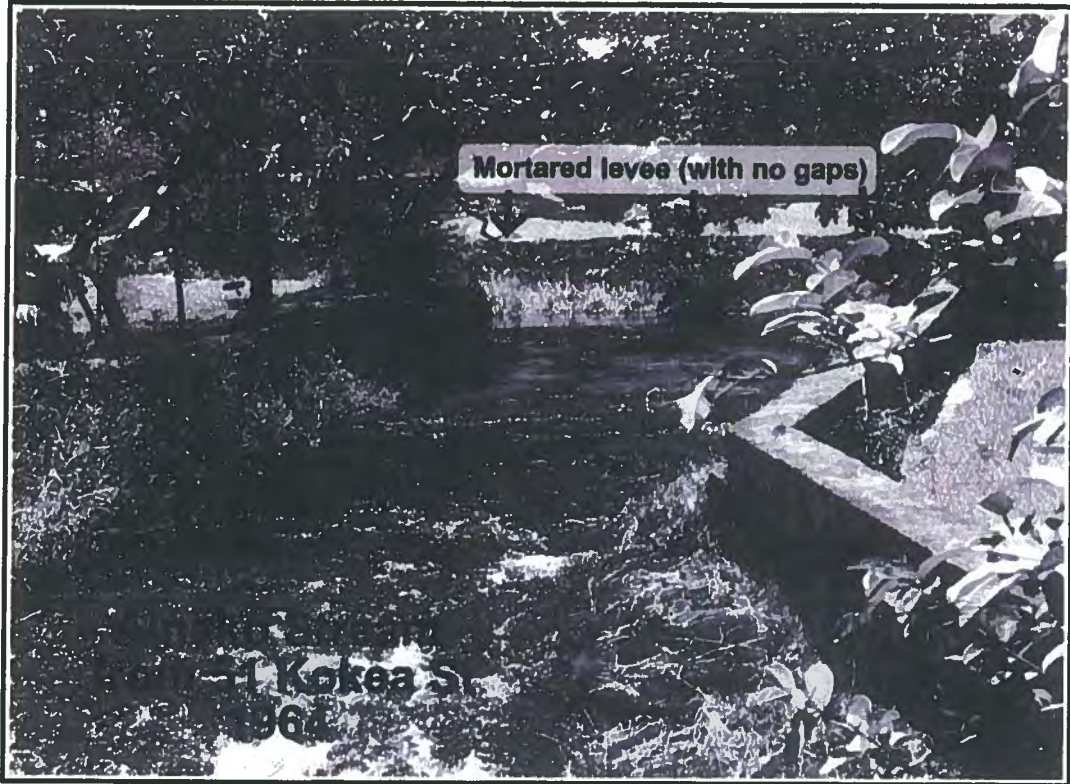
EXHIBIT "C"

Stream-side views of rock and concrete levees walls on present-day Marsh and Weight properties. Photographs from Henderson photo collection, 1960 & 1964.

SH & AW can identify no “pile of rocks near tip of V-shaped levee that seemed different than the upper levee area and V-notch levee along Ainako Stream.” Such an anomaly simply does not exist. The rocks and mortar that occur near the “tip” are no different from rocks and mortar that occur along the upstream portion of the mortared levee. Many of the loose rocks (used as back-fill along the landward edge of the levees within about 60 feet of the “V” buttress) have been disturbed by several years of invasion by a ginger patch and its recent removal. Attached photographs in *Exhibit D* show streamside and landside views of the “tip” area in question and show that rock and mortar structure over the entire area is homogenous.

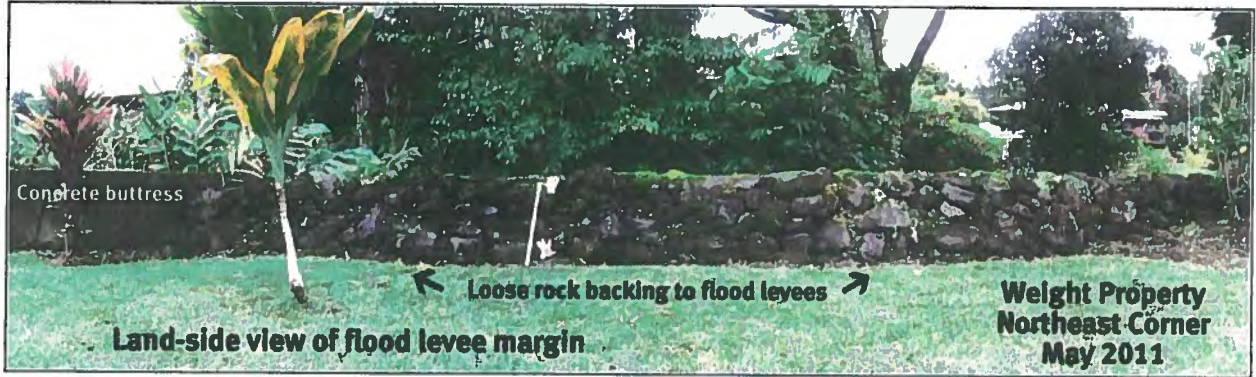
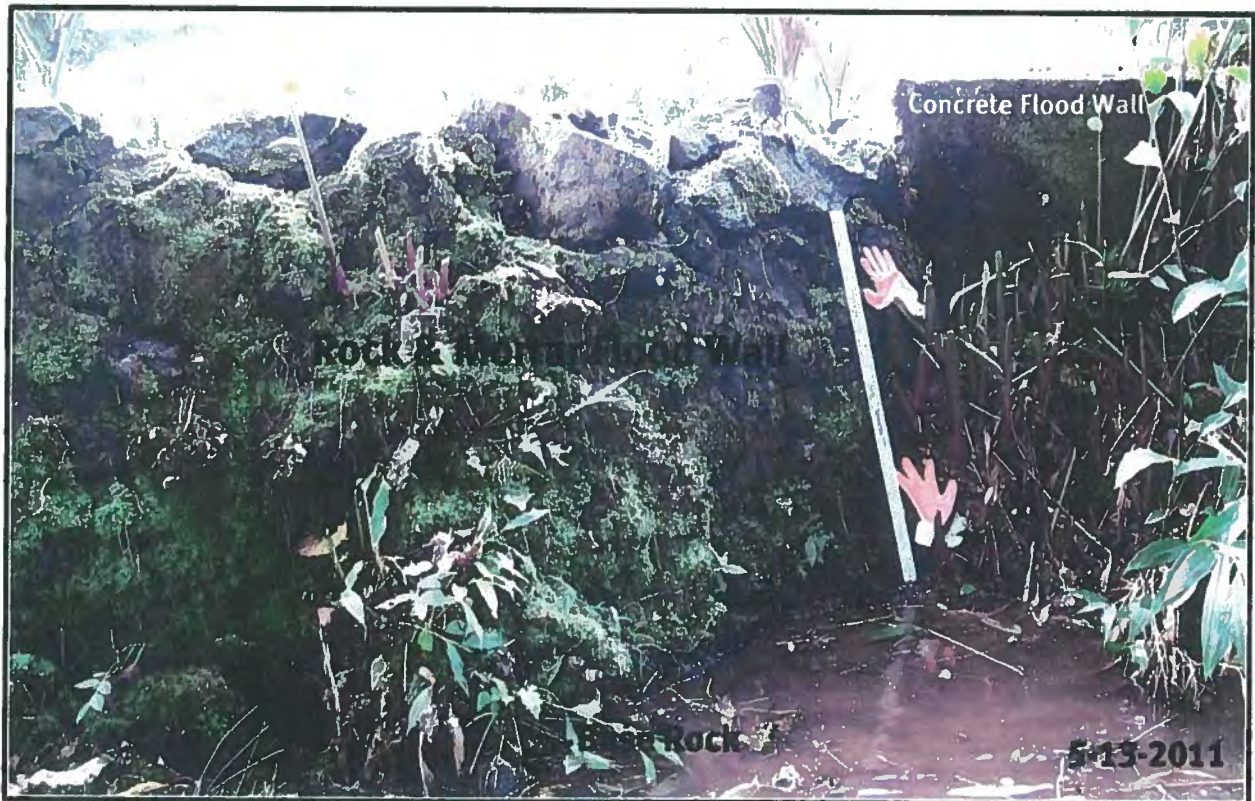
EXHIBIT "D"

Land-side and stream-side views of mortared rock levees on Weight property at junction of concrete buttress.
