STAFF SUBMITTAL

COMMISSION ON WATER RESOURCE MANAGEMENT

September 27, 2011
Honolulu, Hawaii

Mediation or Binding Arbitration for Complaint/Dispute Resolution (CDR.2769.8)
Application for After-the-Fact Stream Channel Alteration Permit,
Stream Diversion Works Permit and Petition to Amend Instream Flow Standard (SCAP.2898.8)
Ainako Branch Stream, Hilo, Hawaii
TMKs: (3) 2-5-025:005, 014 and 006, 2-5-024:028, 029 and 045

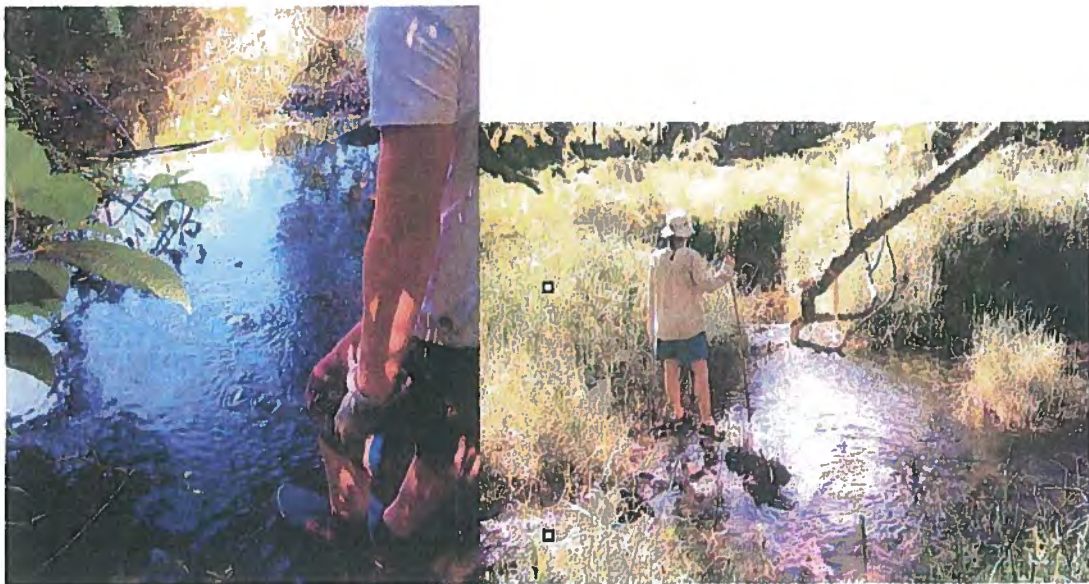
Figure 1. Typical springs at Ainako stream origin area (approximate location N 19 42 26.4, W155 07 56.1, 250 meter elevation).

Ainako stream originates at about 820-foot elevation about 0.4 mile upslope from the 1000 Ainako Avenue bridge. The origin area is roughly a half-mile square of boggy scrub forest and grasslands immediately below Akolea Road. Numerous springs arise from the origin area (Figure 1) and converge on the stream channel via a network of ill-defined meandering routes. Substrate over the entire length of Ainako stream is dominated by pahoehoe lava flows dating to 5,000 to 10,000 years of age. This same substrate dominates slopes extending more than five miles above the stream origin. The pahoehoe flows are very porous, and lava blisters, tumuli and lava tubes are common. Less than a half-mile to the south of the stream origin area, an extensive lava tube system contains underground streams that flow most of the year. Similar subterranean systems likely feed the Ainako stream springs.

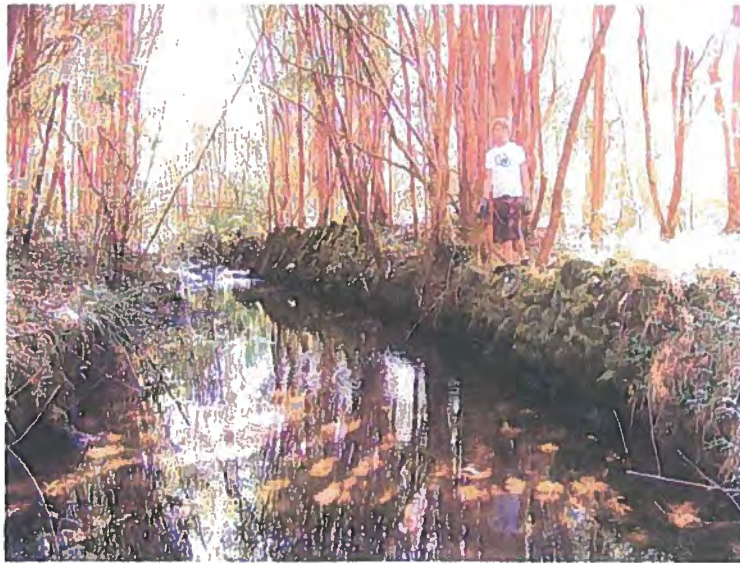
Figure 2. Ainako stream in lower portion of origin area. The rock embankments were possibly built by Hilo Sugar Plantation Company.

In a few locations, stacked rock lines the borders of the stream (Figure 2), possibly put in place by Hilo Sugar Plantation Company for flood control or water diversion purposes. Below the origin area, the stream flows over gentle relief through forest composed of strawberry guava, tibuchina, ferns, ginger and tall grasses (Figure 3).

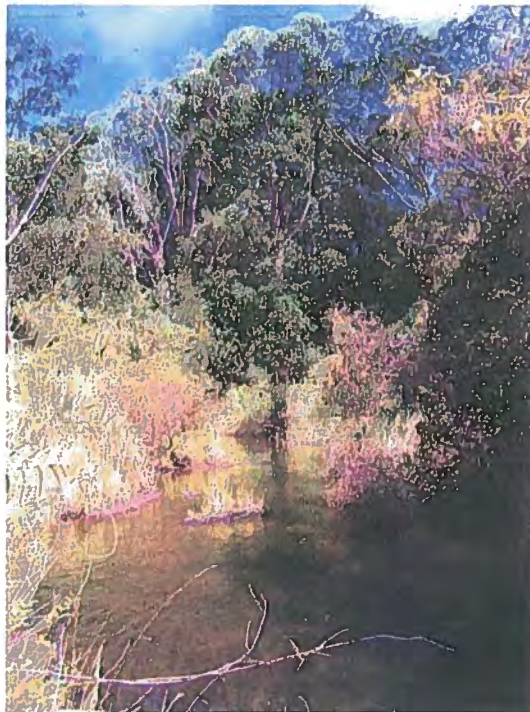
Figure 3. Ainako stream in forest above Ainako subdivision.

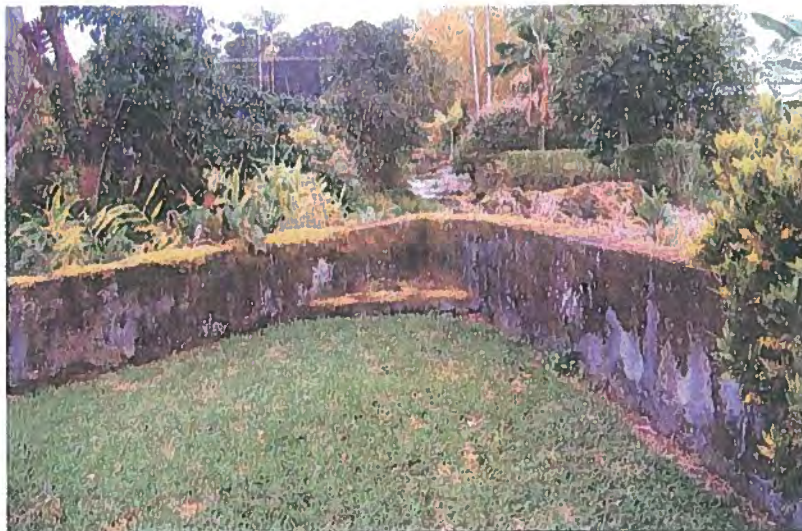
Figure 4. Flood levee along Ainako stream on upstream border of Marsh property. Built circa 1956-58 soon after damaging flood of 1956.

By the time that the Henderson family moved to 51 Kokea Street in August 1958, substantial flood control levees of mortared rock and solid concrete had been built along several flood-prone sections of Ainako stream between Ainako Avenue and Koula Street (a distance of 0.2 mile). Those levees are generally 2 to 5 feet high and 0.5 to 1.5 foot thick (Figures 4 & 5). The levees were likely built by the Hilo Sugar Plantation Company (developer of the Ainako subdivision) and individual landowners in the subdivision. During a major flood in 1964, water level in the Ainako stream rose to within a few inches of the top of the levee in back of the Henderson's house.

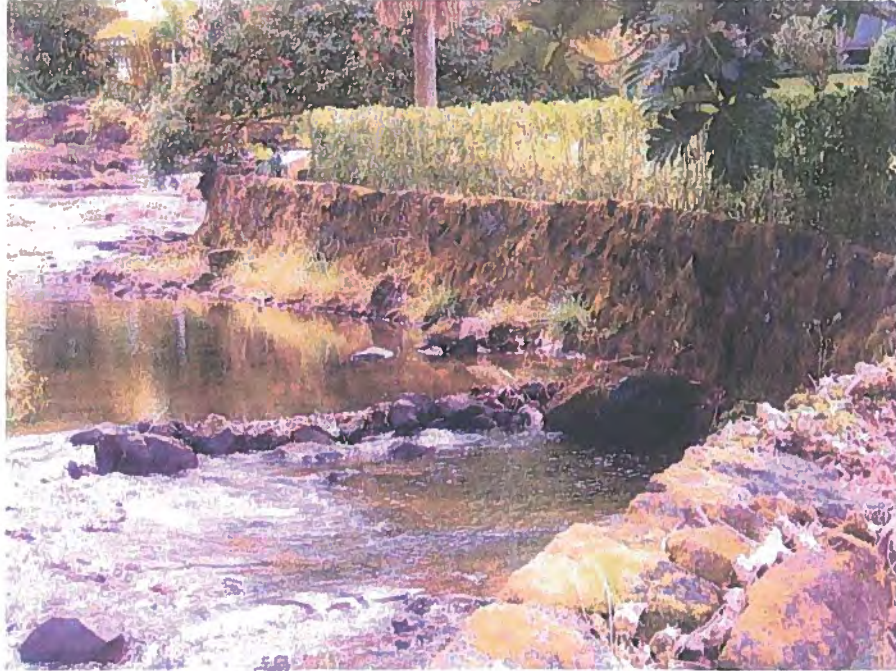
Figure 5. Levee embankments along the Ainako stream Weight property margin.

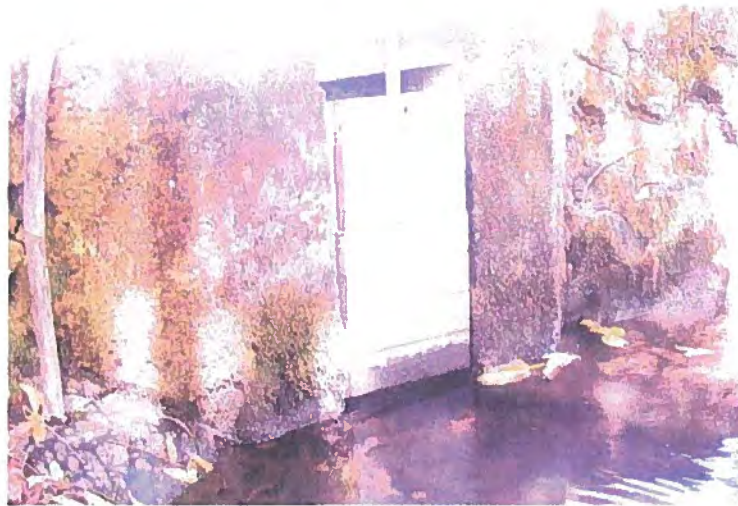
Figure 6. Flood control gate that buffers water flow into the branch stream. In back of the gate is a 14-inch ID diameter four-foot section of concrete culvert. Historic (2 to 4 decade) setting of the gate opening gap (3 ½ -4 inches) provides steady day-to-day water supply while keeping storm flow to non-damaging levels on downstream properties. The present gate, built of plastic wood, replaces the pre-existing steel gate and is set at the historical gap. Station1 in Figure 11.

The Weights purchased their first Ainako property, that included Lot 6, sometime in 1954-55. At that time the property was covered with tall grass and ferns and the branch stream ran through the property along the same general route that it follows today. The Weights moved onto the Ainako property in 1956. In the 1950s, or possibly earlier, a small flood gate was installed at the junction of the main stream and Ainako stream, most likely by the Sugar Company or Dr. Weight. The gate structure appears to be integral with the 3-foot-high retaining wall that runs along the entire Ainako stream boundary of the Weight property (Figures 5, 6 & 7). A steel plate of 14-inch width and 36-inch height slid vertically within grooves in the sides of the gate structure (Figures 6 & 7). For two or three decades, the steel plate had been jammed in a position that was about 3 ½ inches above the bottom of the gate. Water flows from Ainako stream, through the gate, into a 4-foot section of 14-inch ID concrete culvert (that passes under a sidewalk), and then into the branch stream (Figure 8).

It appears that the concrete culvert piece had been placed onto an unaltered pahoehoe lava surface in a natural low spot through which water would have flowed. Primary function of the flood gate over the last three decades has been to prevent very high levels of water from flowing into the branch stream during storm flow.

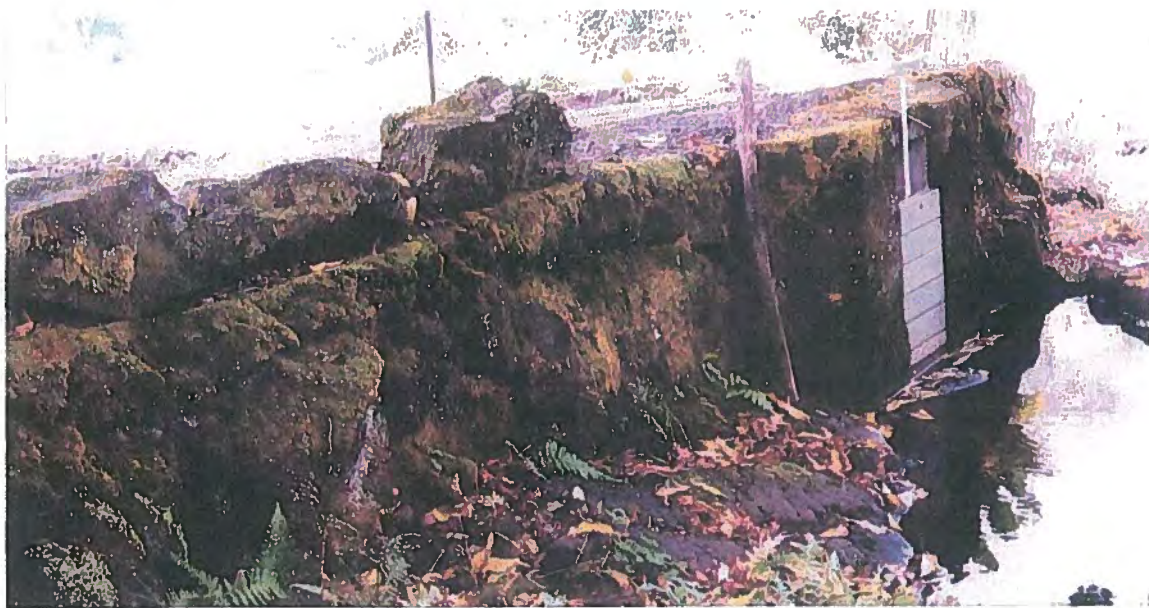
Figure 7. Flood control gate and reinforced embankment at origin of branch stream.

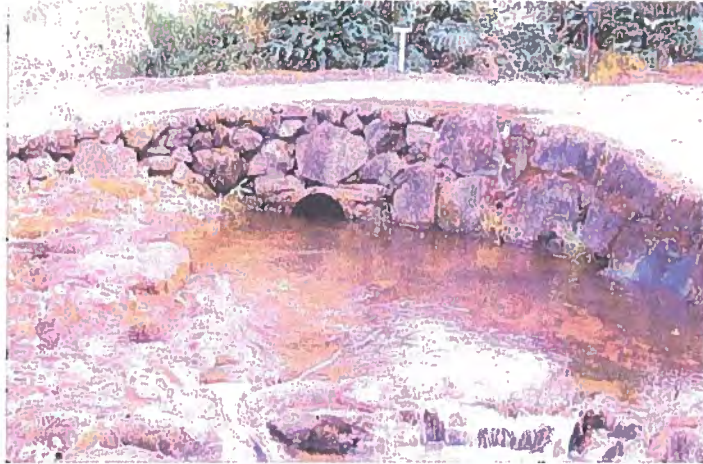
Figure 8. Culvert that supplies flow to branch stream from Ainako stream. View from branch stream side. Station 1 in Figure 11.

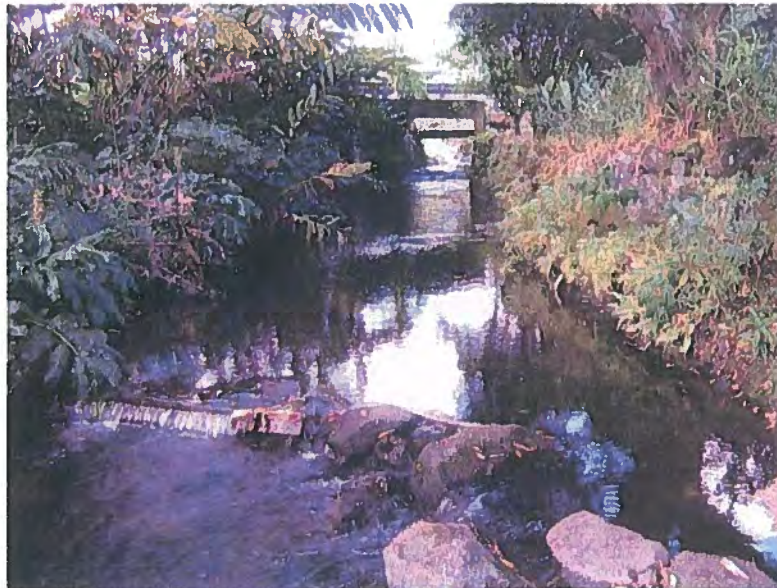
Figure 9. Diversion dam (in left foreground) that raises Ainako stream level to divert water into the branch stream culvert. Ainako Avenue bridge is seen in background.

To ensure that the water level of Ainako stream is maintained at a level that will provide ample flow of water into the branch stream, a diversion dam was built across half the width of Ainako stream (Figures 9 & 10). The diversion dam is made of loose-stacked rock and is topped by a length of railroad track. Landside end of the track piece is buried in soil. It is not known who first built the diversion dam, but it was likely either the Sugar Company or Dr. Weight. Over the years, Dr. Weight periodically repaired storm flow damage to the dam by recovering loose rocks in the stream and placing them back on the dam face.

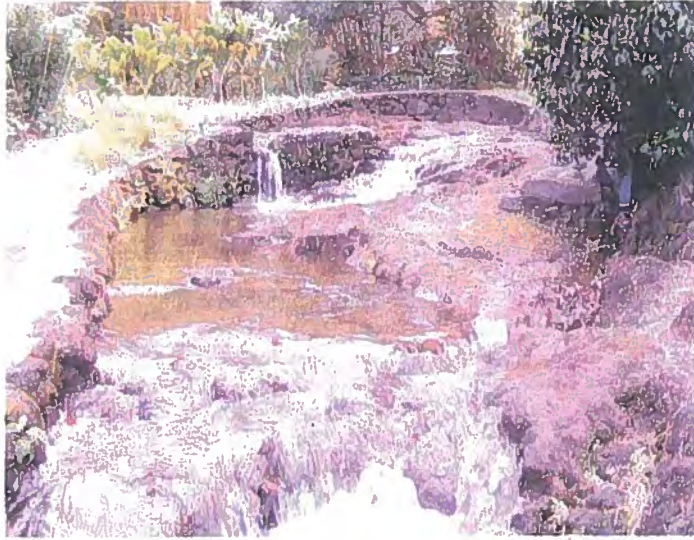
Figure 13. Station 3 of branch stream looking upstream.

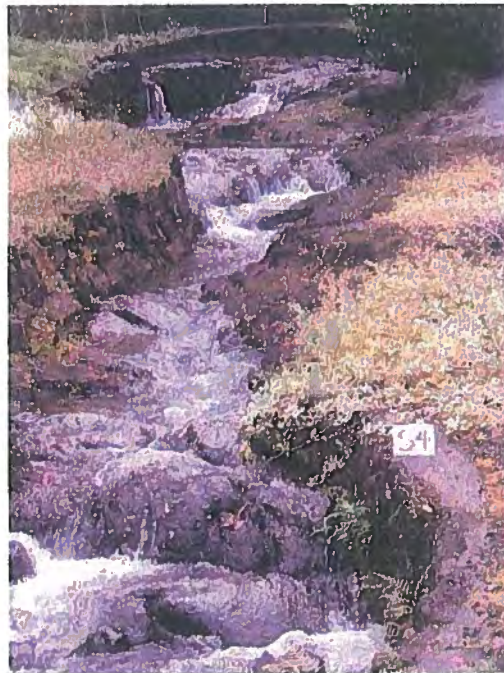
Figure 14. Station 4 of branch stream looking upstream.

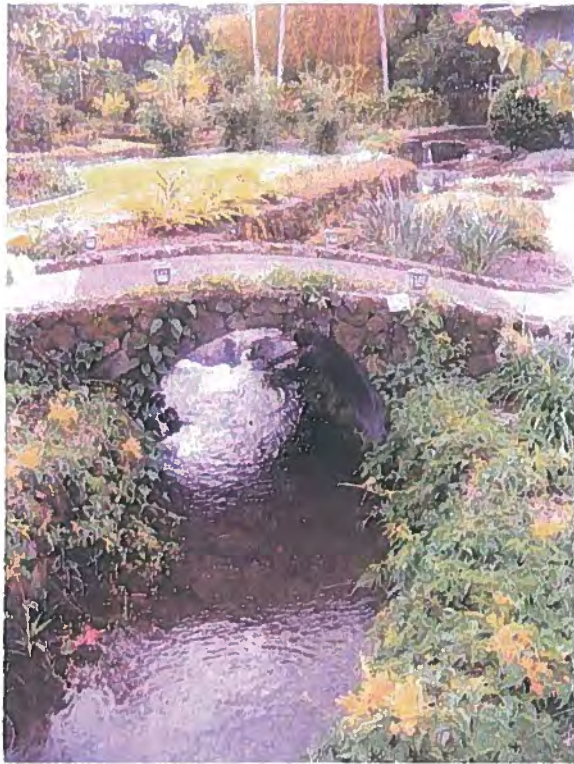
Figure 15. Station 5 of branch stream looking upstream.

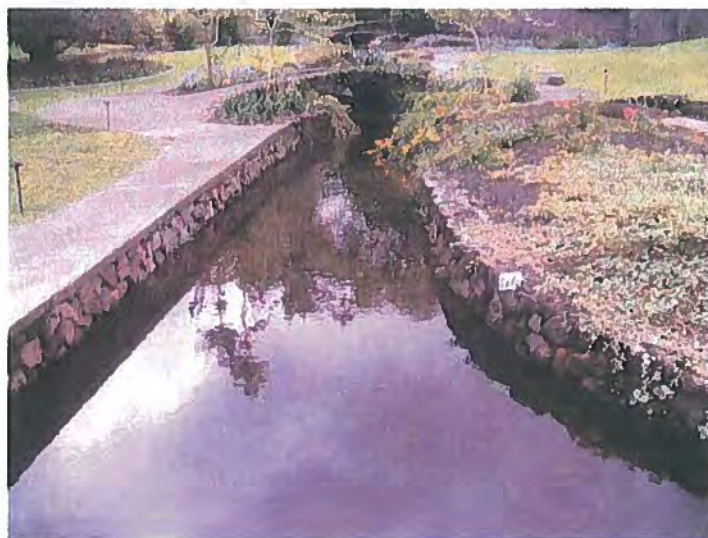
Figure 16. Station 6 of branch stream looking upstream.

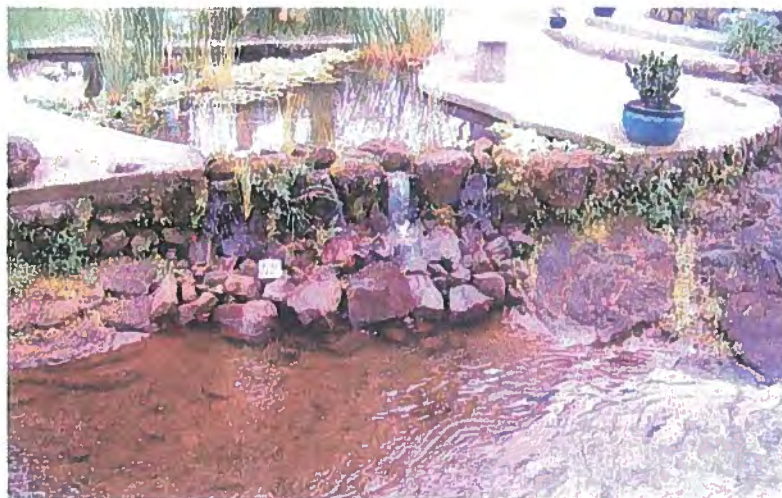
Figure 18. Station 8 of branch stream looking across stream to pond overflow.

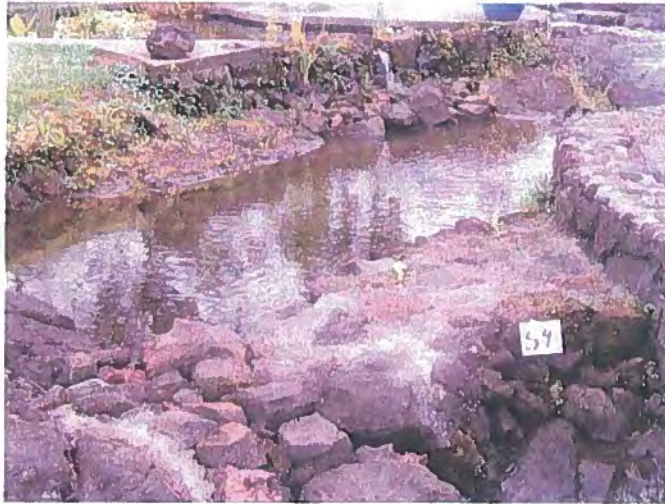
Figure 19. Station 9 of branch stream looking upstream.

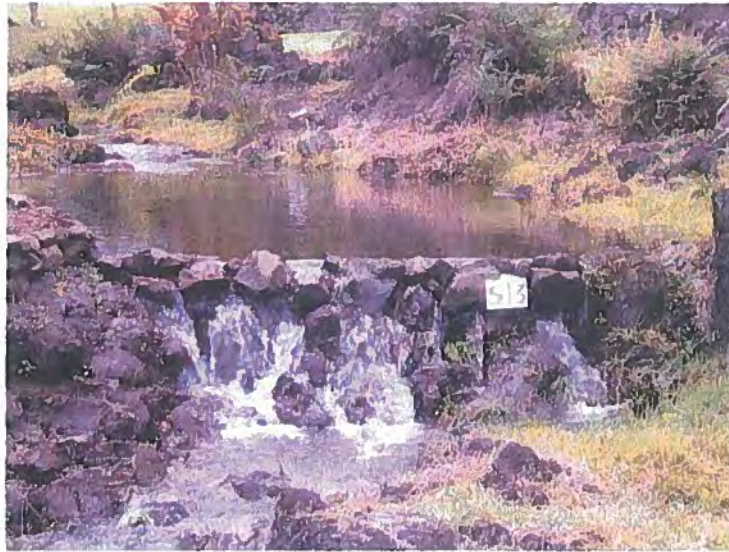
Figure 23. Station 13 of branch stream looking upstream.

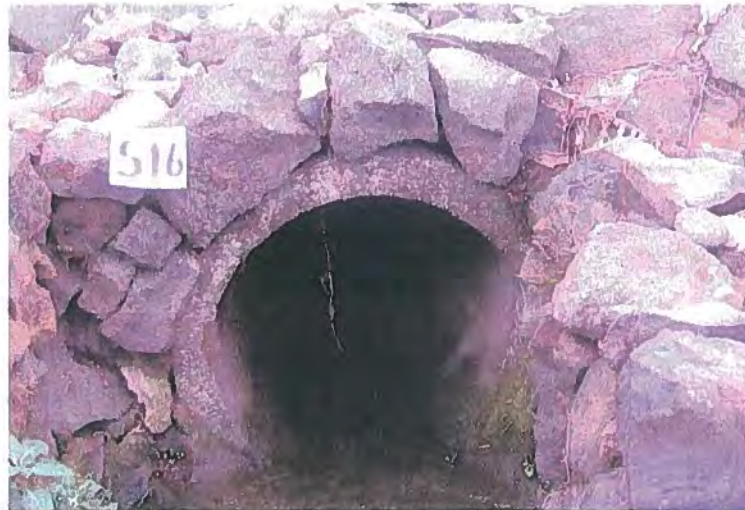
Figure 26. Station 16 of branch stream looking downstream at culvert that passes under Kokea Street.

View lower section of Branch Stream and Kokea St culvert. Very little water that flows under Kokea St actually flows through the under-road culvert. Instead, it flows through porous fill under the road, emerging on a broad, diffuse front on the downstream side of the road. Photograph 9 in the Complainants package shows the culvert on the downstream side and they claim that "This shows no water as the stream crosses under Kokea Street and enters the Okazaki residence". Water can clearly be seen in the stream (being fed by diffuse flow around the culvert). Twenty-six hours after the photo was taken (on 05/06/2010, 0726 hrs), the Branch Stream Inlet Culvert Depth was 8.5 inches (SH records). That level is considered slightly above "average normal" for the Branch Stream and maintains the Hannenburg pond and Okazaki pond at overflowing levels. The claim by the Complainants that the photo shows "no water" is erroneous and misleading.

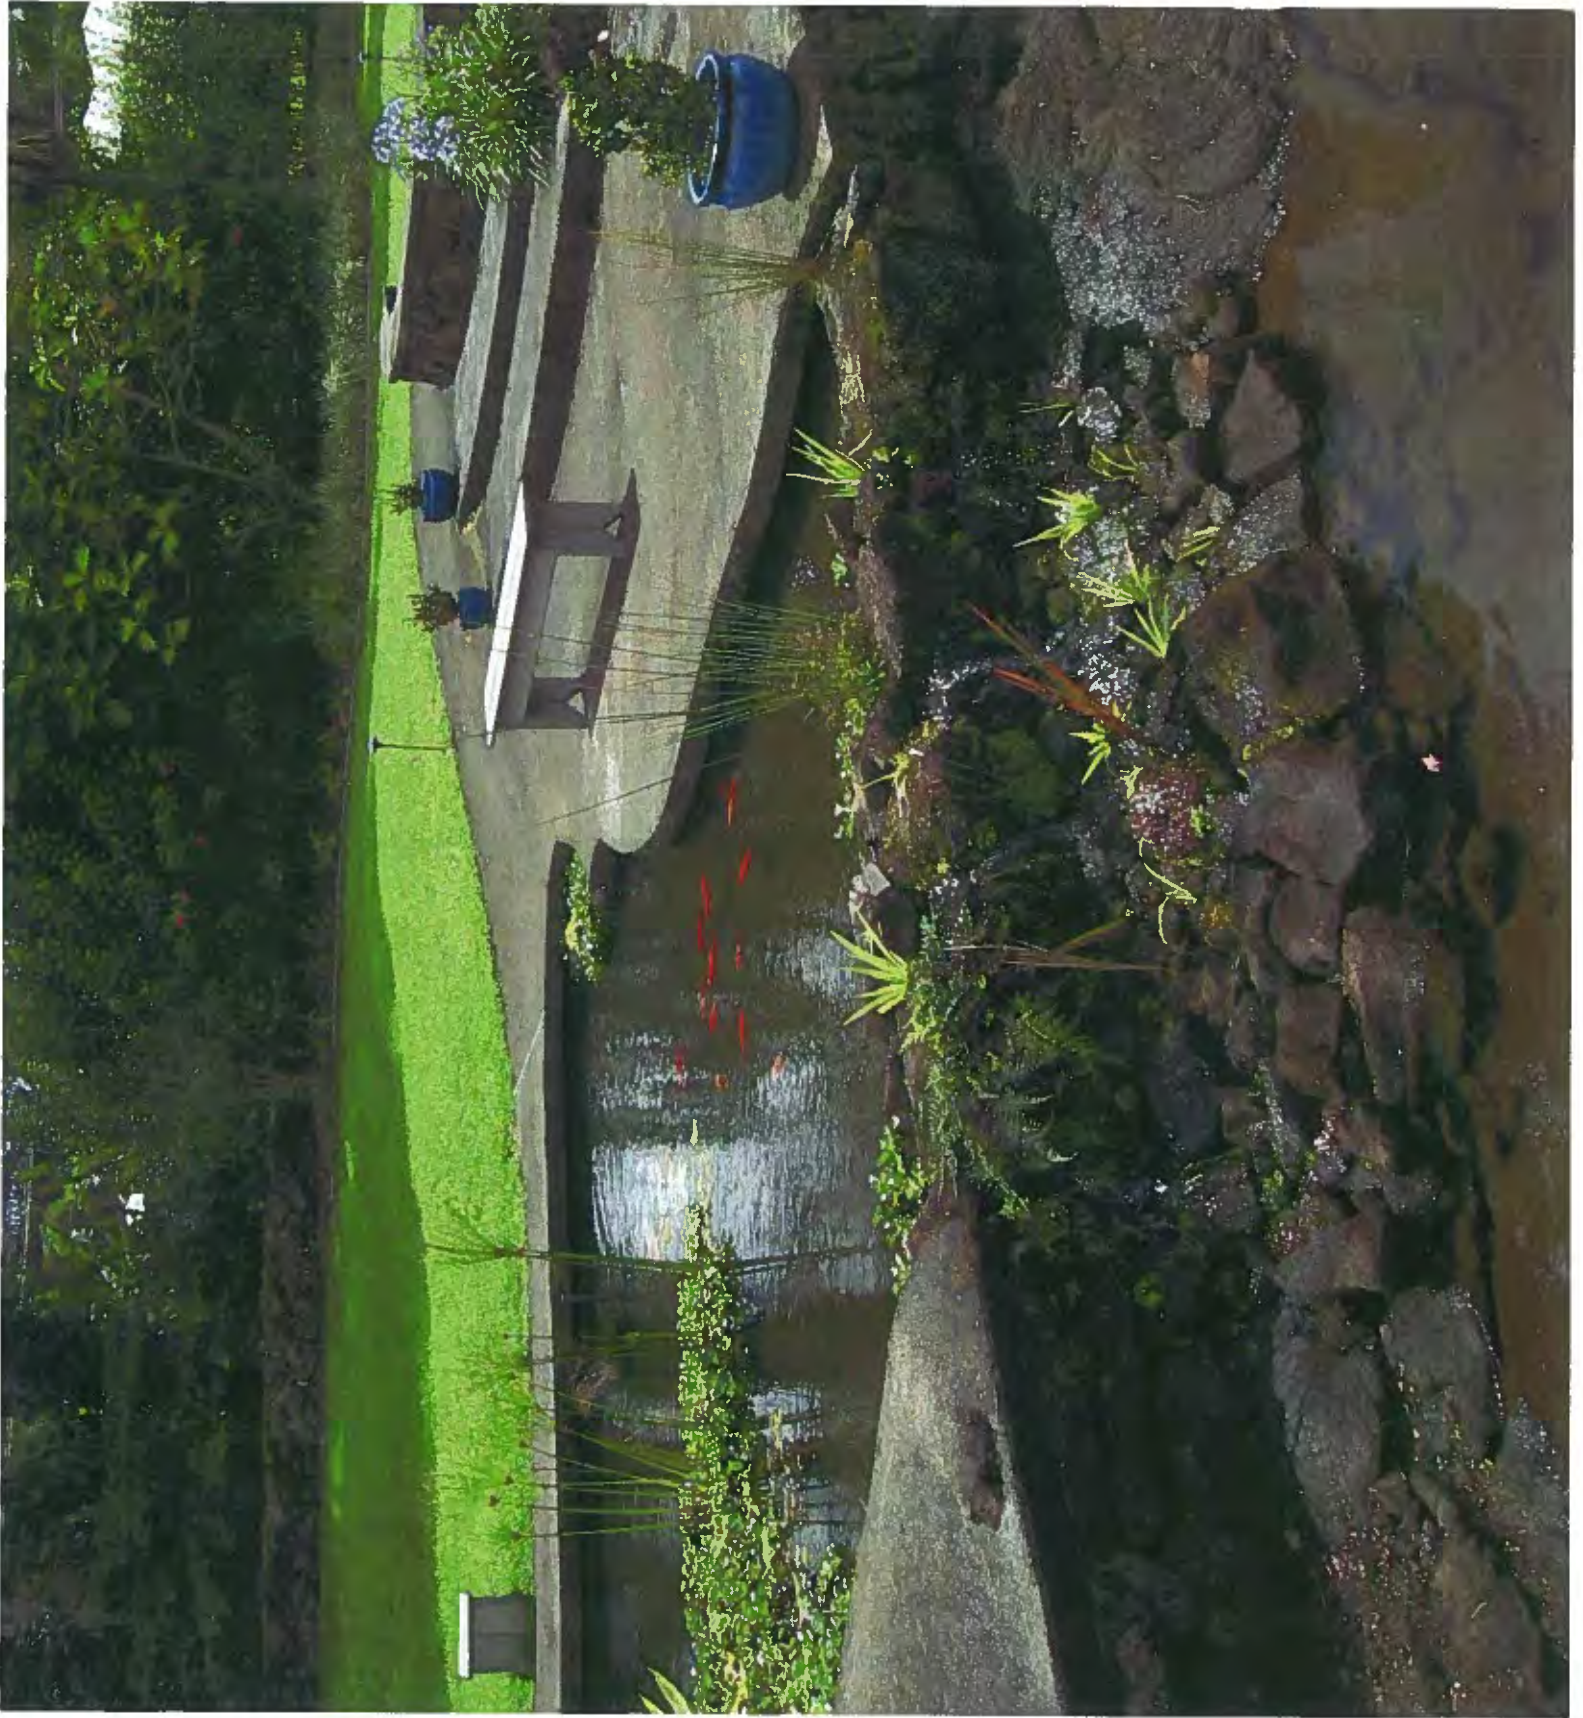
New concrete-lined pond

New retaining wall

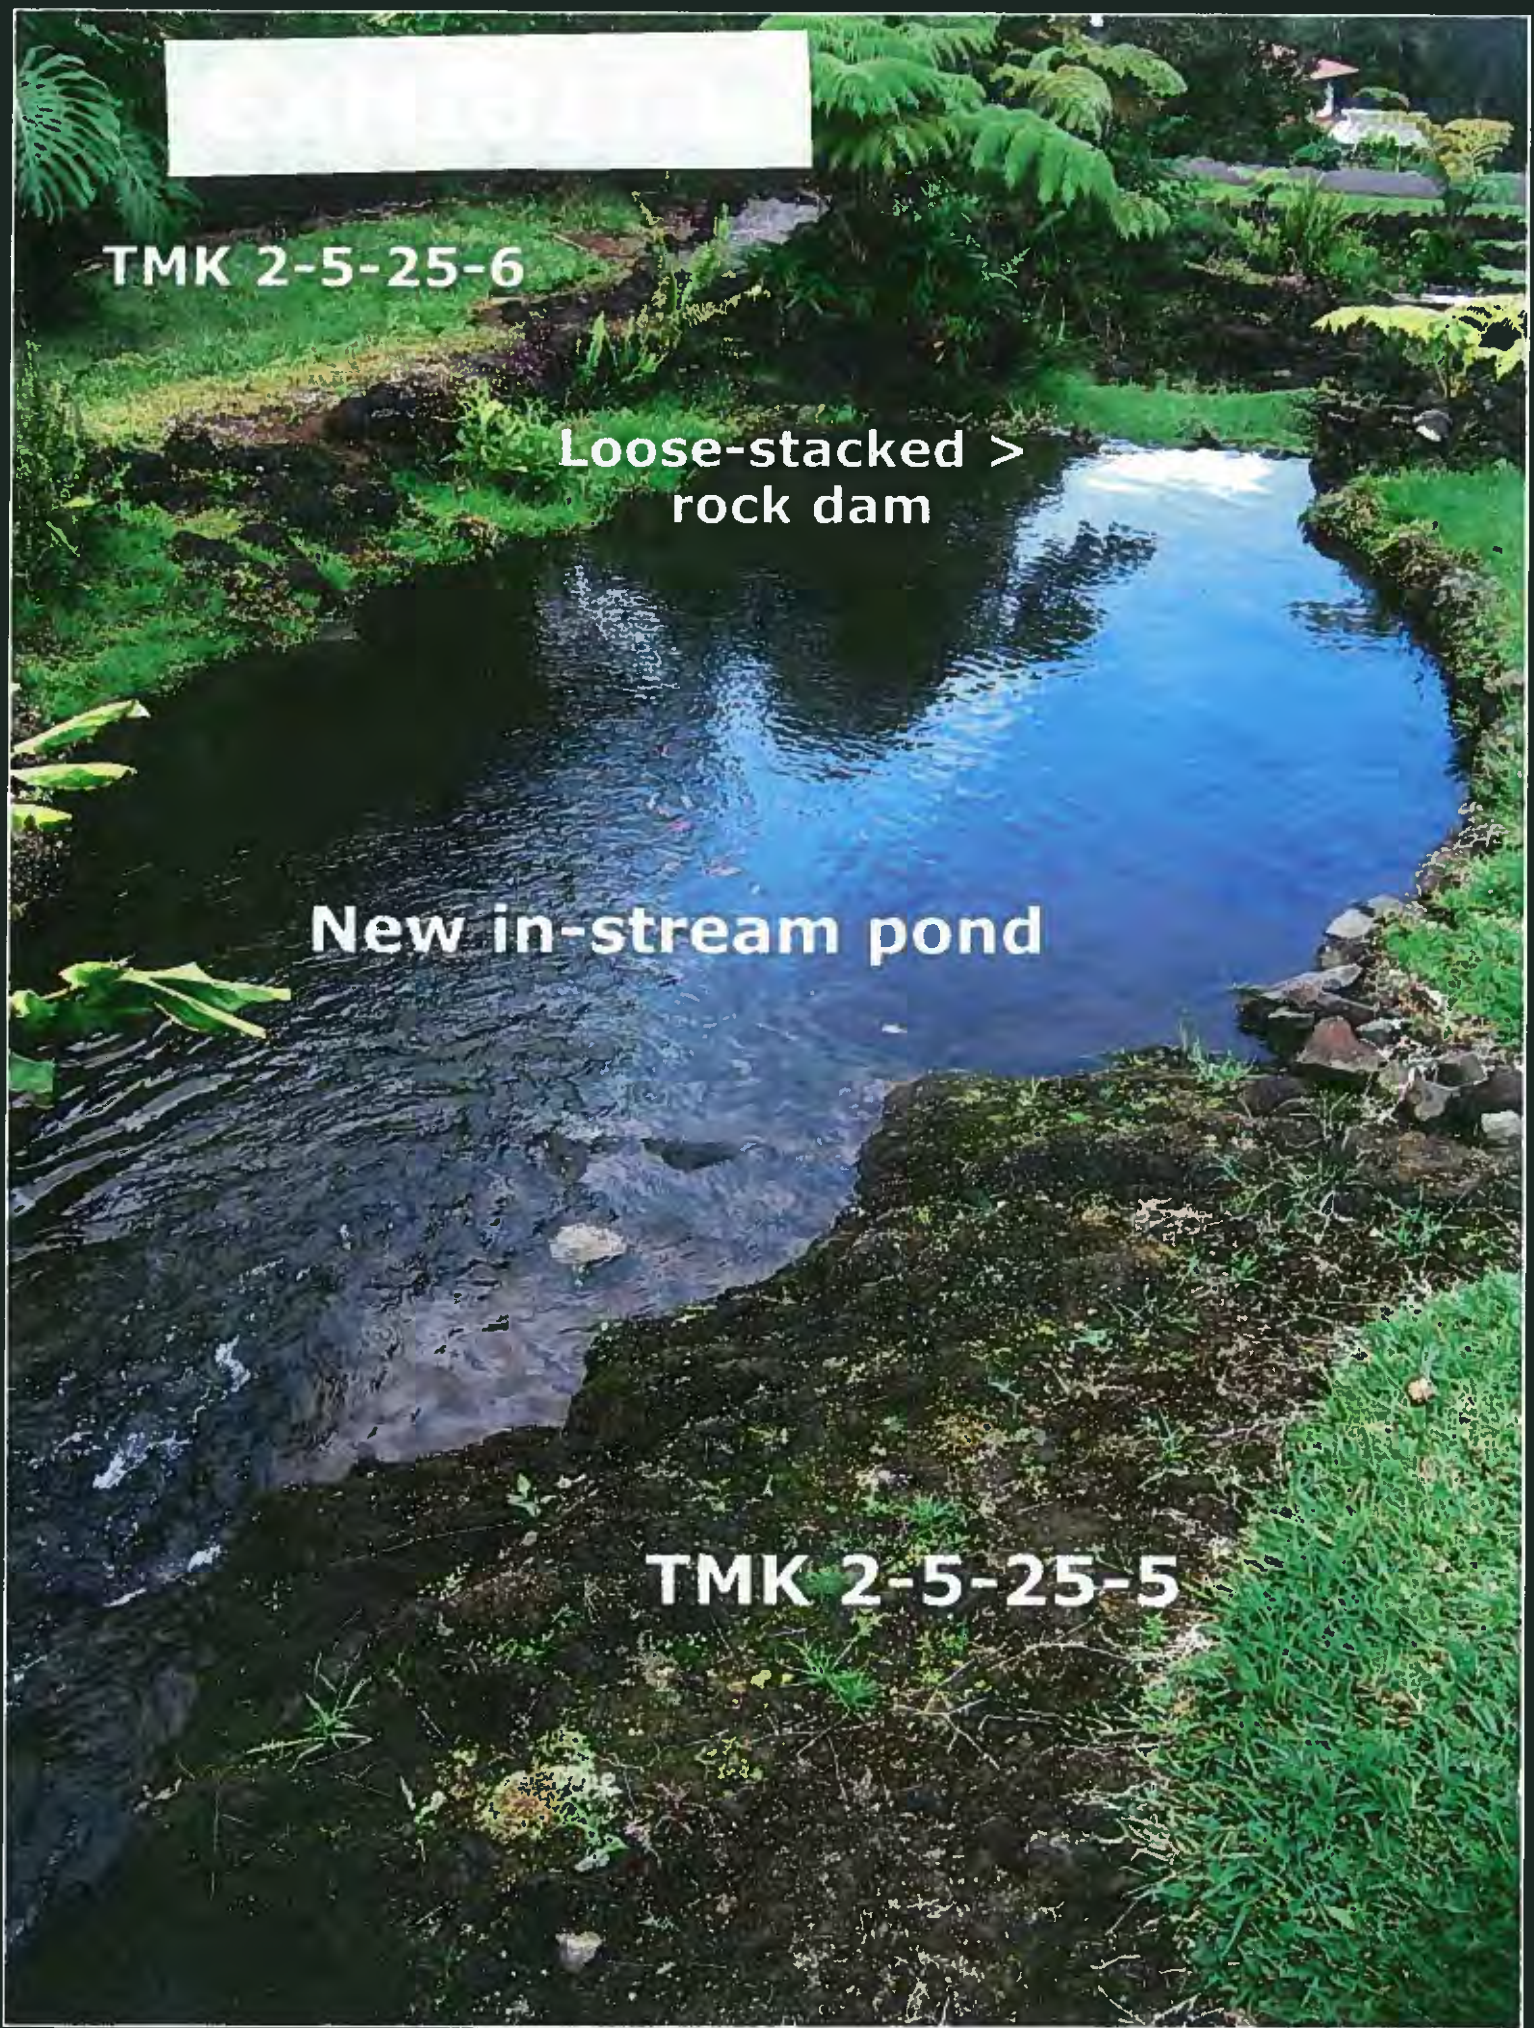
Monthly Mean Discharge for USGS Station 16704000 Wailuku River at

Piihonua, HI

Period of Record: October 1989 - September 2010
