Banyan Drive Sea Level Rise Assessment Report

BANYAN DRIVE IN HILO, HAWAII

**State of Hawaii, Department of
Land and Natural Resources**

July 2014

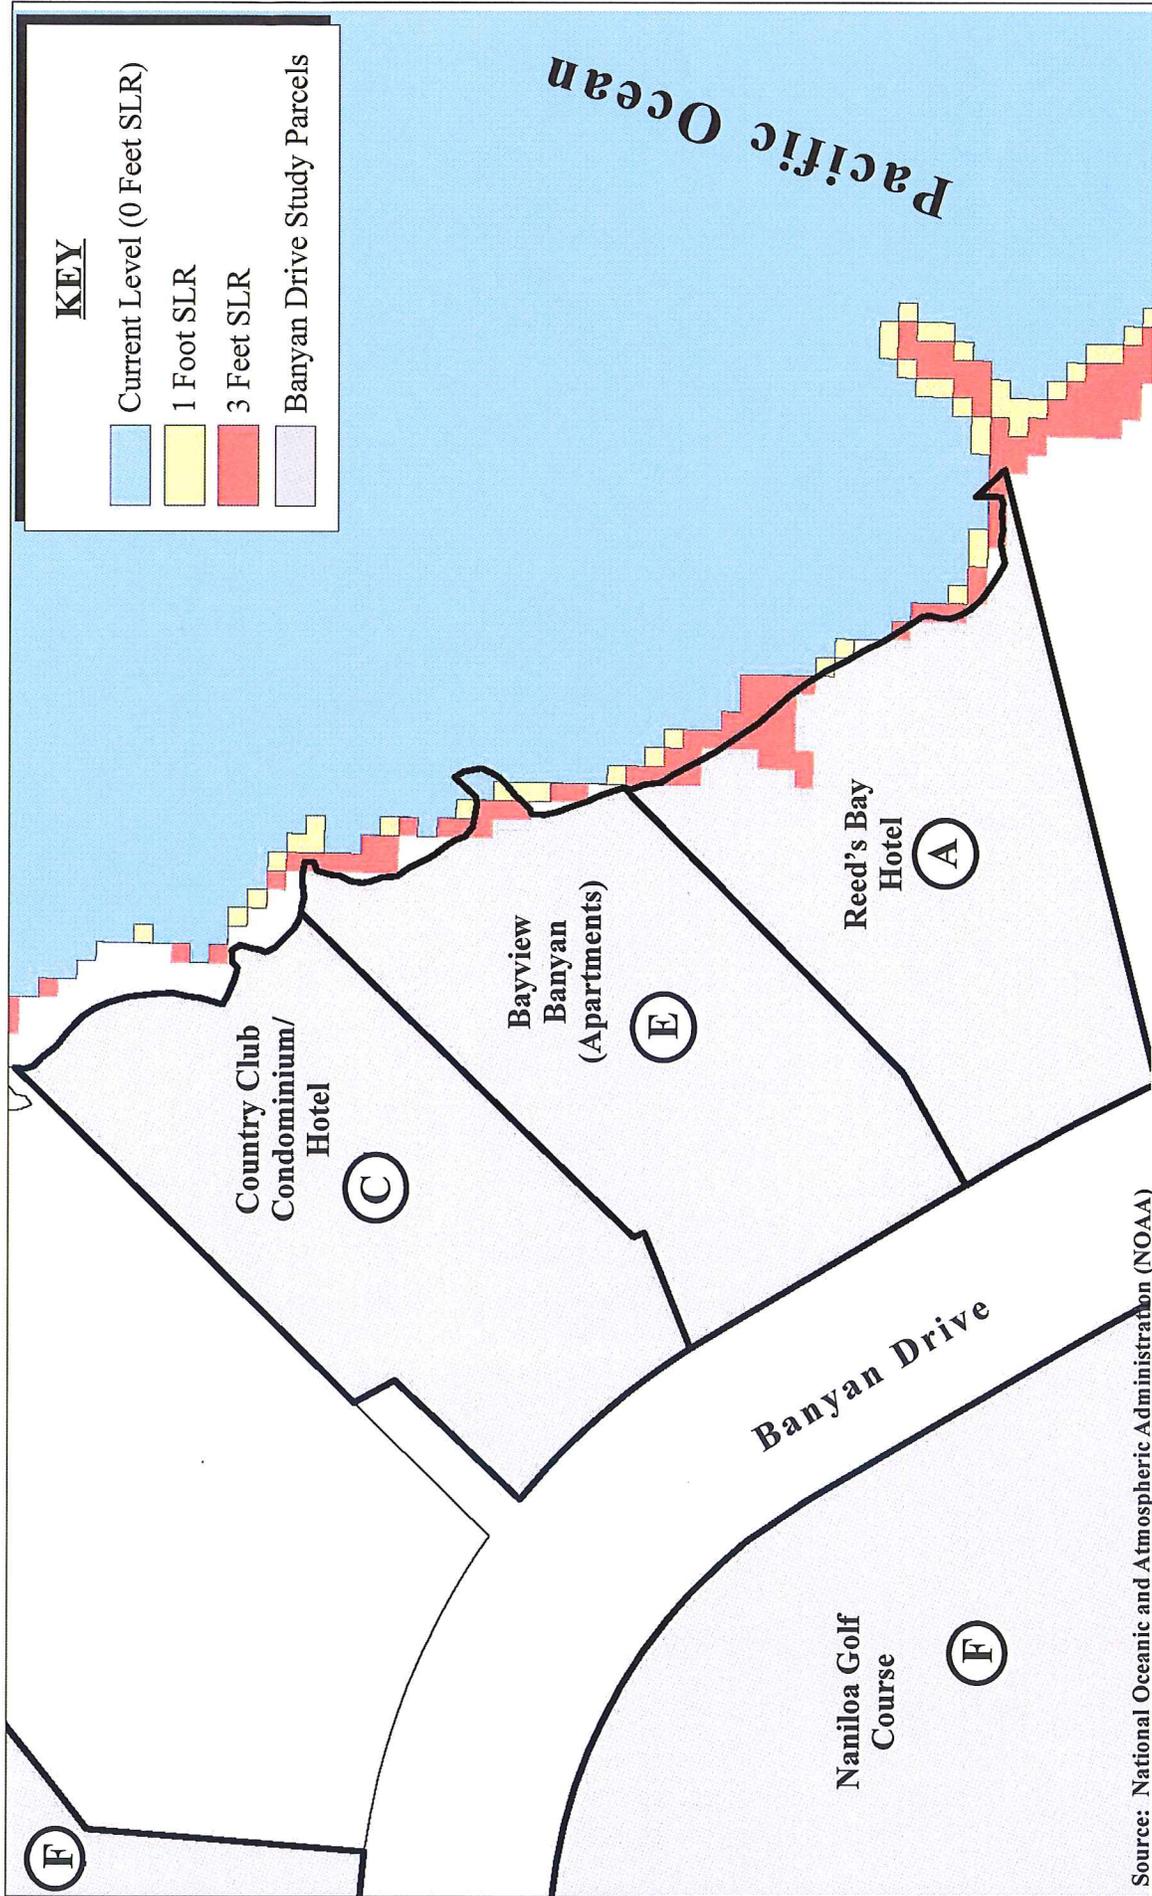
Figure 14
Banyan Drive Sea Level Rise Assessment
NOAA Sea Level Rise Map Visualizations -
Parcels A, E, and C

Applying the NOAA mapping models for the current sea level, 1-foot benchmark at year 2050 and 3-foot benchmark at year 2100 yields map visualizations shown in **Figure 14**, **Figure 15** and **Figure 16**. These figures show the relative differences under the different scenarios. **Figure 17** illustrates the 3-foot sea level rise scenario over an aerial map base.

At year 2050 or about 35 years from now, the impact of a 1-foot sea level rise shows little to no loss of area on the studied parcels. For the 3-foot benchmark at year 2100 or about 85 years from now, there is some minor sea level rise encroachment landward into the parcels. Assuming a linear rate of change from 2050 to 2100, the situation at year 2065 or about 50 years from now will be about 30 percent change from the 1-foot to 3-foot benchmarks or approximately 0.6 feet.

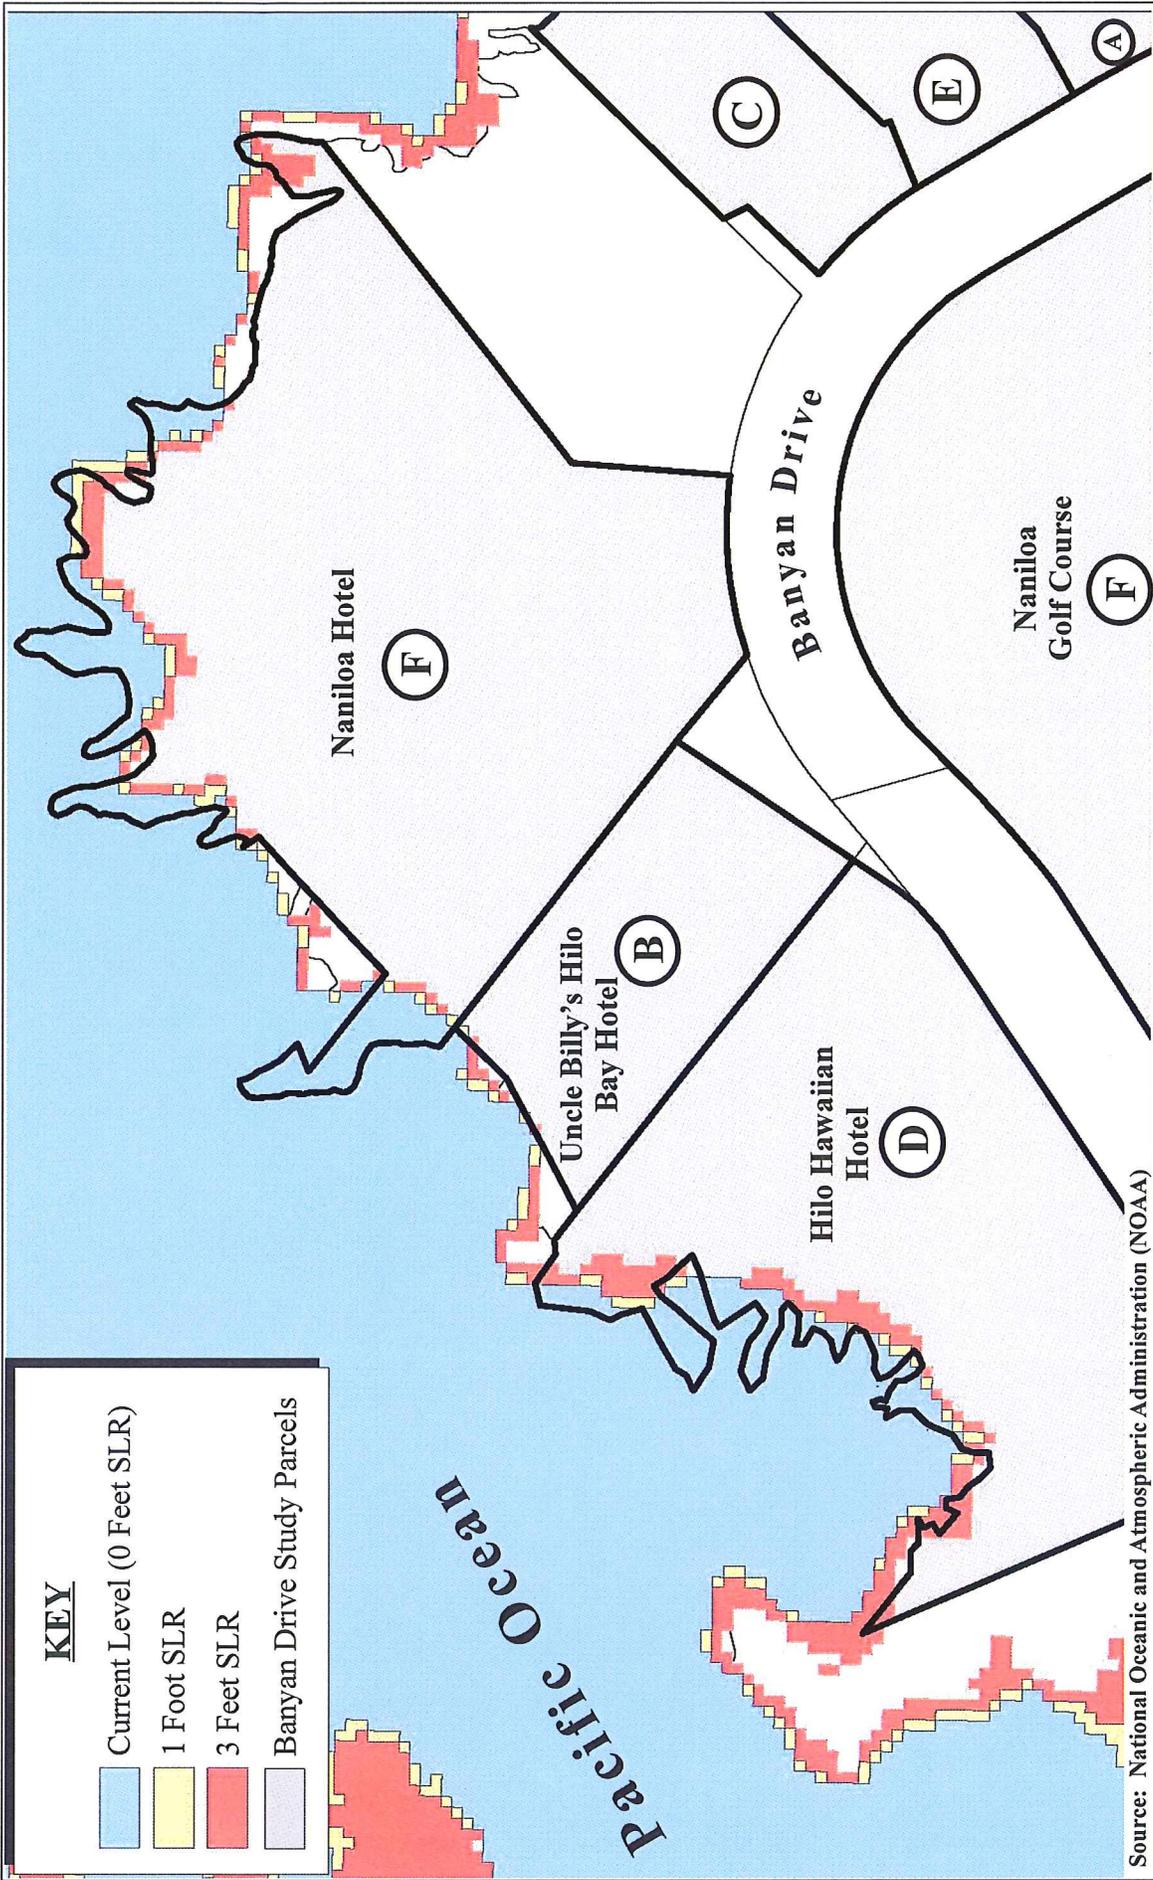
Figure 15 Banyan Drive Sea Level Rise Assessment
 NOAA Sea Level Rise Map Visualizations -
 Parcels D, B, and F

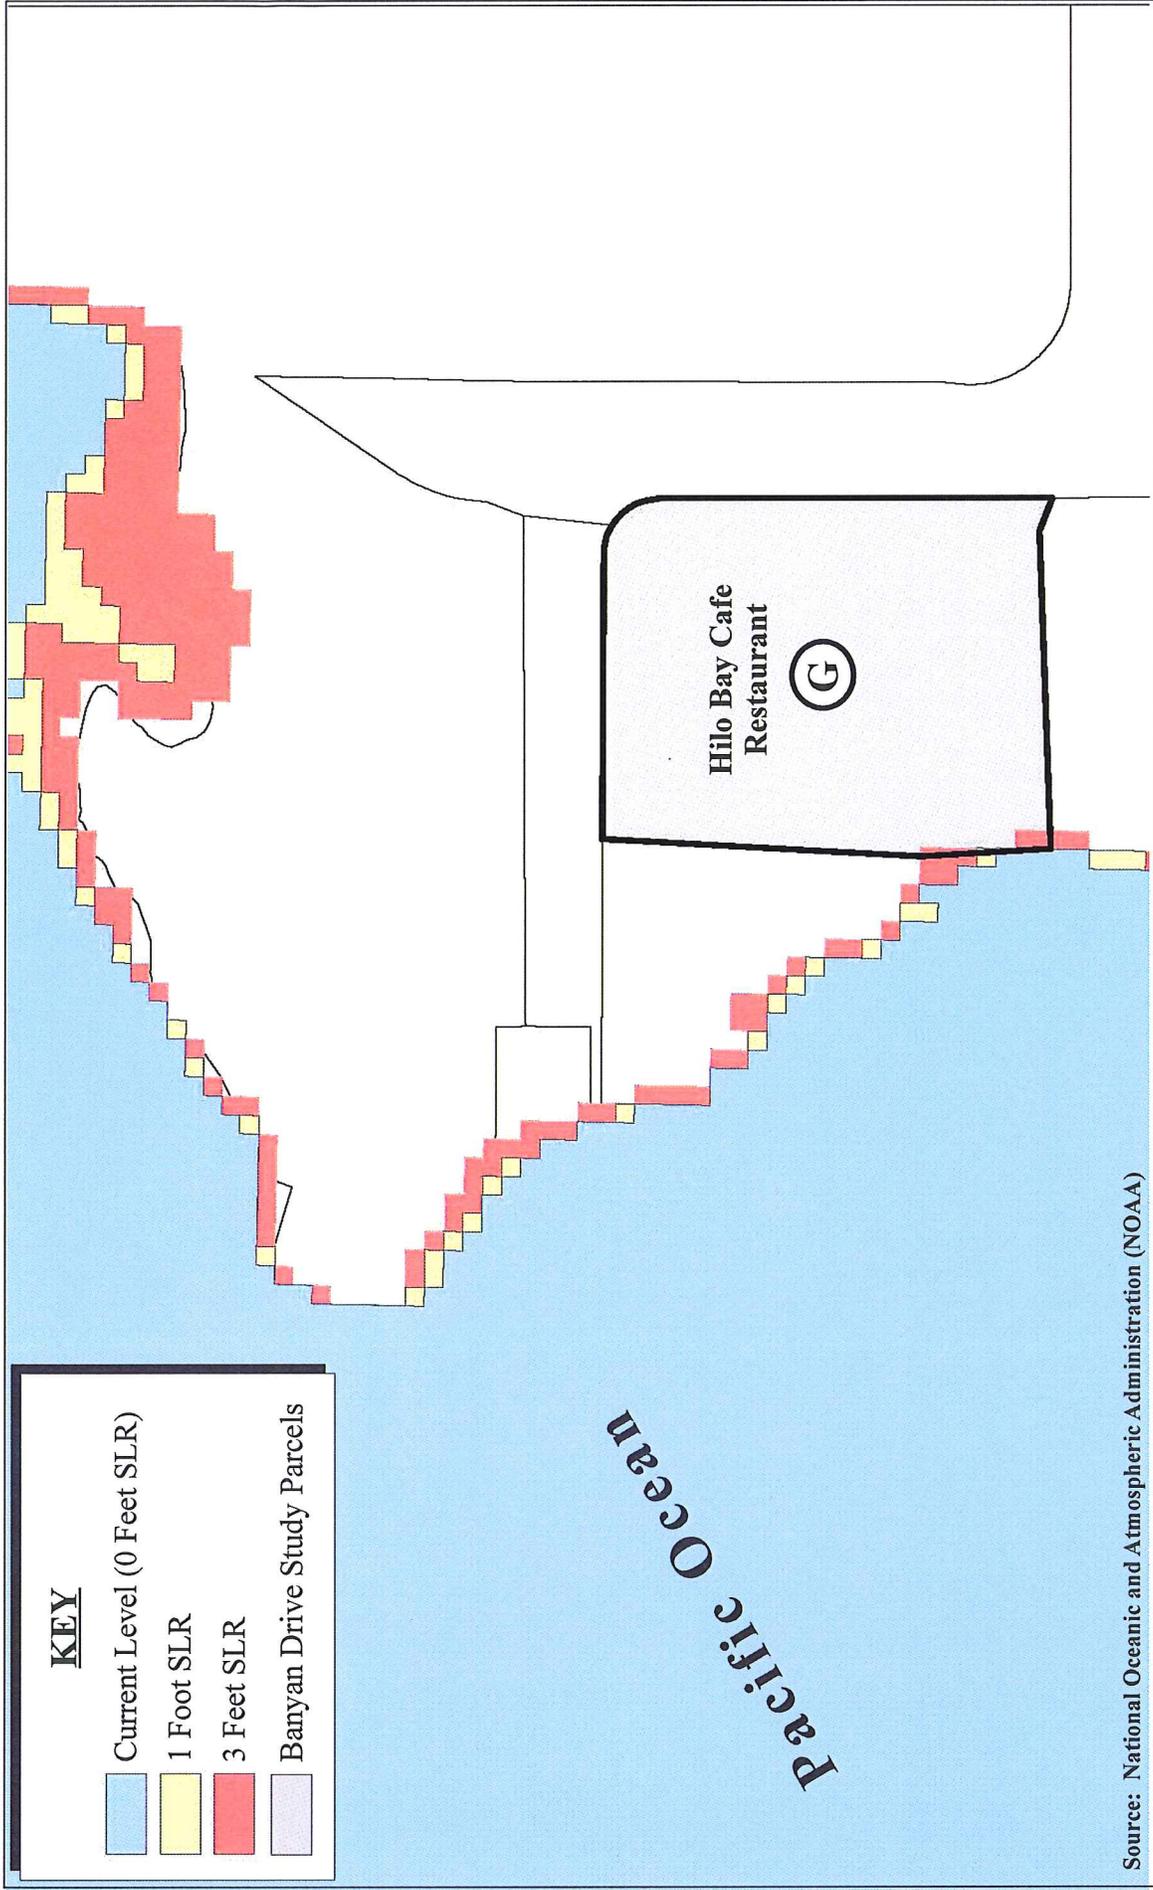
Figure 16 Banyan Drive Sea Level Rise Assessment
NOAA Sea Level Rise Map Visualizations - Parcel G

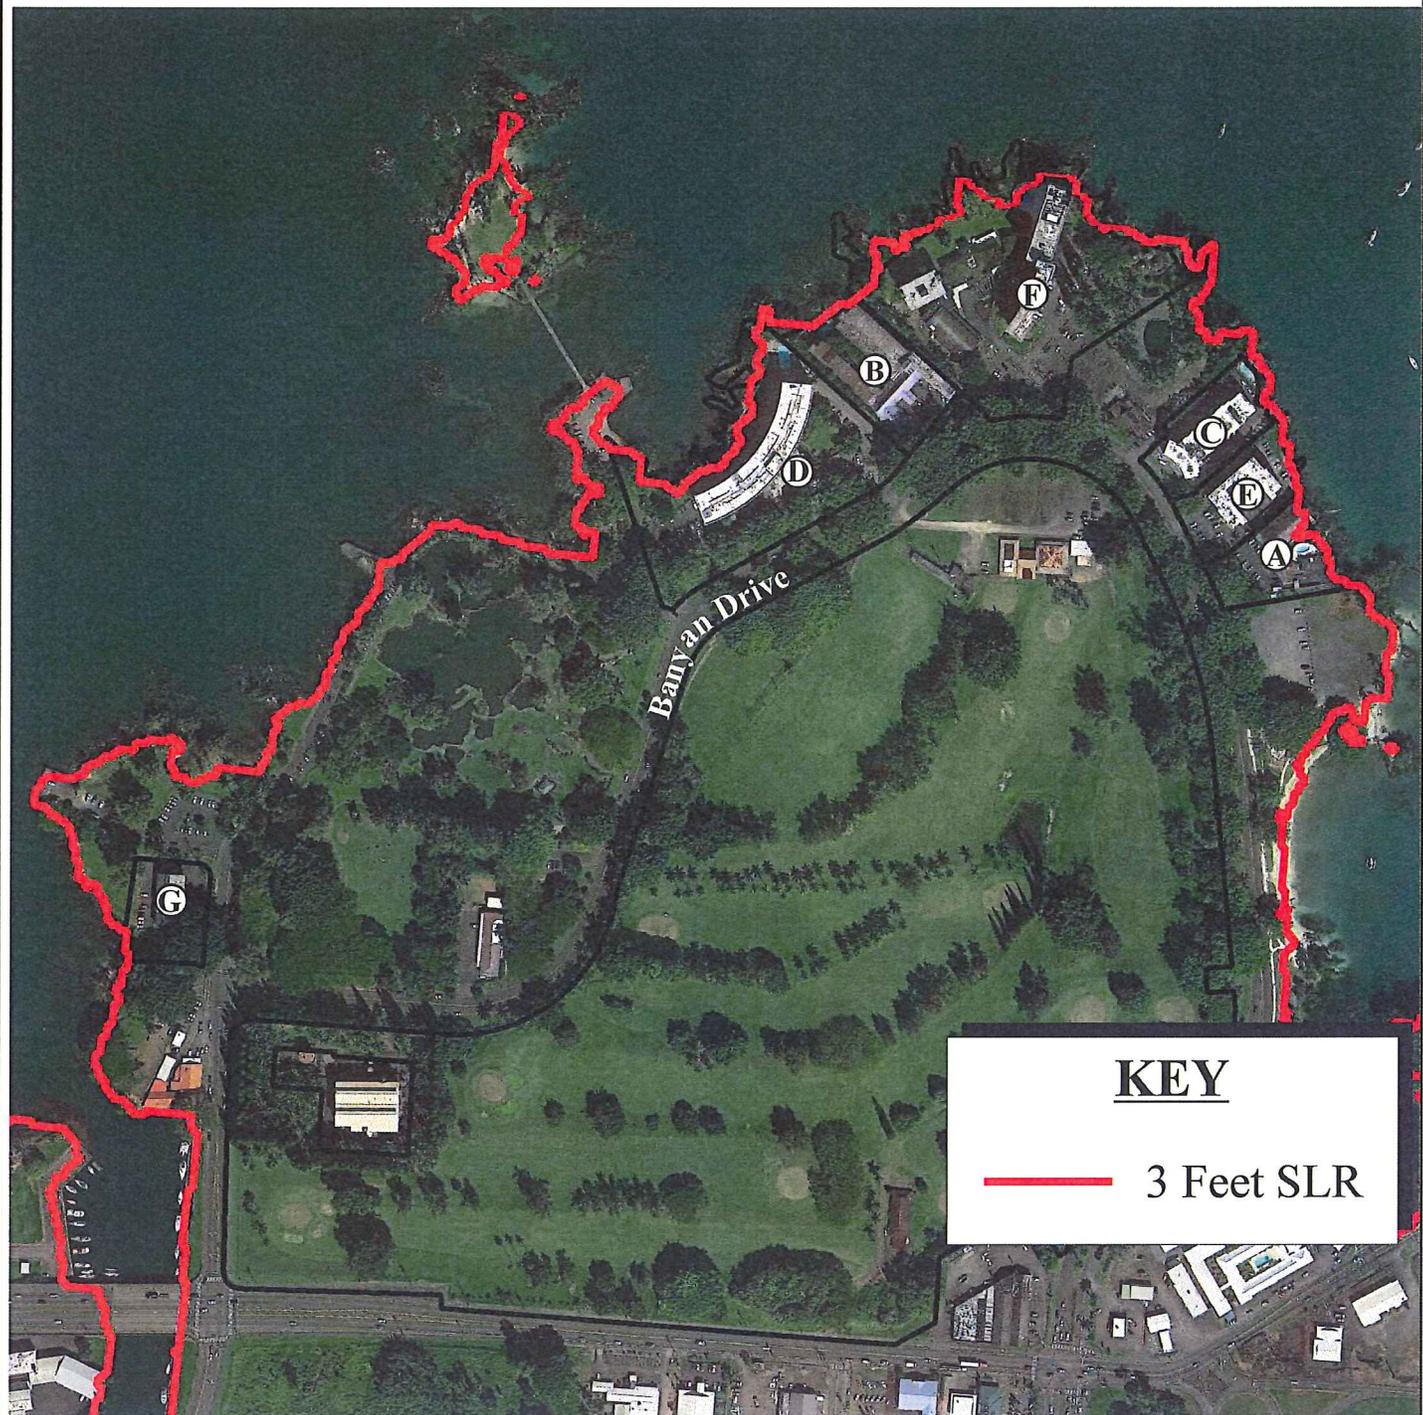
Figure 17

— 3 Feet SLR

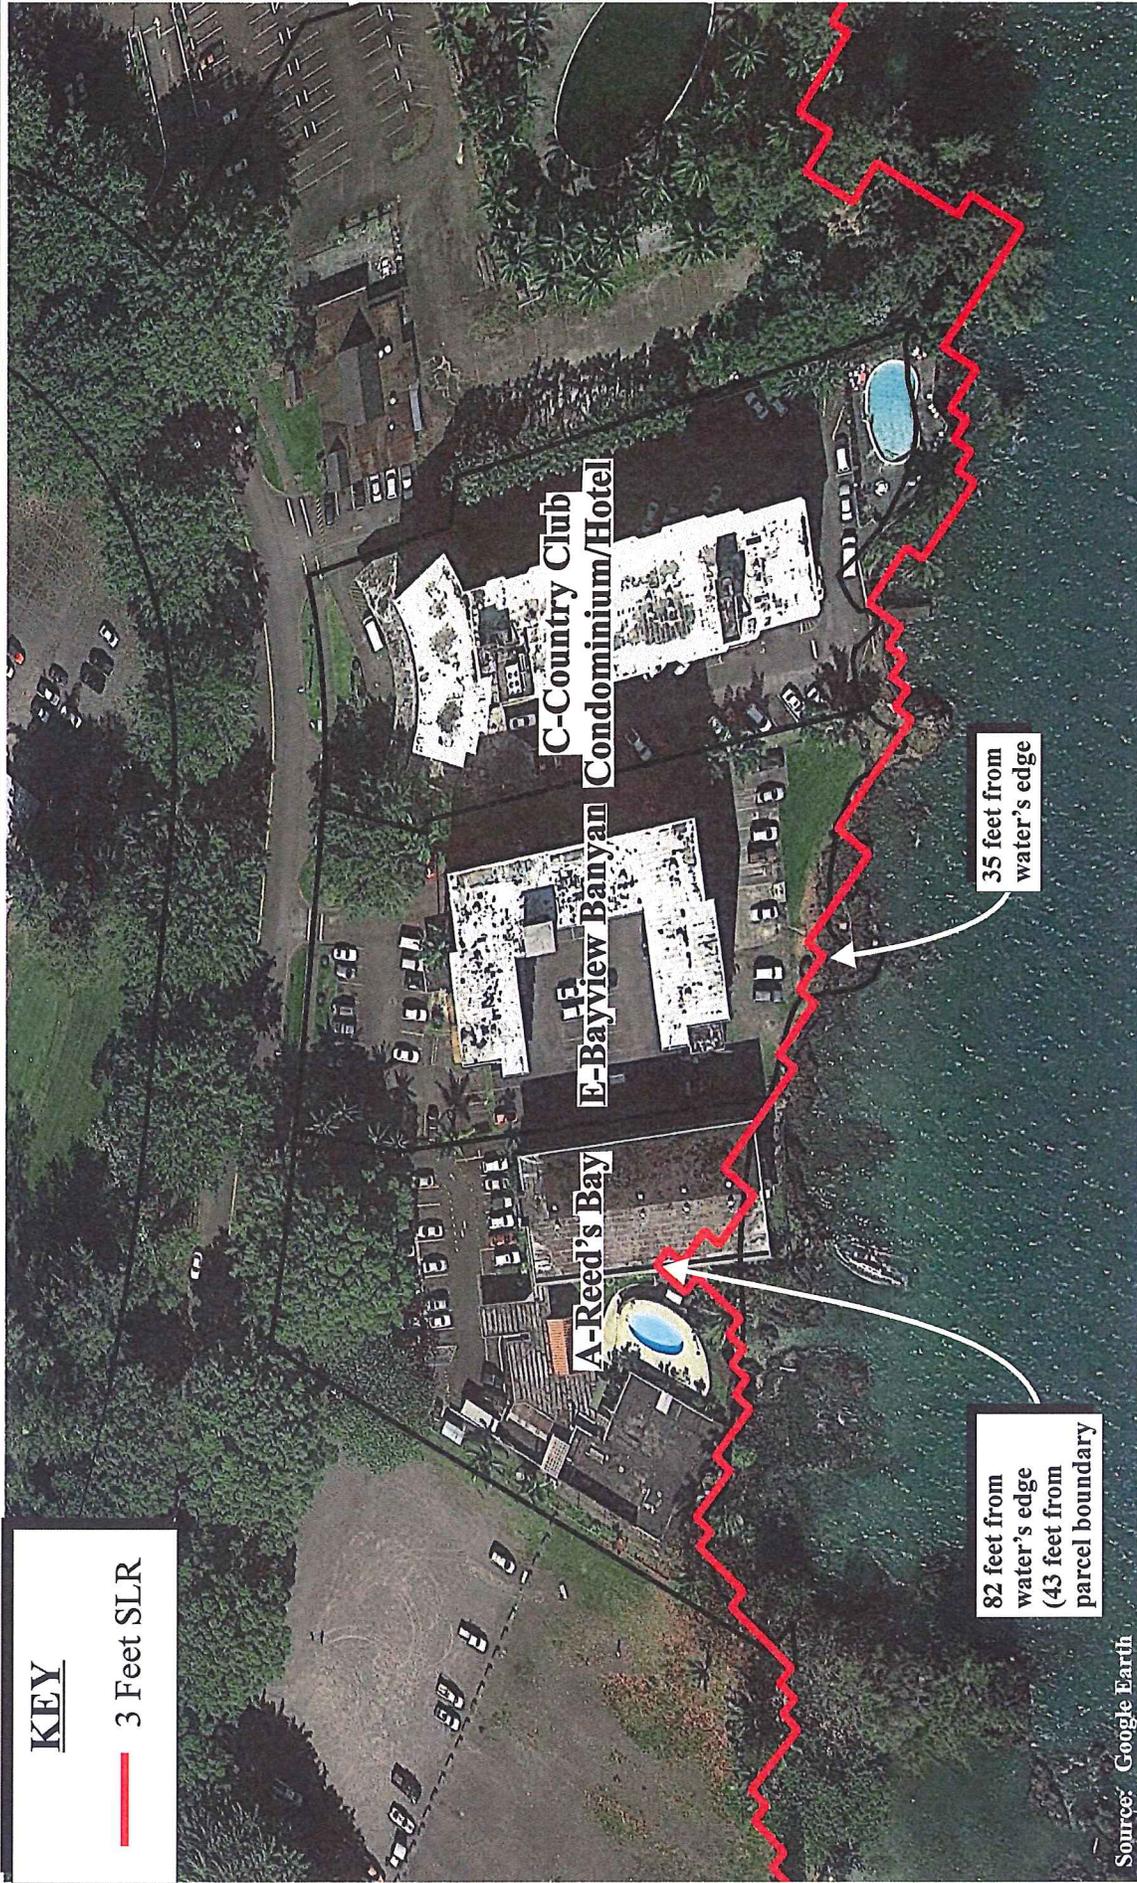
Figure 18 Banyan Drive Sea Level Rise Assessment
Coastline Bird's Eye View (A-Reed's Bay Resort, E-Bayview Banyan Apartments, and C-Country Club Condominium/Hotel)

Visual representations of the relationship between existing landside ground elevations relative to existing ocean delineations are shown in **Figure 18**, **Figure 19**, and **Figure 20**. The three (3) foot sea level rise scenario is mapped on these figures to illustrate the relationship between the predicted sea level rise and existing buildings. The distances of the 3-foot sea level rise inundation noted on these figures are approximate distances to the water's edge as depicted by Google Earth. The distances do not represent setbacks from a certified shoreline. More detailed photographic evidence of ocean to land elevation differentials are presented in **Appendix "A"**.

Although two (2) of the parcels had shoreline surveys done about four (4) years apart, the time period difference was not significant enough to indicate a trend. However, comparing the photographic exhibits in **Appendix “A”**, **Figure 18**, **Figure 19**, and **Figure 20** with the topographic features documented in the certified shoreline surveys for these lava rock shoreline parcels suggests little change since the early to late 1970s. Certified shoreline changes which may have occurred between mapping events would likely be attributed to shoreline interpretation methodologies rather than actual physical changes in the rocky shoreline’s characteristics.

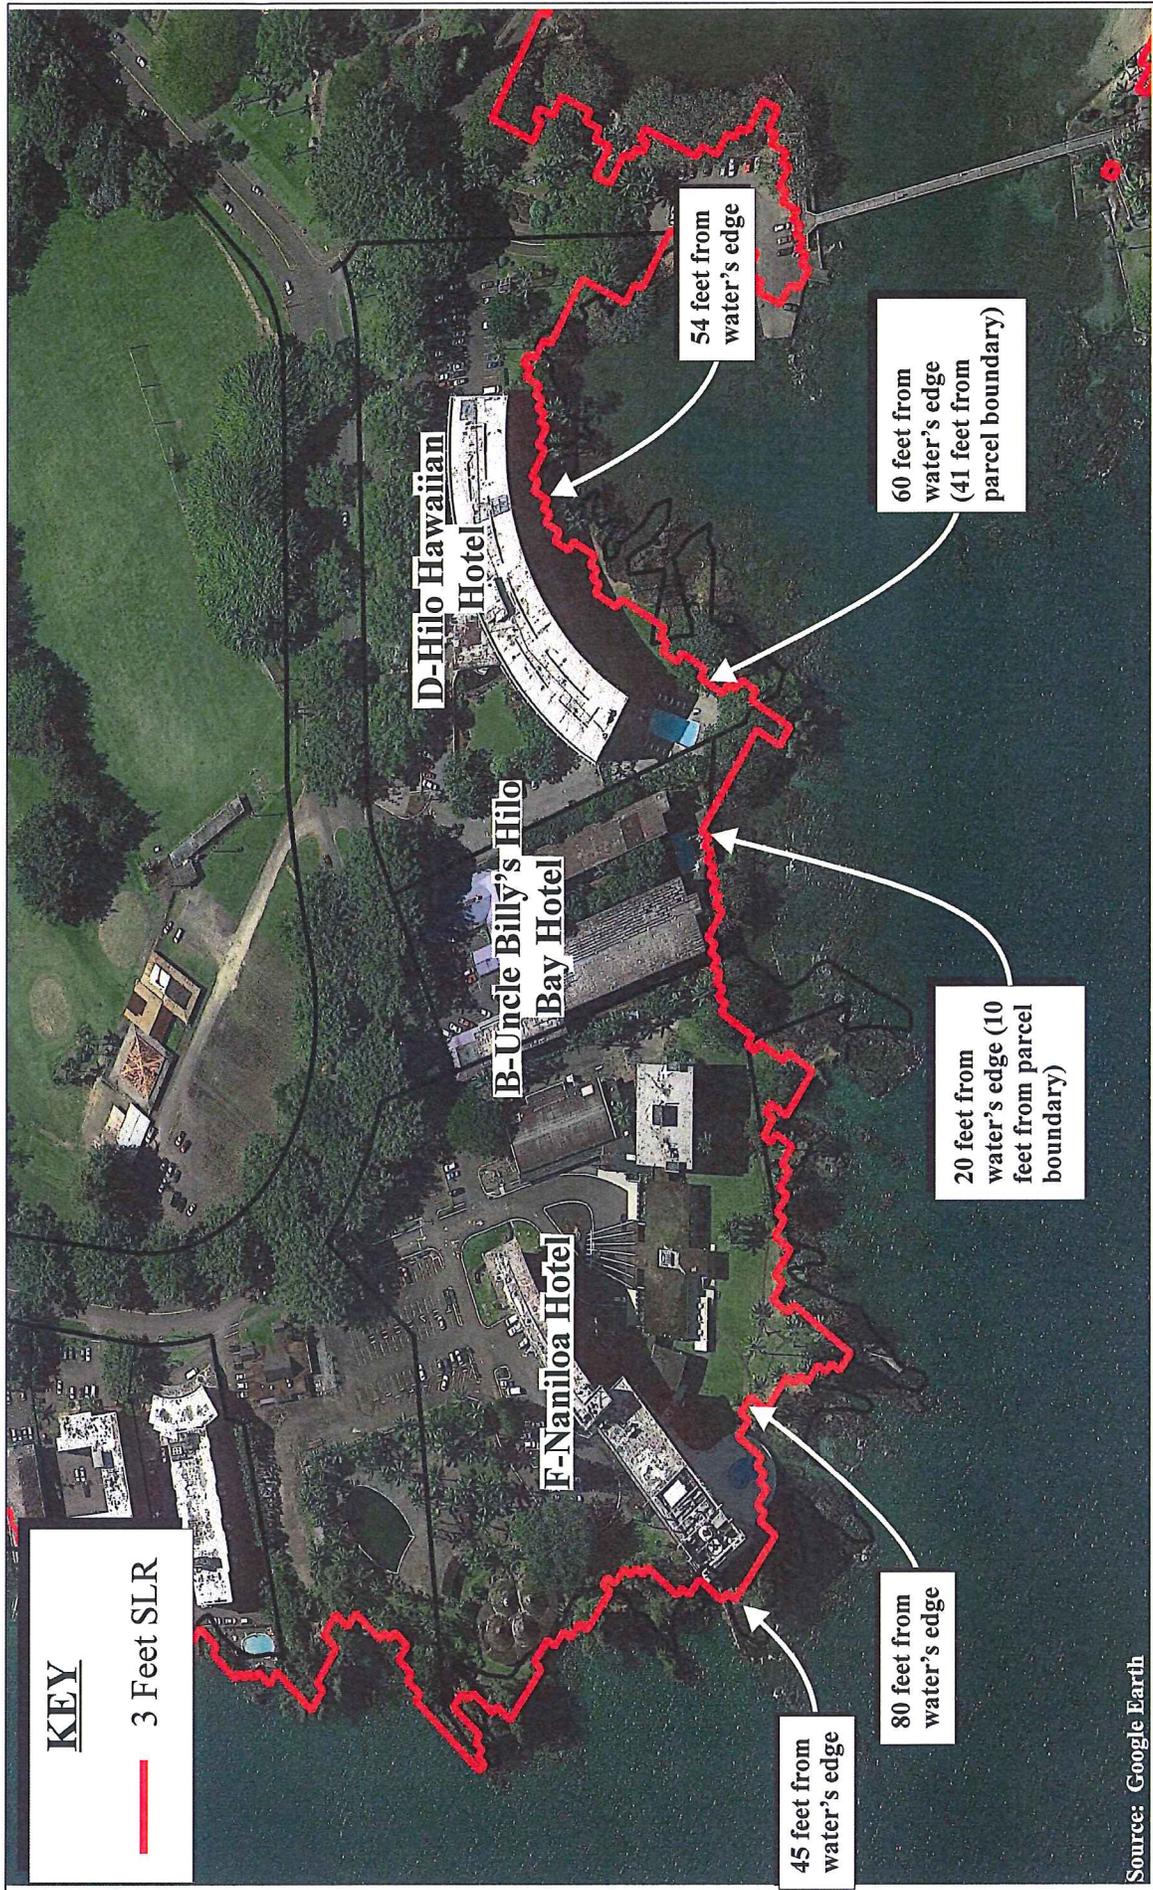
Figure 19 Banyan Drive Sea Level Rise Assessment
 Coastline Bird's Eye View (F-Naniiloa Hotel, B-Uncle Billy's Hilo Bay Hotel, and D-Hilo Hawaiian)

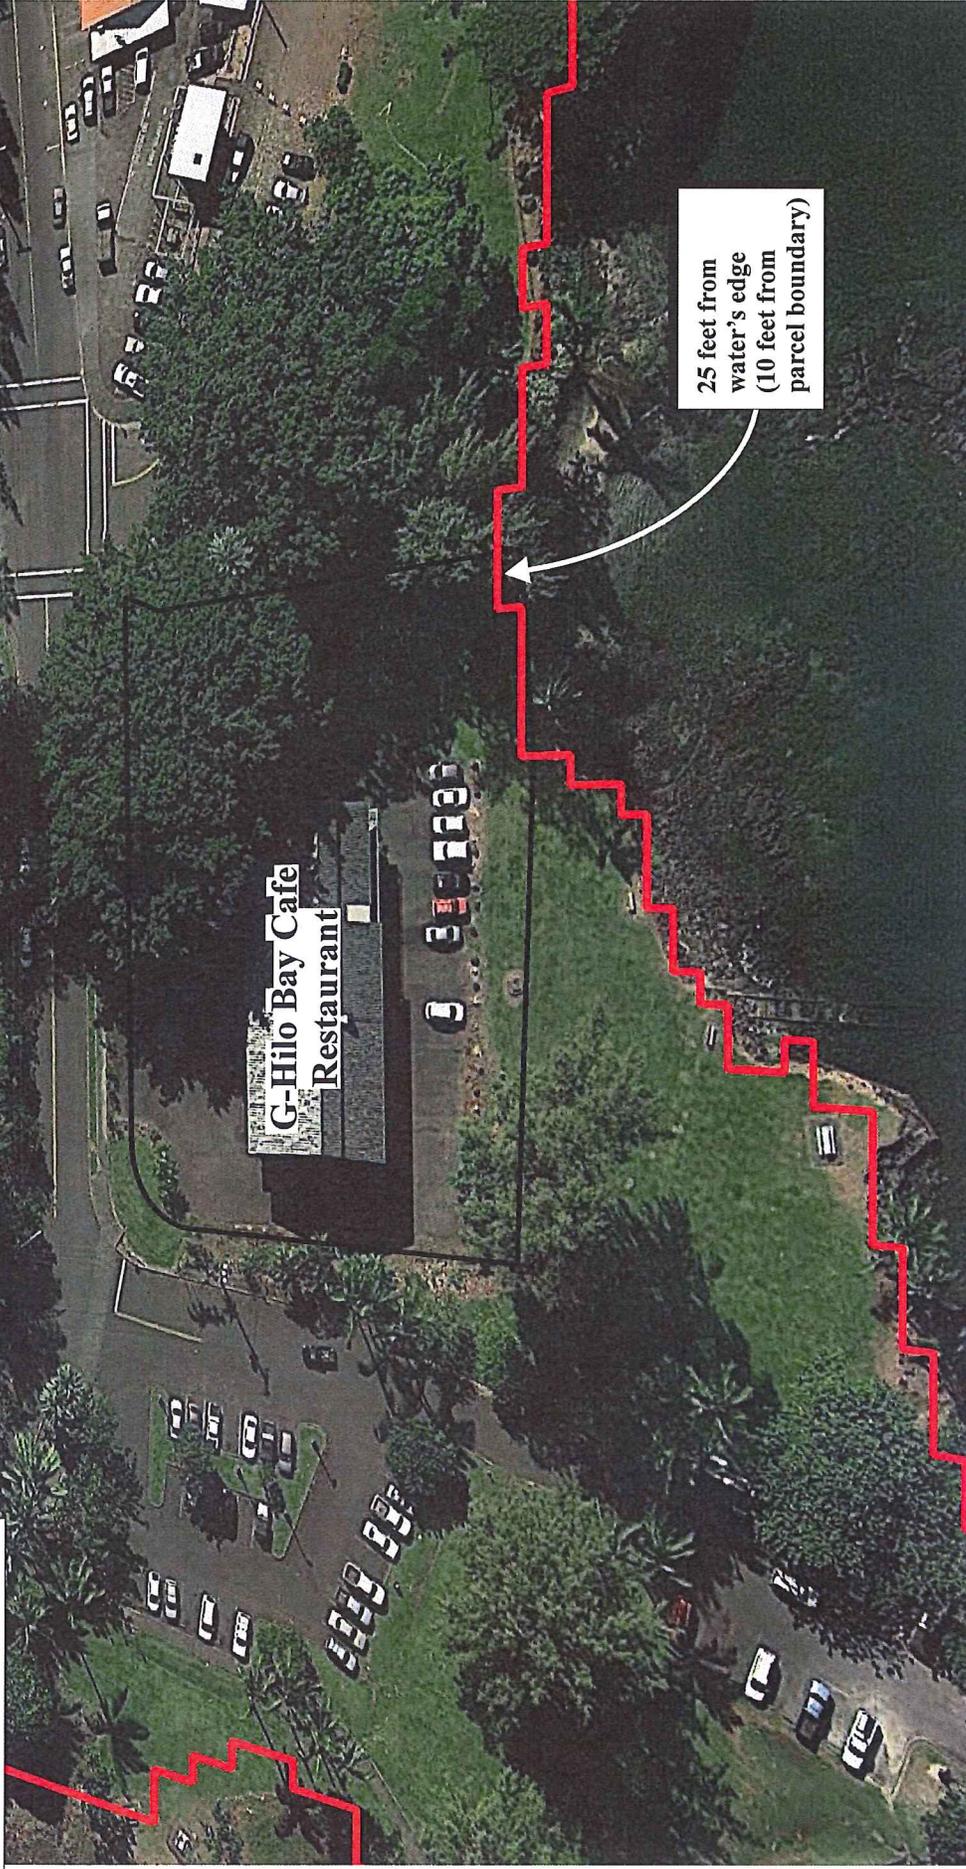
Figure 20

Banyan Drive Sea Level Rise Assessment
Coastline Bird's Eye View (G-Hilo Bay Cafe Restaurant)

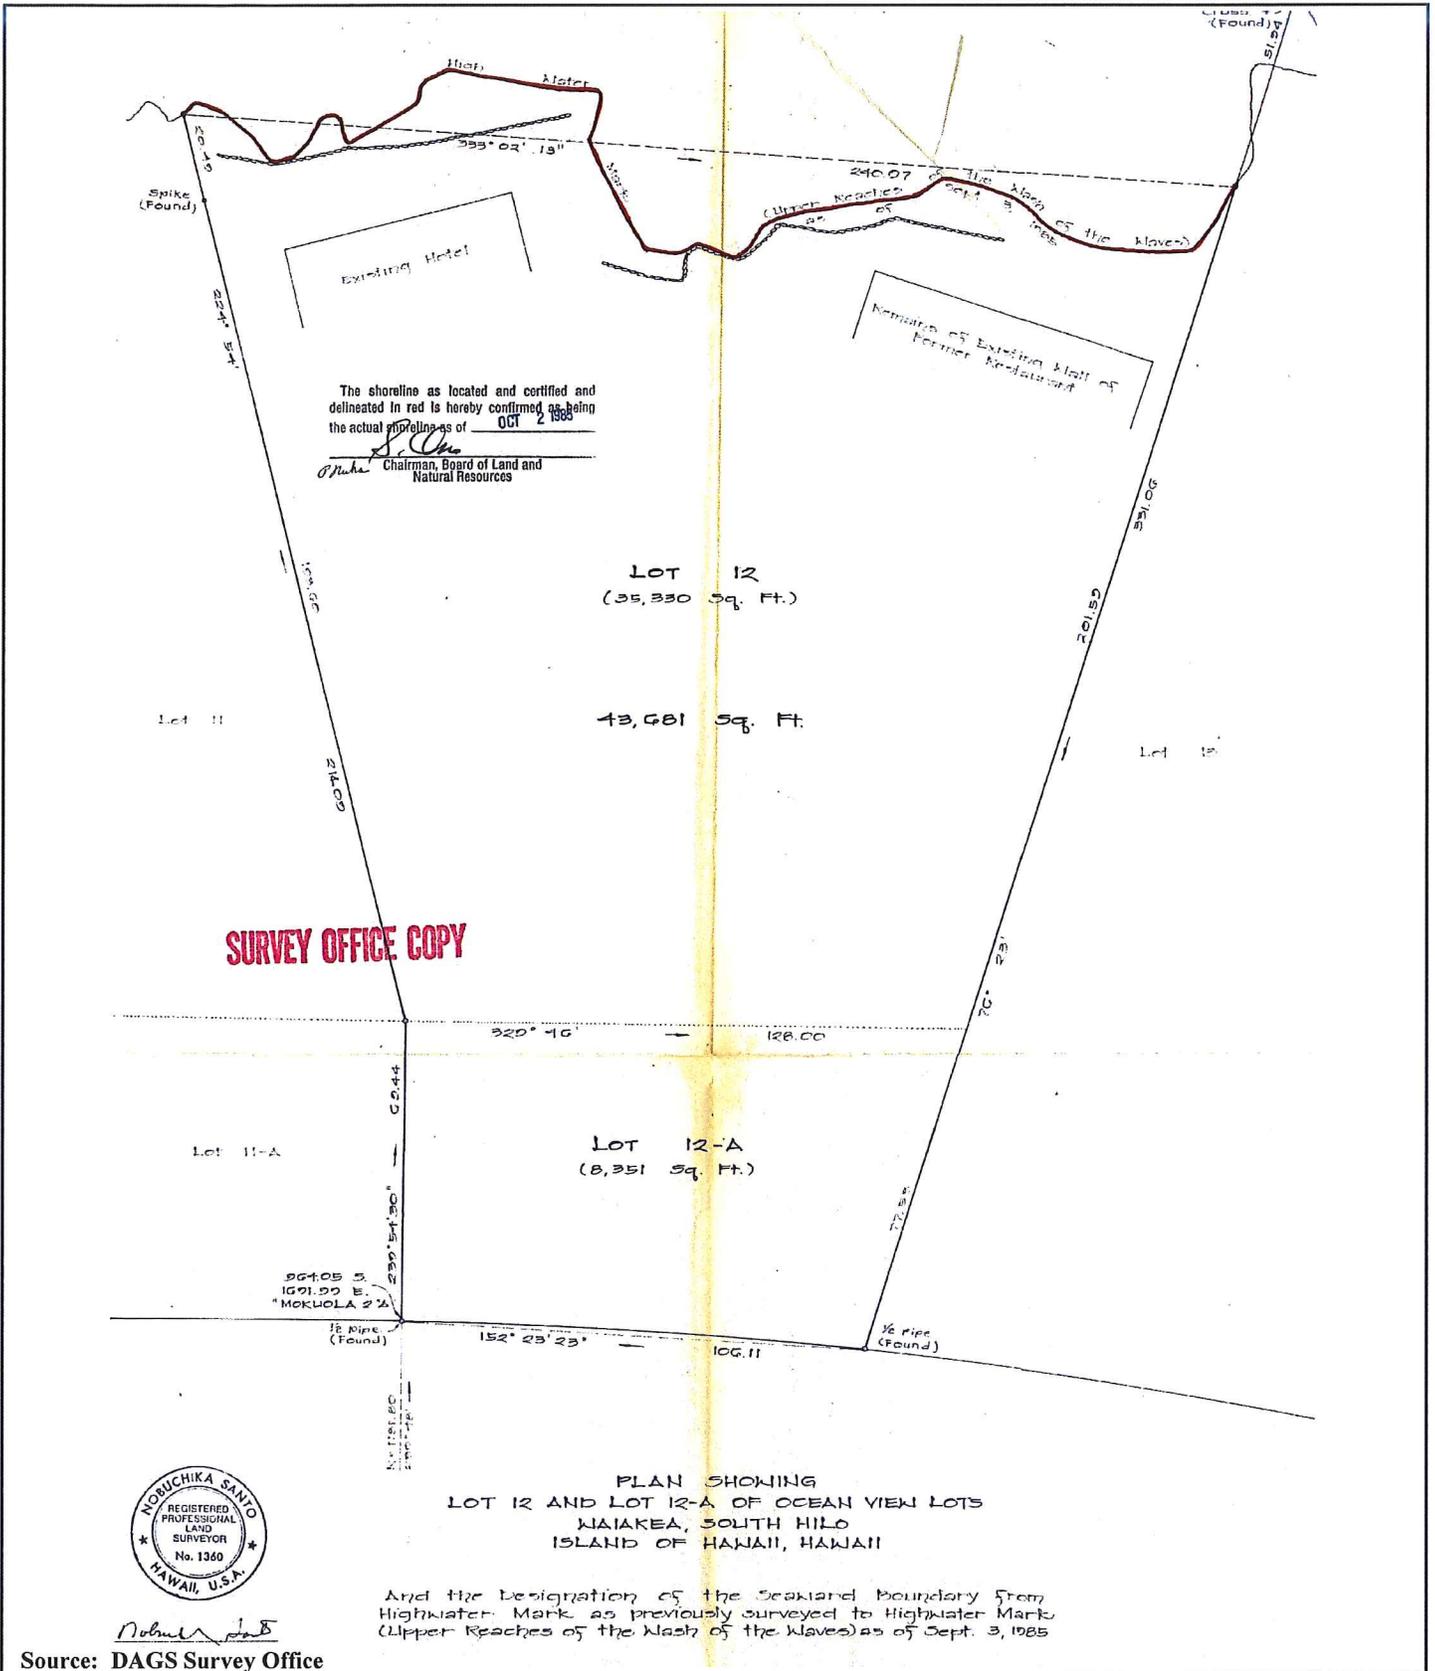
Figure 21 **Banyan Drive Sea Level** **NOT TO SCALE**
Rise Assessment
Certified Shoreline Survey - Reed's Bay Resort

Further research was done to verify if any historical mapping information may suggest any significant trends in changes to the shoreline over the years. The State of Hawaii, Department of Accounting and General Services (DAGS) survey office has limited historical information available relating to Certified Shoreline Maps for the properties studied. See **Figure 21**, **Figure 22**, **Figure 23**, **Figure 24**, and **Figure 25**.

Reed’s Bay Resort had a record of a September 3, 1985 shoreline survey. The Hilo Hawaiian Hotel had a record of a July 31, 1975 shoreline survey. The Country Club Condo had a record for shoreline surveys done on February 16, 1970 and August 7, 1974 which showed some small changes both landward and seaward of the older high water mark. The Hilo Bay Cafe parcel had its shoreline surveyed on November 6, 1978 and April 23, 1982 with essentially no change.
