Banyan Drive Sea Level Rise Assessment Report

BANYAN DRIVE IN HILO, HAWAII

**State of Hawaii, Department of
Land and Natural Resources**

July 2014

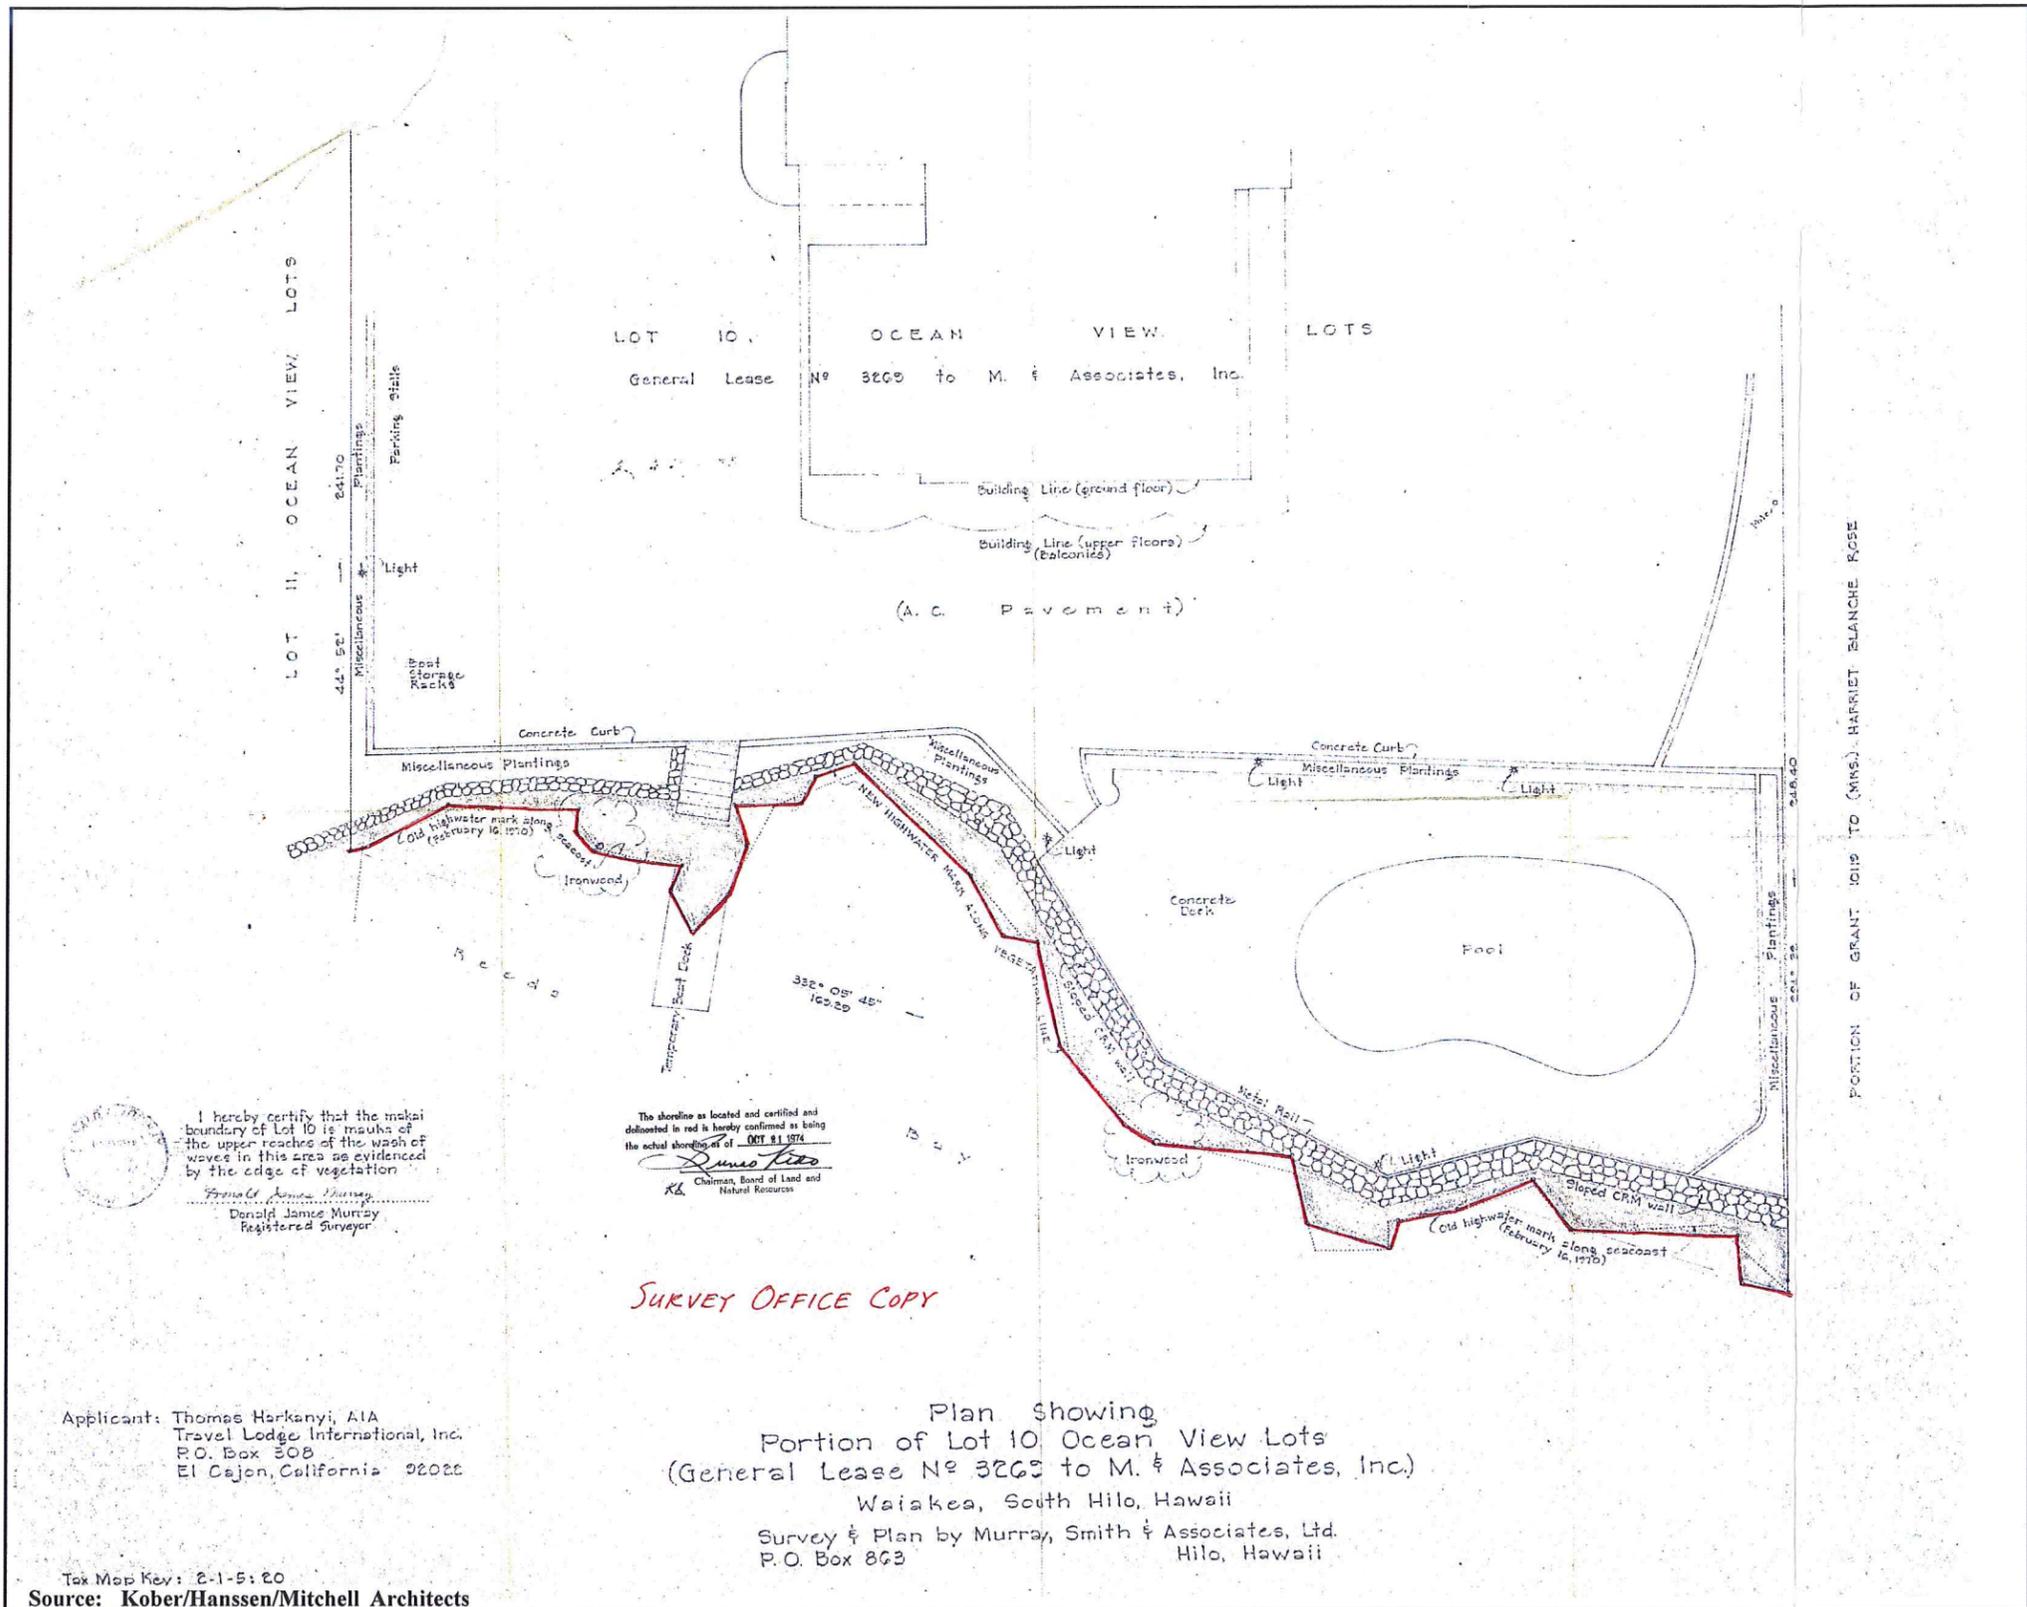
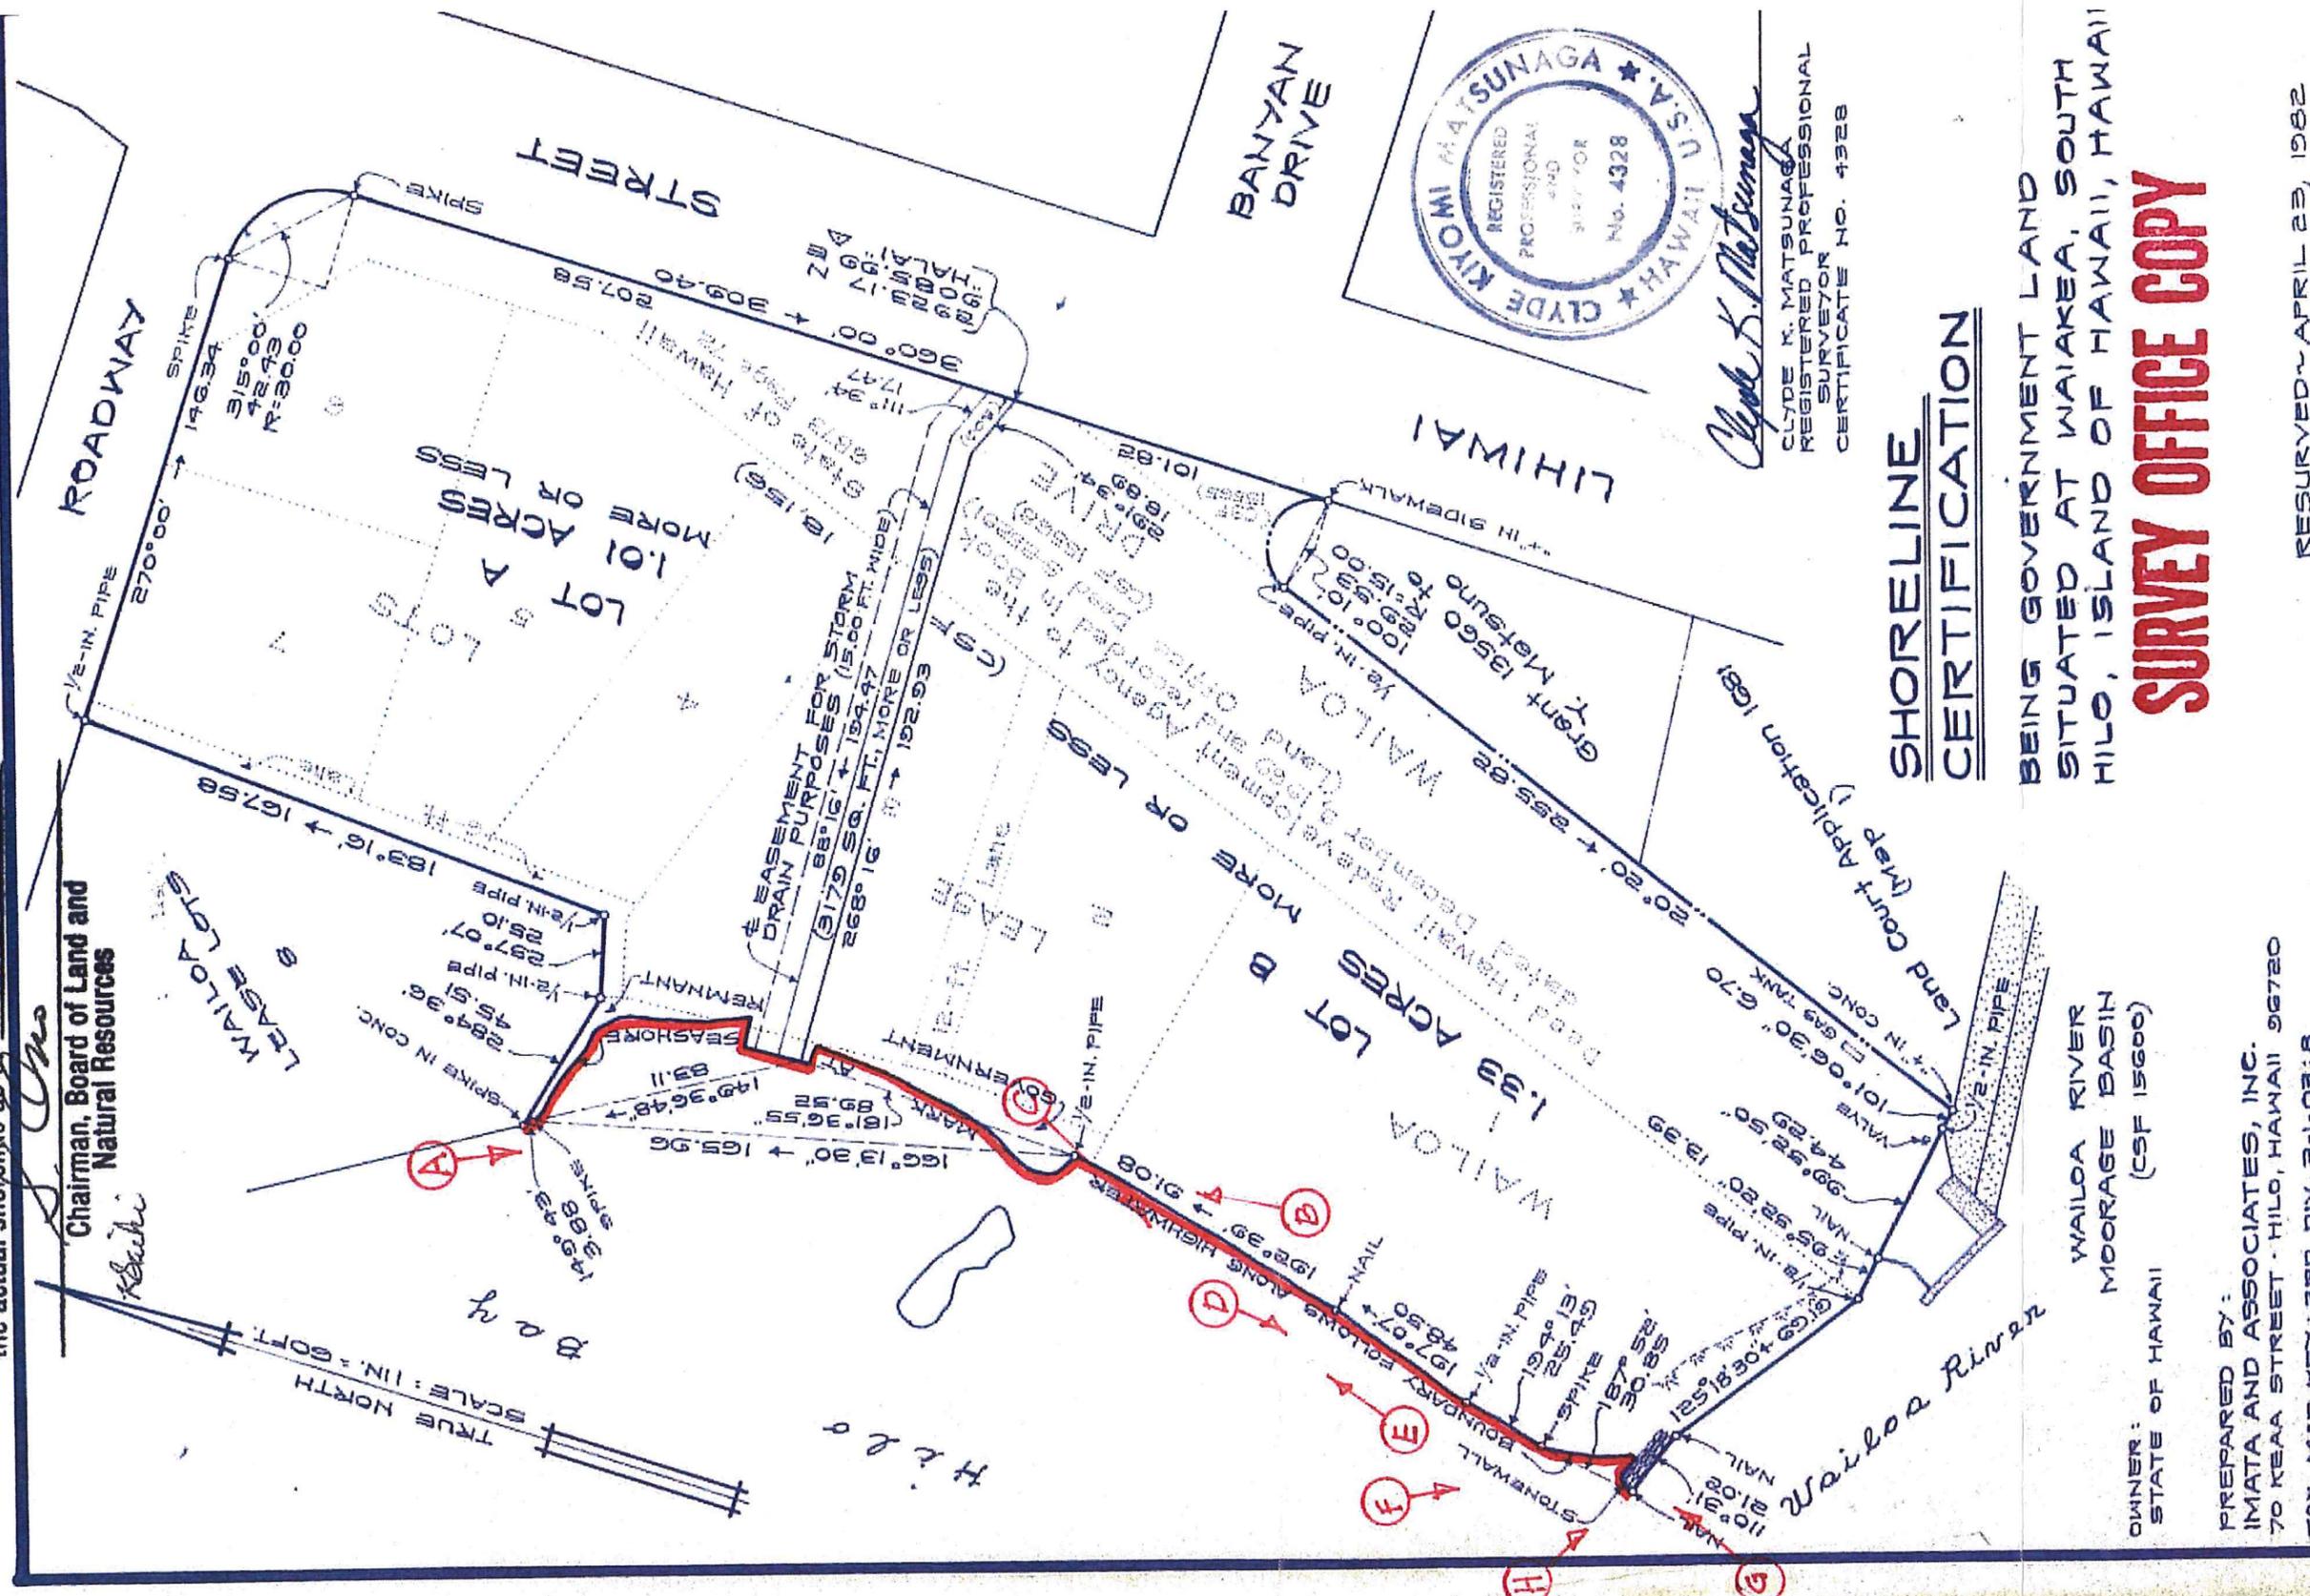
Figure 23

Banyan Drive Sea Level Rise Assessment
Certified Shoreline Survey - Country Club Condominium/Hotel

The shoreline as shown and certified and delineated in red is hereby confirmed as being the actual shoreline as of **APR 30 1982**

Further research was done to verify if any historical mapping information may suggest any significant trends in changes to the shoreline over the years. The State of Hawaii, Department of Accounting and General Services (DAGS) survey office has limited historical information available relating to Certified Shoreline Maps for the properties studied. See **Figure 21**, **Figure 22**, **Figure 23**, **Figure 24**, and **Figure 25**.

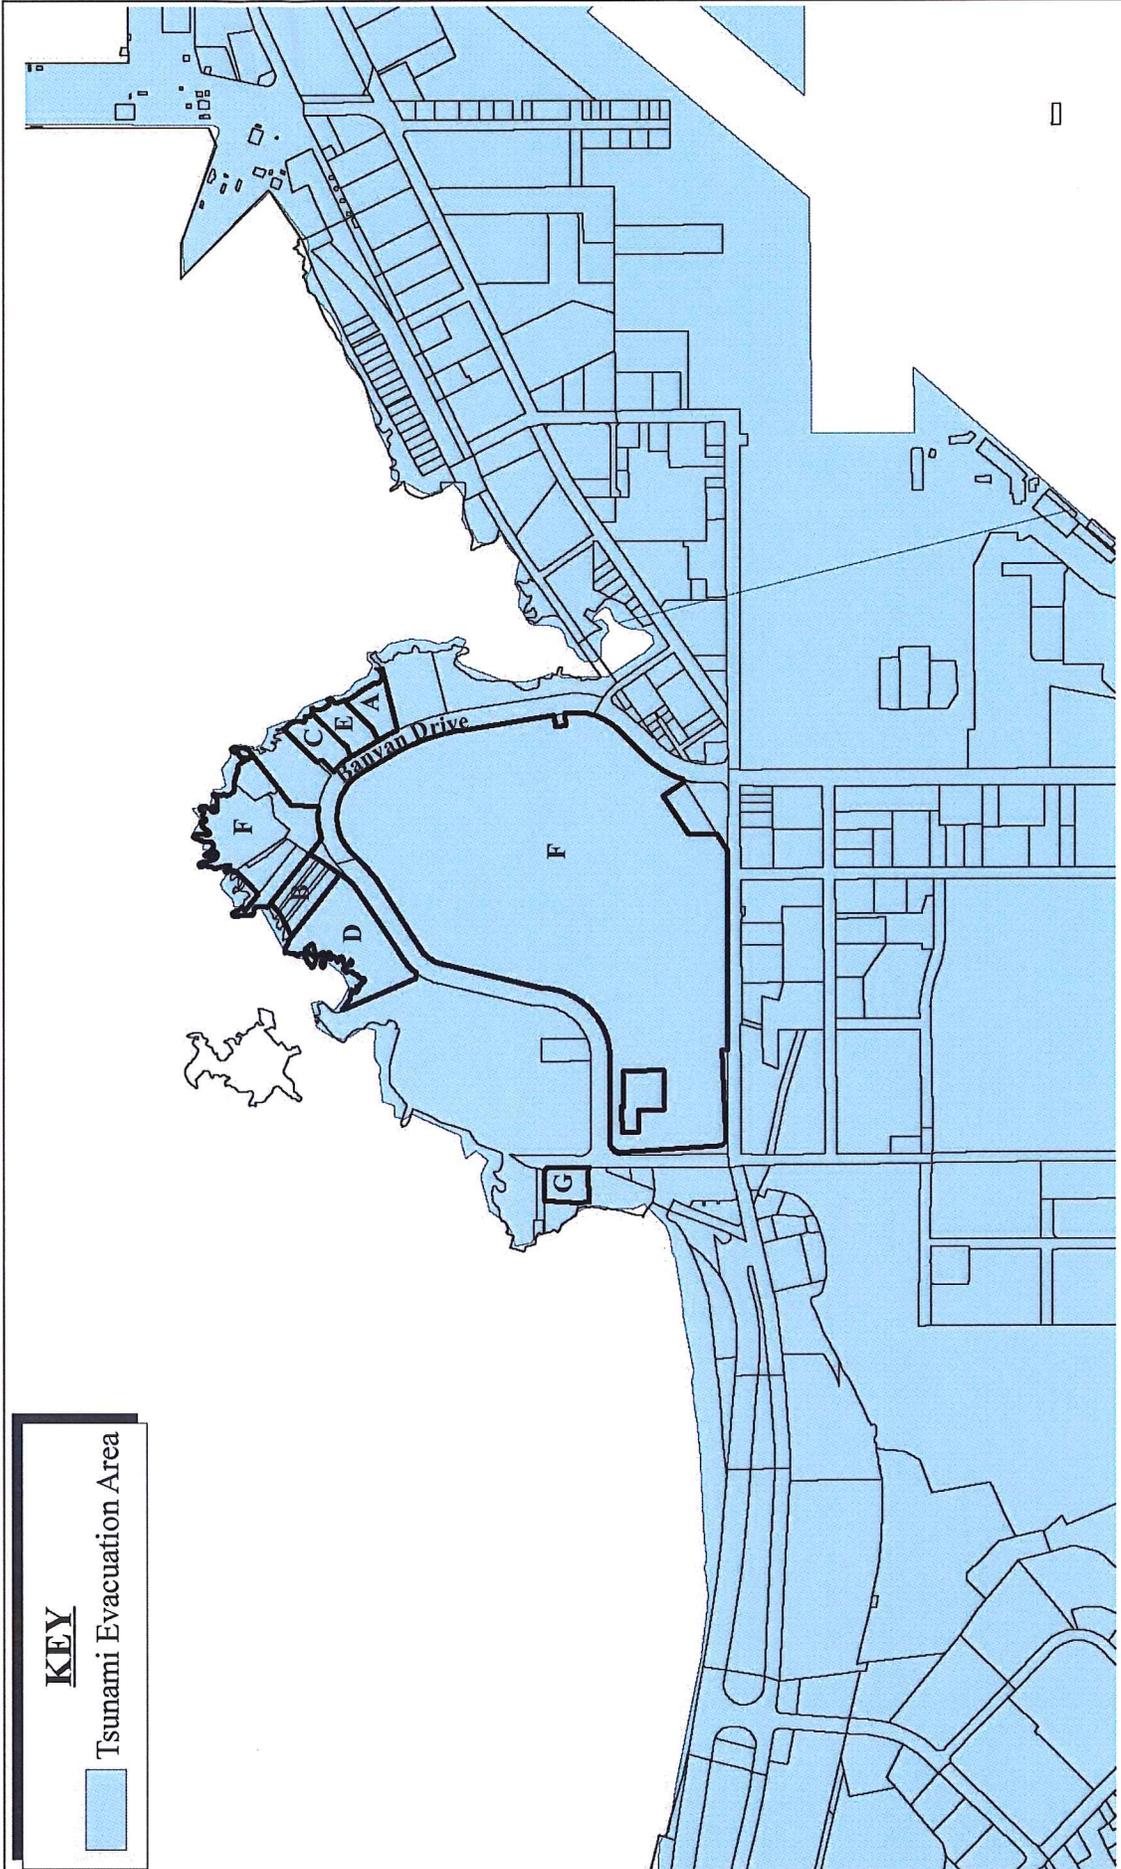
Figure 26 Banyan Drive Sea Level Rise Assessment
Tsunami Evacuation Areas

The entire peninsula of properties along Banyan Drive lies within a tsunami hazard evacuation zone. See **Figure 26**. According to NOAA, the evacuation zone maps are based on data from tsunamis that hit Hawaii in the past. This is the best information available at this time and the University of Hawaii, under the direction of State Civil Defense is using the latest scientific technology to improve on this information.

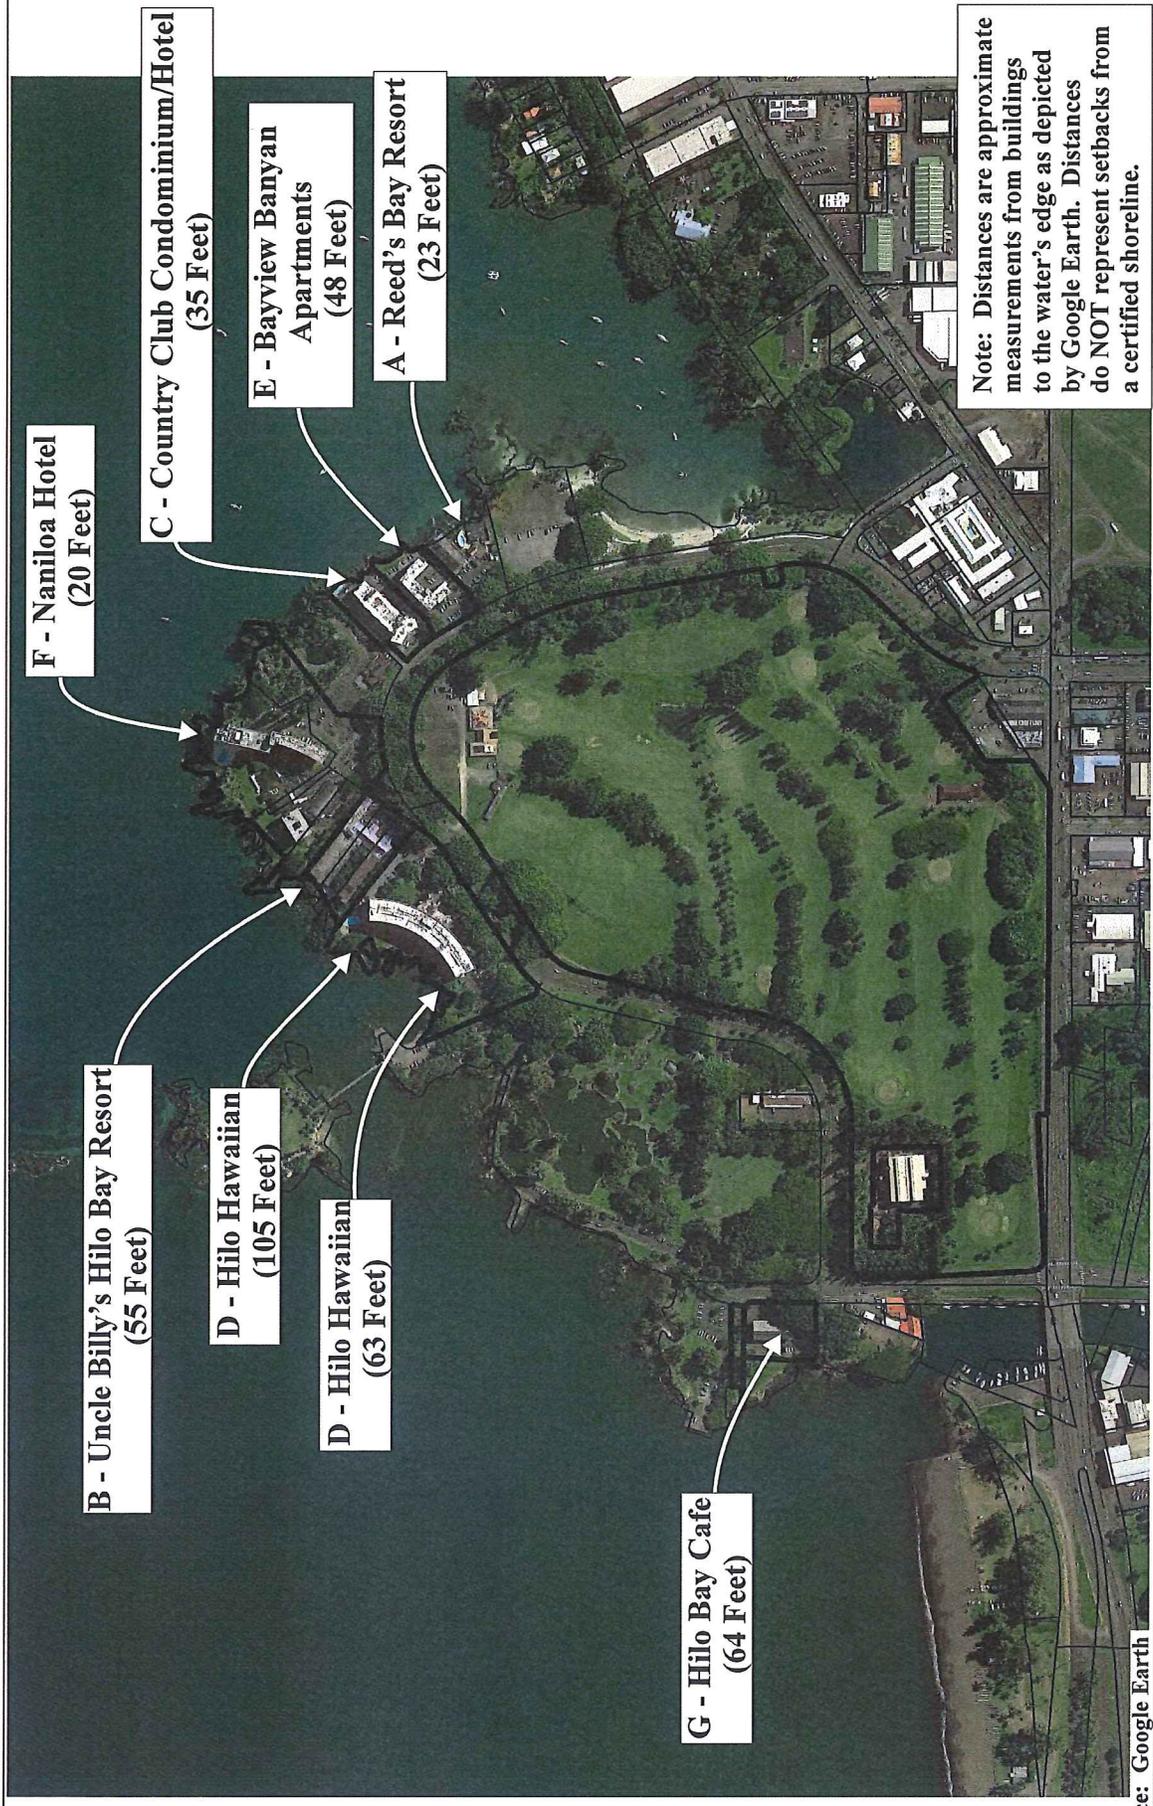
Figure 28 Banyan Drive Sea Level Rise Assessment
 Approximate Building Setbacks

As shown in **Figure 28**, buildings on the Reed's Bay Resort, Country Club Condominium/Hotel, and Naniloa Hotel properties appear to have structures that fall within 40 feet of the water's edge. The rules pertaining to the shoreline setback establish permitted uses within the shoreline to minor structures and activities which may include landscape features, such as plantings and sprinkler system, benches, chairs, signs, walkways for access, etc., that shall not alter the existing grades. However, it is noted that structures approved prior to June 16, 1989 are permitted within the shoreline setback area.
