SUBJECT: Document for Publication in the OEQC Bulletin
Environmental Assessment for Conservation District Use
Application OA-10/28/91-2530 for Commercial Aquaculture at
Heeia Fishpond, Koolaupoko, Oahu, Hawaii
TMK: 4-6-05: 01

1991-12-08-0A-FEA-Heeia Fishpond Commercial aquaculture

HEEIA POND Cдуа

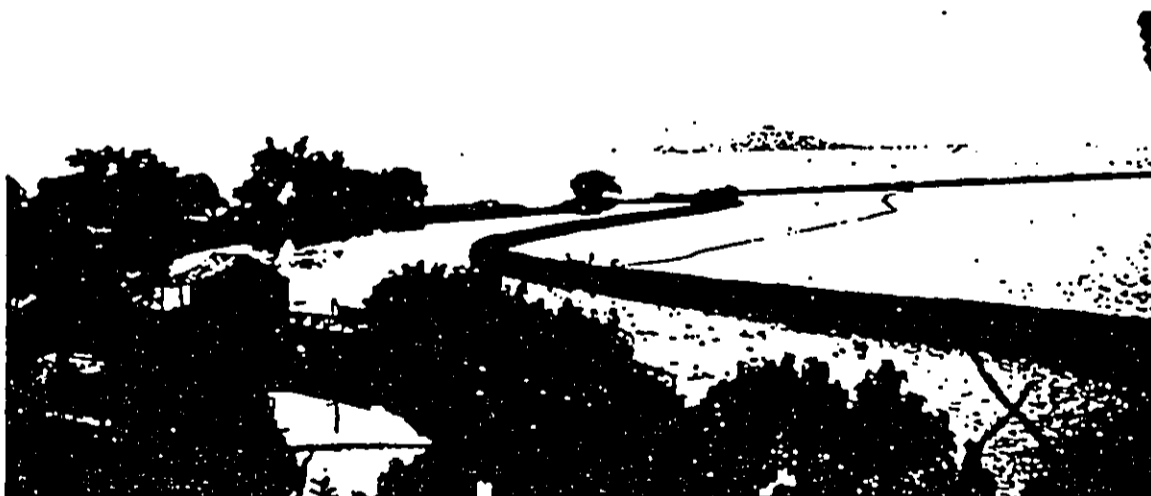
Figure 11

a. Looking southeast from above the northwest walls, c. 1915.
(R. J. Baker, photog., BPBM Coll.)

b. Looking toward Mokapu, c. 1920. Notice wide stream, bridge,
and internal pond for fry. (C. S. Judd, Jr. coll.)

Fig. LATER PHOTOS OF NORTHWEST PORTION OF HEEIA FISHPOND.
