Subject: Negative Declaration for Huilua Fishpond Restoration
and Revitalization, Kahana Valley, Oahu

2.1 Introduction

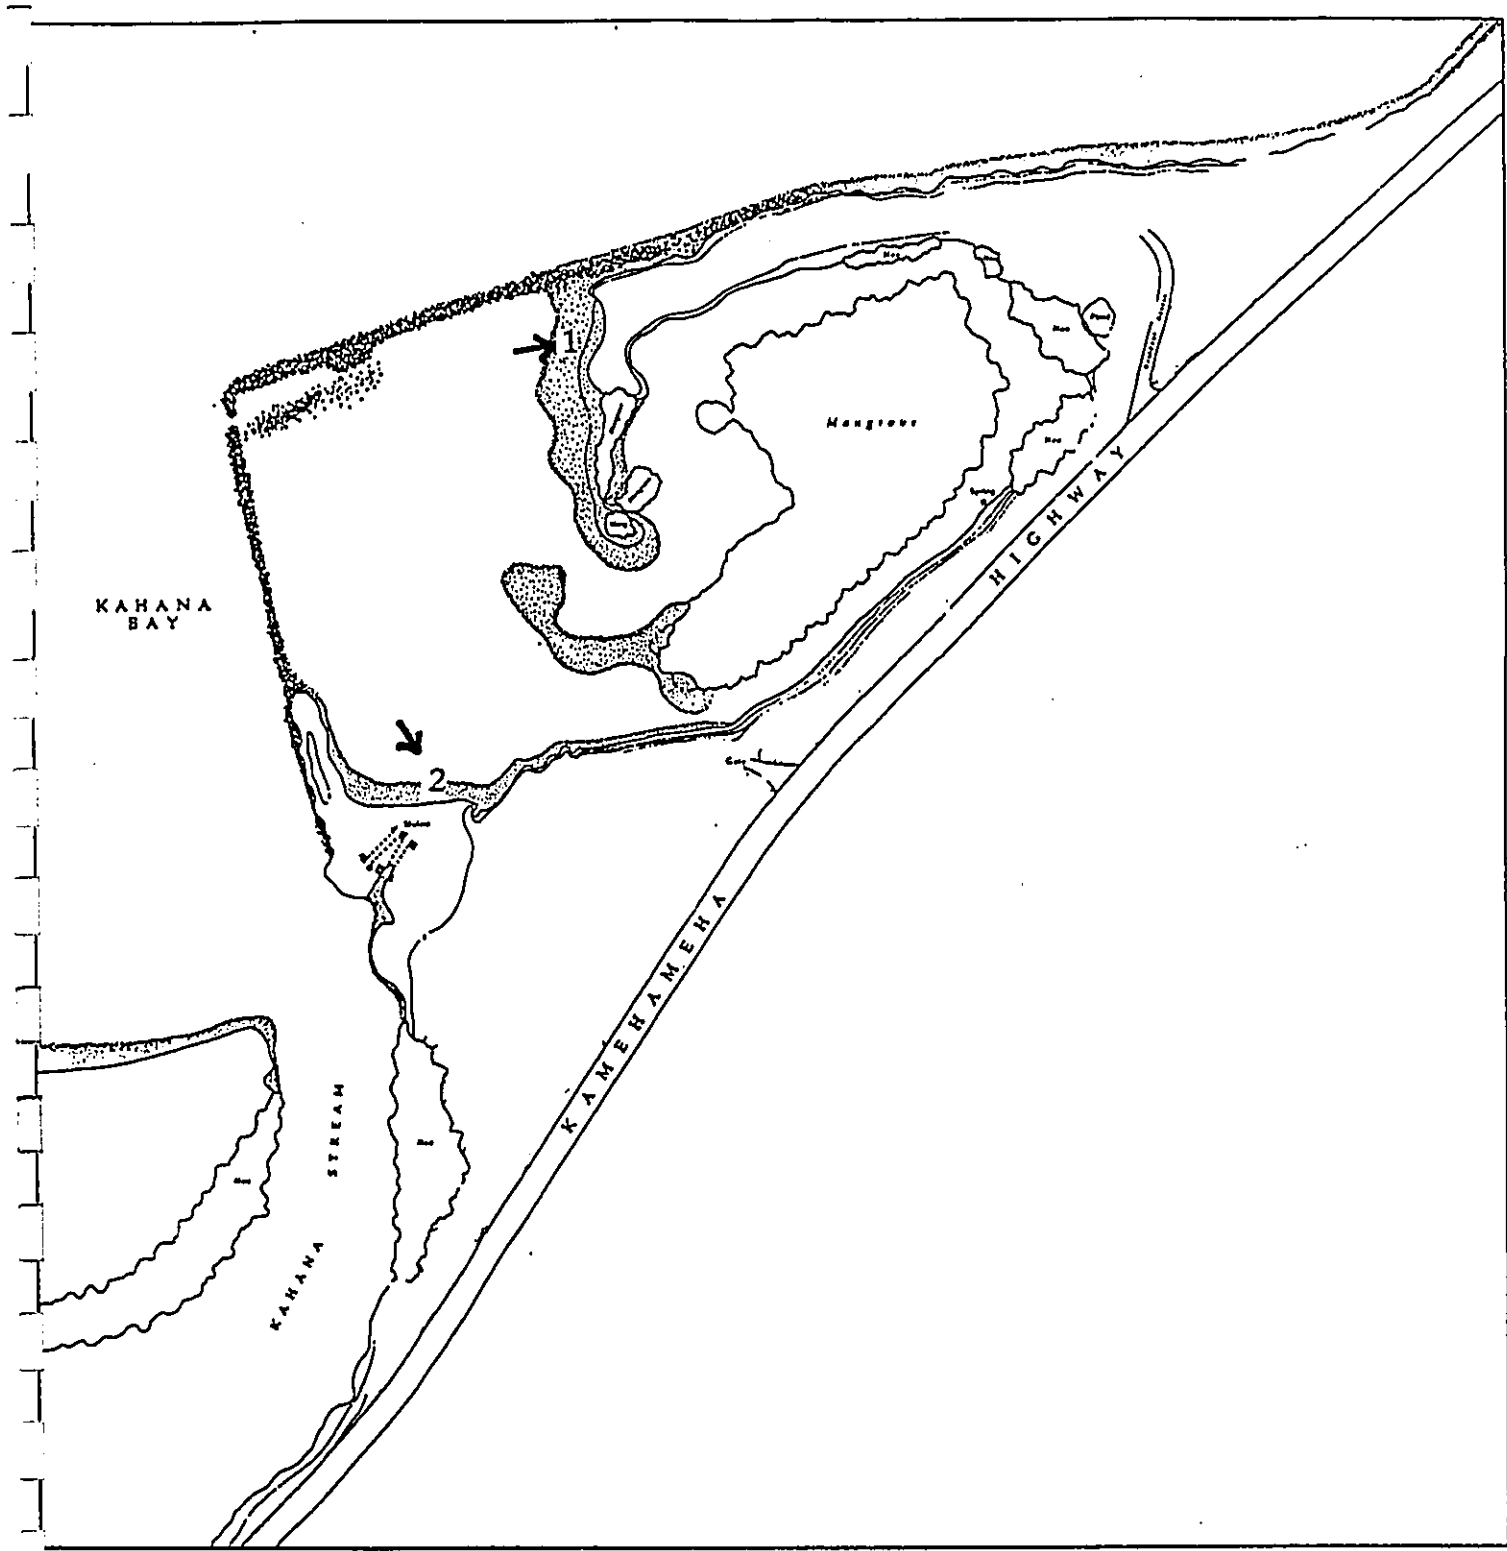
A three foot length of two inch pvc pipe was pounded into the sand berm in two locations shown in Figure 12. The pipe was then dug out of the ground and a plunger was used to extrude the core from the pipe. One sample was taken on the sand berm on the interior of the fishpond near the ocean and the other was taken on the pond-side of the sluices. Sample sites were chosen to give the widest range of variability in relation to tidal action and river accretion. A Munsell color chart was used to determine color.

Figure 14. Location of sites for core samples

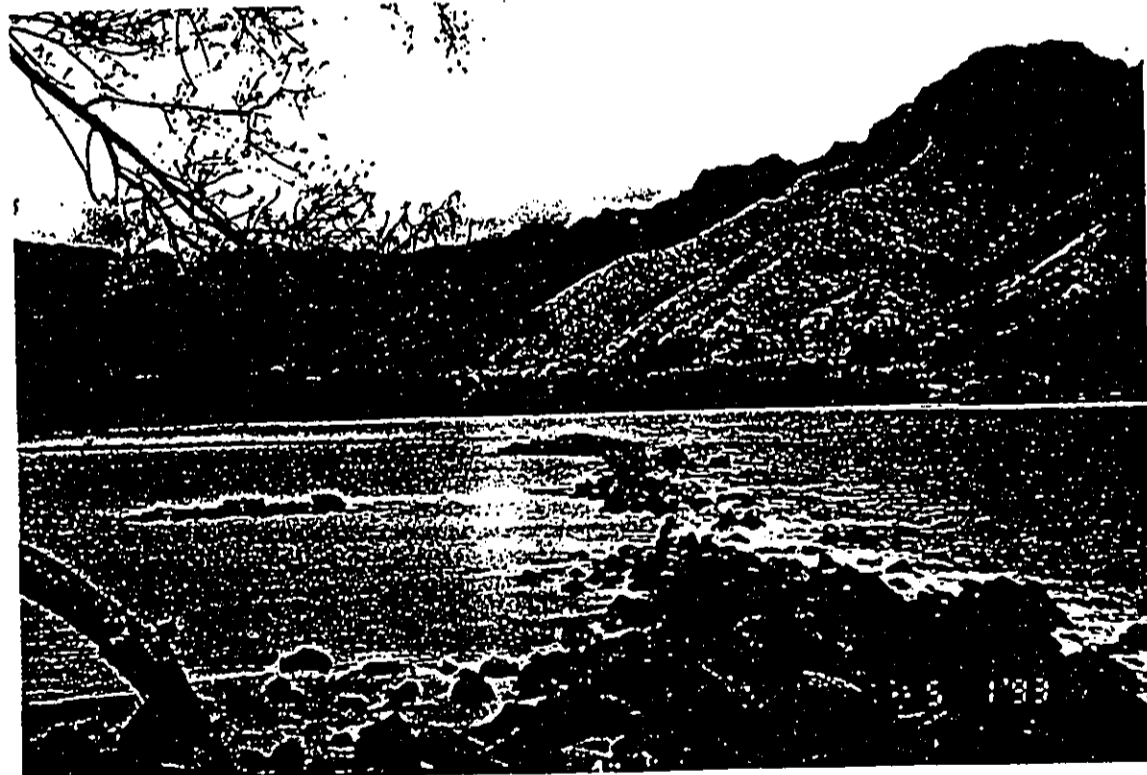
The North wall has been altered considerably. The line of basalt stones in this zone approximates the area of the sand berm which once formed the boundary of the fishpond from the ocean. This wall receives the most wave activity from waves which move in a Southwesterly pattern.

Figure 23 Zone G. North Wall.

At one time a sand berm peninsula extended out from East to West comprising portions of this wall. Areas were reinforced with rock. Following tsunami of 1957, this wall was damaged extensively and repaired by machinery.

As recommended in the archaeological survey by Carpenter and Yent, the double faced rock wall with fill of stone and coral will be built in the alignment of the North wall. This basic design is consistent with the one established on the West wall, however, to withstand the wave action, the wall will be higher, wider, and have more of an exterior slope than the West wall.
