FINAL ENVIRONMENTAL ASSESSMENT

***IMPROVEMENTS TO KOKOLAU TUNNEL
AND PIPELINE***

T.M.K. 3-04-06: portion of 12
Lihue, Kauai, Hawaii

DEPARTMENT OF WATER
County of Kauai

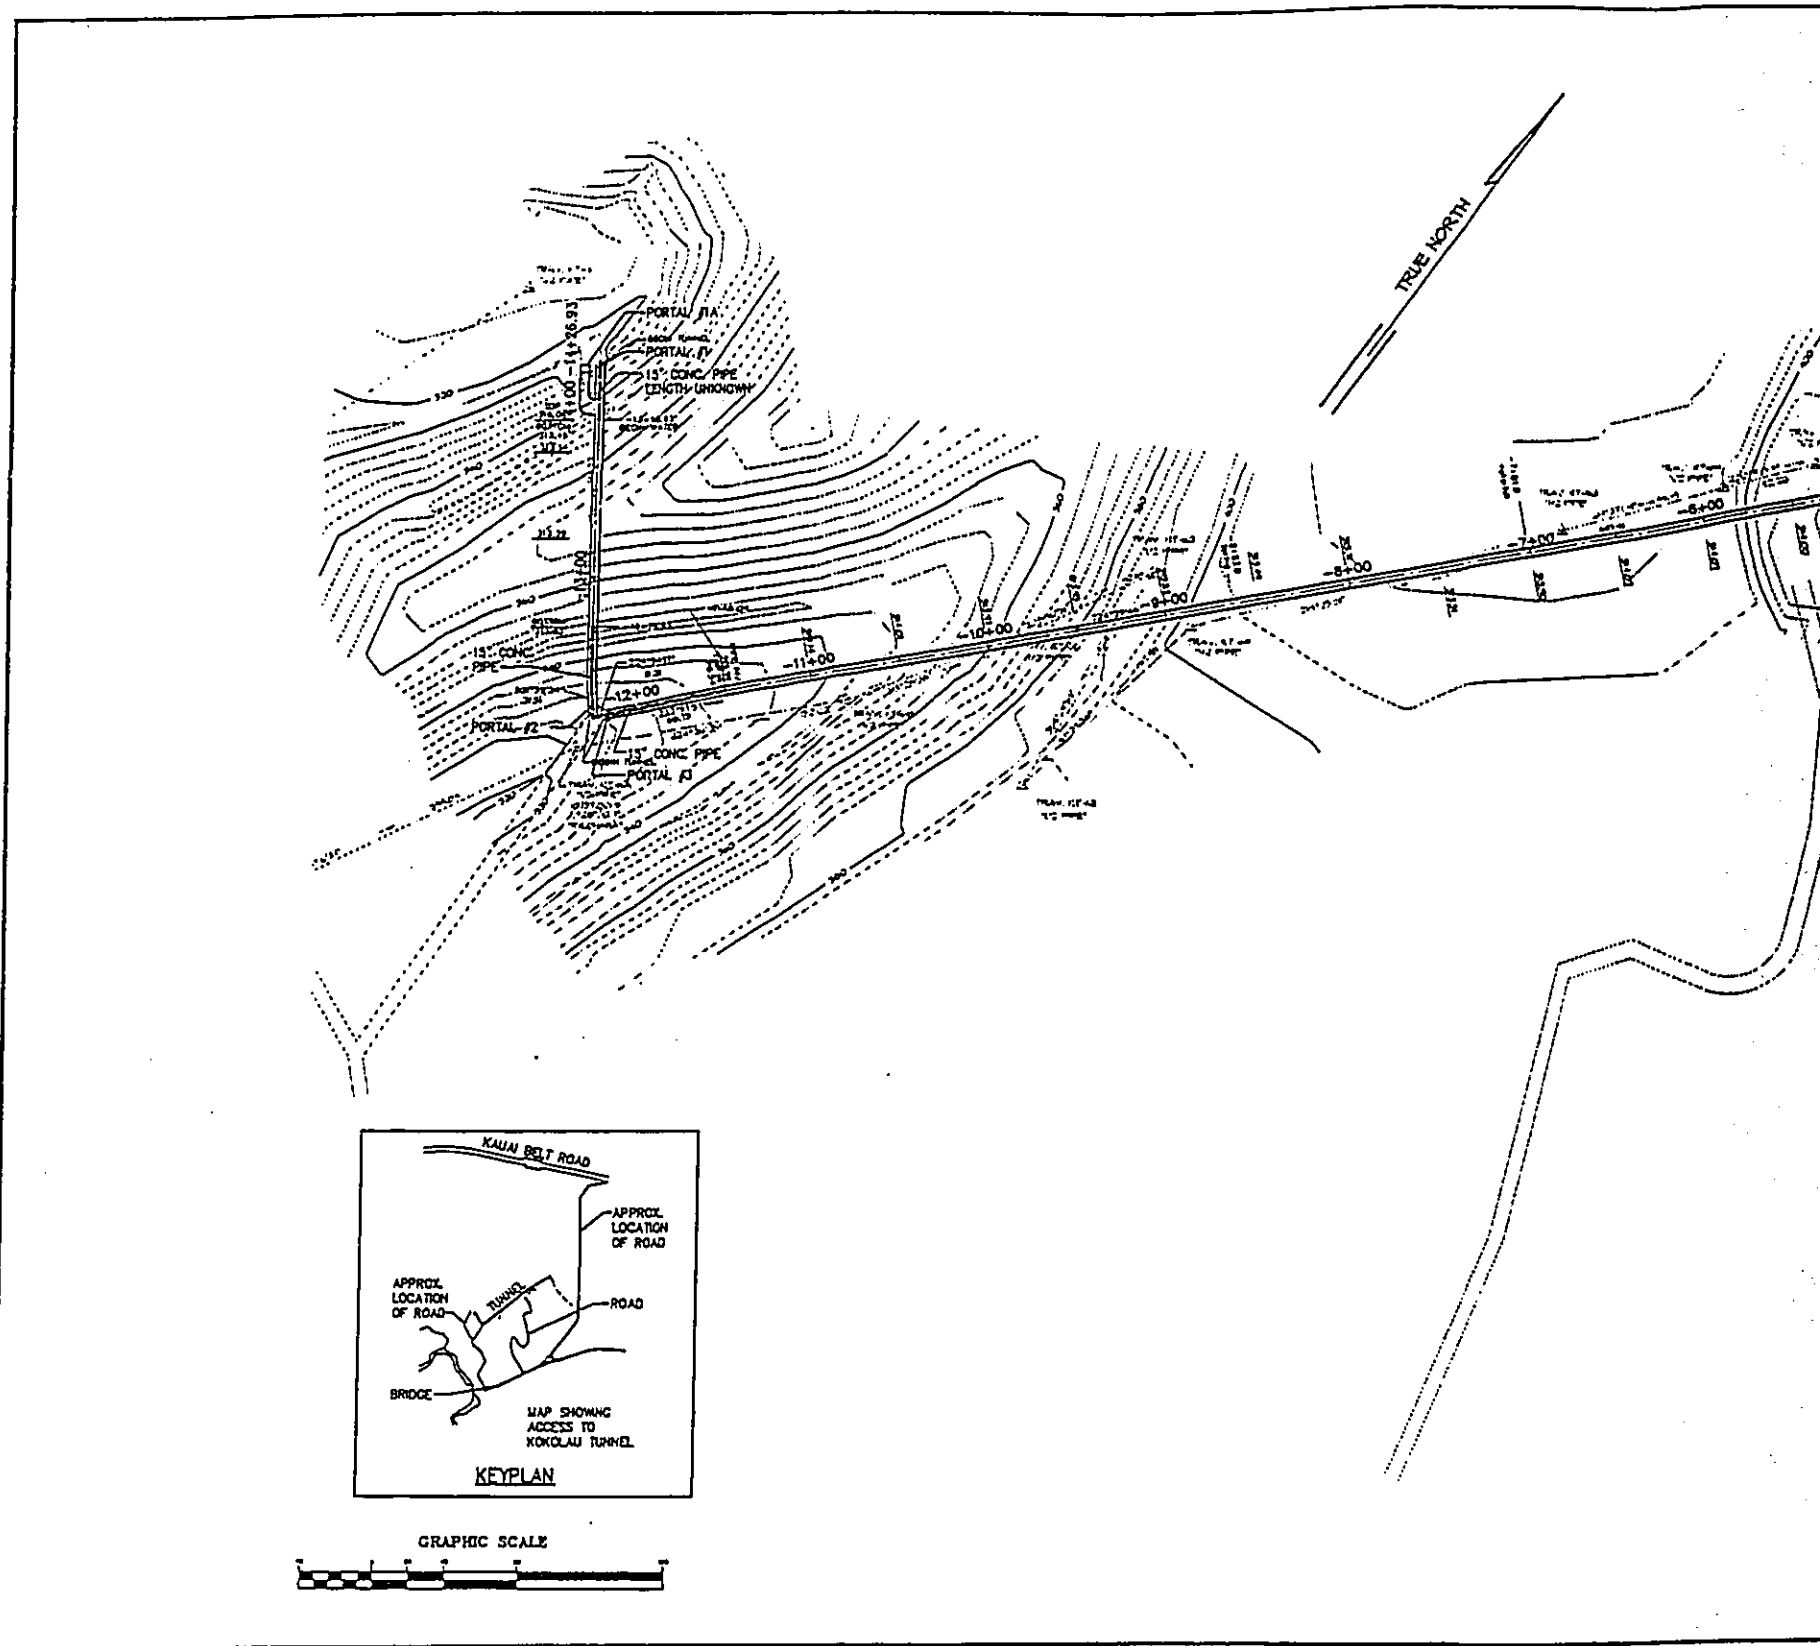
KOKOLAU TUNNEL EXISTING LAYOUT PLAN

The Kokolau Tunnel is an approximately 1,550-foot unlined water development tunnel situated on a mountain ridge at an elevation of about 300 feet mean sea level (msl). This tunnel intercepted former springs in a tributary on the north side of Huleia Valley during its construction in 1929. The aquifer occurs in lava flows that are probably from the Kilohana vent. The aquifer may be perched on a nearly-horizontal red soil layer which is several feet below the tunnels in formerly observed exposed road cuts (MFA 1999). Figure 2.1 graphically shows this tunnel and identifies existing portals.

As shown on Figure 2.1, this tunnel complex has a shape of a reversed "Z." It has a main tunnel segment about 1,200 feet long generally running in a west to east direction along two ridge peaks on this mountain. A short tunnel segment located on the western end generally runs in a south to north direction for about 200 feet further up the ridge. Two other short tunnel segments are located on the eastern end running in a north to south direction ranging from about 500 to 1,000 feet long. There are a total of six entrances into this tunnel complex which are identified as Portals No. 1, 1A, 2, 3, 4, and 5. These portals are identified on Figure 2.1, and photos of these entrances are provided in Appendix A of this document.

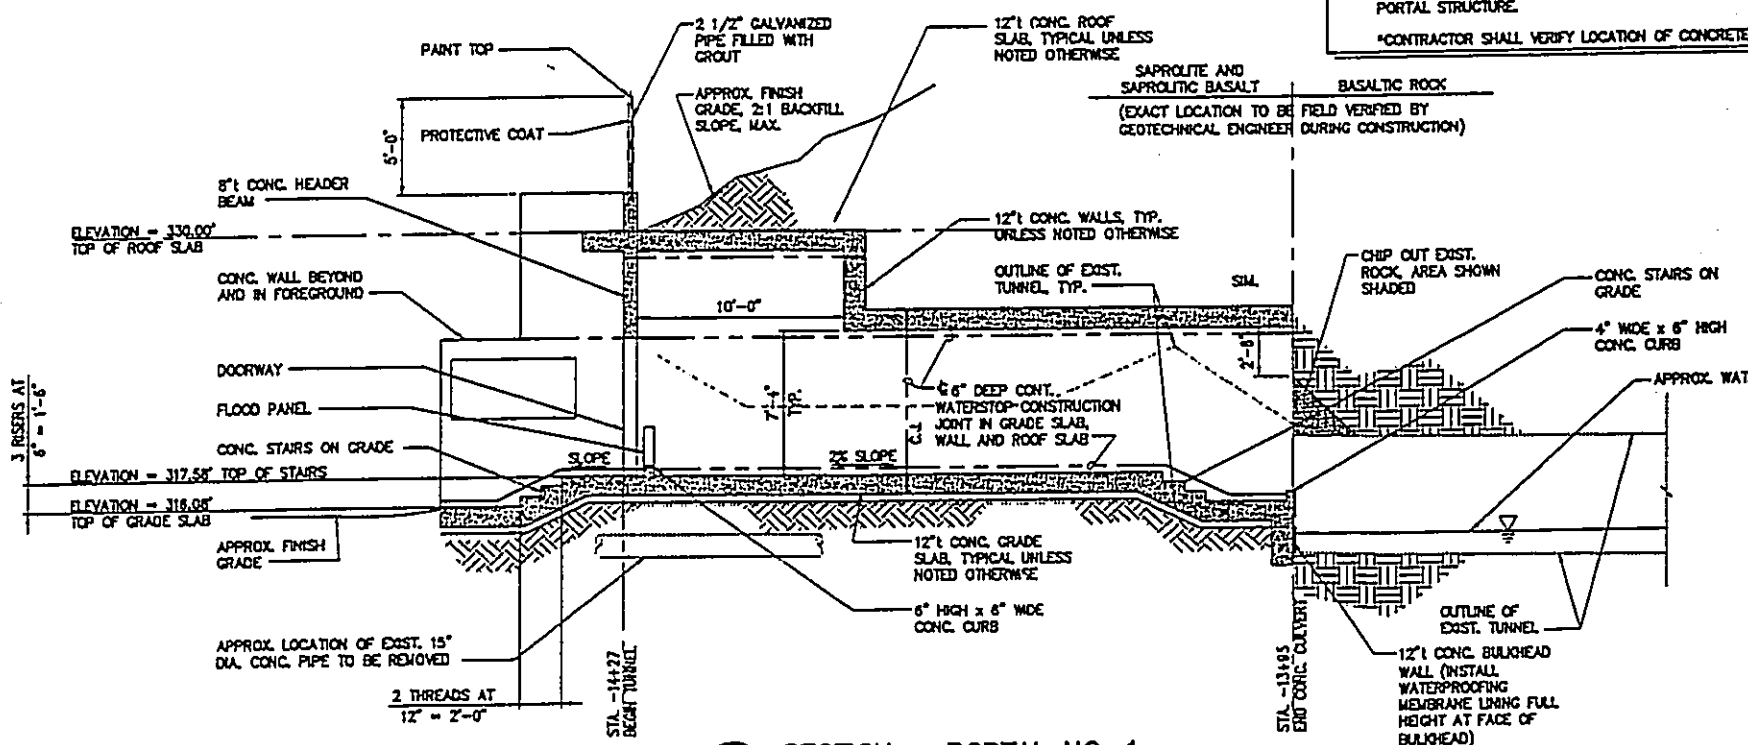
A SECTION - PORTAL NO. 1
NOT TO SCALE

SPECIAL NOTE:
SOFT MATERIAL AND LOOSE FILLS BELOW THE PORTAL STRUCTURE SHALL BE EXCAVATED TO FIRM GROUND. LEAN CONCRETE SHALL THEN BE PLACED IMMEDIATELY IN THE EXCAVATED AREAS TO FORM A LEVEL SURFACE FOR THE STRUCTURE.

CONCRETE PIPE NOTES:
1. EXISTING 15" DIA. PIPE BENEATH THE NEW PORTAL SLAB SHALL BE CUT & REMOVED AND PLUGGED 5' FROM THE PORTAL STRUCTURE.
*CONTRACTOR SHALL VERIFY LOCATION OF CONCRETE

Construction of the portal structure and the segment of tunnel excavated up to the basalt would then occur. Figure 2.3 shows a typical section of the types of improvements to occur. This portal structure would have concrete roof, walls, and flooring, a partially louvered hollow metal door about 3 feet wide by 6 feet tall, concrete steps leading up to the door, and an aluminum lift-out flood panel with frame. Water in this segment of the tunnel would be directed in a southern direction towards Portal No. 3. Once the portal structure is completed, the tunnel entrance would be backfilled to original elevations, and excavated areas would be landscaped. Figure 2.4 shows a typical landscape plan for these portals.

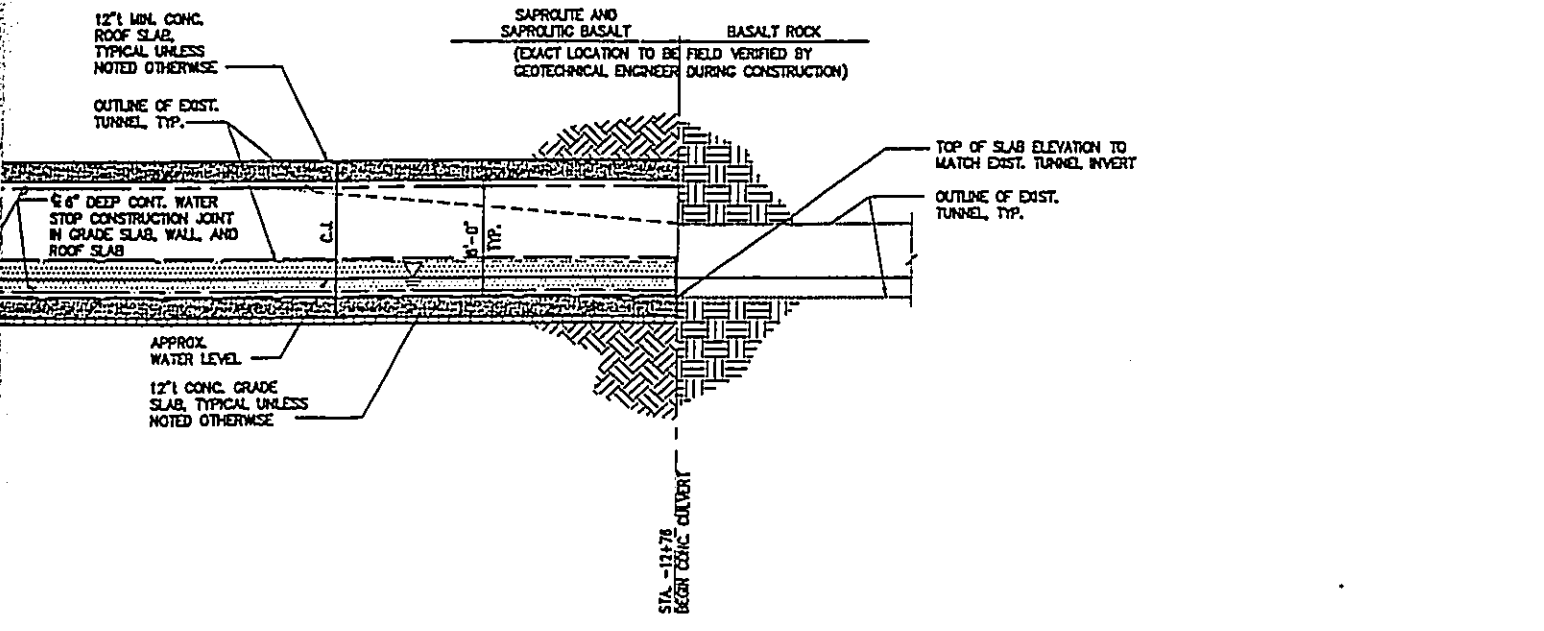
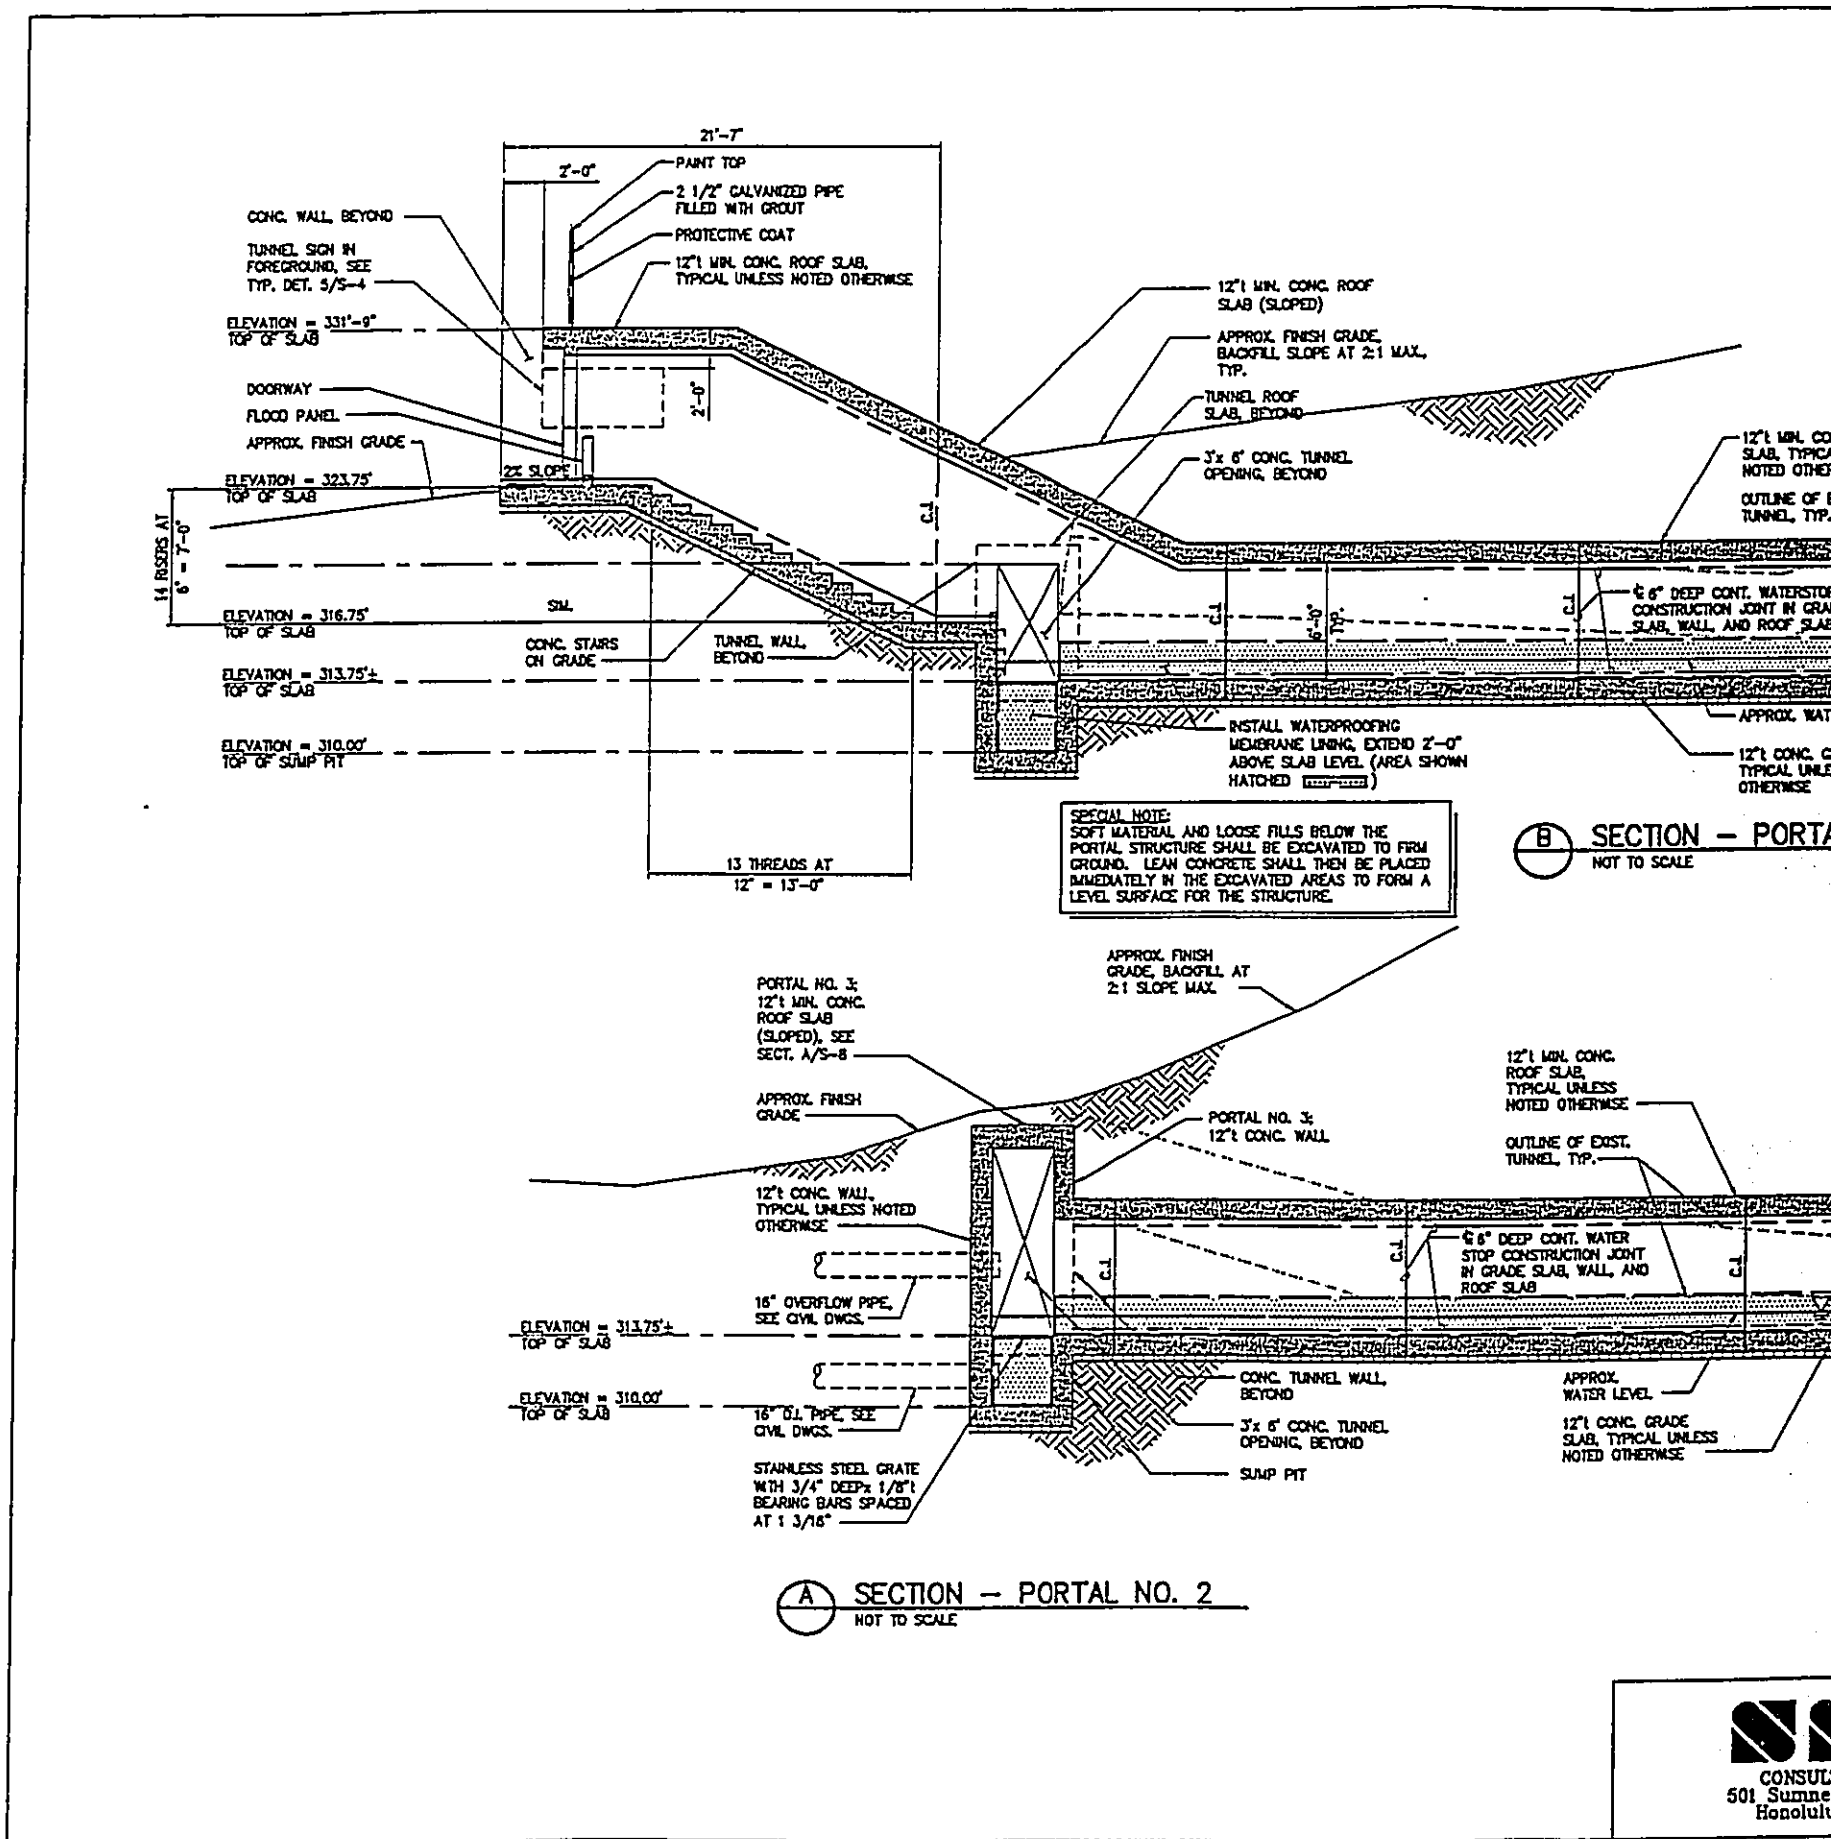
B SECTION - PORTAL NO. 3
NOT TO SCALE

CONSULTING ENGINEERS 501 Sumner Street, Suite 502 Honolulu, Hawaii 96817	KOKOLAU TUNNEL ENVIRONMENTAL ASSESMENT PORTALS NO. 2 AND 3 SECTIONS		FIGURE 2.5
	SCALE: AS NOTED	DATE: OCTOBER 1999

Portals No. 2 and 3 would be replaced to create a new single tunnel entrance situated near the general area of Portals No. 2 and 3. This new portal would serve as the new main entrance into the tunnel. Portal No. 2 would be excavated about 60 feet in the tunnel up to the basaltic rock. A concrete box culvert would be constructed, and the existing portal entrance would be closed off. The concrete culvert would allow water flow from the area near Portal No. 1 to continue towards the new tunnel entrance.

Portal No. 3 would be similarly excavated about 120 feet into the tunnel up to the basaltic rock before a concrete box culvert can then be constructed. The new portal entrance created would have a metal door, flood panel, steps leading down into the tunnel, a sump pit, and a concrete culvert. A new 16-inch waterline would also be constructed to transport water along the dirt access road. Figure 2.5 shows a typical section of improvements at this new portal.

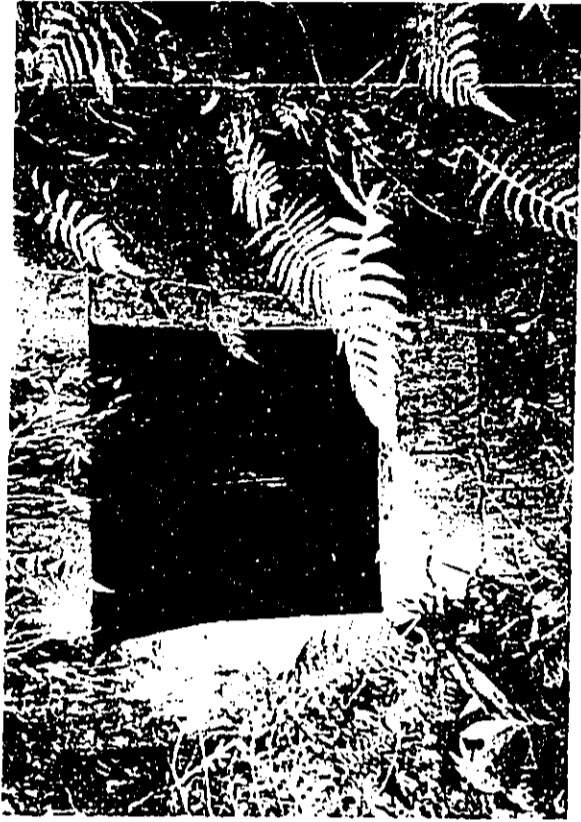
PHOTO 4A
View Of Portal No. 4

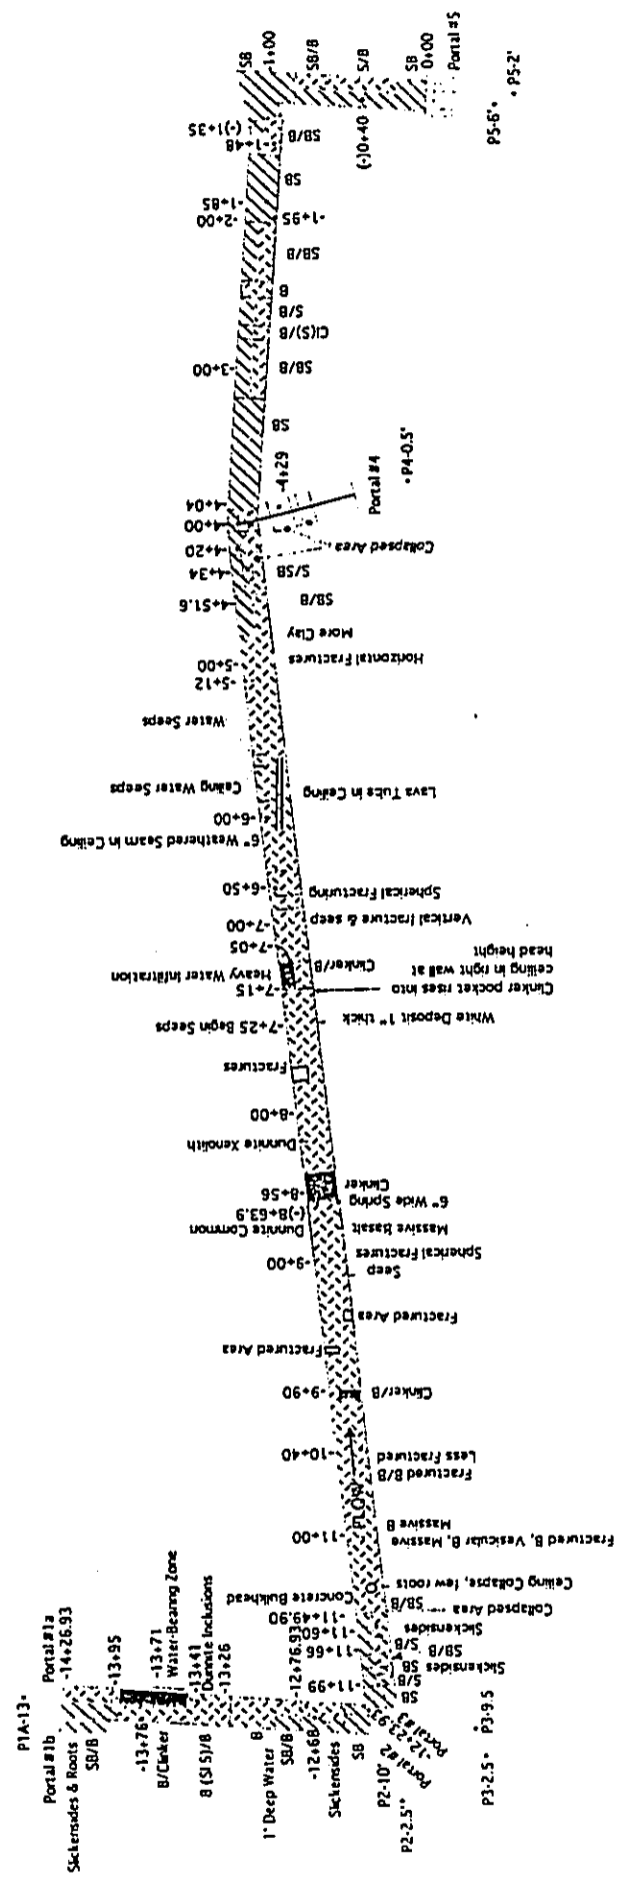
Drawing No.	02
Drawn by: WCS	
Approved by: DDD	
Rev: 04	
Date: 9-16-98	
Scale: 1" = 20'

Modified After: Advanced Worksheet 98-37A.dwg, Dennis M. Esahi

Figure 2 is a plan view of the tunnels that shows generalized lithology within the tunnels. Figure 2 shows the strata as well as water-bearing zones, fractured zones, collapsed areas, and clinker zones.

The major water-bearing zones within the tunnels are found in clinker zones. The "waterfall" area of the tunnels is the major source of water for the system, and is located within a clinker zone shown from (-)7+05 to (-)7+15 feet on Figure 2. The majority of the water in this zone is infiltrating from the top half of the tunnel, on the northwestern side of the tunnel. A small, six-inch wide spring is located at the base of the tunnel on the southeastern wall at station (-)8+63.9 feet (Figure 2). Several other water-bearing zones and seeps of apparently lesser magnitude are also shown in Figure 2. These zones generally occur in areas of fractured Koloa basalt.

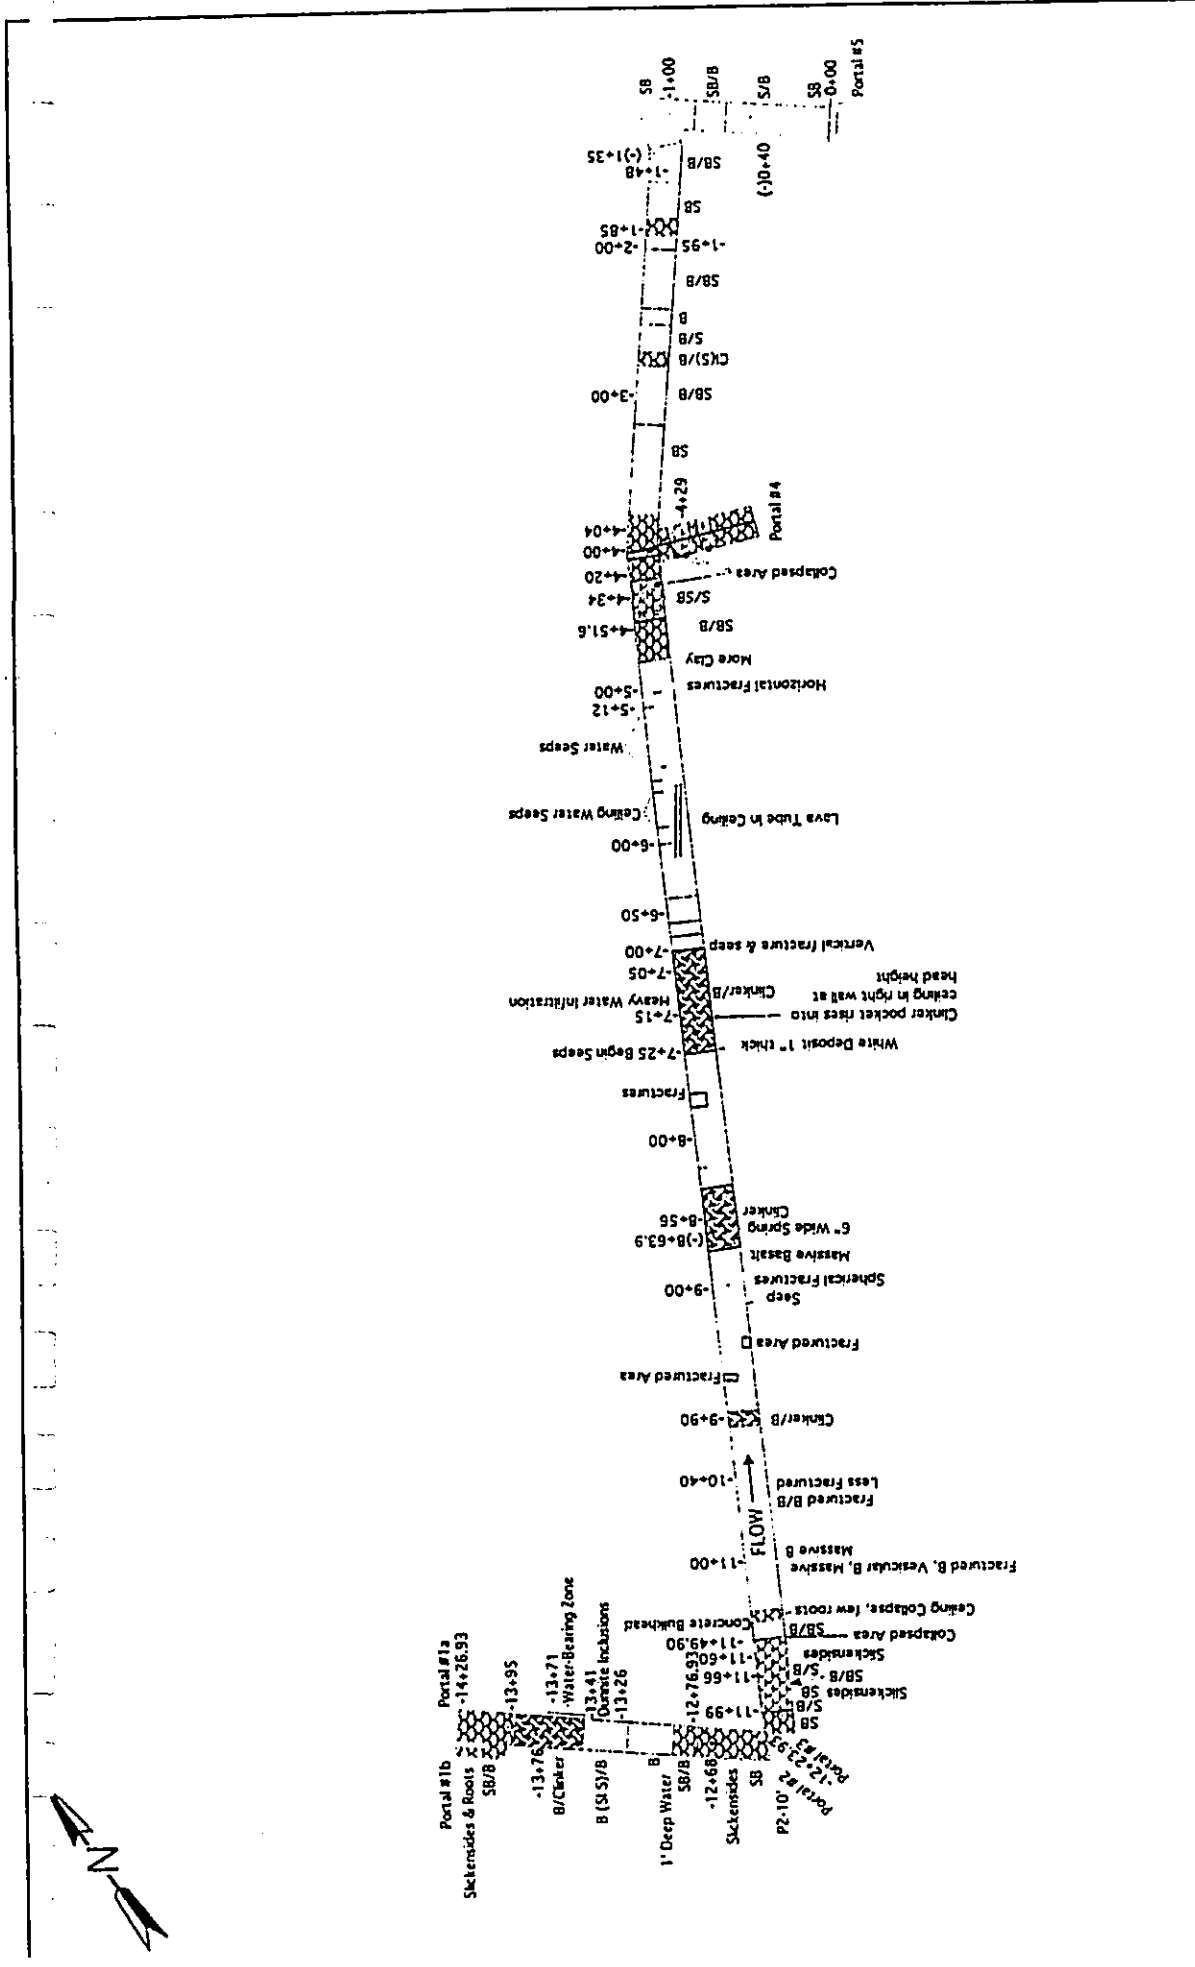
Project No: 98088-012
Drawing No: 04
Drawn by: M335EL
Approved by: DRD
Per: 04
Date: 8.15.98
Scale: 1" = 80'

Figure 4
SITE PLAN - Areas of Concern
 Kotou Water Tunnels at Hahaione
 Board of Water Supply
 Lihue, Kauai, Hawaii

Basalt		Geotechnically Weak Zones
	Saprock		Geotechnically Weak Cinder Zones
	Clayey Silt		Collapsed Area
	Cinder

3. The clinker zones within the tunnels will need to be supported to prevent collapse in these areas. These areas are shown on Figure 4 - Areas of Concern. The clinker zones that need to be supported include the following areas:

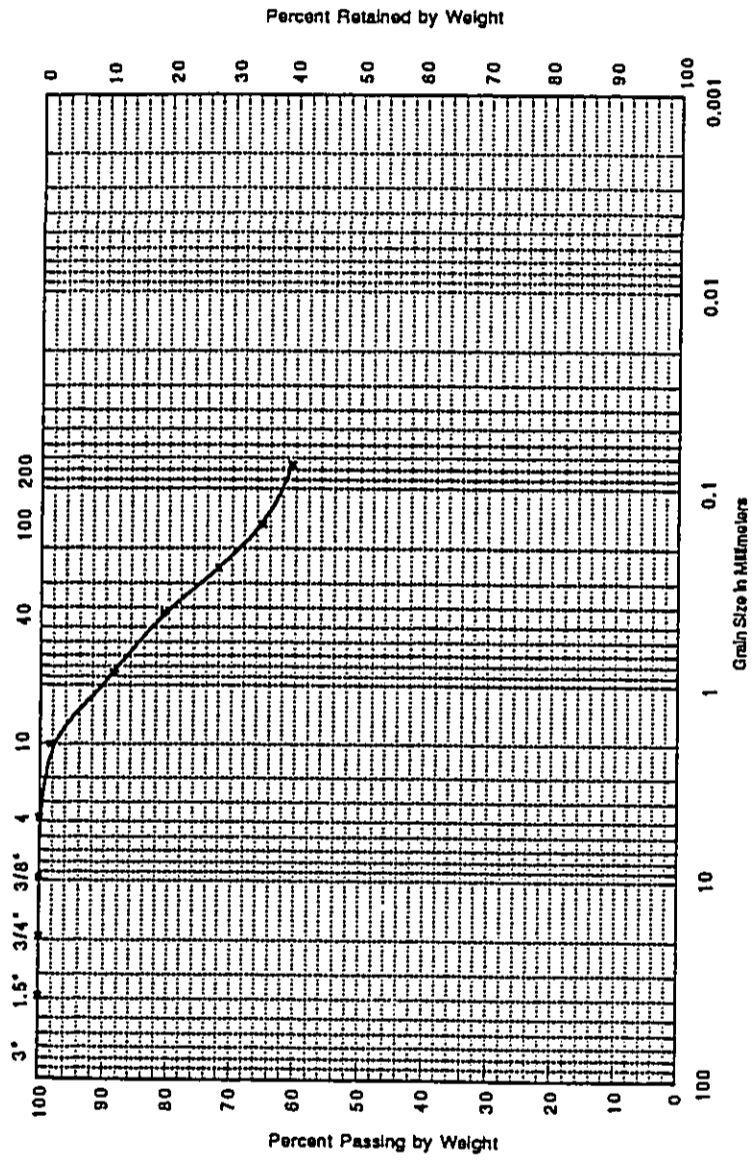
Figure A1
 MASA FUJIOKA & ASSOCIATES

Project: Kokoiu Water Tunnels at Haku
 Job No: 88086-012
 Sample: Brown sandy silt
 Station: 3+24
 Depth:

SOIL CLASSIFICATION: M L

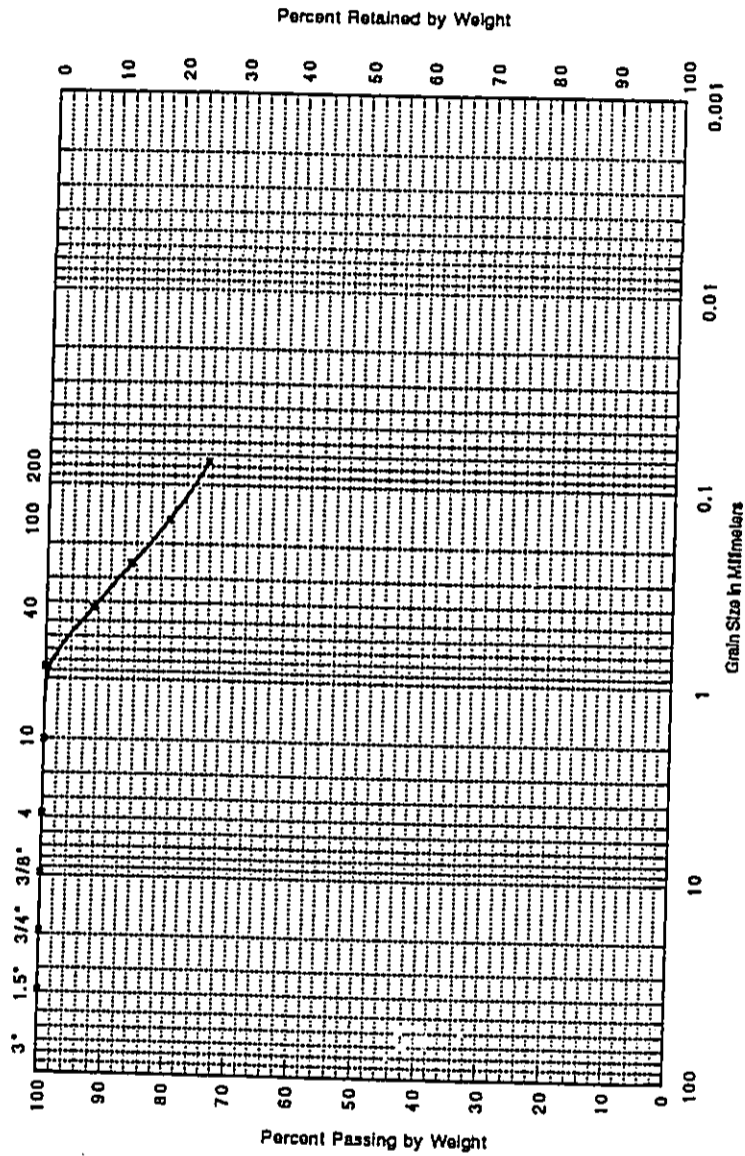
Figure A2
 MASA FUJIOKA & ASSOCIATES

Project Kokoleu Water Tunnel at Hailu
 Job No: 98088-012
 Sample: Brown sandy silt
 Station: -4+04
 Depth:

SOIL CLASSIFICATION: **ML**

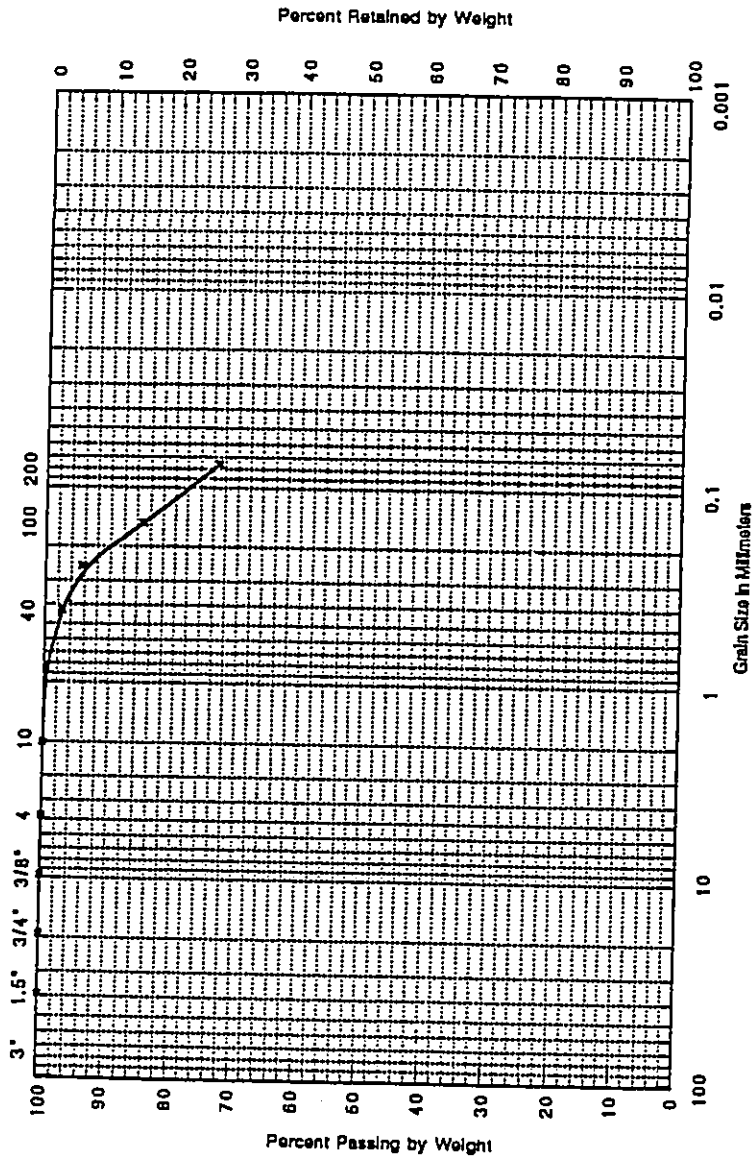
Figure A3
 MASA FUJIOKA & ASSOCIATES

Project: Kokolau Water Tunnels at Haku
 Job No: 98088-012
 Sample: Brown sandy silt
 Station: -4+29
 Depth:

SOIL CLASSIFICATION: M L

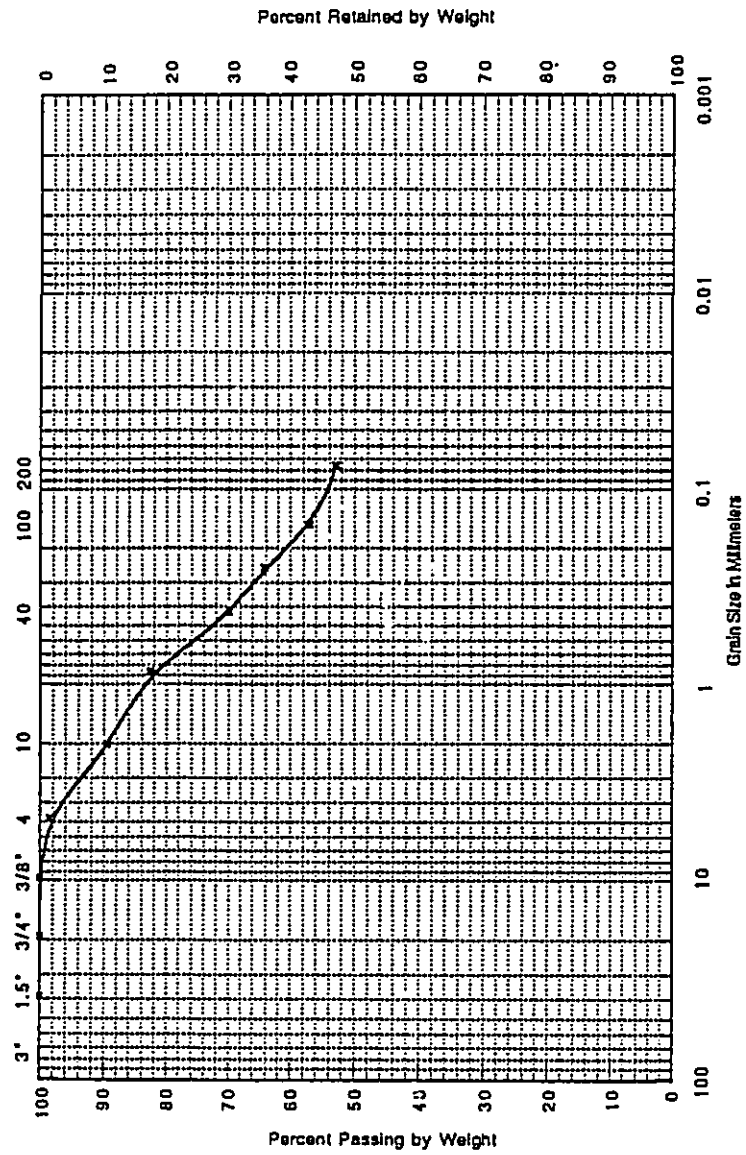
Figure A4
 MASA FUJIOKA & ASSOCIATES

Project: Kokolau Water Tunnels at Heiaku
 Job No: 88088-012
 Sample: Brown sandy silt
 Station: -1+34
 Depth:

SOIL CLASSIFICATION: M L

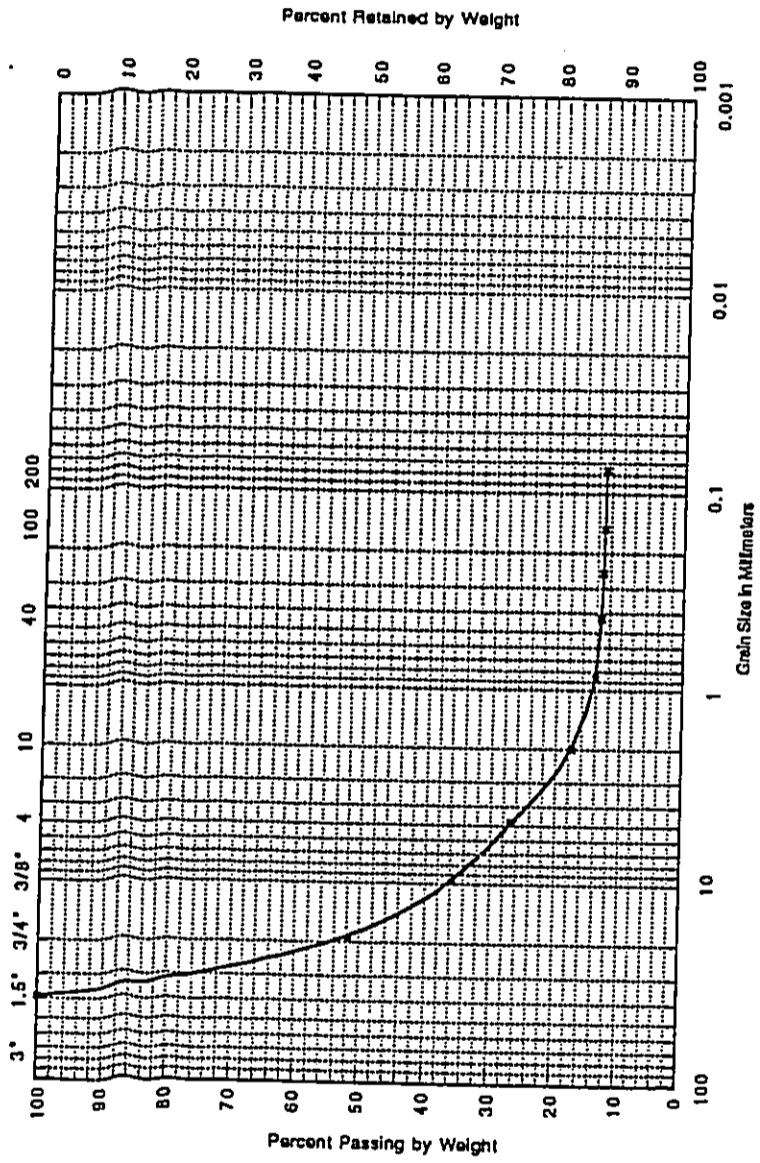
Figure A5
 MASA FUJIOKA & ASSOCIATES

Project: Kokodau Water Tunnels at Hailu
 Job No: 98086-012
 Sample: Silty Gravel (Claybars)
 Station: -7+05 (Water Fall Area)
 Depth:

SOIL CLASSIFICATION: GM

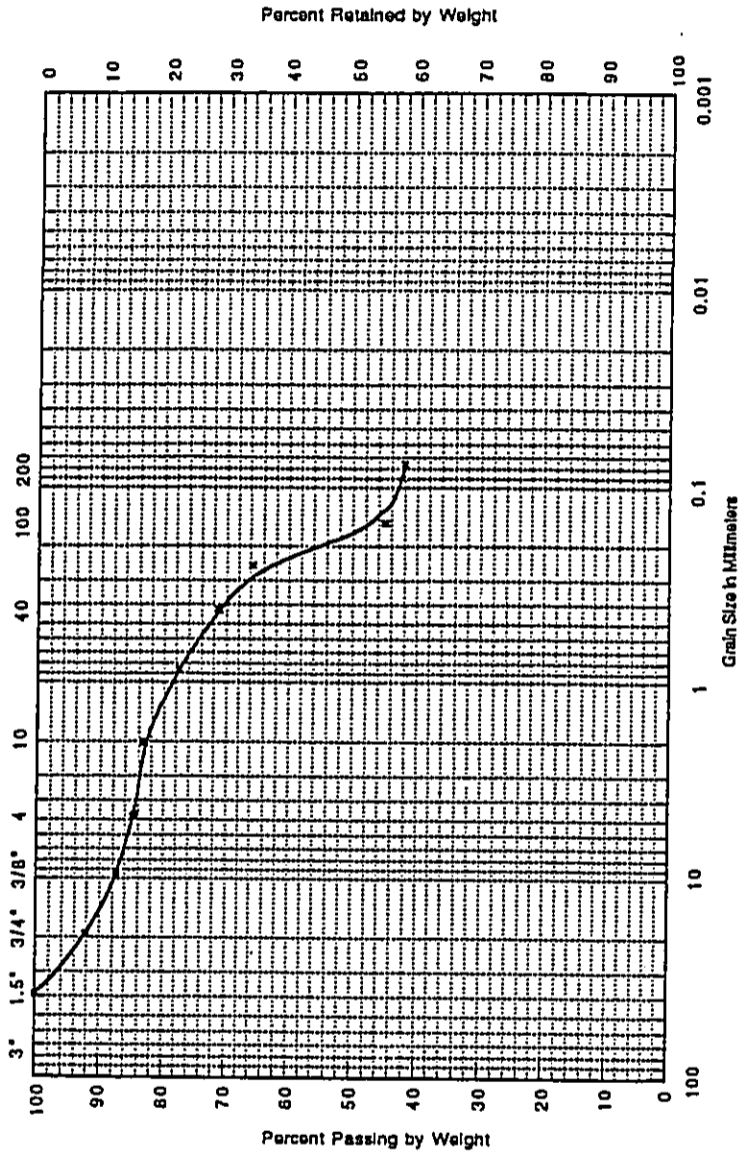
Figure A8
 MASA FUJIOKA & ASSOCIATES

Project: Kokoleau Water Tunnels at Haku
 Job No: 98088-012
 Sample: Brown silty sand w/ gravel
 Station: -11+88
 Depth:

SOIL CLASSIFICATION: S M

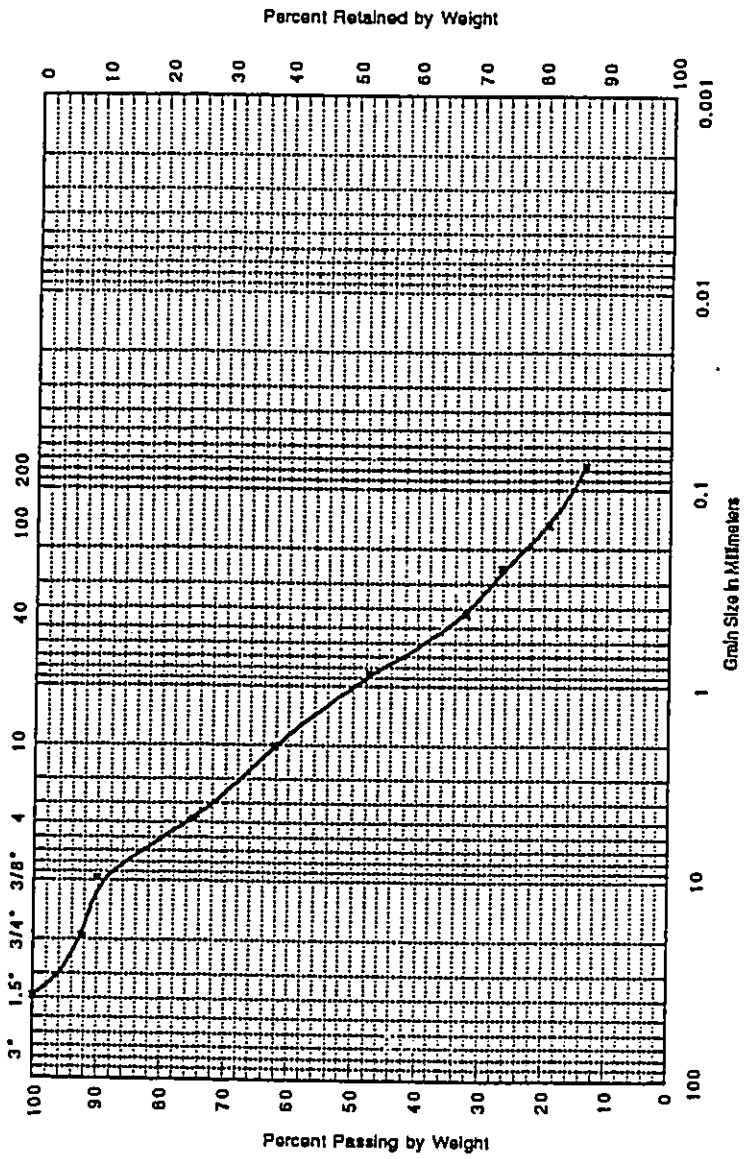
Figure A7
 MASA FUJIOKA & ASSOCIATES

Project: Kokoiu Water Tunnels at Haku
 Job No: 98086-012
 Sample: Brown silty sand w/ gravel
 Location: P1
 Depth: 10 ft. blocs (below top of cut slope)

SOIL CLASSIFICATION: S M

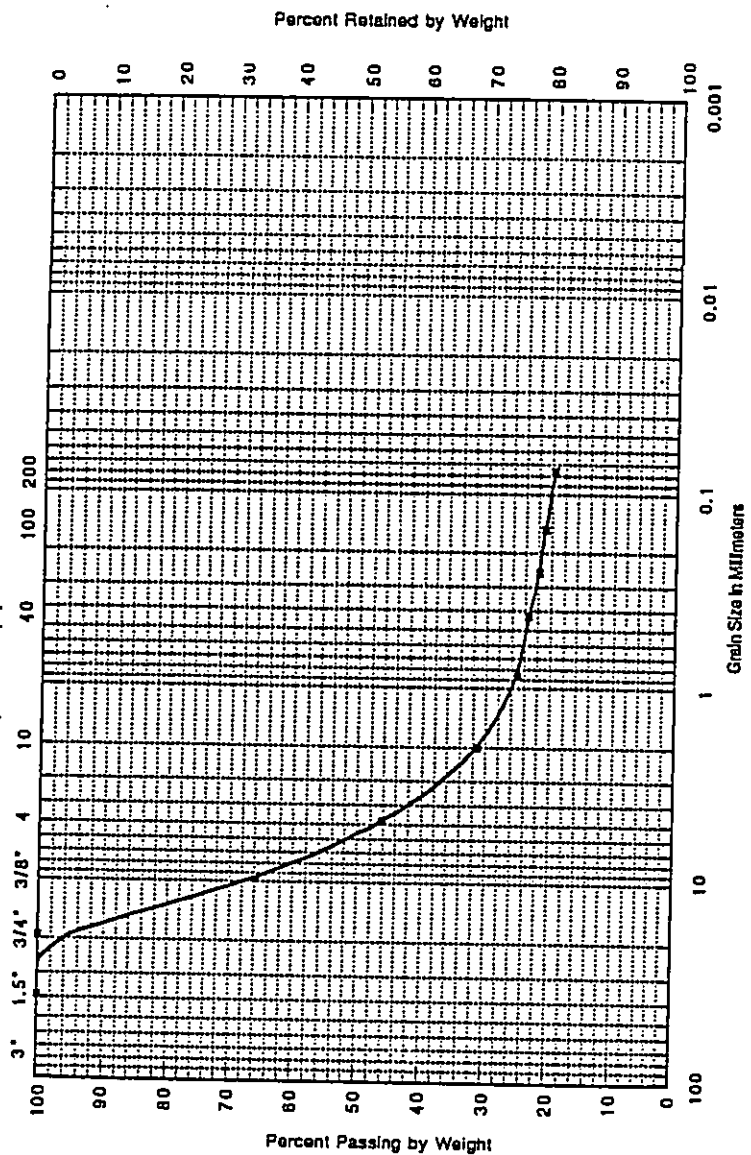
Figure A8
 MASA FUJIOKA & ASSOCIATES

Project: Kokoiu Water Tunnels at Haku
 Job No: 98088-012
 Sample: Brown silty gravel w/ sand (Saprolite)
 Location: P1
 Depth: 15 ft. blocs (below top of cut slope)

SOL CLASSIFICATION: GM

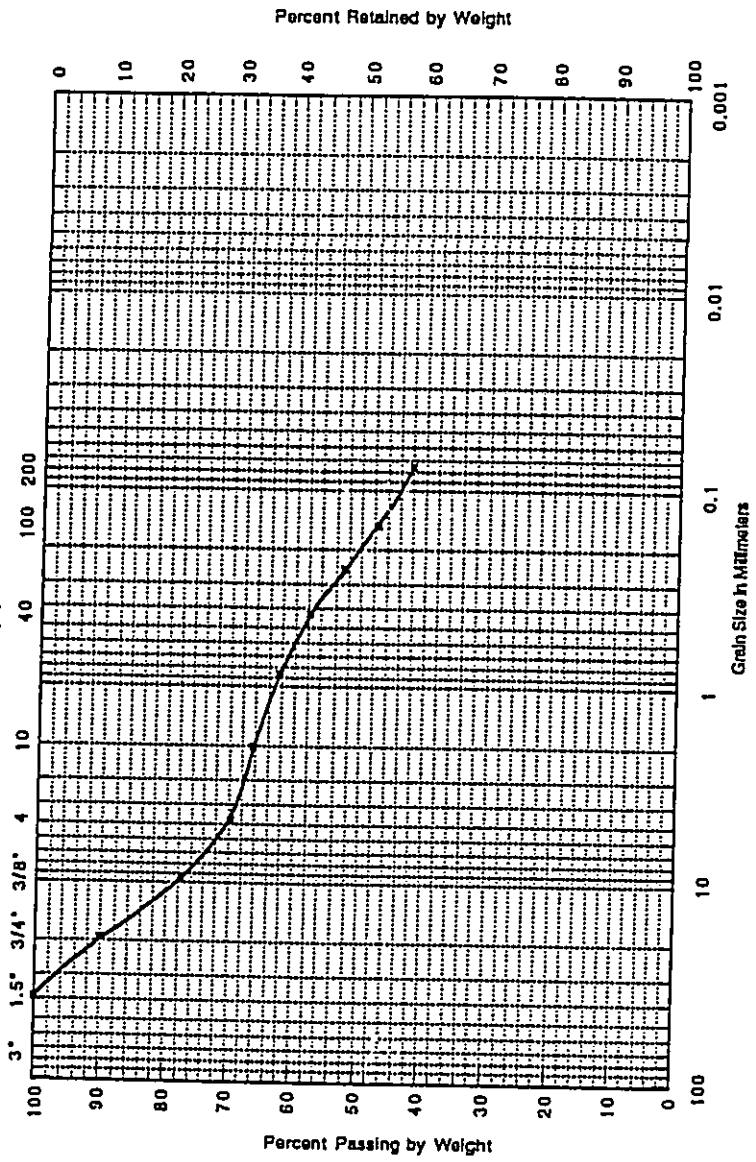
Figure A9
 MASA FUJIOKA & ASSOCIATES

Project: Kokoau Water Tunnels at Heiuku
 Job No: 98086-012
 Sample: Brown silty sand w/ gravel (Saprdllie)
 Location: P1A
 Depth: 13 IL blocs (below top of cut slope)

SOIL CLASSIFICATION: SM
