FINAL ENVIRONMENTAL ASSESSMENT

***IMPROVEMENTS TO KOKOLAU TUNNEL
AND PIPELINE***

T.M.K. 3-04-06: portion of 12
Lihue, Kauai, Hawaii

DEPARTMENT OF WATER
County of Kauai

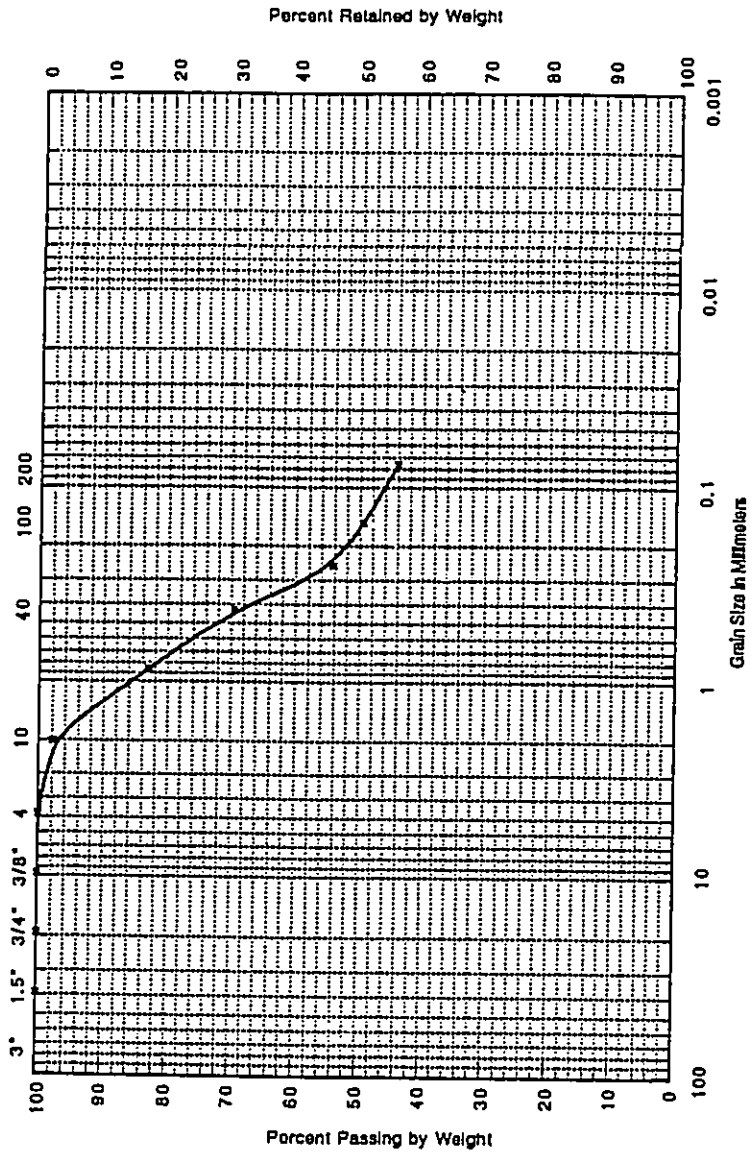
Figure A10
 MASA FUJIOKA & ASSOCIATES

Project: Kokoleu Water Tunnels at Haku
 Job No: 98088-012
 Sample: Brown silty sand
 Location: P2
 Depth: 10 ft. blocs (below top of cut slope)

SOIL CLASSIFICATION S M

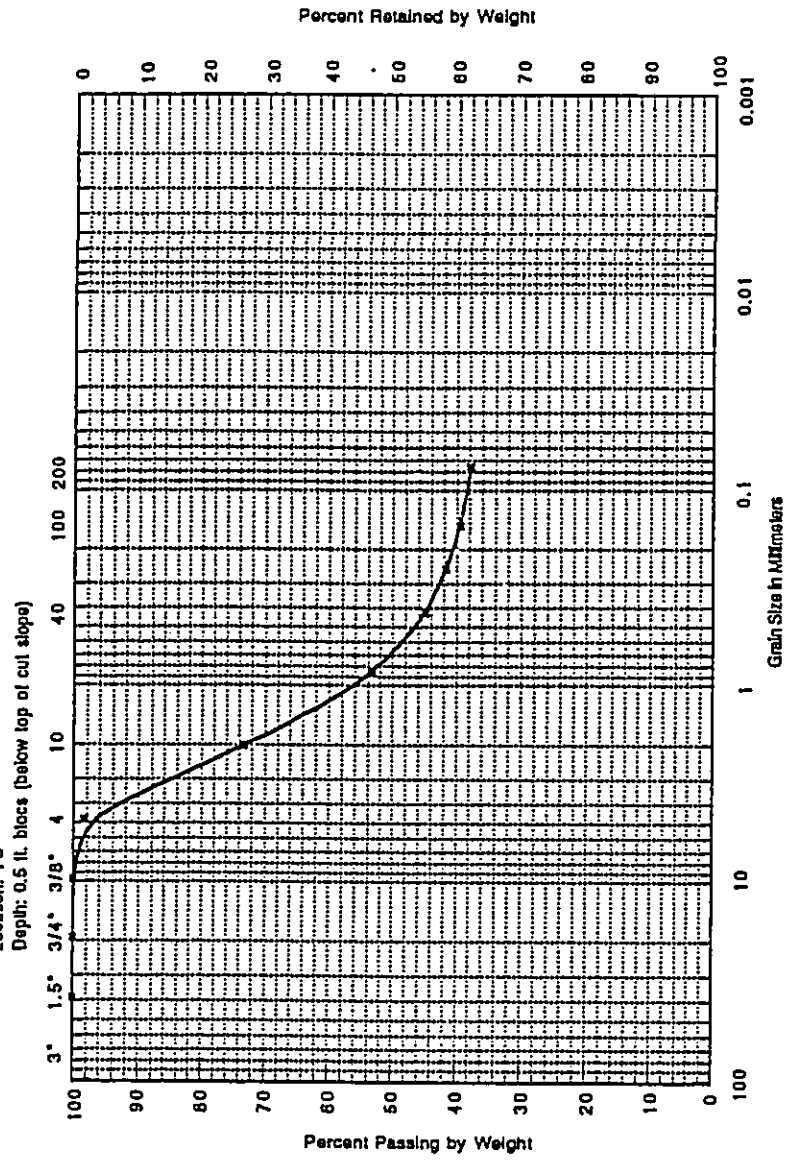
Figure A11
 MASA FUJIOKA & ASSOCIATES

Project: Kokolau Water Tunnels at Haku
 Job No: 98088-012
 Sample: Brown silty sand
 Location: P3
 Depth: 0.5 ft. below top of cut slope)

SOIL CLASSIFICATION: S.M

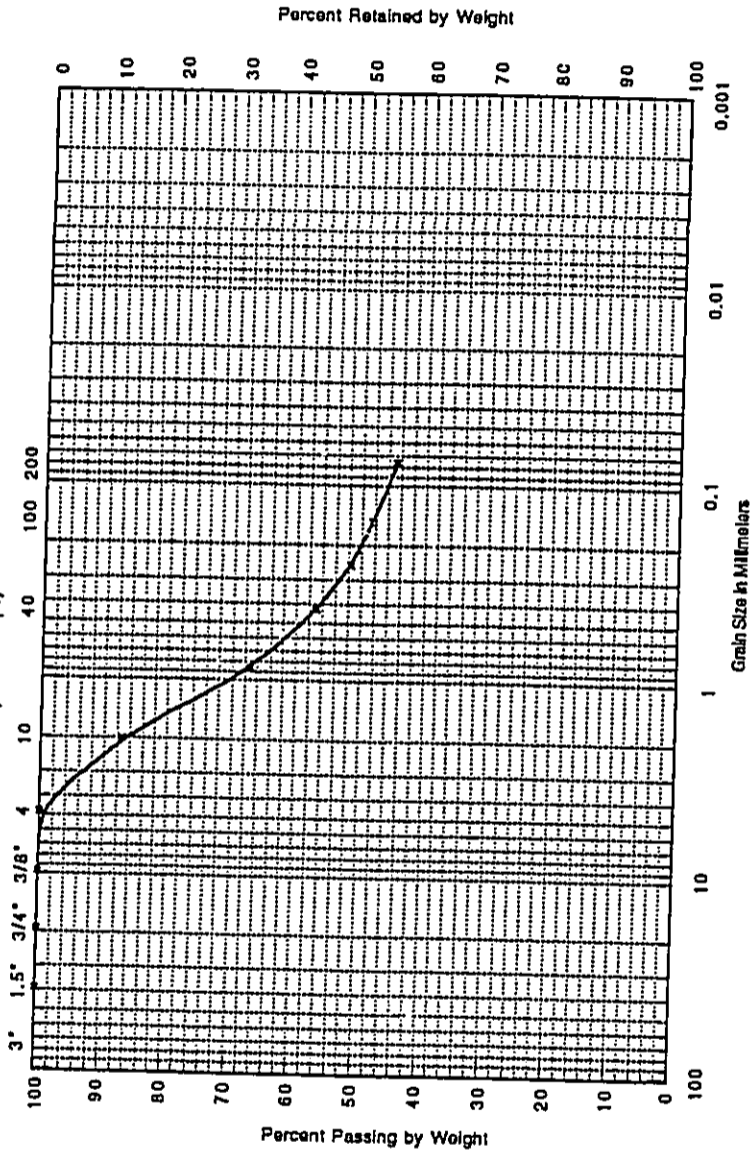
Figure A12
 MASA FUJIOKA & ASSOCIATES

Project: Kokolau Water Tunnels at Heleku
 Job No: 98088-012
 Sample: Brown silty sand
 Location: P3
 Depth: 2.5 ft. blocs (below top of cut slope)

SOIL CLASSIFICATION: SM

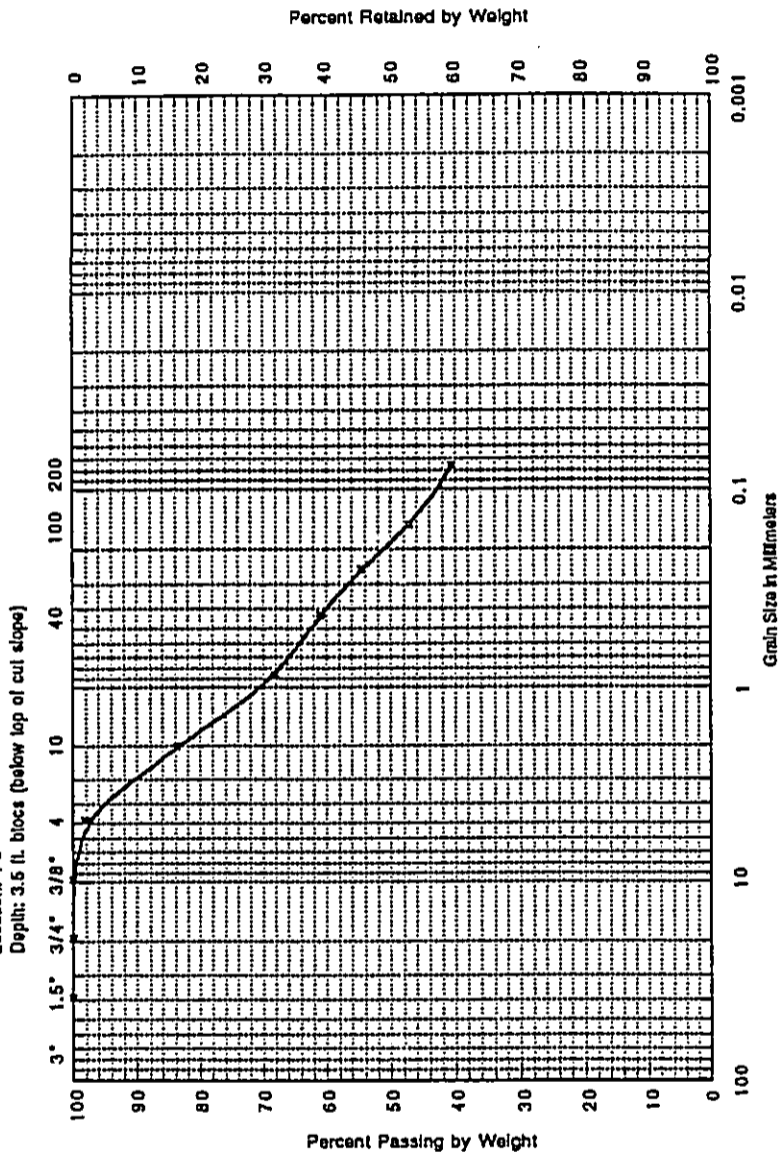
Figure A13
 MASA FUJIOKA & ASSOCIATES

Project: Kokoleu Water Tunnels at Hailu
 Job No: 98066-012
 Sample: Brown silty sand
 Location: P3
 Depth: 3.5 ft. below top of cut slope)

SOIL CLASSIFICATION: SM

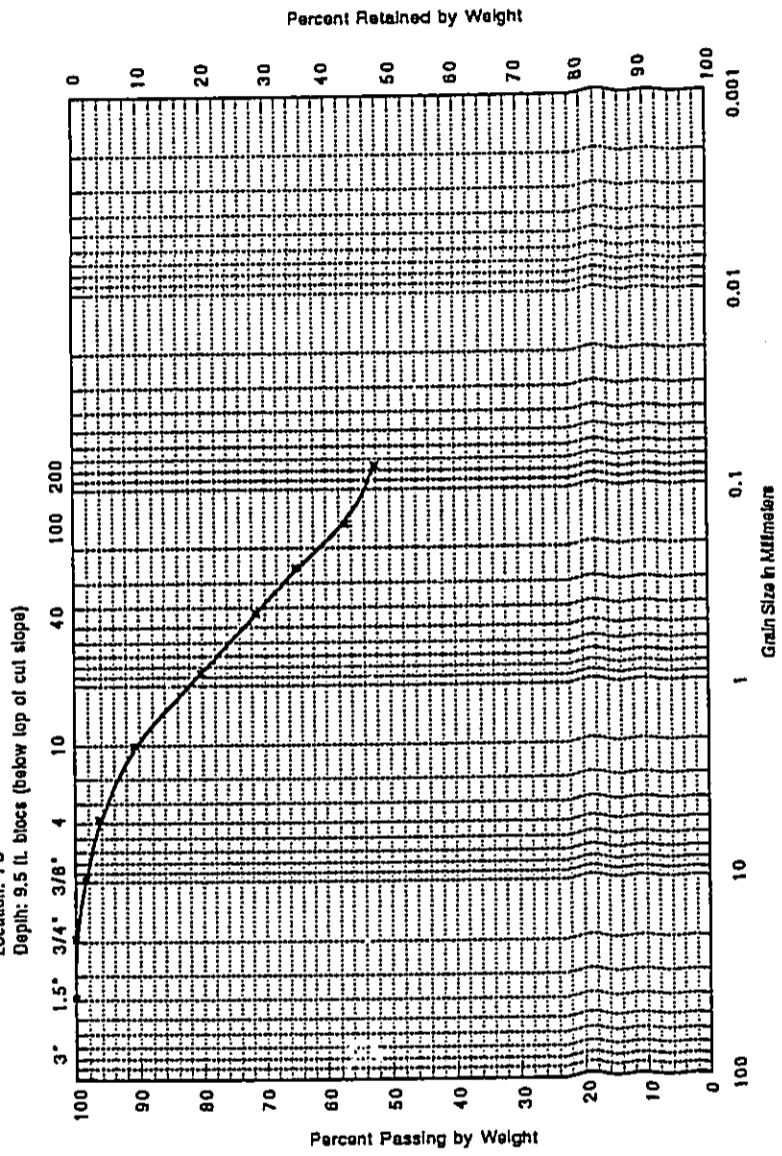
Figure A14
 MASA FUJIOKA & ASSOCIATES

Project: Kokoleu Water Tunnels at Halku
 Job No: 98088-012
 Sample: Brown sandy silt
 Location: P3
 Depth: 9.5 ft. blocs (below top of cut slope)

SOIL CLASSIFICATION: M.L

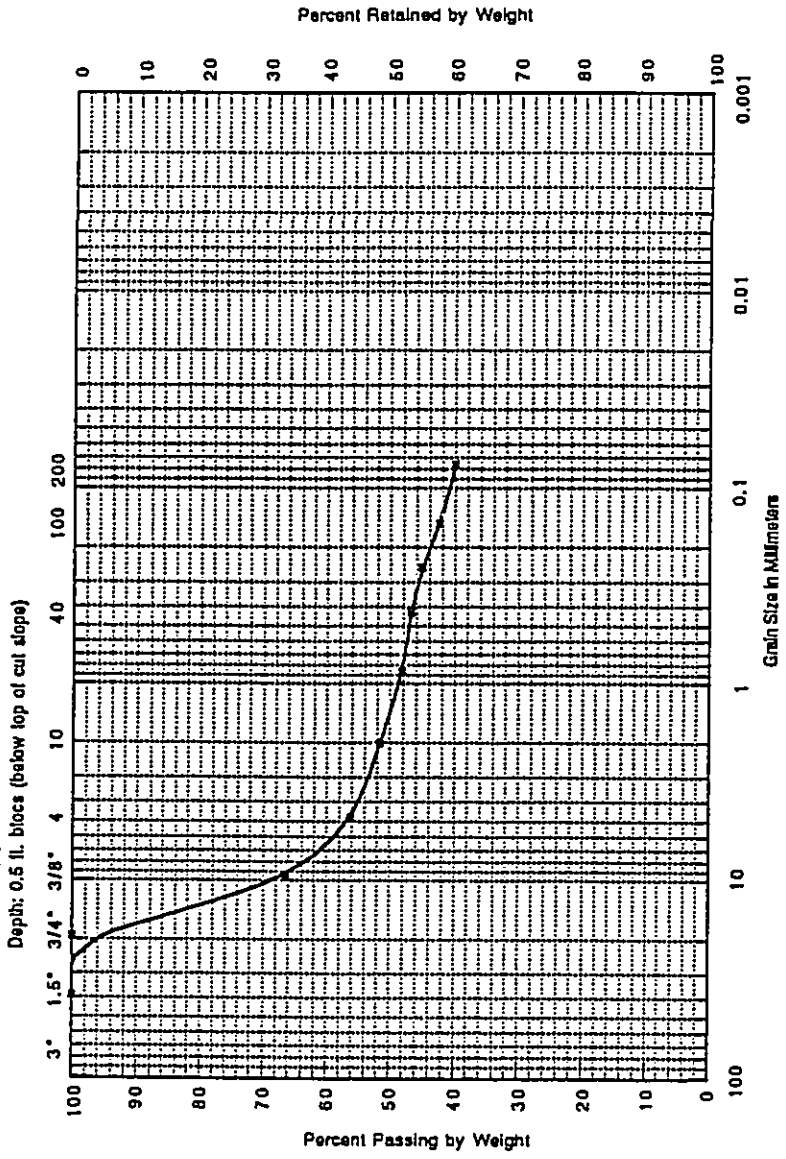
Figure A15
 MASA FUJIOKA & ASSOCIATES

Project: Kokolau Water Tunnels at Haku
 Job No: 98066-012
 Sample: Brown silty gravel w/ sand
 Location: P4
 Depth: 0.5 ft. blocs (below top of cut slope)

SOIL CLASSIFICATION: **GM**

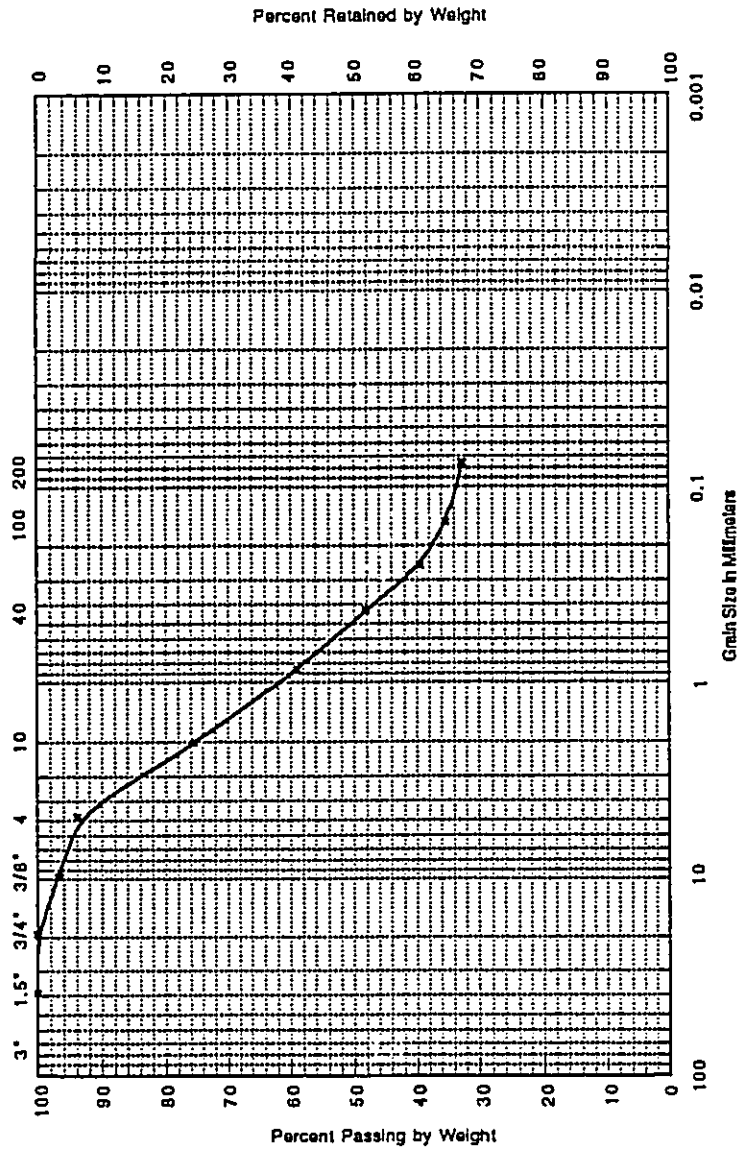
Figure A16
 MASA FUJIOKA & ASSOCIATES

Project: Kokoleu Water Tunnels at Haiku
 Job No: 88088-012
 Sample: Brown silty sand
 Location: PS
 Depth: 2.0 ft. blocs (below top of cul slope)

SOIL CLASSIFICATION: SM

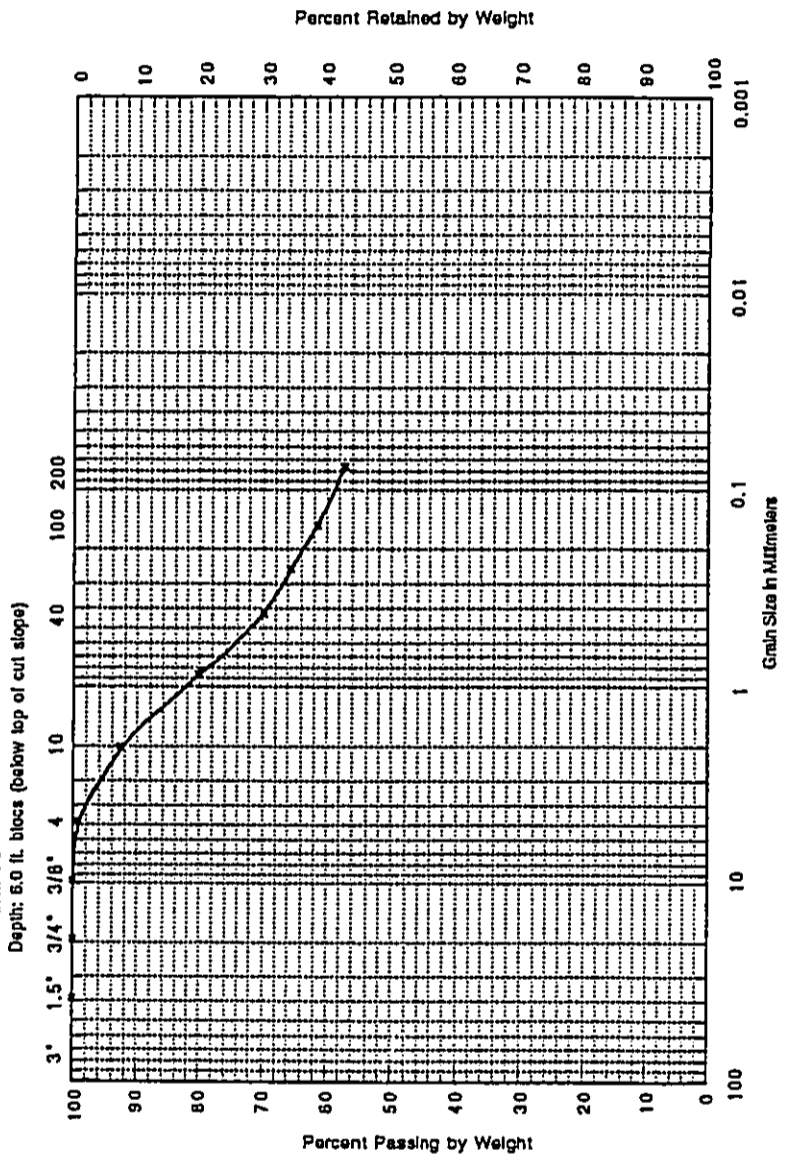
Figure A17
 MASA FUJIOKA & ASSOCIATES

Project: Kohoku Water Tunnels at Haiku
 Job No: 98086-012
 Sample: Brown sandy silt
 Location: P5
 Depth: 6.0 ft. below (below top of cut slope)

SOIL CLASSIFICATION: M L

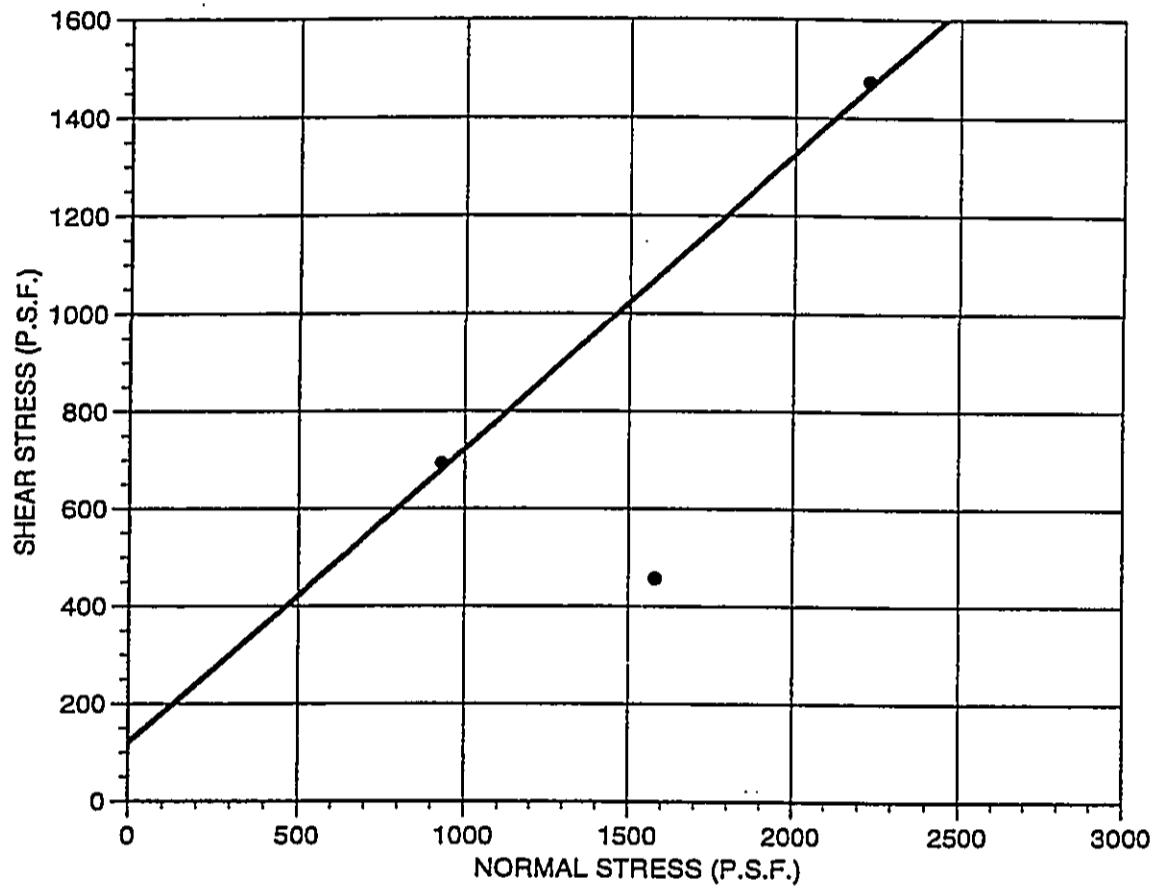
Station: -4+04

Cohesion = 121 P.S.F.

Angle of Internal Friction = 31.1°

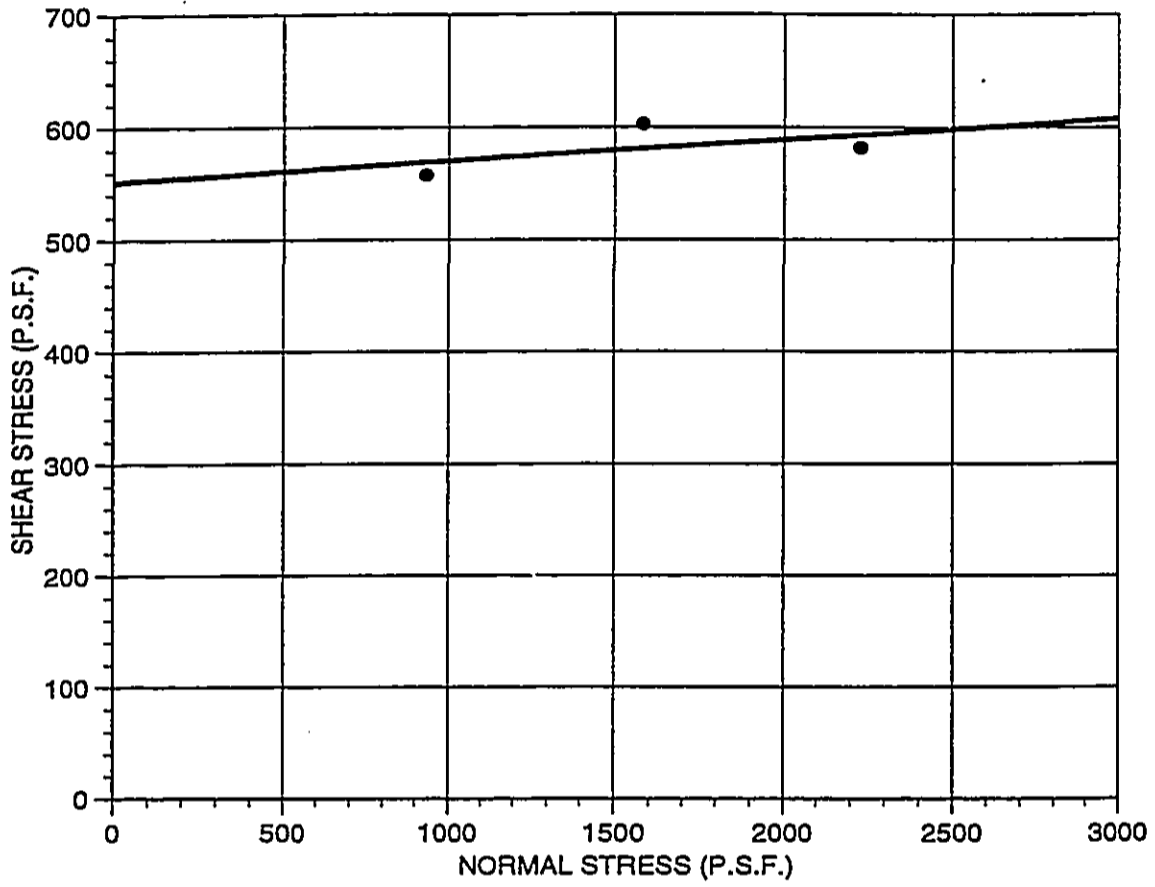
Station: -4+29

Cohesion = 552 P.S.F.

Angle of Internal Friction = 1.1°

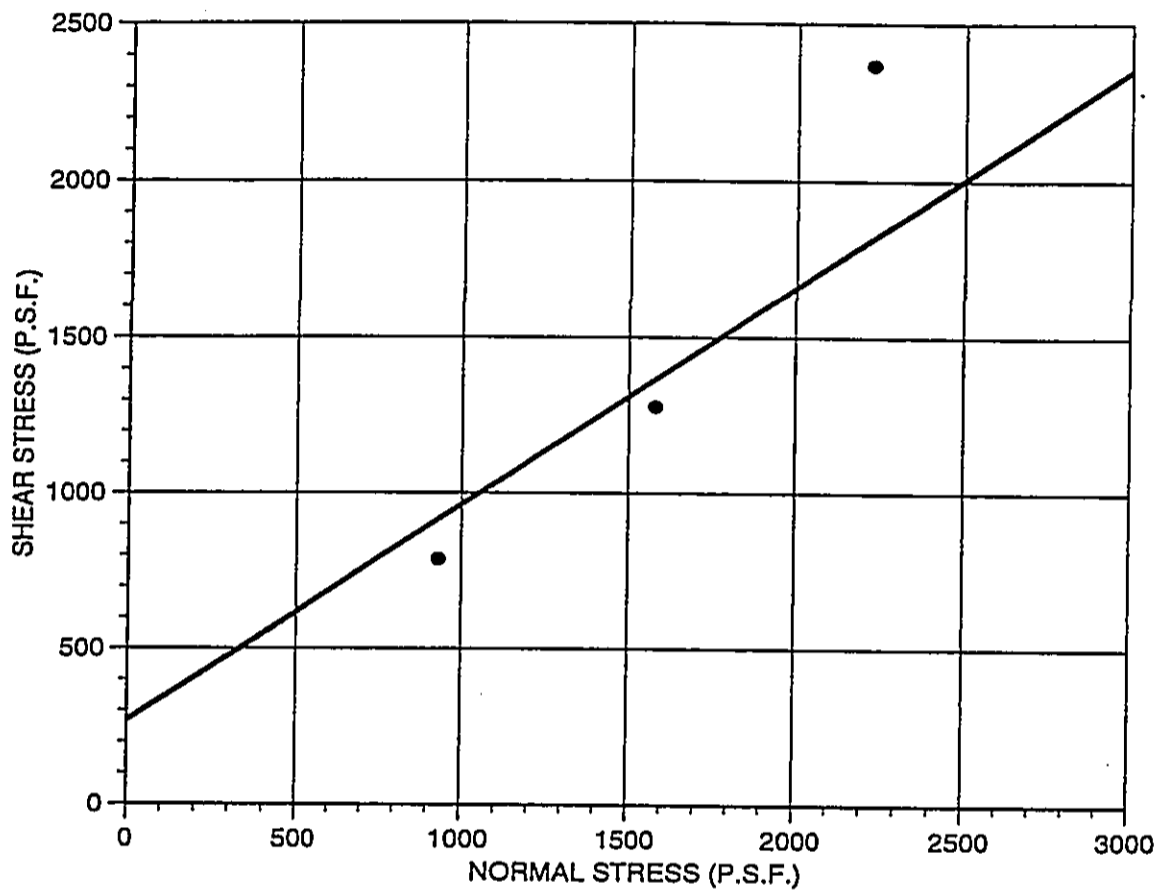
Location: -4+34

Cohesion = 269 P.S.F.

Angle of Internal Friction = 34.8°

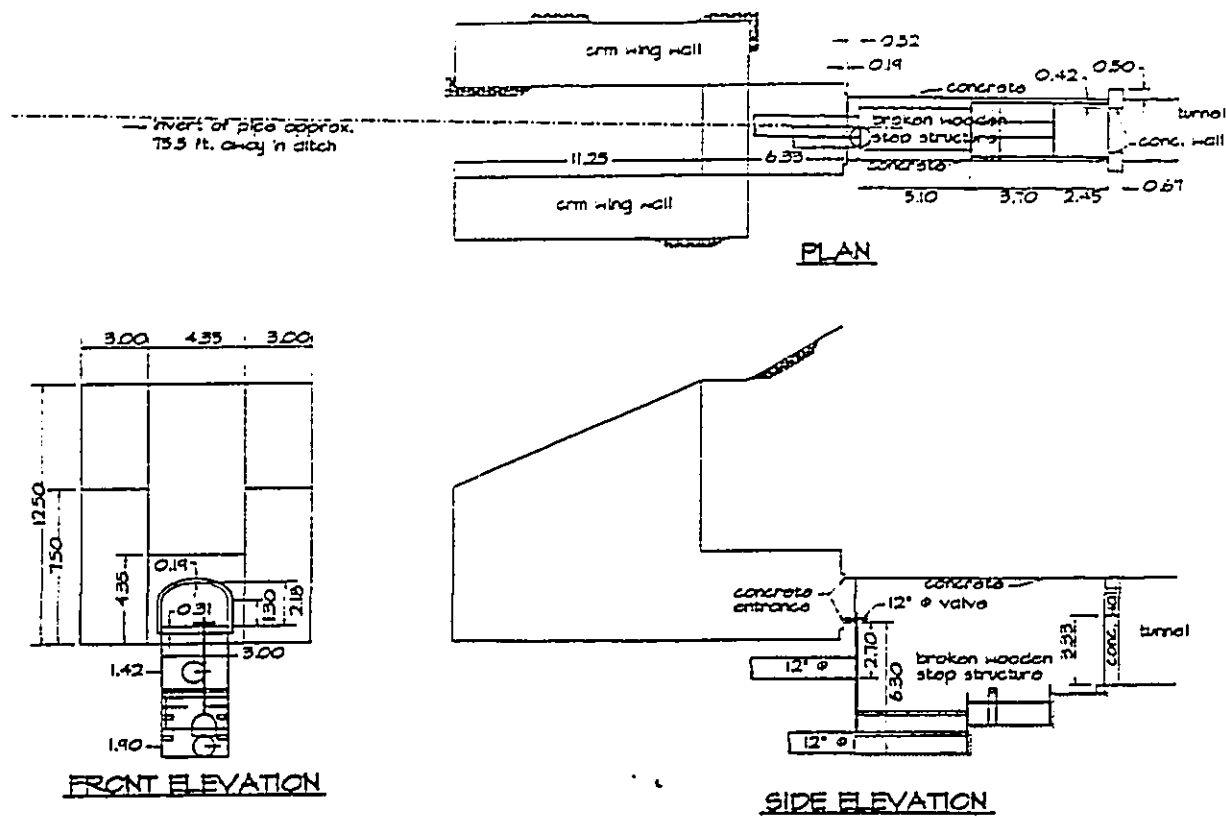
Figure 11 Engineering Plans of Portal # 5

We first visited Portal # 5, accessing it from a cane haul road to the southeast. Of the six portals (1, 1A, and 2 to 5), Portal #5 is by far the most visually impressive (Figures 11 and 12). The extra care given to facing this portal may have been because it is the closest to Lihu'e and public scrutiny. The entrance is 10.35' wide and 12.5' tall and features wing walls faced with cut basalt blocks on either side measuring 11.25' long, 3' wide and, in height, from 7.5' angling upwards to 12.5' high above the entrance. The entrance is a short tunnel section, 4.35' by 4.35' square, but soon constricts down to a crawl-through entrance formerly closed by an iron door. The door hinges have rusted through and the door is off to one side.

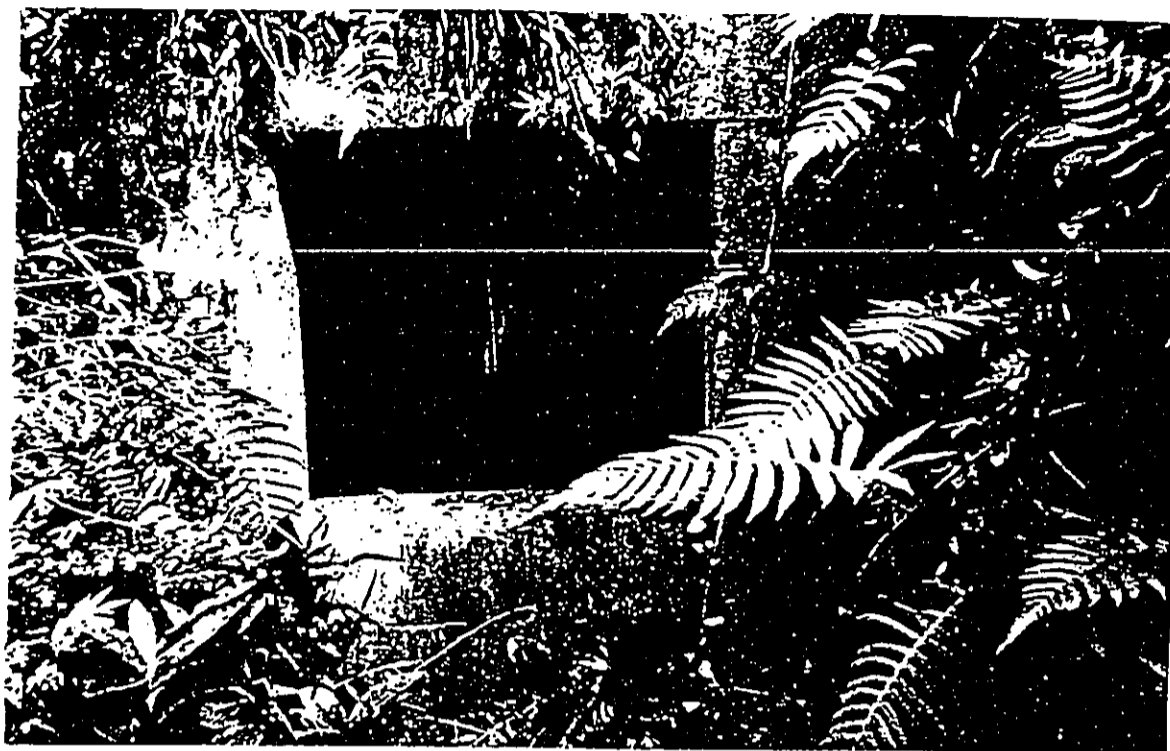
Figure 13 View of Entrance to Portal # 4, View to North West

The entrance to Portal #4 opens up into a small natural plunge pool. Its opening is a window-frame shaped structure built of 8" by 8" by 16" (standard) concrete masonry units (Figure 13). The opening of the concrete frame was 68 cm tall and 70 cm. wide. There is a U-shaped ditch leading out of the plunge pool area that seems unnaturally U-shaped. The near vertical walls had the appearance of stacked stone but are in fact of natural in situ mud-rock or decomposed basalt. The intended function of Portal # 4 is something of a mystery. The portal was sealed off in the 1980s because of concern that muddy water was entering the tunnel system through this opening and it remained sealed for approximately ten years. While it is presently open, plans are to reseal this entrance. Our assessment was that this portal was not significant owing to its mundane nature and lack of architectural merit.
