# DRAFT ENVIRONMENTAL ASSESSMENT

Improvement of Nonconforming Seawall &

Other Improvements within the Shoreline Setback Area

Kahala, Oahu

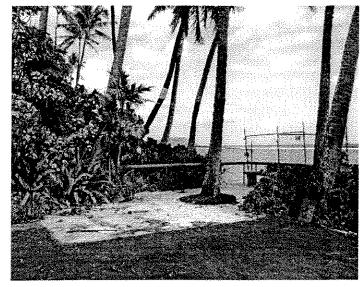
Observation Deck and Walkway: Parcel 8

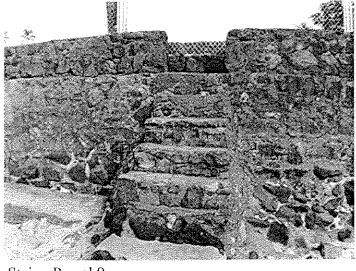
Stairs: Parcel 9

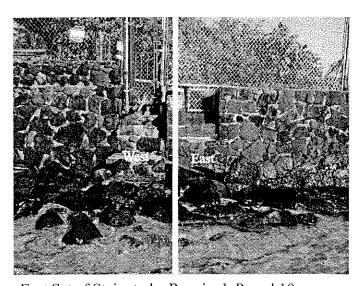
East Set of Stairs to be Repaired: Parcel 10

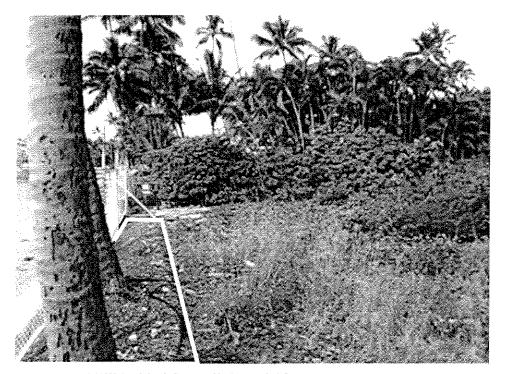
Gravel Fill Behind Seawall: Parcel 10

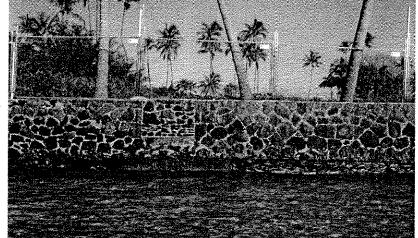
Seawall: Parcel 10-Center

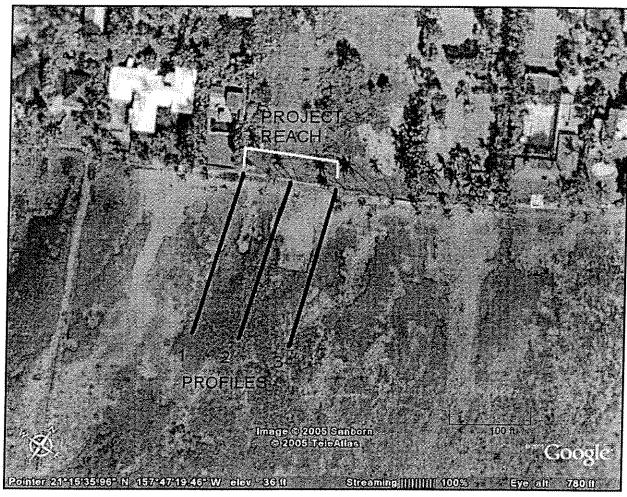
Figure 1-3. Aerial Photograph of Project Site (2) showing the project reach and profile locations (from Google Earth)

This coastal engineering assessment has been prepared as part of a project to repair a seawall fronting a shoreline lot in Kahala on the south shore of Oahu. The project site is located east of Diamond Head at 4415 Kahala Avenue, between Elepaio St. and Kala St. Three adjacent properties at 4415, 4423, and 4433 Kahala Avenue (TMK 3-5-059, parcels 10, 9, and 8, respectively) are proposed for development. Although similar protective seawalls front all three properties, repairs are necessary at only the western-most lot (parcel 10). The regional location of the project is shown in Figure 1-1. Figures 1-2 and 1-3 are aerial photographs of the site.

Three beach profiles were taken at the project site, at either end and at the middle of the property shoreline, extending 200 feet offshore. The locations of the profiles are shown in Figure 1-3. The profiles are shown in Figure 2-3. All profiles are similar, showing a near vertical seawall with an elevation just over 6 feet msl, some form of hard rock adjacent to the wall, a short sandy section less than 50 feet in width, and a wide expanse of limestone reef without appreciable elevation change. The sand is typically a few inches or less in thickness. The limestone reef flat has a typical relief less than 0.5 feet. Some areas in the reef flat appear to have been excavated on the order of 1 foot. These areas can be seen in the aerial photographs (e.g. Figure 1-3) and are often delineated by straight excavation edges and corners. The reef flat elevation is typically about -1.5 feet msl 50 feet offshore, and grades to about -2.5 feet at 200 feet offshore.

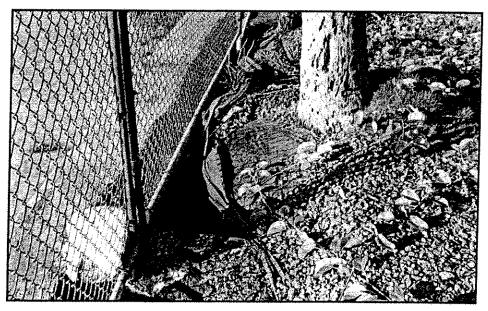
Figure 1-5. Sinkhole formation behind the seawall

The project site is approximately one mile east of Diamond Head Beach Park, and approximately 1,000 feet east of the Black Point Peninsula. The lots are located on Kahala Beach, a 2-mile reach bordered by Black Point on the west and Wailupe Peninusla on the east. While much of Kahala Beach has a narrow sand beach, the western portion, including the project site, has only isolated sandy areas, and is mostly characterized by bare reef and rocks fronting the properties. All of the properties in the region are fronted by seawalls. Figure 1-4 is a photograph of the project reach at 4415 Kahala Avenue. The seawall fronting the property is 12 to 36 inches lower than adjacent walls. Figure 1-5 shows the general deterioration that has occurred behind the wall due to erosion of back fill material. The back fill probably leaked out through voids at the base of the wall.
