2005/ED-23(AA)

Subject: Chapter 343, Hawaii Revised Statutes  
Environmental Assessment (EA)/Determination  
Finding of No Significant Impact

Landowner/Applicant: Regina Constantinau Trust and Renau P. Constantinau Trust  
Agent: Analytical Planning Consultants, Inc.  
Location: 68-691 Farrington Highway - Mokuleia  
Tax Map Key: 6-8-10: 22  
Request: Shoreline Setback Variance  
Proposal: To retain a reinforced concrete seawall and other structures within the shoreline setback.  
Determination: A Finding of No Significant Impact is Issued

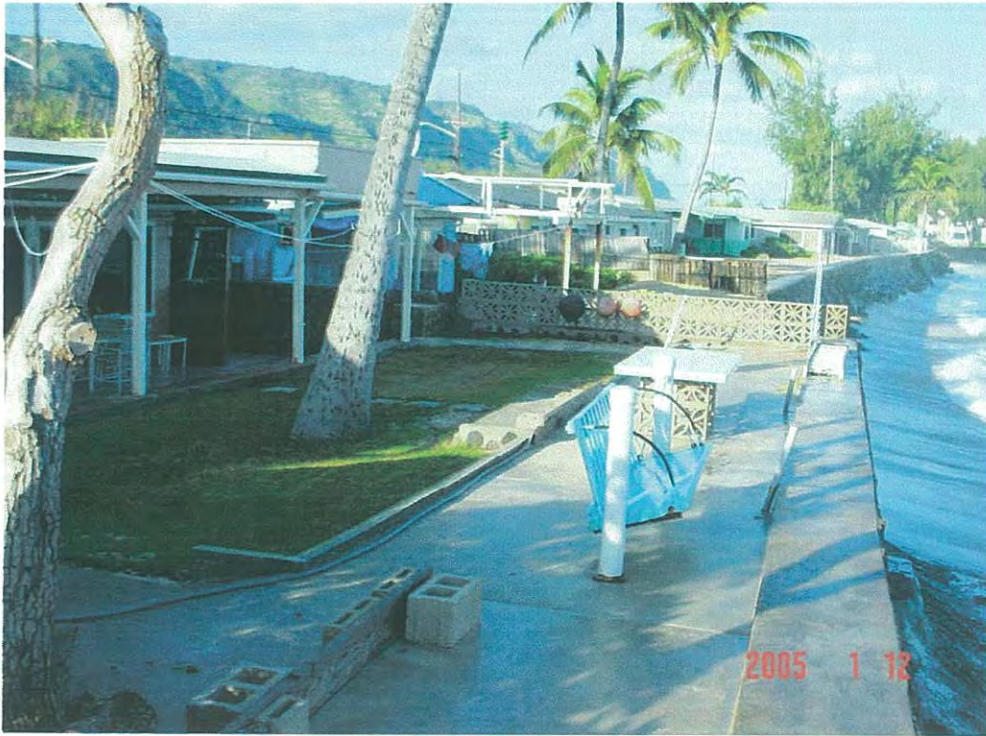
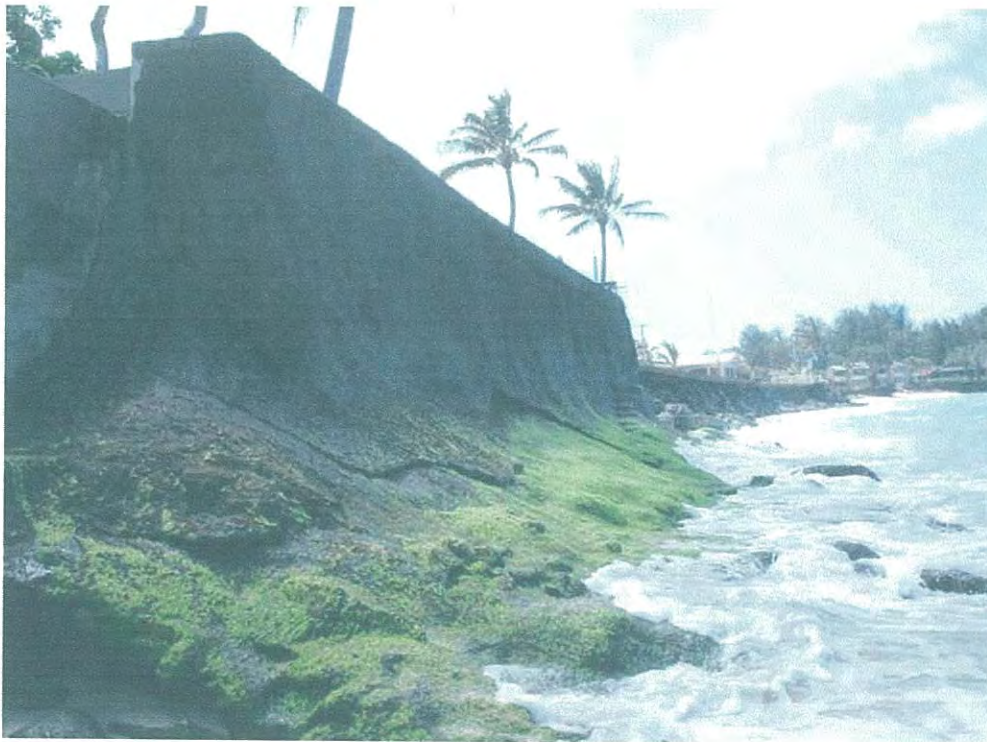
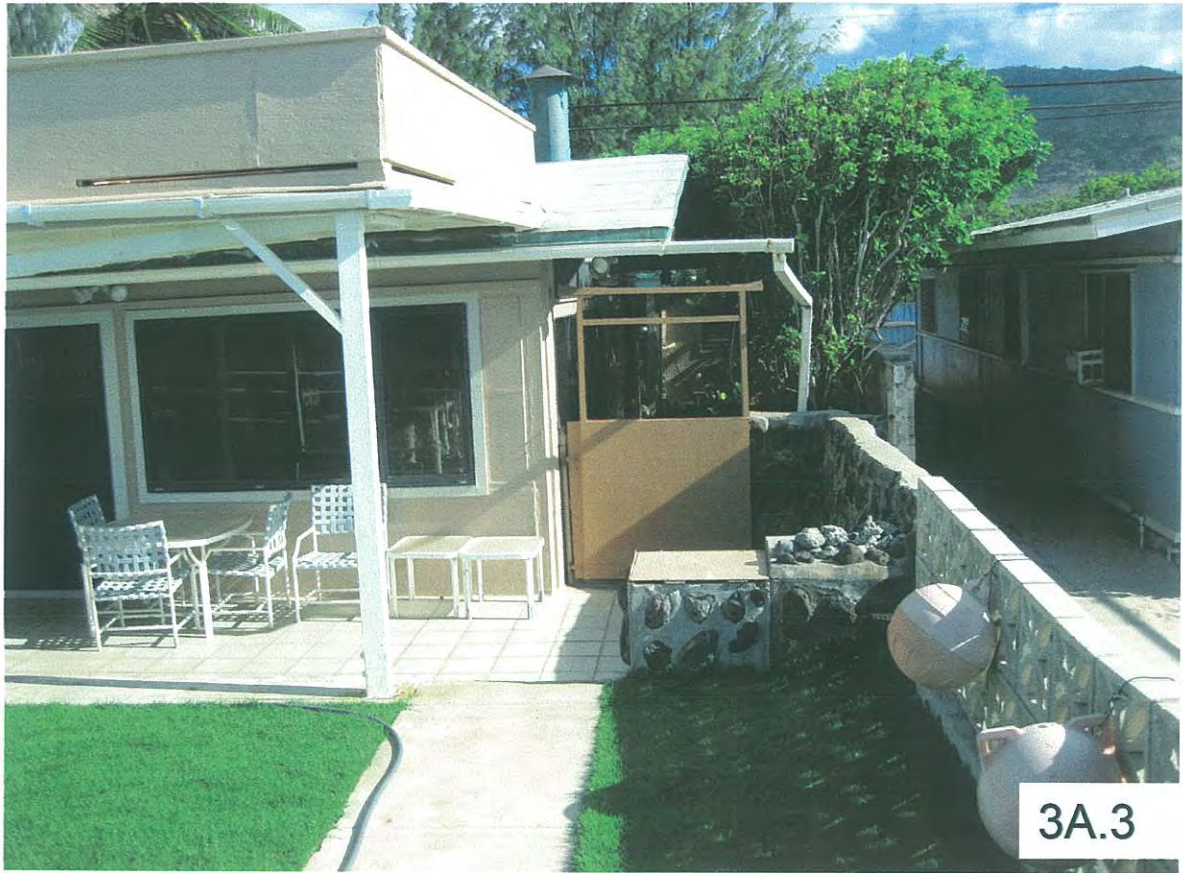
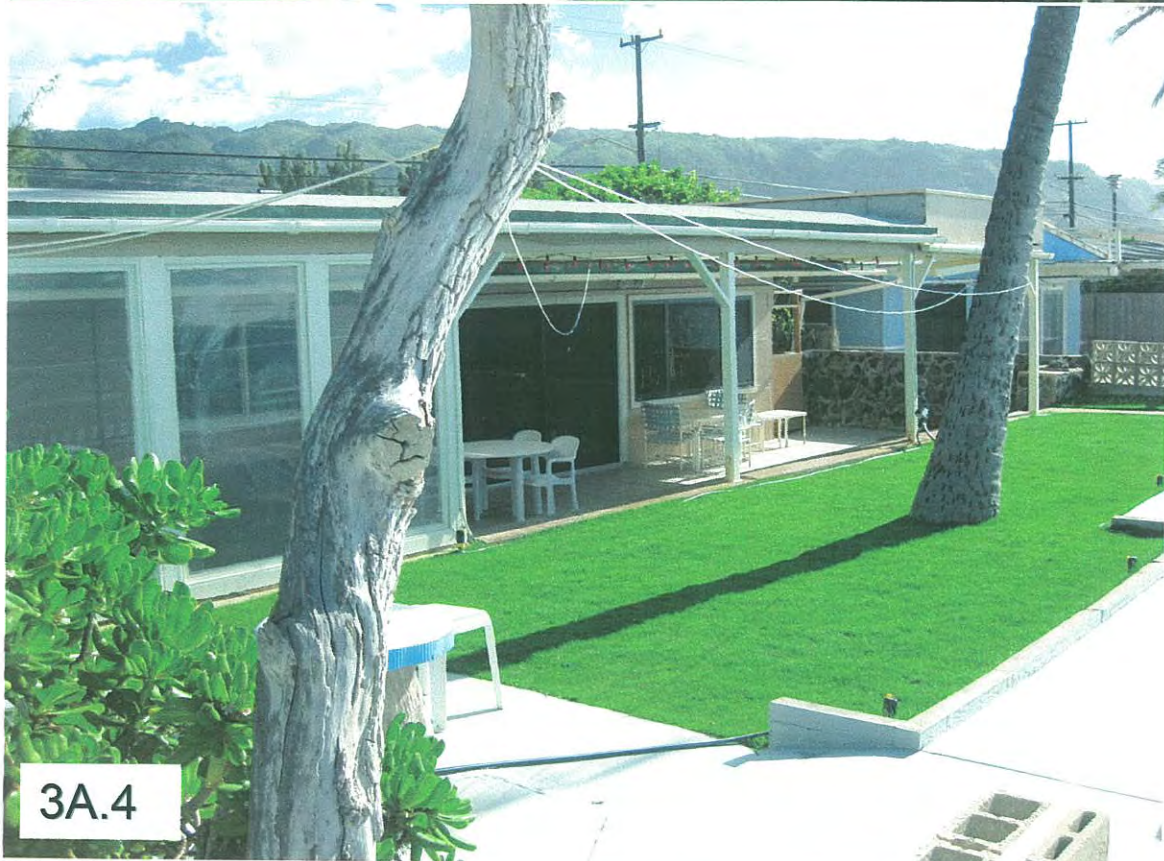
**Figure 3A**

Mokuleia  
TMK: 6-8-10:22  
Photo date 04-02-05  
Time 2:00 pm  
By EKNA Services  
Tide approx. 0.1' MLLW

**SUBJECT SEAWALL TMK: 6-8-10: 022**  
68-691 Farrington Highway, Mokuleia, Oahu, Hawaii

The subject property was purchased in December 1967 by the applicants, Mr. and Mrs. Renau Constantinou, who have lived in the house for 38 years. The recorded lot area to which the owners hold title is 8,594 square feet. After subtracting the eroded seaward portion of 2,518 square feet, the net area of the lot is 6,076 square feet. The shoreline is defined by the existing seawall located between 40 feet to 43 feet inland of the seaward property boundary of record. Vegetation on the site consists of yard grass and various residential landscaping materials. The topography of the lot is flat as is evident in the site photos in **Figure 3A**.

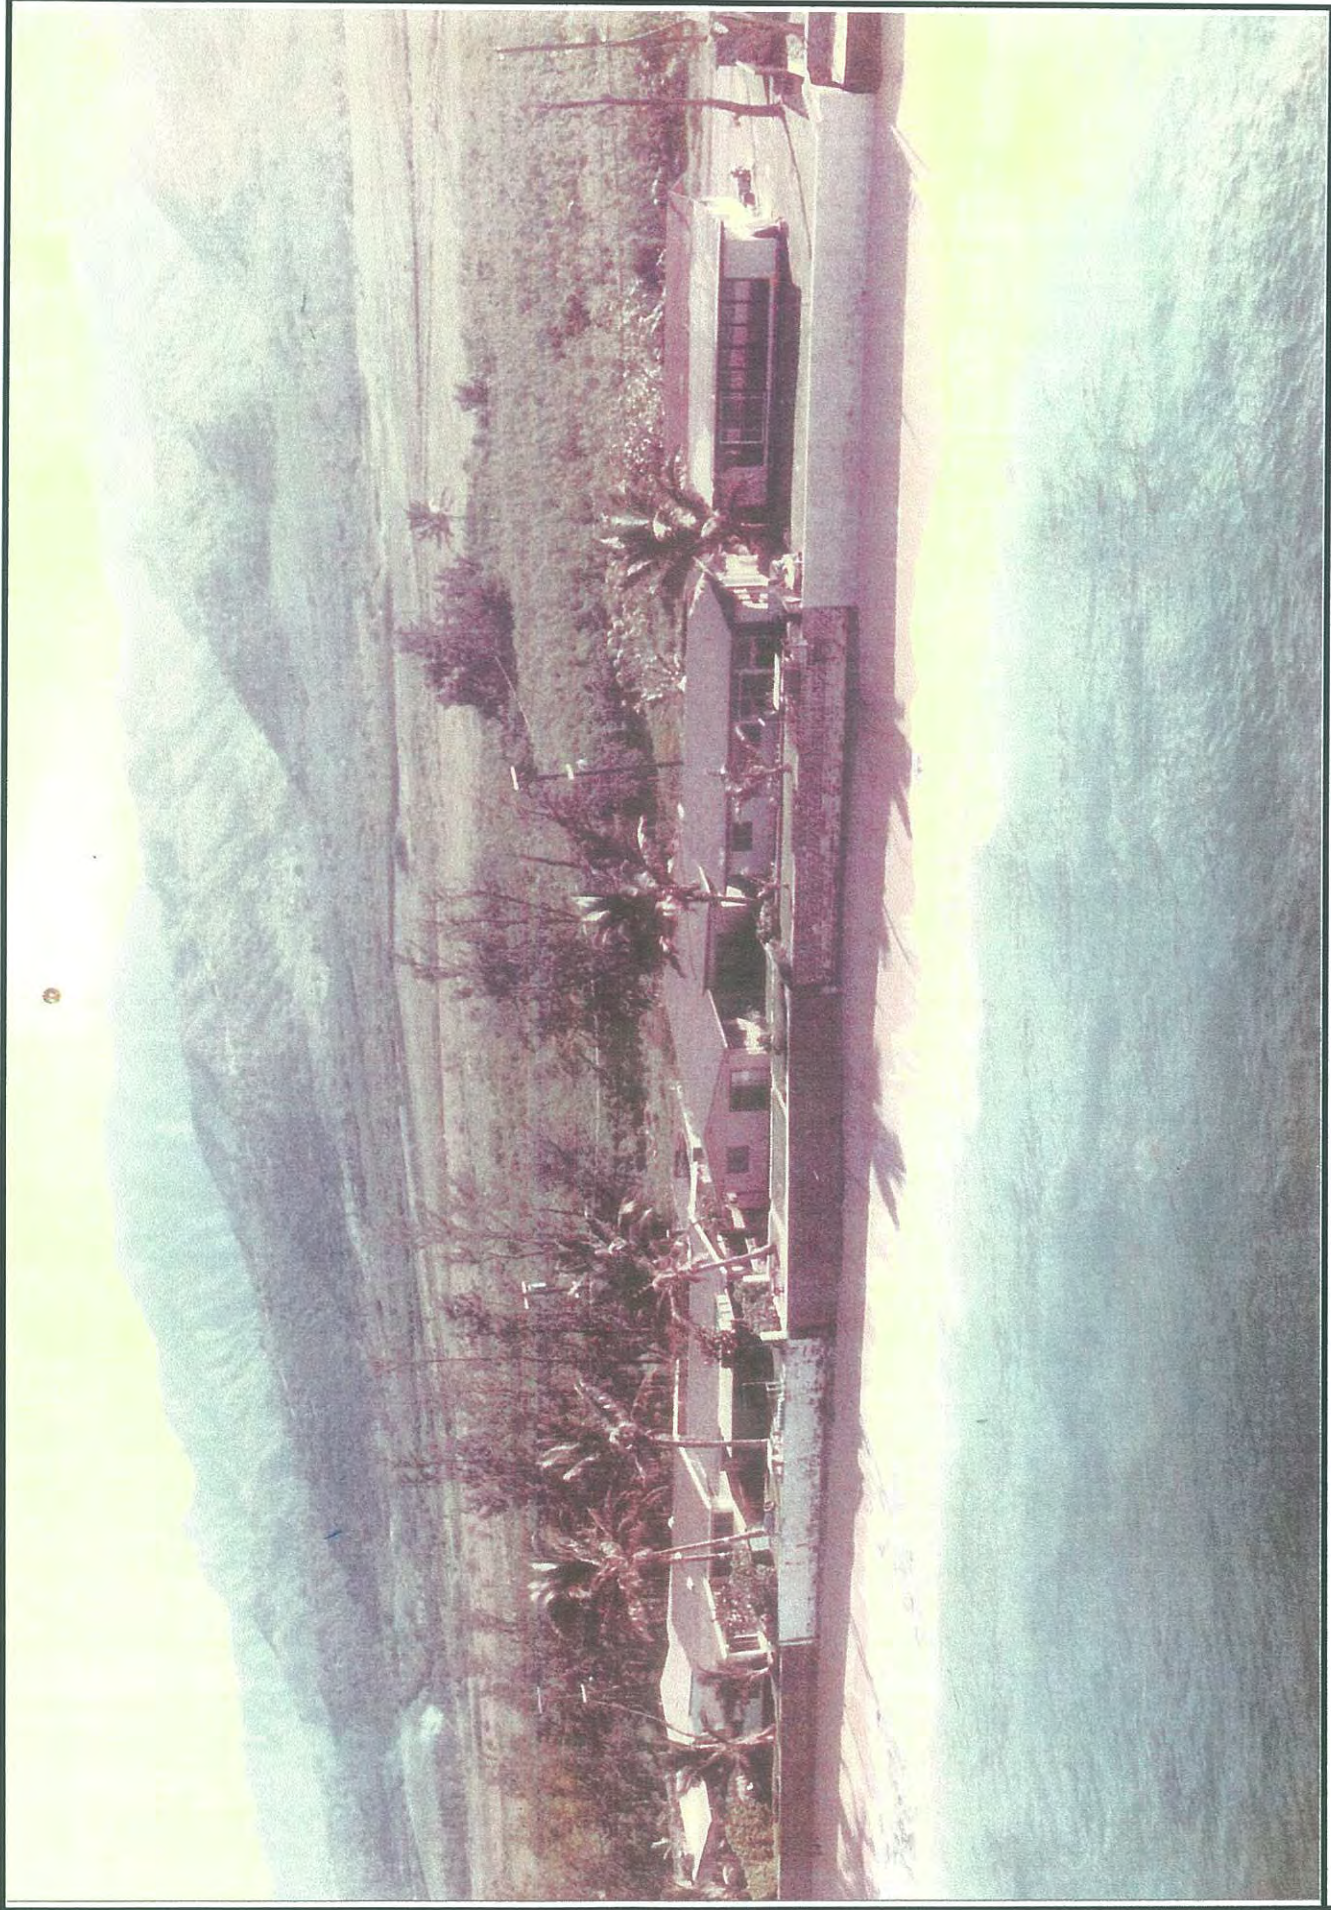
Figure 8

**CONSTANTINAU SEAWALL – 2<sup>ND</sup> ON LEFT PAINTED WHITE**

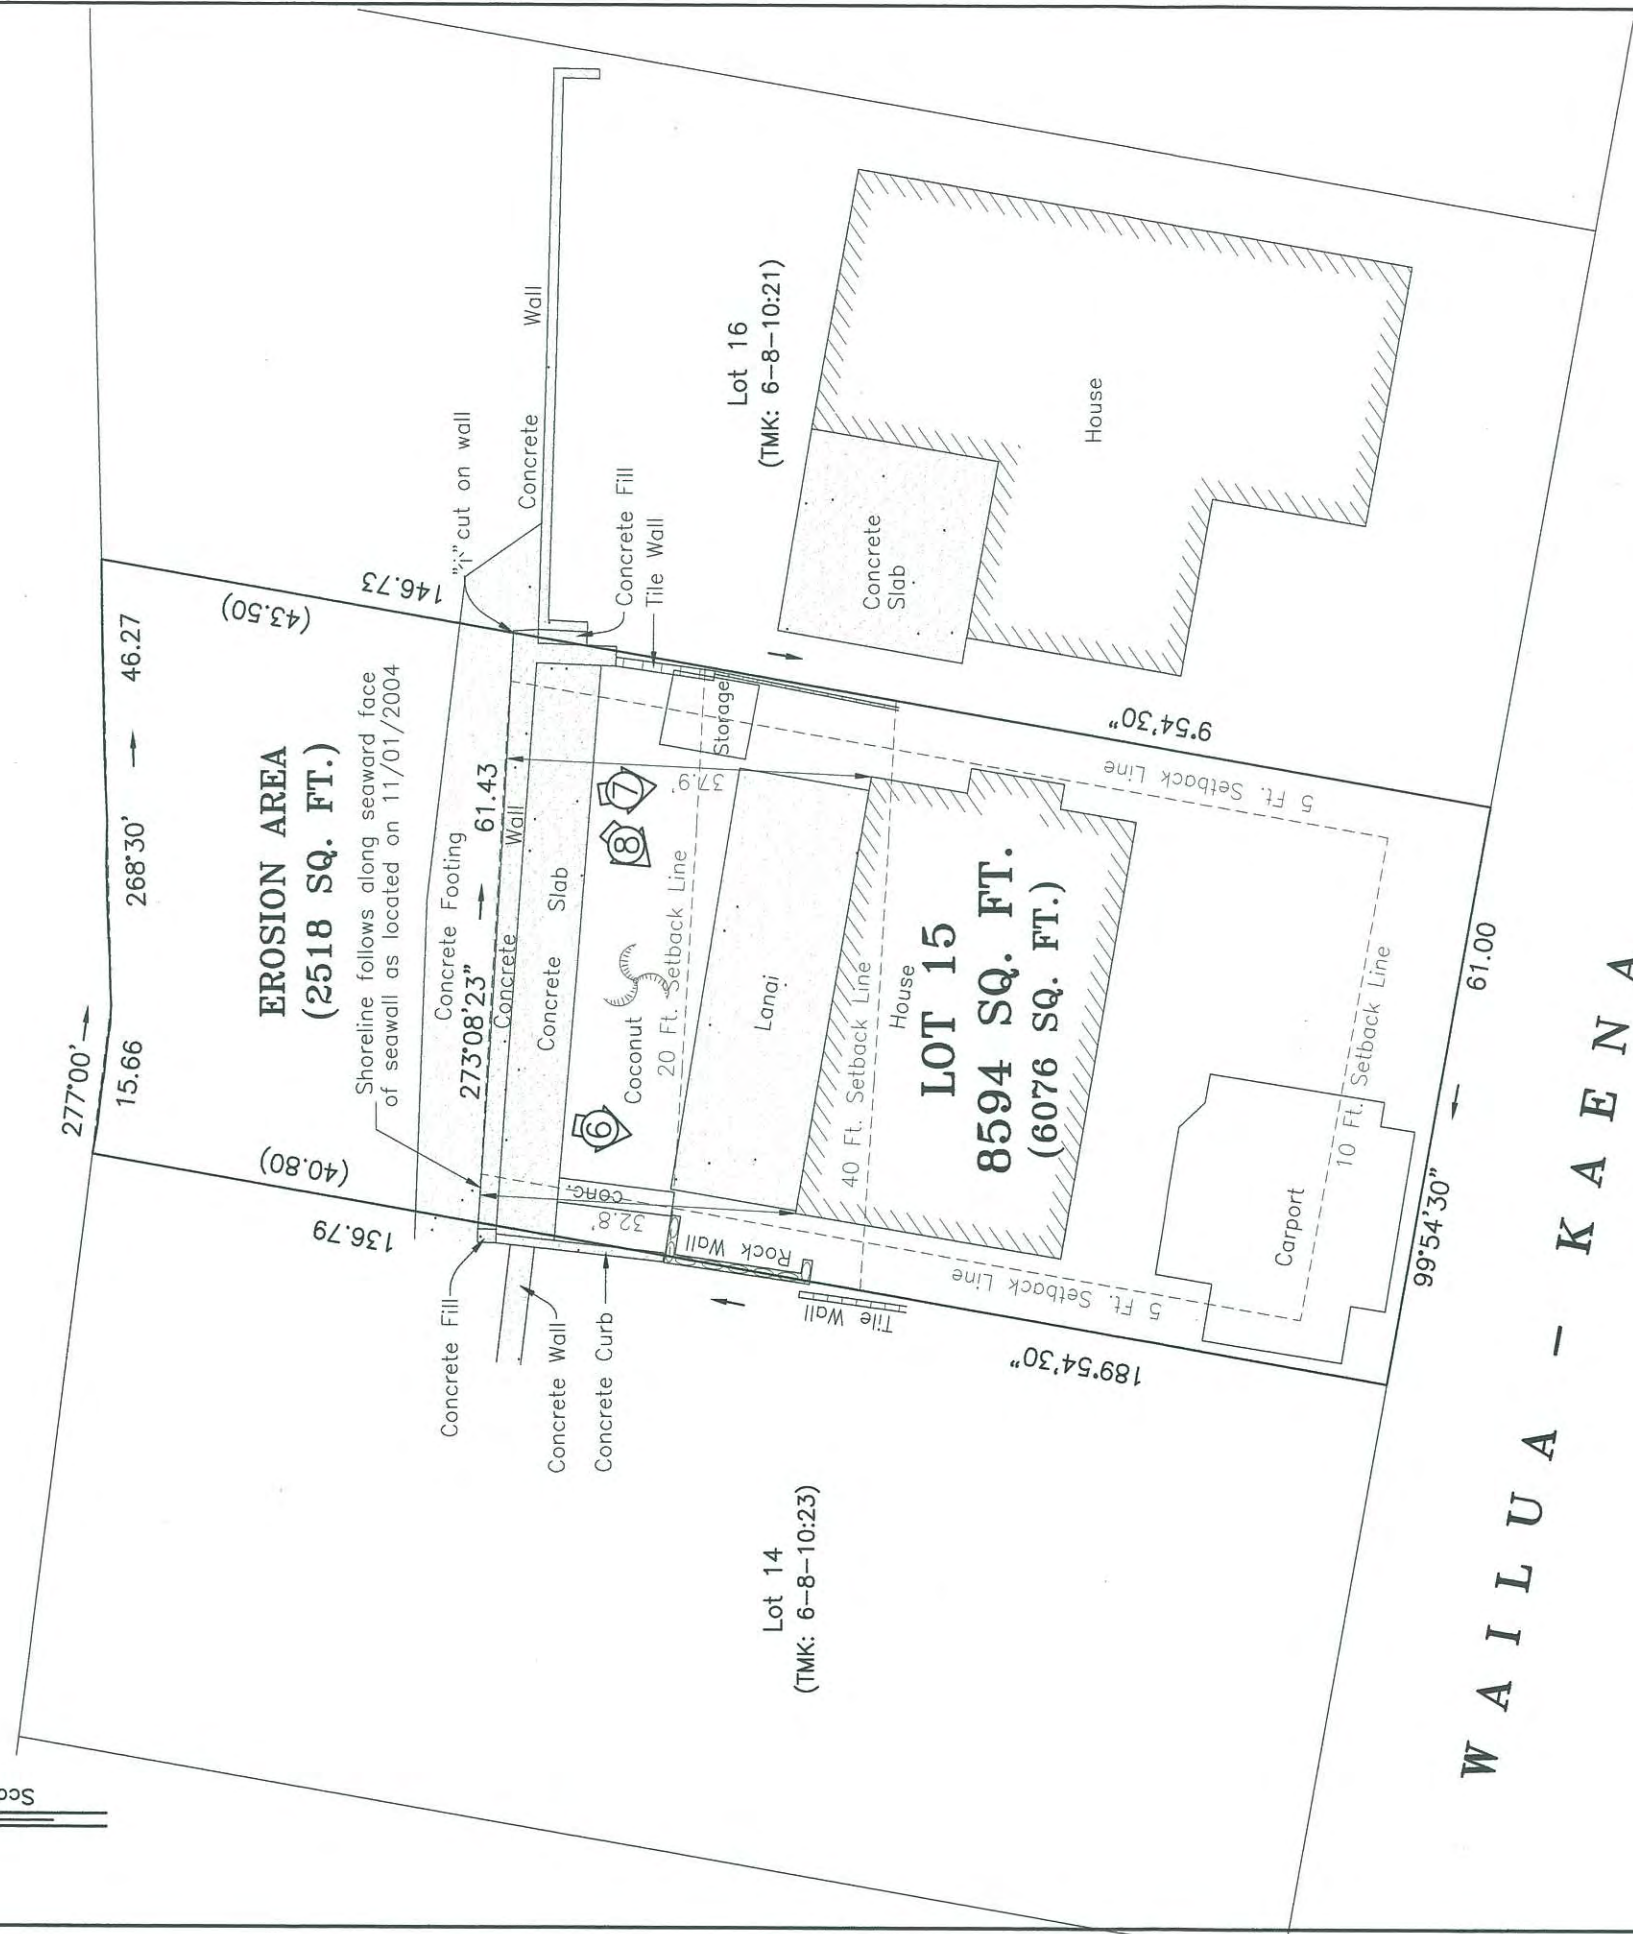
SHORELINE SURVEY MAP

Tax Map Key: 6-8-10:22  
Scale: 1 inch = 20 feet  
Date: November 1, 2004  
Revised: June 9, 2008

The existing subject seawall has been repaired since it was originally constructed and a comparison of the certified shoreline done in 1973 for parcel 21 and the one done in 2004 shows that portions of the reconstructed wall has been extended makai of the previous seawall.

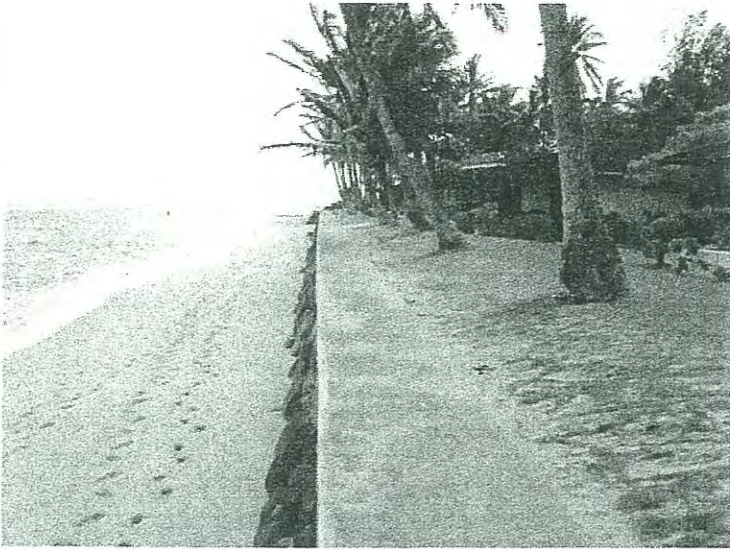
View eastward along the top of the seawall fronting the Mokuleia Beach Colony. Note the narrow beach.

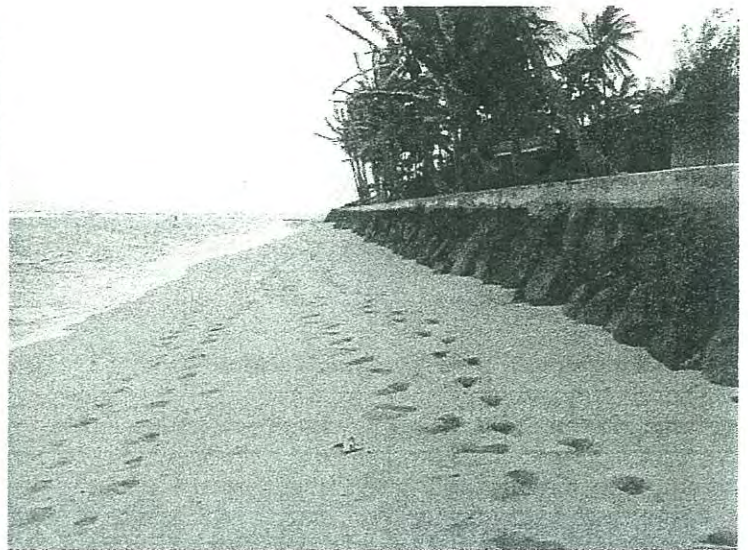
View eastward along the beach fronting the Mokuleia Beach Colony seawall. Note the narrow and steep beach profile.

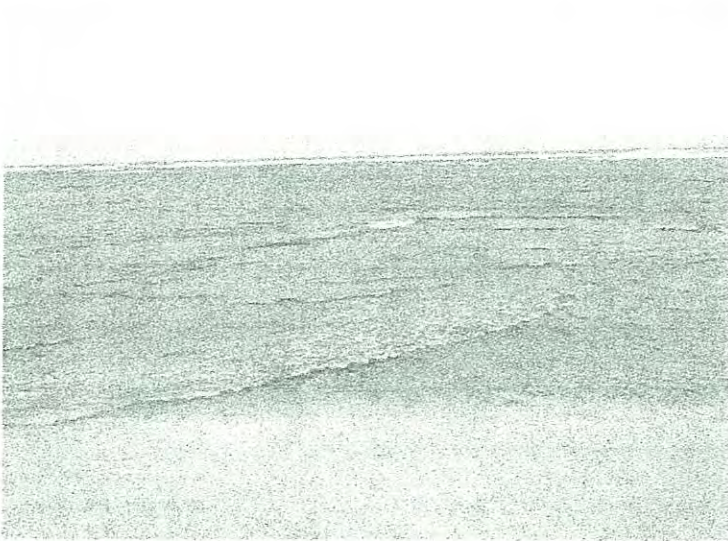
View offshore Parcel 10. Note the shallow reef and wave angle at the shoreline indicating eastward longshore transport.

Winter North Pacific swell were causing breaking waves across entire embayment.

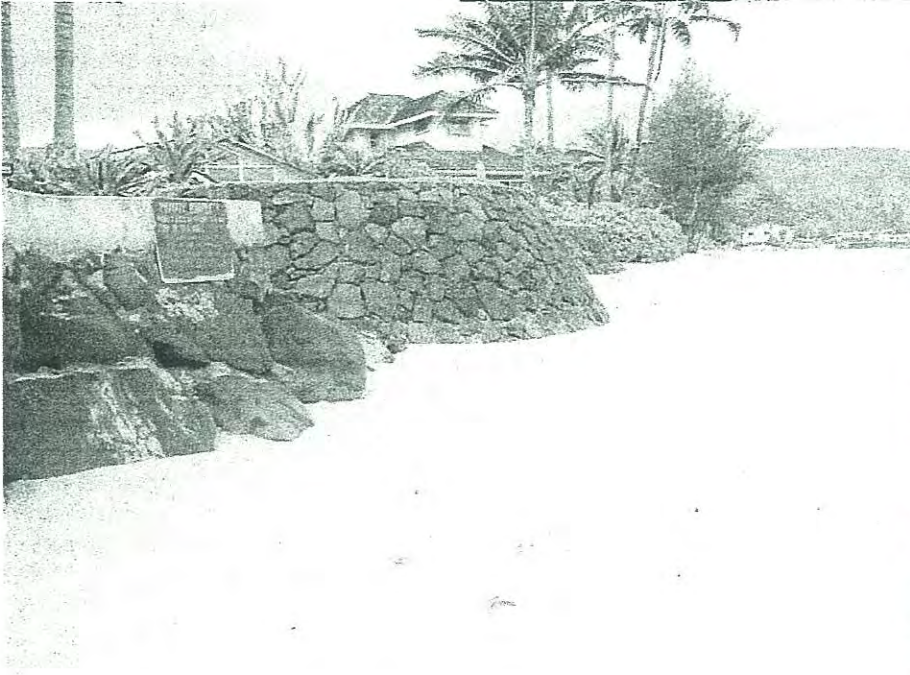
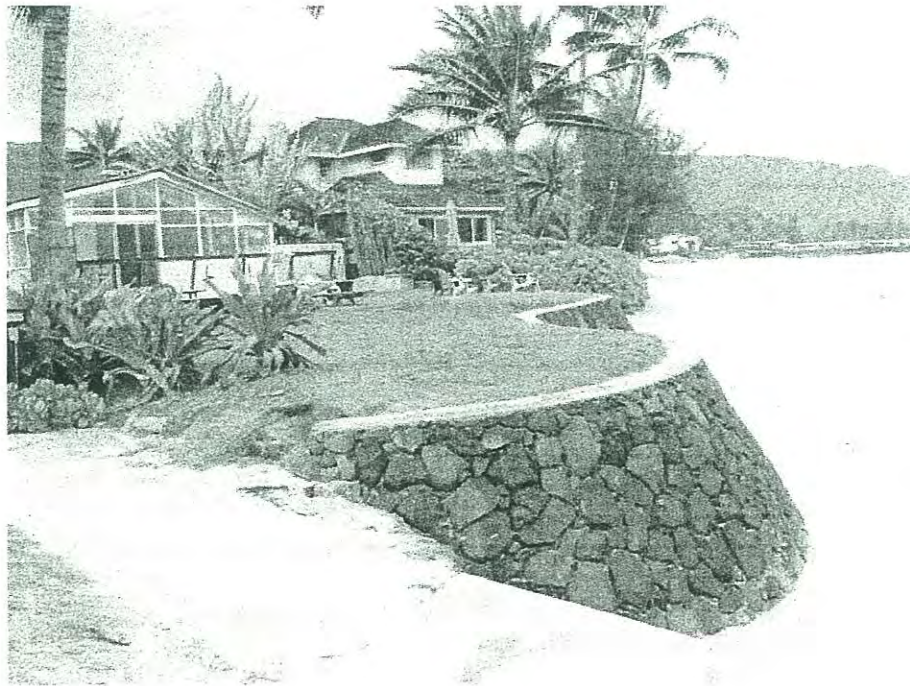
**PHOTO page-2**

Views westward from west end of Mokuleia Beach Colony seawall. Parcel 10 is in the foreground. Parcel 11 is next to Parcel 10. (Sign is on the west end of the Mokuleia Beach Colony seawall. The sign permits the public to walk on the top of the seawall.)

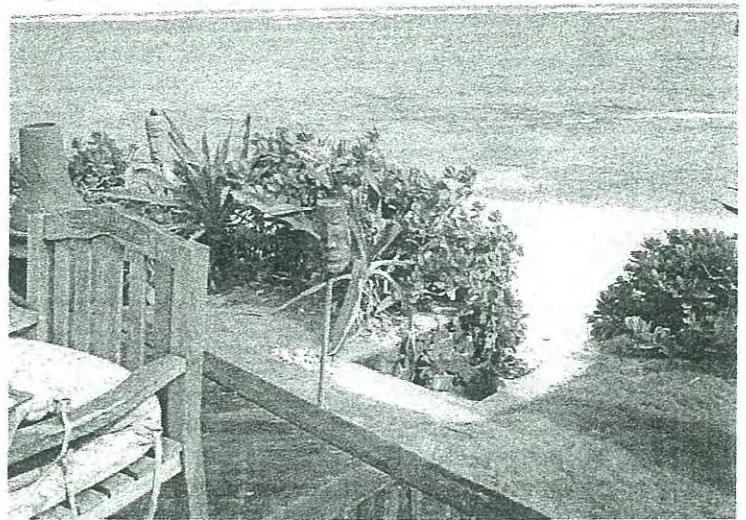
View offshore from porch on Parcel 11.  
Steps in seawall lead down to the beach.

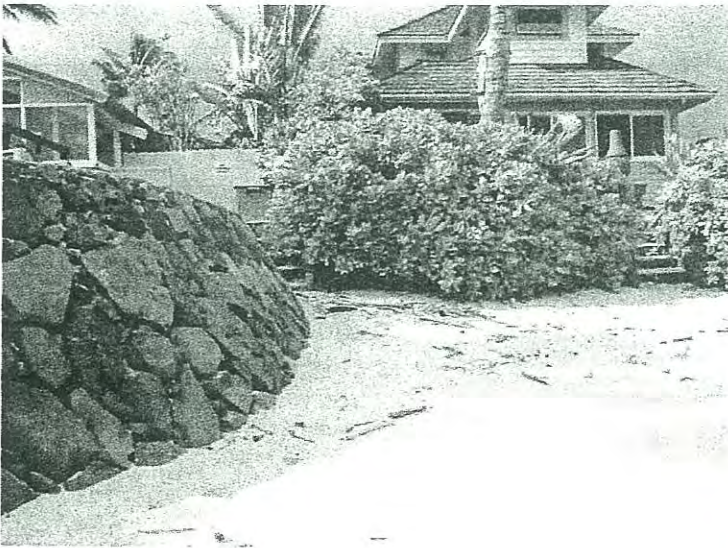
View of Parcel 11 seaward frontage. Seawall is hidden by naupaka vegetation. Curved seawall on left fronts Parcel 10.

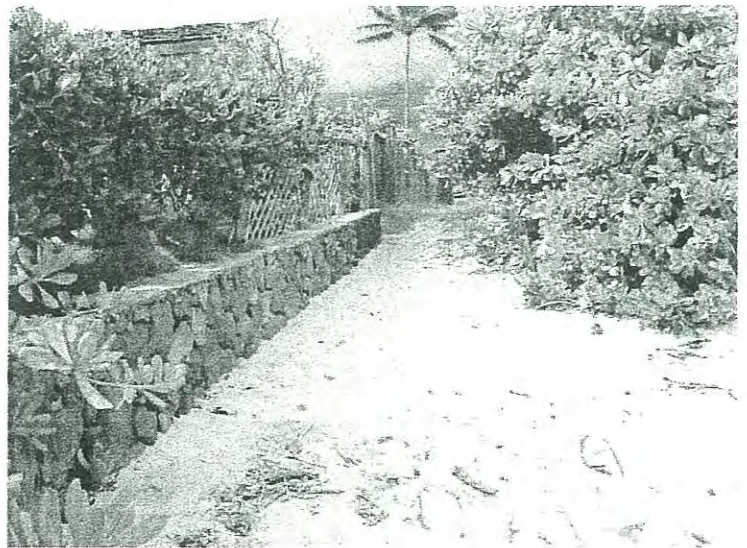
View mauka along private right-of-way. The CRM wall on left is Parcel 11's return wall.

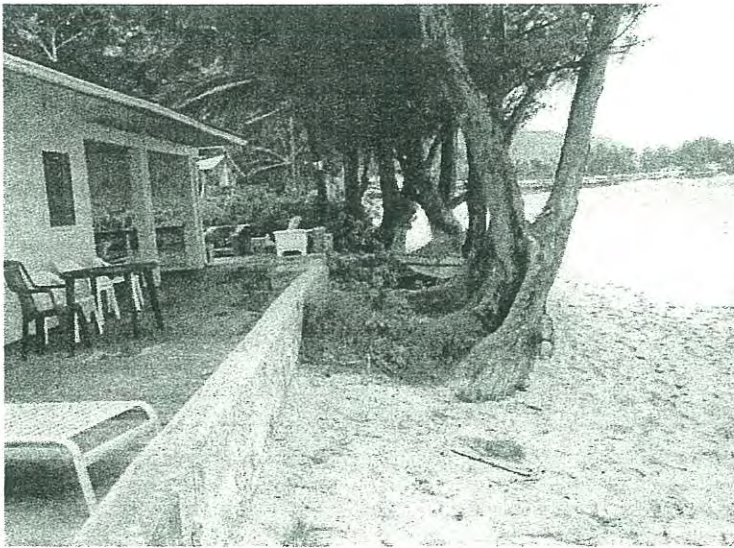
CMU wall fronts Parcel 13 .

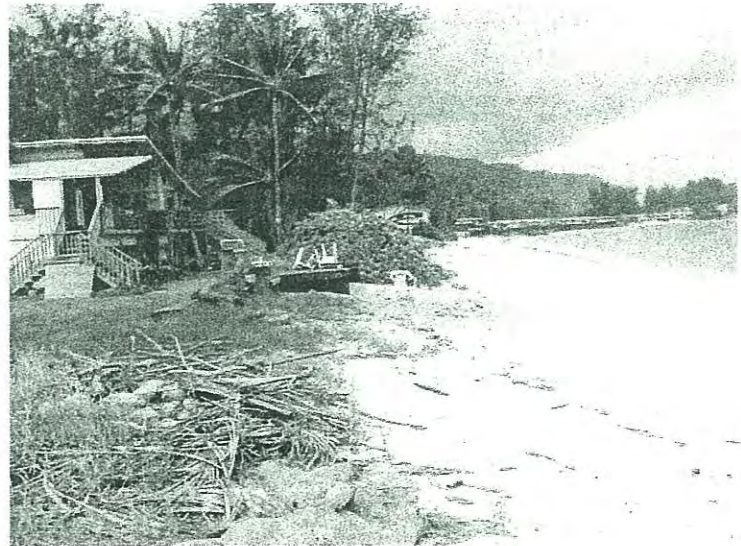
Shoreline fronting Parcel 20 on east side  
of stream. Note debris line at edge of  
vegetation.
