Subject: Chapter 343, Hawaii Revised Statutes
Environmental Assessment (EA)/Determination
Finding of No Significant Impact

Landowner/Applicant: George T. Murakami Trust and Alan H. Kodama Trust
Agent: Analytical Planning Consultants, Inc.
Location: 68-681 Farrington Highway - Mokuleia
Tax Map Key: 6-8-10: 18
Request: Shoreline Setback Variance
Proposal: To retain a concrete masonry unit (CMU) seawall and
other structures within the shoreline setback.
Determination: A Finding of No Significant Impact is Issued

SHORELINE SURVEY MAP
LOT 19
 as shown on Map 4
 of Land Court Application 1810
 Mokuleia, Waiailua, Oahu, Hawaii

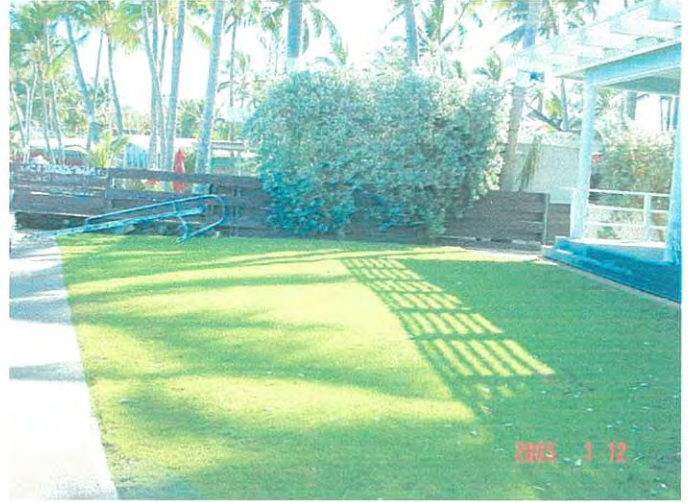
3A.2

Mokuleia
TMK: 6-8-10:18
Photo date 01-12-05
By Hida, Okamoto & Assoc.

The existing seawall is a concrete tile block wall with a top elevation of about +10'MSL (see Figure 7). The seawall, which spans a width of 61.64 feet across the makai side of the property (see Figure 4), has a return wall along the east side of the property line to stabilize and likely help to anchor the seawall into the interior of the property; not just a freestanding face that could fall over. The original concrete tile blocks are visible as the face of the seawall (see Figure 3A.3). The concrete slab that is level with the rear yard behind the lip of the seawall is structurally part of the seawall; it is the concrete cap over the material that comprises the backfill behind the seawall (see Figure 3A.1 and 3A.2).

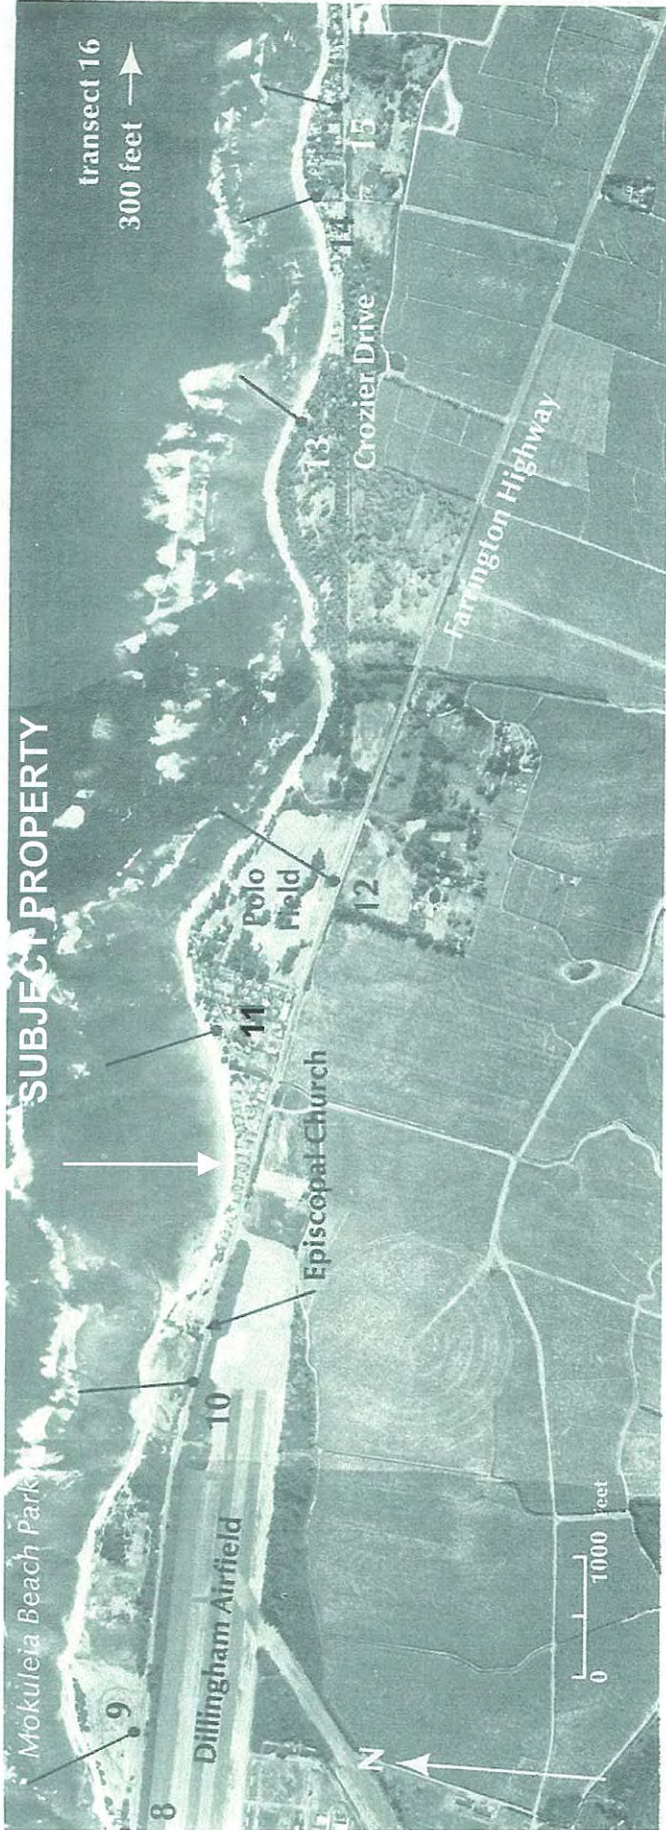
Photomap 2. Mokuleia Beach (Middle Section)

Photographs by Air Survey Hawaii: March 1971

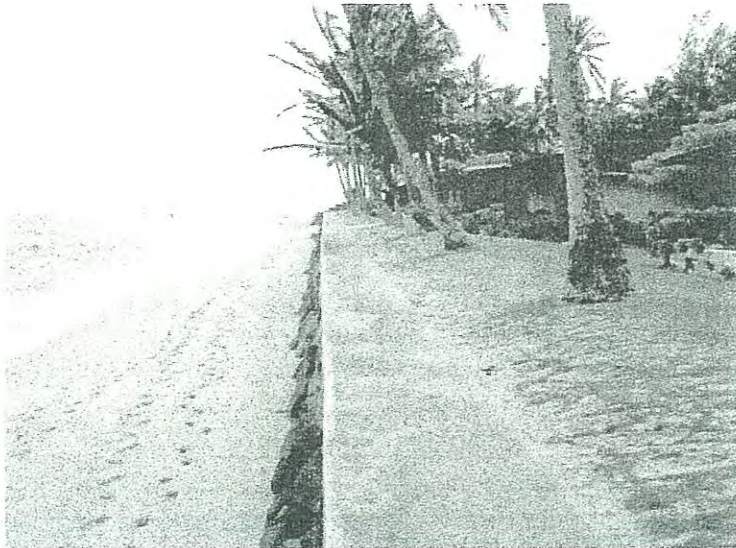
View eastward along the top of the seawall fronting the Mokuleia Beach Colony. Note the narrow beach.

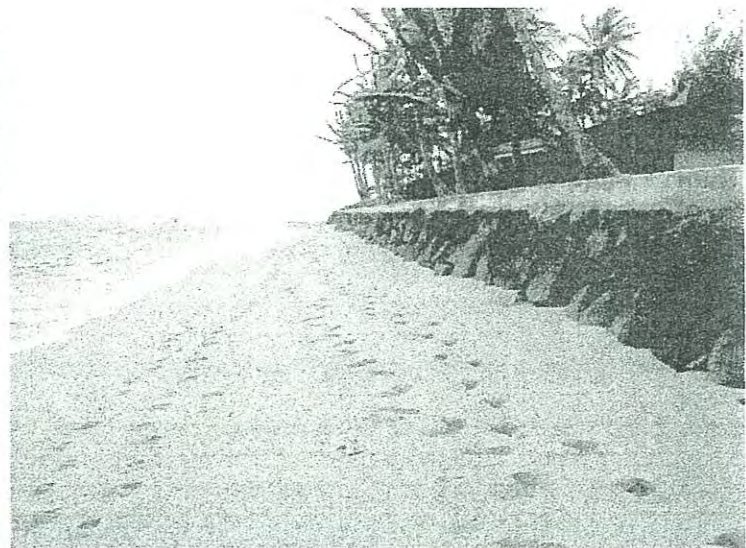
View eastward along the beach fronting the Mokuleia Beach Colony seawall. Note the narrow and steep beach profile.

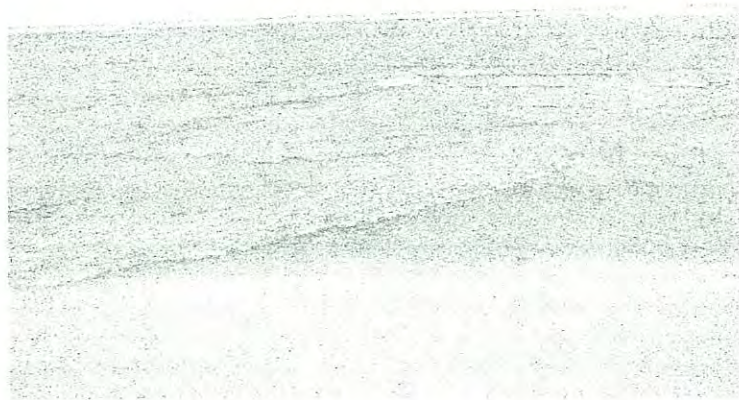
View offshore Parcel 10. Note the shallow reef and wave angle at the shoreline indicating eastward longshore transport.

Winter North Pacific swell were causing breaking waves across entire embayment.

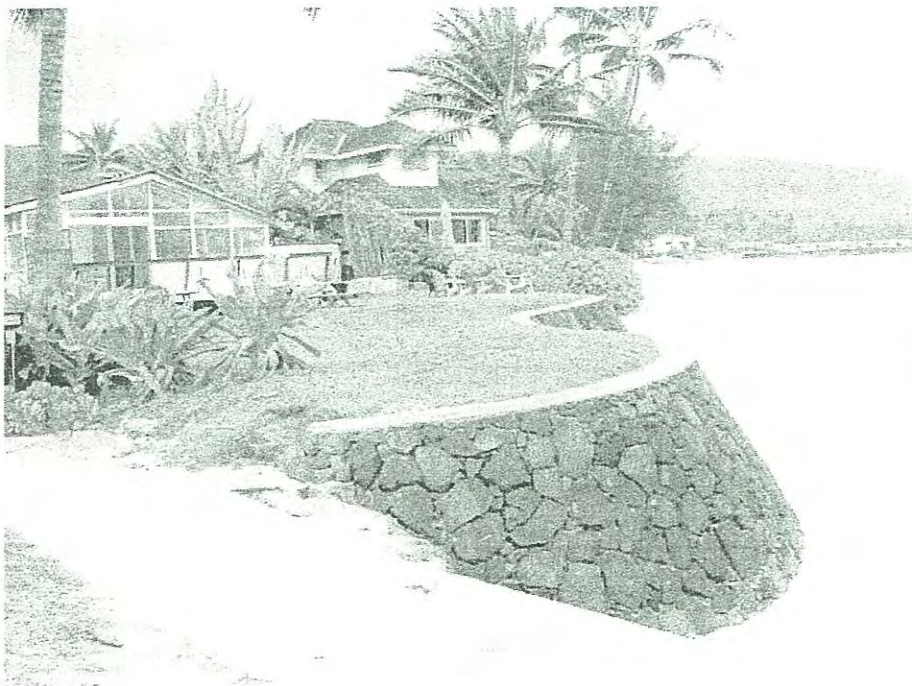
PHOTO page-2

Views westward from west end of Mokuleia Beach Colony seawall. Parcel 10 is in the foreground. Parcel 11 is next to Parcel 10. (Sign is on the west end of the Mokuleia Beach Colony seawall. The sign permits the public to walk on the top of the seawall.)

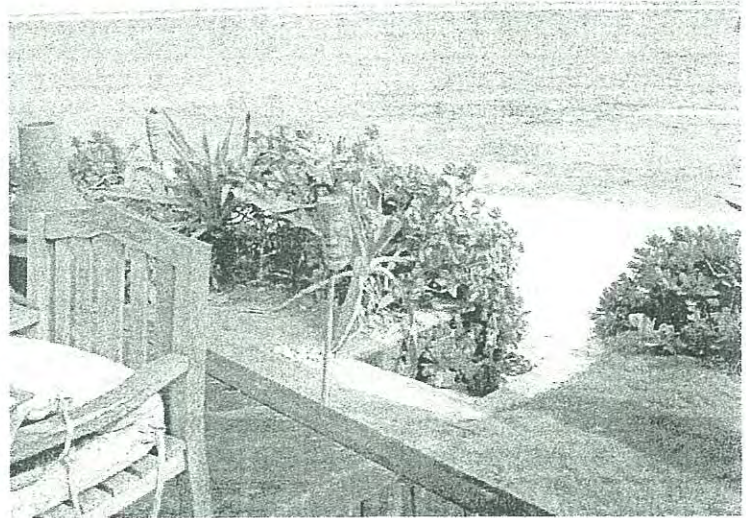
View offshore from porch on Parcel 11.
Steps in seawall lead down to the beach.

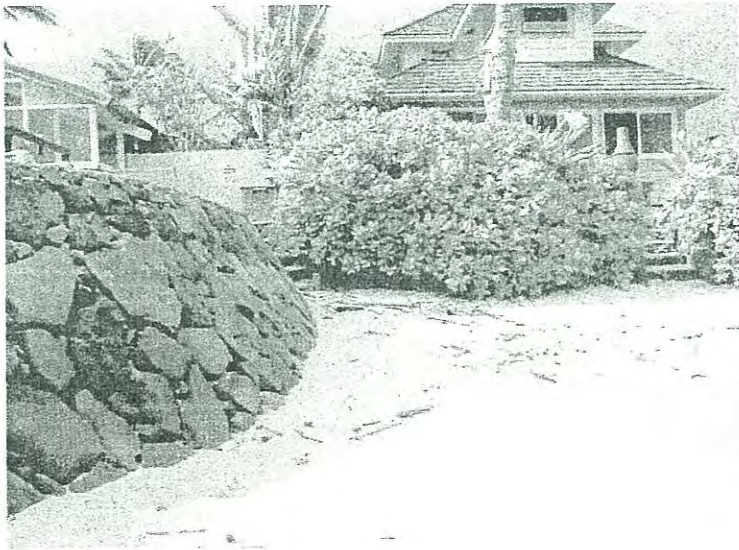
View of Parcel 11 seaward frontage. Seawall is hidden by naupaka vegetation. Curved seawall on left fronts Parcel 10.

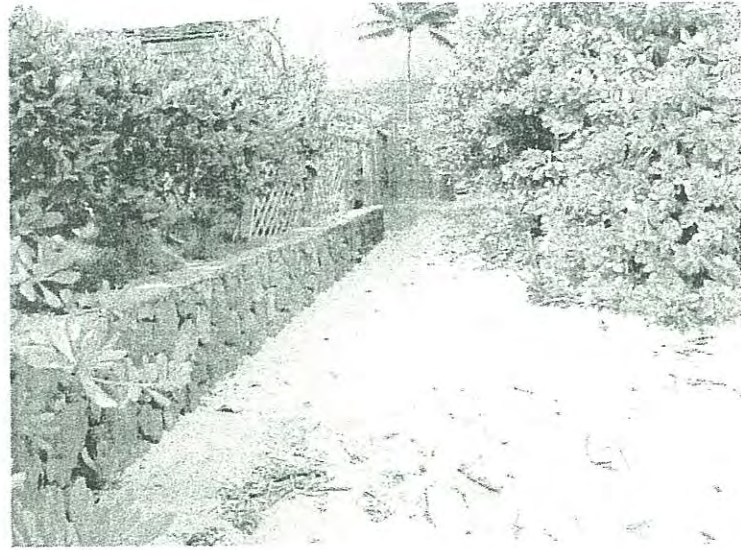
View mauka along private right-of-way. The CRM wall on left is Parcel 11's return wall.

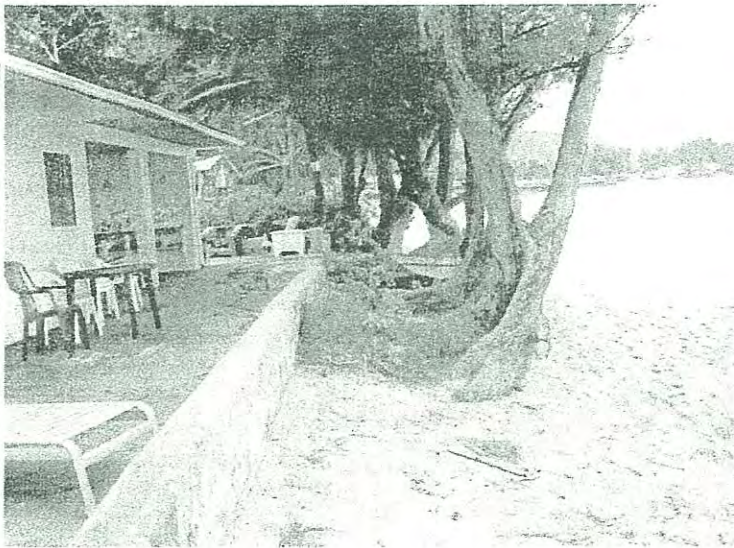
CMU wall fronts Parcel 13 .

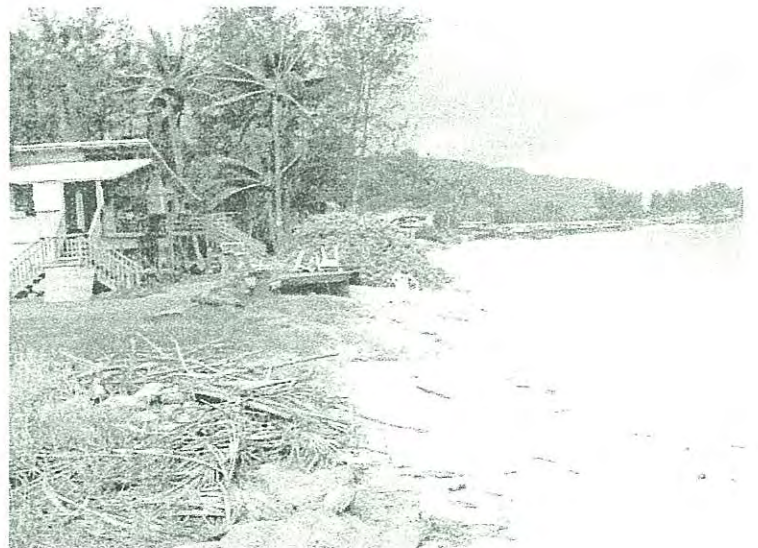
Shoreline fronting Parcel 20 on east side
of stream. Note debris line at edge of
vegetation.
