Subject: Chapter 343, Hawaii Revised Statutes
Environmental Assessment (EA)/Determination
Finding of No Significant Impact

Landowner/Applicant: Sutton Family Partners
Agent: Analytical Planning Consultants, Inc.
Location: 68-673 and 68-675 Hoomana Place - Mokuleia
Tax Map Key: 6-8-10: 14 and 15
Request: Shoreline Setback Variance
Proposal: To retain a concrete rubble masonry seawall and other structures within the shoreline setback.
Determination: A Finding of No Significant Impact is Issued

**Properties seeking Shoreline
Setback Variance to repair existing
seawalls.**

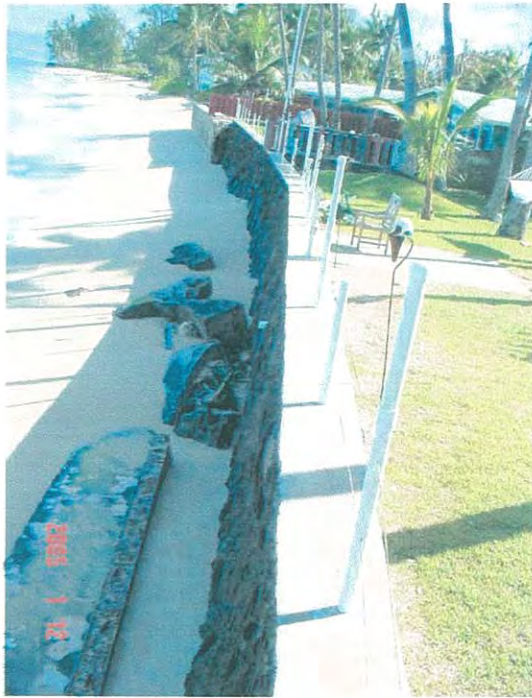
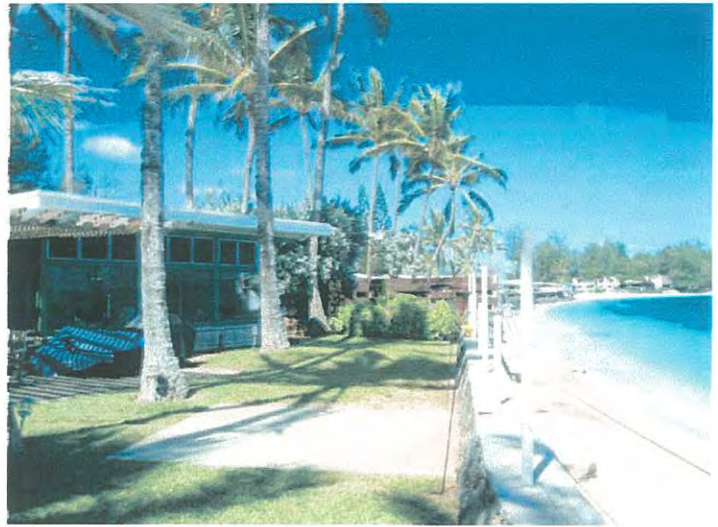
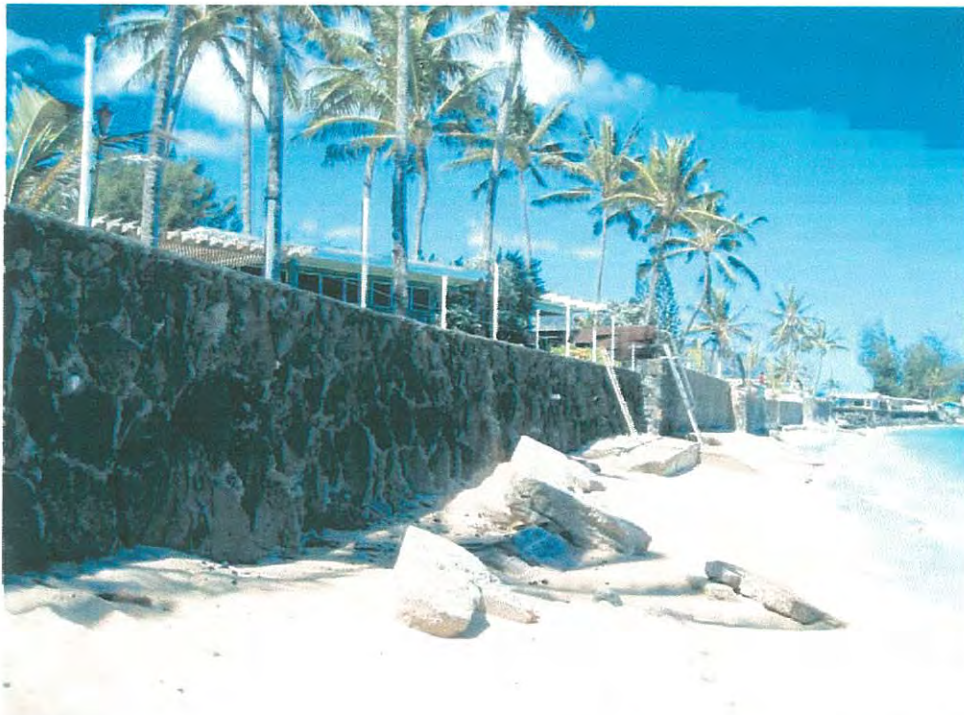
Figure 3A
SUBJECT SEAWALL TMK: 6-8-10: 015
68-675 Hoomana Place, Mokuleia, Oahu, Hawaii

3A.1 TMK: 6-8-10:15
Photo date 01-12-05
By Hida, Okamoto & Assoc.

3A.2 Mokuleia
TMK: 6-8-10:15
Photo date Fall 2004
By Land Planning Consultants

3A.3
Mokuleia
TMK: 6-8-10:15
Photo date Fall 2004
By Land Planning Consultants

Parcel 015 was purchased in 1979 and Parcel 014 was purchased in 1989, both by the applicant's parents. The properties are now owned by the "Sutton Family Partners". The recorded lot area for Parcel 15 to which the owners hold title is 11,109 square feet. After subtracting the eroded seaward portion of 3,394 square feet, the net area of the lot is 7,715 square feet. The recorded lot area for Parcel 14 to which the owners hold title is 9,407 square feet. After subtracting the eroded seaward portion of 2,813 square feet, the net area of the lot is 6,594 square feet. The shoreline is defined by a single continuous existing seawall located about between 40 to 45 feet inland of the seaward property boundary of both lots of record. Vegetation consists of yard grass and various residential landscaping materials. The topography of both lots is flat as is evident in **Figures 3A and 3B**. **Figure 3** is a photo key map showing where pictures were taken from.

In 1998, about 9 years after the Sutton's bought the second property (Parcel 014), the seawalls were damaged from years of pounding storm surf. According to the Sutton family, following a particularly severe period of weather in the winter of 1997/1998, the seawalls across Parcel 015 and 014 were failing and were about to collapse onto the beach. Remnants of the original seawalls are evident in the photos and a portion of one of the concrete tile walls still stands at the far end of Parcel 014 (**Figure 3A and 3B**).

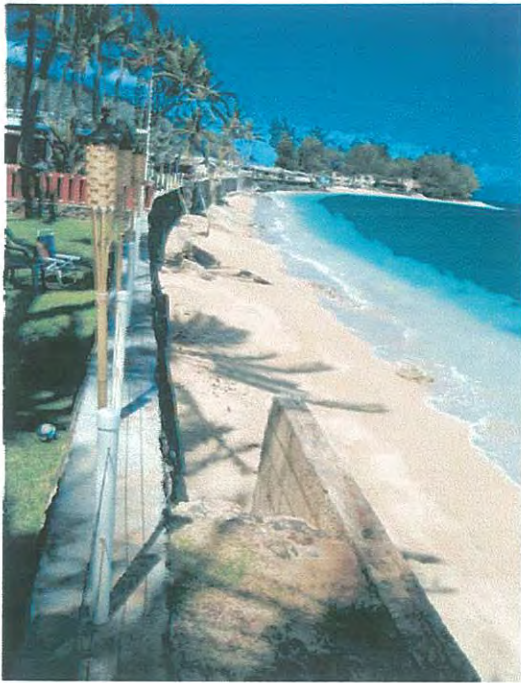
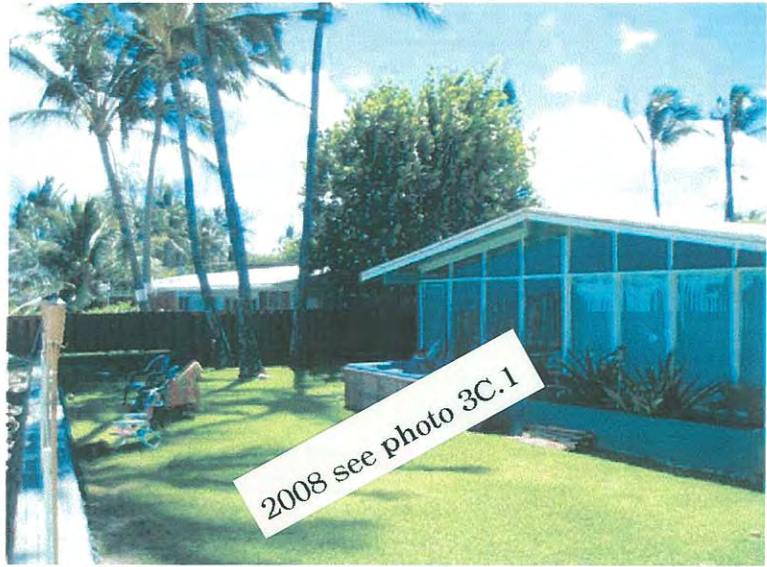
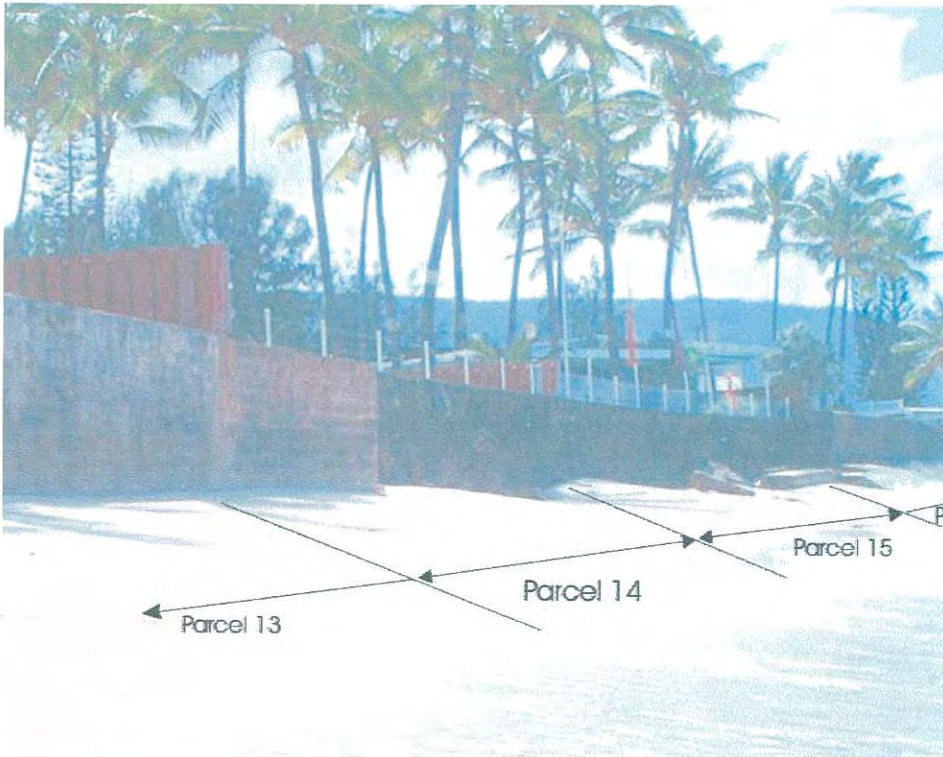
Figure 3B
SUBJECT SEAWALL TMK: 6-8-10: 014
 68-673 Hoomana Place, Mokuleia, Oahu, Hawaii

Mokuleia
 TMK: 6-8-10:14
 Photo date Fall 2004
 By Land Planning Consultants

Mokuleia
 TMK: 6-8-10:14
 Photo date 04-02-05
 Time 2:00 pm
 By EKNA Services
 Tide approx. 0.1' MLLW

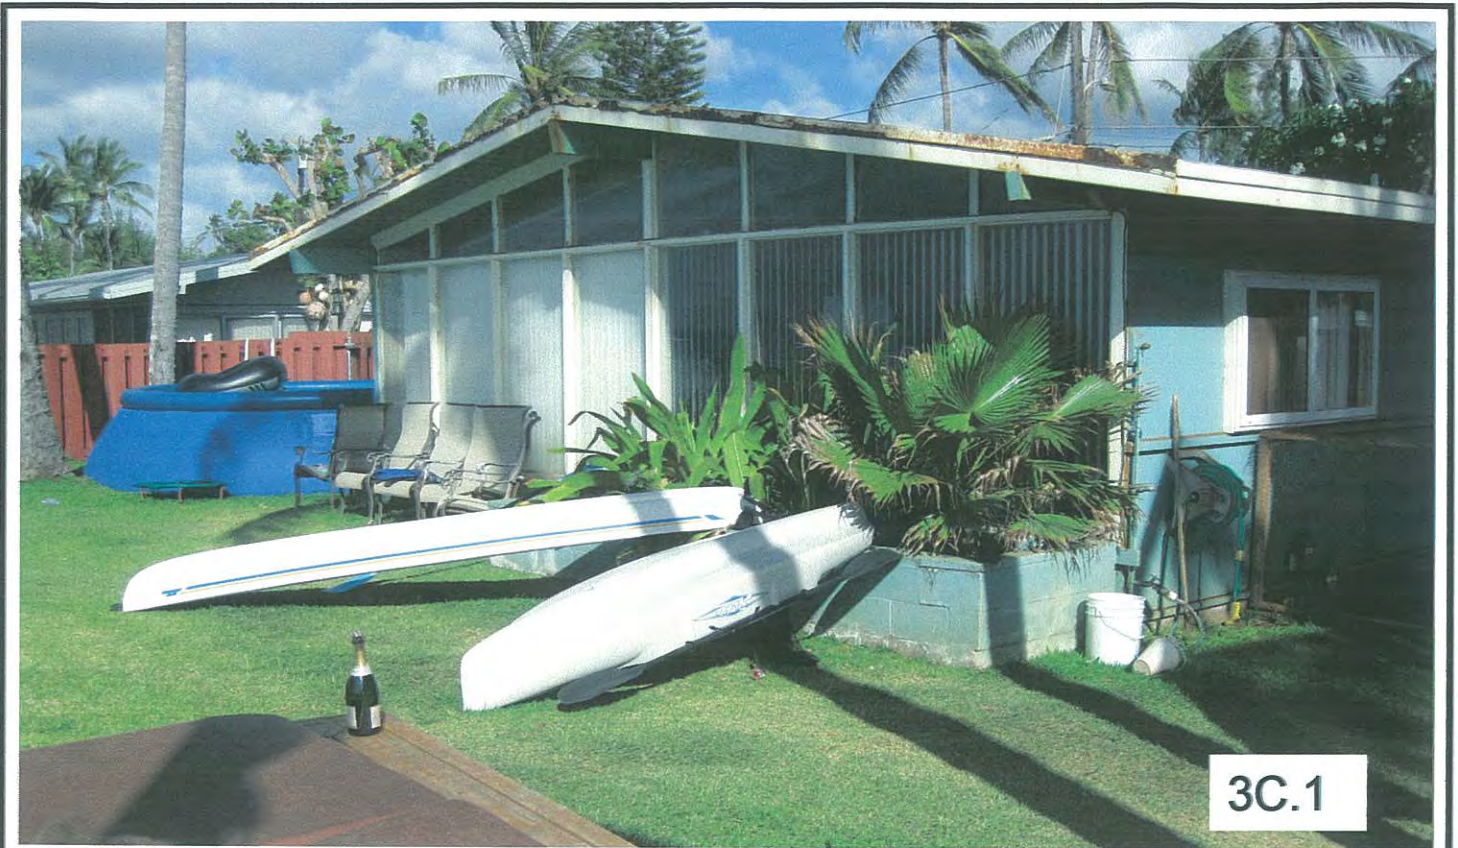
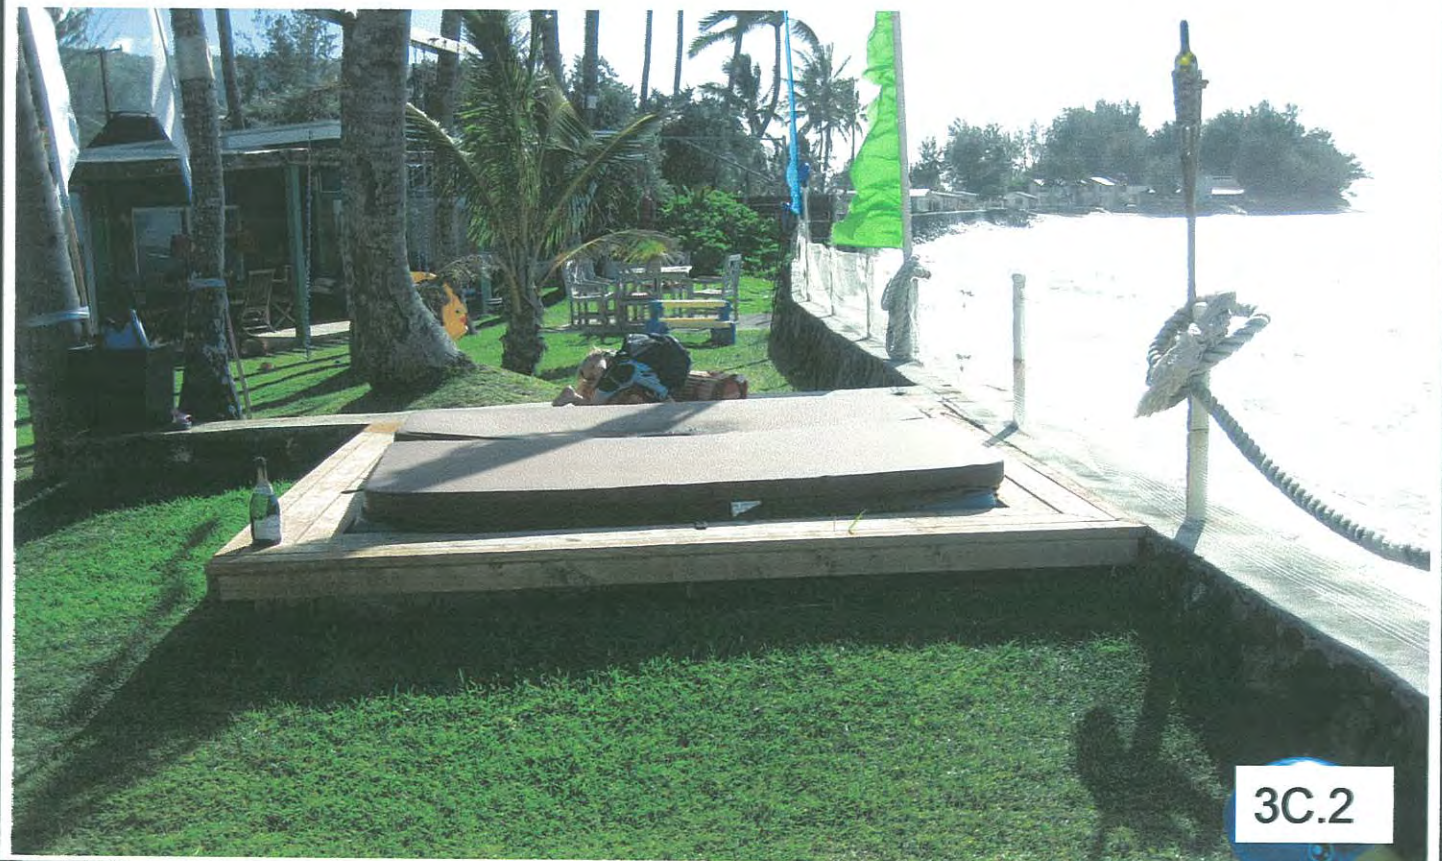
Figure 3C
Parcel 14 2008

68-673 Hoomana Place, Mokuleia, Oahu, Hawaii

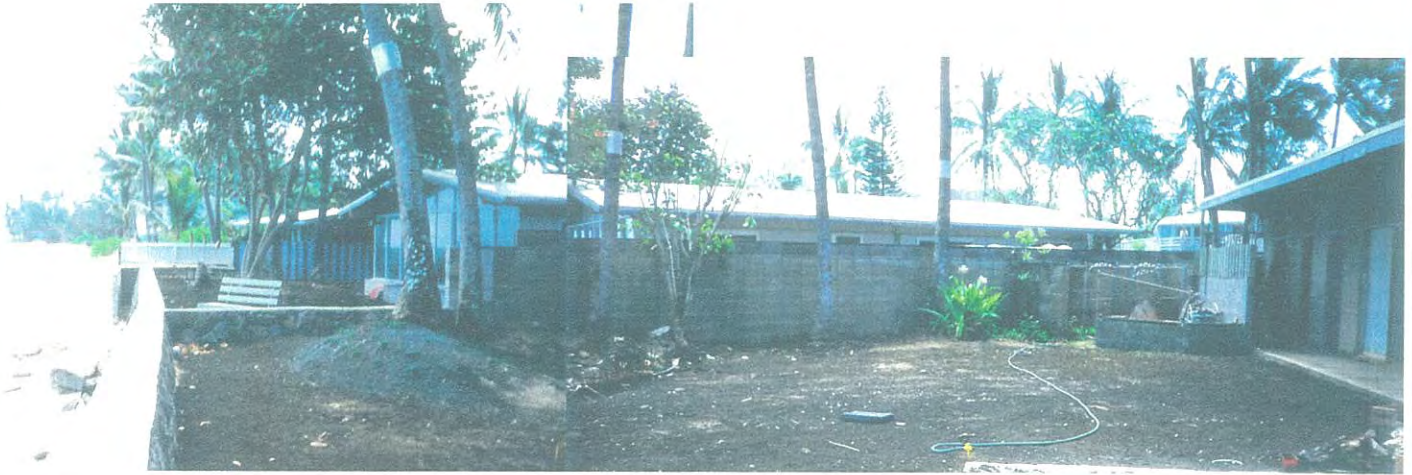
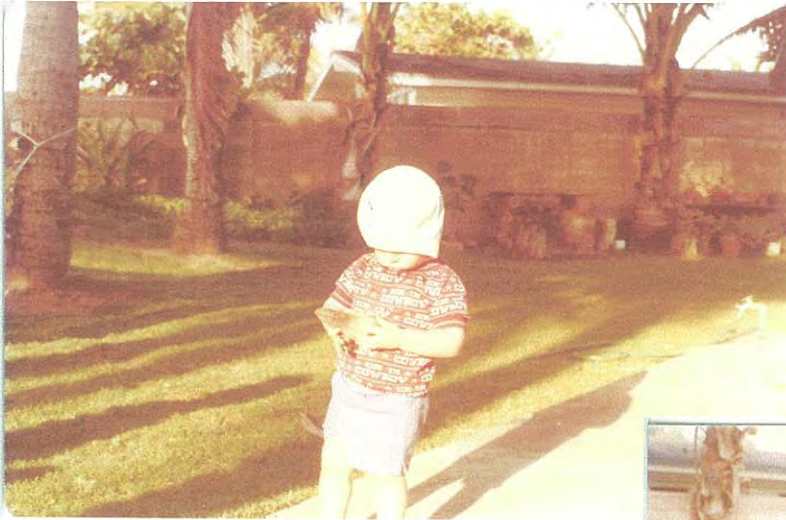
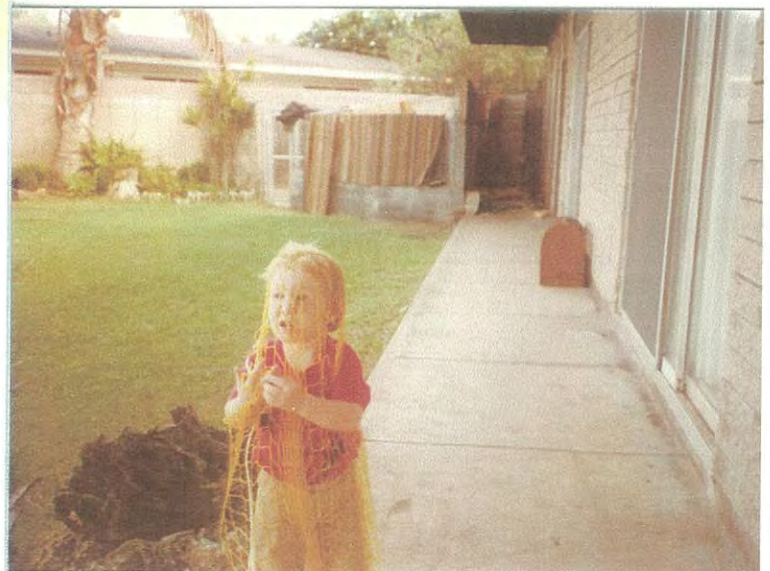
Sutton photo dated April 13 1998. New seawall built across Parcels 015 and 014. Side yard concrete tile wall was partially demolished along makai edge.

Sutton photo May 1981. Side yard concrete tile wall protrudes well makai of and beyond house roof of Parcel 014

Sutton photo November 1981. Side yard concrete wall is evident between Parcels 015 and 014.

Figure 6 contains Sutton family photos taken in 1981 and photos taken in 1998 of the new seawall across both Parcel 015 and 014. In the 1981 photos, there is a tile wall along the side yard property line between 015 and 014. The center photo taken in May 1981 shows the side yard wall is built well beyond the seaward roofline of the house on Parcel 014. The 1998 photo shows that some of that tile wall was taken down in the 1998 and was replaced with a lava rock wall that is integrated with the new seawall when the new seawall was built. Today there is a wooden fence atop the lava rock wall along the side property line between Parcel 015 and 014, while a portion of the original tile wall remains in its mauka location between the two properties.

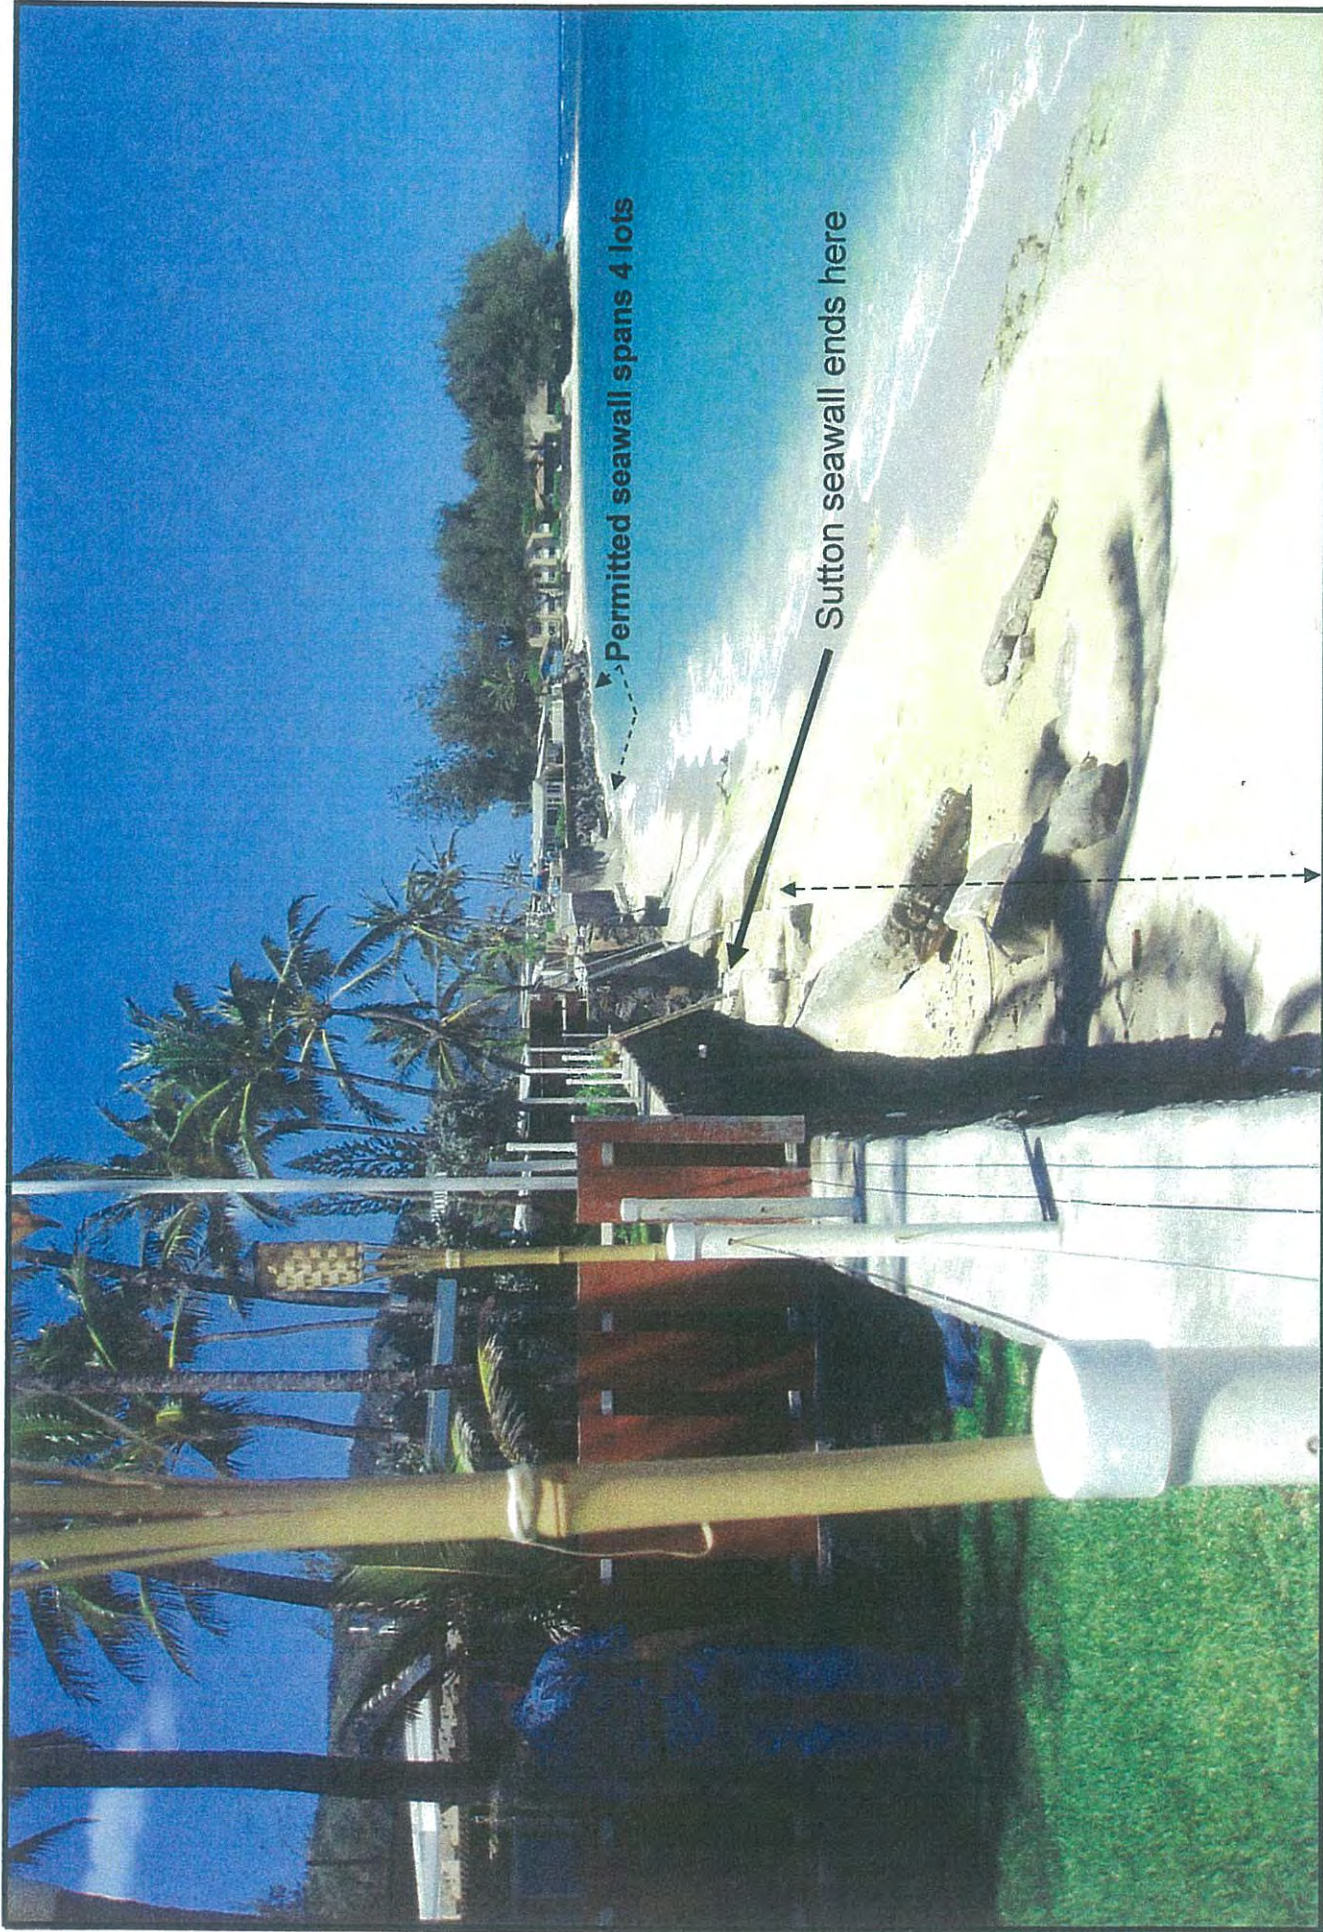
Figure 10

EXISTING CONTINUOUS SEAWALLS ALONG EMBAYMENT

Taken from TMK: 6-8-10: 014, Mokuleia, Oahu, Hawaii

All of the residential lots on both sides of the subject property along this embayment have existing seawalls or revetments to provide shoreline erosion protection (**Figure 10**). Many of these shoreline protection structures were likely built in the 1970’s and 1980’s due to chronic erosion.” As further evidence of the longstanding seawalls along this embayment, in 1986 the owner of Parcel 19 received written confirmation from the City’s Department of Land Utilization that the seawall on Parcel 19 (just 2 lots west of the parcel 015) was “built prior to the adoption of the Shoreline Setback Rules of the City and County of Honolulu in 1971” (**Figure 5**).

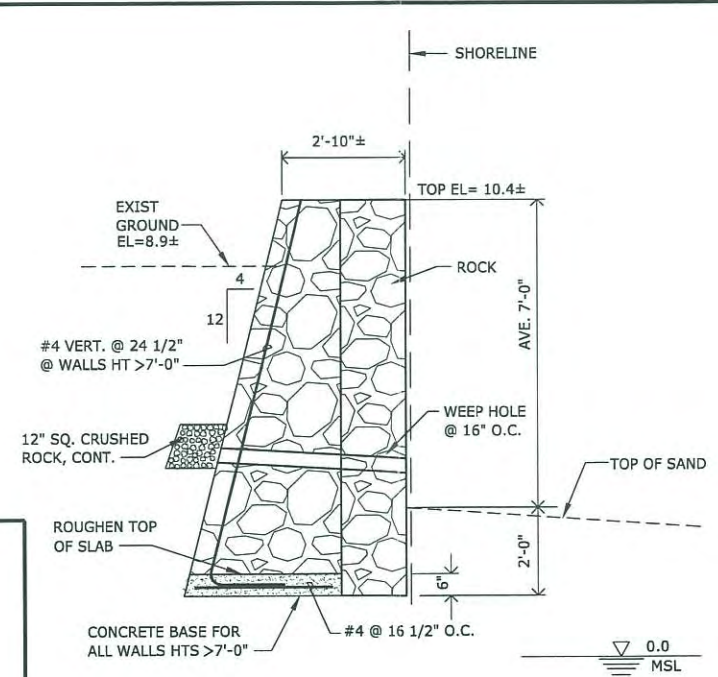
FIGURE 8A

NOTE: BACKFILL UTILIZED : 48 Cu. Yd.

SEA WALL AFTER-THE-FACT
Makuleia, Waihua, Oahu
Tax Map Key: 6-8-10:14

Figures 8A and 8B are the as-built plans prepared by Hida Okamoto & Associates, Inc. with a site plan, elevation, section and typical wall detail drawings. The seawall is built of concrete rubble masonry and stands 7 feet tall from its base atop a concrete foundation. The top elevation of the seawall is approximately +10.4' MSL. Built into the wall are weep holes set about 16-inches apart. Backfill is estimated at 48 cubic yards for parcel 14 and 46 cubic yards for parcel 15. Life expectancy for the wall is estimated at 30 years.

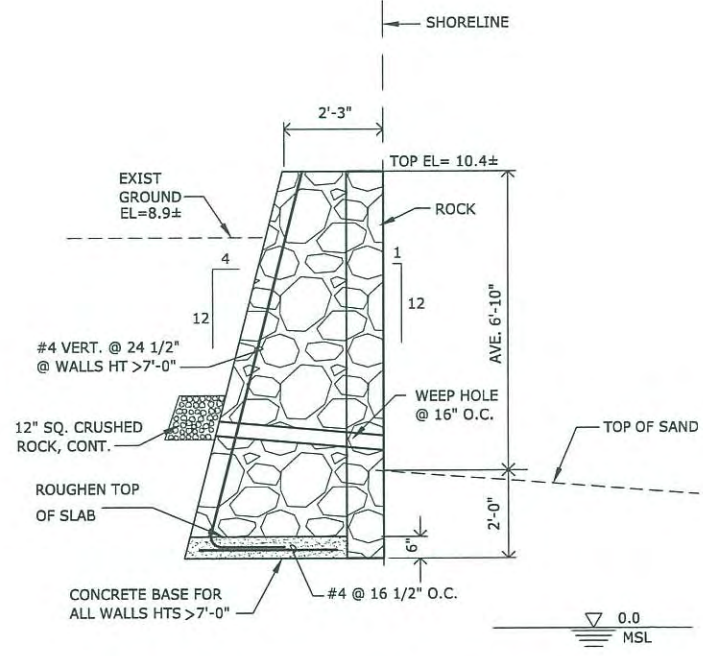
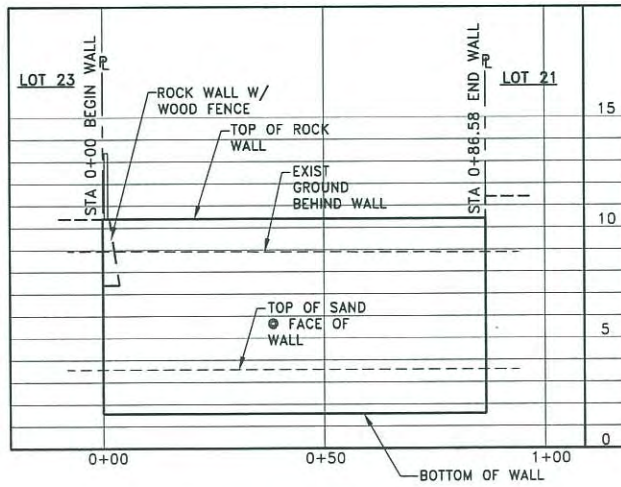
NOTE: BACKFILL UTILIZED : 46 Cu. Yd.

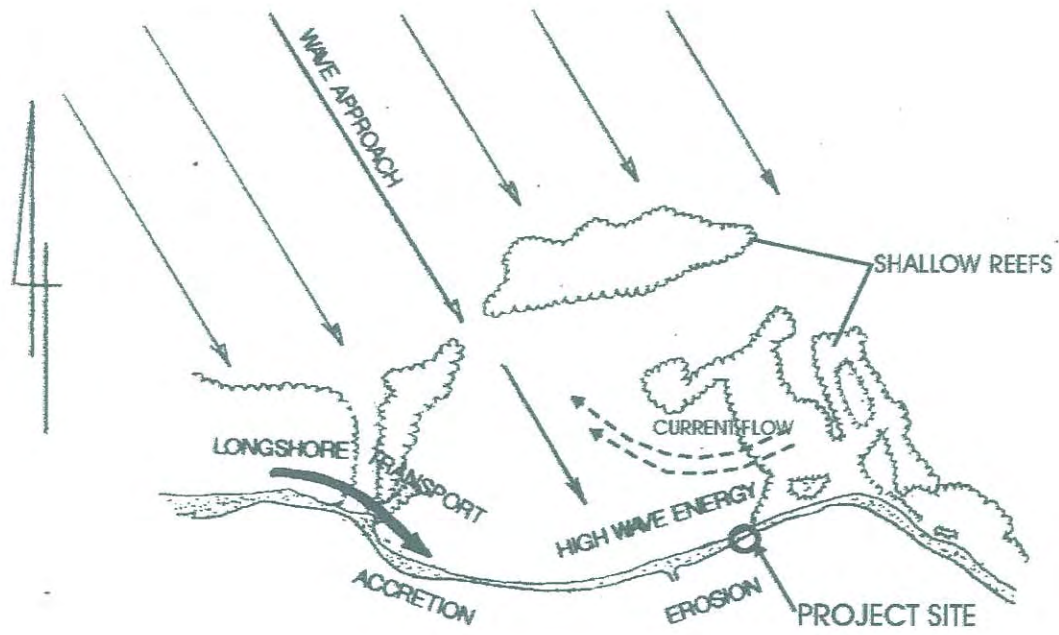
WINTER NORTHWEST SWELL CONDITIONS

Source: EKNA Services, Inc.

The following information is taken from the EKNA Services, Inc. 2004 and 2005 Coastal Engineering Assessment (**Appendix D**). It is apparent that during high tide, wave runup reaches the base of the existing seawall. During storms and large winter swell conditions, wave runup and overtopping of the beach likely causes flooding and sand transport into the properties that are not protect by seawalls. The owner of the subject property has also experienced sand deposited into the rear yard and significant amount of wave runup and water have overtopped the wall and ocean water is deposited in the rear yard.

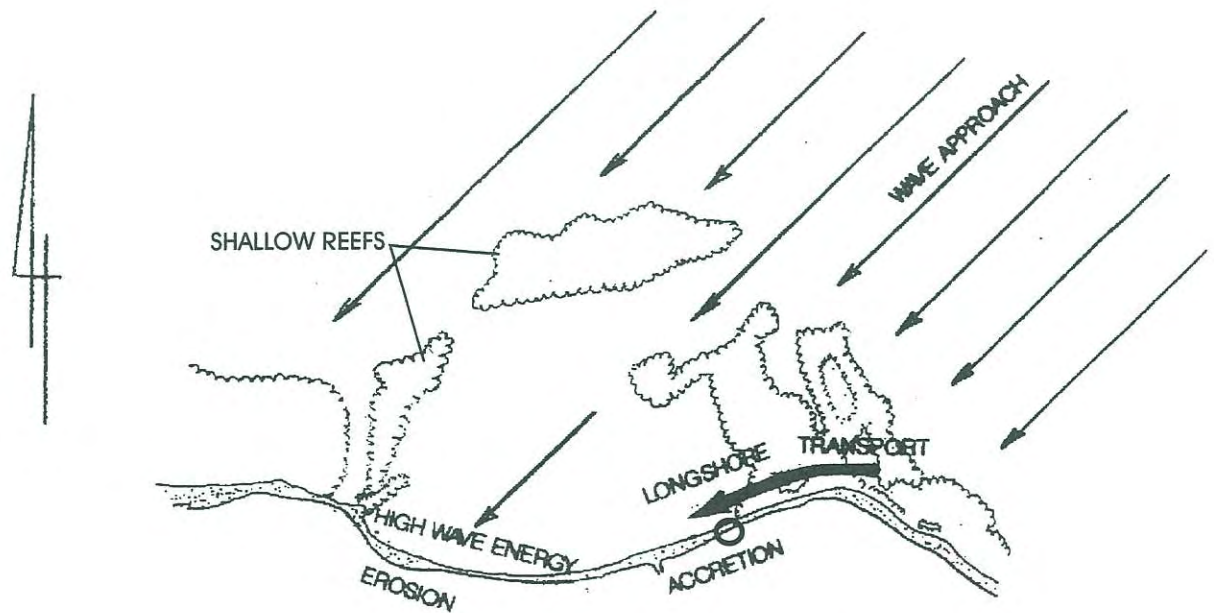
FIGURE 3

WINTER NORTHWEST SWELL CONDITIONS

SUMMER NORTHEAST TRADEWIND CONDITIONS

While net long-term erosion is evident, residents also indicated that seasonal fluctuation of beach width occurs. According to the residents, there is a pattern of erosion along the eastern part of the embayment during the winter, with restoration of the beach width during the summer. Conversely, for the shoreline reach towards the western part of the embayment, there is a pattern of erosion during the summer and restoration during the winter. Because water depths in the central part of the embayment are too deep for transmitted wave energy to move sediments back to shore, the seasonal fluctuation of beach width is presumably due to longshore transport of sediments from the shoreline and shallow nearshore areas around the headlands. Figure 3 depicts the probable seasonal transport processes.

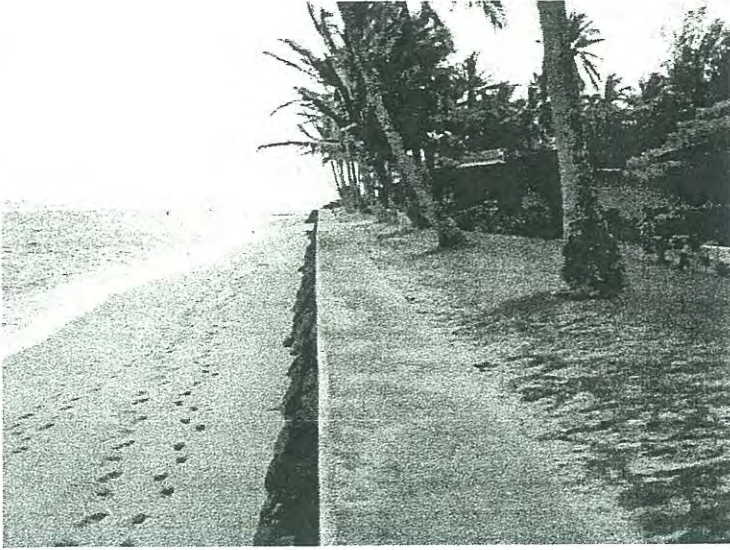
View eastward along the top of the seawall fronting the Mokuleia Beach Colony. Note the narrow beach.

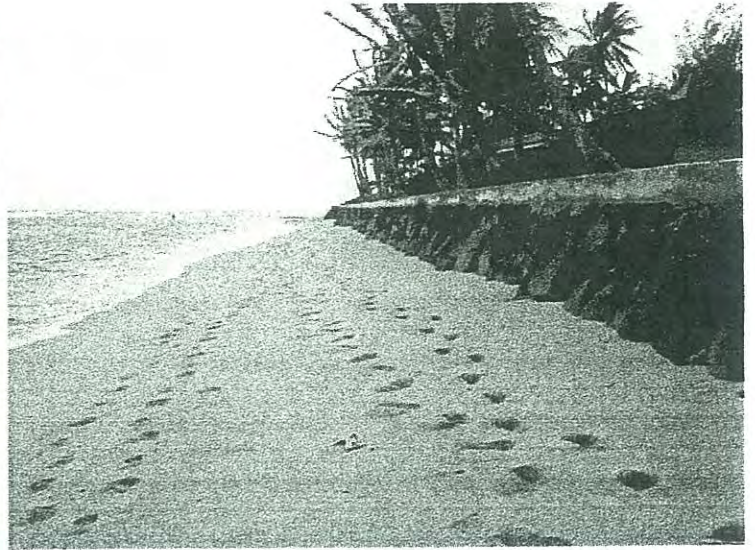
View eastward along the beach fronting the Mokuleia Beach Colony seawall. Note the narrow and steep beach profile.

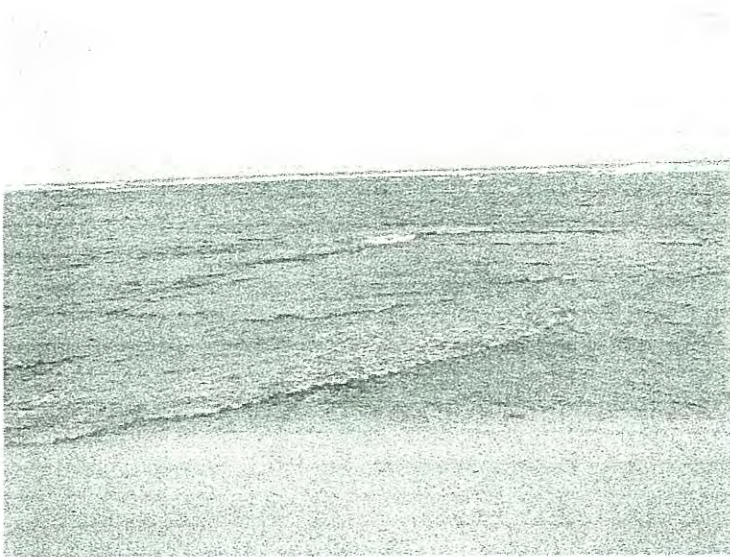
View offshore Parcel 10. Note the shallow reef and wave angle at the shoreline indicating eastward longshore transport.

Winter North Pacific swell were causing breaking waves across entire embayment.

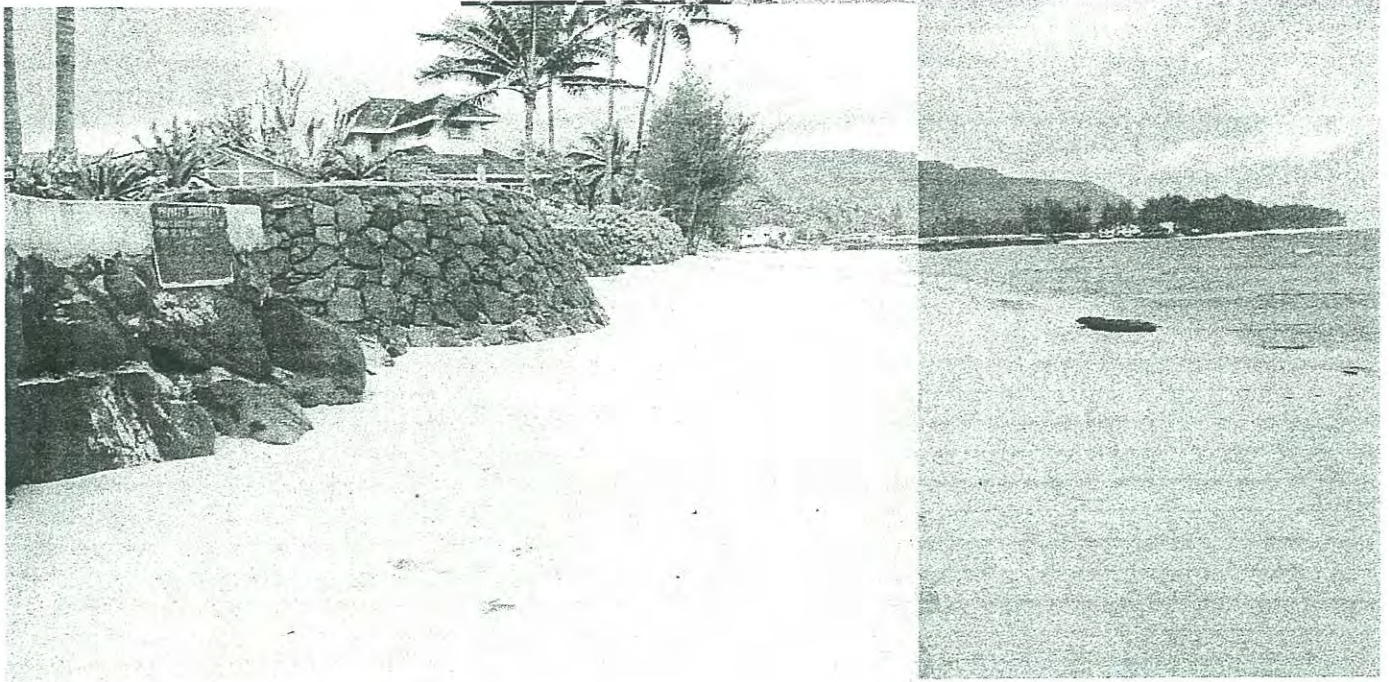
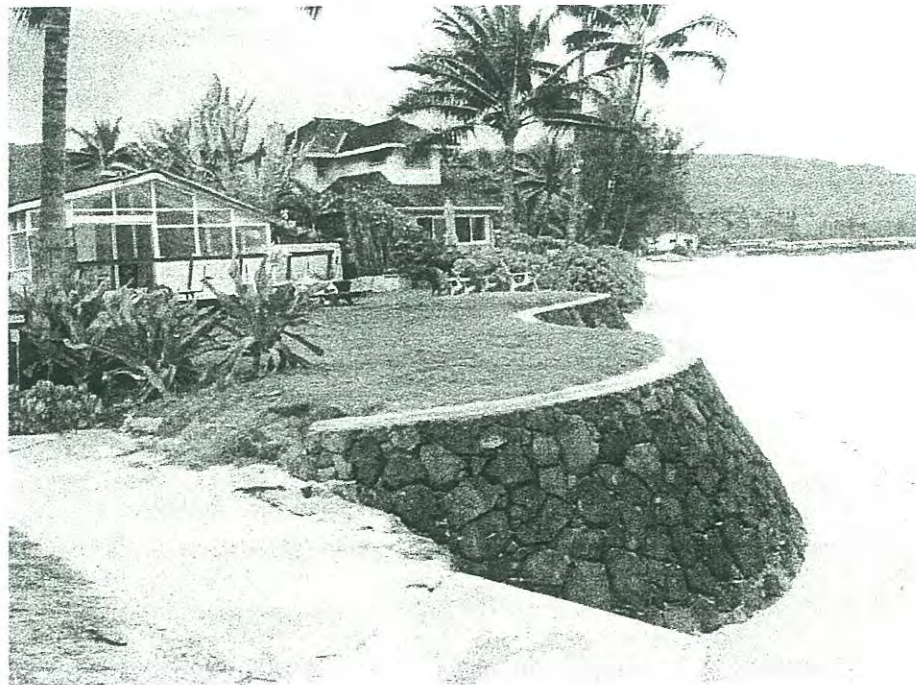
Views westward from west end of Mokuleia Beach Colony seawall. Parcel 10 is in the foreground. Parcel 11 is next to Parcel 10. (Sign is on the west end of the Mokuleia Beach Colony seawall. The sign permits the public to walk on the top of the seawall.)

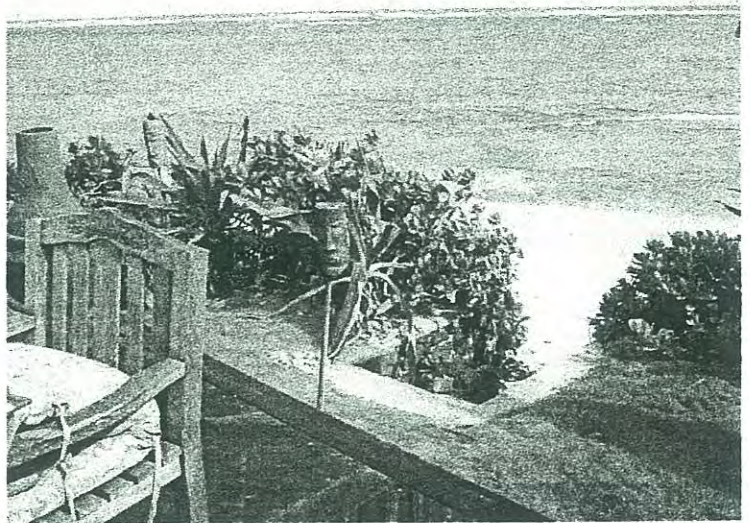
View offshore from porch on Parcel 11.
Steps in seawall lead down to the beach.

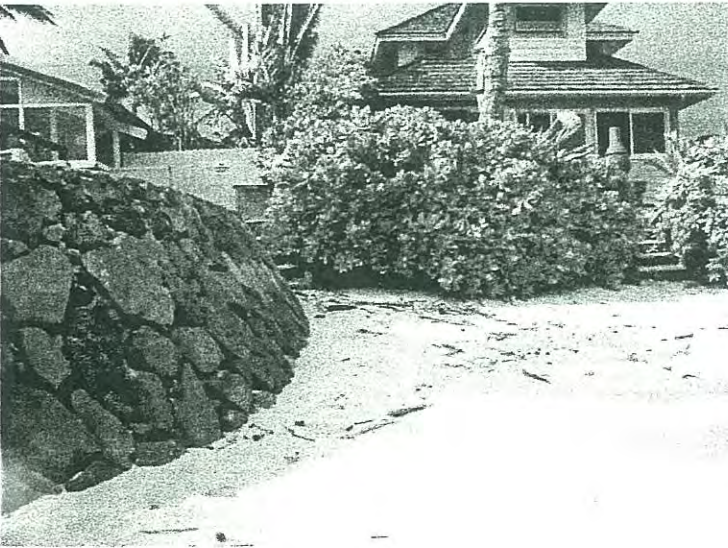
View of Parcel 11 seaward frontage. Seawall is hidden by naupaka vegetation. Curved seawall on left fronts Parcel 10.

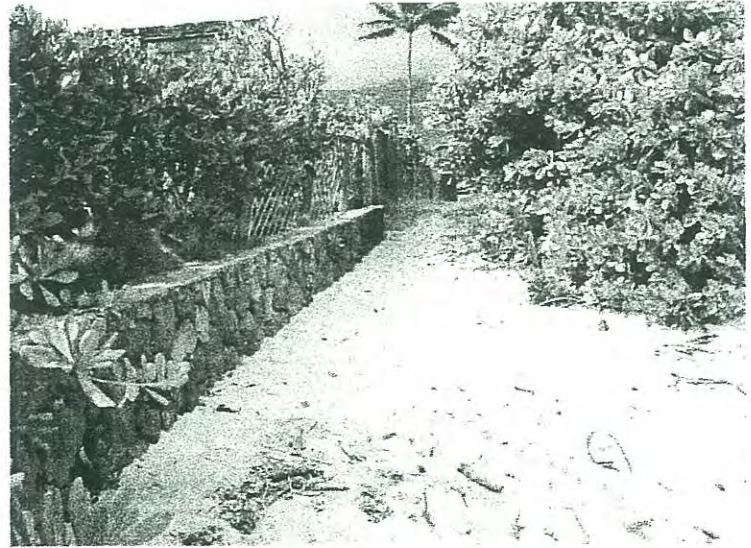
View mauka along private right-of-way. The CRM wall on left is Parcel 11's return wall.

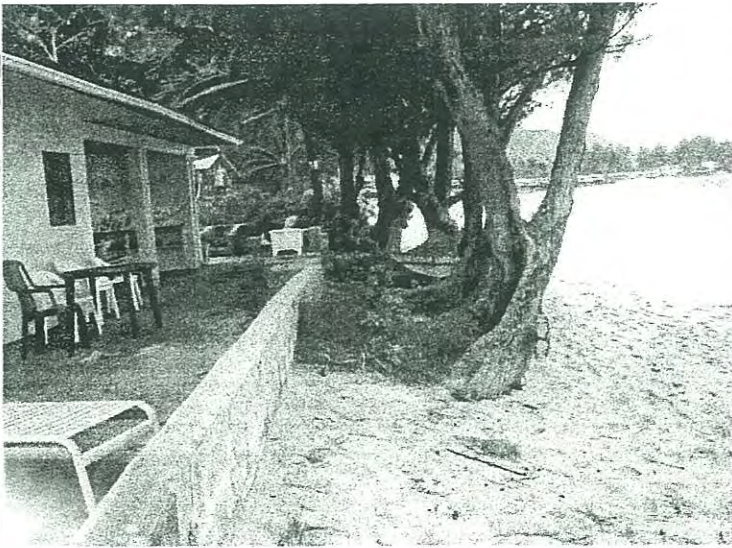
CMU wall fronts Parcel 13 .

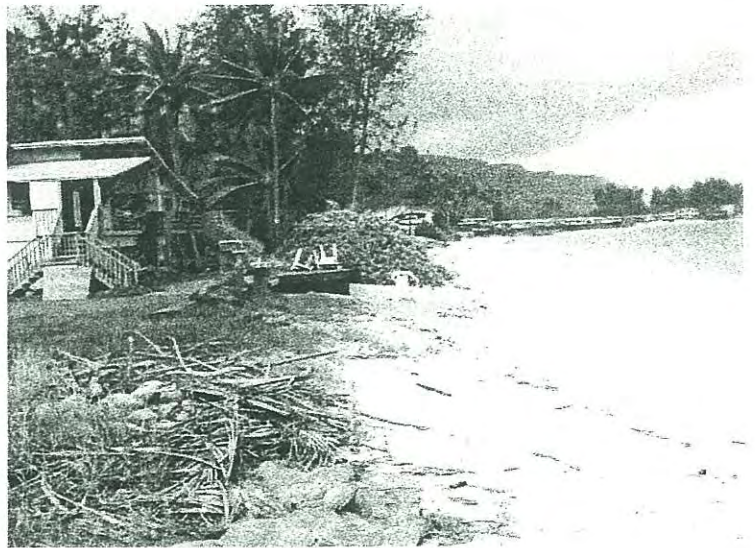
Shoreline fronting Parcel 20 on east side
of stream. Note debris line at edge of
vegetation.

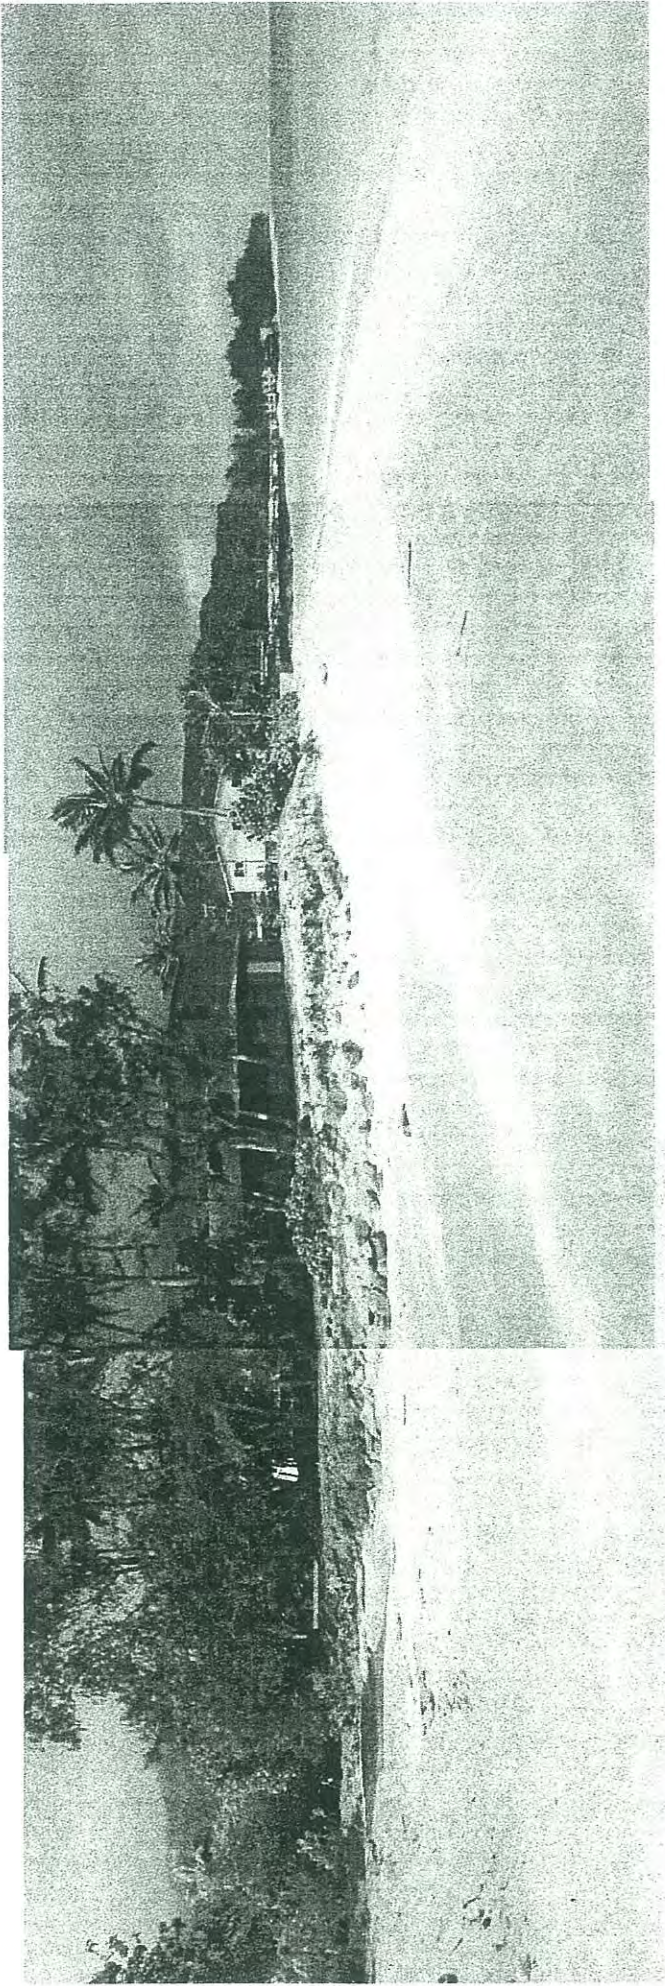
View westward from stream mouth. Note eroded condition of embankment on west side of the stream. Continuous line of seawalls protect entire central shore frontage within the embayment.
