Project Name: Proposed Breach of Ku Tree Dam at Schofield Barracks-East Range Environmental Assessment and Draft Finding of No Significant Impact

**ENVIRONMENTAL ASSESSMENT AND DRAFT FINDING OF
NO SIGNIFICANT IMPACT**

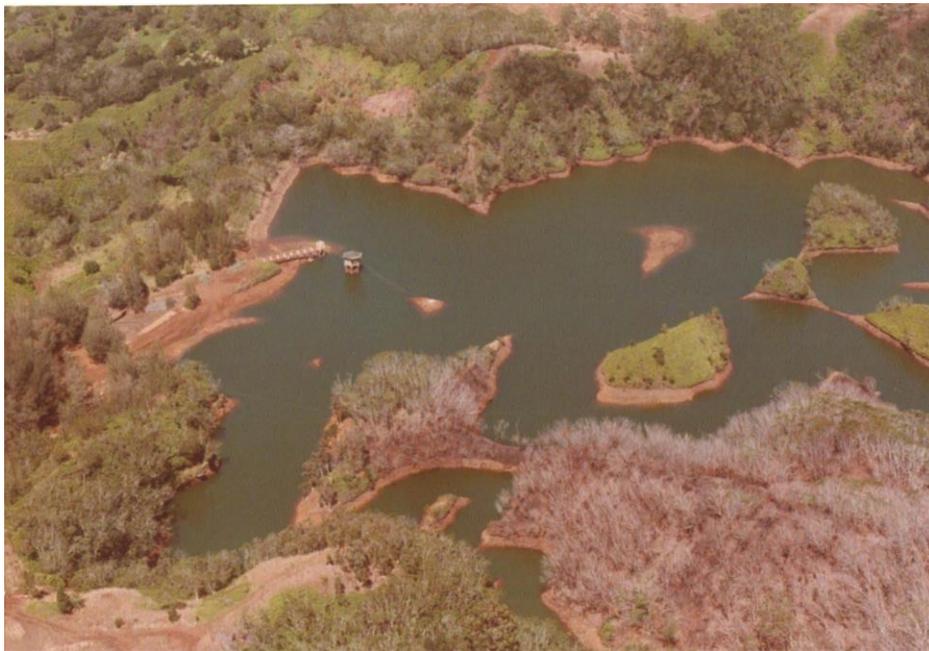
36 **Plate 1. Ku Tree Reservoir** (date unknown)

13
14 At maximum capacity, the reservoir pool was 32 acres (13 hectares) in size and provided storage
15 of 900 acre-feet (293 million gallons) of water. Plate 1 below shows dam and reservoir at full
16 capacity.

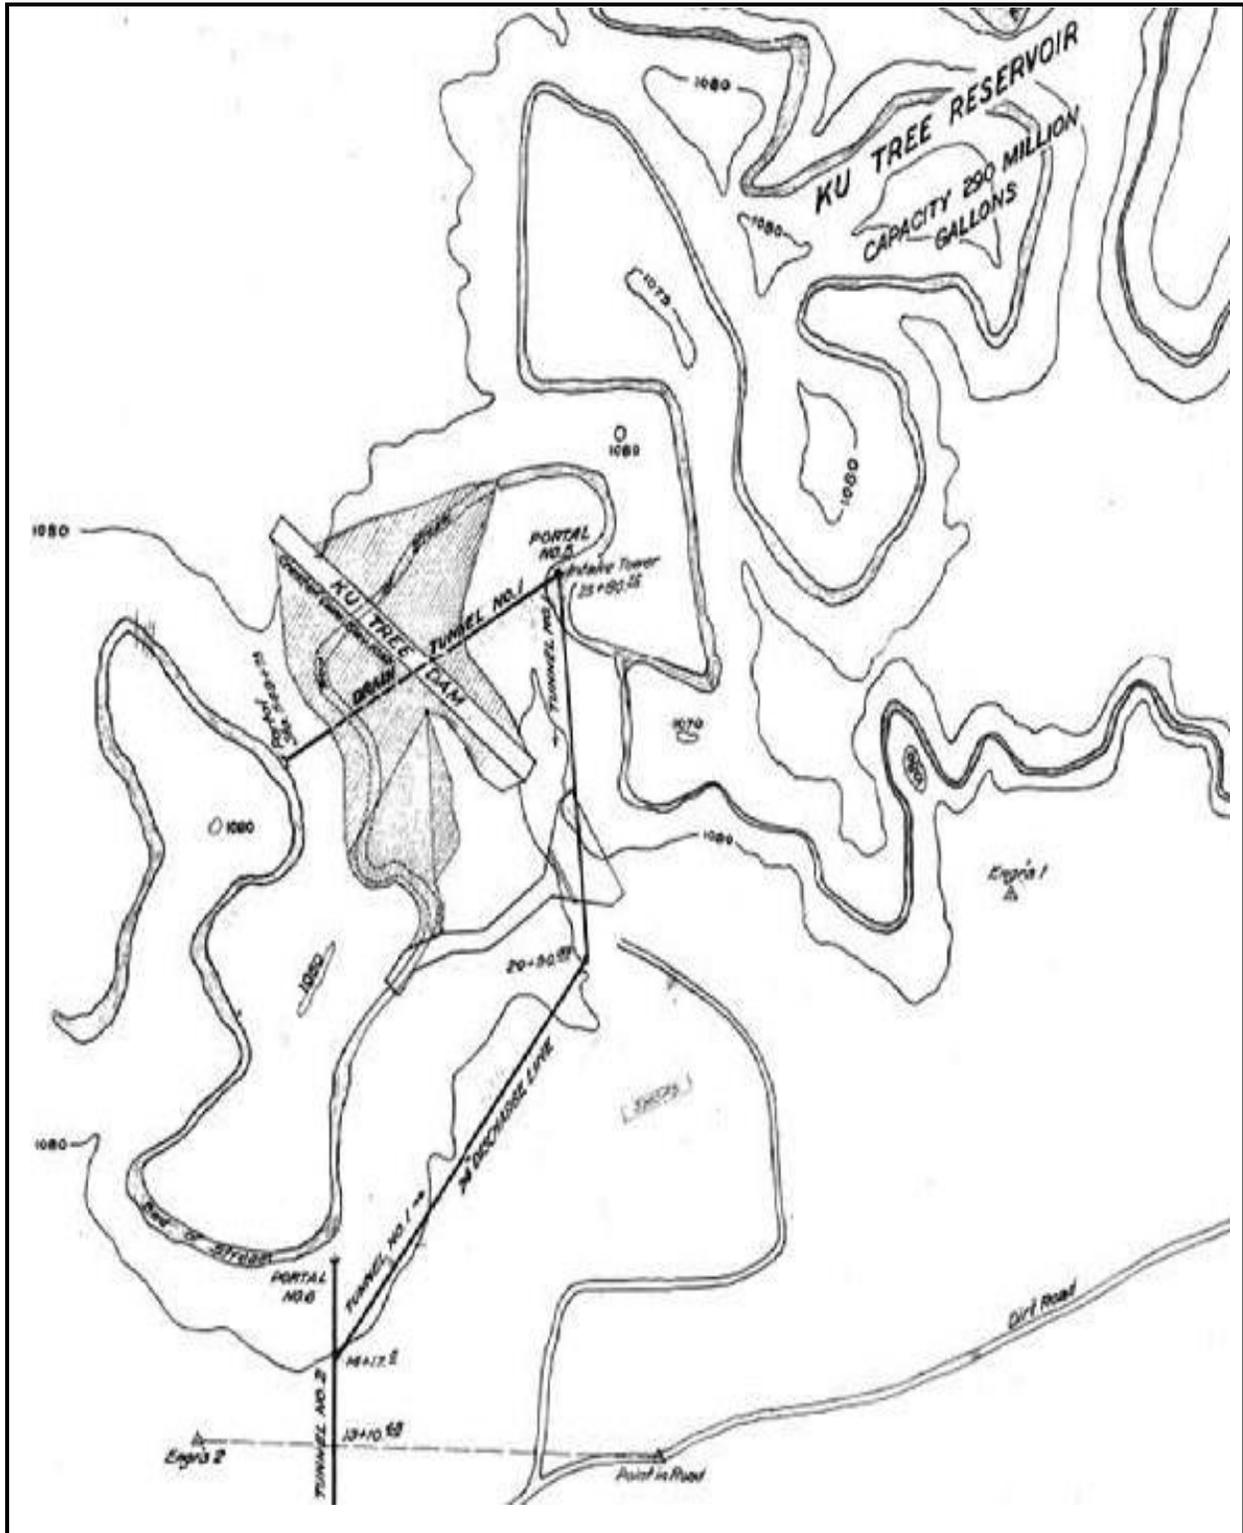
Figure 1. Relationship of Original Flow Path to Dam and Spillway

5
6 Ku Tree Dam is a hydraulic earth-filled dam that is approximately 550 feet long by 90 feet high
7 with a crest width of 30 feet. Construction of the dam crest blocked the original flow path of
8 South Kaukonahua Stream, impounding water behind the dam, and creating Ku Tree Reservoir
9 which drowned the two meandering tributaries of South Kaukonahua Stream behind the dam at
10 the 1,159-foot elevation. Looking downstream, a concrete converging spillway is located on the
11 left abutment of the dam. The spillway has a 160-foot ogee weir and drop section into a stilling
12 basin. Figure 1 below shows the relationship of the original flow path to the dam and spillway.

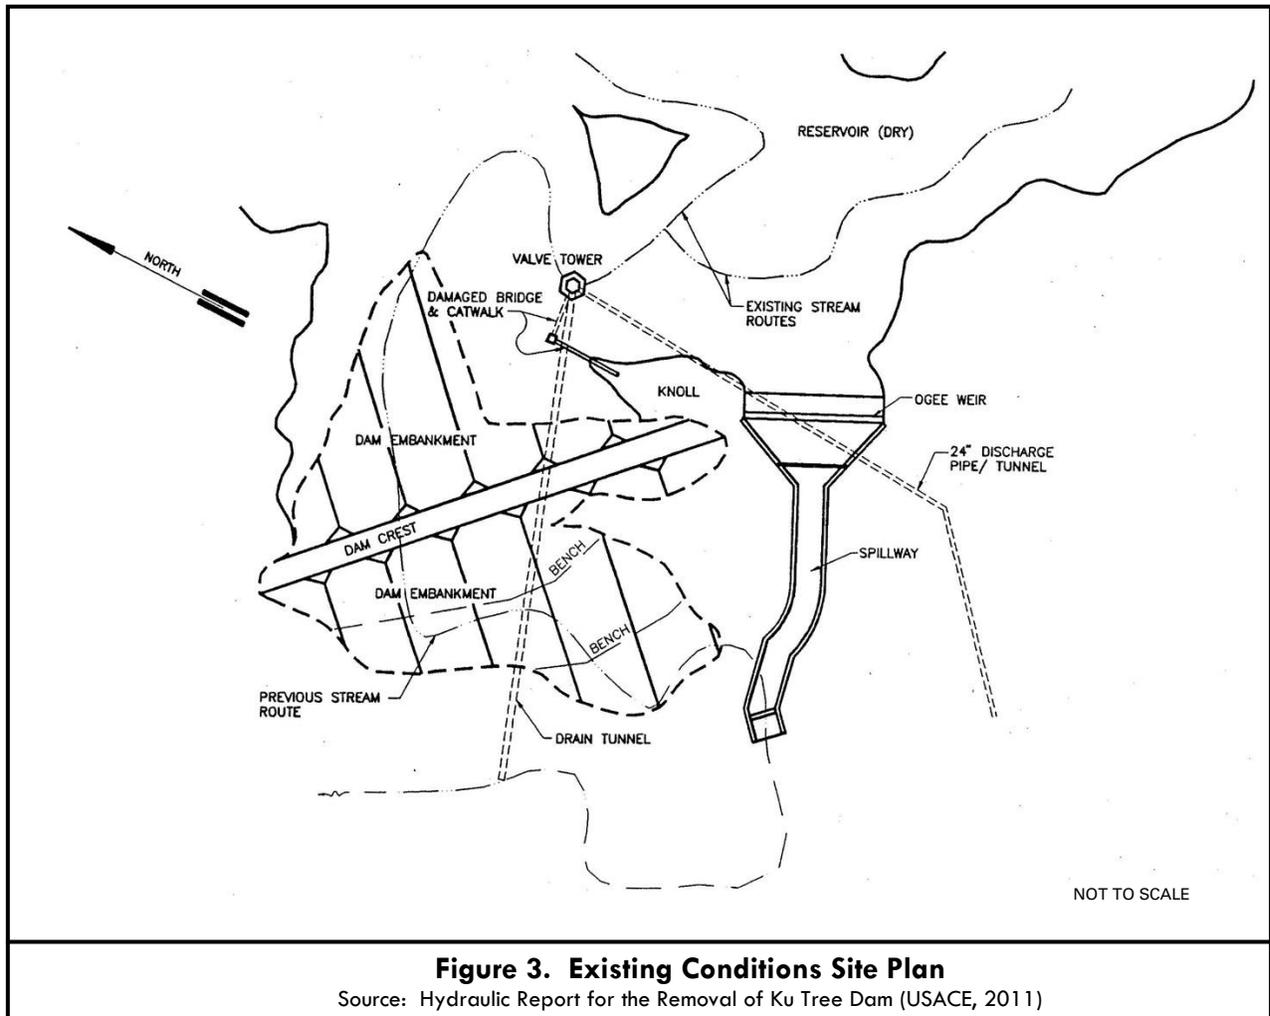
The Ku Tree Dam and Reservoir is composed of several structural components, which are described below. Figure 3 shows a site plan of the dam and appurtenant structures.

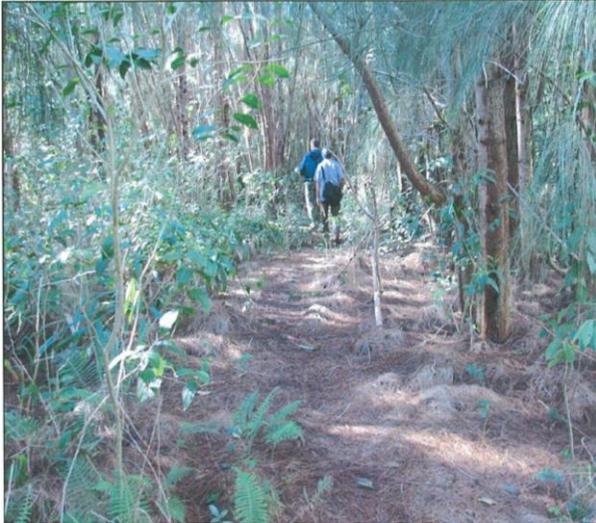
Plate 2. **Dam Crest**
Source: Phase I Investigation Report (Gannett Fleming, 2008)

The Ku Tree Dam is approximately 550 feet long and 90 feet high with a crest width of 30 feet. Both the upstream and downstream faces are sloped one vertical to three horizontal. The upstream slope is protected by riprap and the crest and downstream slope is grassed. Plates 2 through 4 show the current condition of the dam's crest and upstream slope. The embankment is homogeneous with the timber diaphragm core wall. The embankment crest is at elevation 1,085 feet above mean seal level (msl). Figure 4 shows a section and elevation of the existing dam structure. At full capacity, the dam was capable of impounding a 0.5-mile long reservoir with an estimated storage volume of 293,000,000 gallons or 900 acre-feet. At crest elevation, the depth of the reservoir was approximately 85 feet at its deepest point. The total surface area at spillway elevation was approximately 32 acres with a drainage area encompassing approximately 531 acres.

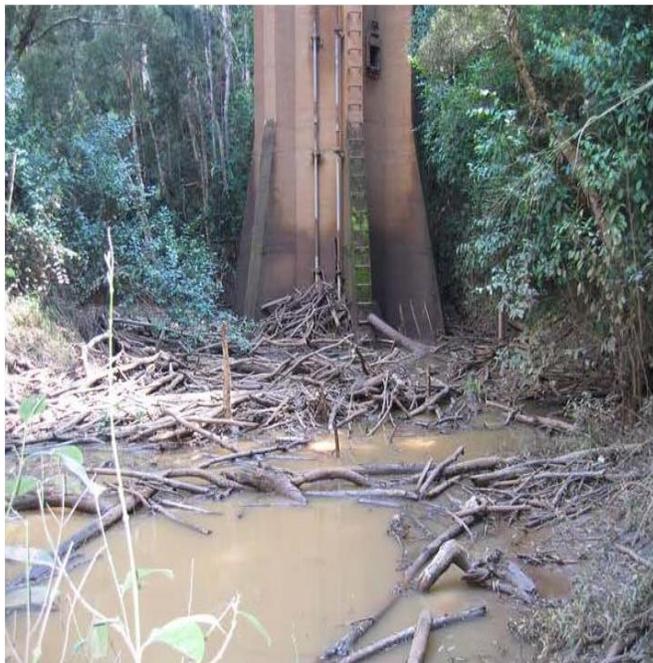
Plate 5. **Base of the Valve Control Tower**
Source: Limited Visual Inspection Report (USACE and DLNR, 2006)

2 The valve control tower contains the outlet works that regulated drainage for the Ku Tree
3 Reservoir when it was in use (Plates 5 and 6). The tower is a hexagonal-shaped, reinforced
4 concrete structure standing 102 feet in height. Five sluice gates are located on the various faces
5 of the structure at incremental elevations of 1,065, 1,050, 1,035, 1,020, and 1,005 feet above msl.
6 The gates are vertical slide mechanisms 18 inches x 24 inches with trash screens to block debris
7 from clogging the outlet. Once manually-operated, the gates are currently inoperable and remain
8 open to allow any retained water to pass through. When it was operational and the water level of
9 the reservoir was at spillway crest-height, the outlet was able to pass a maximum of 619 cfs. At
10 the base of the valve tower are inlets to the drain and discharge tunnels. Since being drawn
11 down, water is discharged back to the stream below the dam through the drain tunnel. It is

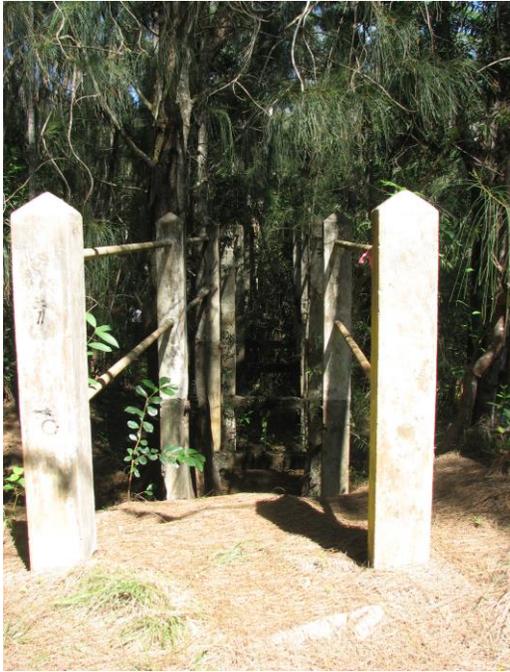
Plate 7. Remnants of Tower Footbridge from Dam Abutment

17 The tower foot bridge provided access from the dam to the wood-framed control room atop the
18 valve control tower (Plates 7 and 8). It extended from a natural knoll along the left abutment of
19 the dam. The bridge system was composed of an approach walk and a suspension bridge span.
20 The 8-spanned approach walk was 80 feet long and had a wood deck. The suspension bridge
21 was 67 feet long and was suspended by a pair of 1-inch diameter steel cables. The suspension
22 spans have collapsed and the approach spans are seriously deteriorated. The wooden deck of the
23 approach walk is no longer existent.

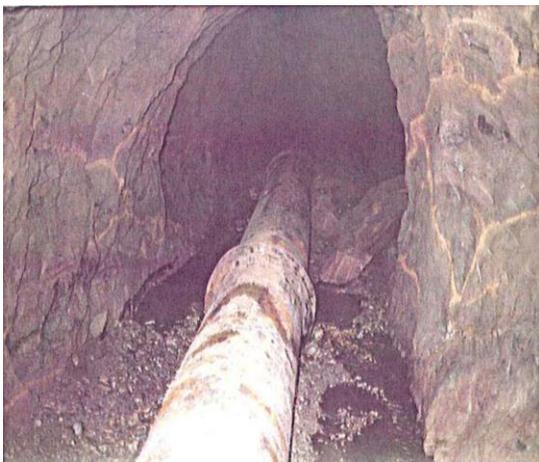
Plate 9. Discharge Tunnel

The discharge tunnel was primarily used to transport water from the reservoir to the Schofield Barracks water system (Plates 9 and 10). It is approximately 5 feet x 6 feet in diameter and accommodates a 24-inch diameter cast-iron pipe that transitions to a 20-inch pipe, which eventually leads to the Schofield Barracks water main. The total length of the tunnel is approximately 2,600 feet. The discharge tunnel is no longer in use.

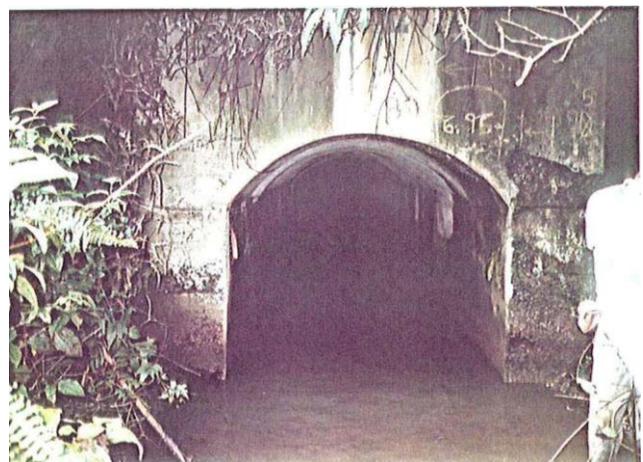
Plate 10. Downstream End of the Drain Tunnel

The drain tunnel is approximately 6 feet x 6 feet with a lined, arched roof and extends approximately 540 feet in length through the dam and discharges water to the stream below. The tunnel connects to the bottom of the valve control tower through a 3-foot x 6-foot sluice gate.

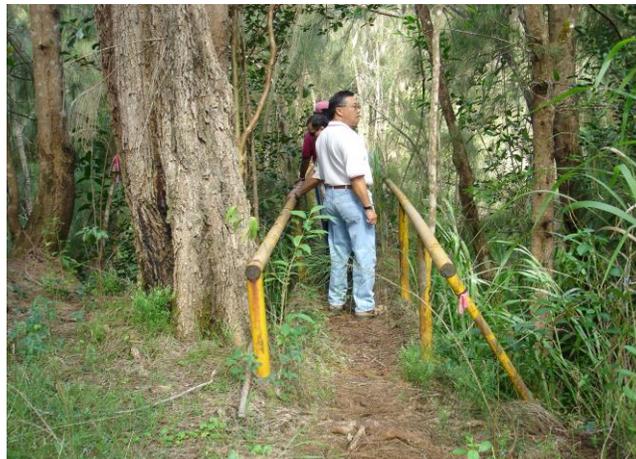
Plate 11. Footbridge Across Spillway

2 Looking downstream, the reinforced concrete spillway is located at the left abutment of the dam,
3 on a natural hillside (Plate 11). The spillway is 160 feet wide, has a 20-foot concrete apron and
4 an 8-foot ogee weir (Plates 12 and 13). The spillway structure converges from 160 feet at its
5 crest to a 30-foot wide chute that drops to a stilling basin, which is approximately 100 feet below
6 the crest. A 3.5-foot high weir is situated about 40 feet from the bottom end of the spillway
7 chute. Refer to Figure 5.

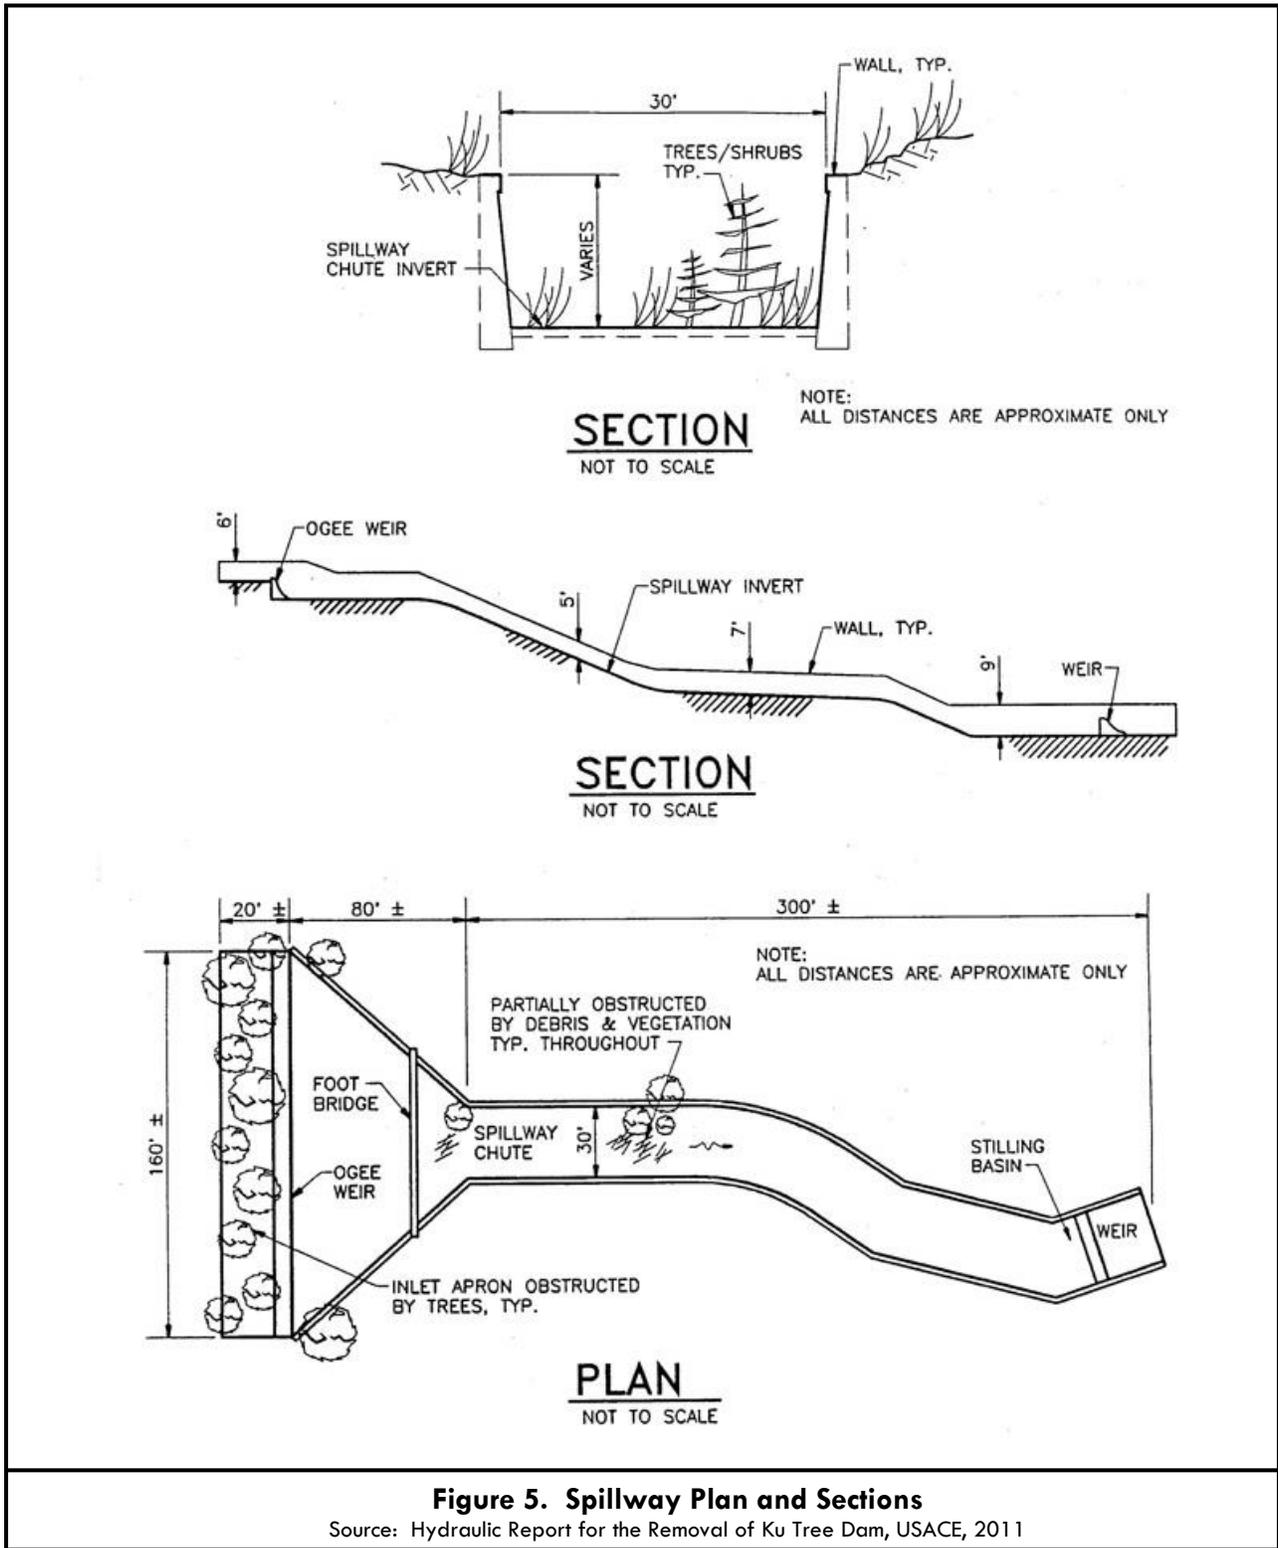
8
9 The spillway training walls vary in height—about 6 feet at the apron, 13 feet after the ogee weir,
10 to approximately 5 to 7 feet at the top of the chute. The height of the chute walls vary from
11 approximately 5 feet along the slope to about 7 to 9 feet at the lower, flat end of the chute.
12 Figure 5 below shows a cross section, a longitudinal section and the plan of the existing spillway.

13
14 According to the 1978 inspection report (C-E Maguire, Inc.), hydraulic analyses indicated that
15 the spillway can discharge capacity of 5,600 cfs at elevation 1,085 feet above msl (top of dam).
16 It further noted that a flood equal to the PMF (8,300 cfs) would over top the dam by 0.87 feet.
17

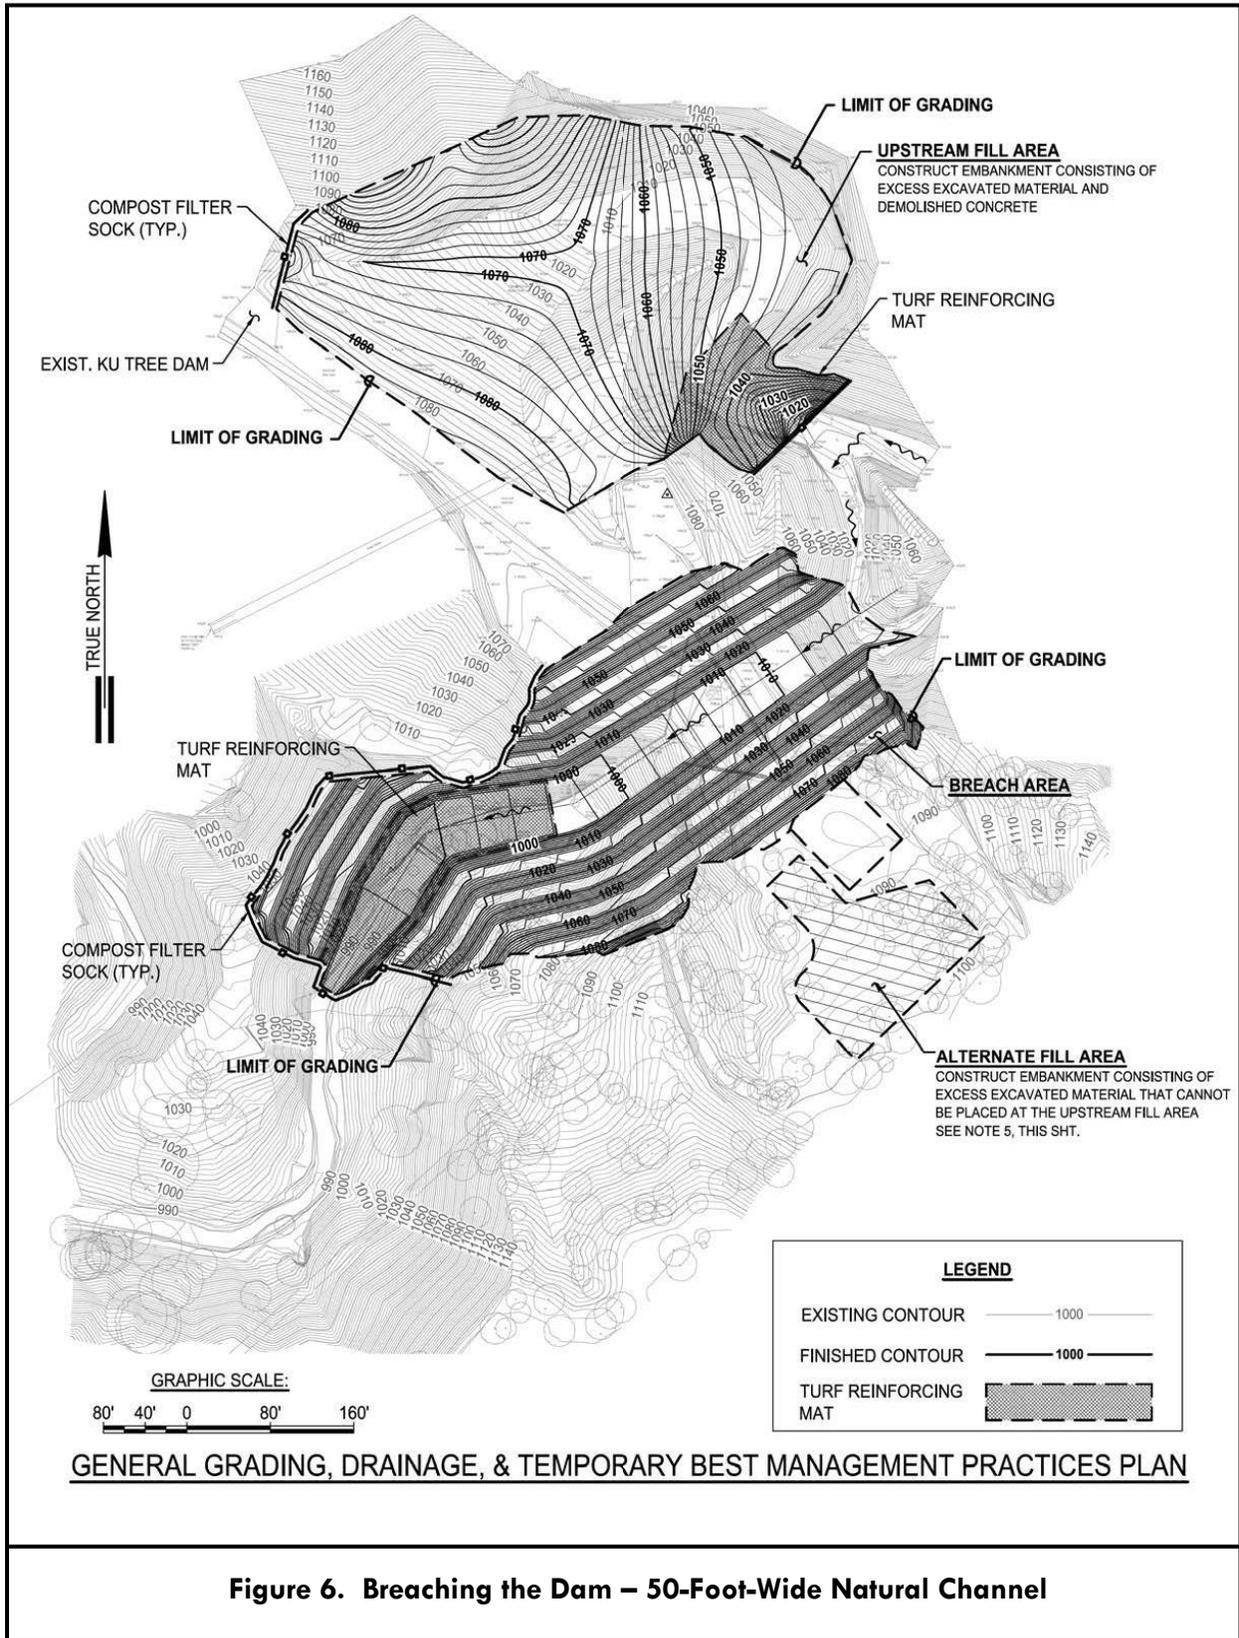
Figure 6. Breaching the Dam – 50-Foot-Wide Natural Channel

The Proposed Action would breach Ku Tree Dam by demolishing the spillway and excavating an approximately 500-foot long, natural channel through the natural hillside that supports the existing spillway. The hillside would be excavated to a depth of approximately 75 feet beneath the existing spillway entrance to match the elevation of the existing streambed. The natural channel would have a bottom width of approximately 50 feet with 1V:1H side slopes, benched every 20 feet to minimize erosion. The invert elevations of the new channel would range from approximately 1,015 feet above msl at its upstream end to approximately 990 feet above msl at the tie-in to the existing spillway channel. Provisions would be provided to ensure slope stability and establishment of vegetation. In areas subject to stream flow, turf reinforcement mats, made of pervious and flexible three-dimensional polypropylene, would be anchored to the soil to provide erosion control while allowing for mature plant growth at the up- and down-stream ends of the newly excavated natural channel. Over time, the environment in the vicinity of the natural channel is expected to transition into one that replicates naturally mature, vegetative conditions, further reducing erosion. Under this alternative, Ku Tree Dam would remain in place. The upstream dam would be filled with construction debris and approximately 112,000 cubic yards of excavated earth to block off water flow from entering the filled dam passage way. Figure 6 shows a conceptual section of the dam breach.

10 Two fill locations would be utilized for the project, the "upstream fill area" and "alternate fill
11 area." The proposed fill locations are identified on Figure 6. To the largest extent possible,
12 excavated material would be reused on site or wasted on the upstream side of the dam (upstream
13 fill area) to minimize any off-site disposal. The alternate fill area would serve as a secondary fill
14 location for the placement of excavated material necessary to finish construction of the natural
15 channel and allow for the Contractor to remove the construction equipment from the site.
16 Demolished concrete would be used as fill at the upstream and alternate fill location.
17 Rebar/metal would be disposed of off-site.
18

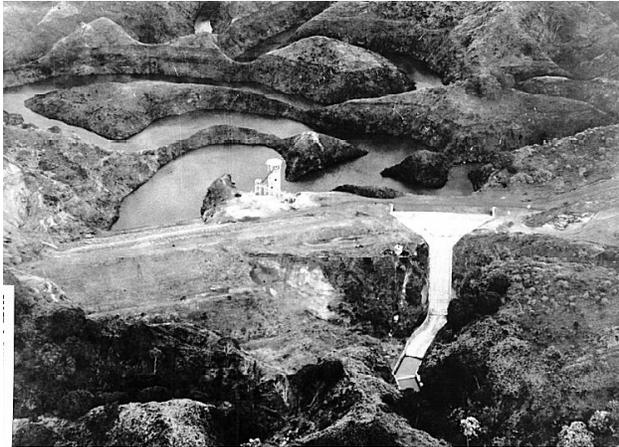
Plate 14 **Looking Upstream at Ku Tree Dam Shortly After Construction (c. 1925)**

22 Ku Tree Dam is a hydraulic earth-filled dam, approximately 550 feet long by 90 feet high with a
23 crest width of 30 feet. Construction of the dam crest blocked the original flow path of South
24 Kaukonahua Stream, impounding water behind the dam, and creating Ku Tree Reservoir which
25 drowned the two meandering tributaries of South Kaukonahua Stream behind the dam at the
26 1,159-foot elevation. Figure 1 shows the relationship of the original flow path to the dam. The
27 captured streams are located in narrow, meandering, forested gulches, populated primarily by
28 alien plant species, which cover 0.83 square miles (531 acres) of drainage area (AECOS, 1984).
29 The drainage area associated with Ku Tree Reservoir represents approximately 5 percent of the
30 drainage basin that supplies water to Wahiawā Reservoir. Plates 14 and 15 below are aerial
31 photos that show the dam, spillway and concrete control tower, which regulated the water levels

32 within the reservoir, shortly after their construction in 1925. At maximum capacity, the reservoir
33 pool was 32 acres (13 hectares) in size and provided storage of 900 acre-feet (293 million
34 gallons) of water
35

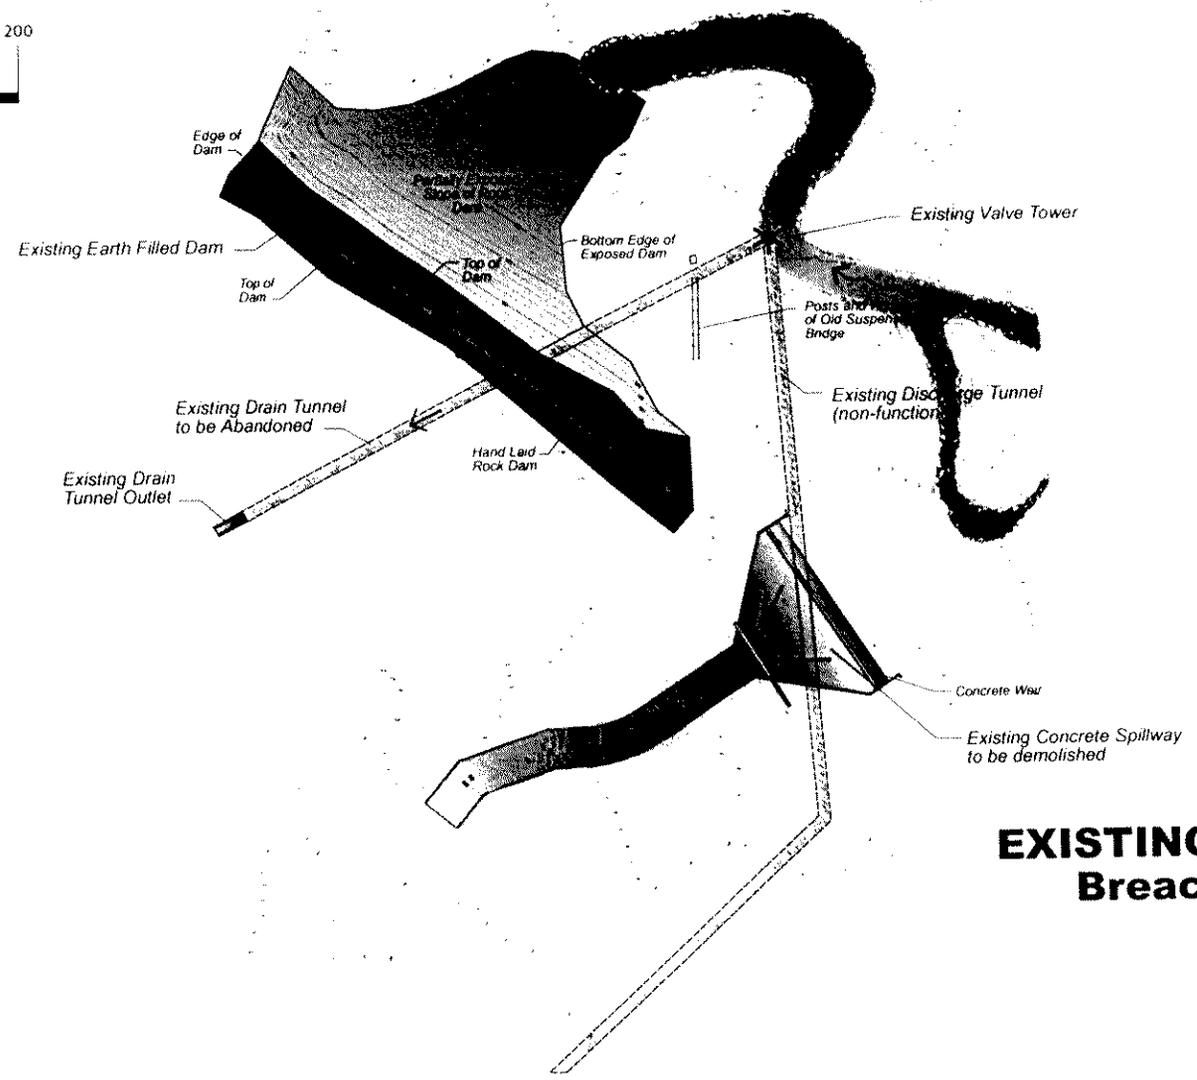
DRAFT
FIGURE 2

**EXISTING CONDITIONS
Breach Ku Tree Dam**

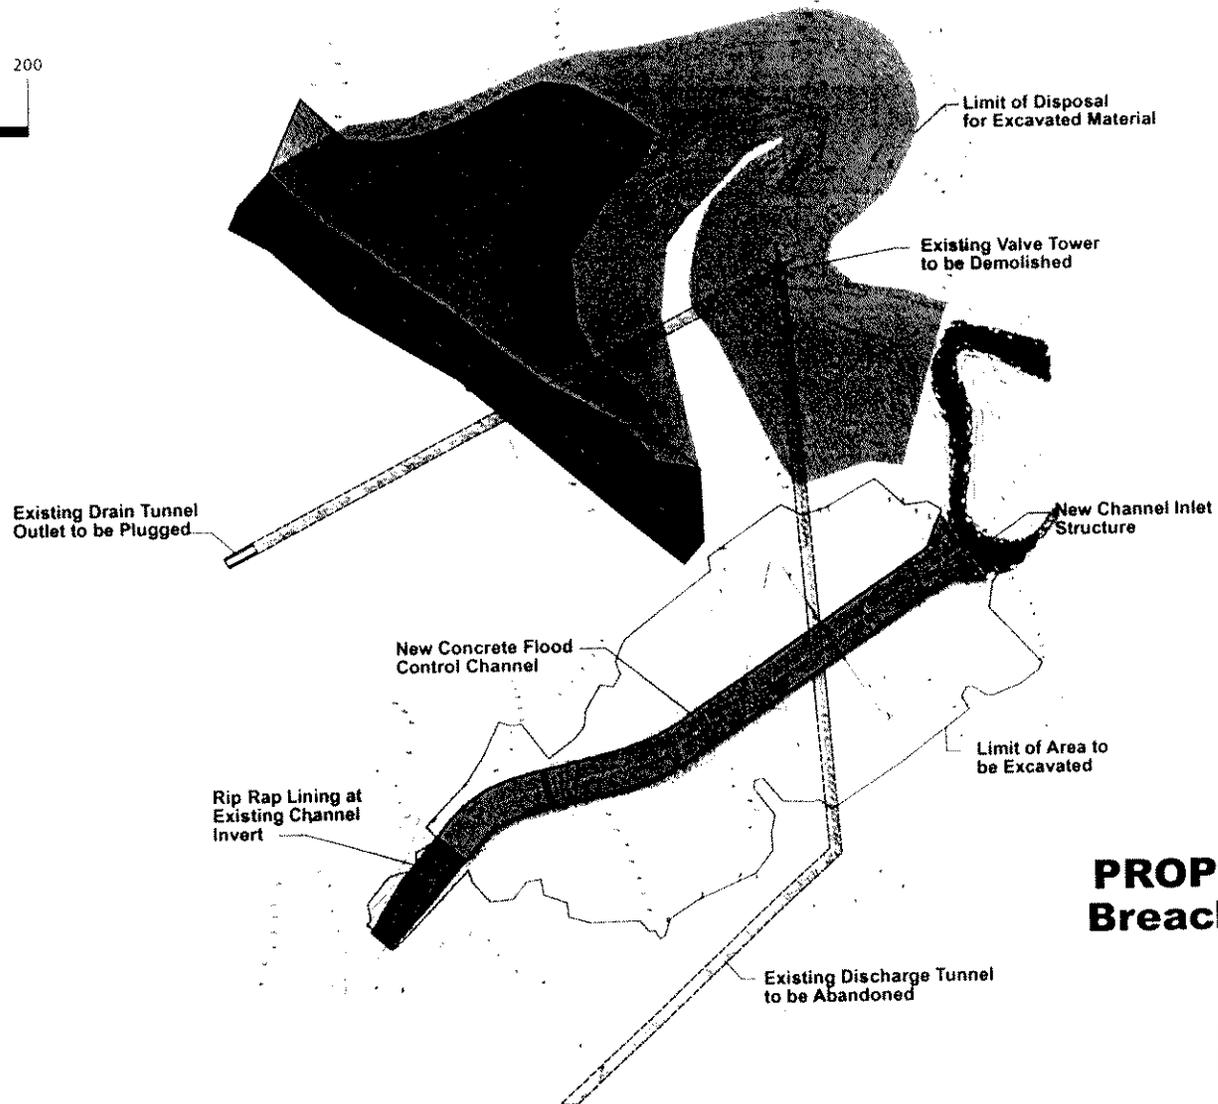
**PROPOSED ACTION
Breach Ku Tree Dam**

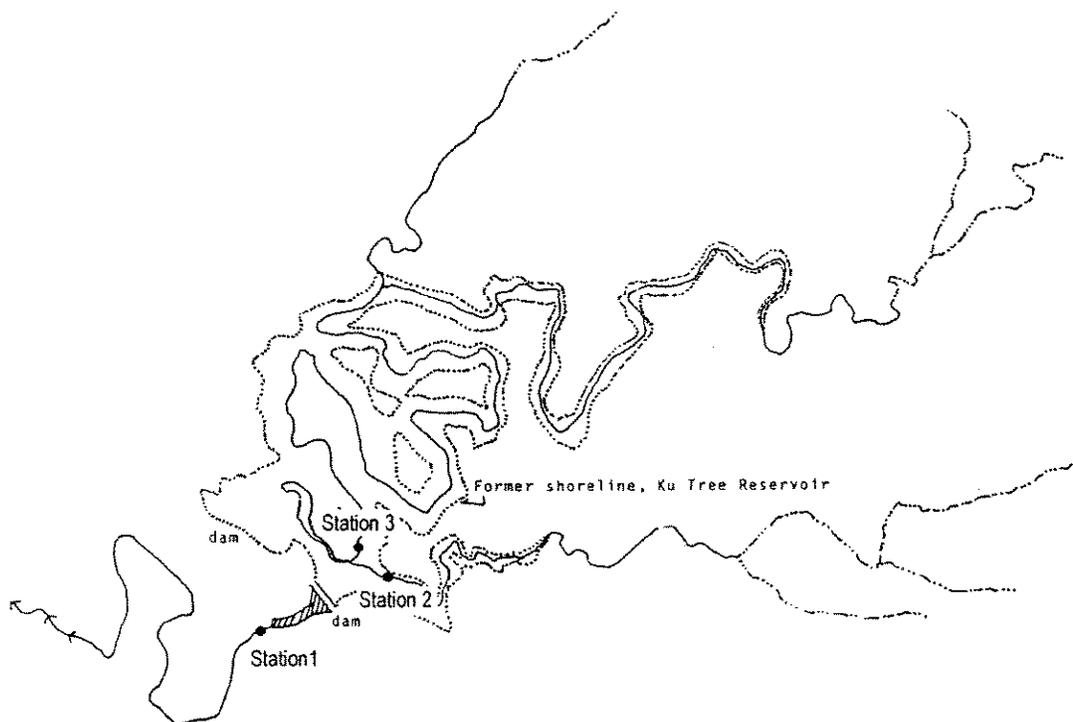
Figure 2. Sampling locations for the January 12, 2004 water quality sampling of an unnamed tributary to South Kaukonahua Stream, East Range, O`ahu.

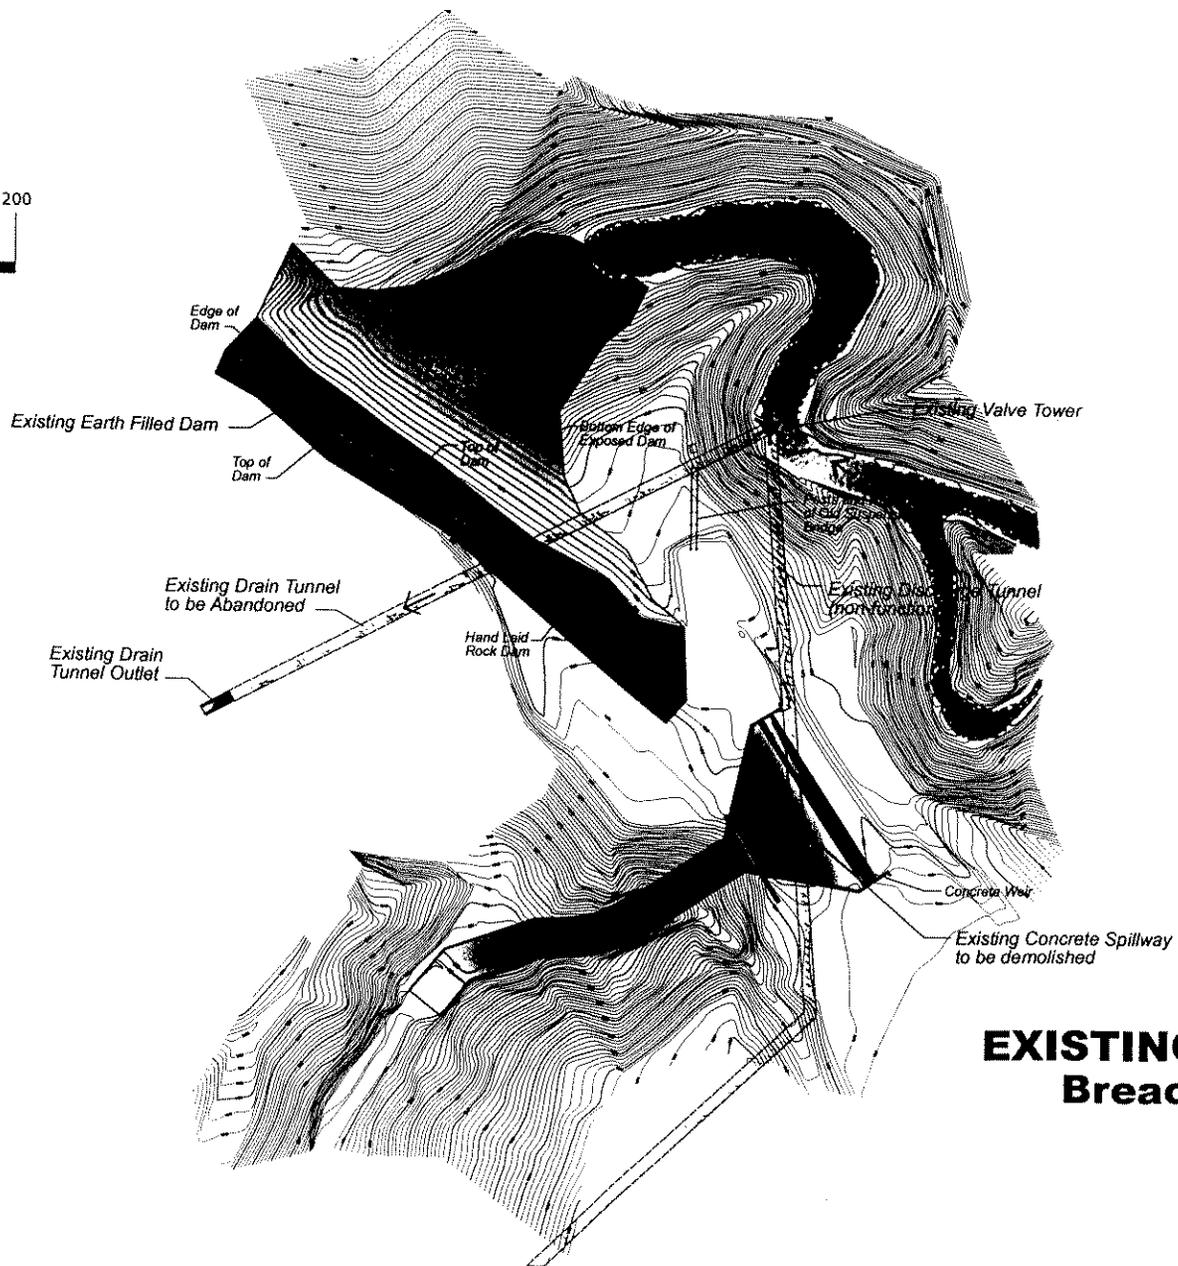
Figure 2

**EXISTING CONDITIONS
Breach Ku Tree Dam**

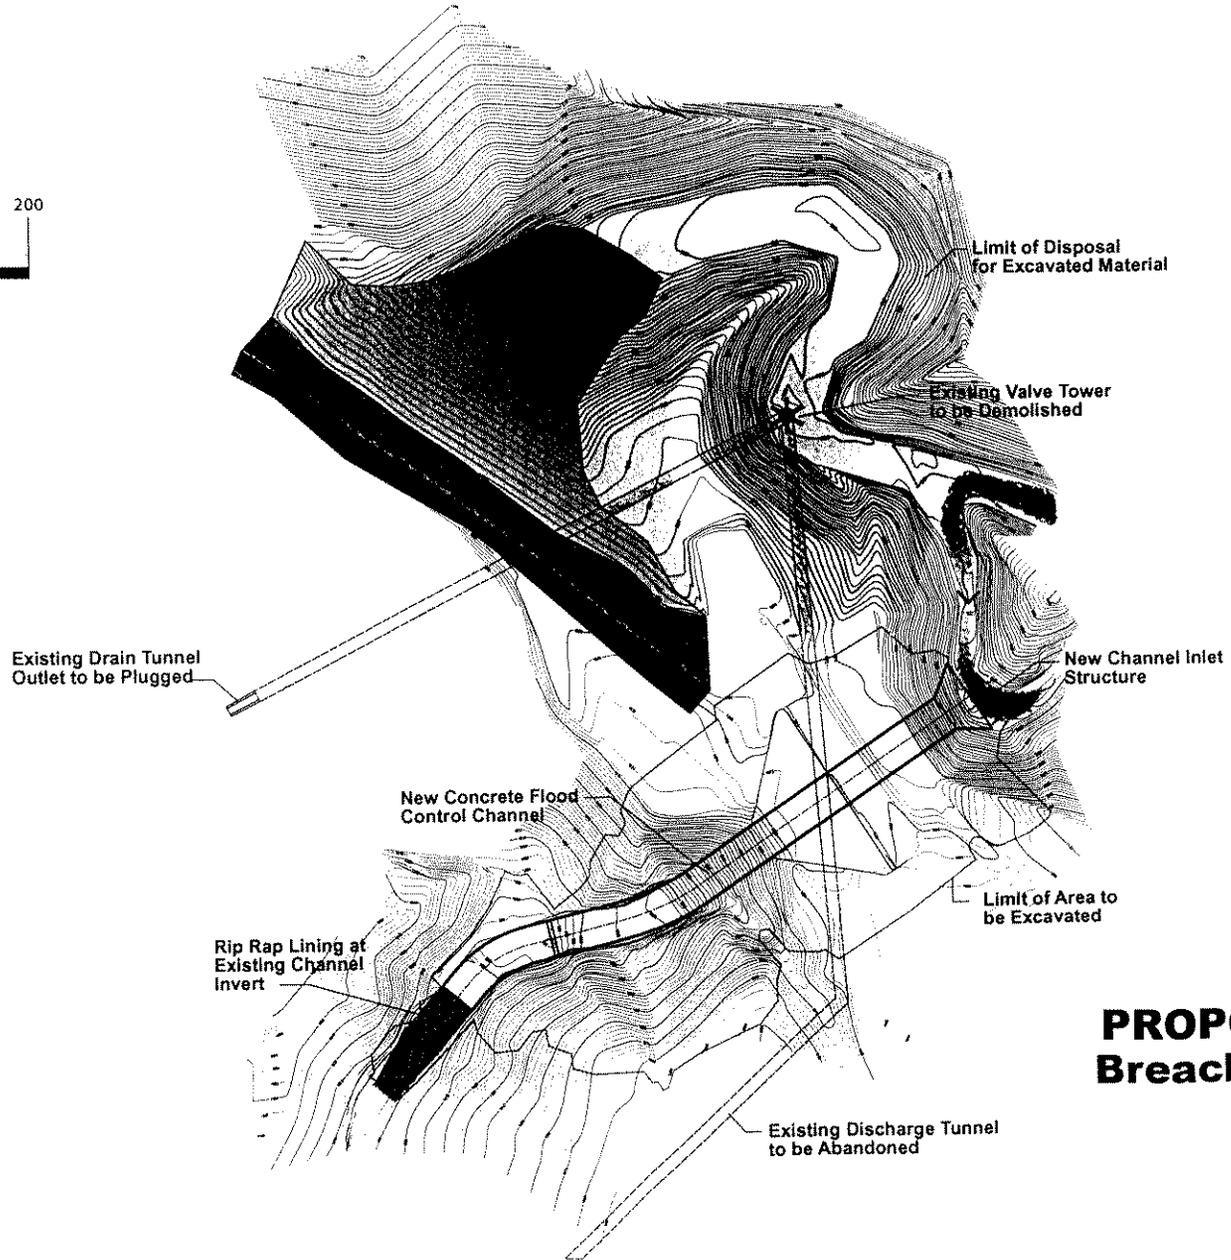
Figure 3
PROPOSED ACTION
Breach Ku Tree Dam

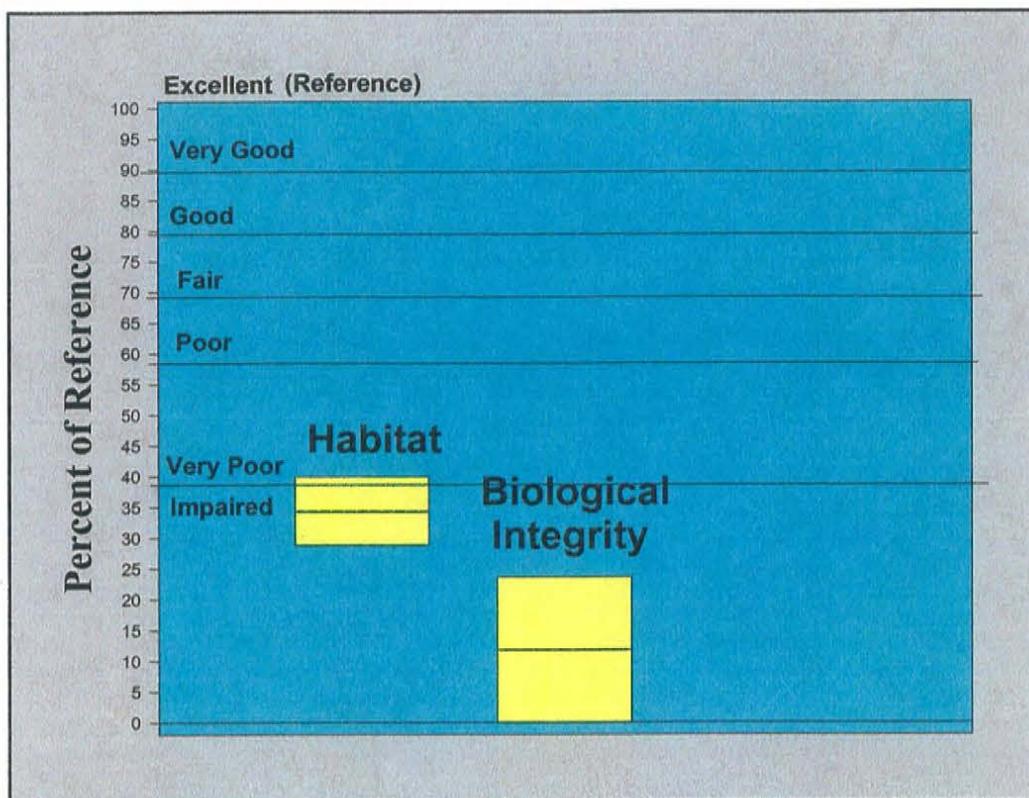
Figure 2. Box plots of overall Habitat and Biotic Integrity ratings by the HSBP of Ku Tree Reservoir streams (upper and lower lines of boxes indicate 90th and 10th percentiles respectively; dotted line inside box is the mean).

Based upon the surveys of the four formal HSBP bioassessment study sites established along the continuum of the stream above and below Ku Tree Reservoir, the overall habitat and biotic integrity condition of these streams were rated as being highly “Impaired” ($34.4 \pm 4.431\%$ and $11.8 \pm 6.813\%$ of reference respectively) (Fig. 2). Impaired habitat and integrity ratings indicate that the stream system had been degraded to the point that it had lost natural ecosystem function and resilience.

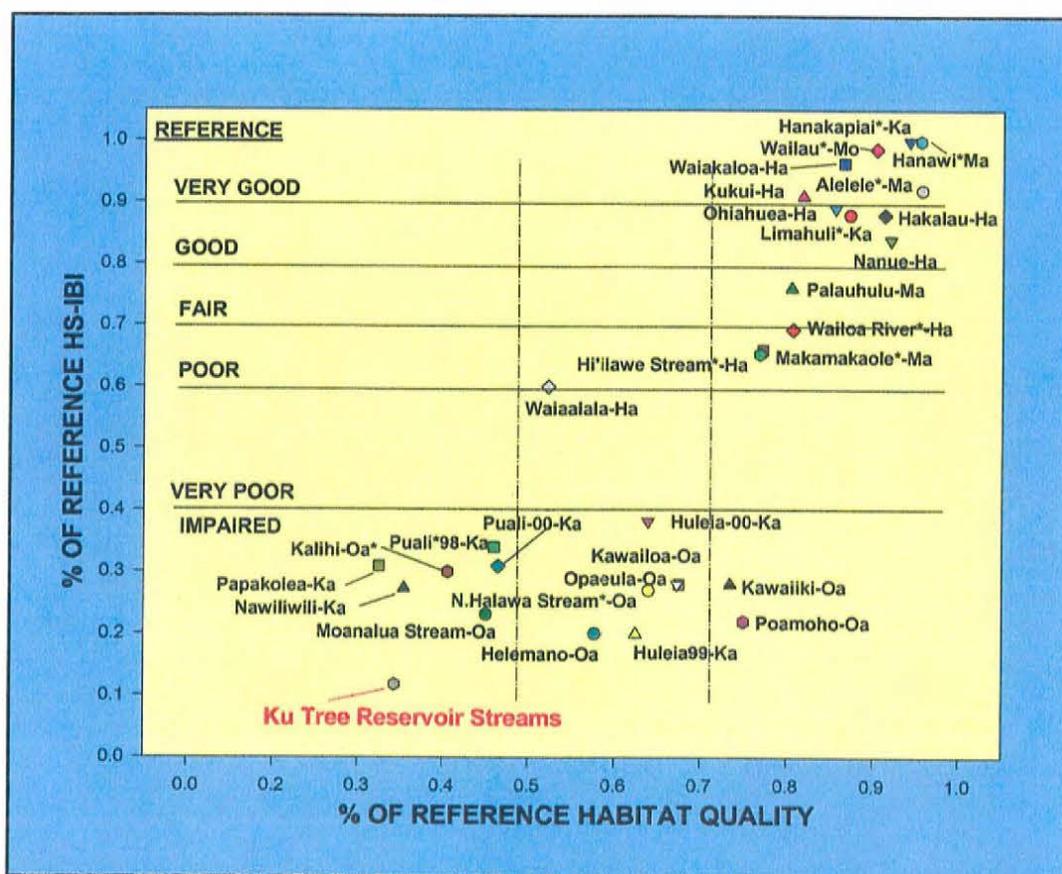
Figure 3. Statewide comparisons of stream biotic integrity (HS-IBI) and condition of supporting habitat in Ku Tree Reservoir streams (Oahu) (*averaged values in streams that have been sampled at multiple elevations and / or times, Ka = Kauai, Oa = Oahu, Ma = Maui, Mo = Molokai, Ha = Hawaii).

Overall physical habitat quality and biological integrity in Ku Tree Reservoir streams were found to be severely “Impaired” by channel modifications, chronic sedimentation, stream flow reductions and the physical presence of the reservoir. HSBP ratings for these particular streams were, in fact, the worst yet determined for streams thus far surveyed in the Hawaiian Islands (Fig. 3). Not only were no native aquatic species observed in stream study sites, but alien species diversity and abundance was also conspicuously low indicating very severe impairment of ecosystem function and loss of resilience.

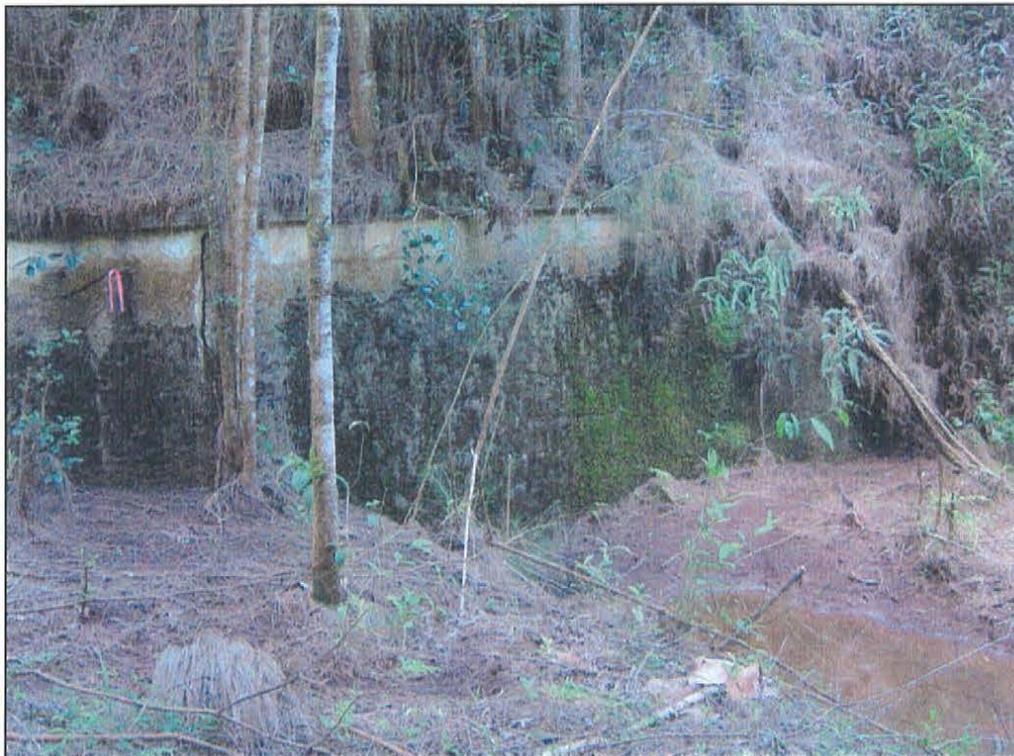
Photo 1. Concrete-lined spillway for reservoir over-flow into the natural stream channel.
