Project Name: Proposed Breach of Ku Tree Dam at Schofield Barracks-East Range Environmental Assessment and Draft Finding of No Significant Impact

**ENVIRONMENTAL ASSESSMENT AND DRAFT FINDING OF
NO SIGNIFICANT IMPACT**

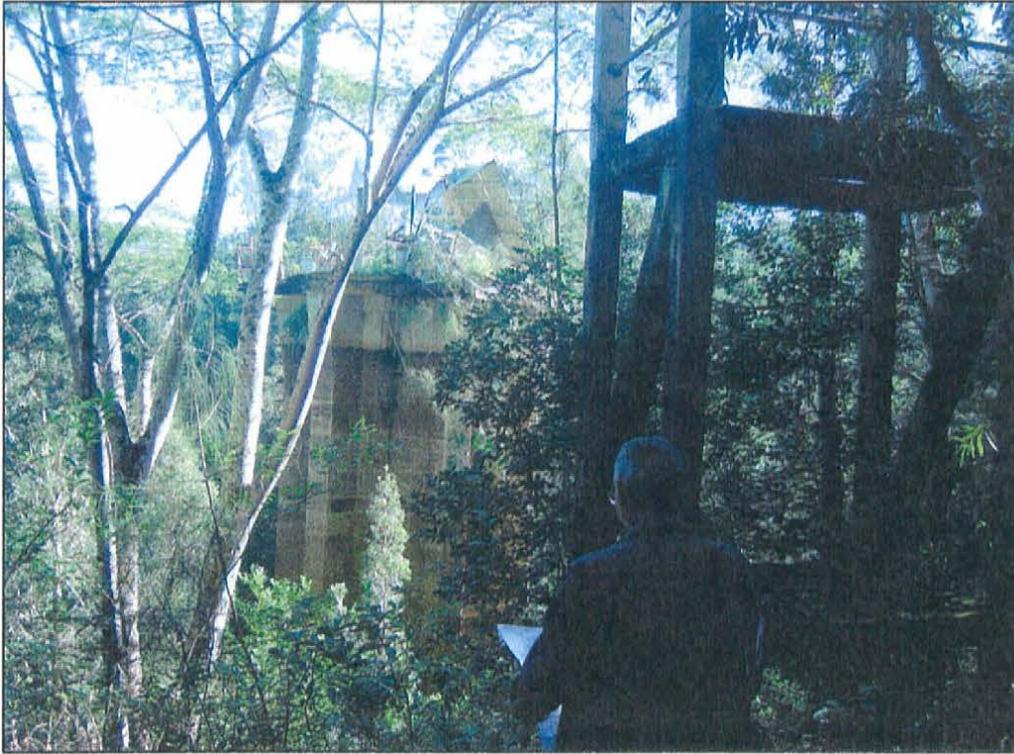
Photo 2. Top of concrete control tower and remnants of elevated access walkway.

17 The tower foot bridge provided access from the dam to the wood-framed control room atop the
18 valve control tower (Plates 7 and 8). It extended from a natural knoll along the left abutment of
19 the dam. The bridge system was composed of an approach walk and a suspension bridge span.
20 The 8-spanned approach walk was 80 feet long and had a wood deck. The suspension bridge
21 was 67 feet long and was suspended by a pair of 1-inch diameter steel cables. The suspension
22 spans have collapsed and the approach spans are seriously deteriorated. The wooden deck of the
23 approach walk is no longer existent.

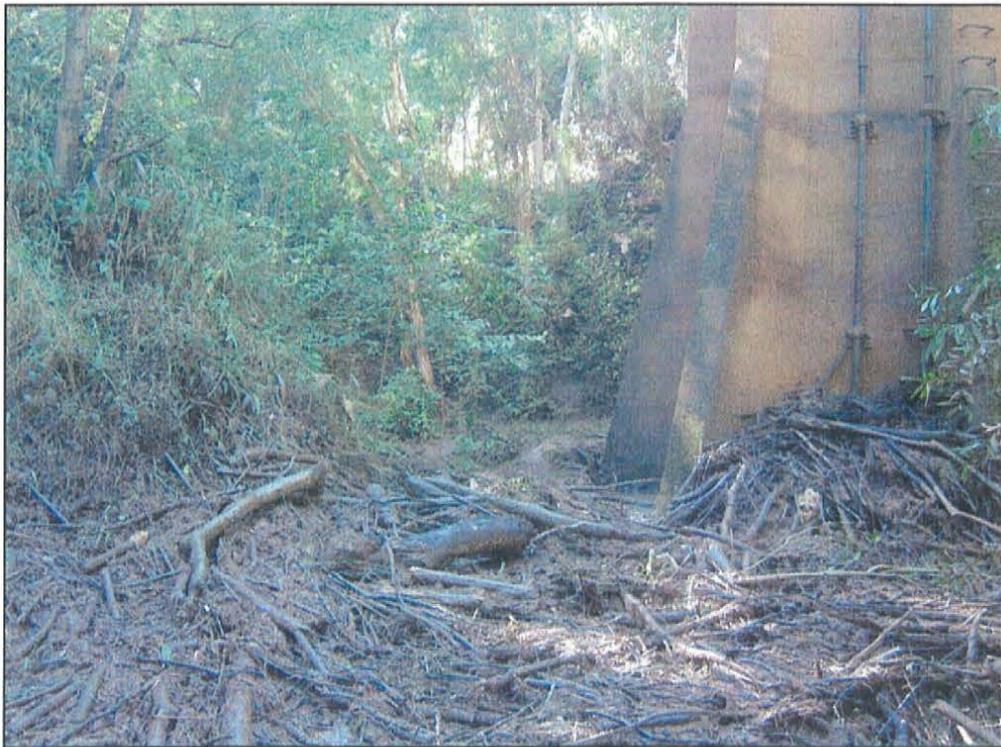
Photo 3. Tons of organic debris deposited at the control tower base after flooding.

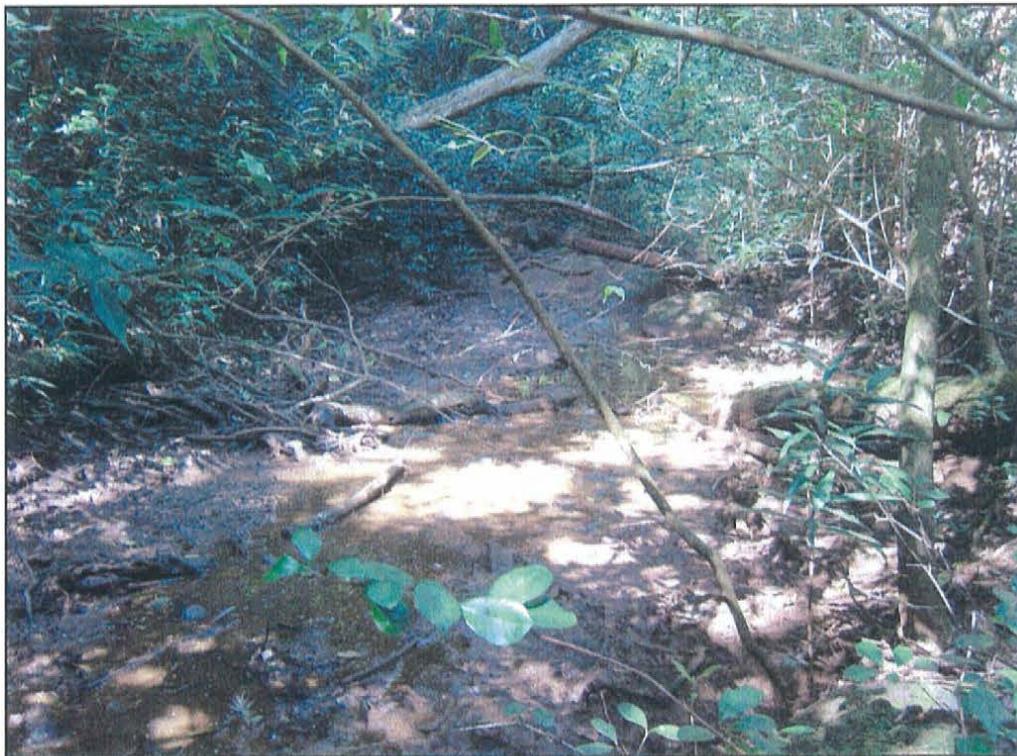
Photo 4. Excessive sedimentation of stream channel in Site 2 below Ku Tree reservoir.

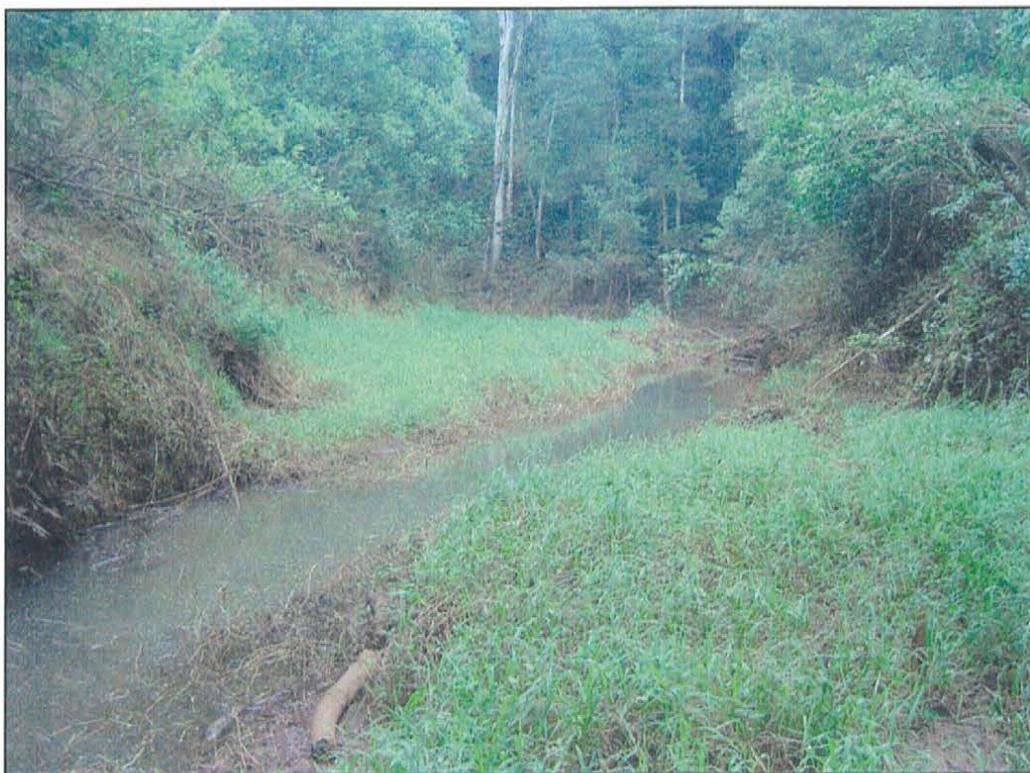
Photo 5. High sediment deposition area in Site 4 above Ku Tree Reservoir intake tower.

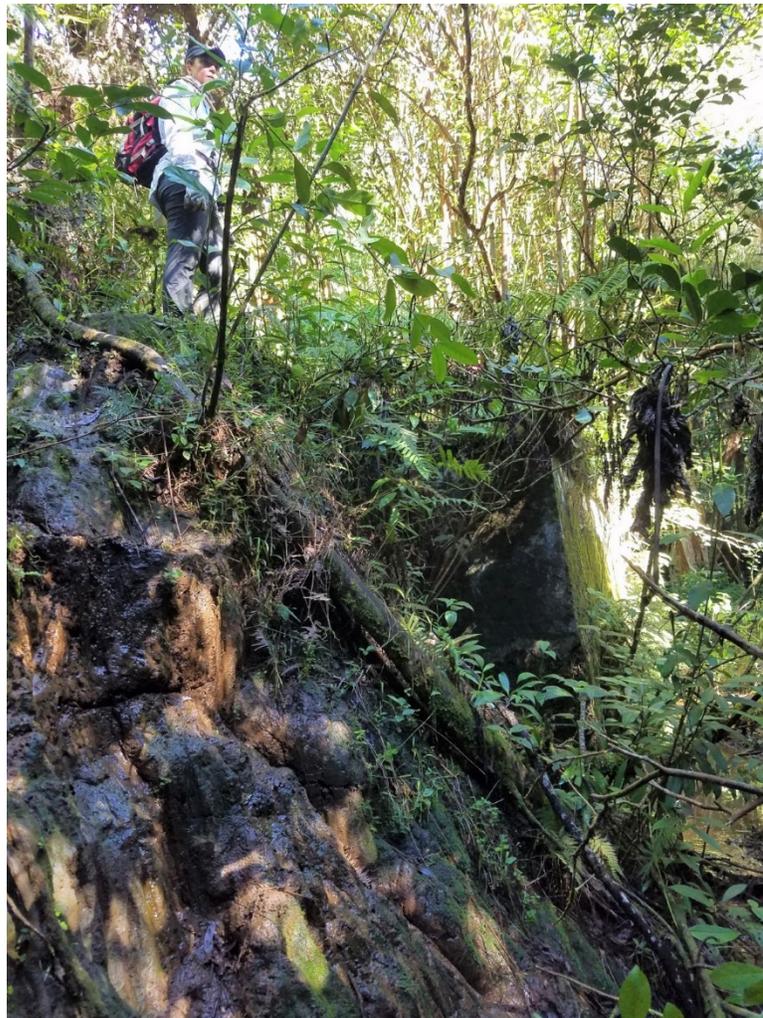
Figure 5 – Looking upstream at the mud and clay walls along the scoured stream channel at the end of the concrete spillway in the downstream portion of the APE.

On December 10, 2019, USAG-HI archaeologists inspected the downstream portion of the project area to document current conditions and look for any cultural resources and potential historic properties that might be present. The team found the area to be a narrow, deeply incised stream channel that was heavily scoured by water, bounded by dangerously steep mud and clay walls and cliffs, and covered with dense, often impassible, vegetation (Figures 5-6).

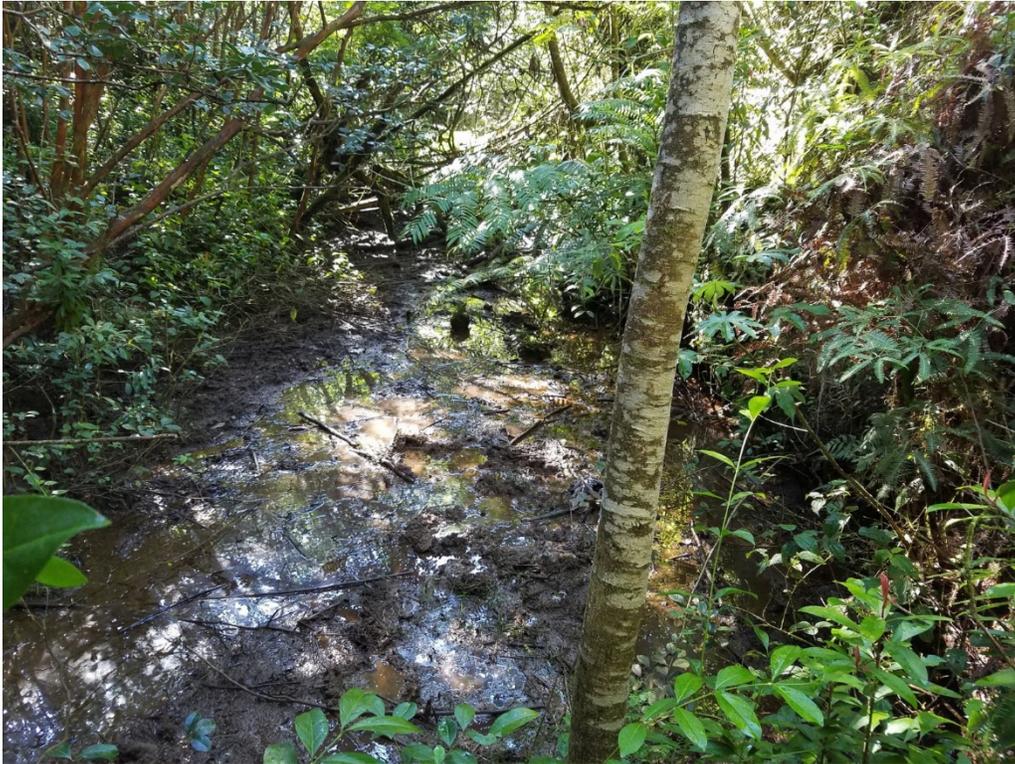
Figure 6 – Looking downstream in the APE at the narrow incised stream channel below the spillway bounded by steep slopes and dense vegetation.

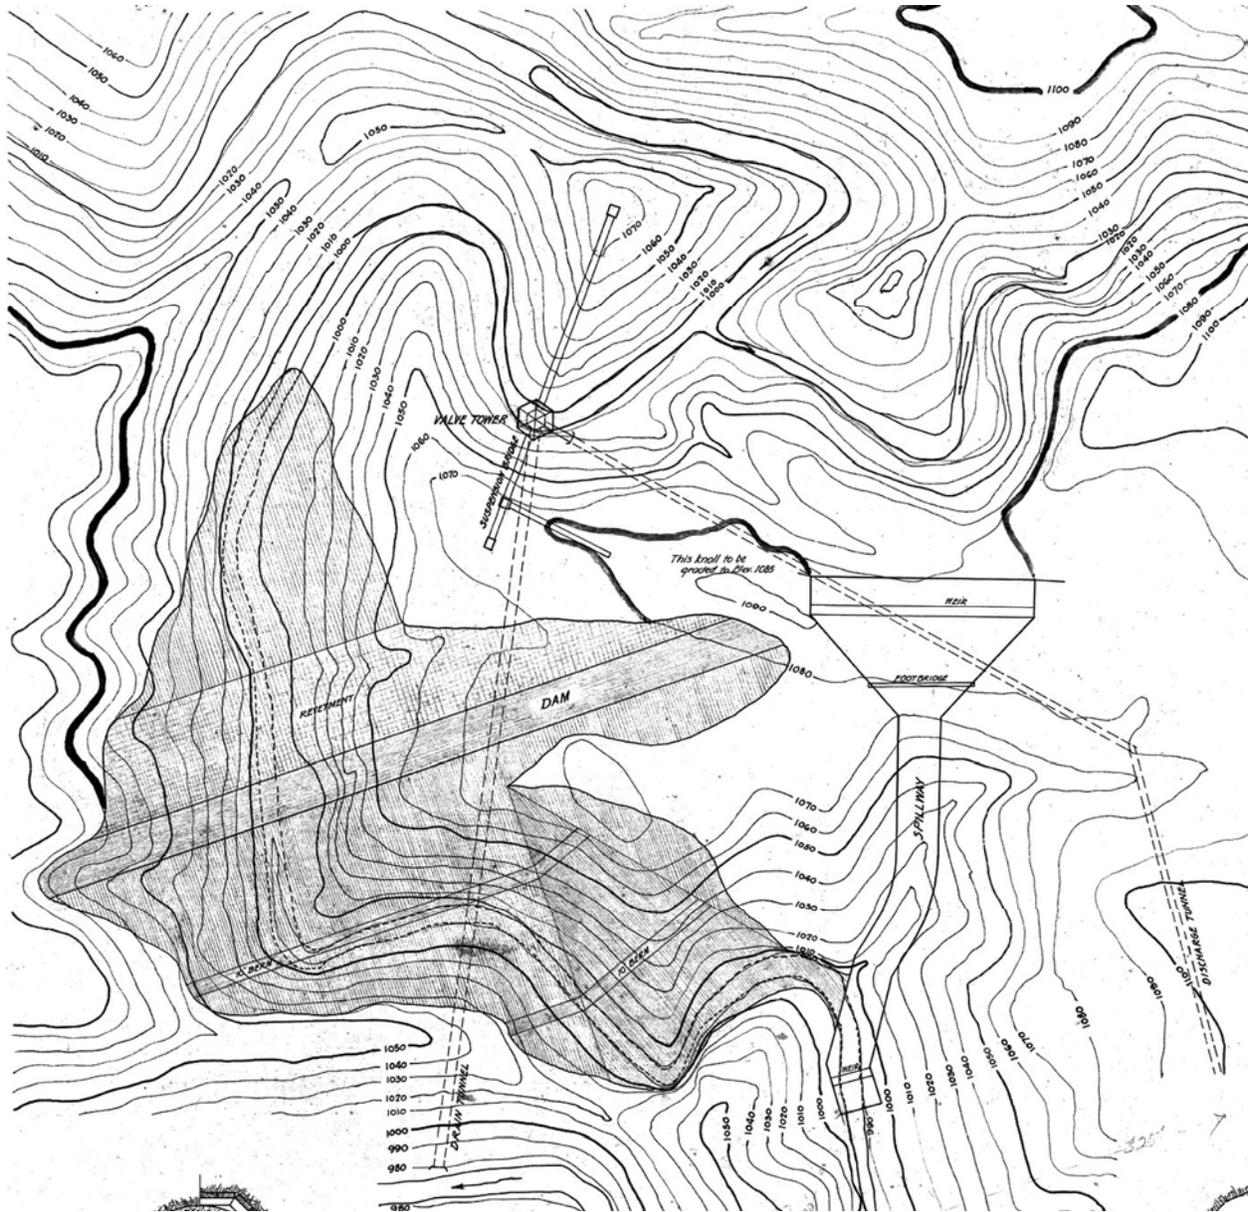
Figure 2: Plan of Dam, Ku Tree Reservoir. Job No. S3603, Sheet 4, dated July 1924.

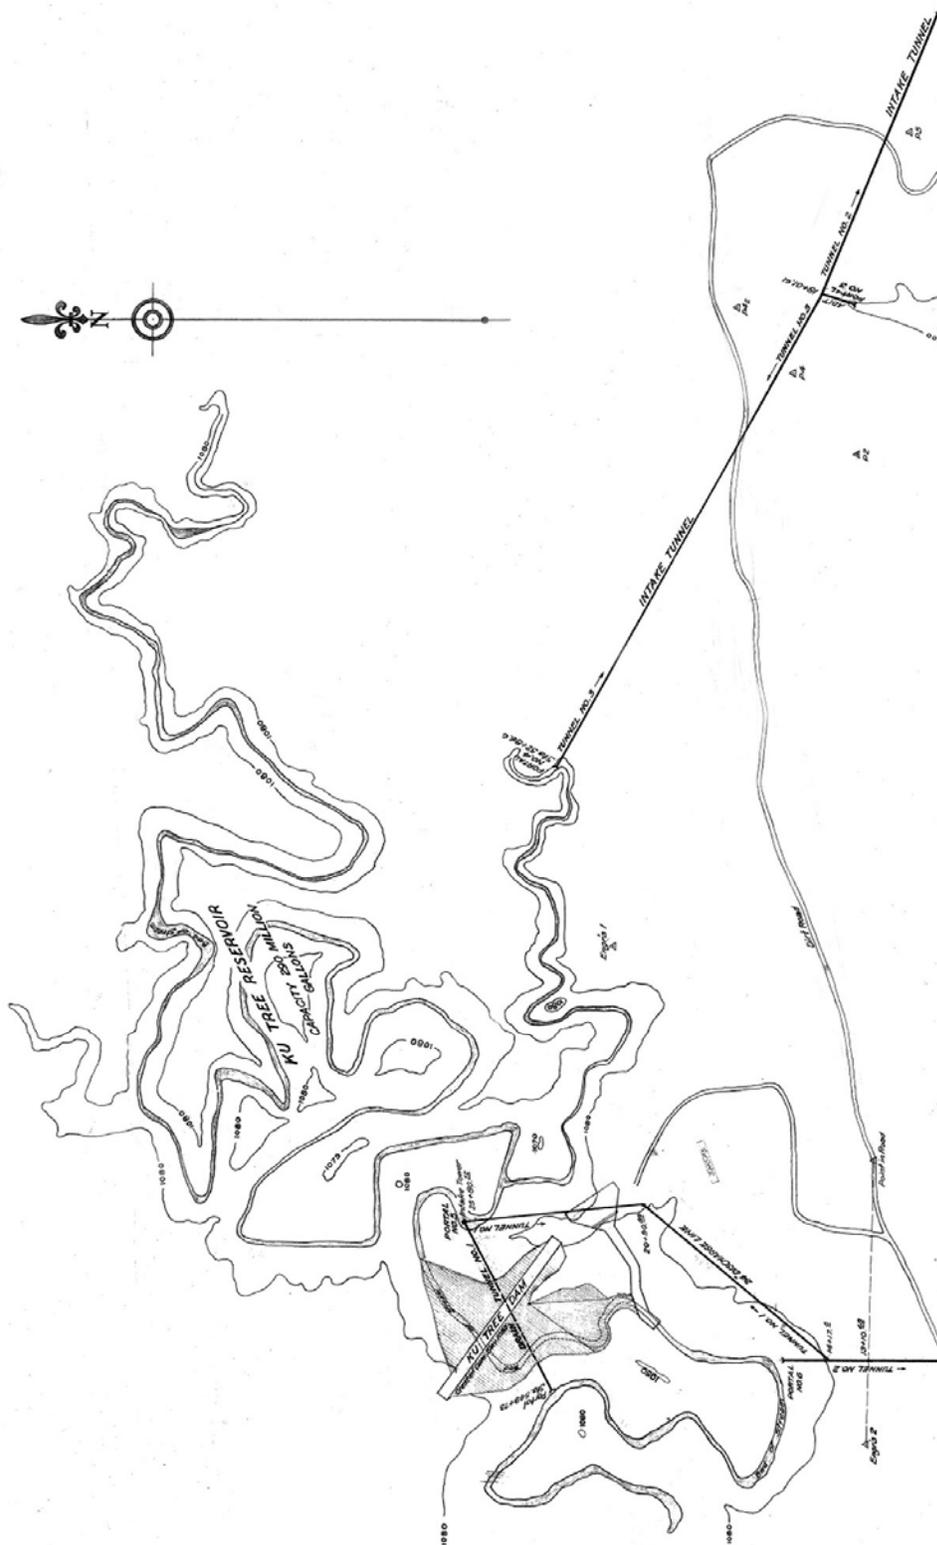
Figure 3: Schofield Barracks Water Supply, Ku Tree Reservoir Site with Connecting Tunnels & Pipelines. Job No. S3603, Sheet 1, dated July 15, 1929.

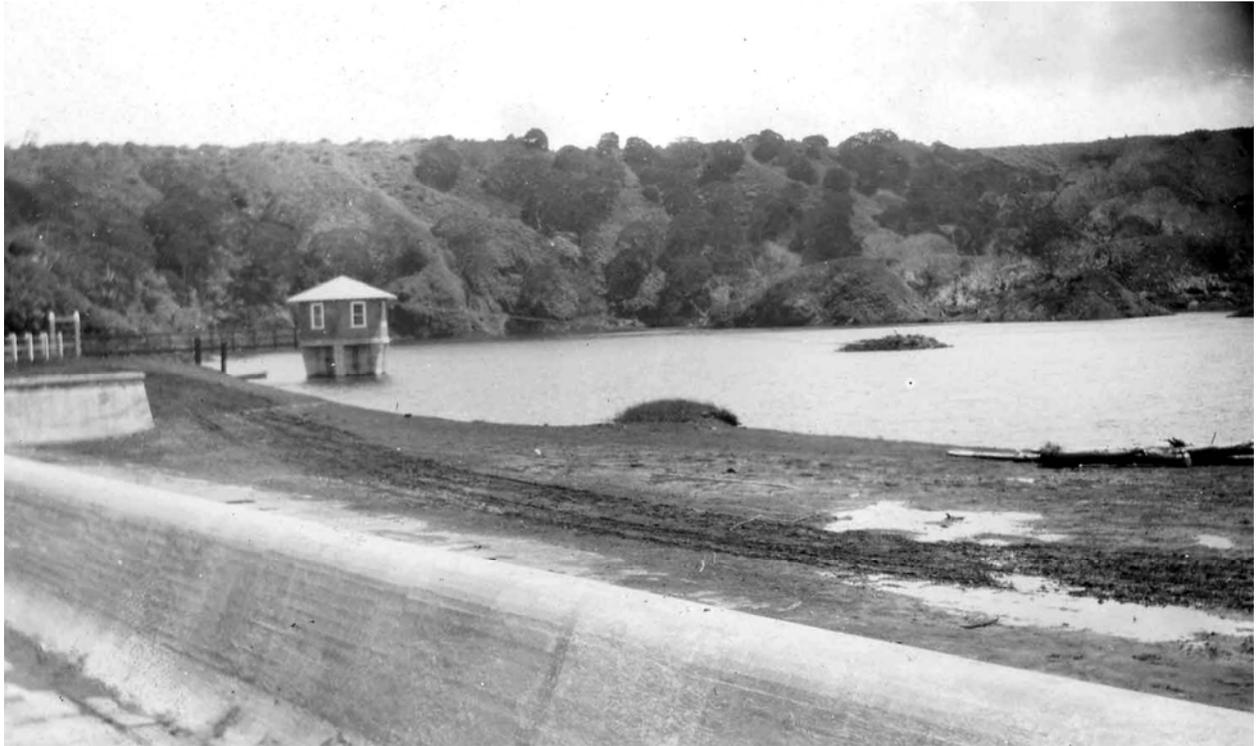
Figure 8: Dam with footbridge and valve house on tower in background. (U. S. Army Museum, Fort DeRussy, Hawaii, Historical photograph USAMH 6349)

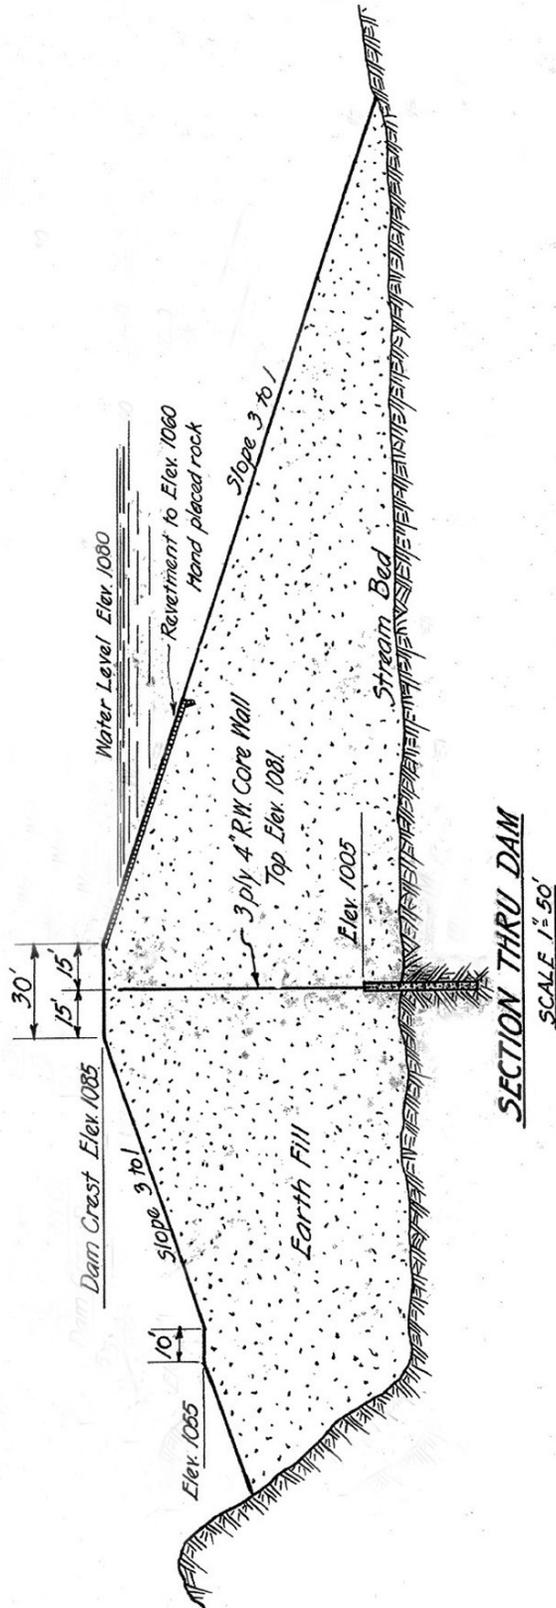
Figure 1: Section Thru Dam. Job No. S3603, Portion of Sheet 4, dated June 1924.

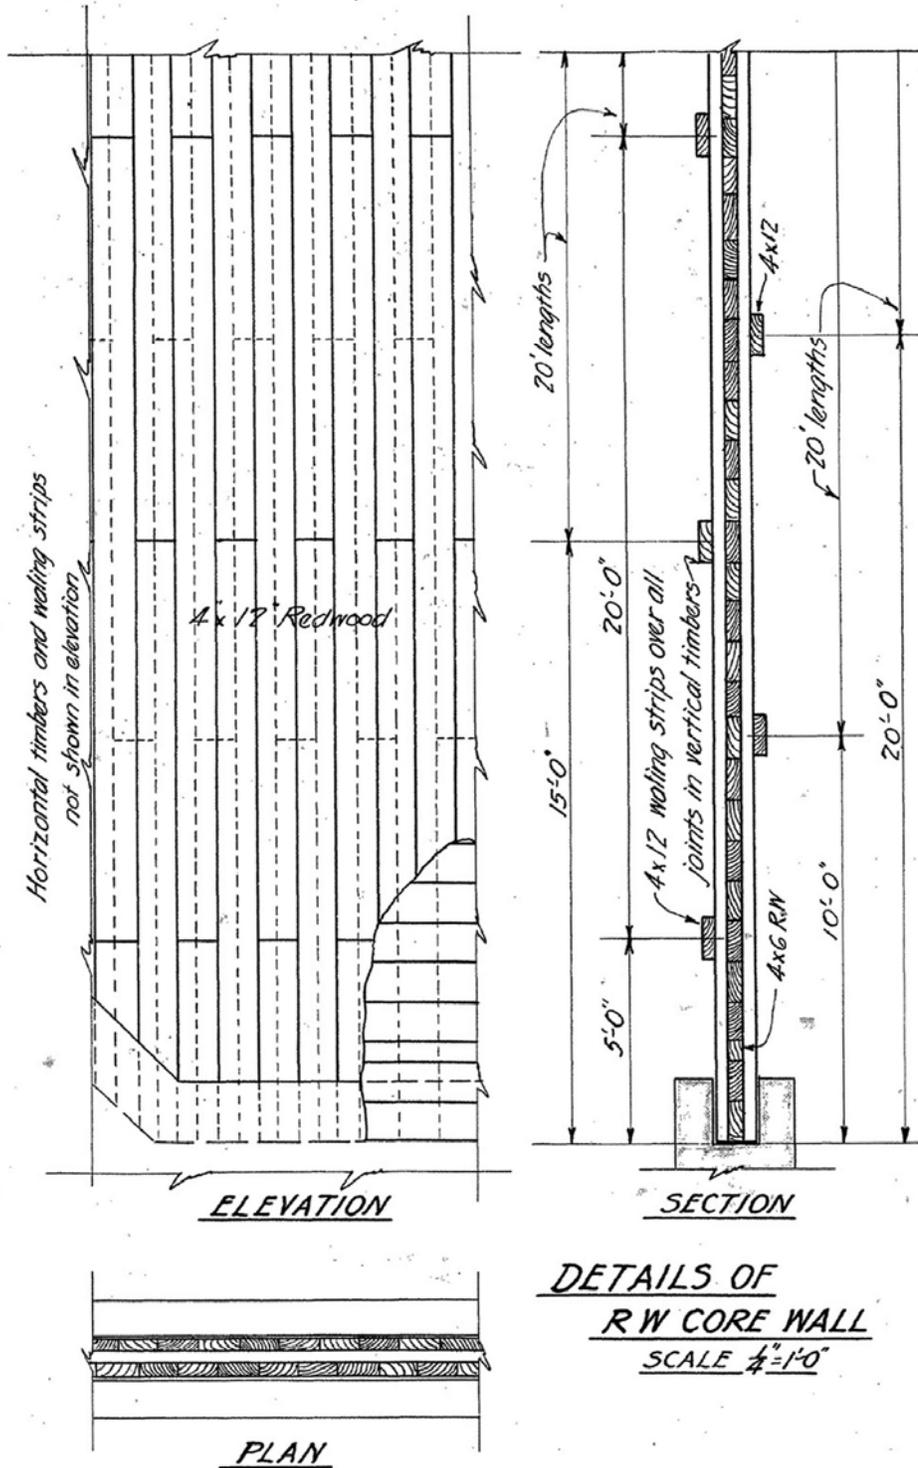
Figure 2: Details of Redwood Core Wall. Job No. S3603, Portion of Sheet 5, dated Dec. 29, 1923

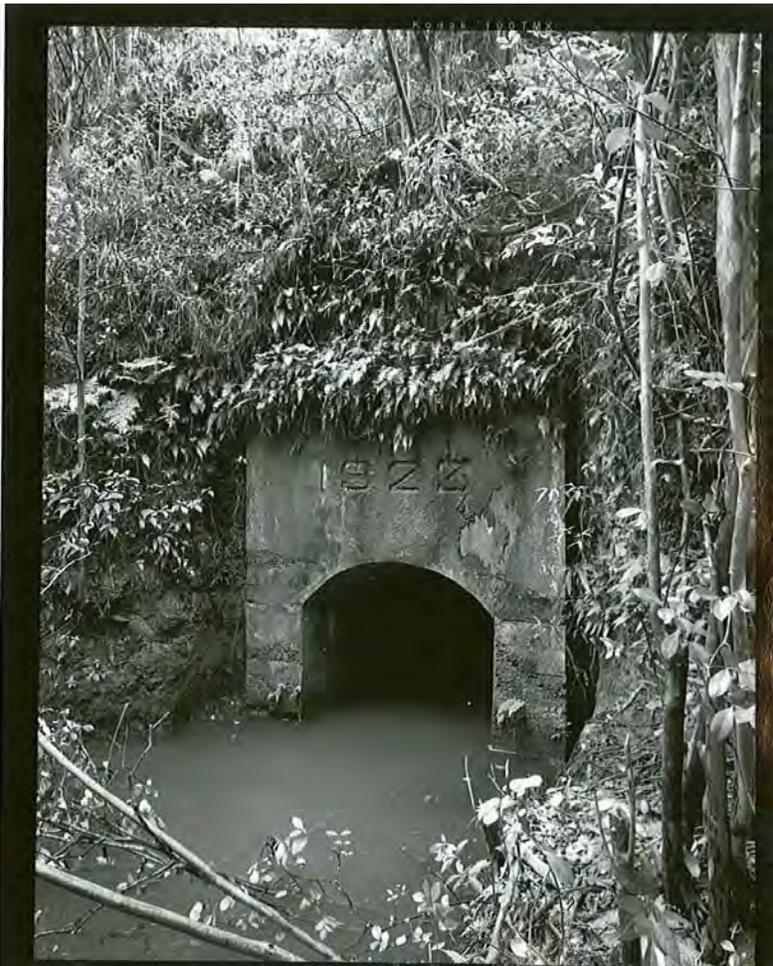
HAER No. HI-81-A-1

HI-81-A-1 DRAIN TUNNEL PORTAL. VIEW FACING NORTH.

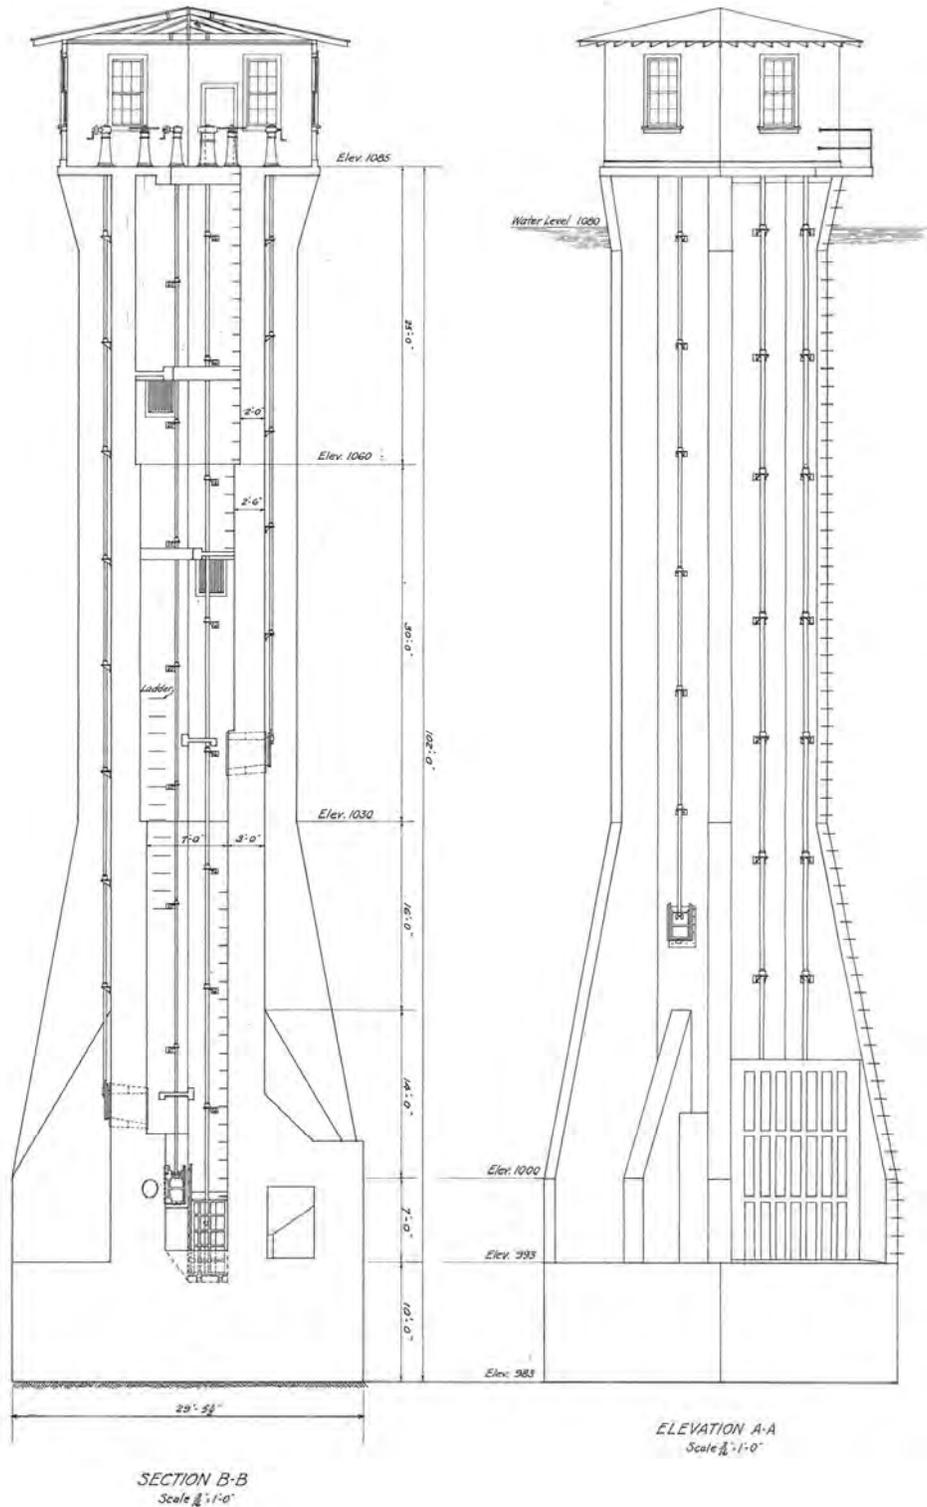
Figure 1: Elevation and Section, Valve Tower, Ku Tree Reservoir. Job No. S3603, Sheet 11, dated Sept. 3, 1924.

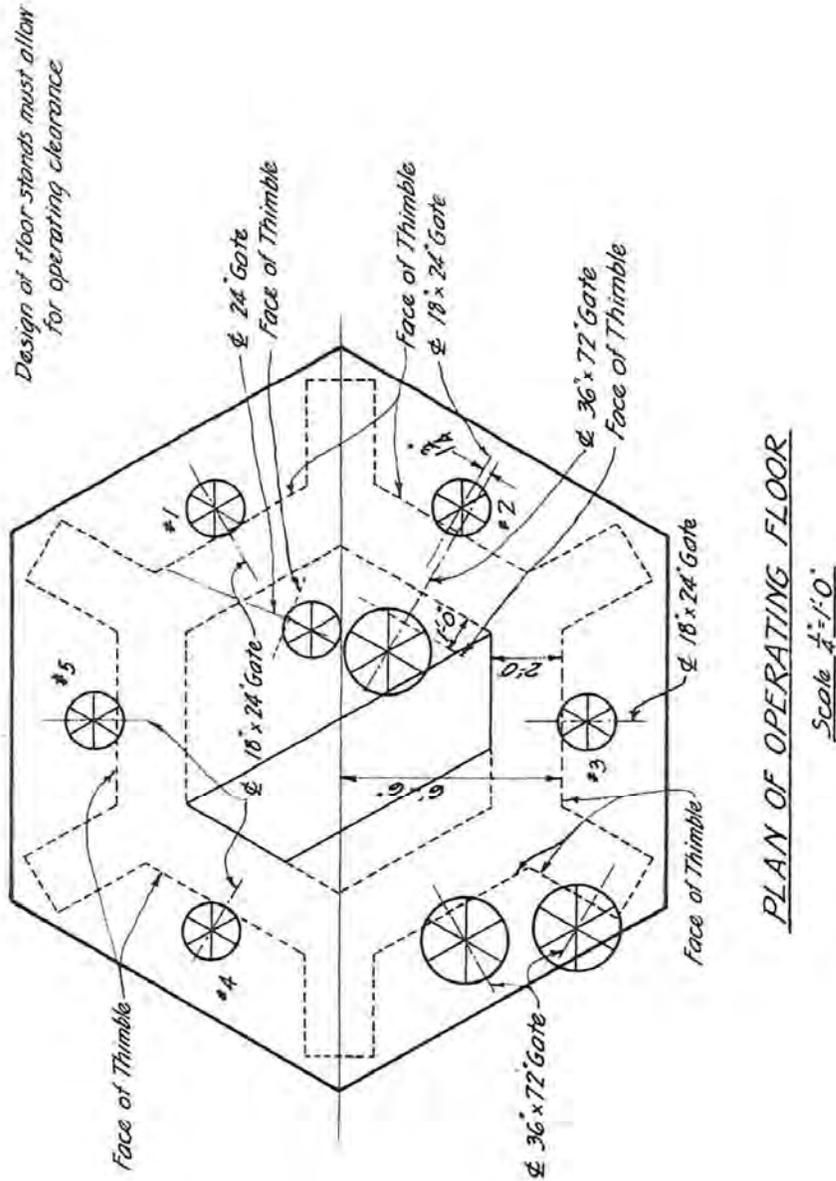
Figure 3: Gates for Valve Tower, Ku Tree Reservoir. Job No. S3603, Sheet 28, dated Dec. 1, 1923.

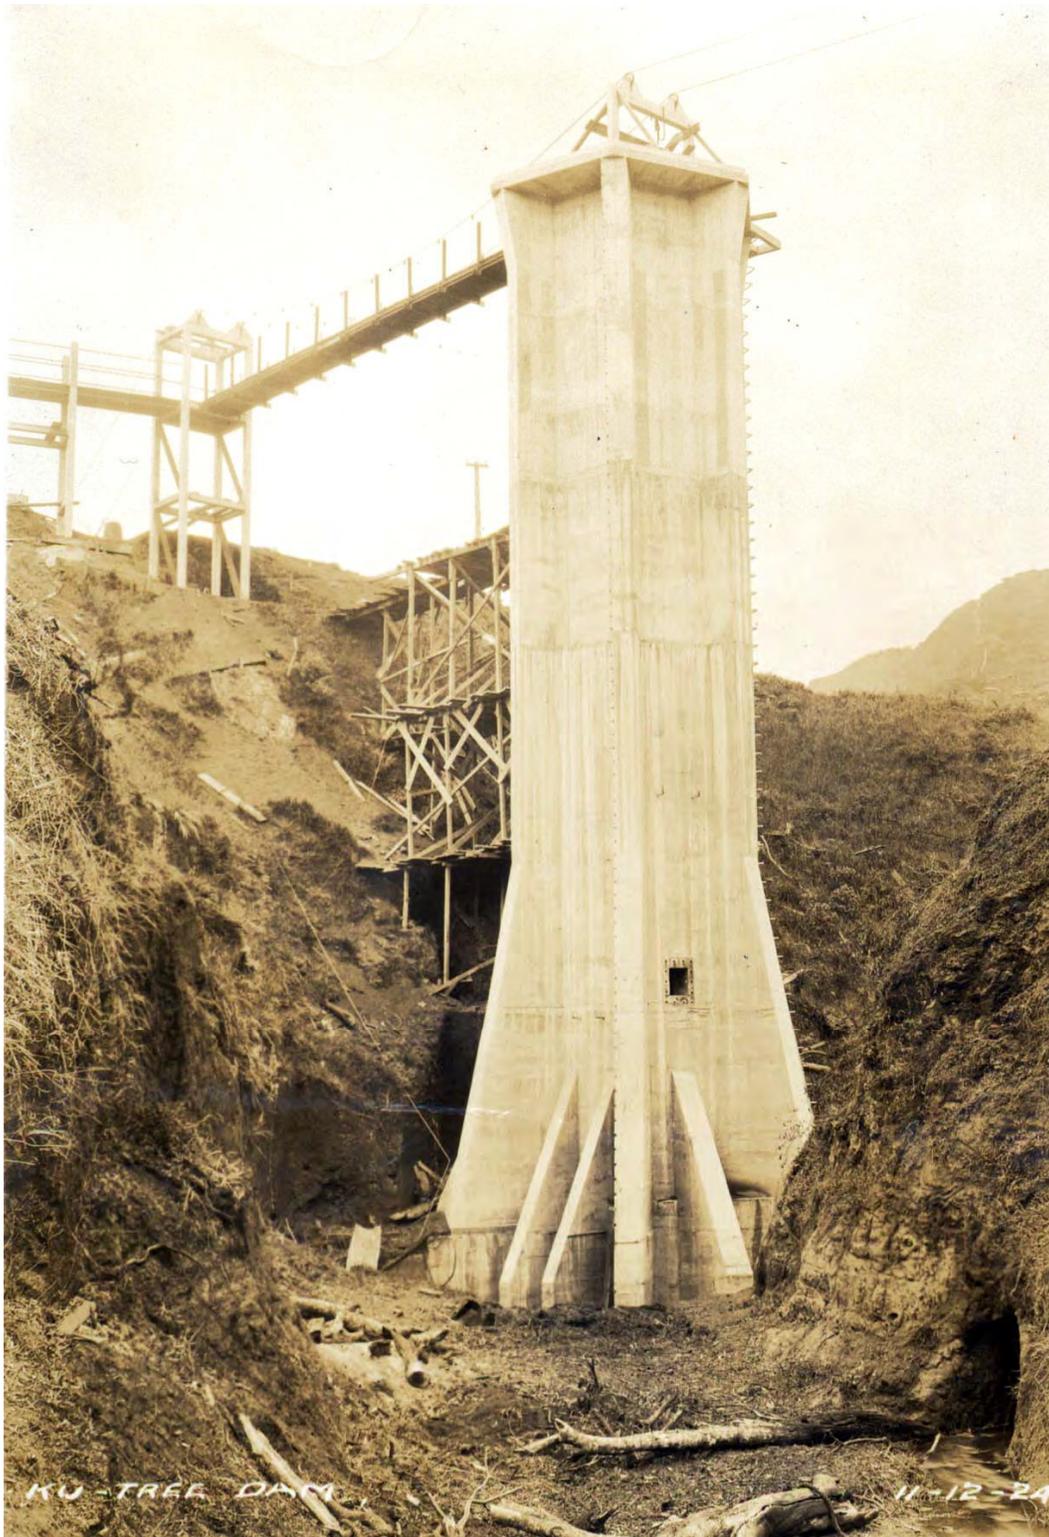
Figure 4: Valve tower, Ku Tree Dam, November 12, 1924. (Tropic Lightning Museum, Schofield Barracks, Hawaii, Historical photograph 87.76.01-27)

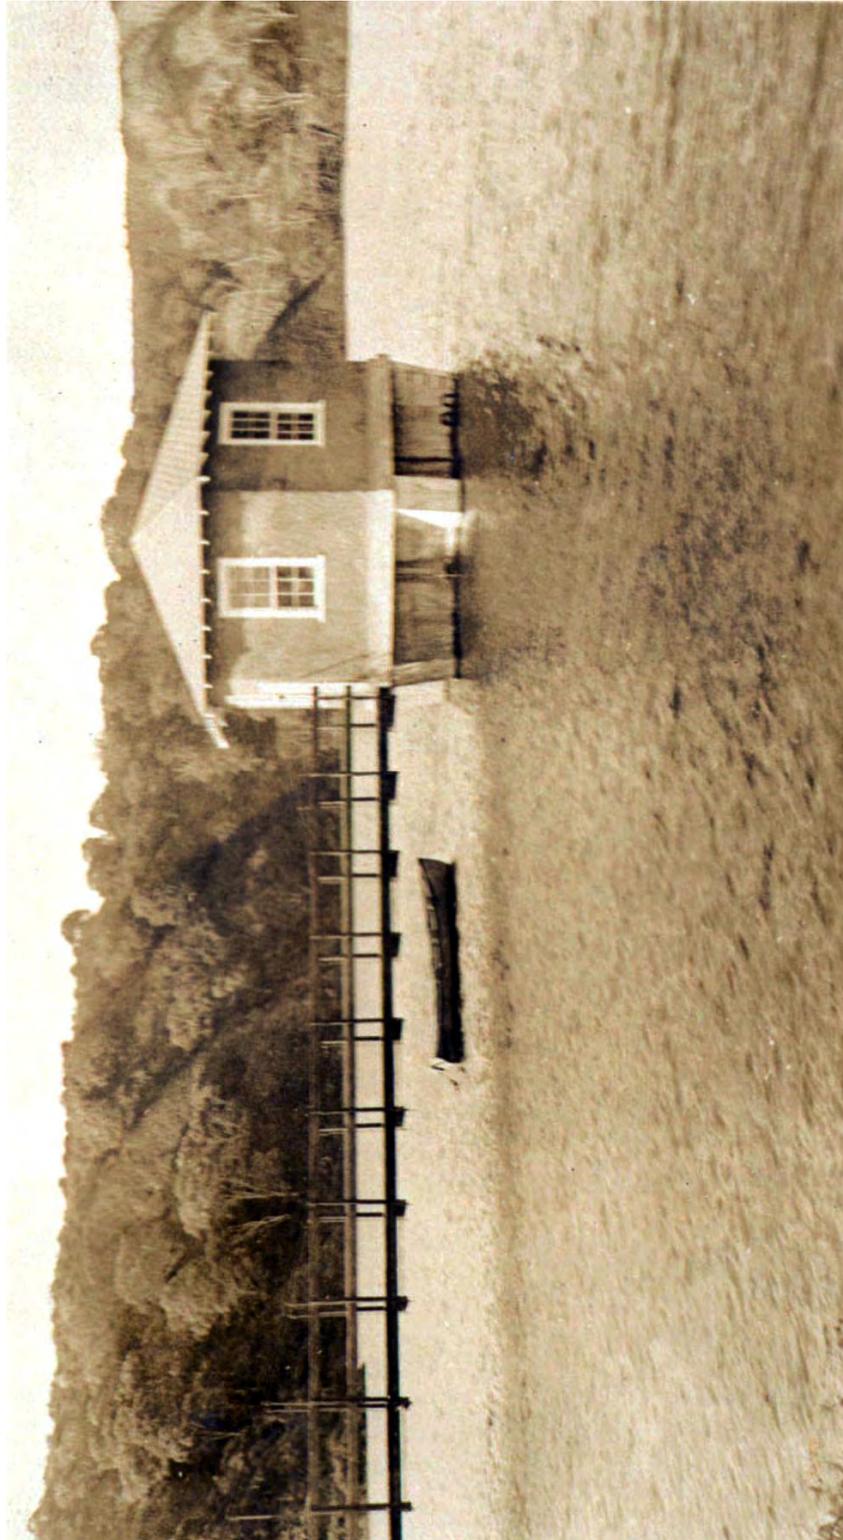
Figure 5: Enclosed valve house on tower with water in reservoir. (Tropic Lightning Museum, Schofield Barracks, Hawaii, Historical photograph 87.76.01-8)

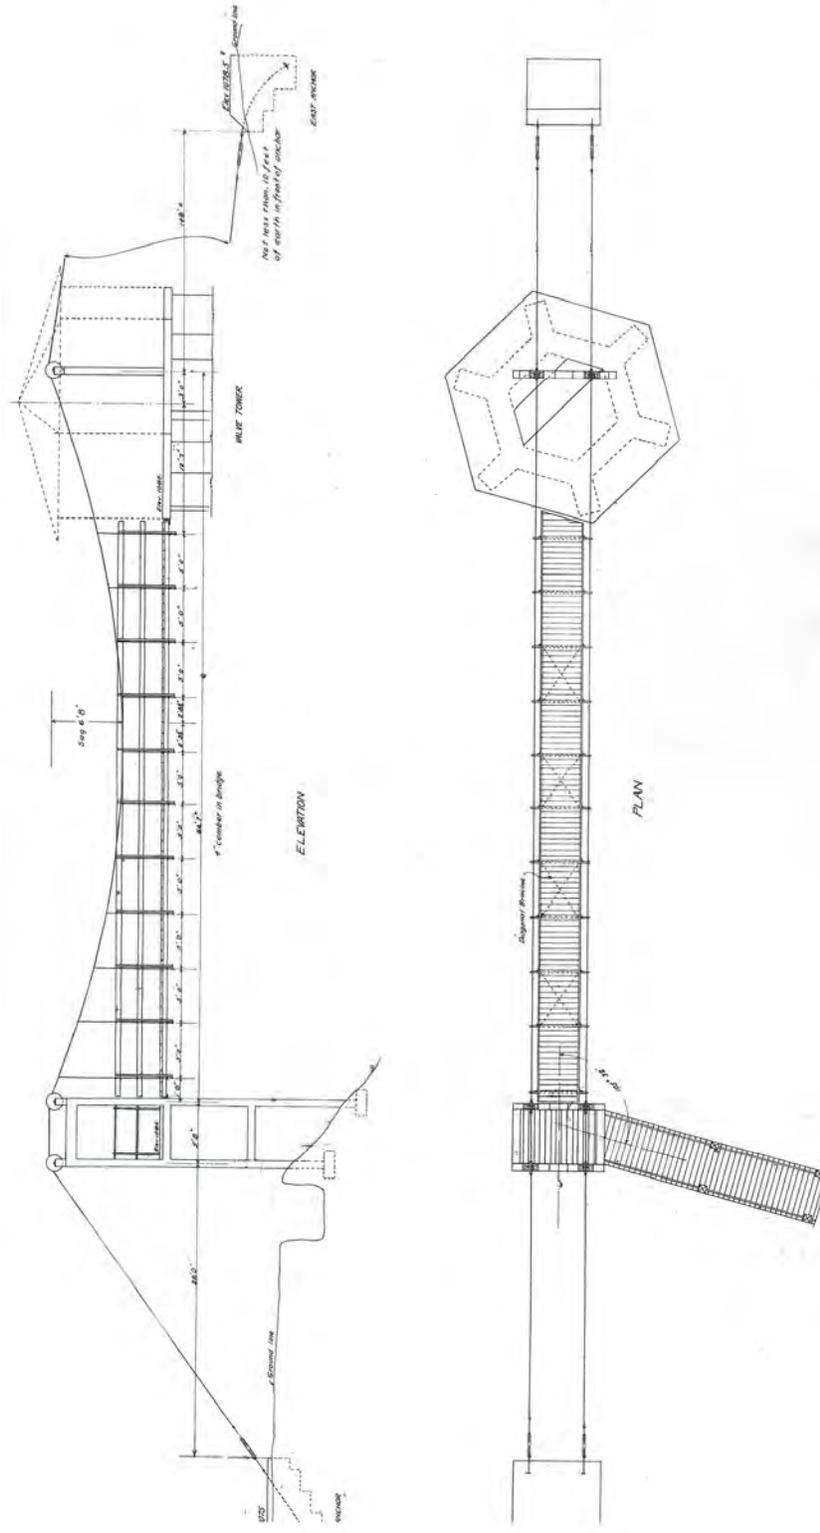
Figure 1: Suspension Bridge to Valve Tower, Ku Tree Reservoir. Job S3603, Sheet 29, dated June 1924.

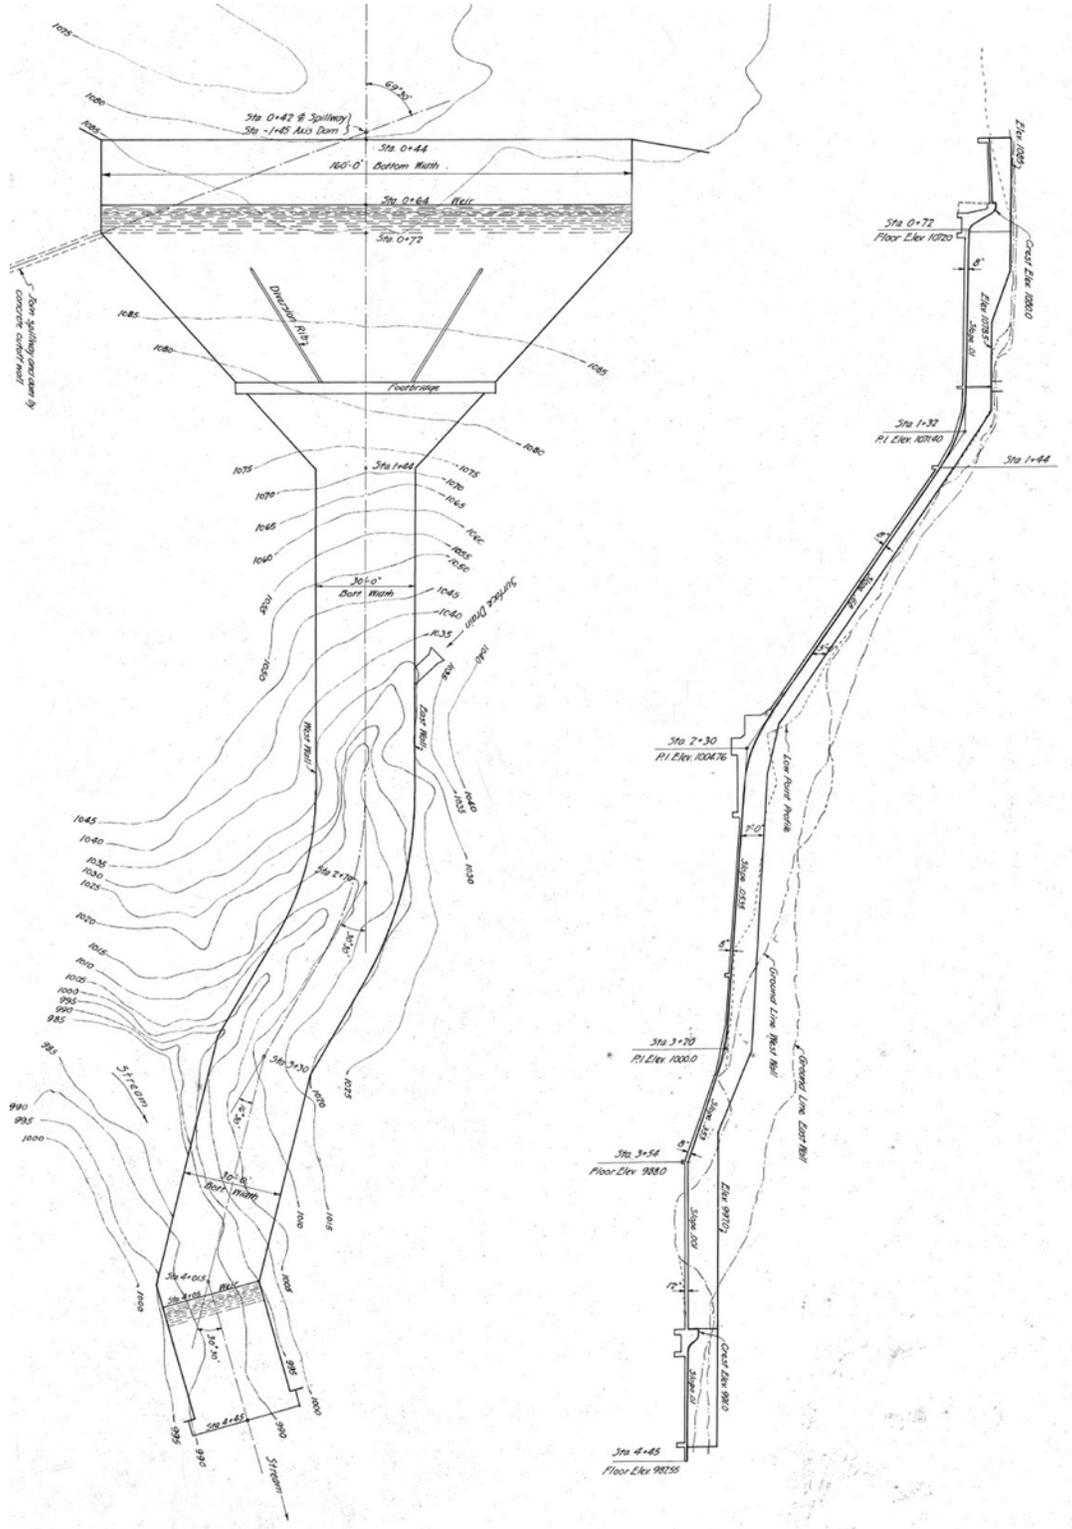
Figure 1: General Plan, Spillway, Ku Tree Reservoir. Job No. S3603, Sheet 6, dated June 14, 1924.

As is typical for spillways in earth-fill dams, this element of the Ku Tree Reservoir is isolated from the dam, traversing the natural abutment outside the limits of the dam. Its crest is at an elevation 5'-0" below the crest of the dam. This is the minimum variance in elevation recommended in a 1907 engineering book, *Design and Construction of Dams*, which suggested the spillway should be 5' to 25' below the top of the dam (Wegmann, 1907: 225).

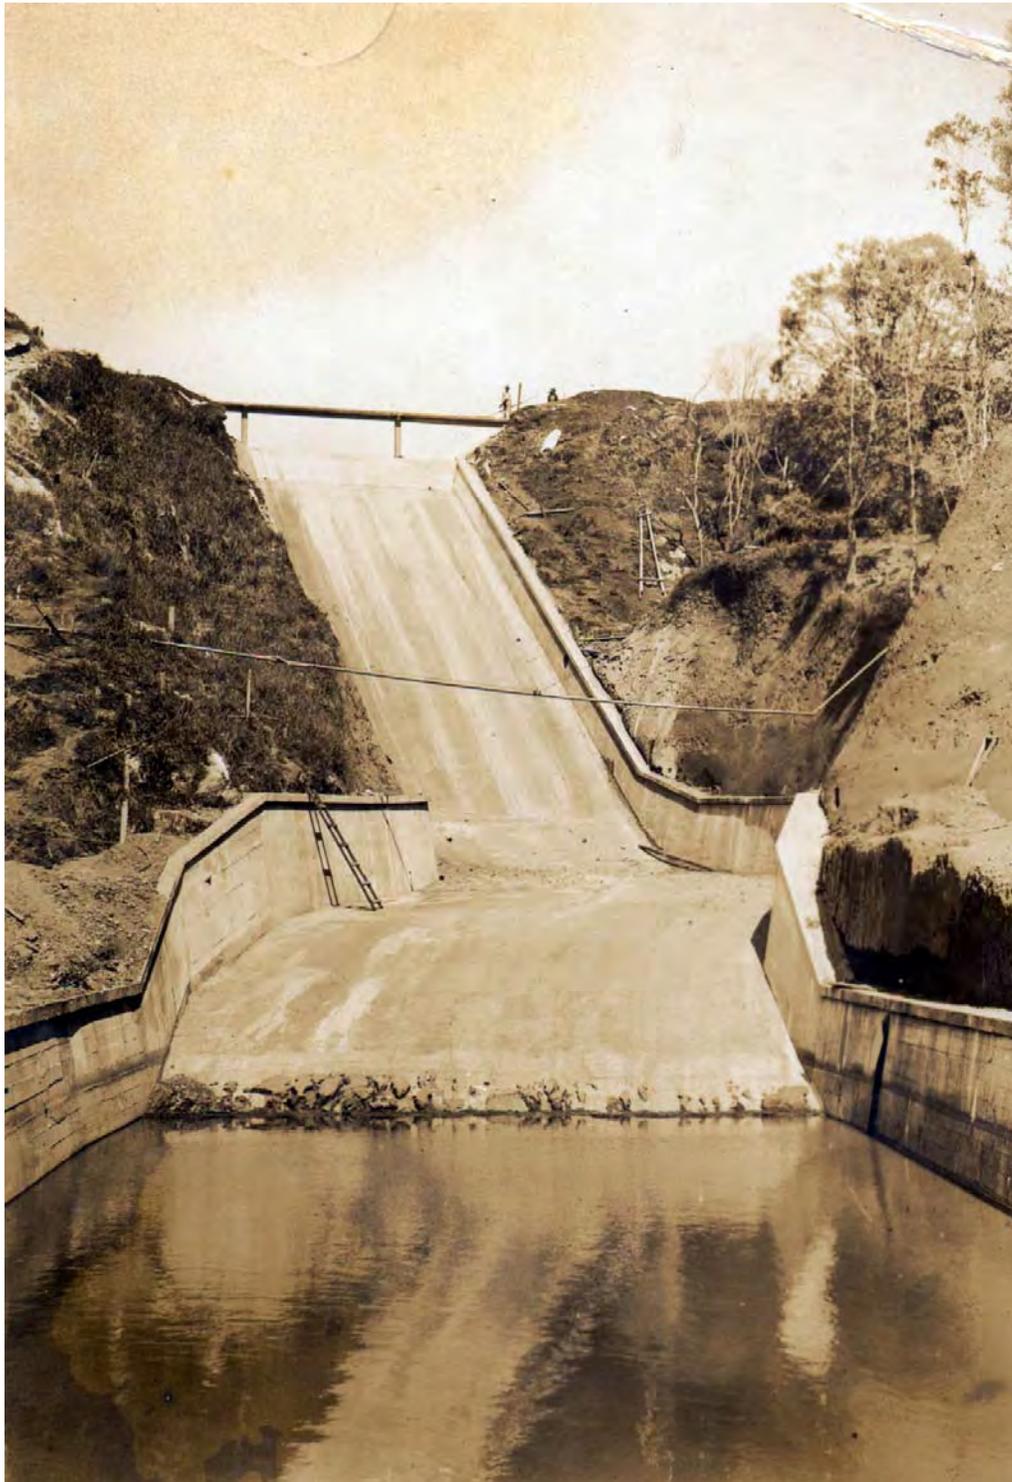
Figure 3: View in 1925 with stilling pond in foreground. (Tropic Lightning Museum, Schofield Barracks, Hawaii, Historical photograph 87.76.01-28)

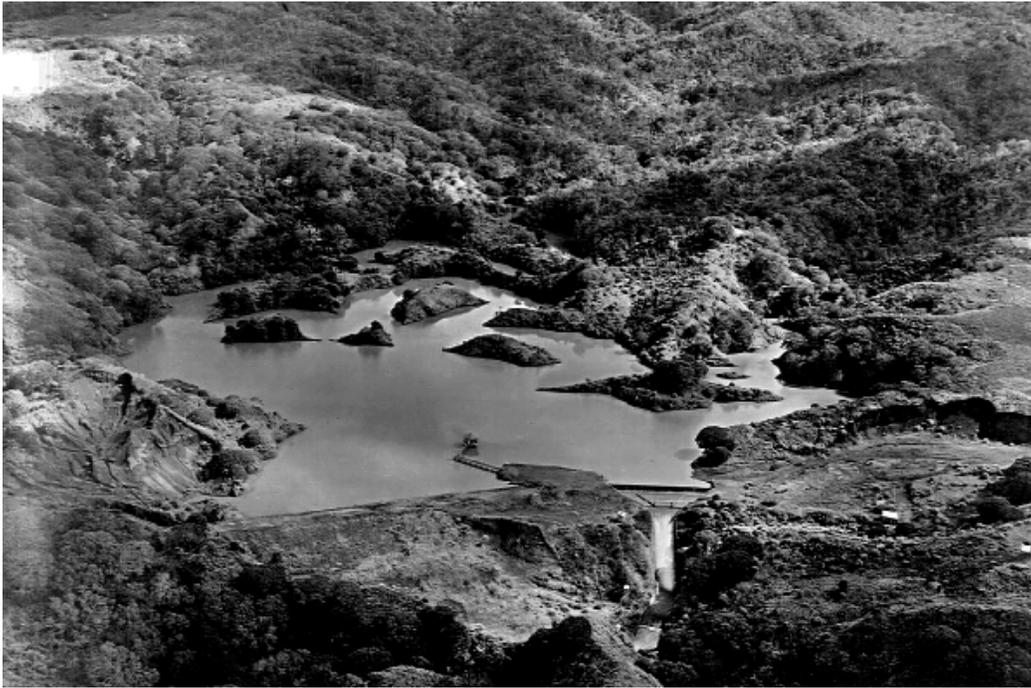
Fig. 1. An aerial photograph of the Ku Tree Dam, taken on 15 February 1932. NationalArchives II, Still Photo Section, photo order #18-AA-51-43.
