Project Name: Proposed Breach of Ku Tree Dam at Schofield Barracks-East Range Environmental Assessment and Draft Finding of No Significant Impact

**ENVIRONMENTAL ASSESSMENT AND DRAFT FINDING OF
NO SIGNIFICANT IMPACT**

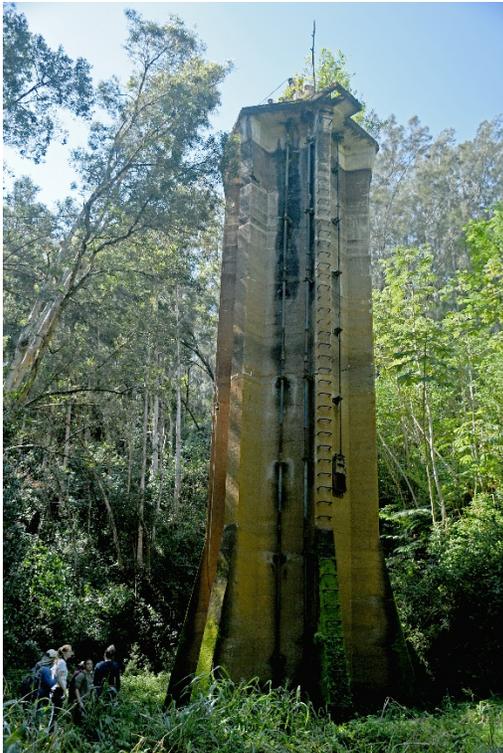
Fig. 3. The valve tower rising from the former reservoir pool area of the Ku Tree Dam.

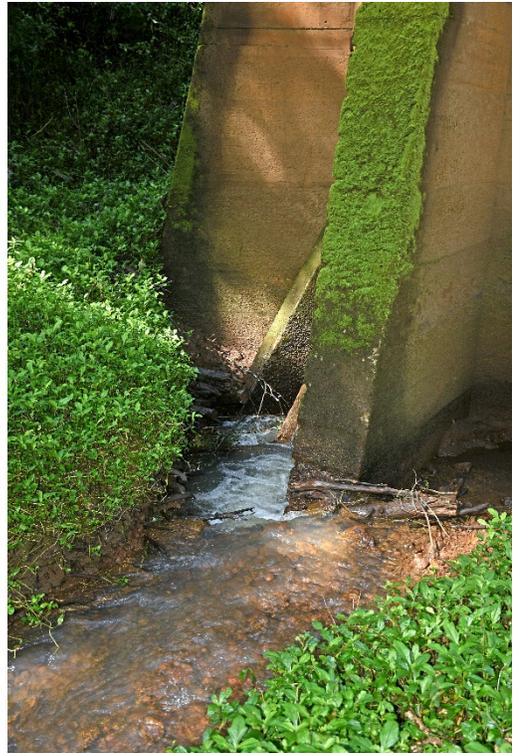
Fig. 4. Water flowing into the inlet to the drain tunnel at the base of the valve tower.

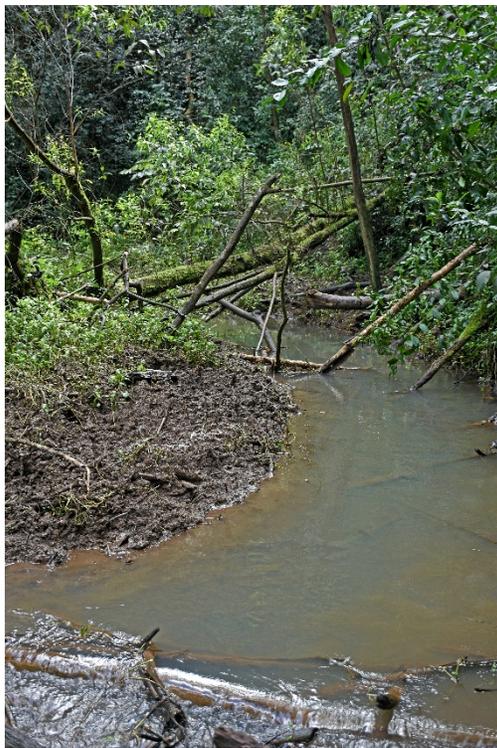
Fig. 5. Station 1, the main channel of the tributary to the South Fork of Kaukonahua Stream above Ku Tree Dam.

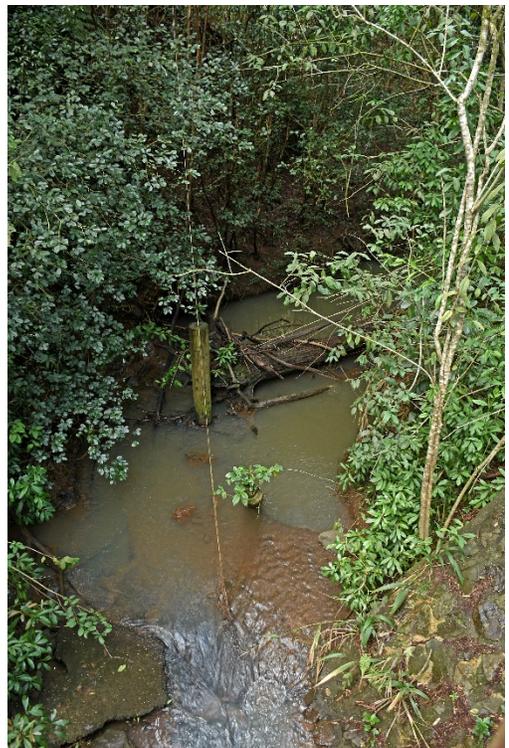
Fig. 6. Station 2, the main channel of the tributary to the South Fork of Kaukonahua Stream below Ku Tree Dam.

A brief visit was also made to the stream reach lying below the dam and the outlet of the drain tunnel, at a point where it is bridged by a road (Station 2, see Fig. 6). The stream had notably higher volume here than above the dam, indicating confluence with another undermined tributary somewhere between the dam and the bridge. Once again, no native freshwater fishes, crustaceans, mollusks, or insects were observed at this site.
