STATE OF HAWAII DEPARTMENT OF LAND AND NATURAL RESOURCES COMMISSION ON WATER RESOURCE MANAGEMENT P.O. BOX 621 HONOLULU, HAWAII 96809

December 18, 2014

Summary of Maui Interim Instream Flow Standards

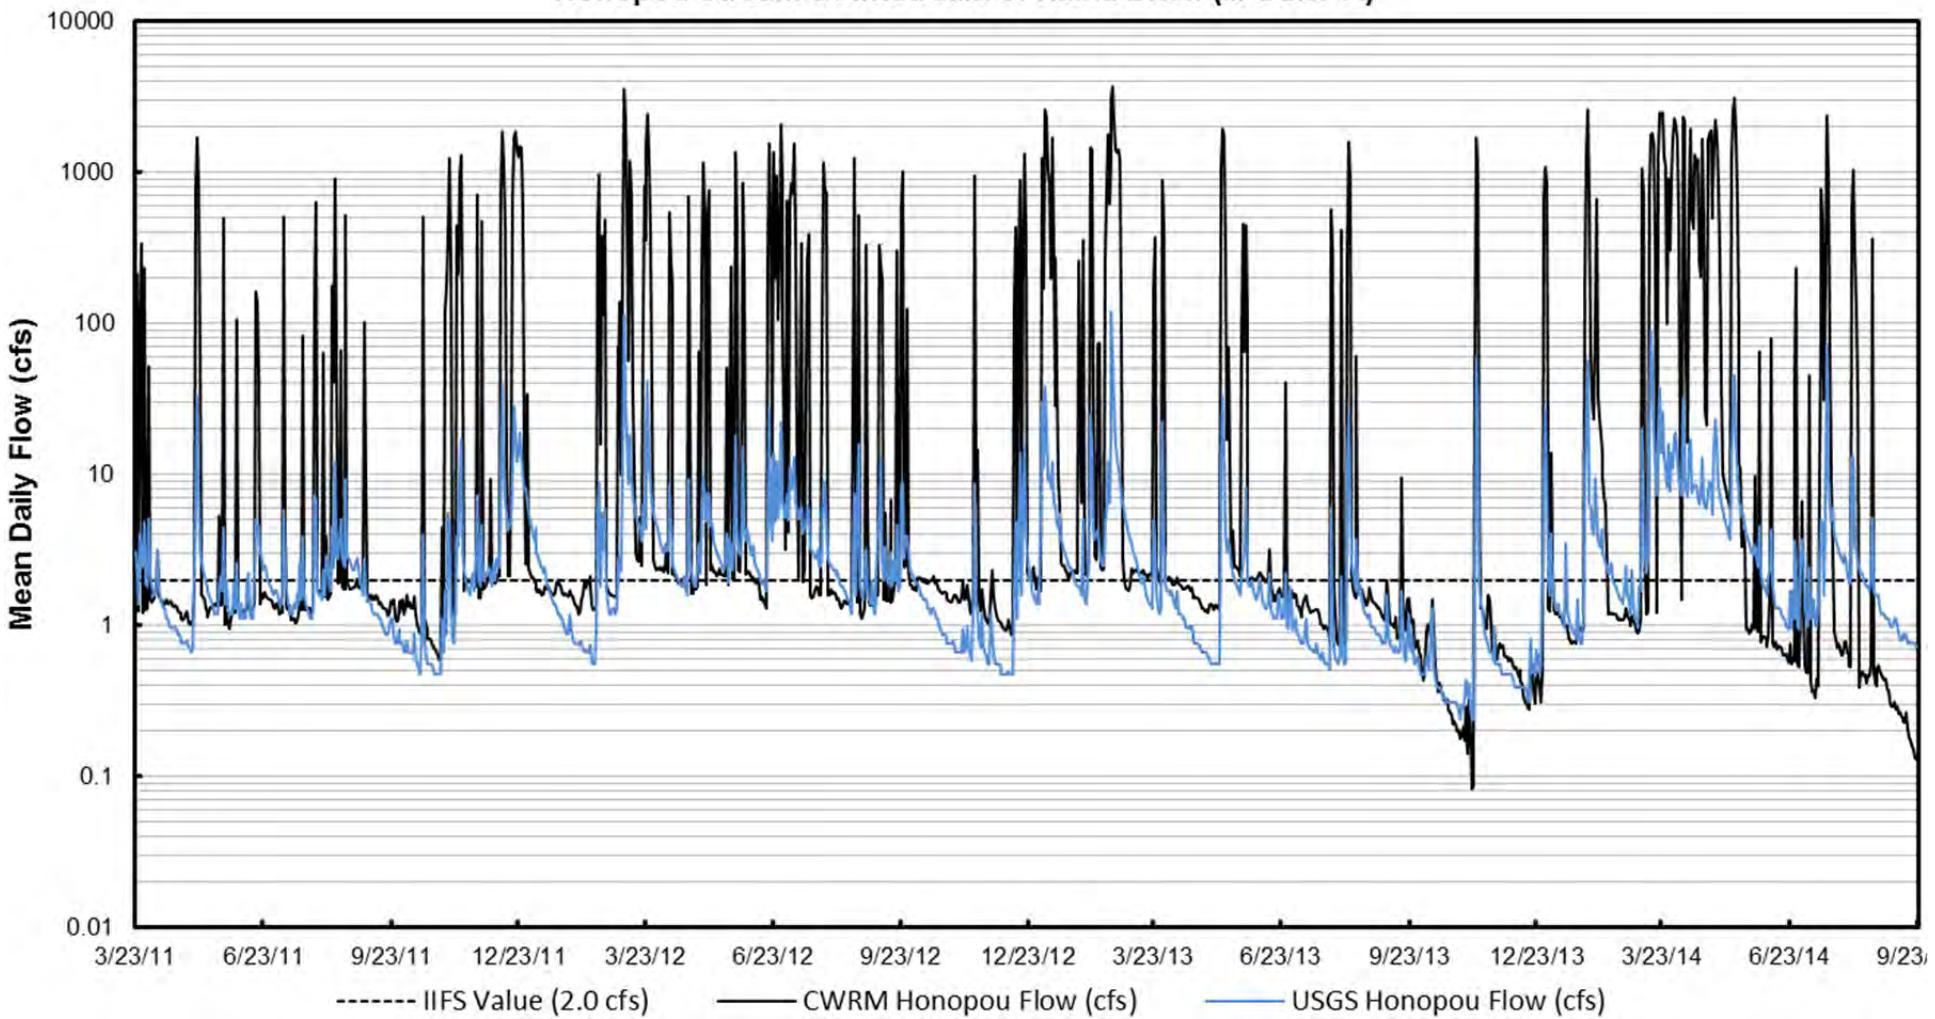
Honopou Stream downstream of Haiku Ditch (IIFSSite A)

The graph below depicts the CWRM-measured streamflows for Honopou Stream (black line) compared with the IIFS (2.0 cfs; black dotted line) and streamflows for the USGS Honopou gage (No. 16587000). The USGS Honopou gage presents natural streamflow conditions above any diversions and is used to illustrate weather patterns that may cause the stream to fall below the IIFS as a result of low rainfall.

Note: There was a lack of regular transducer data collections and streamflow measurements from September 2013 to September 2014. As a result, the chances of transducer failure and the amount of zero drift can increase. Zero drift is defined as an undesired change in zero over a period of time. CWRM staff is working to fully restore its quarterly monitoring schedule.

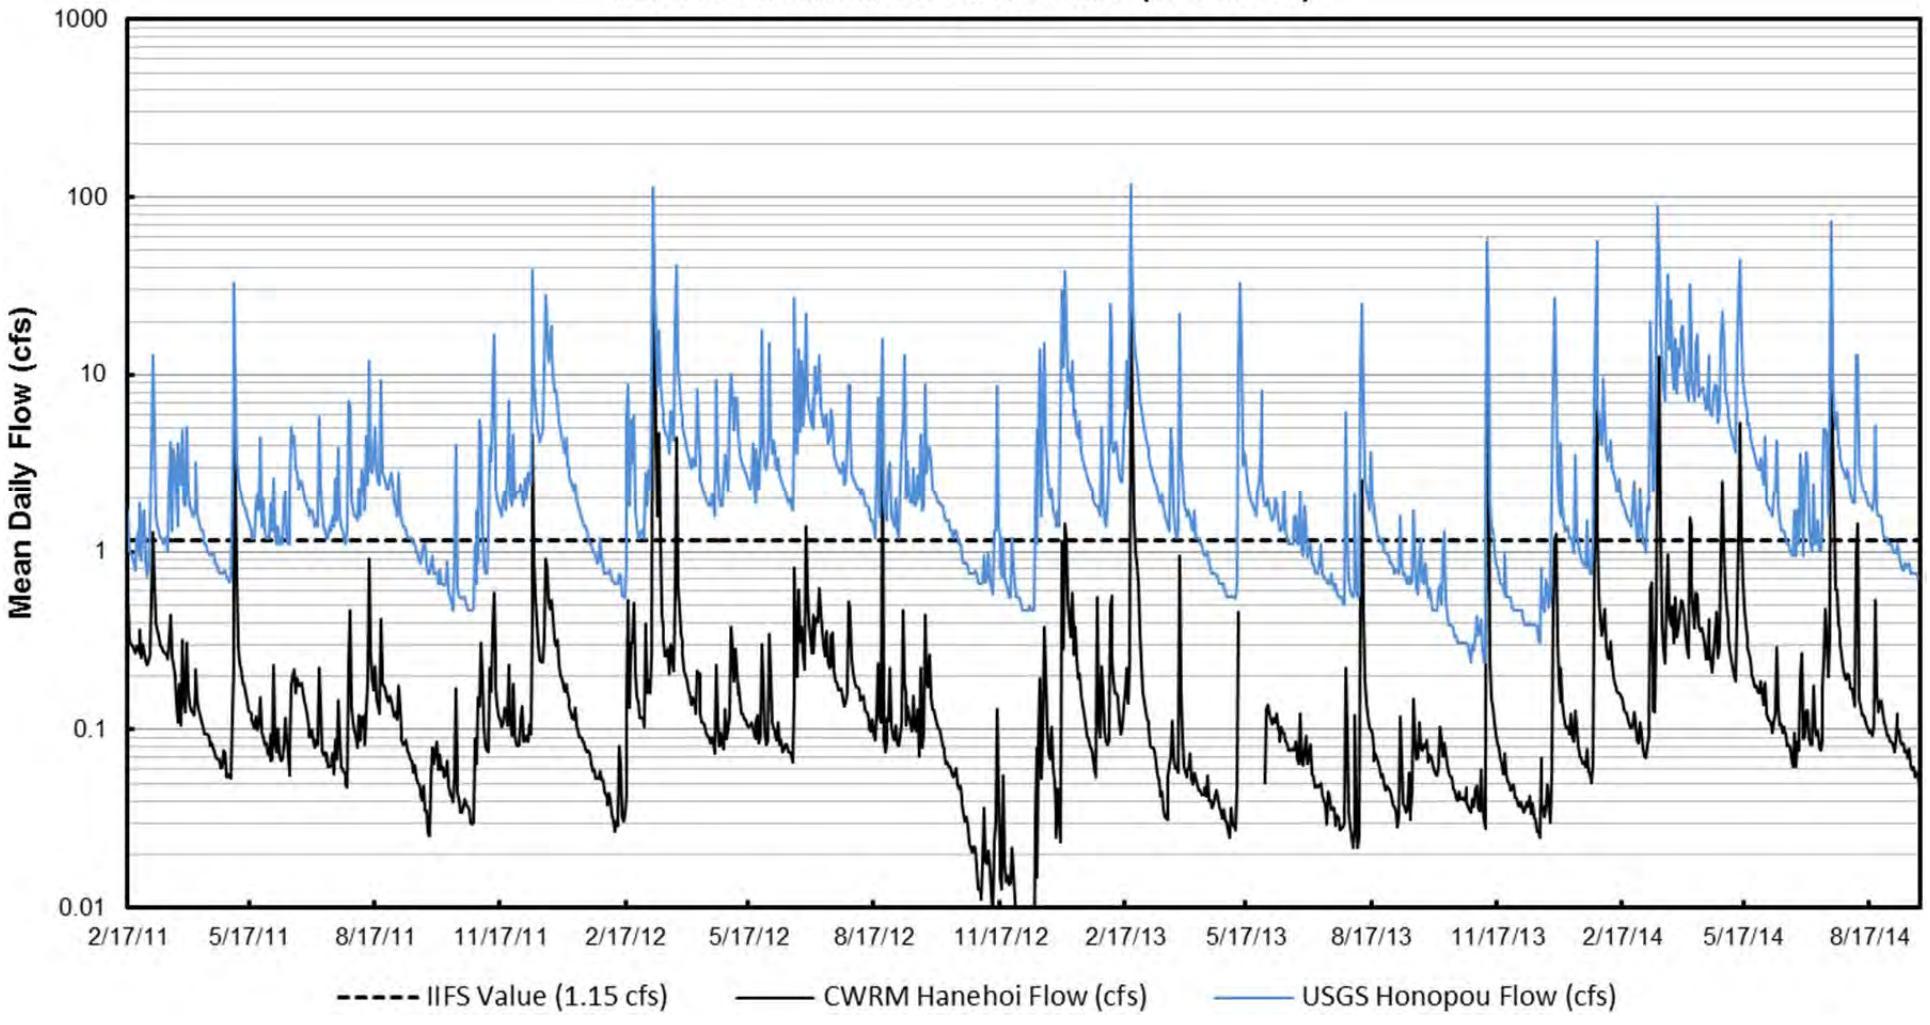
Hanehoi Stream above Lowrie Ditch (IIFS Site C)

The graph below depicts the CWRM-measured streamflows for Hanehoi Stream (black line) compared with the IIFS (1.15 cfs; black dotted line) and streamflows for the USGS Honopou gage (No. 16587000). The USGS Honopou gage presents natural streamflow conditions above any diversions and is used to illustrate weather patterns that may cause the stream to fall below the IIFS as a result of low rainfall.

Note: There was a lack of regular transducer data collections and streamflow measurements from September 2013 to September 2014. As a result, the chances of transducer failure and the amount of zero drift can increase. Zero drift is defined as an undesired change in zero over a period of time. CWRM staff is working to fully restore its quarterly monitoring schedule. Some errors may also result from the lack of a dedicated barometric pressure transducer operated in conjunction with the current stream transducer.

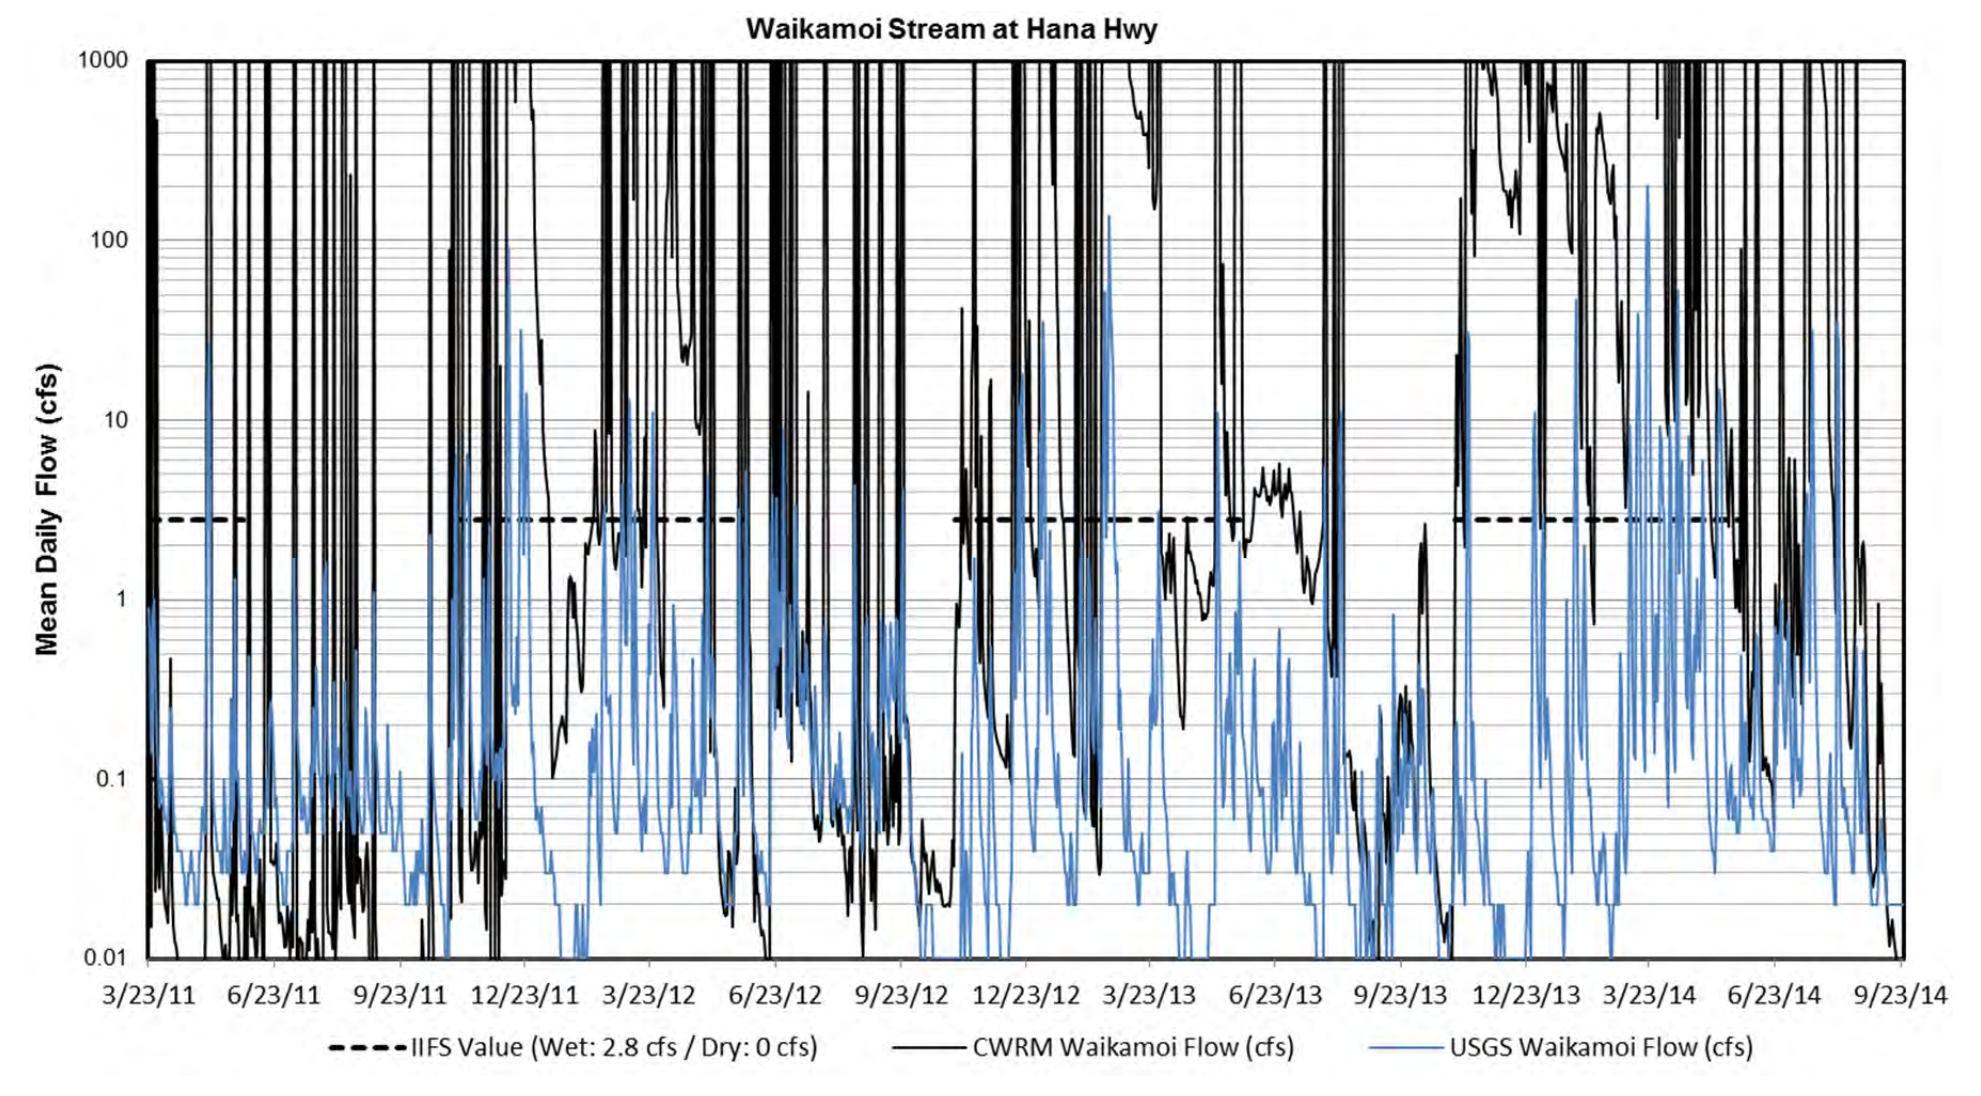
The graph below depicts the CWRM-measured streamflows for Waikamoi Stream (black line) compared with the IIFS (2.8 cfs in the wet season / 0.0 cfs in the dry season; black dotted line) and streamflows for the USGS Waikamoi gage (No. 16552800). The USGS Waikamoi gage presents natural streamflow conditions above any diversions and is used to illustrate weather patterns that may cause the stream to fall below the IIFS as a result of low rainfall.

Note: There was a lack of regular transducer data collections and streamflow measurements from September 2013 to September 2014. As a result, the chances of transducer failure and the amount of zero drift can increase. Zero drift is defined as an undesired change in zero over a period of time. CWRM staff is working to fully restore its quarterly monitoring schedule. Some errors may also result from the lack of a dedicated barometric pressure transducer operated in conjunction with the current stream transducer.

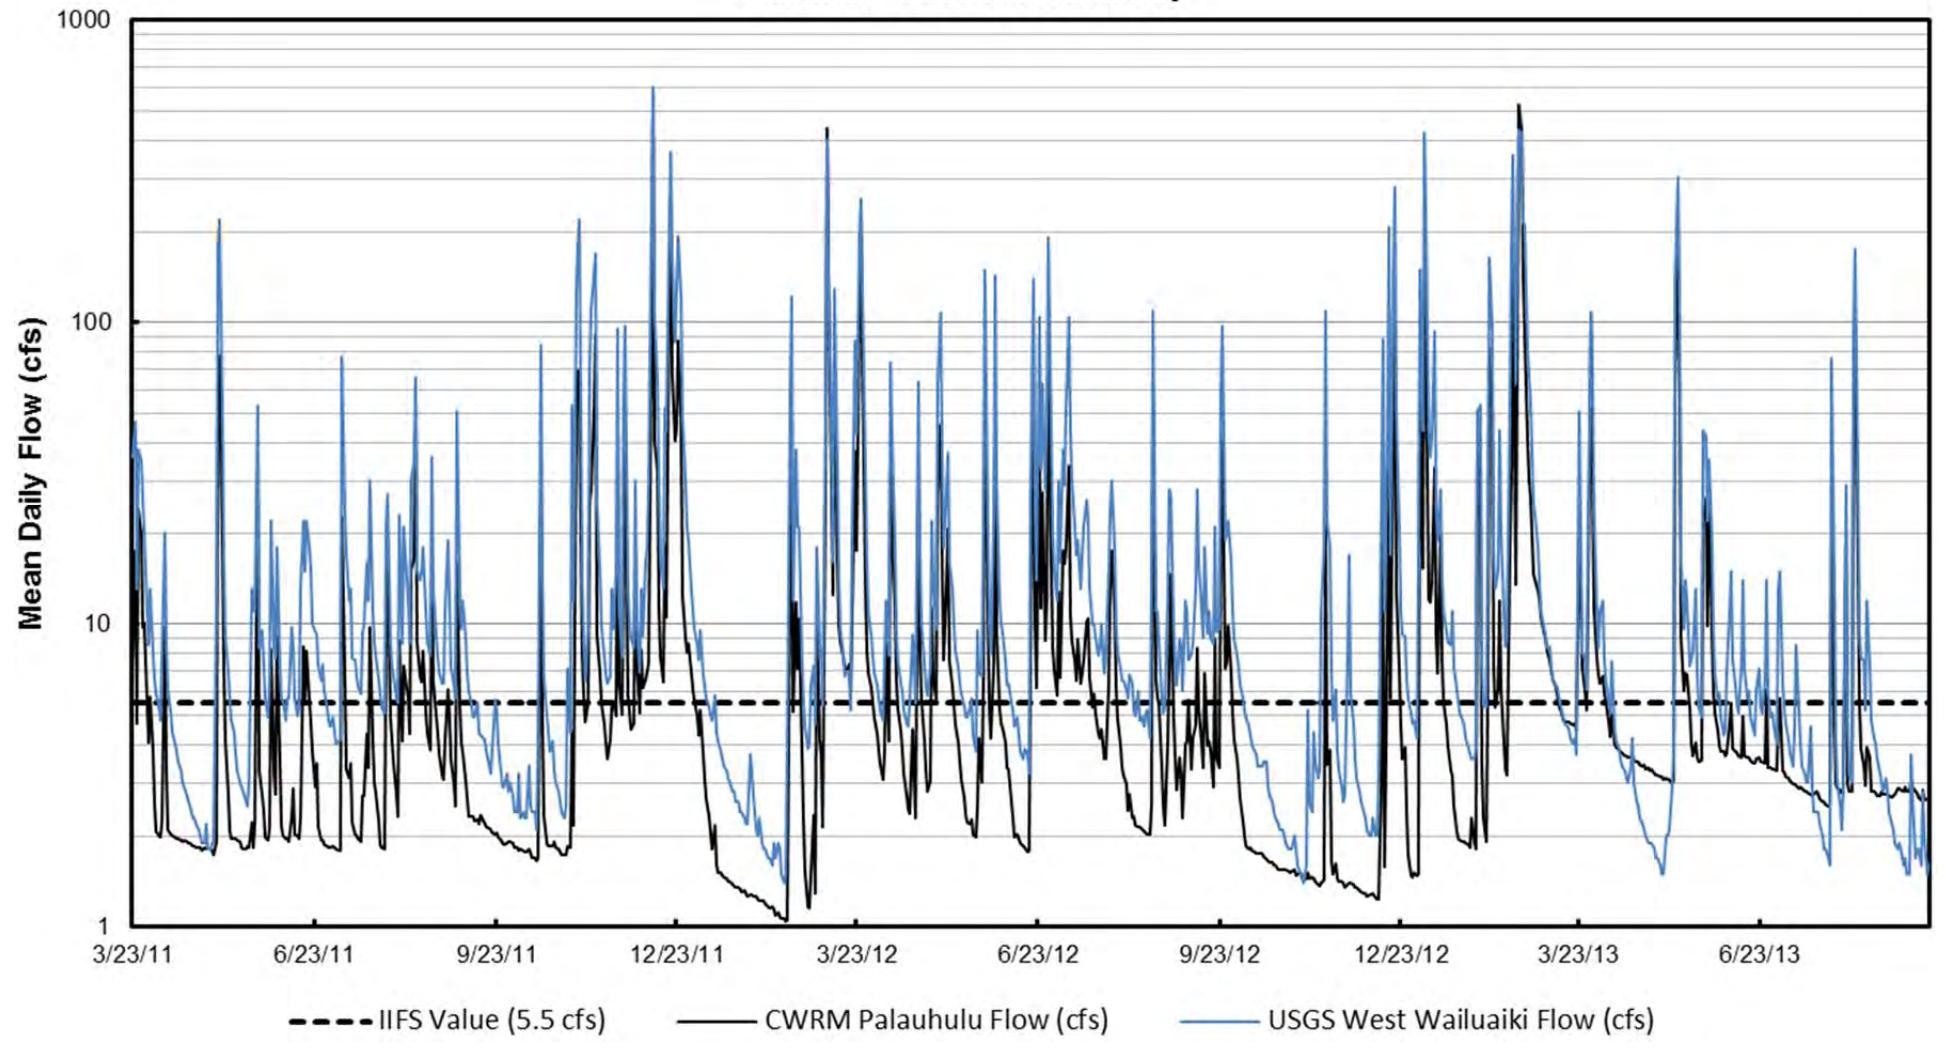
Palauhulu Stream at Hana Hwy

The graph below depicts the CWRM-measured streamflows for Palauhulu Stream (black line) compared with the IIFS (5.5 cfs; black dotted line) and streamflows for the USGS West Wailuaiki gage (No. 16518000). The USGS West Wailuaiki gage presents natural streamflow conditions above any diversions and is used to illustrate weather patterns. CWRM were unable to retrieve data from the transducer from September 2013 to September 2014 and are working with the manufacturer to retrieve the data that may cause the stream to fall below the IIFS as a result of low rainfall.

Note: There was a lack of regular transducer data collections and streamflow measurements from September 2013 to September 2014. As a result, the chances of transducer failure and the amount of zero drift can increase. Zero drift is defined as an undesired change in zero over a period of time. CWRM staff is working to fully restore its quarterly monitoring schedule. Some errors may also result from the lack of a dedicated barometric pressure transducer operated in conjunction with the current stream transducer.

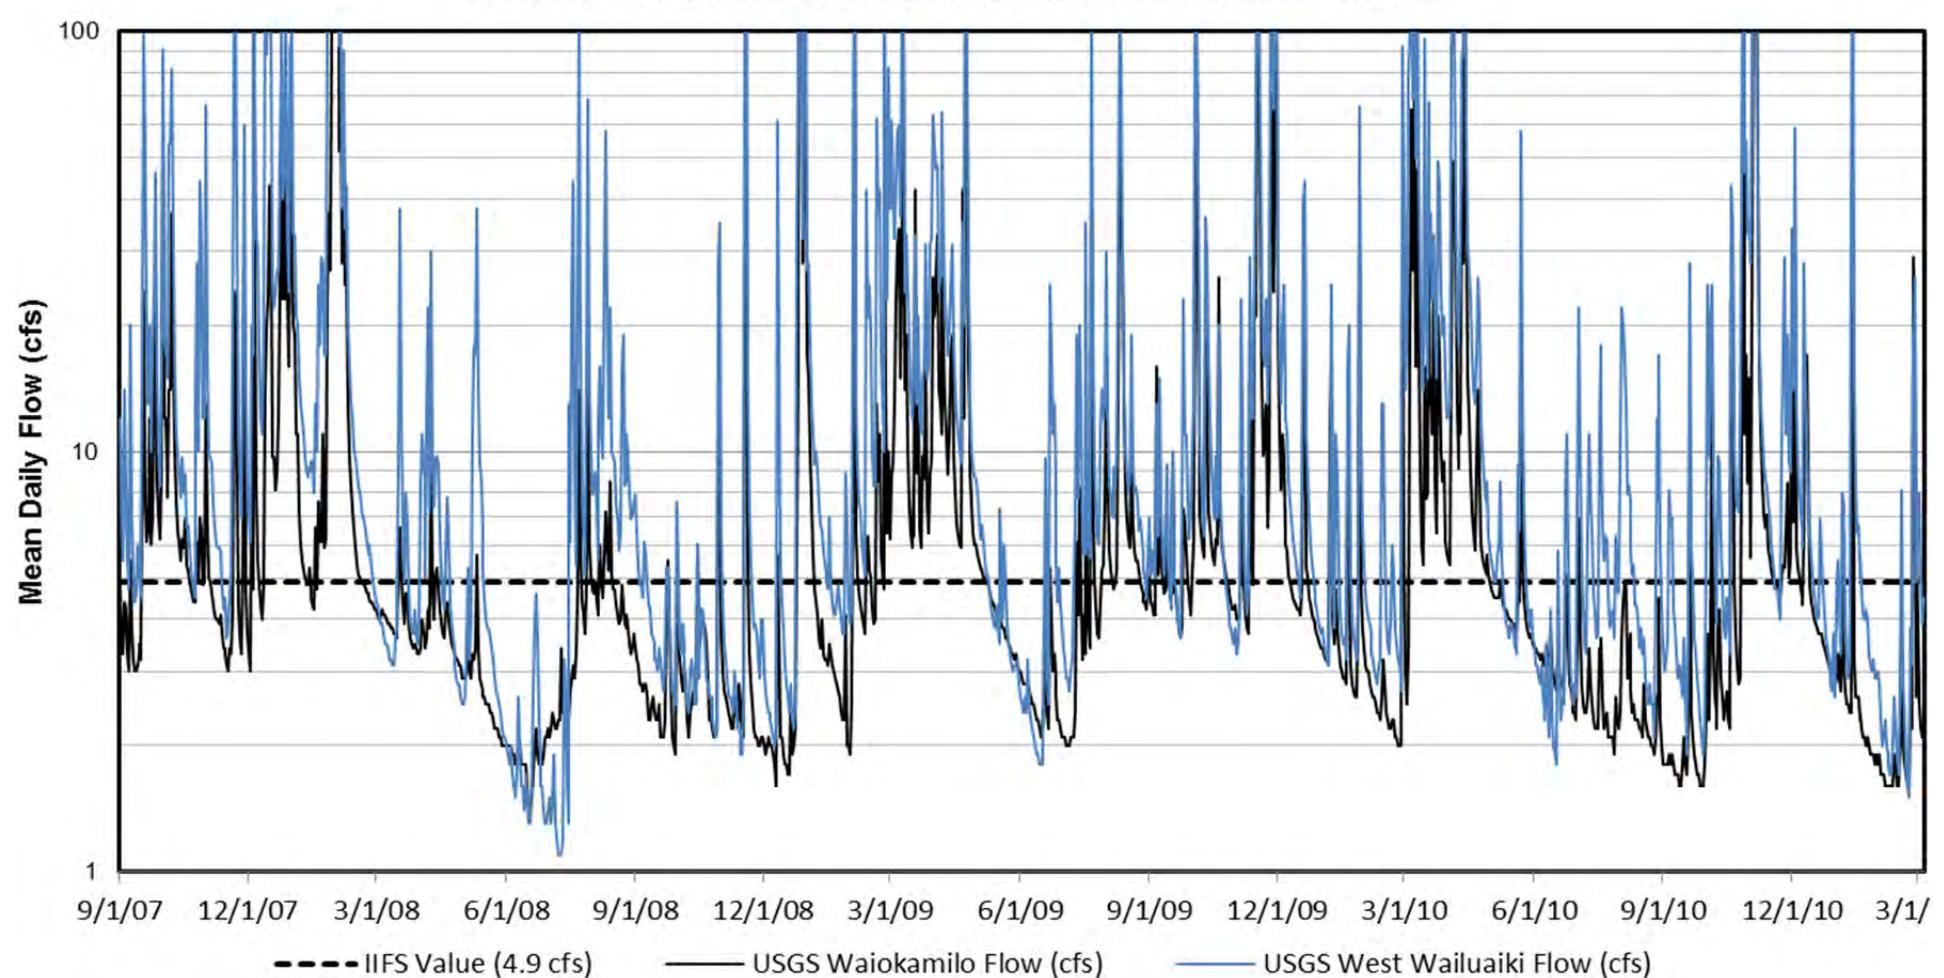
Waiokamilo Stream at Dam 3 near Keanae (USGS Gage 16521300)

The graph below depicts the USGS-measured streamflows for Waiokamilo Stream (black line) compared with the IIFS (4.9 cfs, black dotted line) and streamflows for the USGS West Wailuaiki gage (No. 16518000). The USGS West Wailuaiki gage presents natural streamflow conditions above any diversions and is used to illustrate weather patterns that may cause the stream to fall below the IIFS as a result of low rainfall.

Note: There was a lack of regular transducer data collections and streamflow measurements from September 2013 to September 2014. As a result, the chances of transducer failure and the amount of zero drift can increase. Zero drift is defined as an undesired change in zero over a period of time. CWRM staff is working to fully restore its quarterly monitoring schedule. Some errors may also result from the lack of a dedicated barometric pressure transducer operated in conjunction with the current stream transducer.

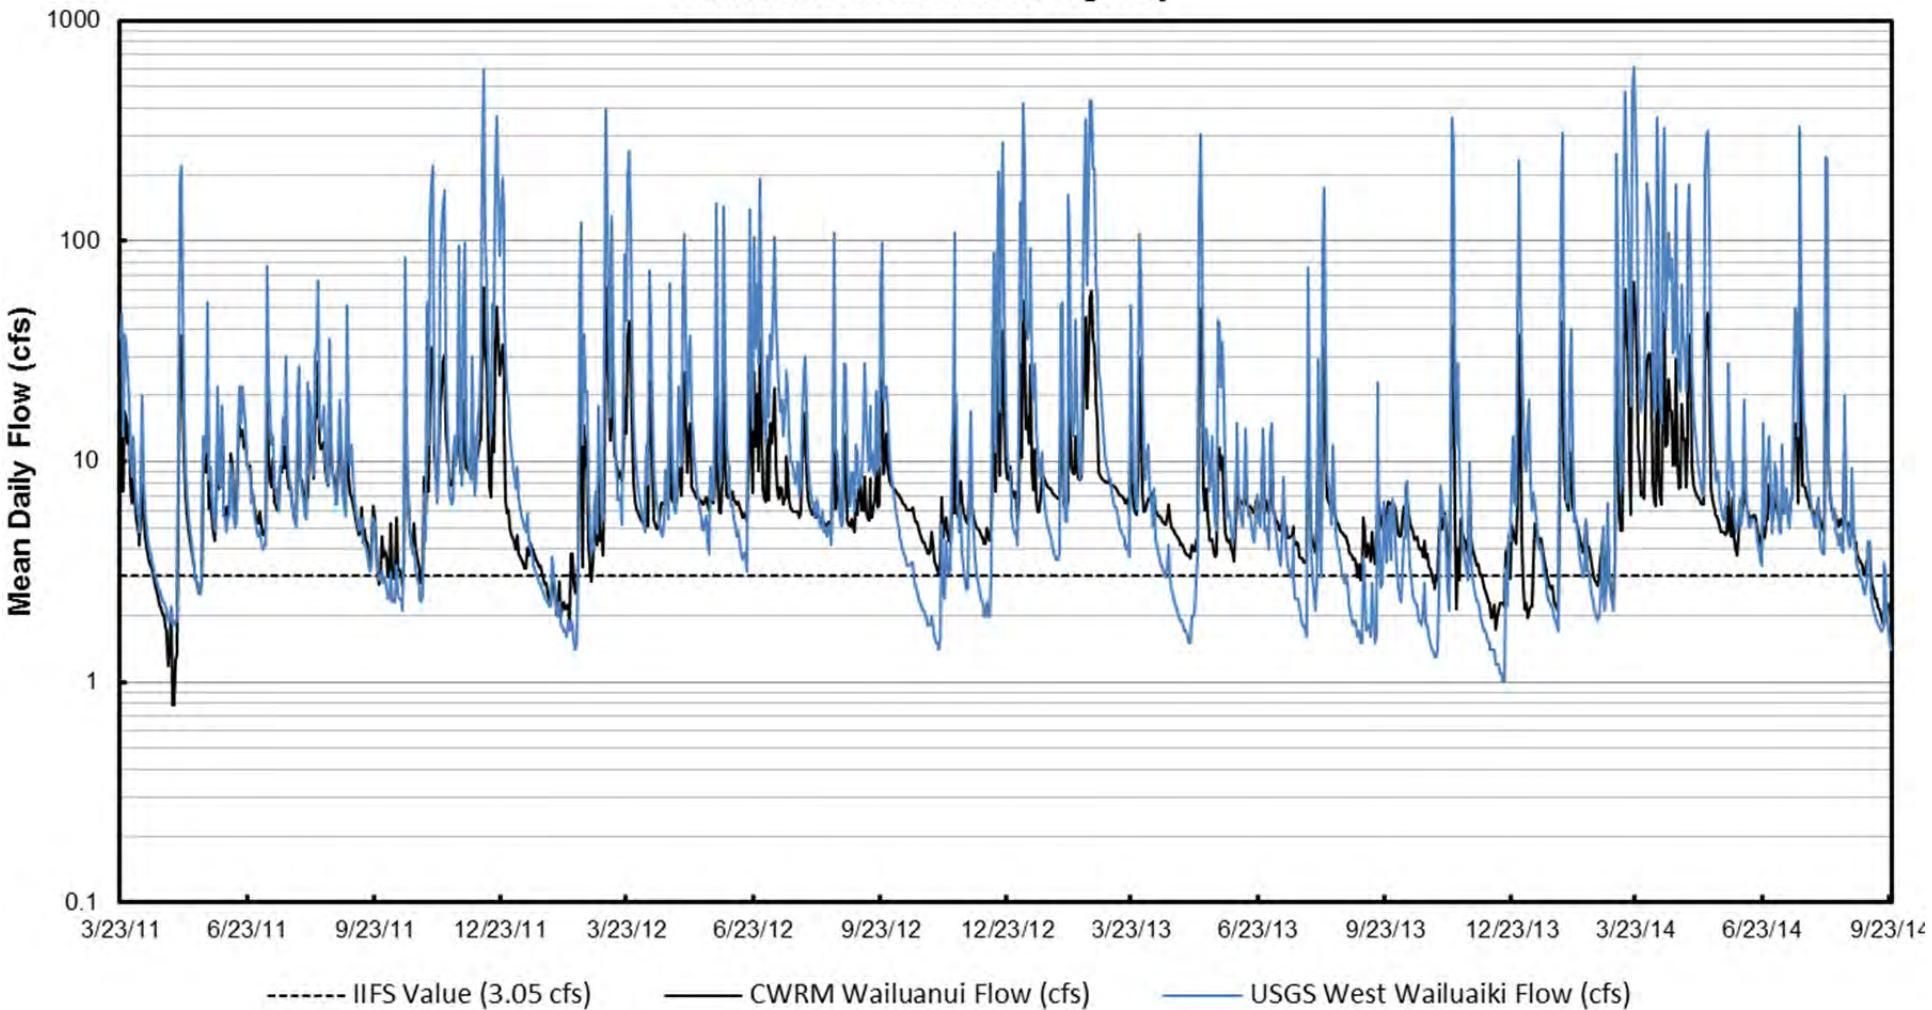
Wailuanui Stream at Hana Highway

The graph below depicts the CWRM-measured streamflows for Wailuanui Stream (black line) compared with the IIFS (3.05 cfs; black dotted line) and streamflows for the USGS West Wailuaiki gage (No. 16518000). The USGS West Wailuaiki gage presents natural streamflow conditions above any diversions and is used to illustrate weather patterns that may cause the stream to fall below the IIFS as a result of low rainfall.

Note: There was a lack of regular transducer data collections and streamflow measurements from September 2013 to September 2014. As a result, the chances of transducer failure and the amount of zero drift can increase. Zero drift is defined as an undesired change in zero over a period of time. CWRM staff is working to fully restore its quarterly monitoring schedule. Some errors may also result from the lack of a dedicated barometric pressure transducer operated in conjunction with the current stream transducer.

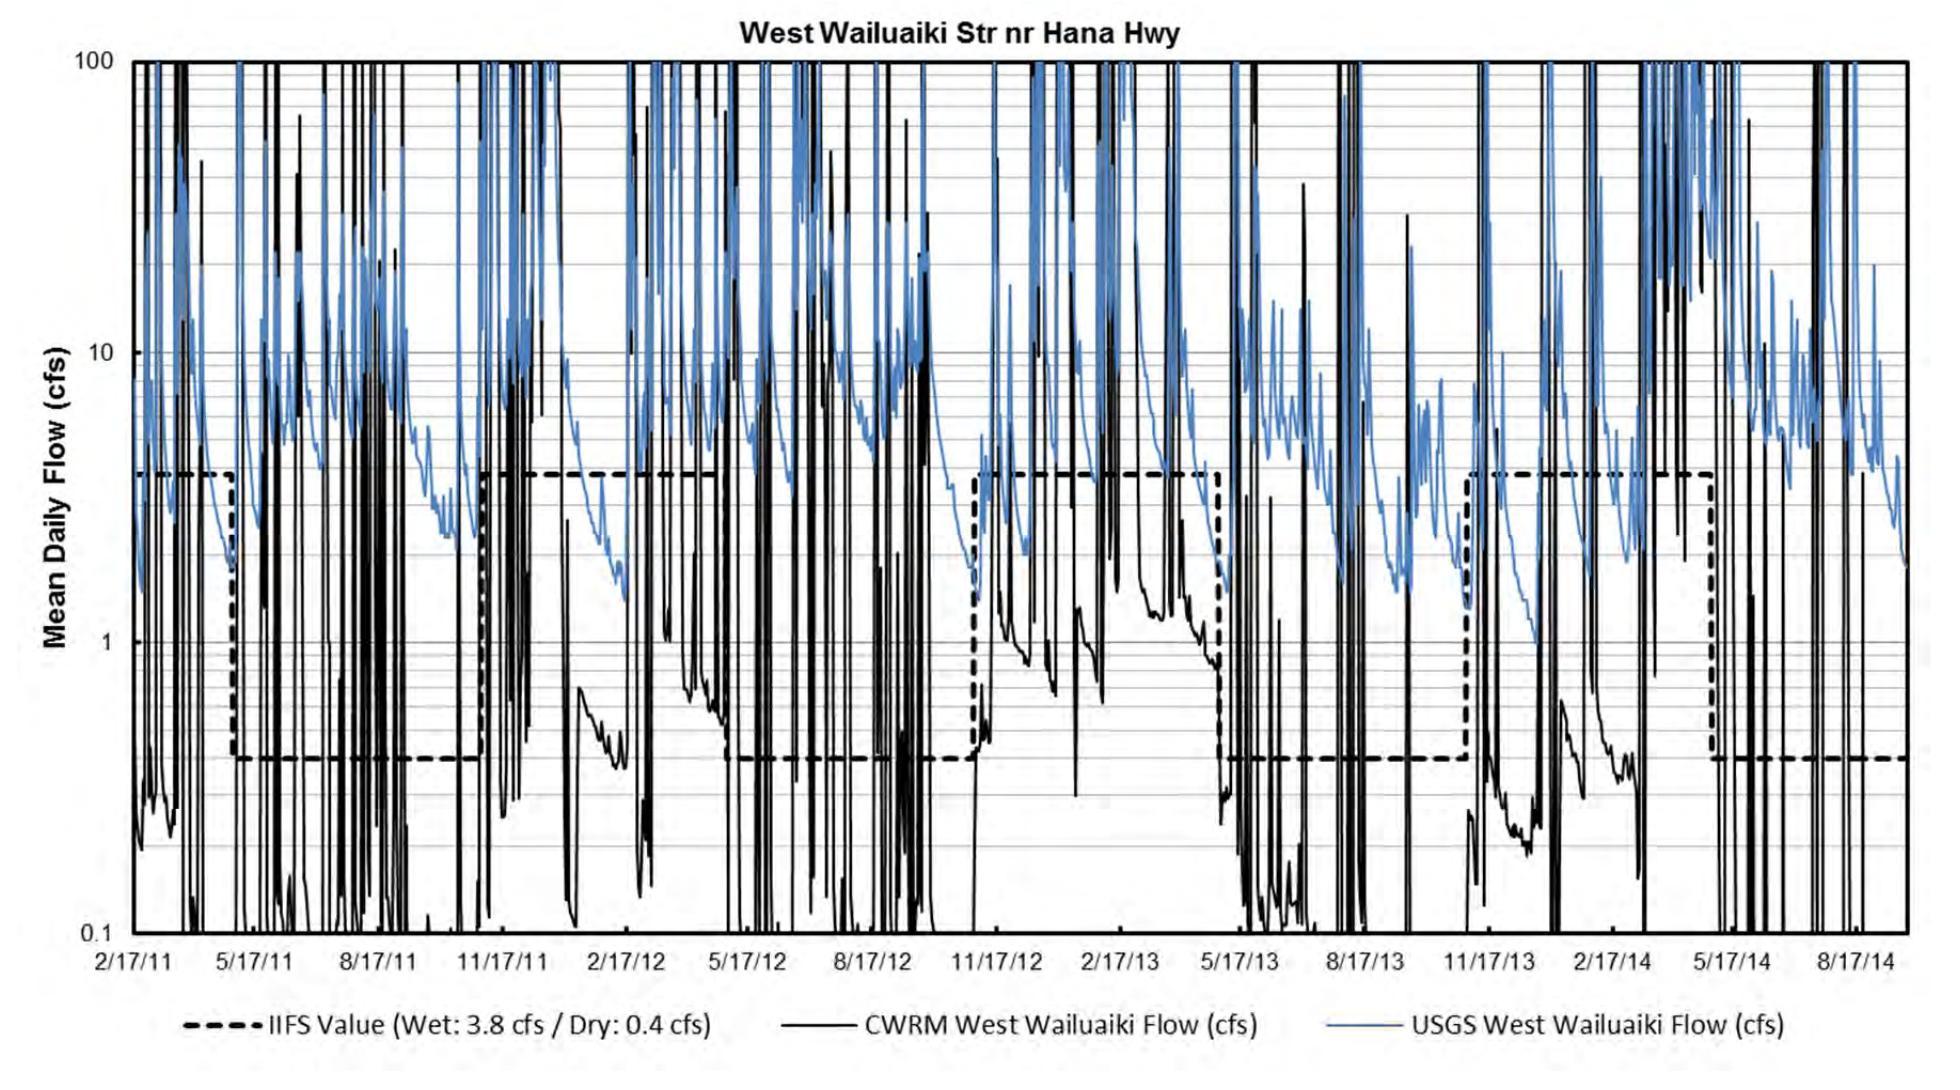
The graph below depicts the CWRM-measured streamflows for West Wailuaiki Stream (black line) compared with the IIFS (3.8 cfs in the wet season / 0.4 cfs in the dry season; black dotted line) and streamflows for the USGS West Wailuaiki gage (No. 16518000). The USGS West Wailuaiki gage presents natural streamflow conditions above any diversions and is used to illustrate weather patterns that may cause the stream to fall below the IIFS as a result of low rainfall.

Note: There was a lack of regular transducer data collections and streamflow measurements from September 2013 to September 2014. As a result, the chances of transducer failure and the amount of zero drift can increase. Zero drift is defined as an undesired change in zero over a period of time. CWRM staff is working to fully restore its quarterly monitoring schedule. Some errors may also result from the lack of a dedicated barometric pressure transducer operated in conjunction with the current stream transducer.

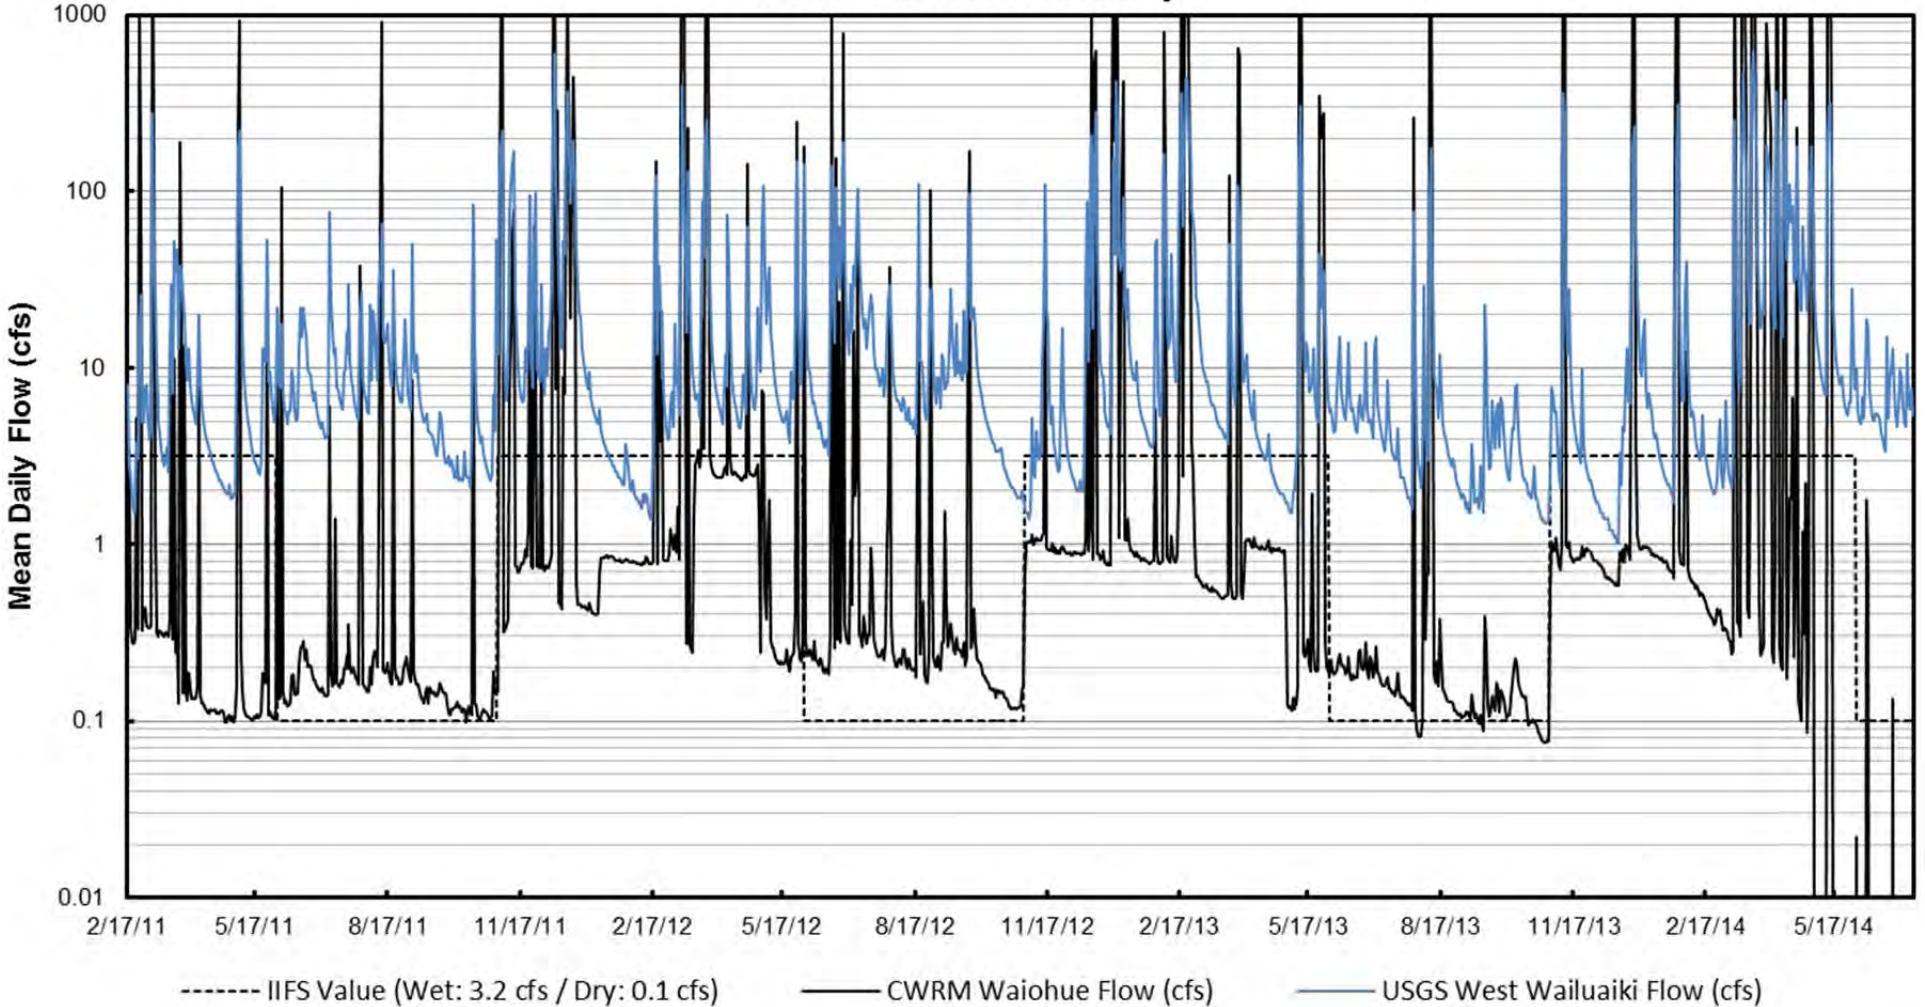
Waiohue Stream nr Hana Hwy

The graph below depicts the CWRM-measured streamflows for Waiohue Stream (black line) compared with the IIFS (3.2 cfs in the wet season / 0.1 cfs in the dry season; black dotted line) and streamflows for the USGS West Wailuaiki gage (No. 16518000). The USGS West Wailuaiki gage presents natural streamflow conditions above any diversions and is used to illustrate weather patterns that may cause the stream to fall below the IIFS as a result of low rainfall. Zero drift appears to be occurring in the transducer data from May 2014 to September 2014.

Note: There was a lack of regular transducer data collections and streamflow measurements from September 2013 to September 2014. As a result, the chances of transducer failure and the amount of zero drift can increase. Zero drift is defined as an undesired change in zero over a period of time. CWRM staff is working to fully restore its quarterly monitoring schedule.

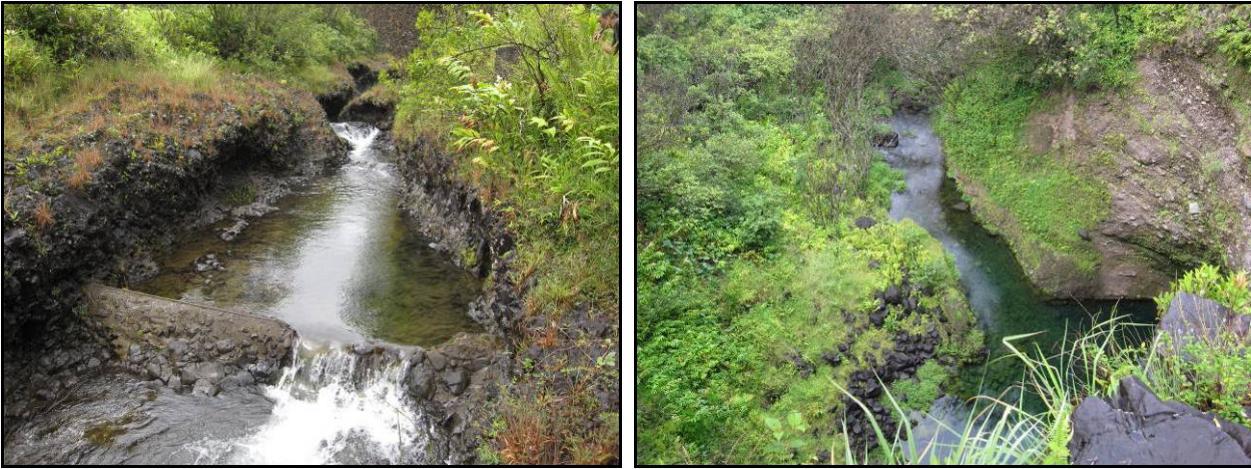
September 15, 2010: Staff conducted a survey of Palauhulu Stream above the interim IFS site at Hana Highway with the assistance of EMI and local residents. The objective was to document losing and gaining reaches and to identify potential monitoring sites that will aid in assessing the interim IFS (Photos 3 and 4). Though EMI has been releasing water from their main Palauhulu intake at Kano Falls since November 2008, the Commission staff has not observed consistent flows that meet the interim IFS.

USGS gage site. Streamflow loses below this site.

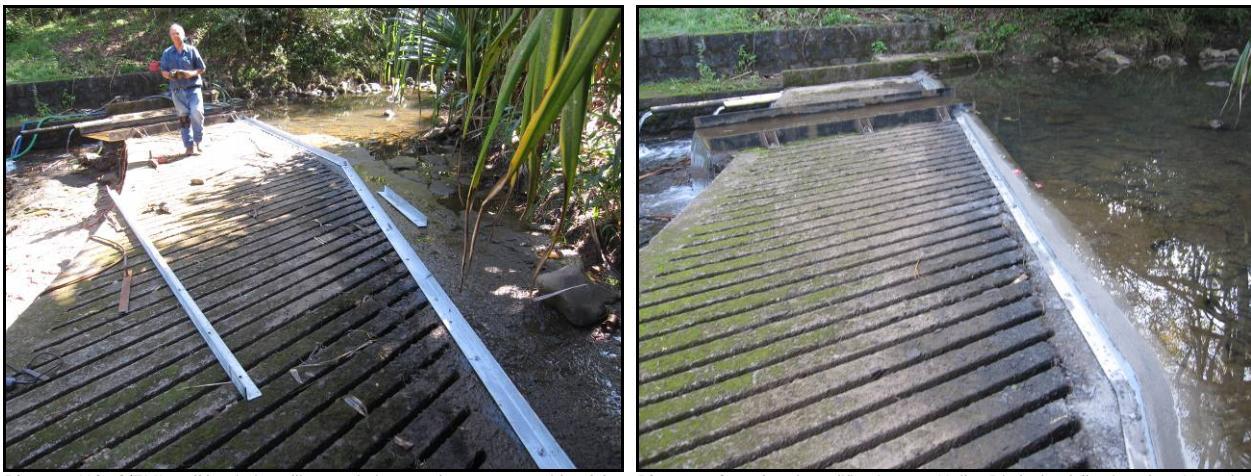
December 7-8, 2010: Staff observed and documented the modification of the low-flow bypass channel at Haiku Ditch on Honopou Stream by Hawaiian Commercial & Sugar Co. (HC&S)/East Maui Irrigation Co. (EMI) staff. The purpose of the modification was to install a more permanent structure on the upstream side of the Haiku Ditch intake grates. The previously installed lumber was removed and angle iron was installed across the entire length of the intake, to raise the head level and allow more water to flow through the low-flow bypass channel (Photo 1). Concrete was also poured on the upstream side of the installed angle iron to prevent leakage into the grates (Photo 2).

Photo 1. HC&S/EMI staff begin installing angle iron on the upstream side of the Photo 2. Completed modifications at Haiku Ditch the following day. Note that Haiku Ditch intake grates. On December 6, the Lowrie Ditch sluice gate was concrete was poured on the upstream side of the angle iron to prevent leakage closed the to lower water levels so work could be performed on December 7.

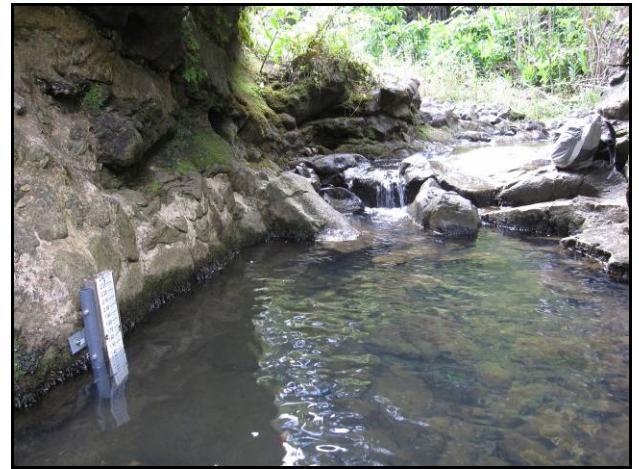
Photo 3. Staff gage site at Waiohue Stream.

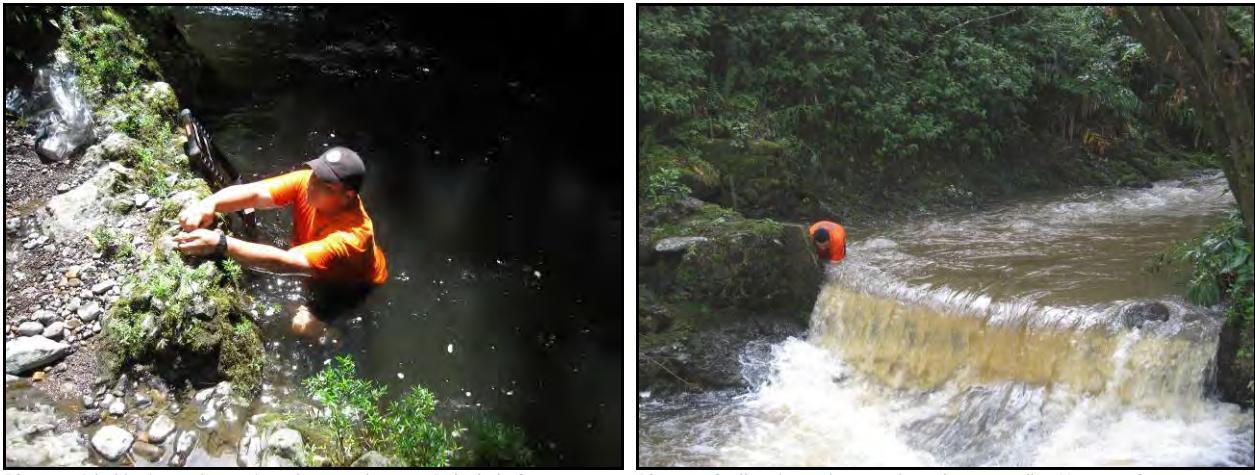
Photo 1. A ladder is used to retrieve the transducer on Palauhulu Stream.

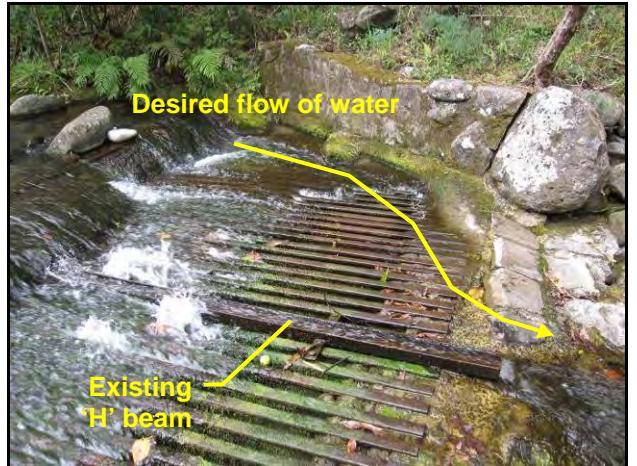
Photo 21, View of Waihee River Waihee Ditch South Fork intake facing the left Photo 22, Upstream view of Waihee River towards the right bank with the bank and the existing iron 'H' beam bypass in the foreground.

- Waihee River at Spreckels Ditch Intake: WWC plans to install an iron 'H' beam channel along the left bank wing wall of the diversion dam. The upstream end of the channel will be installed in a small pool approximately 10 ft. upstream of the dam (Photo 22). The downstream end of the channel will drop water atop the diversion dam nearest the left bank. An eroded portion of the concrete apron downstream of the bypass channel will be repaired.

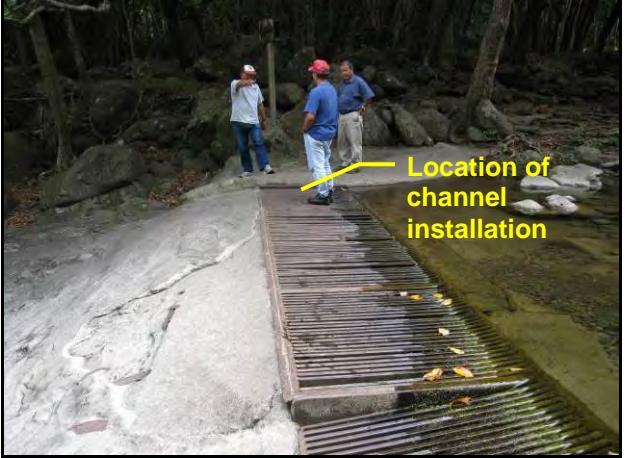
Photo 26. View of the Iao-Maniania Ditch intake grates looking towards the right bank of Iao Stream.

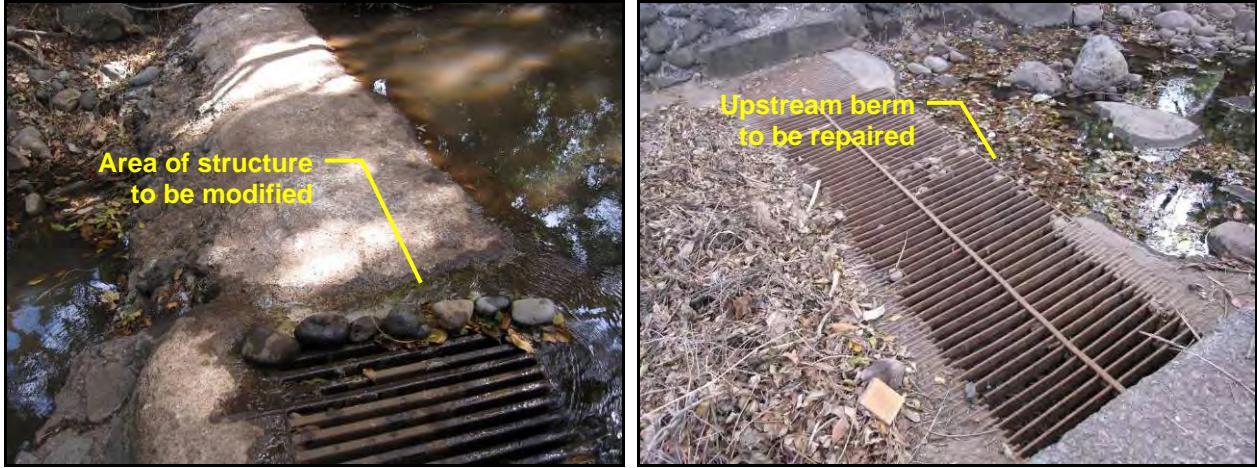
Photo 27. Diversion Intake structure to Waihee Ditch facing towards the right bank on Waikapu Stream. Photo 28. Reservoir 6 diversion intake grate across the stream channel, facing towards the right bank on Waikapu Stream.

- Waikapu Stream at Waihee Ditch Intake: A portion of the concrete dam near the middle of the diversion structure will be chipped away to create a small channel towards the right bank side of the intake grates (Photo 27). The iron 'H' beam channel currently installed across the intake grates will remain in place; however, DAR has suggested that slower velocity and shallower flow across the concrete apron will promote biota migration.
- Waikapu Stream at Reservoir 6 Intake: The upstream berm of the diversion intake grates will be repaired with concrete to raise the water level (Photo 28). WWC will install an iron 'H' beam channel across the width of the intake grates. The eroded section in the concrete apron downstream of the intake will be left as is, but may be repaired if connectivity is not established after the bypass channel is installed.
