STATE OF HAWAII DEPARTMENT OF LAND AND NATURAL RESOURCES COMMISSION ON WATER RESOURCE MANAGEMENT P.O. BOX 621 HONOLULU, HAWAII 96809

December 18, 2014

Summary of Maui Interim Instream Flow Standards

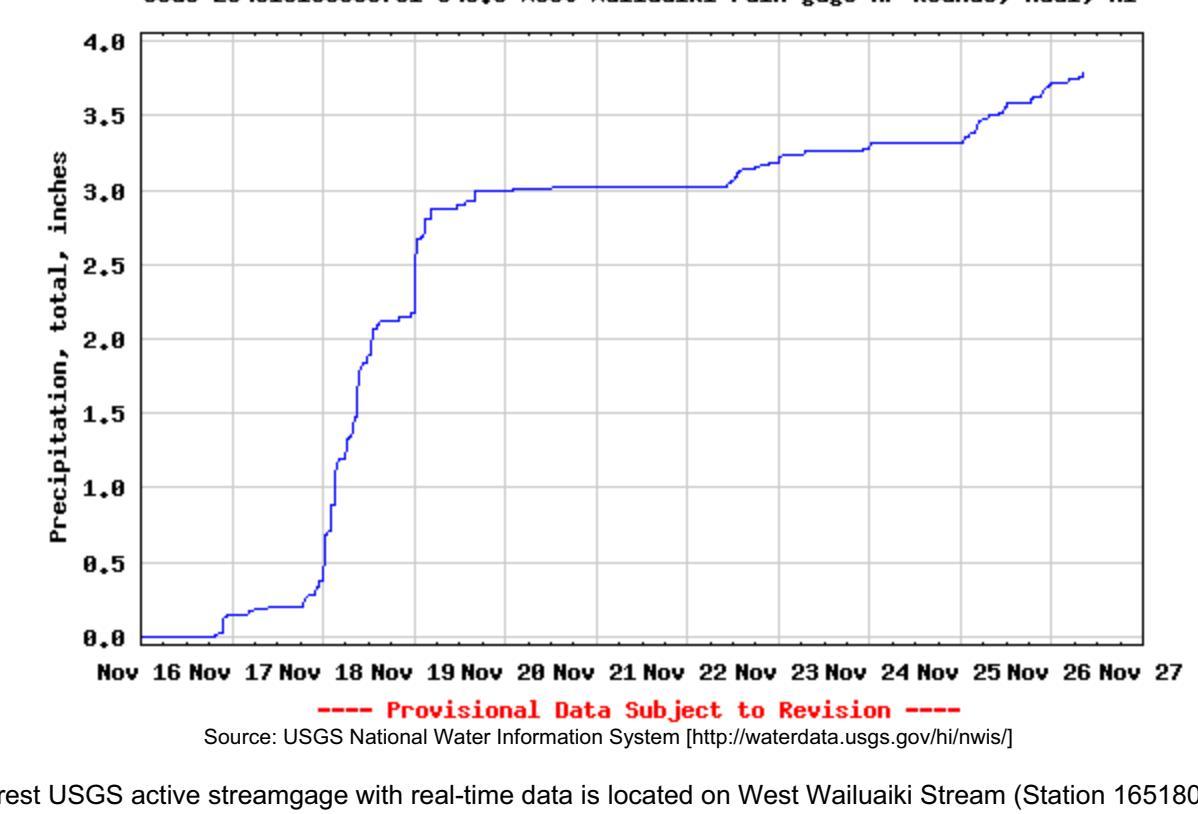
Heavy rain fell on East Maui on the morning of Nov. 18. USGS rain gage (Station 204916156083701) in West Wailuaiki near Keanae recorded 1.8 inches of rain on Nov 18, and 0.82 inches on Nov. 19. Most of the rain fell on the early morning of Nov. 18, between 12AM and 3:30AM.

USGS 204916156083701 348.5 West Wailuaiki rain gage nr Keanae, Maui, HI

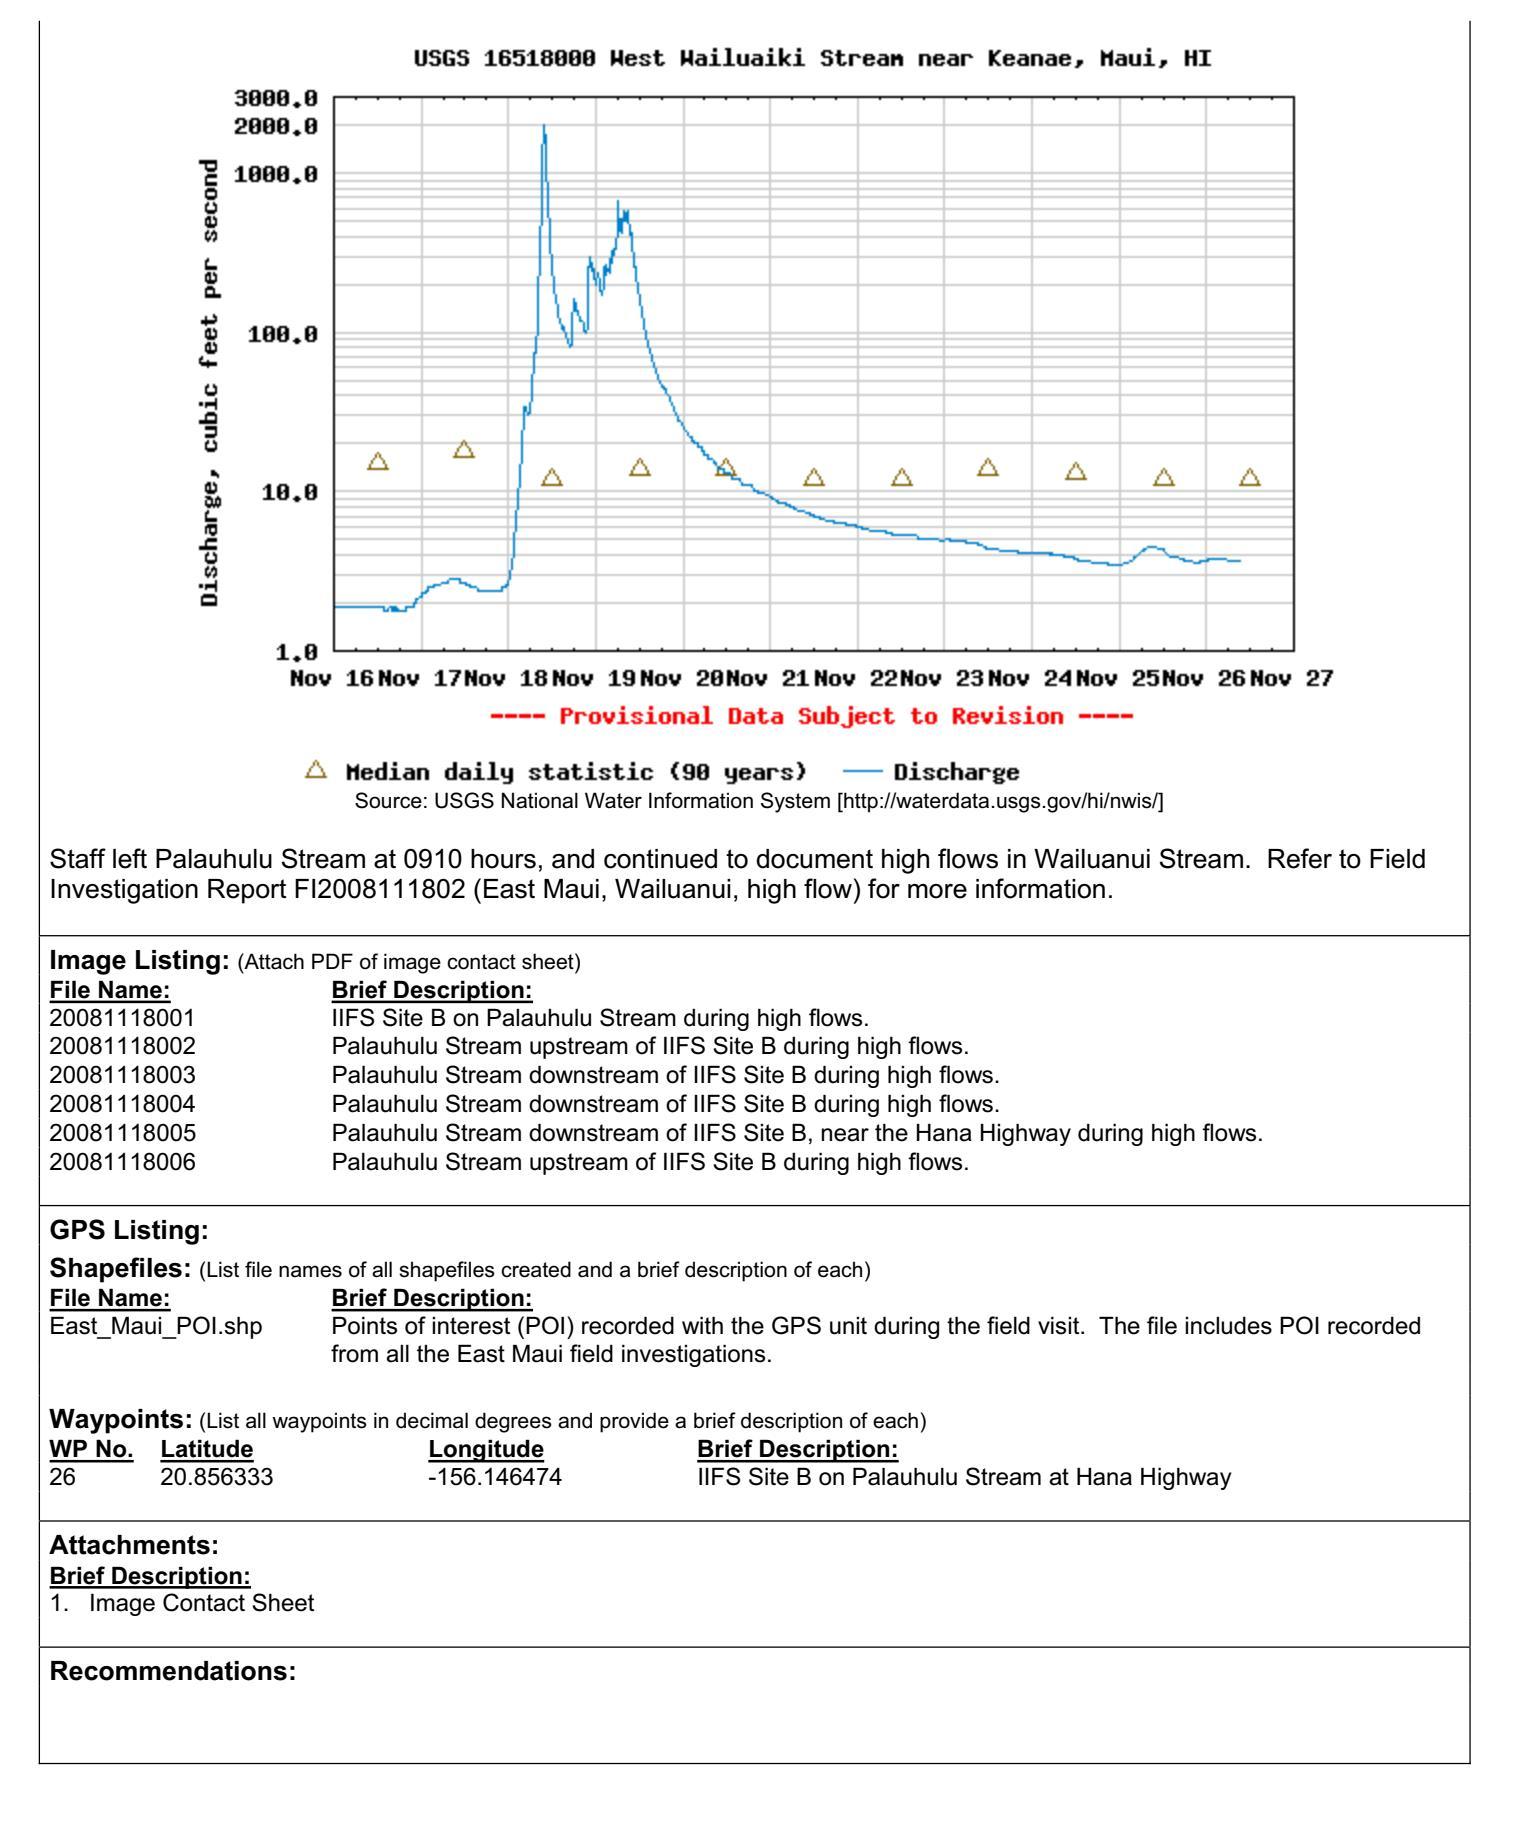
The nearest USGS active streamgage with real-time data is located on West Wailuaiki Stream (Station 16518000). At approximately 12:00AM on Nov. 18, discharge in West Wailuaiki Stream began to increase from 2.7CFS to a peak flow of 2,010 CFS at 9:45AM. By Nov. 26, streamflow returned to normal conditions at 3.7 CFS.

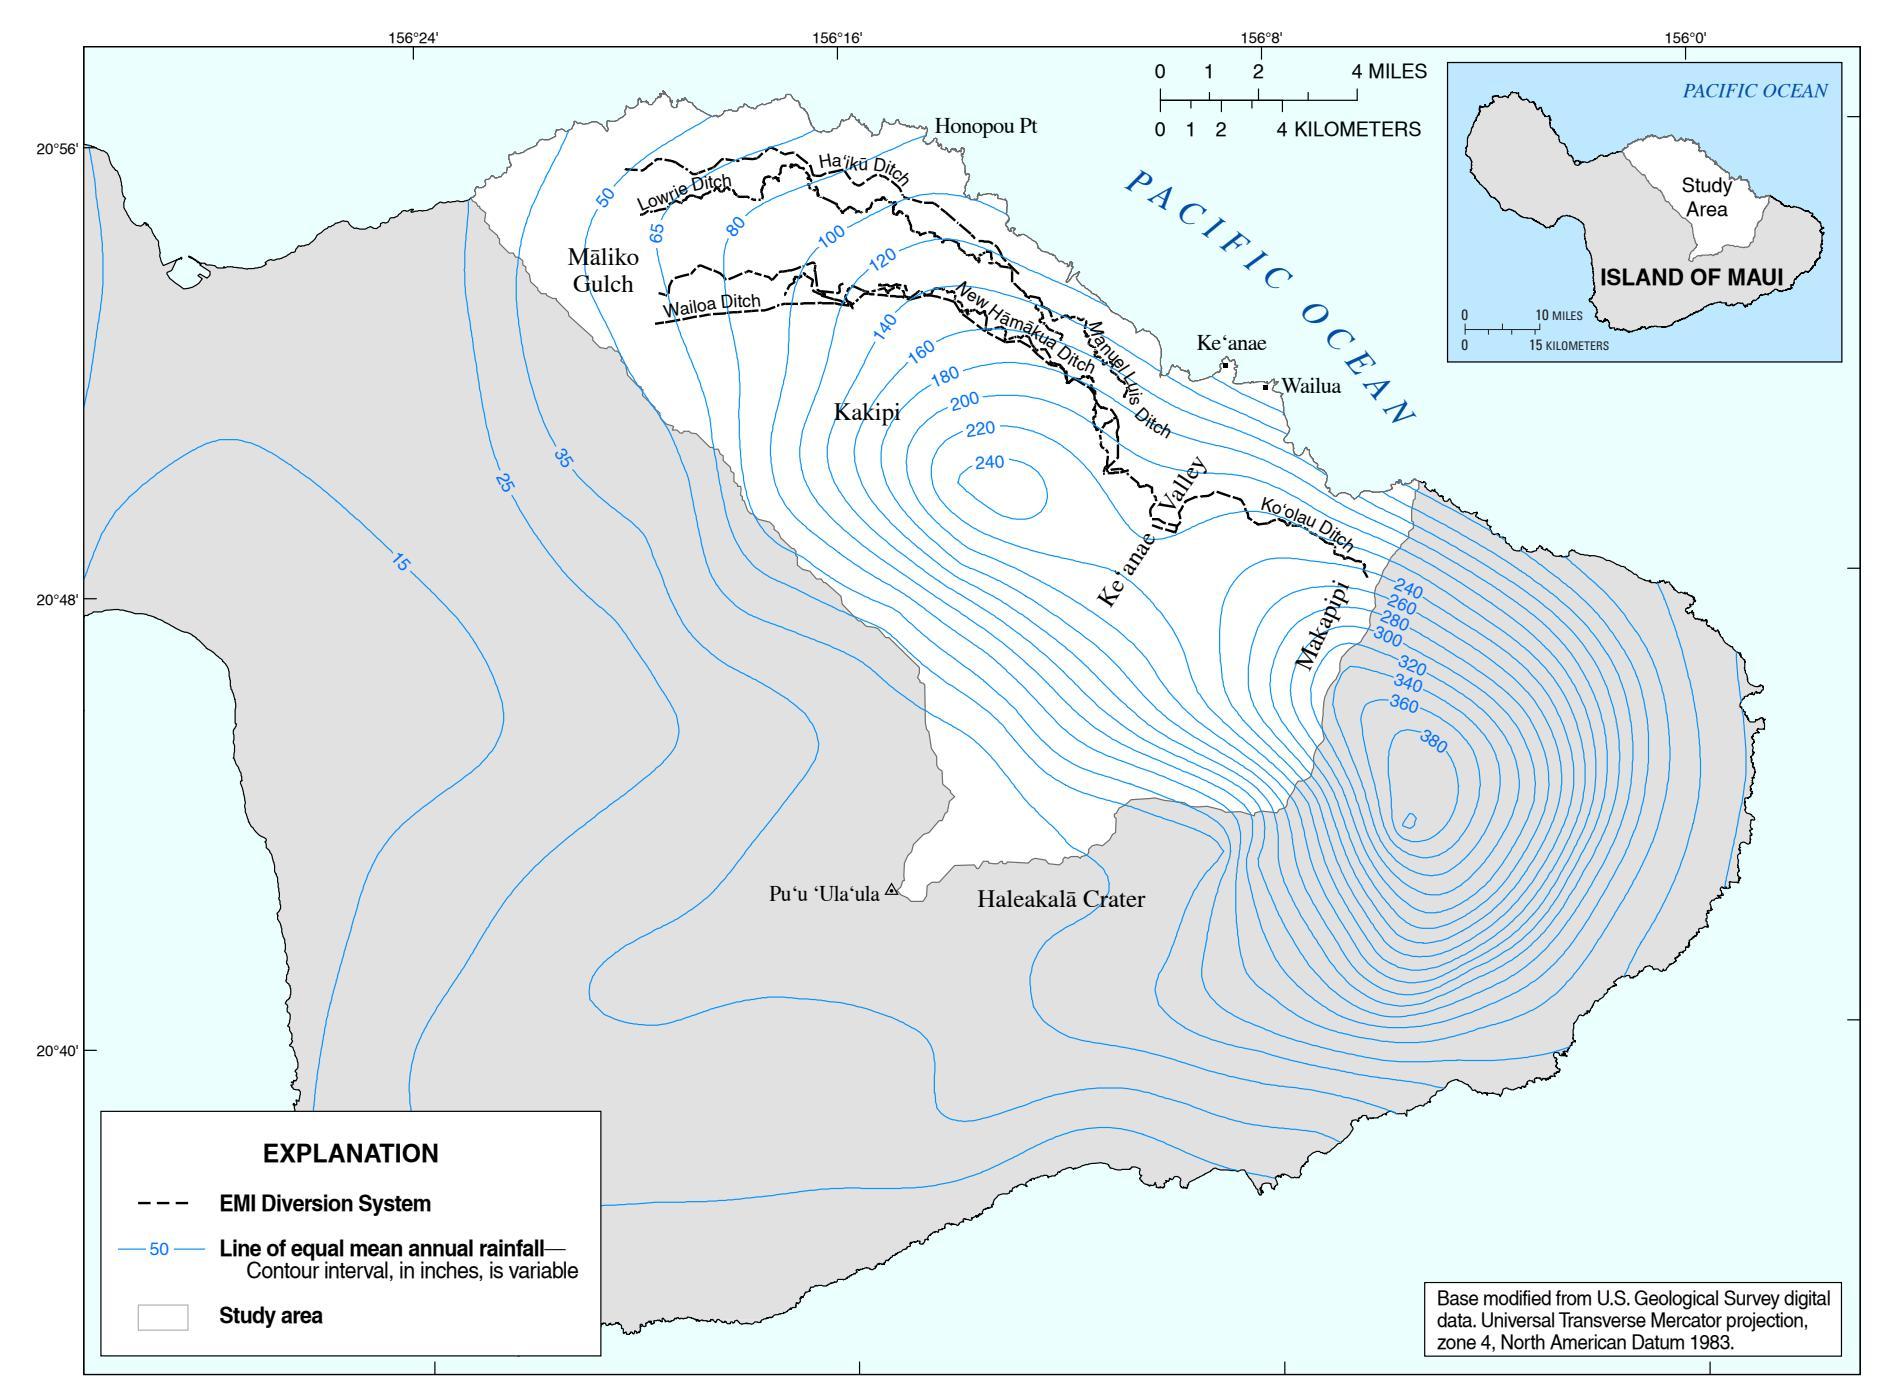
Figure 2. Mean annual rainfall, east Maui, Hawai'i (modified from Giambelluca and others, 2011). EMI, East Maui Irrigation.

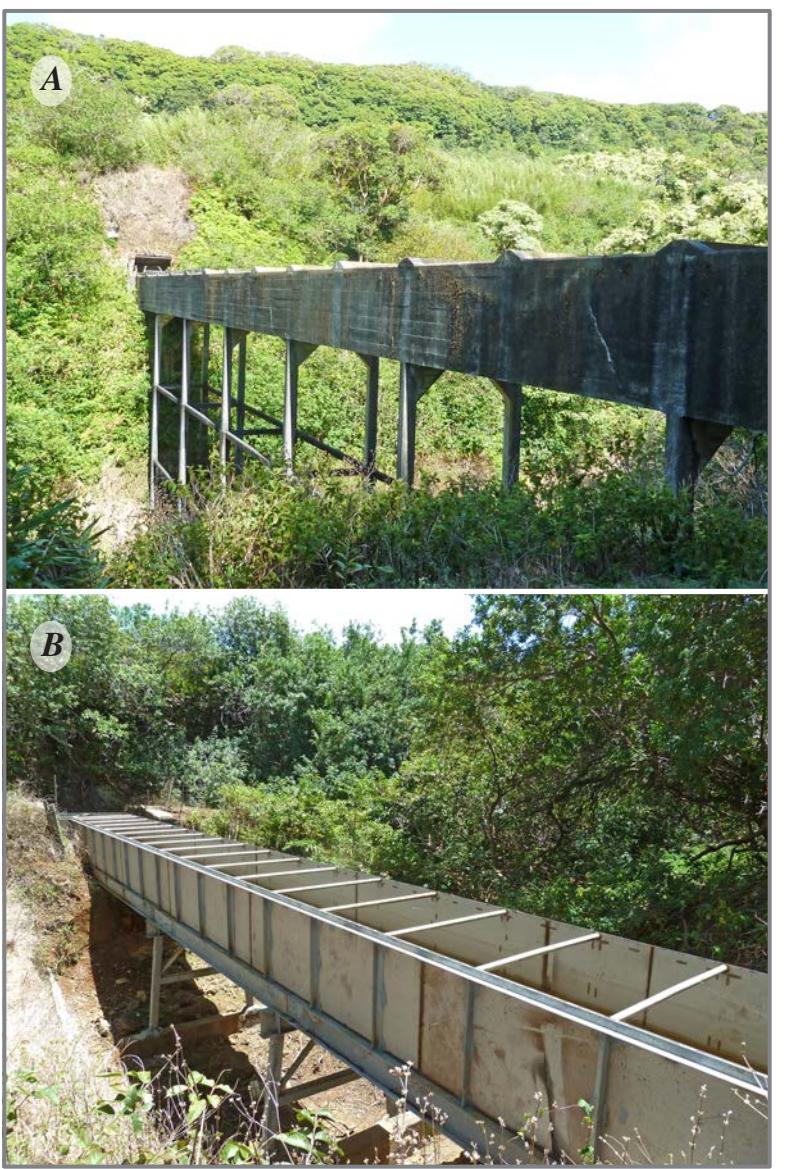
**Figure 4.** Photographs of two flumes that are part of the East Maui Irrigation diversion system, east Maui, Hawai'i. *A*, Concrete-lined flume along the Wailoa Ditch at 'Ōpana. *B*, Stainless-steel flume along the Lowrie Ditch near Kuiaha Gulch, also known as Labasan flume.

Koʻolau and Wailoa Ditches.—Koʻolau Ditch conveys water between Makapipi Stream and Alo Stream, a tributary of Waikamoi Stream, where the ditch is thereafter referred as Wailoa Ditch. Ko'olau Ditch has a total length of 10.2 miles, 75 percent of which is tunnels and most of the remainder of which (about 2.5 miles) is lined open ditches that have concrete or armored cut-stone walls such as those shown in figure 5. From the start of the ditch at Makapipi Stream to Kopili'ula Stream, Ko'olau Ditch consists of a combination of tunnel and lined open-ditch sections. The remainder of the ditch between Kopili'ula and Waikamoi Streams is entirely tunnel, except a short lined open-ditch section near Pi'ina'au Stream. Heading west from Alo Stream, the Wailoa Ditch conveys water for about 9.6 miles mostly in tunnels and terminates at Māliko Gulch, where the water is delivered to the HC&S plantation. The open-ditch sections of Wailoa Ditch are limited to concrete-lined flumes, one of which is illustrated in figure 4A.

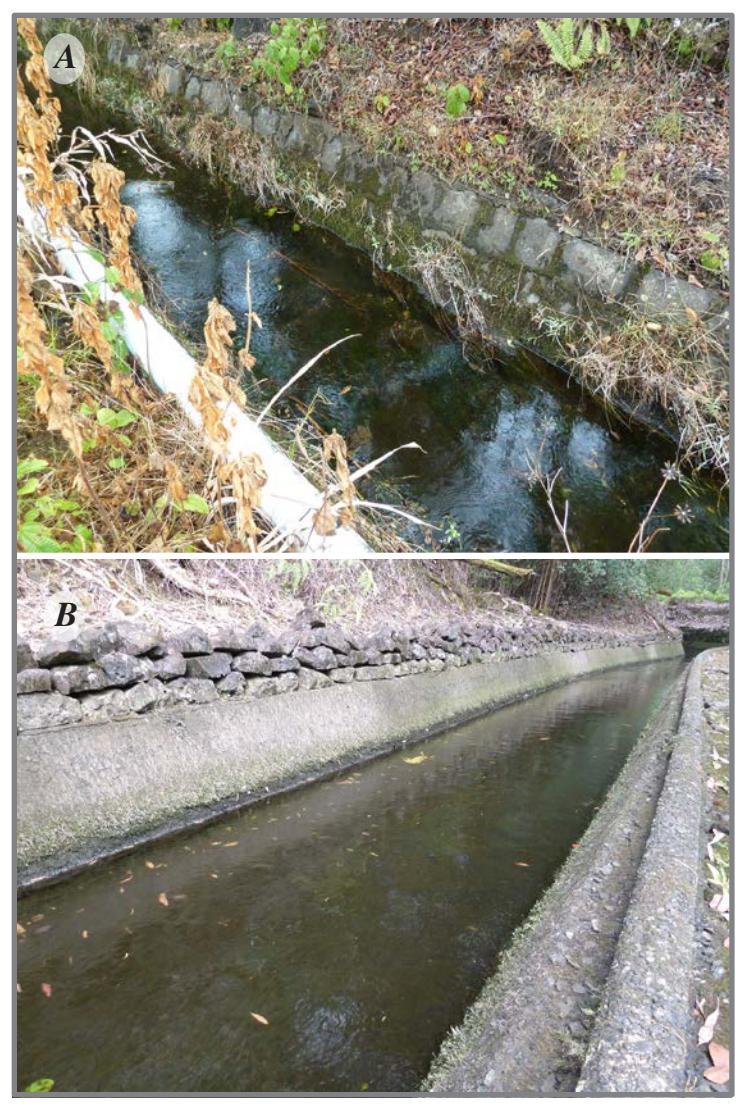
**Figure 5.** Photographs of two sections of the Ko'olau Ditch, East Maui Irrigation diversion system, east Maui, Hawai'i. *A*, Lined open-ditch section near Makapipi Stream with armored cut-stone walls and concrete bottom. *B*, Lined open-ditch section near Waiohue Stream with concrete walls and bottom.

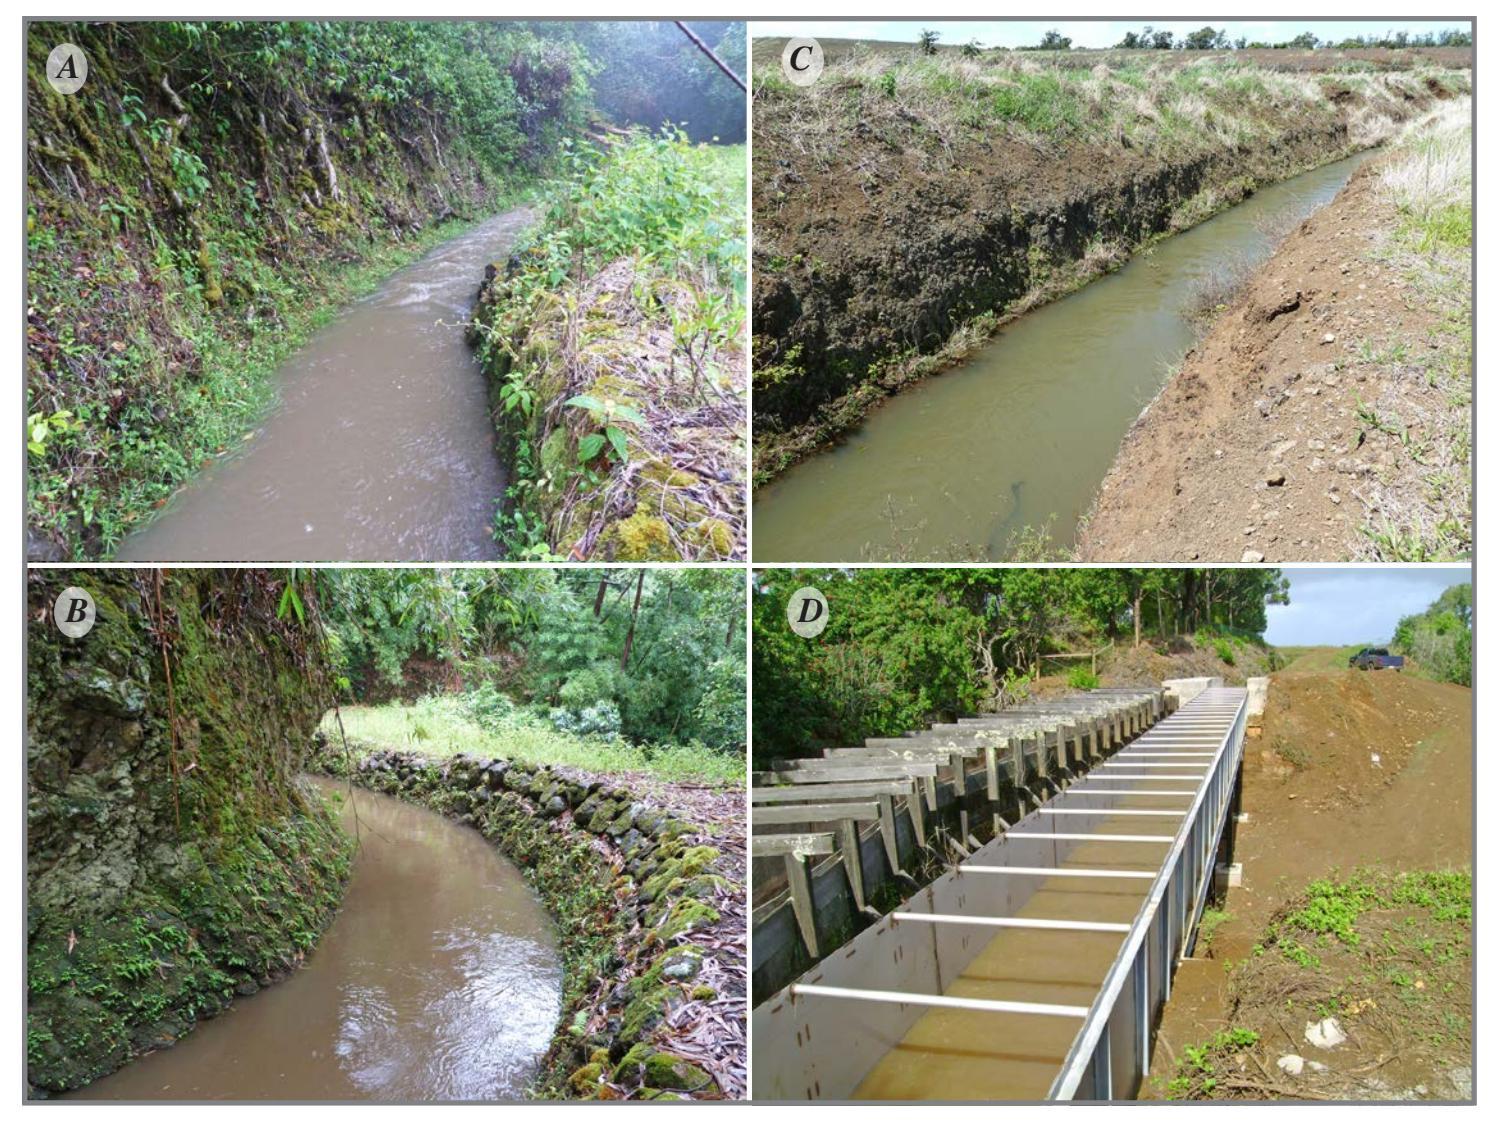
**Figure 9.** Photographs of Manuel Luis, Center, and Lowrie Ditches, East Maui Irrigation diversion system, east Maui, Hawai'i. *A*, Manuel Luis Ditch, unlined open-ditch section near Puohokamoa Stream. *B*, Center Ditch, unlined open-ditch section between Kōlea and Punalu'u Streams. *C*, Lowrie Ditch, unlined open-ditch section near Māliko Gulch. *D*, Lowrie Ditch, old wood flume and replacement stainless-steel flume near Pe'ahi Reservoir (photograph by Garret Hew, East Maui Irrigation Company).

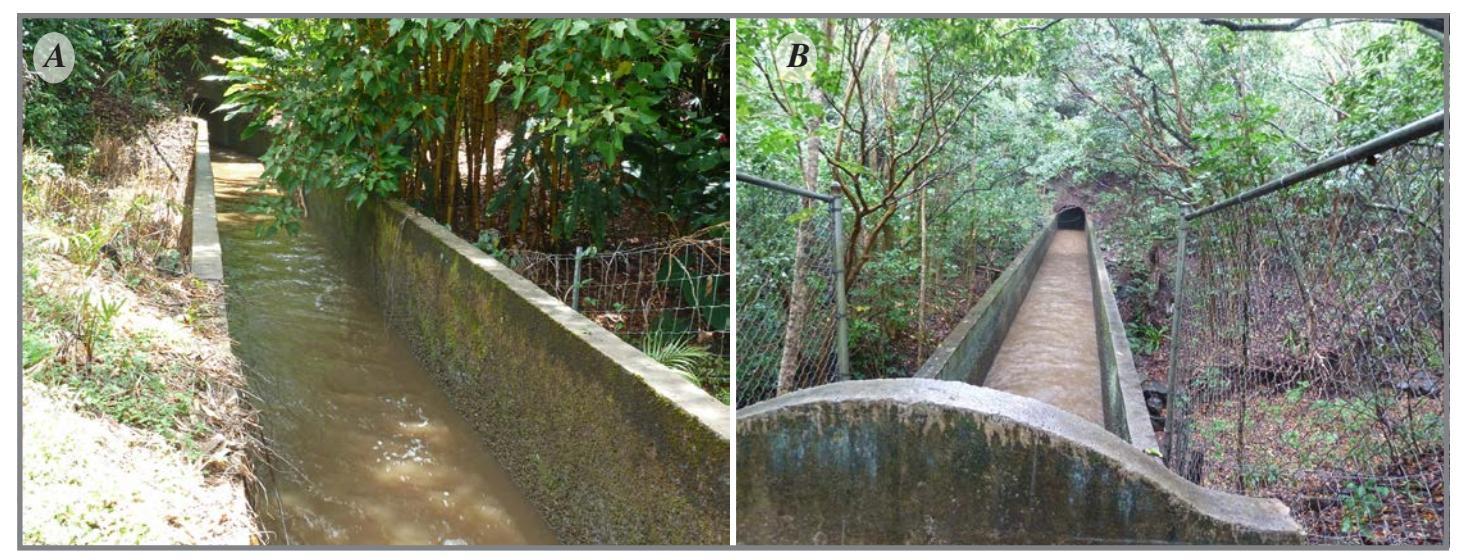
Figure 10. Photographs of two sections of the Ha'ikū Ditch, East Maui Irrigation diversion system, east Maui, Hawai'i. A, Eby Flume at Manawaiiao Stream. B, Shirota Flume at Kuiaha Gulch.
