STATE OF HAWAII
DEPARTMENT OF LAND AND NATURAL RESOURCES
COMMISSION ON WATER RESOURCE MANAGEMENT
 Stream Protection and Management Branch

FIELD INVESTIGATION REPORT
FI2008111803 (East Maui, Lakini and Kualani)

Date of Field Investigation:	November 18, 2008	Time (24-hour):	1030 - 1500
CWRM Staff:	Ed Sakoda, Dean Uyeno, and Chui Ling Cheng		
Individuals Present:	DAR - Skippy Hau; Wailua Valley - Ed Wendt and Carl Wendt		
Hydrologic Unit:	Waiokamilo (6055)		
Stream Name:	Kualani Stream

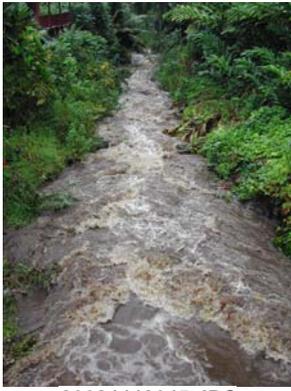
20081118015.JPG

<u>File Name:</u>	<u>Brief Description:</u>
20081118015	Waiokamilo Stream downstream from Hana Highway.
20081118017	Waiokamilo Stream downstream from Hana Highway.
20081118019	Waiokamilo Stream upstream from Hana Highway.
20081118021	Waiokamilo Stream upstream from Hana Highway.
20081118022	Kualani Stream downstream from Hana Highway.
20081118024	Kualani Stream upstream from Hana Highway.
20081118026	Kualani Stream upstream from Hana Highway.
20081118028	Bridge on Hana Highway that crosses Waiokamilo Stream and Kualani Stream.
20081118029	Dam 4 of the auwai for the Na Moku Project, downstream from Hana Highway.
20081118030	Kualani Stream and the auwai for the Na Moku Project, downstream from Hana Highway but upstream from Dam 4.
20081118031	Auwai for the Na Moku Project, downstream from Hana Highway.
20081118032	Kualani Stream and the auwai for the Na Moku Project, downstream from Hana Highway but upstream from Dam 4.

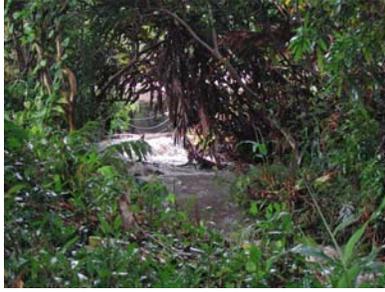
20081118033.JPG

20081118033	Auwai for the Na Moku Project, downstream from Hana Highway.
20081118034	Confluence of Kualani Stream and Waiokamilo Stream downstream from Hana Highway.
20081118038	Auwai for the Na Moku Project, downstream from Hana Highway.
20081118045	Lakini taro patch.
20081118049	Dam 1 upstream of the Lakini taro patch. Kualani Stream flows into the auwai for Lakini.
20081118051	Kualani Stream upstream of Dam 1.
20081118052	Kualani Stream upstream of Dam 1.
20081118055	Kualani Stream upstream of Dam 1.
20081118057	Kualani Stream upstream of Dam 1.
20081118058	Kualani Stream upstream of Dam 1.
20081118059	Concrete diversion box downstream of Hana Highway.
20081118061	Concrete diversion box downstream of Hana Highway.
20081118065	Taro patches in Wailua Valley.
20081118066	Kikokiko Falls on Waiokamilo Stream.
20081118068	Kualani Stream upstream from Hana Highway.
20081118070	Kualani Stream upstream from Hana Highway, on the way to Kualani Falls.

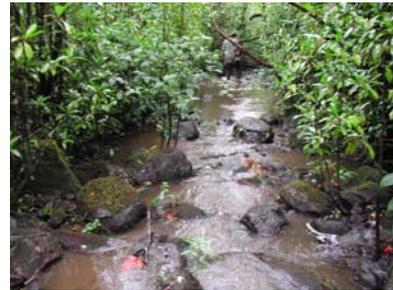
20081118071.JPG

20081118071	Kualani Stream upstream from Hana Highway, on the way to Kualani Falls.
20081118072	Kualani Falls on Kualani Stream.
20081118075	Kualani Falls on Kualani Stream.
