STATE OF HAWAII
DEPARTMENT OF LAND AND NATURAL RESOURCES
COMMISSION ON WATER RESOURCE MANAGEMENT
 Stream Protection and Management Branch

FIELD INVESTIGATION REPORT
FI2009021003 (East Maui, Waiokamilo Stream)

Date of Field Investigation:	February 10, 2009	Time (24-hour):	1230 - 1330
CWRM Staff:	Ed Sakoda, Dean Uyeno, Ronnie Torres, and Chui Ling Cheng		
Individuals Present:			
Hydrologic Unit:	Waiokamilo (6055)		
Stream Name:	Waiokamilo Stream

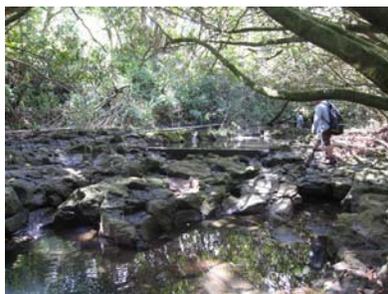
20090210048.jpg

<u>File Name:</u>	<u>Brief Description:</u>
20090210048	Diversion dam on Waiokamilo Stream 360 feet upstream from Hana Highway.
20090210050	Diversion dam on Waiokamilo Stream 360 feet upstream from Hana Highway.
20090210051	Water overflowing the diversion dam on Waiokamilo Stream 360 feet upstream from Hana Highway.
20090210052	Waiokamilo Stream splits 10 upstream from the diversion dam above Hana Highway.
20090210054	Waiokamilo Stream upstream of diversion dam above Hana Highway.
20090210056	Pond 710 feet upstream from Hana Highway on Waiokamilo Stream.
20090210059	Small waterfall at Kualani Stream.
