STATE OF HAWAII
DEPARTMENT OF LAND AND NATURAL RESOURCES
COMMISSION ON WATER RESOURCE MANAGEMENT
 Stream Protection and Management Branch

FIELD INVESTIGATION REPORT
FI2009021102 (East Maui, Hanehoi Haiku Ditch)

Date of Field Investigation:	February 11, 2009	Time (24-hour):	0900 - 0945
CWRM Staff:	Ed Sakoda, Dean Uyeno, and Chui Ling Cheng		
Individuals Present:	Garret Hew		
Hydrologic Unit:	Hanehoi (6037)		
Stream Name:	Hanehoi Stream

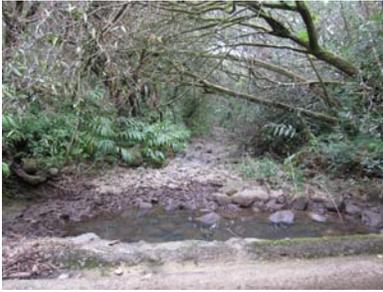
20090211012.jpg

File Name:	Brief Description:
20090211012	Hanehoi Stream upstream of Haiku Ditch.
20090211013	Hanehoi Stream downstream of Haiku Ditch.
20090211014	Haiku Ditch at Hanehoi Stream.
20090211015	Haiku Ditch bypass sluice gate at Hanehoi Stream.
20090211016	Haiku Ditch bypass sluice gate at Hanehoi Stream.
20090211017	CWRM staff Dean Uyeno taking physical measurement of the Haiku Ditch bypass sluice gate at Hanehoi Stream.
20090211024	Haiku Ditch bypass sluice gate at Hanehoi Stream after adjustment.
20090211026	Haiku Ditch bypass sluice gate at Hanehoi Stream after adjustment.
20090211029	Haiku Ditch bypass sluice gate at Hanehoi Stream after adjustment.
20090211030	Haiku Ditch bypass sluice gate at Hanehoi Stream after adjustment.

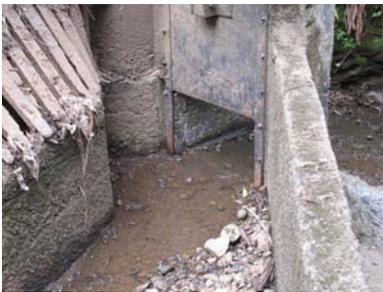
20090211015.jpg

CWRM staff measured the dimensions of the sluice gate opening to be 2.0 x 1.37 feet (W x H). Hanehoi Stream was relatively dry. Flow was not sufficient for taking a flow measurement.
