STATE OF HAWAII
DEPARTMENT OF LAND AND NATURAL RESOURCES
COMMISSION ON WATER RESOURCE MANAGEMENT
 Stream Protection and Management Branch

FIELD INVESTIGATION REPORT
FI2009021103 (East Maui, Huelo IIFS Site A)

Date of Field Investigation:	February 11, 2009	Time (24-hour):	1000 - 1200
CWRM Staff:	Ed Sakoda, Dean Uyeno, and Chui Ling Cheng		
Individuals Present:	Ernie Schupp, Garret Hew		
Hydrologic Unit:	Hanehoi (6037)		
Stream Name:	Puolua (Huelo) Stream

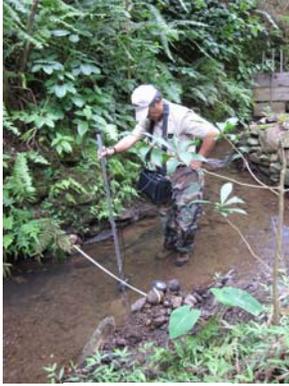
20090211031.jpg

<u>File Name:</u>	<u>Brief Description:</u>
20090211031	CWRM staff Ed Sakoda taking flow measurement at IIFS Site A on Puolua (Huelo) Stream.
20090211032	Puolua (Huelo) Stream upstream from IIFS Site A.
20090211033	Puolua (Huelo) Stream downstream from IIFS Site A.
20090211034	Haiku Ditch bypass sluice gate at Puolua (Huelo) Stream.
20090211035	Haiku Ditch at Puolua (Huelo) Stream.
20090211036	Puolua (Huelo) Stream downstream from Haiku Ditch bypass sluice gate.
20090211039	Ernie Schupp and Garret Hew at the Haiku Ditch bypass sluice gate on Puolua (Huelo) Stream.
20090211040	Ernie Schupp and Garret Hew at the Haiku Ditch bypass sluice gate on Puolua (Huelo) Stream.
20090211042	Haiku Ditch bypass sluice gate on Puolua (Huelo) Stream.

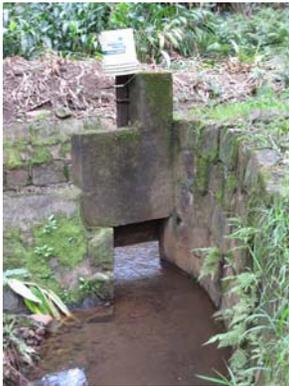
20090211034.jpg

CWRM staff measured the dimensions of the sluice gate opening to be 2.0 x 1.13 feet (W x H). The depth of water at the sluice gate on the left bank was 0.5 feet.

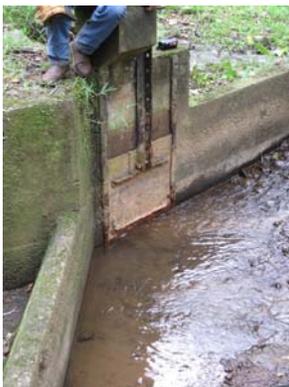
20090211044.jpg

The final height of the sluice gate opening after adjustment was 0.50 feet. CWRM staff used fluorescent yellow flagging tape to mark the height of the sluice gate opening.

20090211044	Haiku Ditch bypass sluice gate on Puolua (Huelo) Stream after adjustment.
20090211045	Haiku Ditch bypass sluice gate on Puolua (Huelo) Stream after adjustment.
20090211046	Haiku Ditch bypass sluice gate on Puolua (Huelo) Stream after adjustment.

As previously measured, discharge at the IIFS Site A on Puolua (Huelo) Stream was 0.380 cubic feet per second (0.246 million gallons per day). Since the adopted IIFS of 0.89 cubic feet per second (0.57 million gallons per day) was not attained, no water from the stream could be diverted. However, the sluice gate could be lowered to a height that, during average flow conditions, allows enough flow bypass the sluice gate to satisfy the IIFS at the selected site further downstream on Puolua (Huelo) Stream. For simplicity, the bypass sluice gate was lowered to the height of the water at approximately 0.50 feet.
