STATE OF HAWAII
DEPARTMENT OF LAND AND NATURAL RESOURCES
COMMISSION ON WATER RESOURCE MANAGEMENT
 Stream Protection and Management Branch

FIELD INVESTIGATION REPORT
FI2009021104 (East Maui, Honopou IIFS Site A)

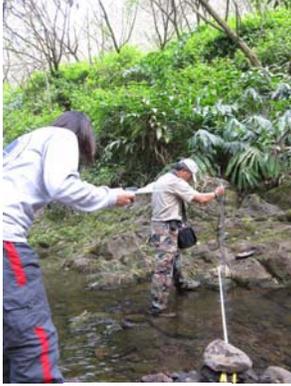
20090211048.jpg

Image Listing: (Attach PDF of image contact sheet)			
File Name:	Brief Description:		
20090211048	CWRM staff conducting flow measurement at IIFS Site A on Honopou Stream.		
20090211049	CWRM staff conducting flow measurement at IIFS Site A on Honopou Stream.		
20090211050	CWRM staff conducting flow measurement at IIFS Site A on Honopou Stream.		
GPS Listing:			
Shapefiles: (List file names of all shapefiles created and a brief description of each)			
File Name:	Brief Description:		
East_Maui_POI.shp	Points of interest (POI) recorded with the GPS unit during the field visit. The file includes POI recorded from all the East Maui field investigations.		
Waypoints: (List all waypoints in decimal degrees and provide a brief description of each)			
WP No.	Latitude	Longitude	Brief Description:
6	20.916212	-156.245203	Bridge on Honopou Stream
7	20.916187	-156.245174	IIFS Site A Reference Point on Honopou Stream
