With this letter, the University of Hawai‘i (UH) transmits the Draft Environmental Assessment (DEA) that assesses the potential effects of the Waikīkī Aquarium Upgrades to improve the Supply Water Intake System. This transmittal is pursuant to requirements set forth in Hawai‘i Revised Statutes Chapter 343 and Hawai‘i Administrative Rule Chapter 11-200.1. As the proposing and approving agency, UH anticipates that the proposed action is not likely to have significant effects and is therefore issuing an Anticipated Finding of No Significant Impact (AFNSI).

Waikīkī Aquarium Upgrades

Draft environmental assessment and anticipated finding of no significant impact (DEA-AFNSI)

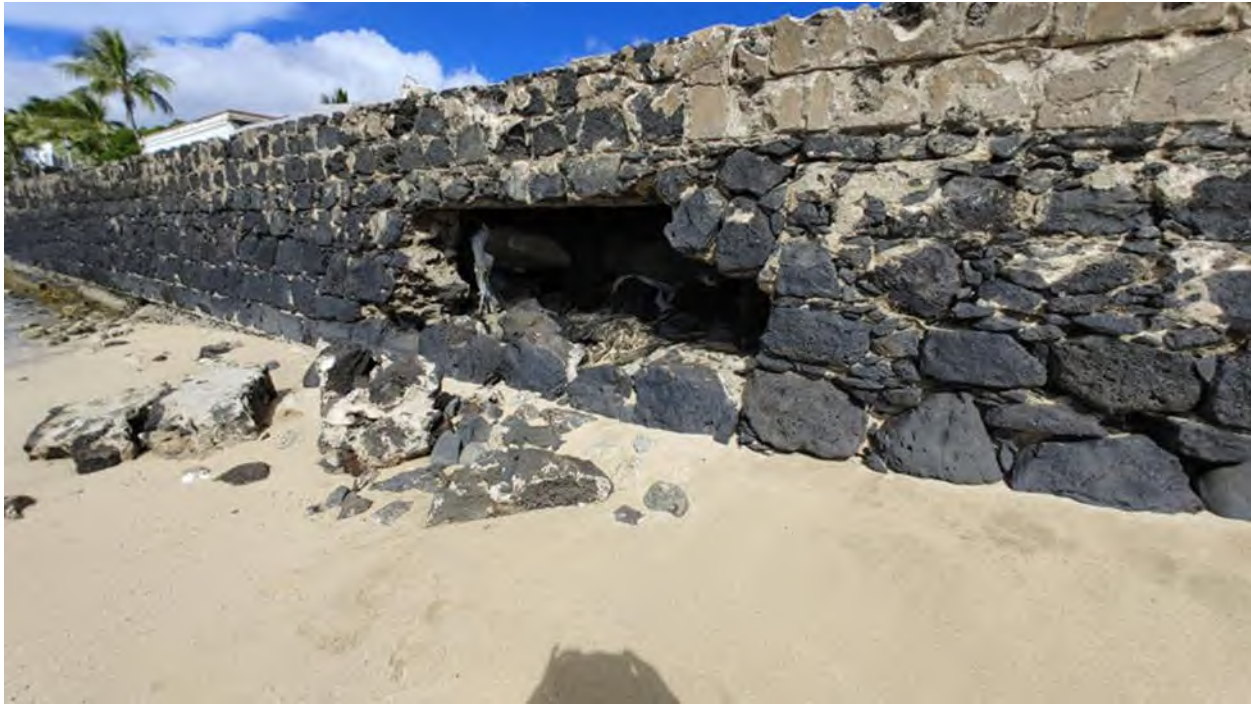
Figure 2-9: Seawall Repair

- Repair approximately 12 linear feet of seawall cavity, to match pre-existing structure footprint;
- Repoint a total of approximately 92 linear feet of seawall façade; and
- Other miscellaneous seawall repairs as called for by structural engineering reports and/or evaluations.

As a part of the pre-consultation process, DLNR Office of Conservation of Coastal Lands (OCCL) commented that the current condition the seawall fronting WAq should be addressed. UH is currently undertaking emergency repairs to the seawall to repair voids as pictured in Figure 2-9. Seawall repairs are part of the Water System Upgrade Plan and therefore included in this Draft EA. However, in discussions with the City and County (CCH) Department of Planning and Permitting (DPP), it was noted that this seawall repair could qualify for an emergency building permit, the application of which will be submitted.

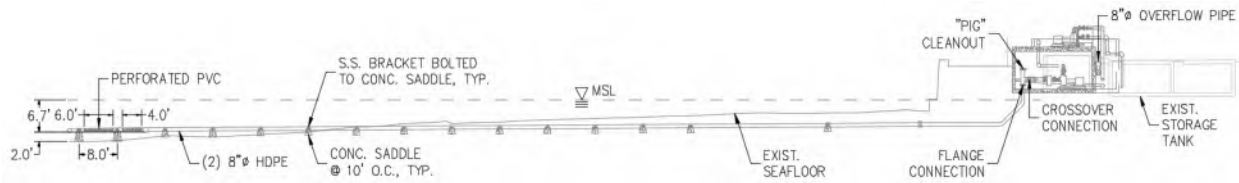
**Figure 3-5: Conceptual Profile of New Intake Pipes**

The openings to the sea water intakes will be designed to minimized entrainment of particulate materials such as microalgae and small fish. Consideration will be given to anchoring the terminus of the new intake, which presently hangs off the edge of the dredged reef face, 2 ft above the existing elevation of the sand bottom of the channel, to make it a few feet deeper than present and improve water quality during winter storm events. Consideration will also be given to extending the intake pipes by 10 ft, from 160 ft to 170 ft in length measured from the existing seawall.

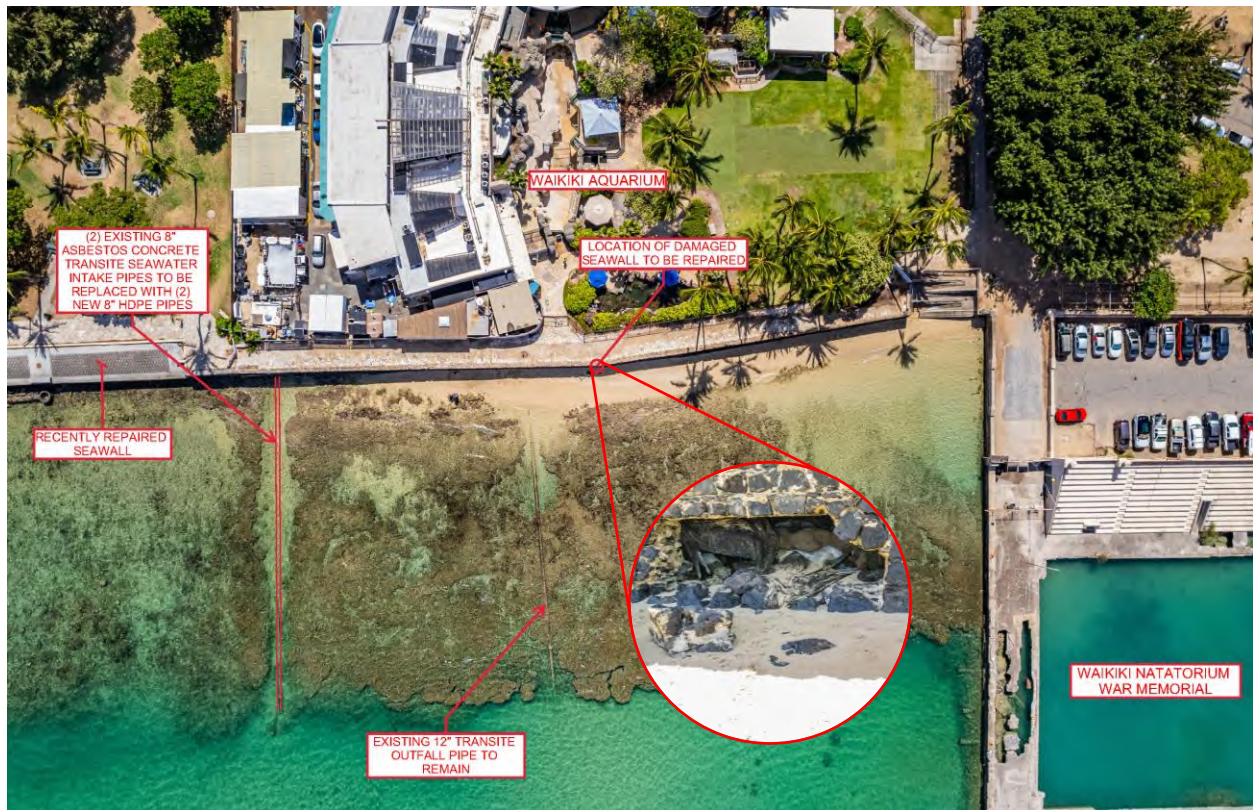
**Figure 3-6: Location of Damaged Seawall to be Repaired**

the Waikīkī Aquarium (Figure 3-6) as well as repoint a total of approximately 92 linear feet of seawall façade. The seawall both protects the Aquarium grounds and supports the public walkway along the shoreline. The walkway has been cordoned off from public access since the discovery of the large void. An assessment of the condition of the seawall and an investigation into the cause of the seawall damage is underway. Site visits with a professional structural engineer, Coffman Engineers, to evaluate the condition of the existing seawall occurred on July 17, 2023 and August 2, 2023. A brief survey to document existing seawall conditions was performed on August 16, 2023.
