SUBJECT: FINAL ENVIRONMENTAL ASSESSMENT (FEA): FINDING OF NO SIGNIFICANT IMPACT FOR THE PROPOSED ADAPTATION PATHWAYS: SEAWALL REMOVAL AND DUNE RESTORATION LOCATED AT 250 HAU'OLI STREET, WAILUKU (MĀ'ALAEA), ISLAND OF MAUI, HAWAI'I; TMKS: (2) 3-8-014:004 AND (2) 3-8-014:005

Adaptation Pathways: Seawall Removal and Dune Restoration

Final environmental assessment and finding of no significant impact (FEA-FONSI)

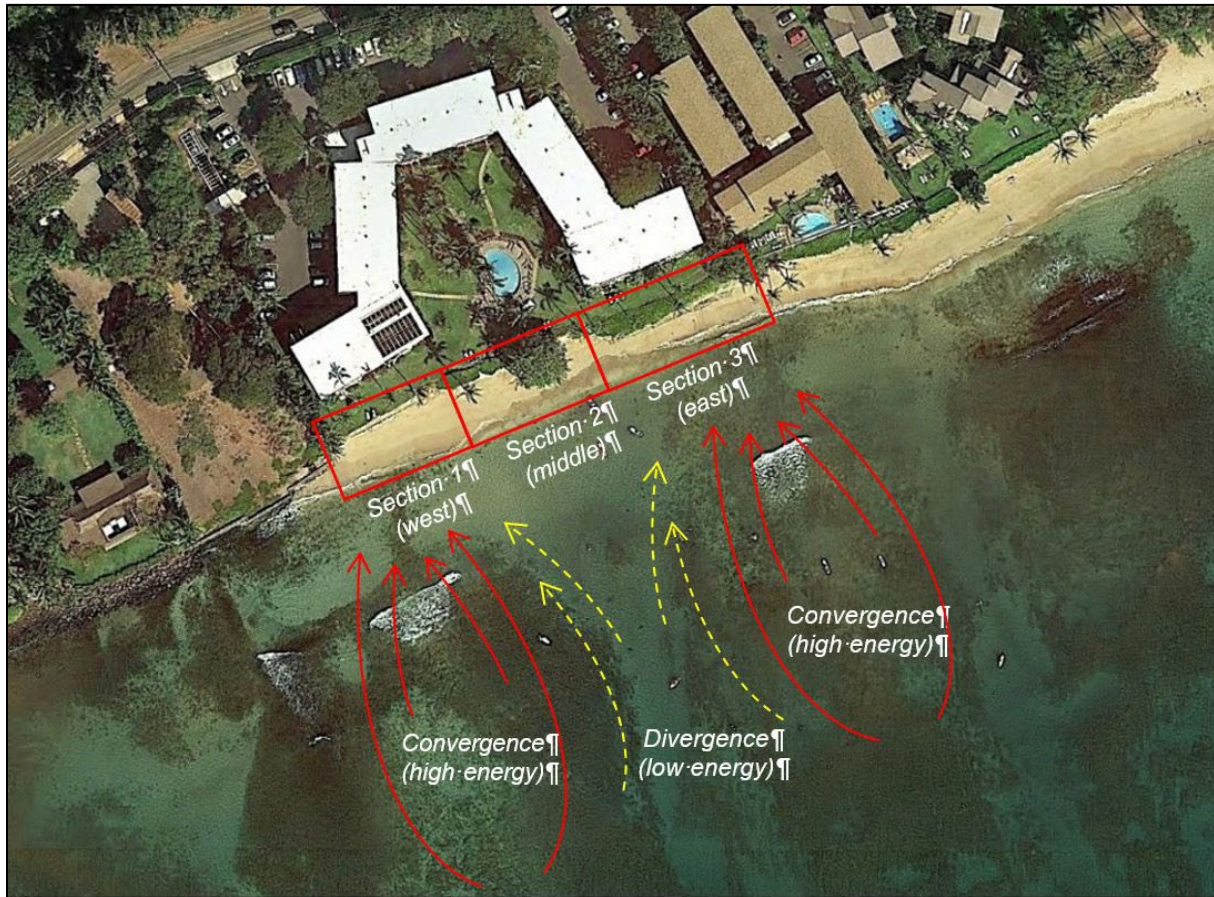
Figure 2: Kanai A Nalu Shoreline Sections and Wave Energy Patterns

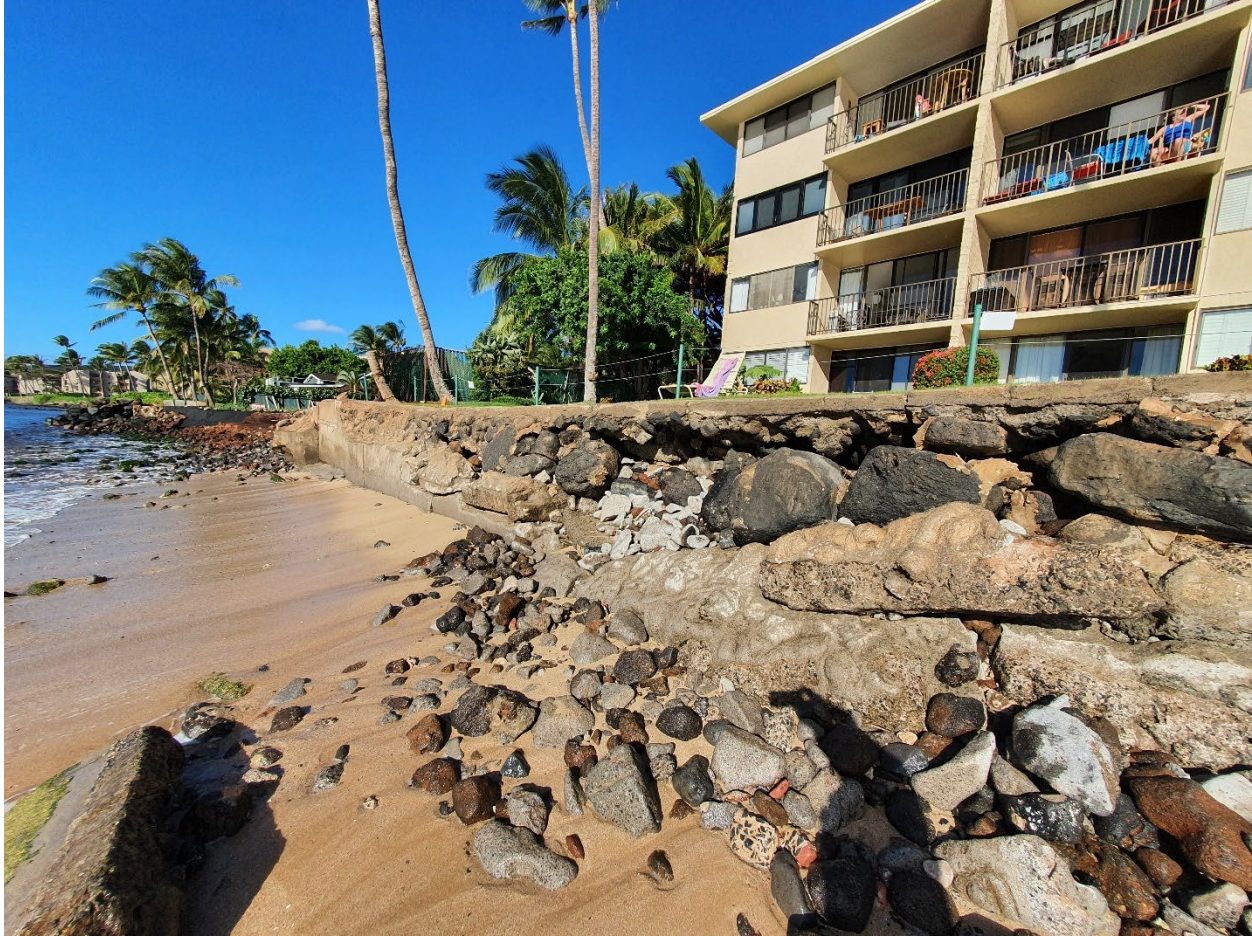
Figure 3: Shoreline Section 1 (east)

In summary, the following damages and structural deficiencies were observed in Section 1:

- Erosion and loss of mortar due to weathering and wave action.
- Undermining and void formation due to erosion of loose sandy material.
- Wall displacement and settlement due to loss of subgrade support.
- West adjacent seawall is damaged and appears to be failing.

Section 1 consists of approximately 90 linear feet of shoreline that is fronted by a CRM seawall. The seawall is approximately 30 to 35 feet seaward of the west wing of the Kanai A Nalu building. The seawall is approximately 5 to 6 feet high and appears to be constructed of mortared stone for the top 2 to 3 feet of wall height with a combination of precast concrete pavers and cast-in-place concrete fill at the lower 2 to 3 feet. It appears that the concrete fill was added to address undermining of the original stone wall as well as missing stones, with possibly more than one layer of concrete fill placed at different times. The wall thickness is unknown.

An approximately 3.5-foot-wide concrete cap has been cast on the top of the wall with the bottom of the stone portion of the wall below extending about 1 foot out beyond the cap on average. It appears this cap may have been cast over a previous cap, possibly to address cracked, displaced or missing portions of the original cap. The center portion of the concrete cap appears to have sagged downward, indicating the center portion of the wall may have settled downward.

Cracks, separations in the mortar, and voids in portions of the wall are also indicators of wall displacement.

Almost the entire wall length is undermined along the base of the wall, with voids between the bottom of the wall and top of the sand fronting the wall base varying in height from less than an inch to several inches and varying in depth up to several feet in from the front face of the wall. At the time of the site inspection, the beach sand elevation was below the elevation of the base of the seawall exposing the majority of the footing including undermined portions of the seawall foundation. The undermined portion beneath the seawall footing was measured and found to be up to 18 inches in height below the bottom of the footing and extending horizontally up to 12 feet under the footing (measured from the seaward face of the wall). No observable rotation of the seawall was noted. However, vertical deformation (gaps) between the building blocks was measured up to 6 inches.

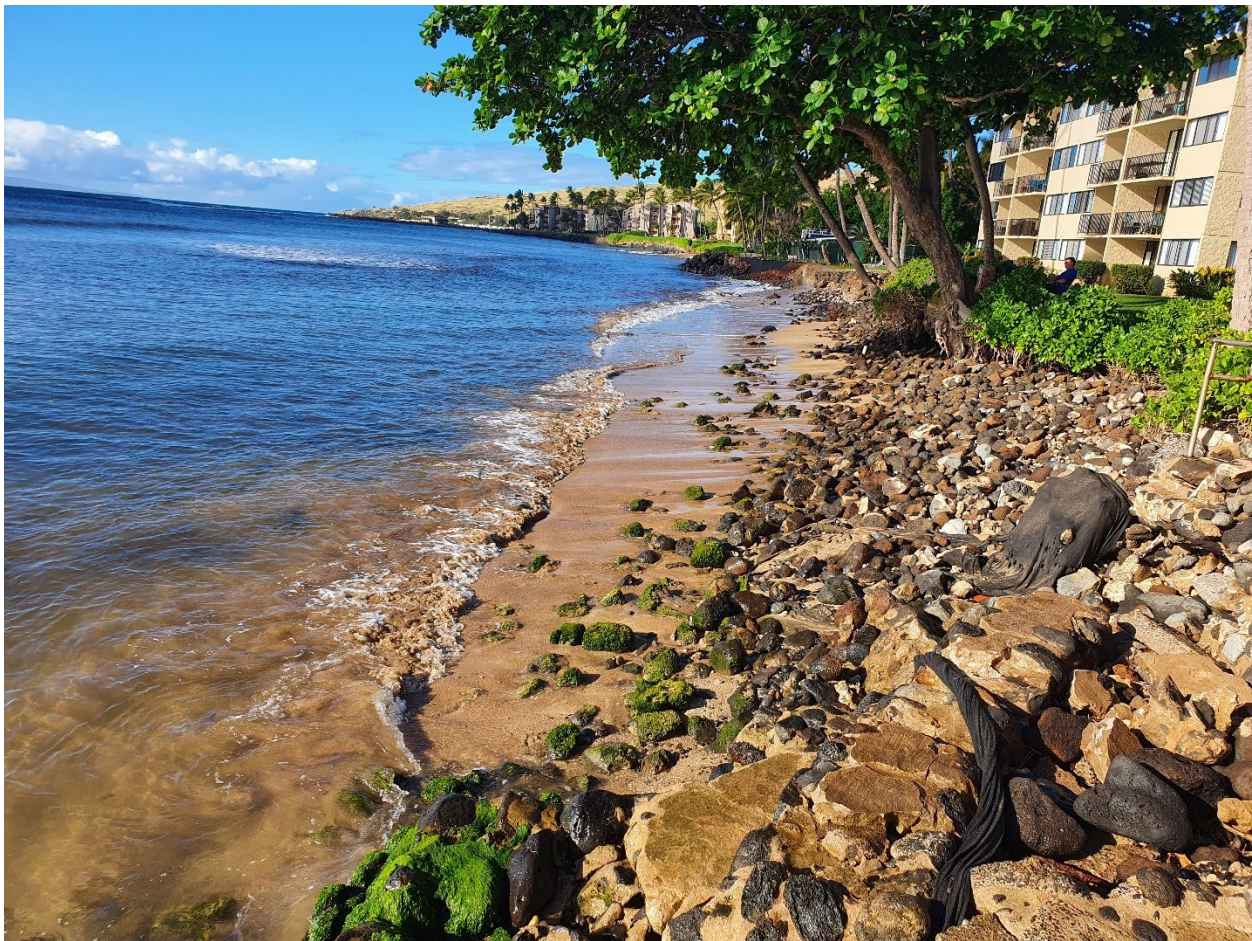
Figure 4: Shoreline Section 2 (middle)

In summary, the following issues were observed in Section 2:

- Shore protection failed and was removed.
- Active erosion.
- Undermining due to wave action.
- Loss of backshore soils.

The erosion scarp is approximately 4 to 5 feet above the current sand elevation. There is evidence of undermining, particularly around the tree root structures. In some areas, the undermining extends 4 to 6 feet landward of the edge of the erosion scarp. There is evidence of active erosion and several of the trees located along the edge of the scarp appear to be leaning in a seaward direction, which suggests they are at risk of falling. A pile of loose cobble and debris material

This section of the shoreline was previously fronted by a CRM seawall. The seawall was damaged, and minor repairs were performed in 2006. The seawall ultimately failed and was removed in 2006. The embankment was graded, a small amount of beach fill was added, and the area was replanted with salt-tolerant grass and Naupaka. The erosion scarp currently appears to be relatively stable; however, the undermining appears to be progressive.

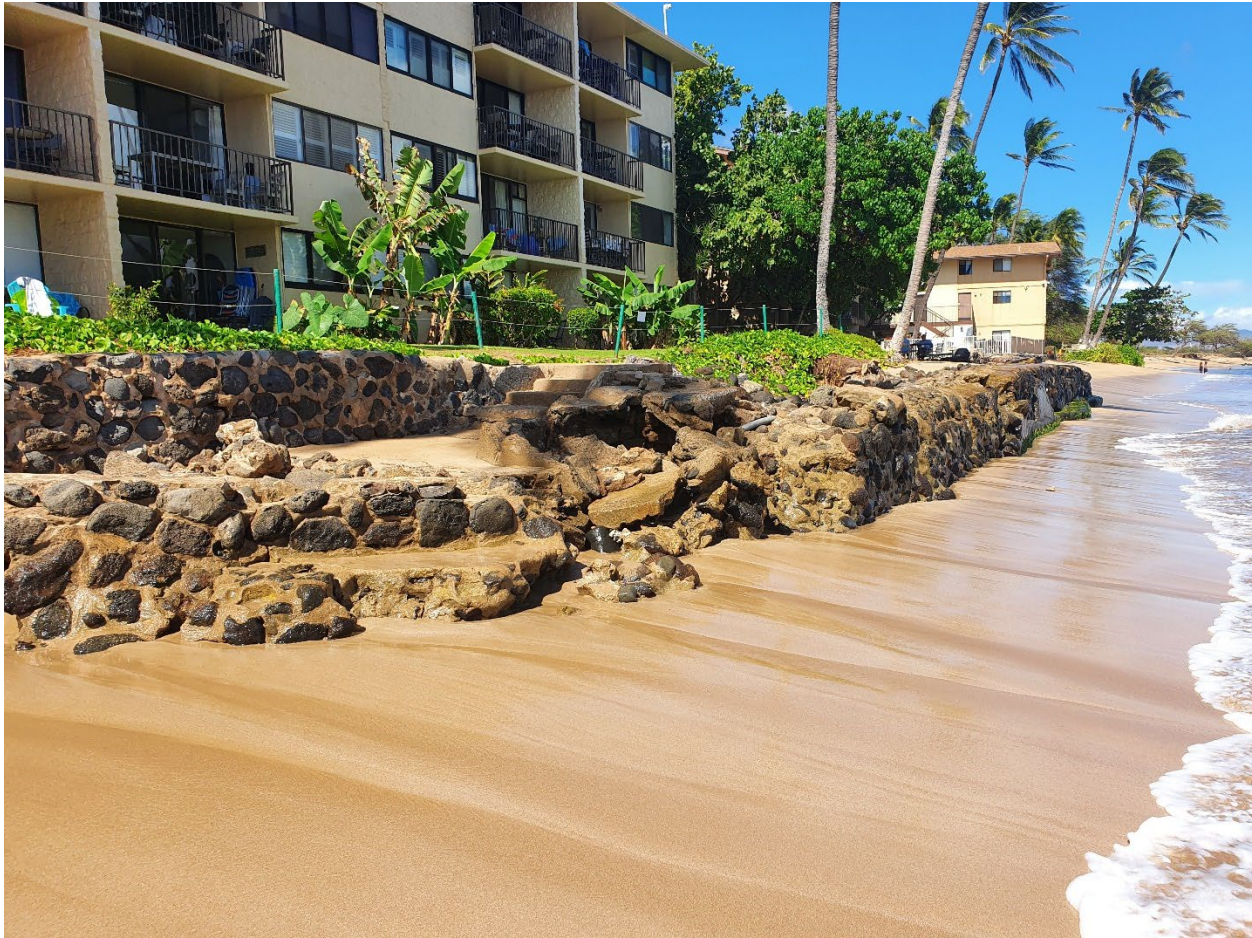
Figure 5: Shoreline Section 3 (west)

In summary, the following damages and structural deficiencies were observed in Section 3:

- Erosion of mortar, cracking, and dislodged stones due to weathering and wave action.
- Vertical and lateral displacement of portions of the wall.
- Undermining due to erosion of the loose sandy material.
- Outward rotation of the seawall.
- East adjacent seawall is damaged and appears to be failing.

The seawall is about 5 to 6 feet high and appears to be constructed of mortared stone for the top 3 to 4 feet of wall height with concrete fill at the lower 1 to 3 feet. It appears that the concrete fill may have been added later to address undermining of the original stone wall as well as missing stones. The thickness of the wall is unknown. A CRM stair leading to the ocean is located at the west end of the wall. Portions of the stairs are undermined, and the stairs and wall are cordoned off for safety.

An approximate 3-foot-wide concrete cap has been cast on the top of the wall with the bottom of the stone portion of the wall below appearing to be nearly plumb with the outside edge of the cap. Some portions of the cap have cracked and become displaced, and some stones have been dislodged, apparently by wave action. An approximate 20-foot portion of the wall east of the stairs is heavily deteriorated, with missing top caps, missing portions of wall, and apparent vertical and lateral displacement of portions of the wall. Similarly, the east end of the wall is cracked and dislodged. Multiple repairs appear to have been performed over the years.

Probing found the bottom of the seaward face of the wall to be several inches below the existing sand elevation. Kanai A Nalu staff reported that the sand has receded in the past to the degree that voids are visible beneath the wall. The depth from the bottom of the wall to a more erosion-resistant layer of substrate is unknown. Under the presumption that the top of the seawall was built at a consistent elevation, portions of the seawall were observed to have settled more than 12 inches. Outward rotation of the seawall was also observed. However, measurement of the amount of rotation was difficult due to the deteriorated condition of the seawall.

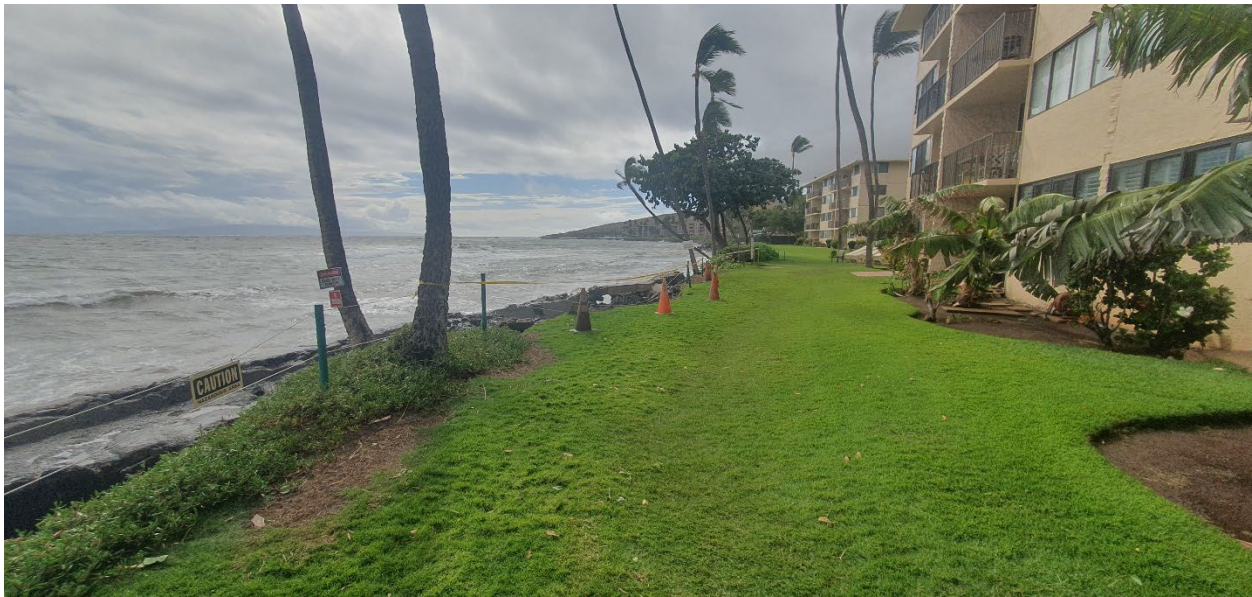
Figure 6: Rear Yard. Location of Geotextile Burrito Installation and Native Dune & Plant Restoration.

On the mauka side of the structure, a three-inch galvanized pipe will be embedded in the geotextile fabric. This pipe will be one side of a Platipus anchoring system. The other side of the Platipus will be secured in the lawn substrate mauka of the burrito. The burrito with its encapsulated sand mass and anchored to the surrounding soil will be able to resist a mass erosion event, like a hurricane, while not creating any hydrostatic pressure mauka of the structure. Water will be able to pass through the structure without taking any of the sand materials with it.

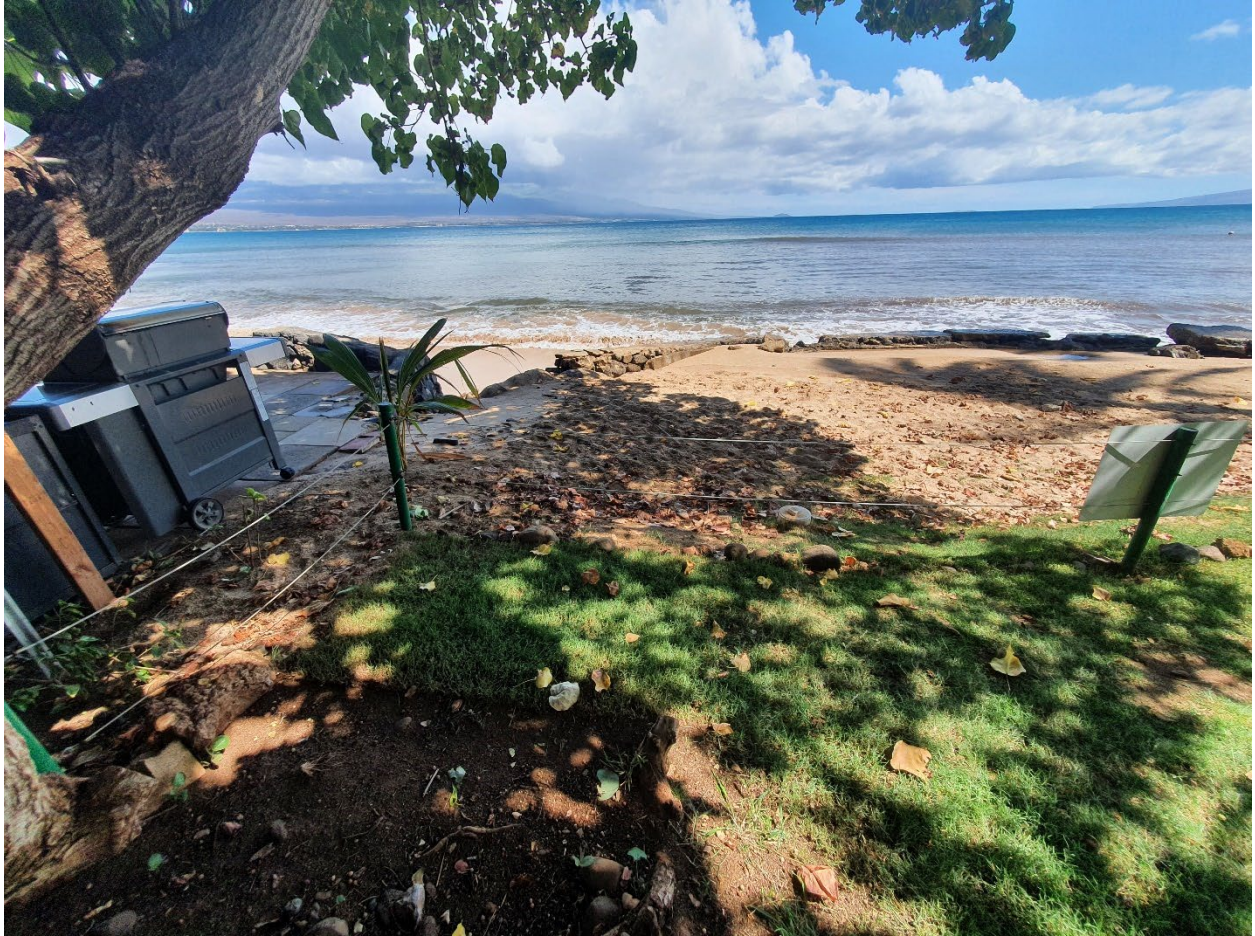
Figure 7: New Ramp Location.

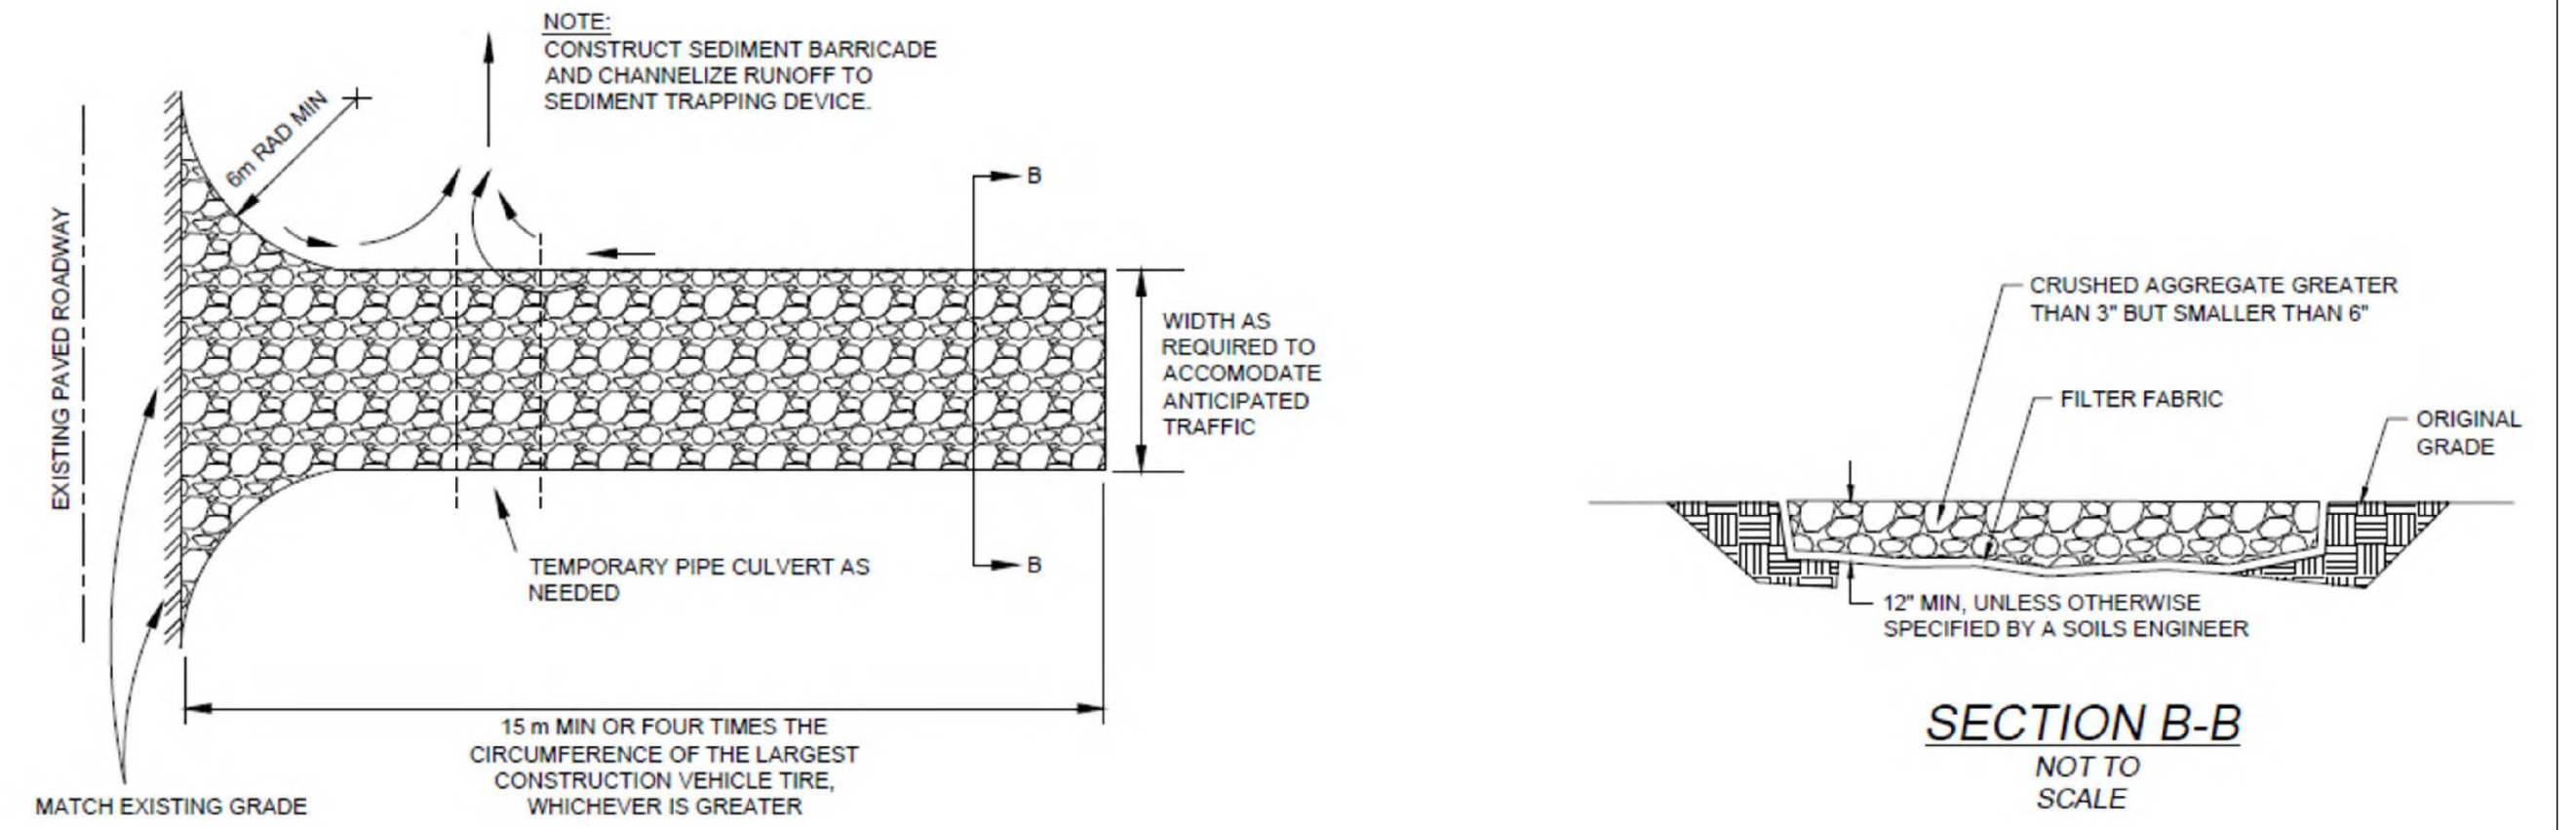
CONSTRUCTION ENTRANCE DETAILS
NOT TO SCALE

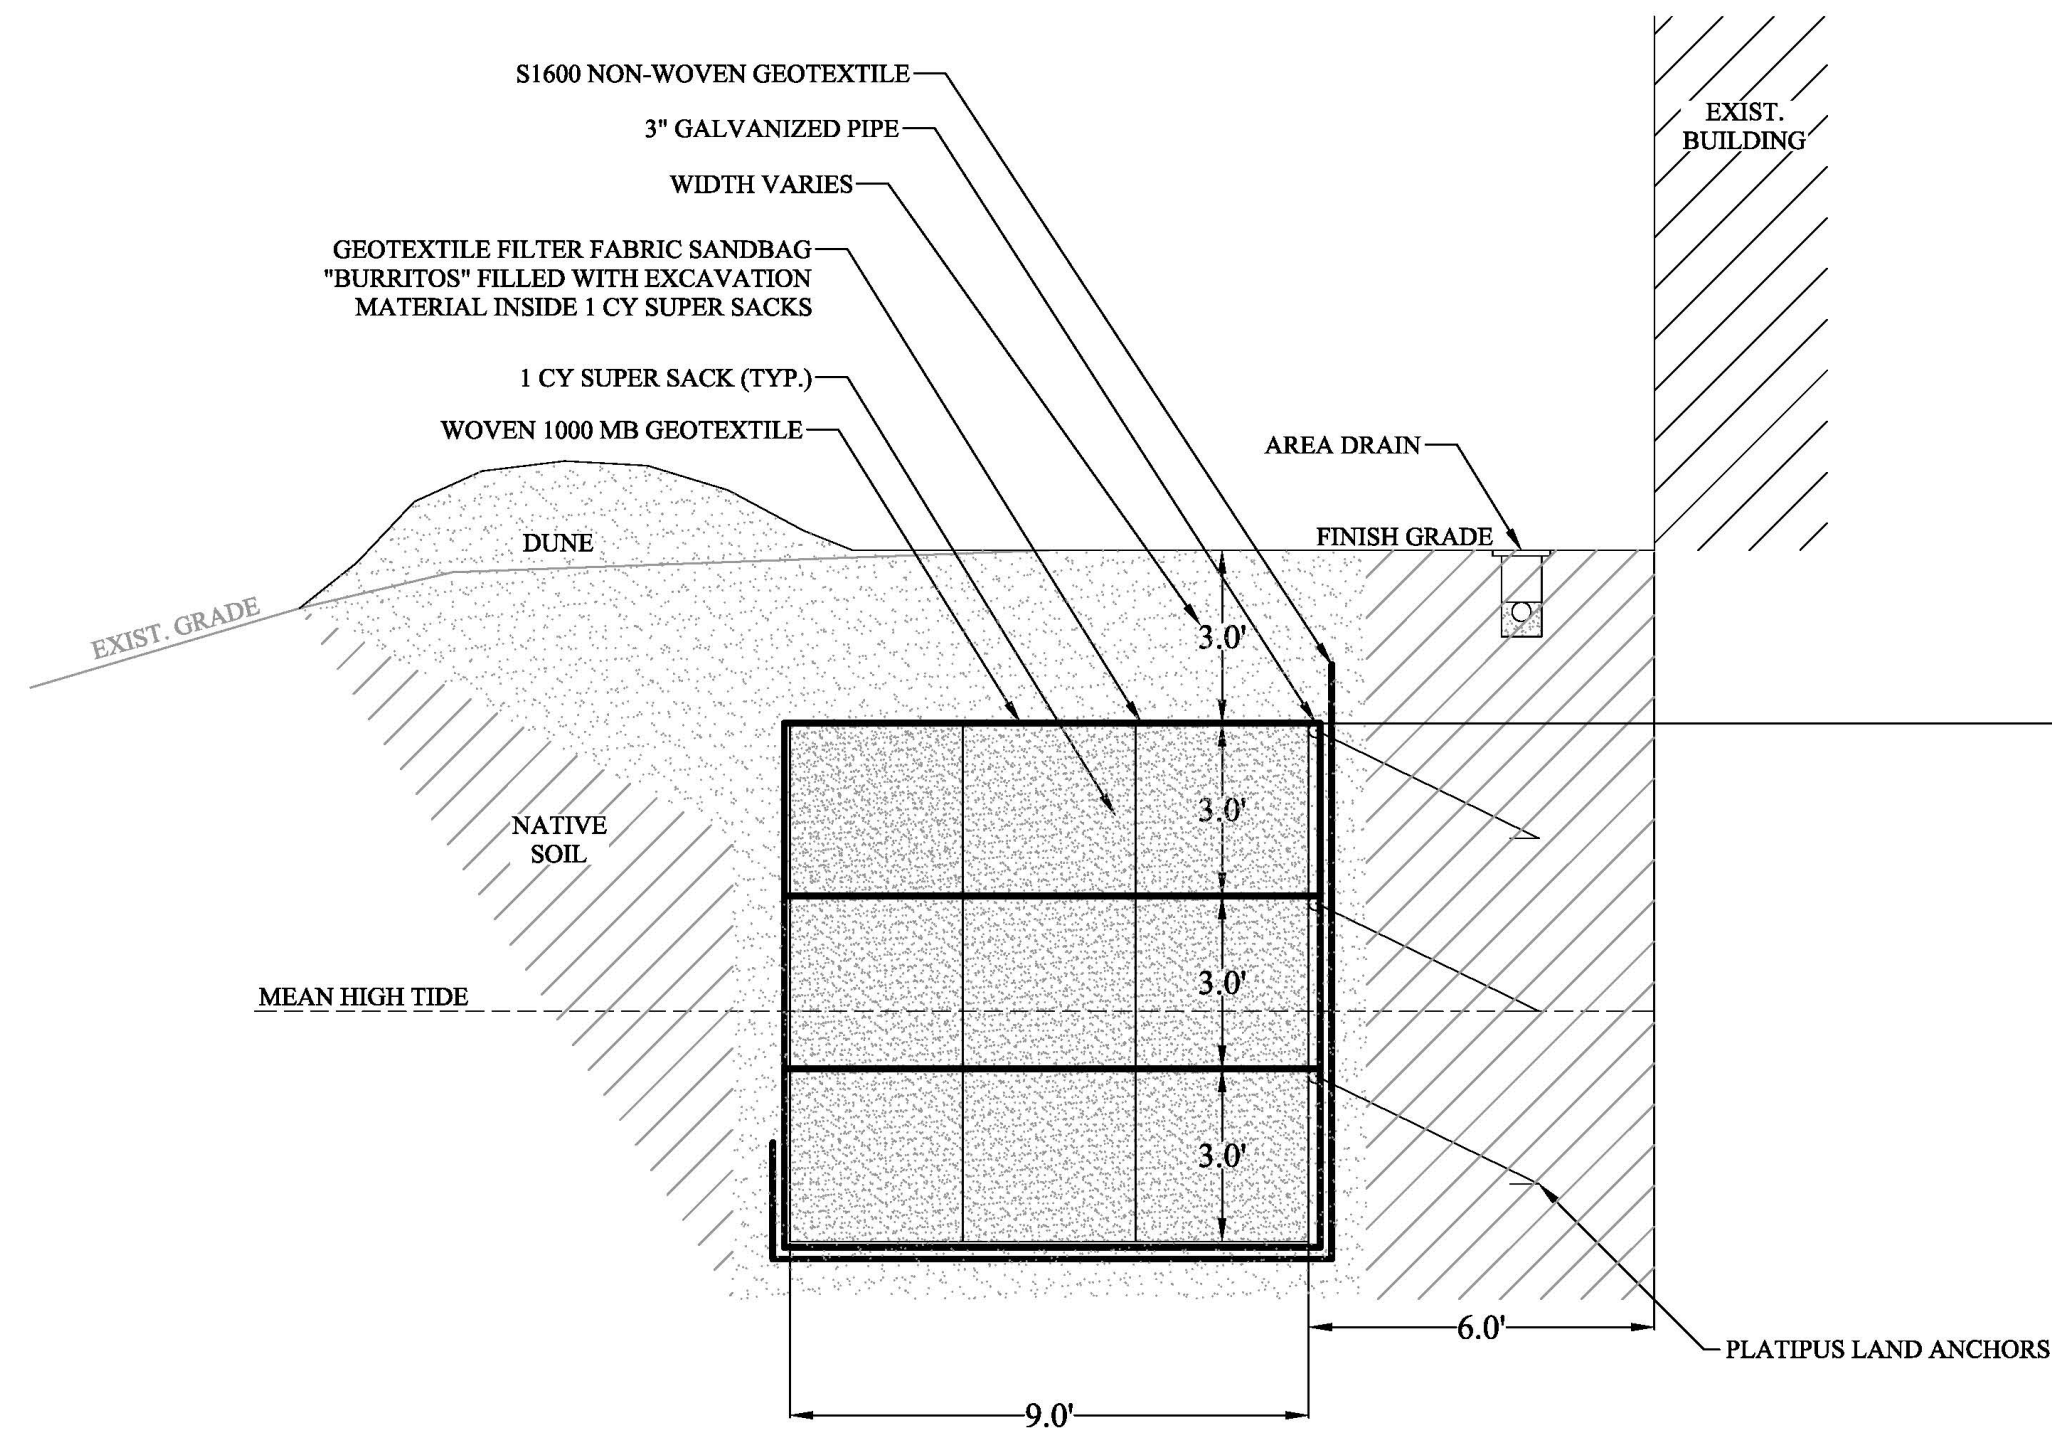
1 SANDBAG "BURRITO" SECTION PROFILE W/O WALL (TYP)
 C-5 SCALE: N.T.S.

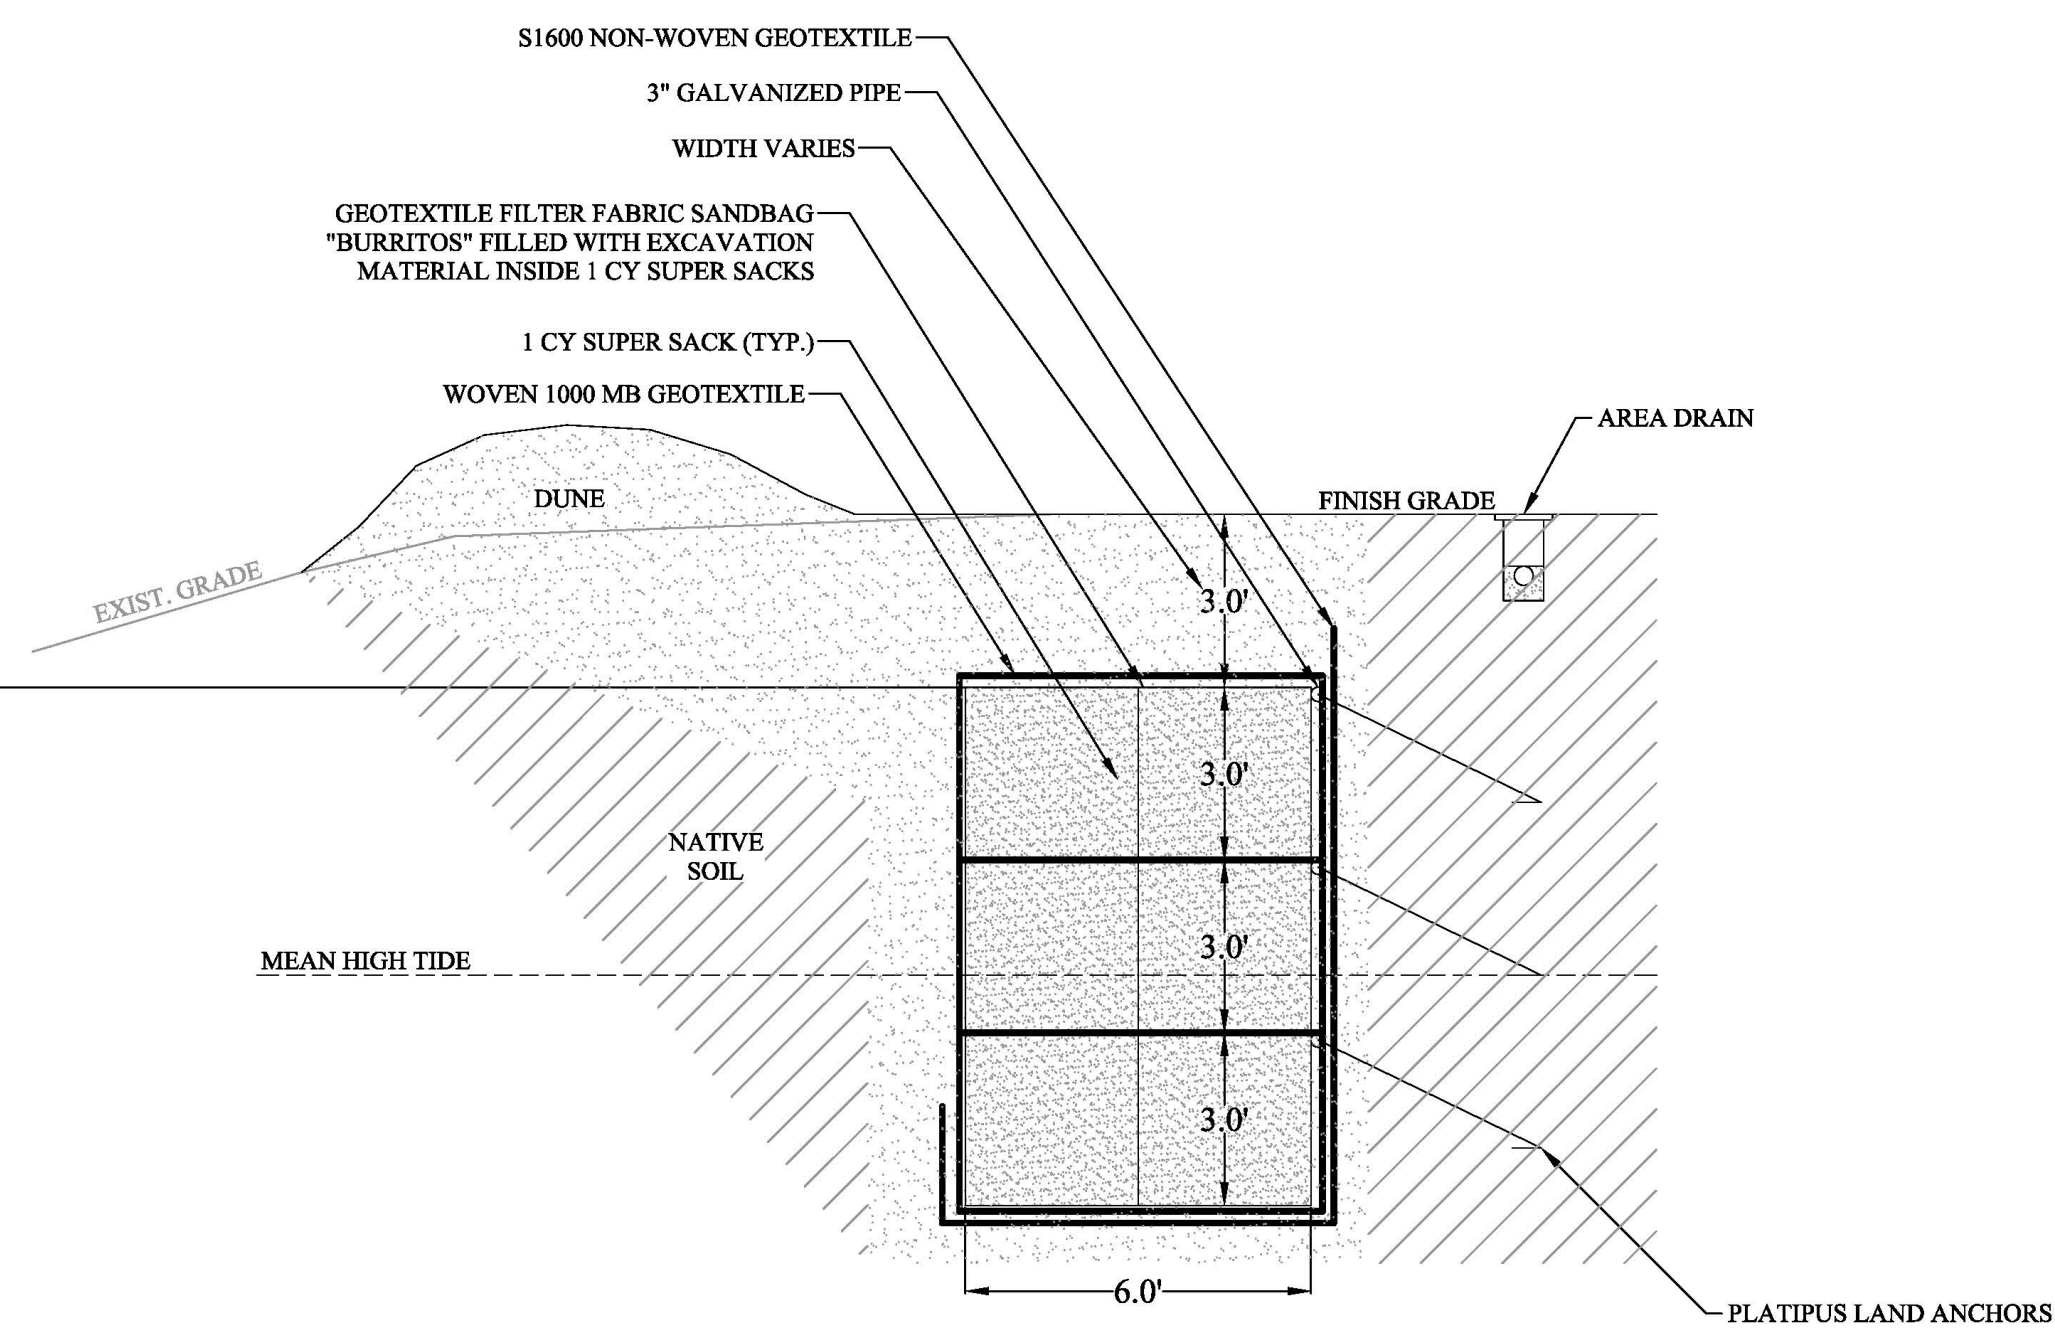
3 SANDBAG "BURRITO" SECTION PROFILE W/O WALL (TYP)
 C-5 SCALE: N.T.S.

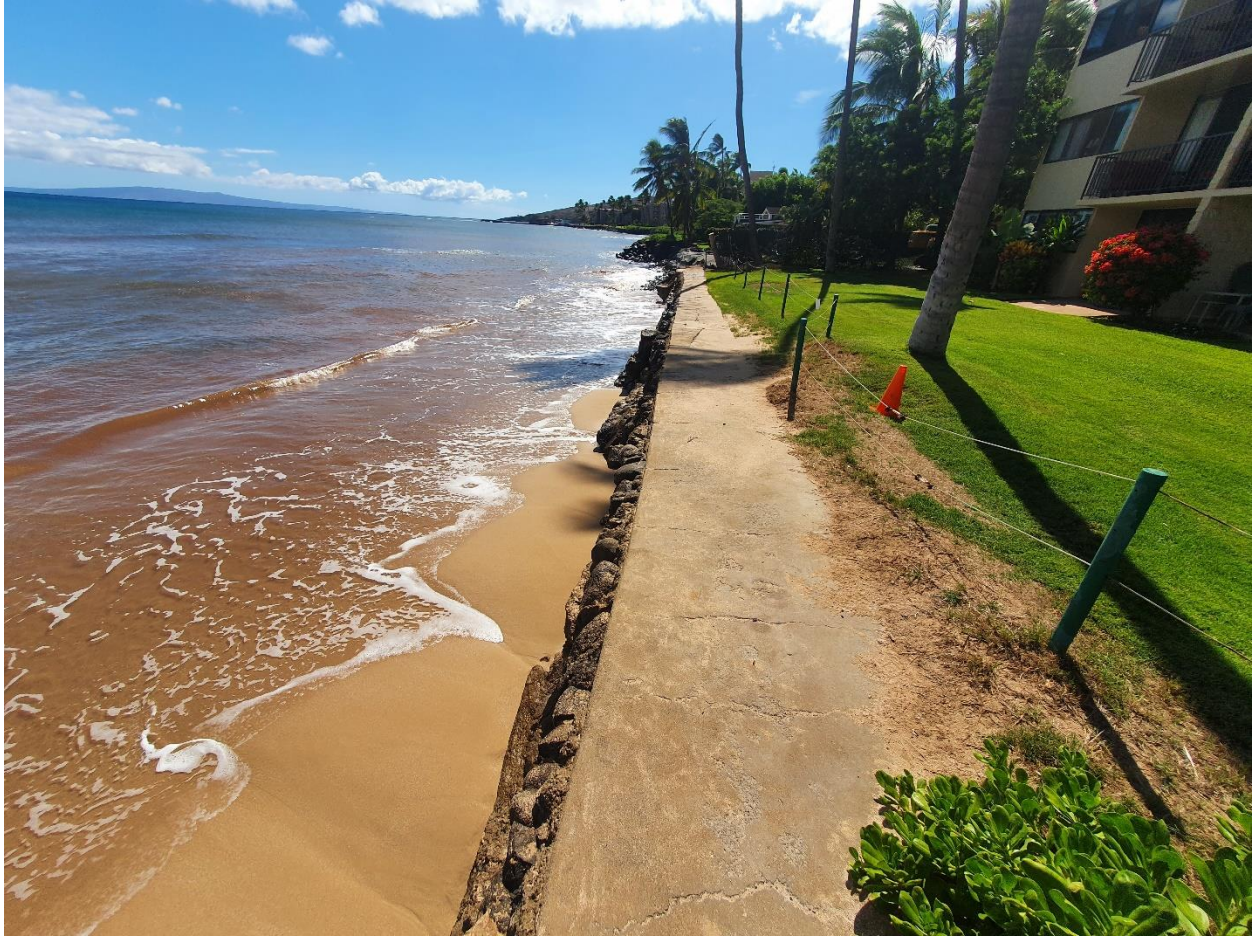
Photograph 14. Section 1 Seawall Looking West

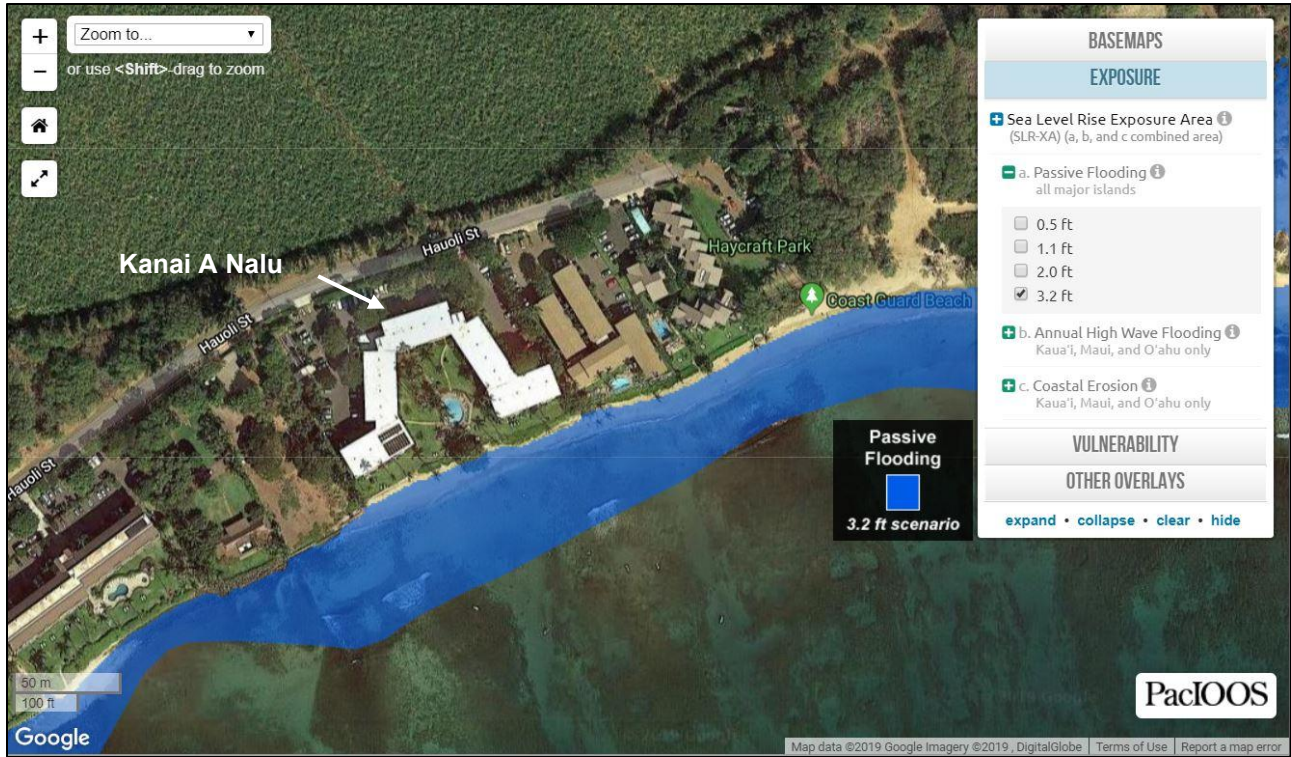
Figure 2-3 Passive flooding with 3.2 feet of sea level rise (PacIOOS)

UH modeled the potential impacts that a 3.2-foot rise in sea level would have on coastal hazards including passive flooding, annual high wave flooding, and coastal erosion. The footprint of these three hazards were combined to define the projected extent of chronic flooding due to sea level rise, referred to as the *sea level rise exposure area (SLR-XA)*. Flooding in the SLR-XA is associated with long-term, chronic hazards punctuated by annual or more frequent flooding events. The UH model results are presented in Figure 2-3 through Figure 2-6.

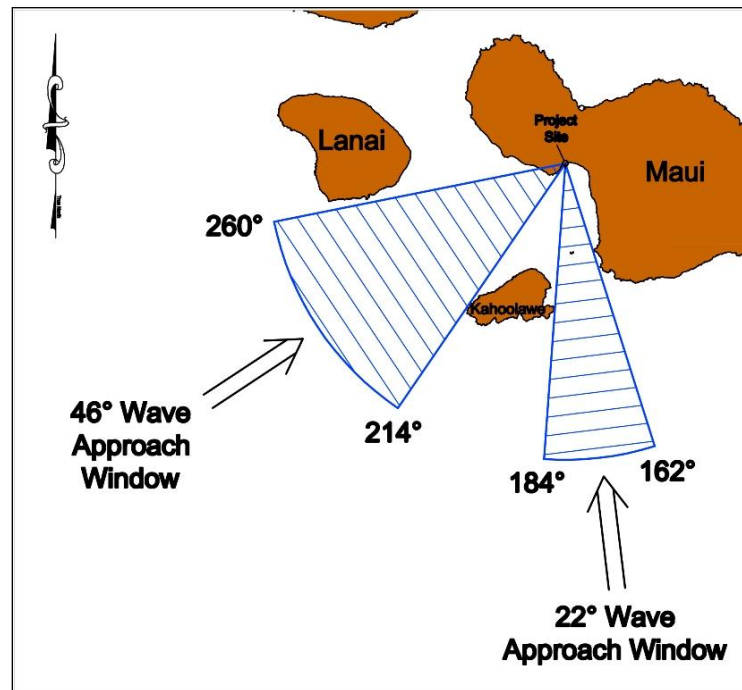
Figure 3-1 Wave approach window toward Maalaea, Maui

The Maalaea project site faces southeast and is affected by south swell during the summer months and Kona storm waves in the winter and spring. Kahoolawe, Lanai, and East and West Maui produce sheltering effects that limit the approach direction of waves that can affect Maalaea. Figure 3-1 shows the possible wave approach windows for Maalaea. The point west of Maalaea Harbor serves to shadow wave energy and cause wave refraction. The closer the wave approach direction is to 260°, the more shadowing can be expected.

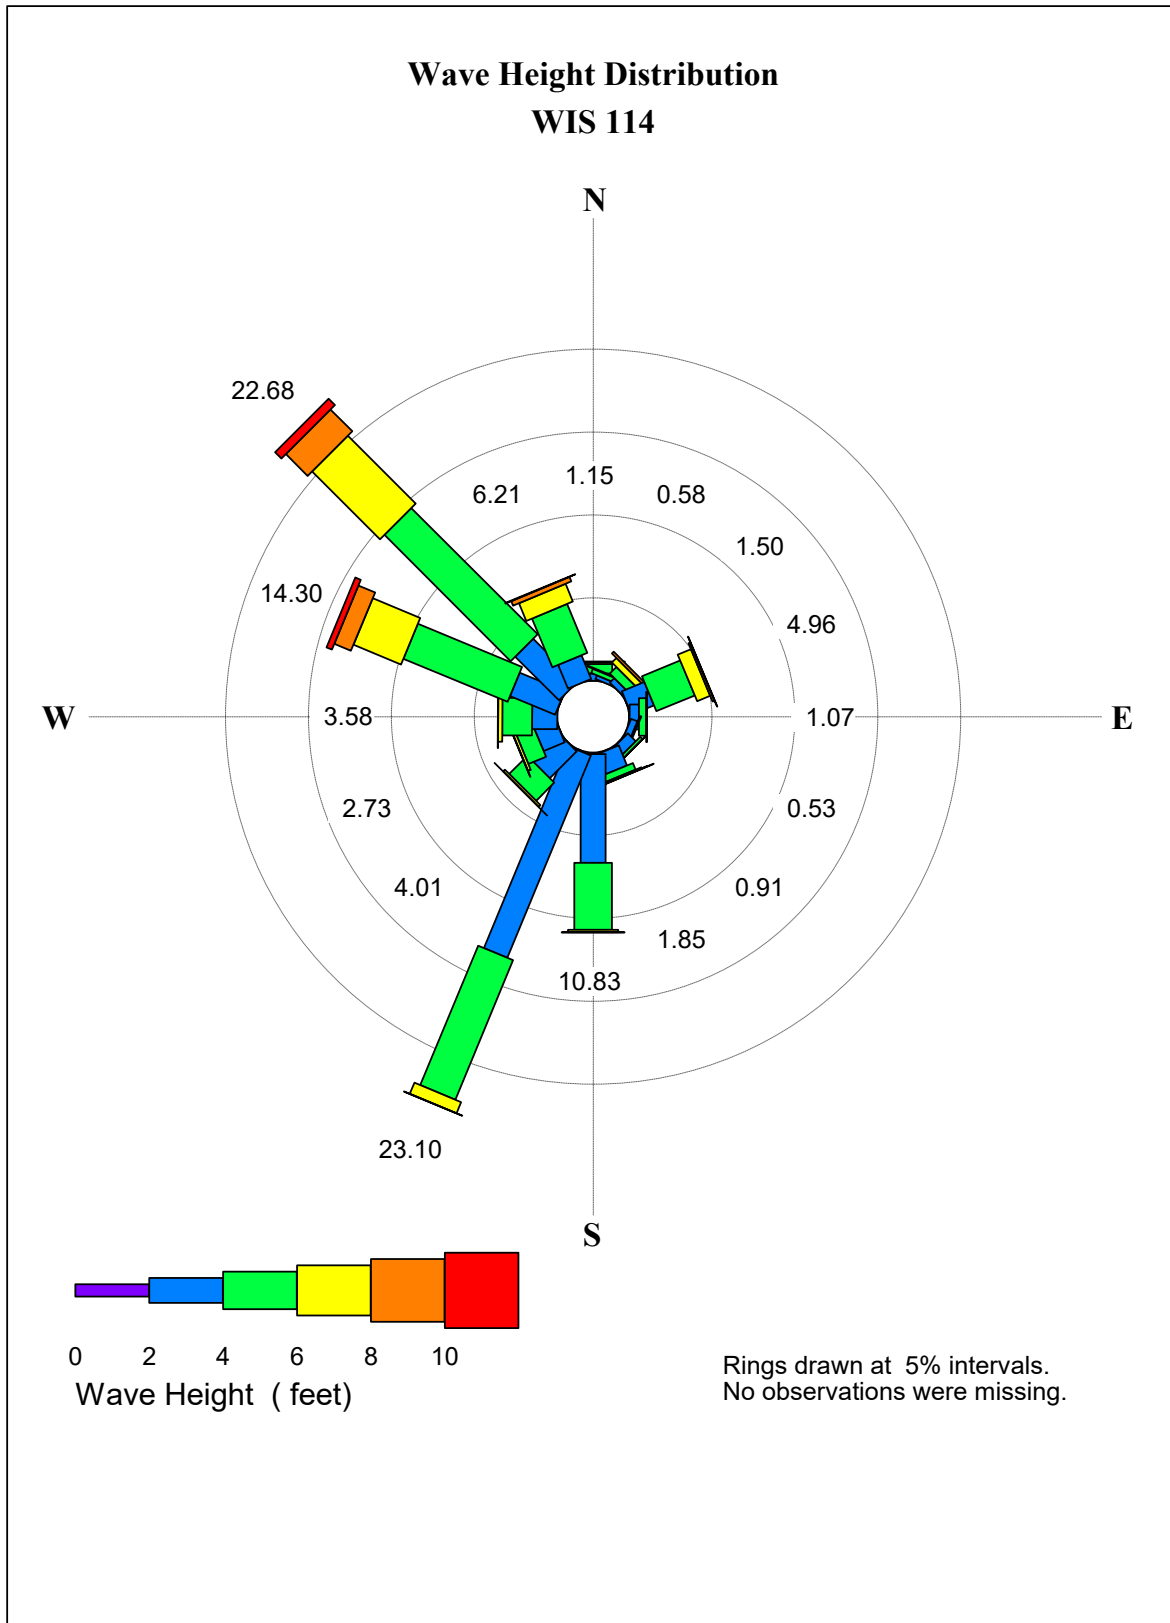
Figure 3-3 Wave height distribution (WIS Station 114)
