SUBJECT: FINAL ENVIRONMENTAL ASSESSMENT (FEA): FINDING OF NO SIGNIFICANT IMPACT FOR THE PROPOSED ADAPTATION PATHWAYS: SEAWALL REMOVAL AND DUNE RESTORATION LOCATED AT 250 HAU'OLI STREET, WAILUKU (MĀ'ALAEA), ISLAND OF MAUI, HAWAI'I; TMKS: (2) 3-8-014:004 AND (2) 3-8-014:005

Adaptation Pathways: Seawall Removal and Dune Restoration

Final environmental assessment and finding of no significant impact (FEA-FONSI)

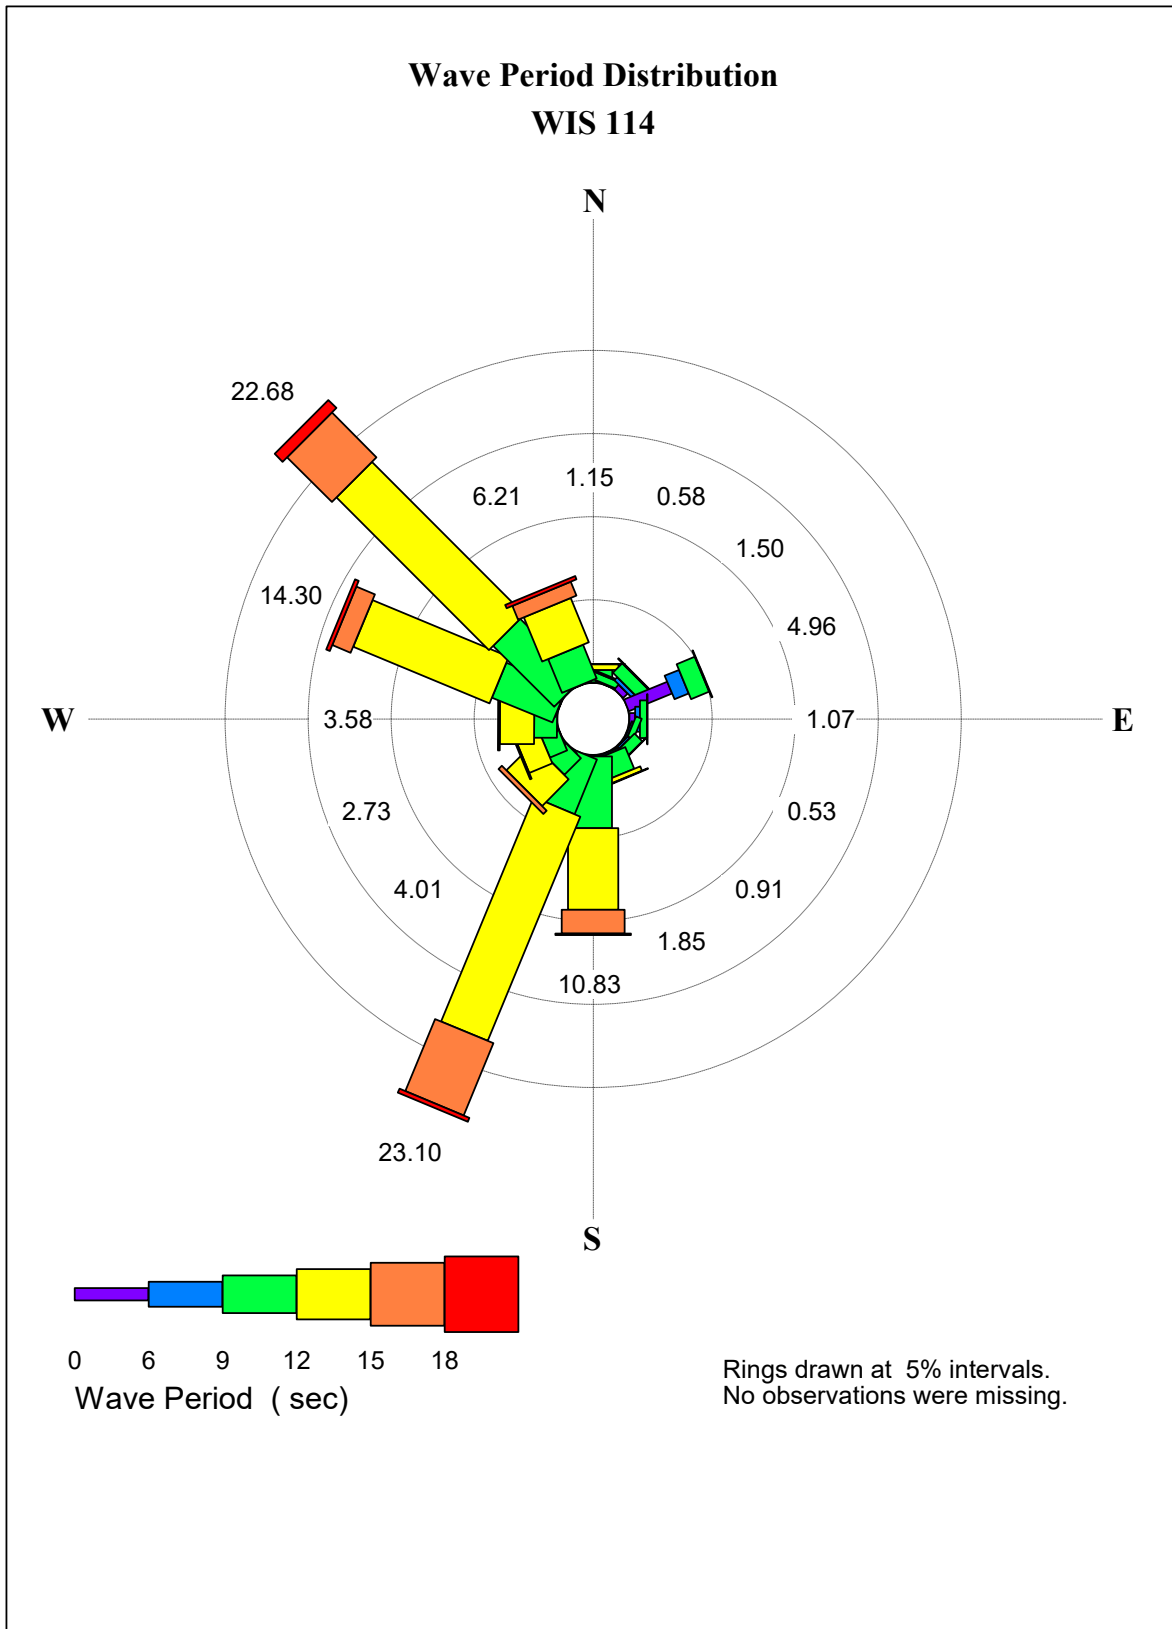
Figure 3-4 Wave period distribution (WIS Station 114)

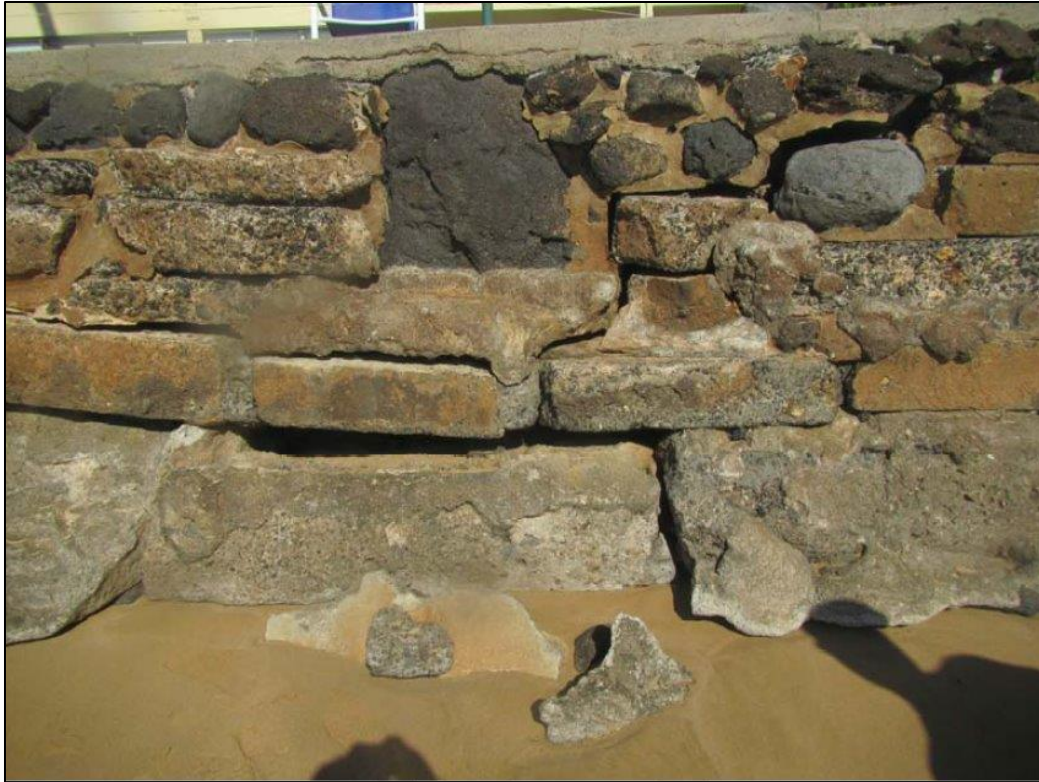
Figure 4-6 Cracks, mortar separation, and voids

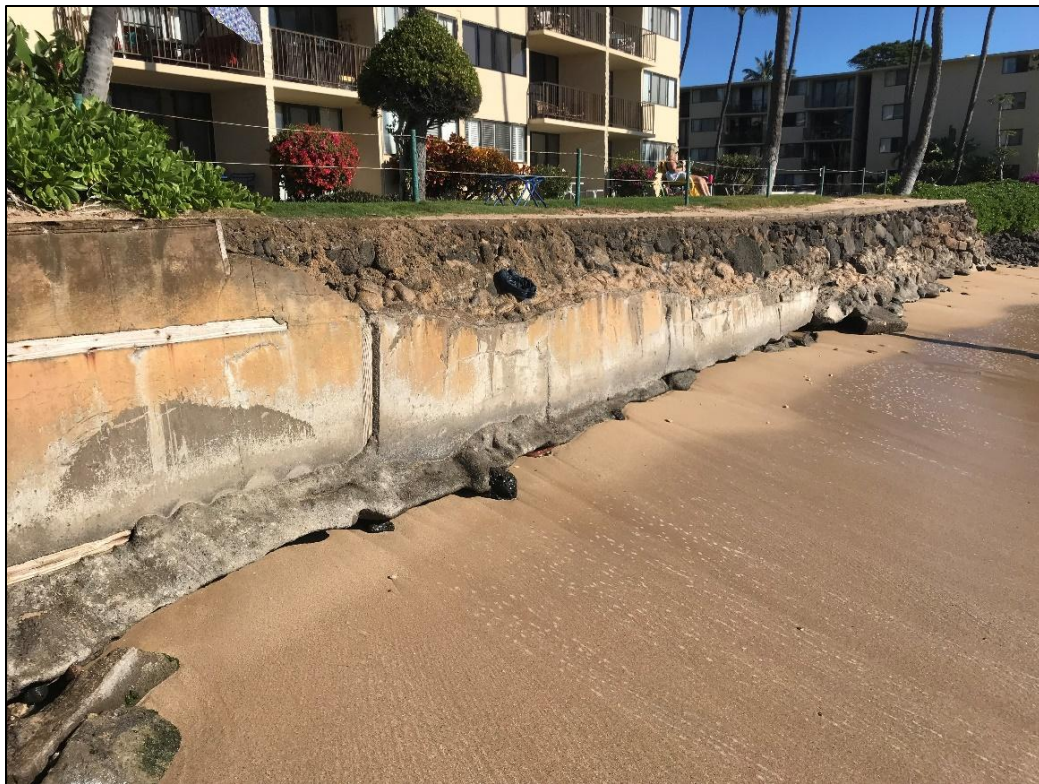
Figure 4-7 Undermining along toe of seawall

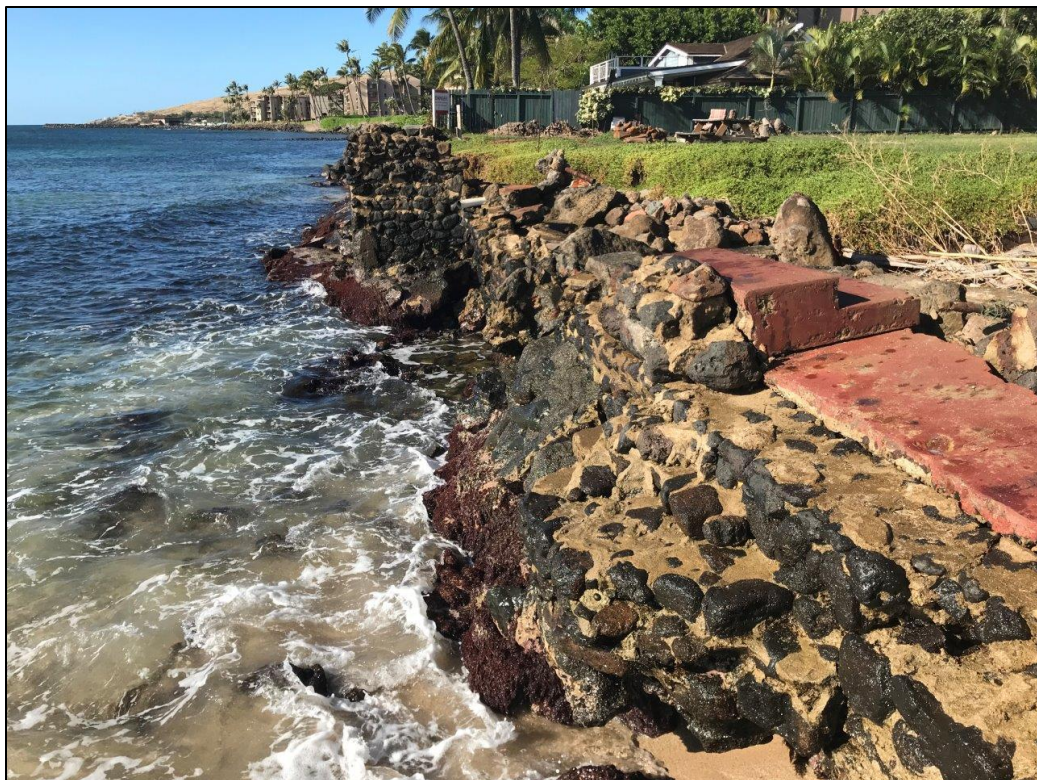
Figure 4-9 Damaged seawall on west adjacent property

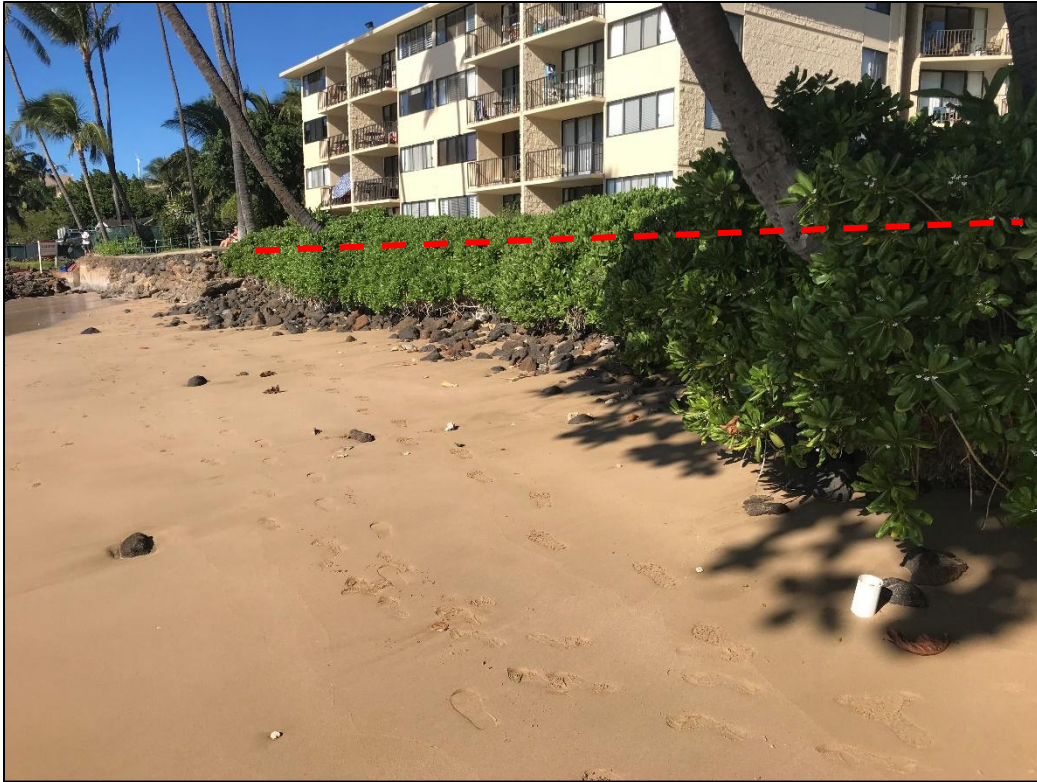
Figure 4-10 Approximate location of erosion scarp (dashed line)

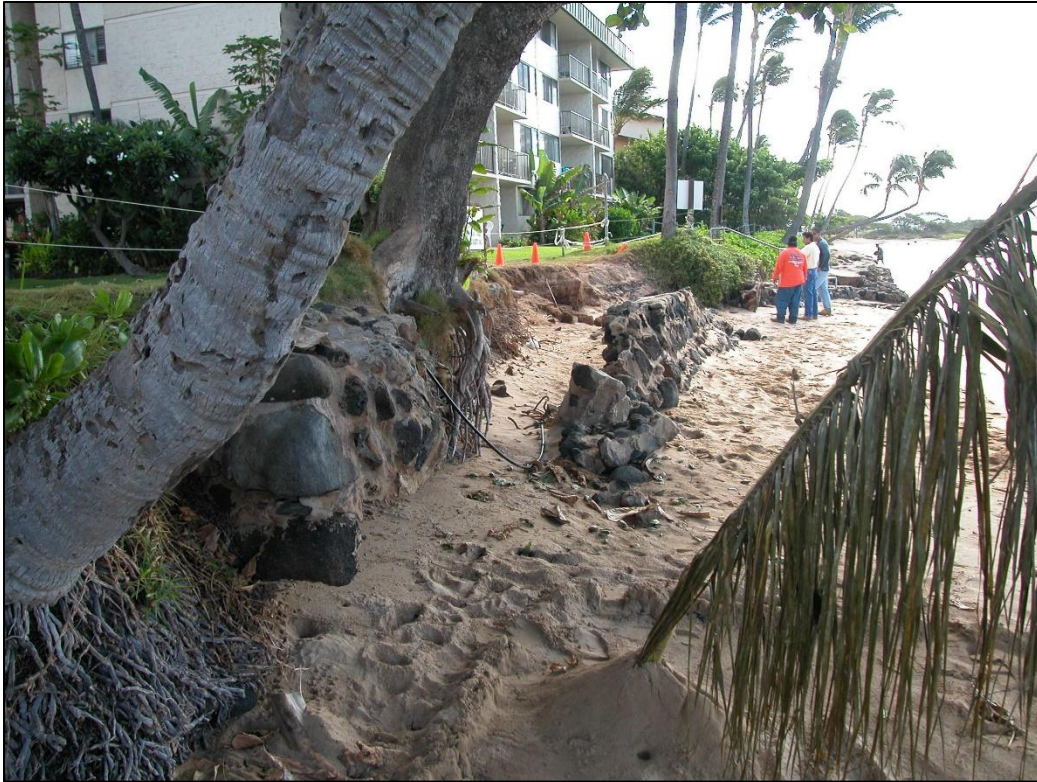
Figure 4-14 Failed seawall section (2009)

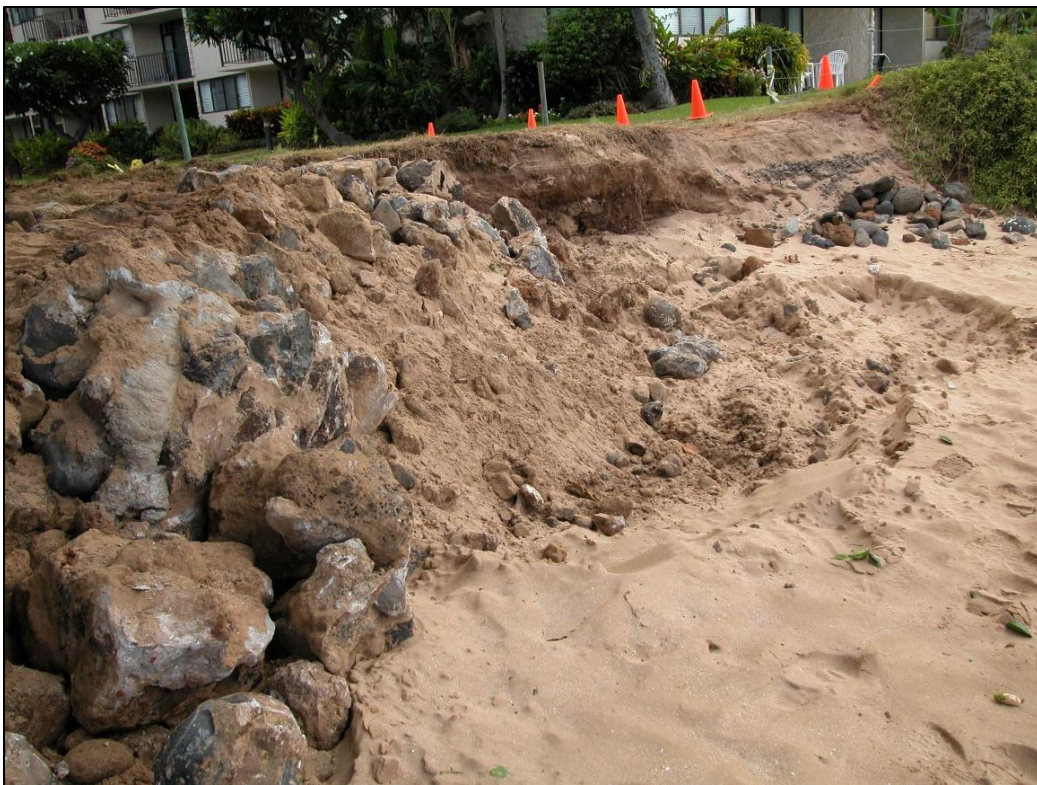
Figure 4-15 Removal of failed seawall section (2009)

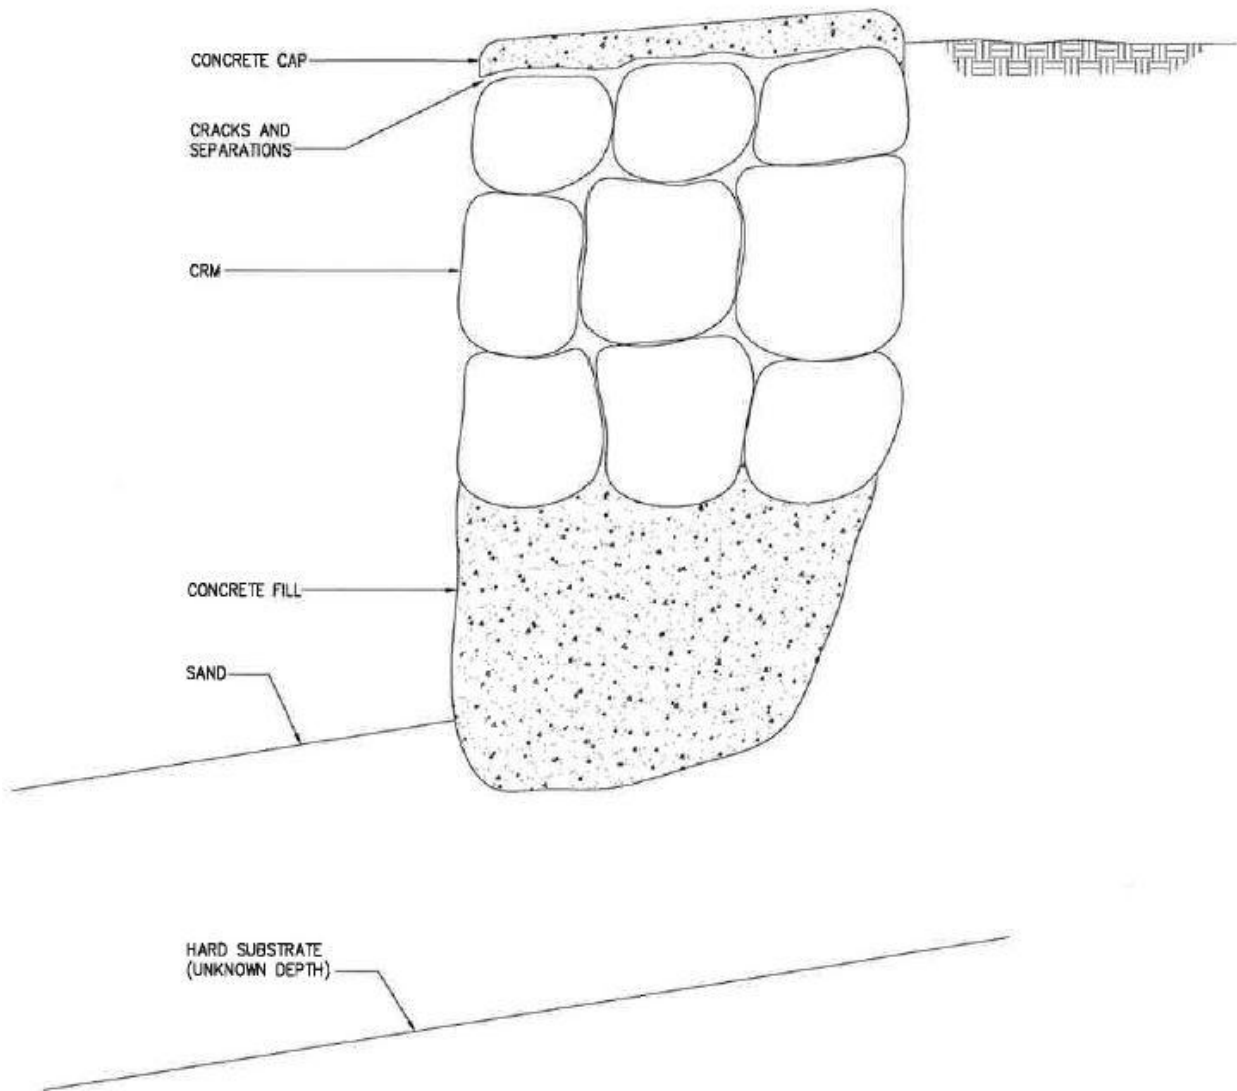
Figure 4-16 Section 3 (east) existing seawall section

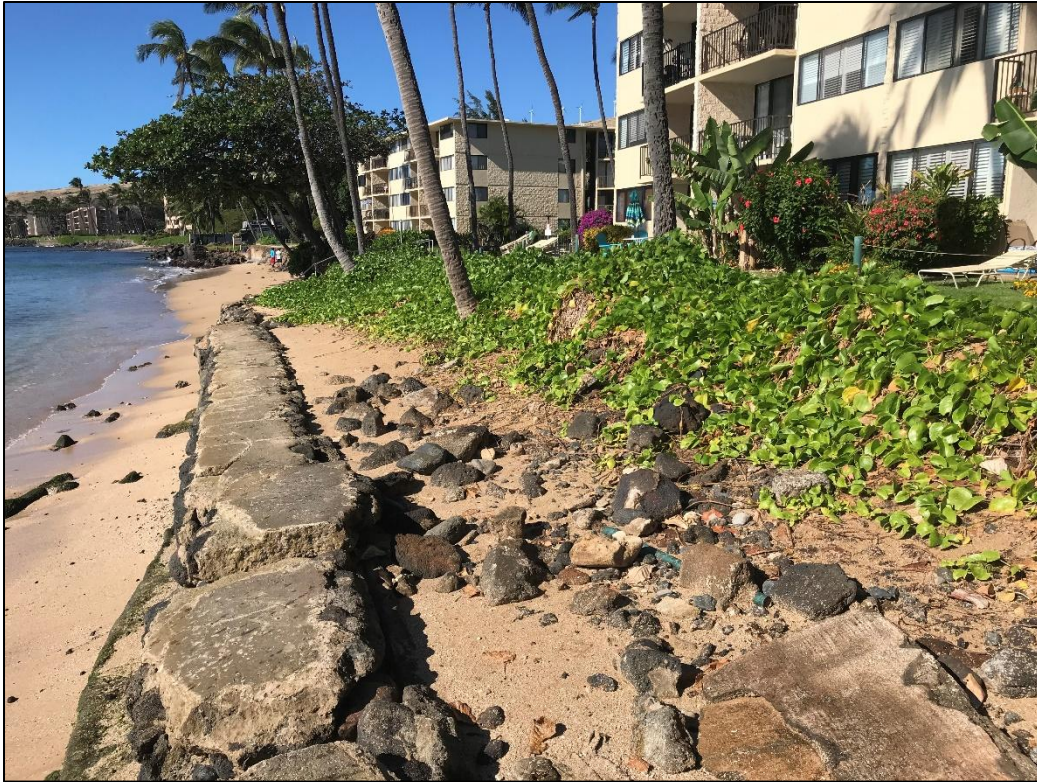
Figure 4-19 Cracking along concrete cap

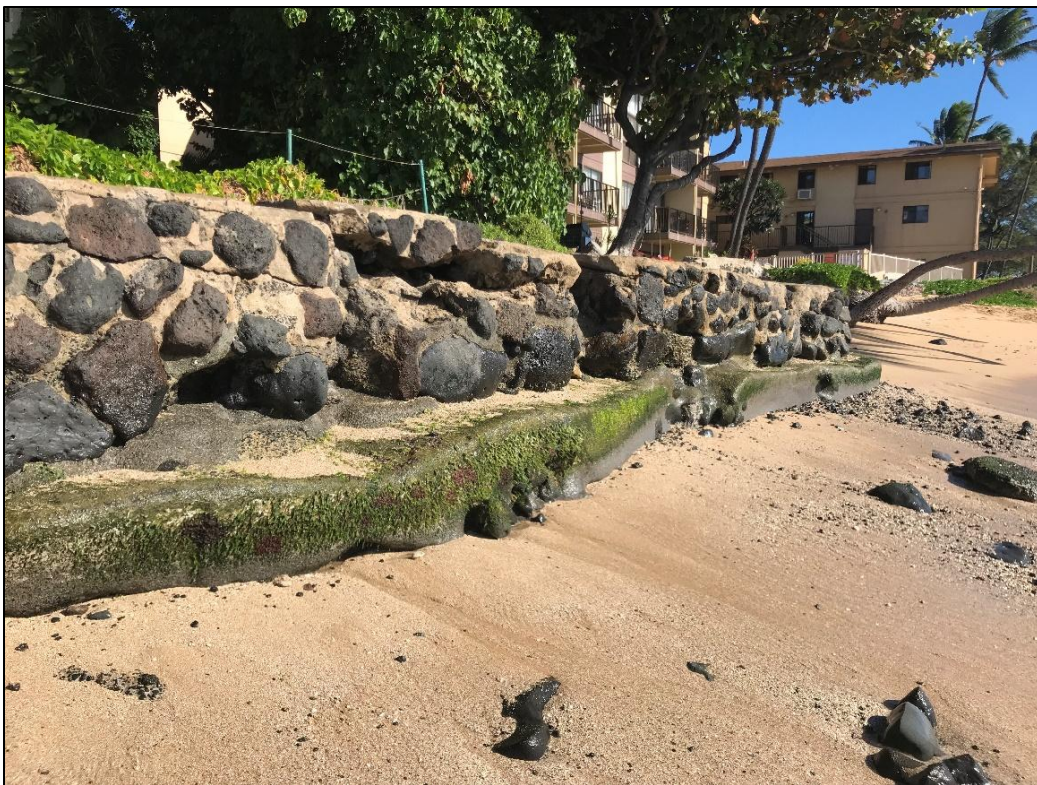
Figure 4-20 Cracking and dislodged stones on seawall face

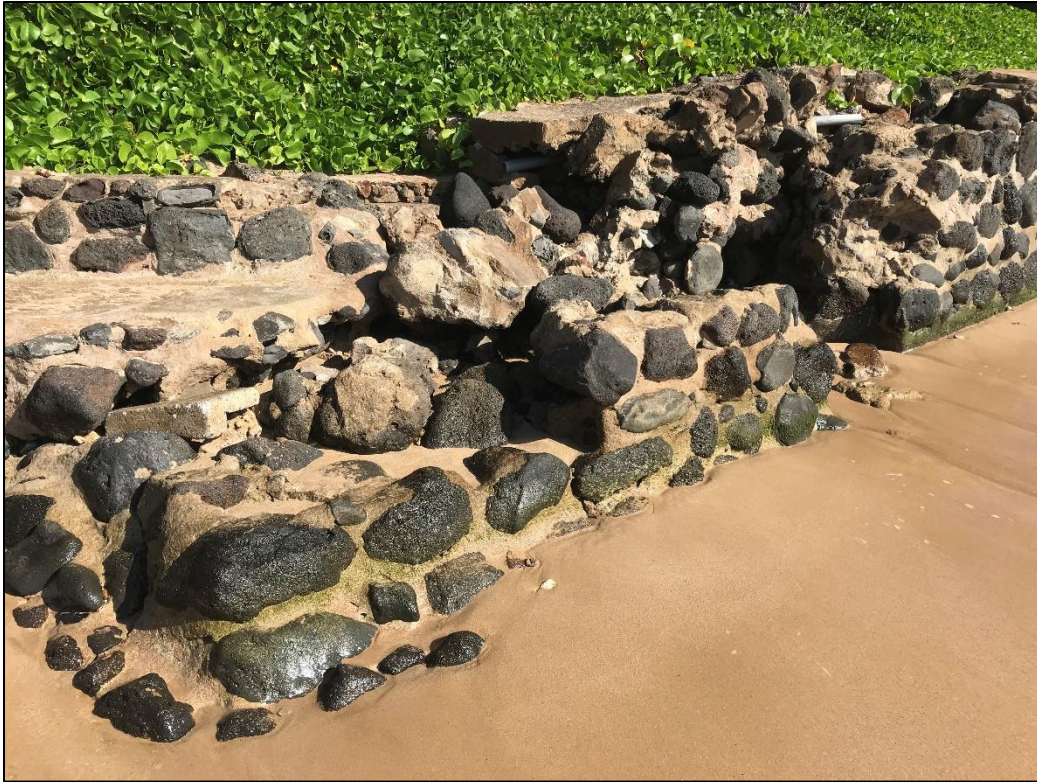
Figure 4-21 Damaged wall section east of CRM stair

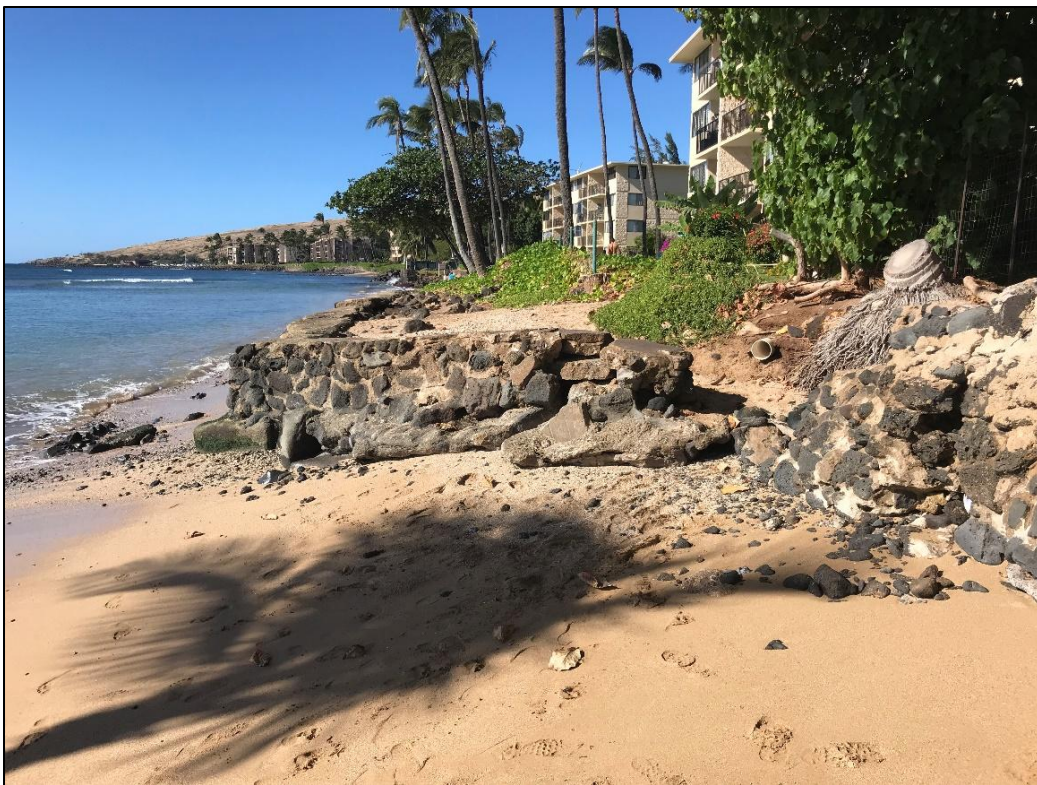
Figure 4-22 Damaged wall section at east end (adjacent seawall is also damaged)

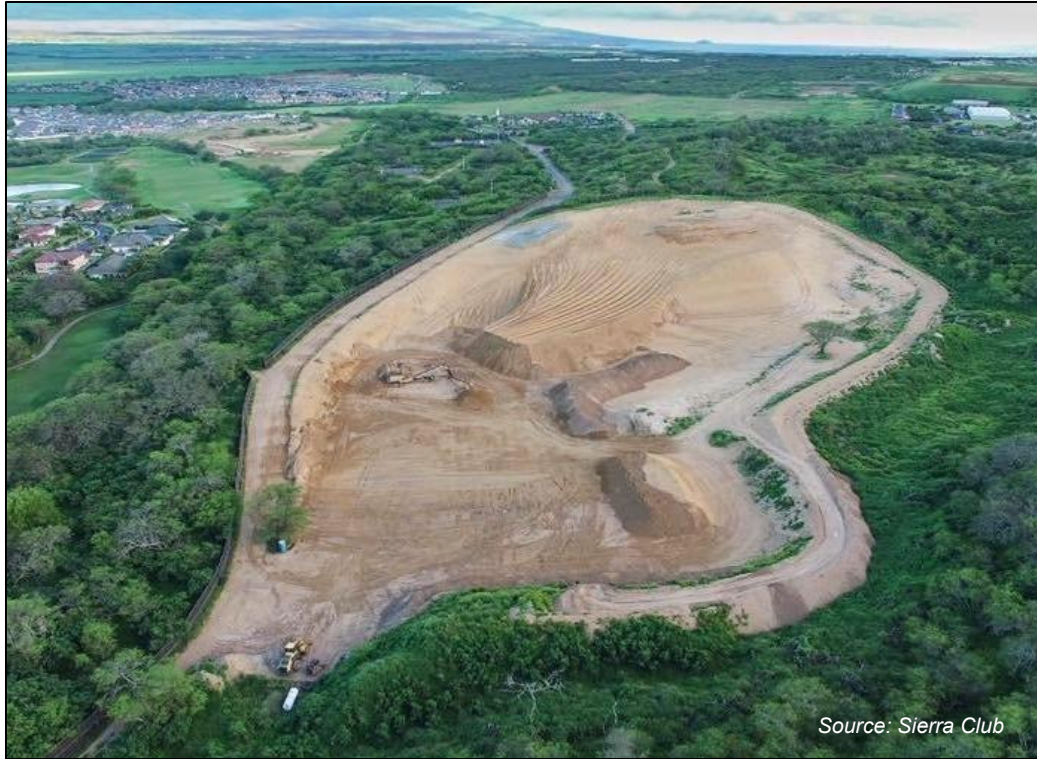
Figure 5-8 Excavation of inland dune sand at Maui Lani

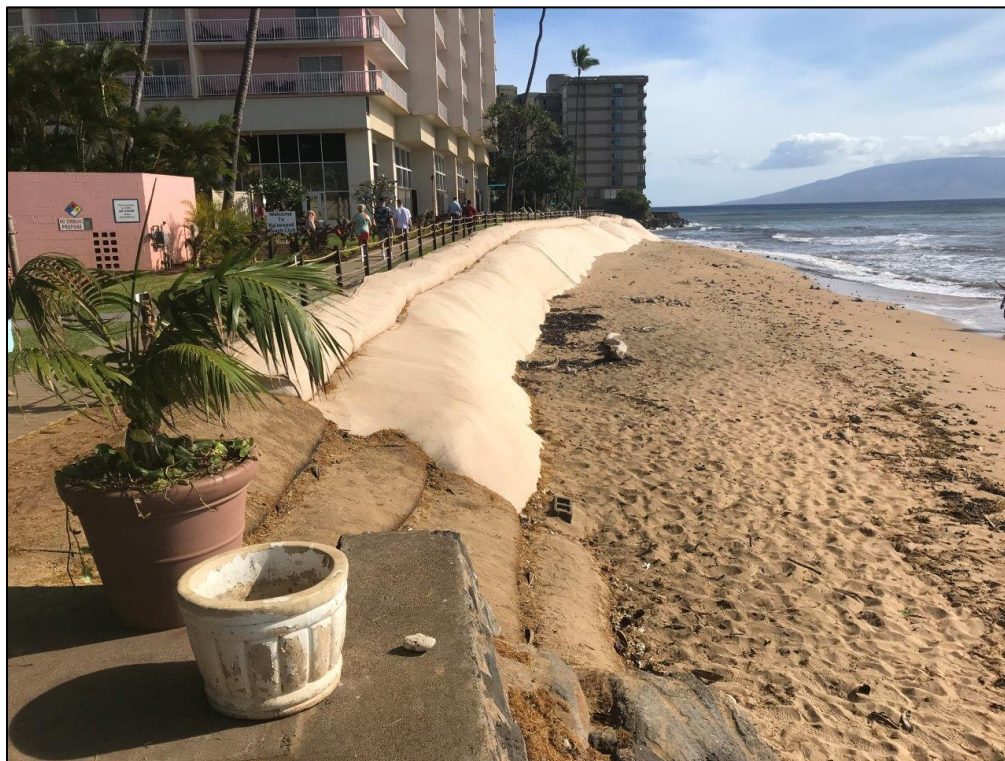
Figure 5-10 Geotextile erosion protection skirt at Honokowai, Maui (2018)

An erosion protection skirt is a method of temporary erosion control that consists of a layer of geotextile fabric (skirt) that is draped over the erosion scarp and anchored to the backshore. An example of an erosion protection skirt at Honokowai, Maui, is shown in Figure 5-10. The structure consists of a core that is constructed of layers of geotextile material that are filled with sand. The skirt is draped over the core and secured to the backshore using earth anchors.

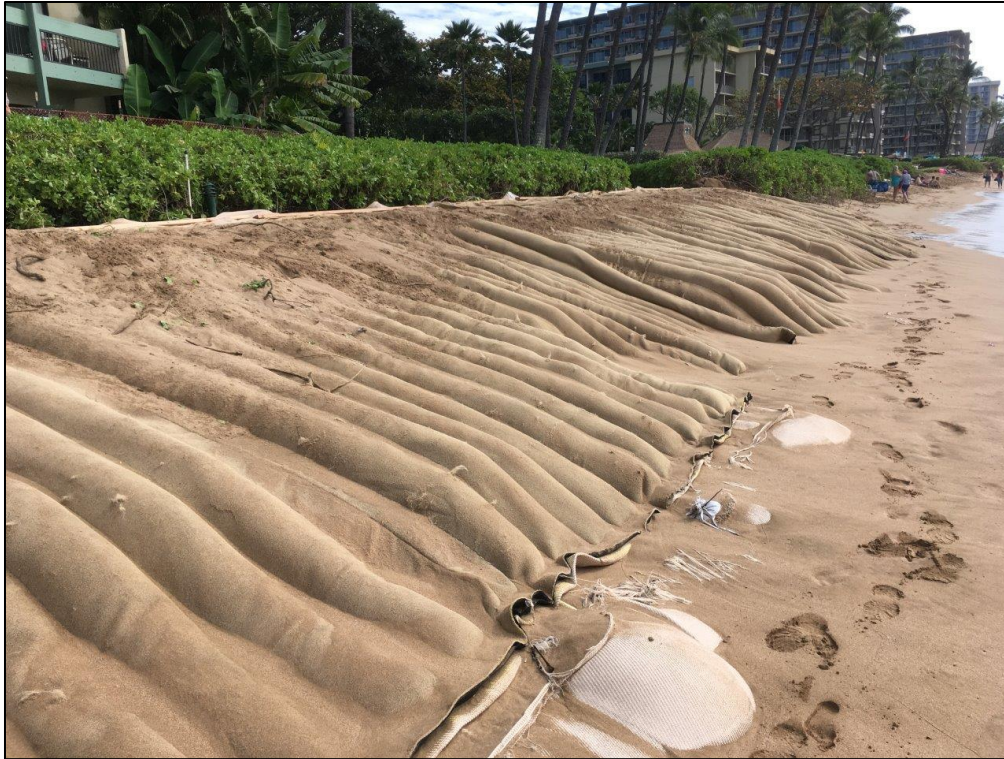
Figure 5-11 Geotextile sand filled mattress at Kaanapali, Maui (2018)

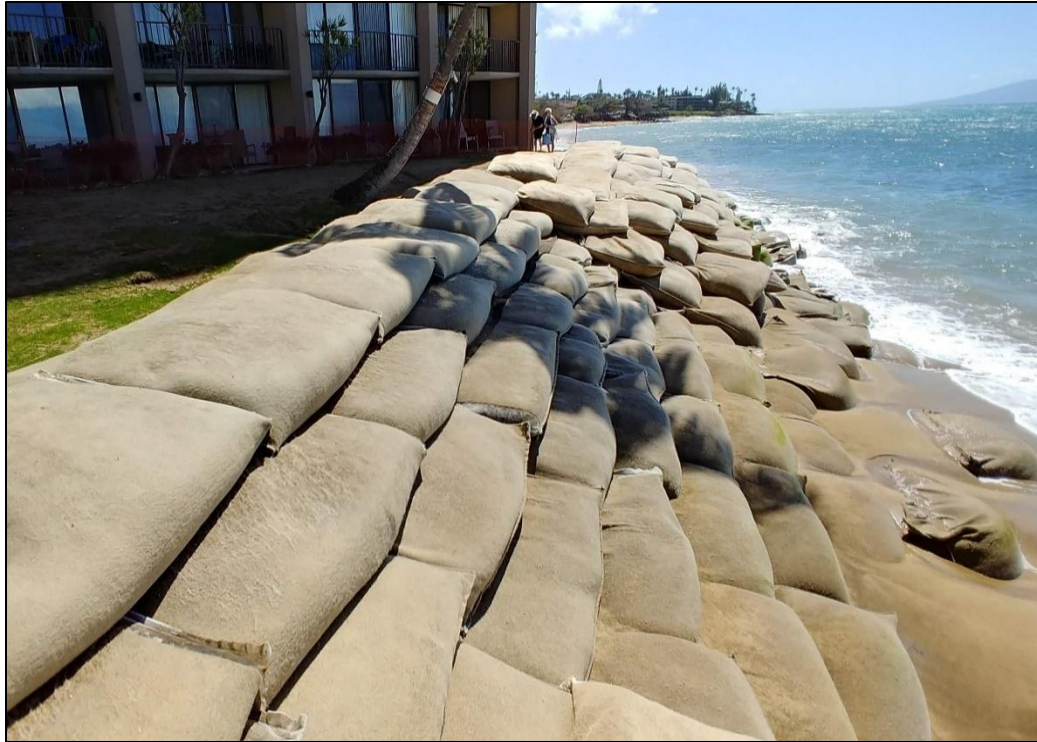
Figure 5-12 Geotextile sandbag revetment at Kahana, Maui (2018)

An advantage of a geotextile sandbag revetment is that the materials are readily available, and the structures have historically been very effective at mitigating erosion. A disadvantage of a geotextile sandbag revetment is that the structure would have a very large structural footprint. Agencies are generally opposed to the use of geotextile sandbags along the shoreline due to concerns regarding the semi-permanent nature of the structures. Recent proposals for geotextile sandbag revetments on Oahu and Maui have been denied, even under emergency conditions.

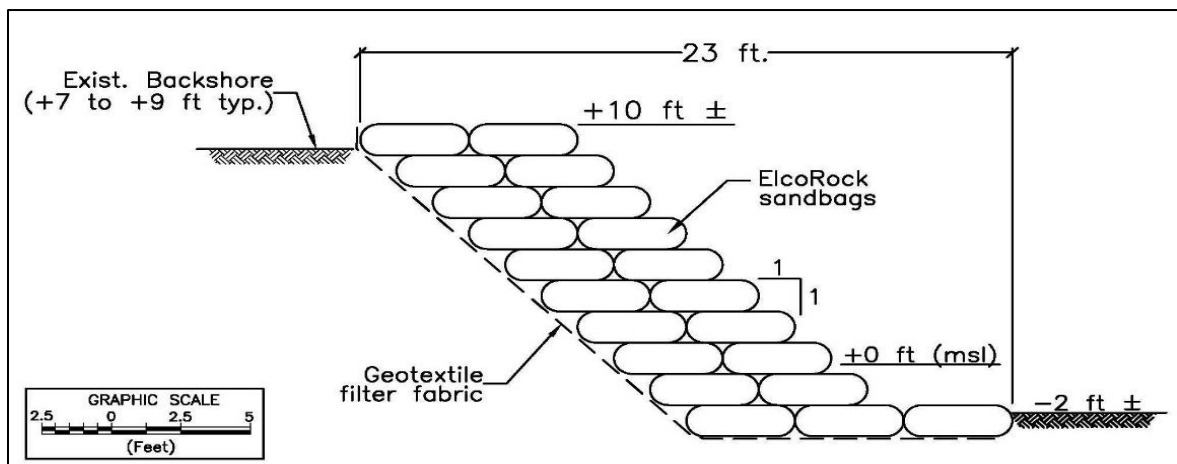
Figure 5-14 Conceptual section view of a geotextile sandbag revetment at KAN

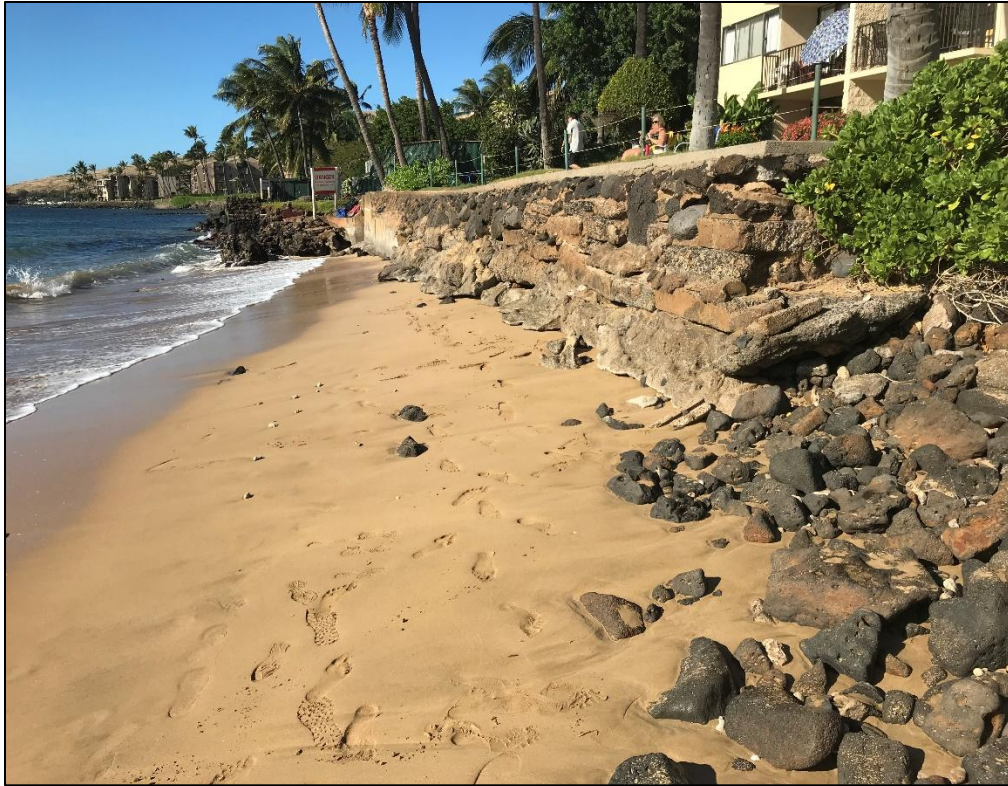
Figure 5-15 Existing CRM seawall at west end of KAN shoreline

As part of the wall repairs, voids and separations in the wall should be filled with mortar and concrete out to the exterior wall face to restore the integrity of the wall and to provide a smoother, less porous face that will reduce the buildup of wave forces within the wall. It is anticipated that similar work would need to be performed on the seawalls at the adjacent properties to protect them from undermining and to restore their structural integrity.

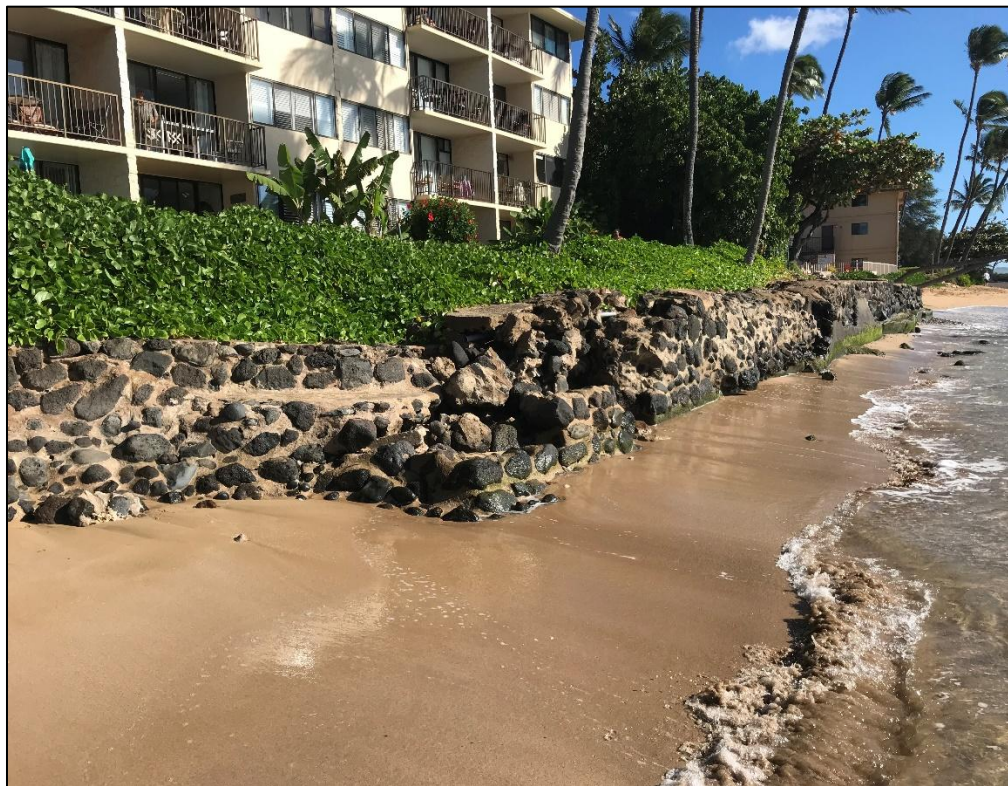
Figure 5-16 Existing CRM seawall at east end of KAN shoreline

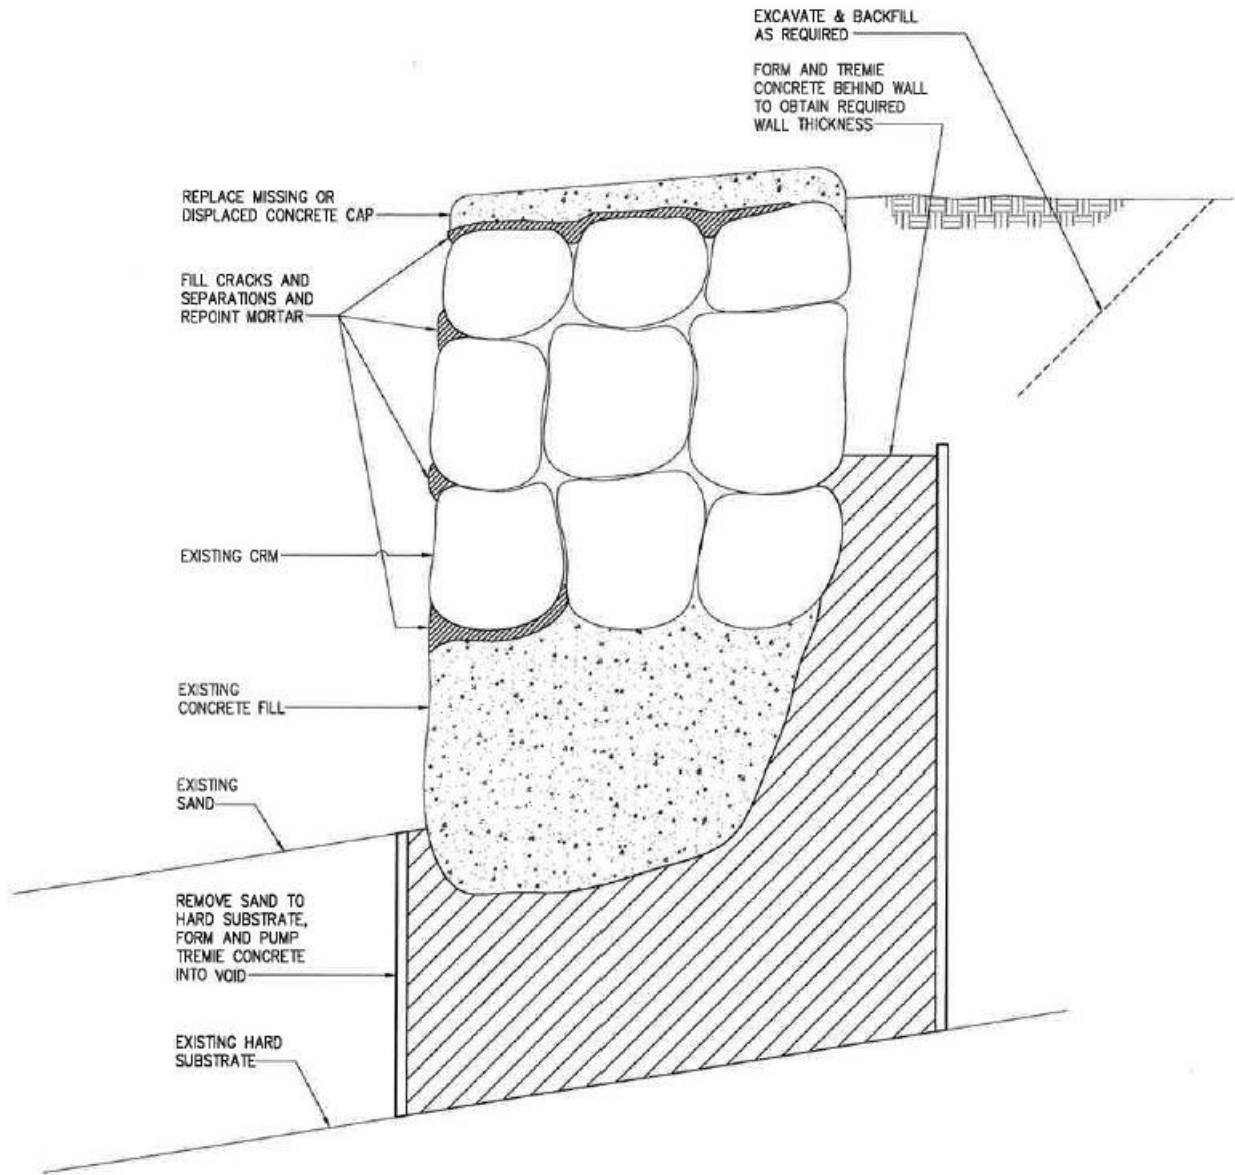
Figure 5-17 Conceptual scheme for seawall repairs in Sections 1 (west) and 3 (east)

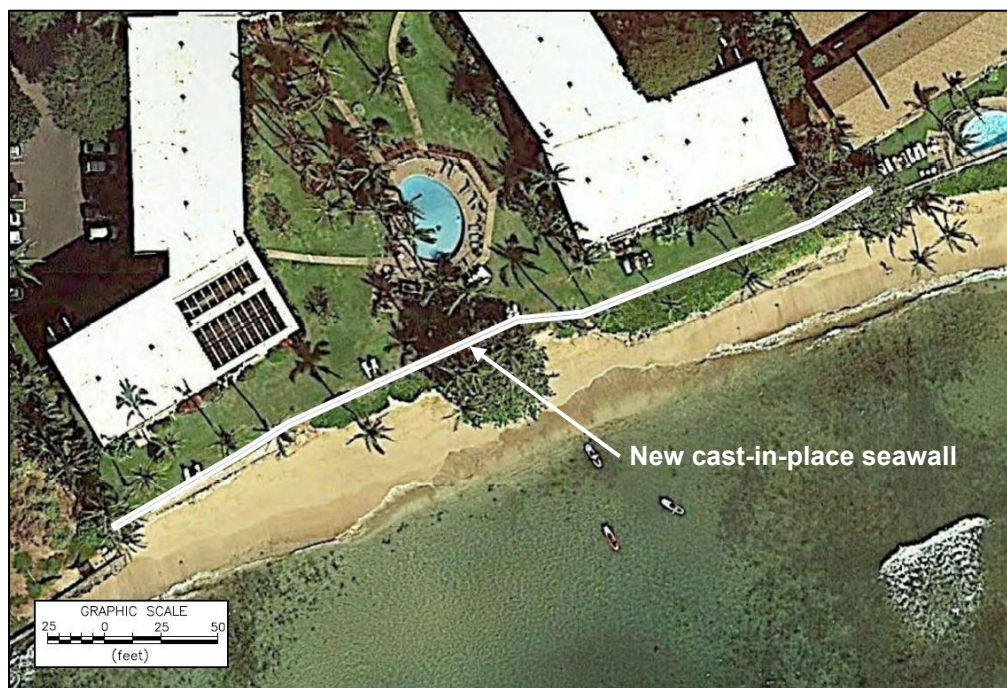
Figure 5-19 Conceptual plan view of a new cast-in-place seawall at KAN

It is anticipated that a new seawall would be constructed of cast-in-place reinforced concrete. Due to existing regulatory restrictions, it is anticipated that the new seawall would be required to be located landward of the certified shoreline outside of the Conservation District. Replacement would also require demolition and removal of the existing structures. A conceptual plan view and section view of a new cast-in-place seawall at KAN are shown in Figure 5-19 and Figure 5-20, respectively.

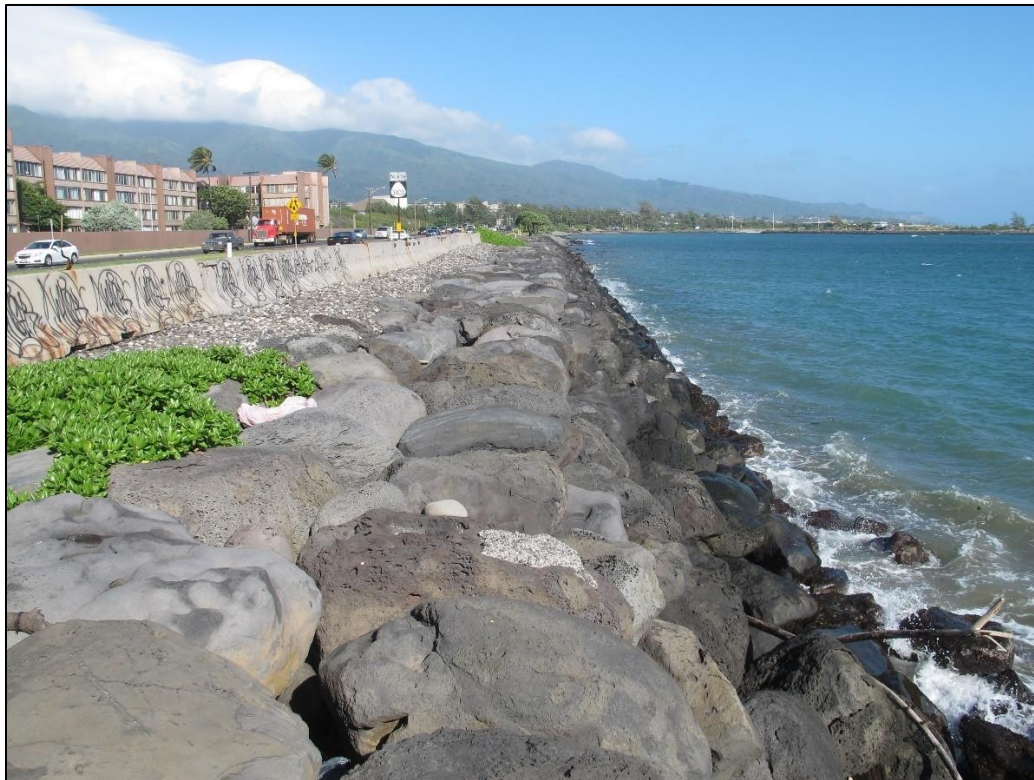
Figure 5-21 Rock rubblemound revetment at Kahului, Maui (2011)

Revetments in Hawaii are typically built on a slope of 1.5 to 2 horizontal to 1 vertical to ensure stability. Toe scour protection can be provided by excavating to place the toe on solid substrate, constructing the foundation below the maximum depth of anticipated scour, or extending the toe to provide a scour apron of excess stone. It is important that the armor stone be carefully chosen and placed in a keyed-and-fitted manner to minimize gaps between stones, which increases the durability of the structure. An example of a rock revetment at Kahului Harbor (Kahului, Maui) is shown in Figure 5-21.

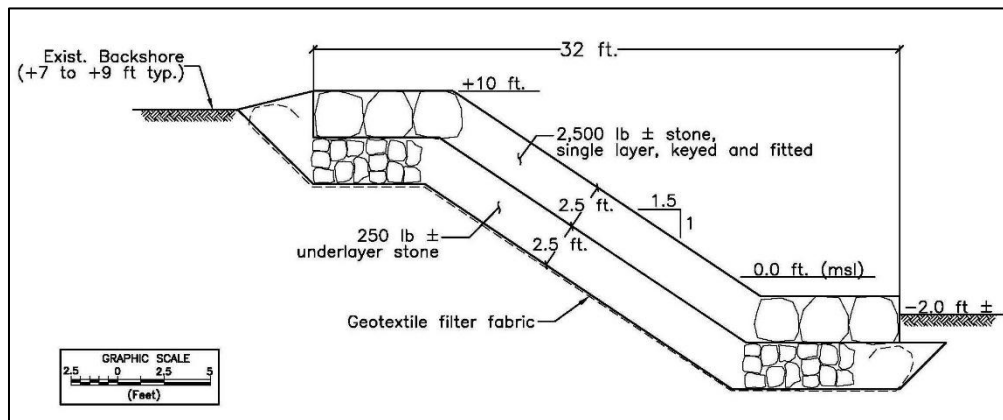
Figure 5-23 Conceptual section view of a rock rubblemound revetment at KAN

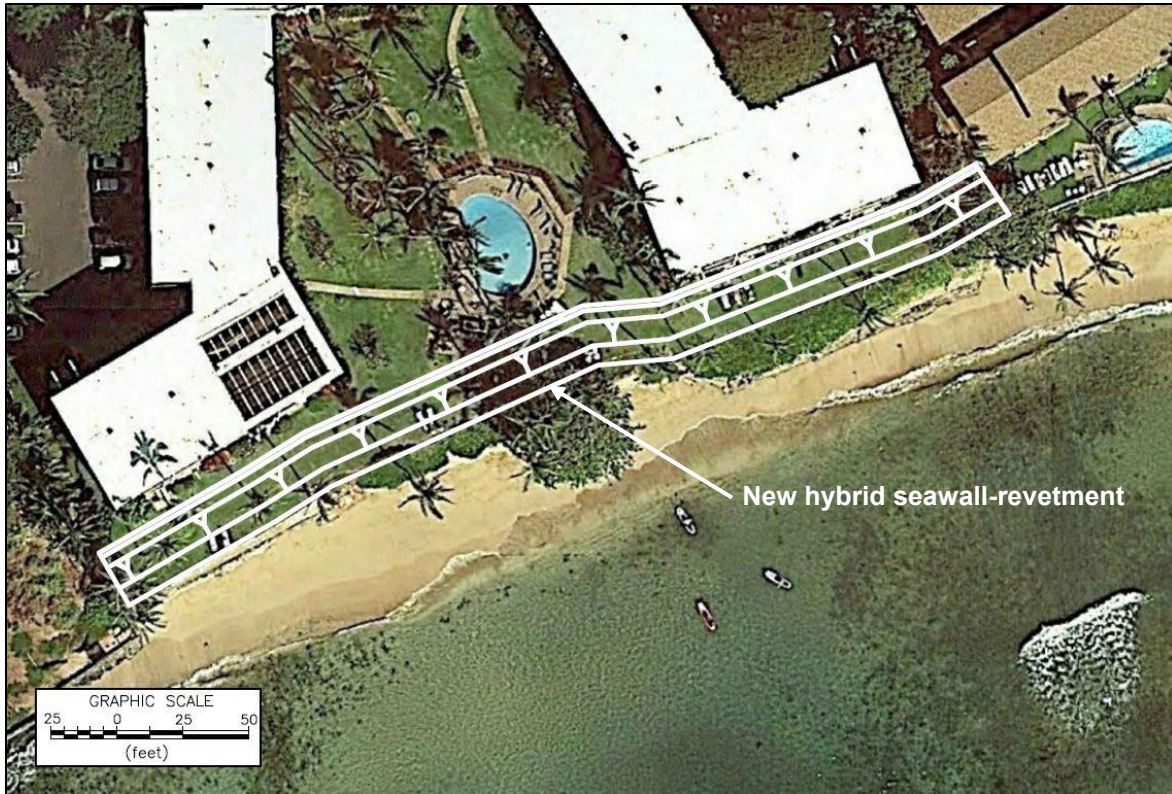
Figure 5-25 Conceptual plan view of a hybrid seawall-revetment at KAN

If a hybrid seawall-revetment were permitted in the Conservation District, KAN would be required to obtain a non-exclusive easement from the State of Hawaii. Even if the structure were located landward of the current certified shoreline, the future certified shoreline would likely be located at or near the crest of the structure, so an easement would eventually be required. In either case, easement costs are likely unavoidable.
