SUBJECT: FINAL ENVIRONMENTAL ASSESSMENT (FEA): FINDING OF NO SIGNIFICANT IMPACT FOR THE PROPOSED ADAPTATION PATHWAYS: SEAWALL REMOVAL AND DUNE RESTORATION LOCATED AT 250 HAU'OLI STREET, WAILUKU (MĀ'ALAEA), ISLAND OF MAUI, HAWAI'I; TMKS: (2) 3-8-014:004 AND (2) 3-8-014:005

Adaptation Pathways: Seawall Removal and Dune Restoration

Final environmental assessment and finding of no significant impact (FEA-FONSI)

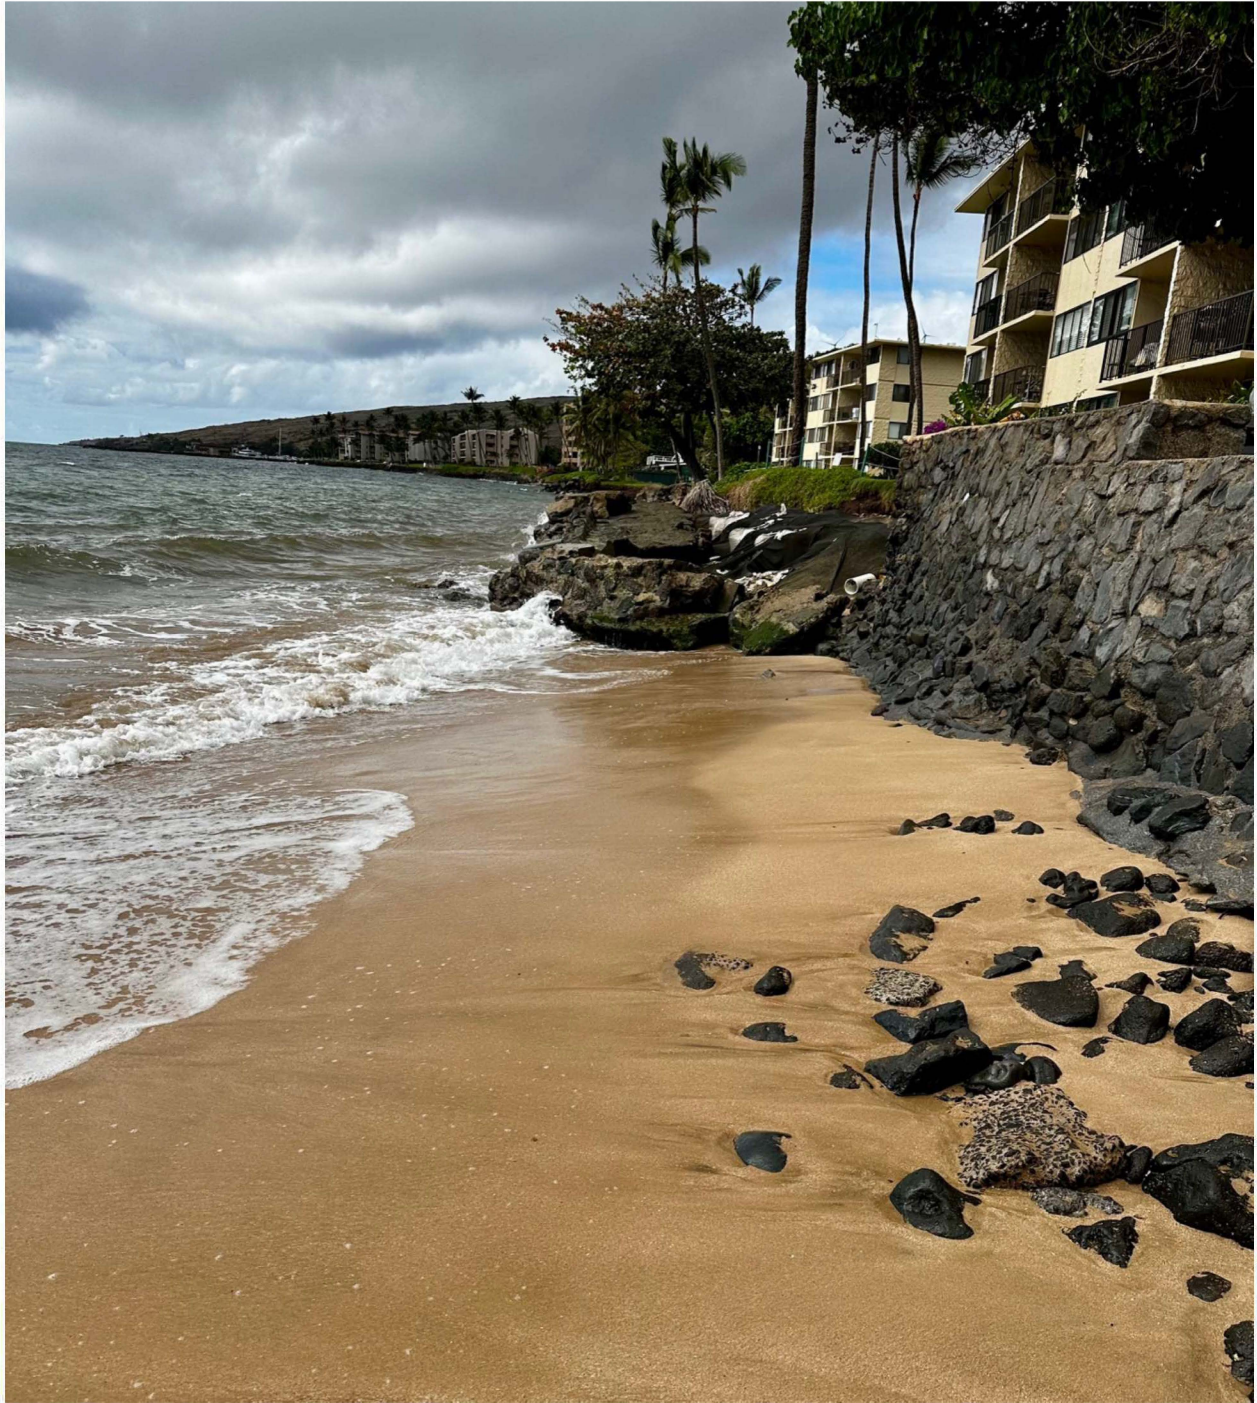
Figure 1 - Photo dated January 6, 2025 looking east to west with Hono Kai Seawall on the right of picture and Kanai A Nalu seawall (Zone 3) at the distant end of sandy beach. Note the natural sand along the shoreline at mid-tide extending approximately 10 feet from Hono Kai seawall. High risk of complete and permanent erosion of the beach with a setback at Kanai A Nalu.

Cumulative effects analysis is critical in the consideration of this project. The EA describes a 72 year history of erosion in Maalaea on Page 9 Paragraph 1 wherein it states “ Construction of Maalaea Harbor in 1952 resulted in the loss of 1,500 feet of narrow beach to the east of the harbor, which led to construction of shore protection structures (i.e., seawalls and revetments) that currently extend 2,400 feet east of the harbor to Haycraft Park, a 6.5-acre public beach park that is managed by the County of Maui.” Accepting the preferred alternative without a cumulative effects analysis of the subject project along with neighboring properties must be considered, particularly since the EA references a long history of independently developed projects along the Maalaea shoreline that have had various responses. We have concerns that the cumulative effects of a combination of hardening and wall removals may lead to the loss of the remaining 900 feet of the 2,400 feet along Maalaea that still have beach.
