SUBJECT: Negative Declaration for Coastal Fishpond Restoration and Operation at
Molokai

MASTER CONSERVATION DISTRICT USE
APPLICATION FORM
AND
FINAL ENVIRONMENTAL ASSESSMENT
FOR
REPAIR, RECONSTRUCTION, MAINTENANCE,
AND USE OF MOLOKA'I FISHPONDS

Aquaculture Development Program
Department of Land and Natural Resources
State of Hawaii
(808) 587-0030

January 1995

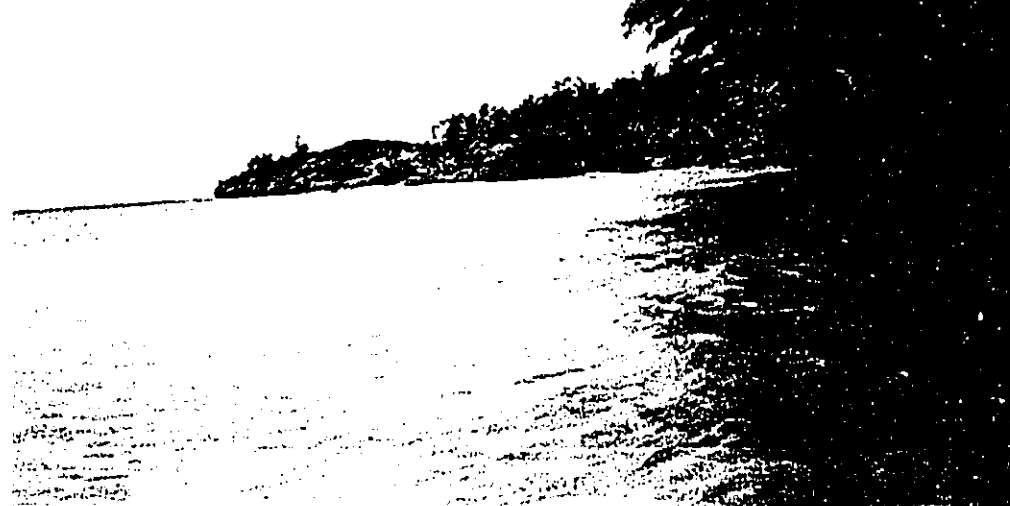
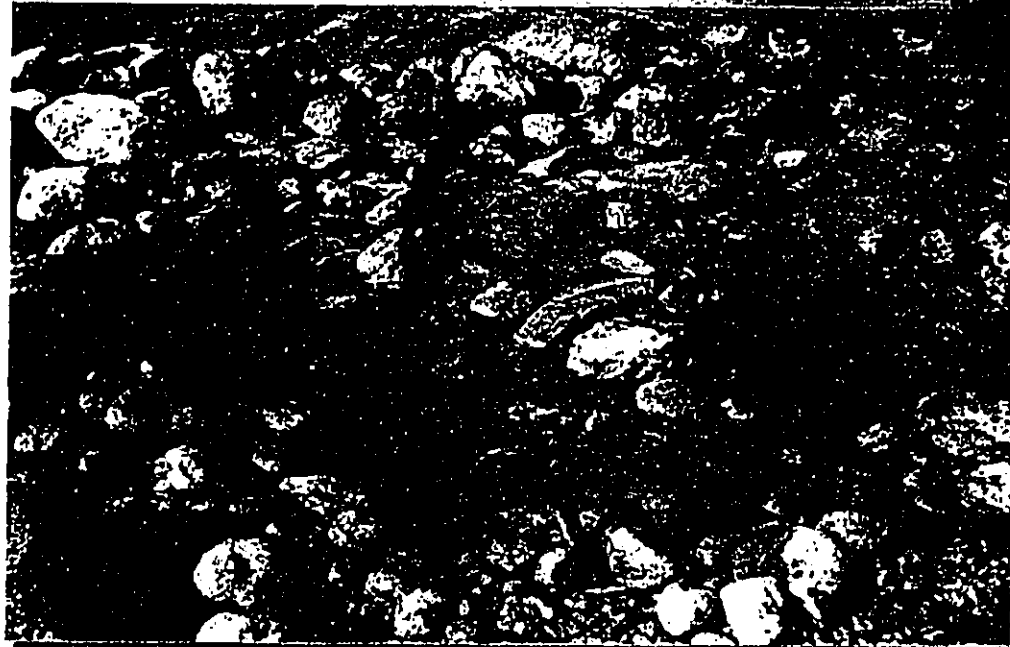
Photos of
Dunbar
Seawall
and
Adjacent
Silty
Waters

(3 years after
construction
of Dunbar
seawall)

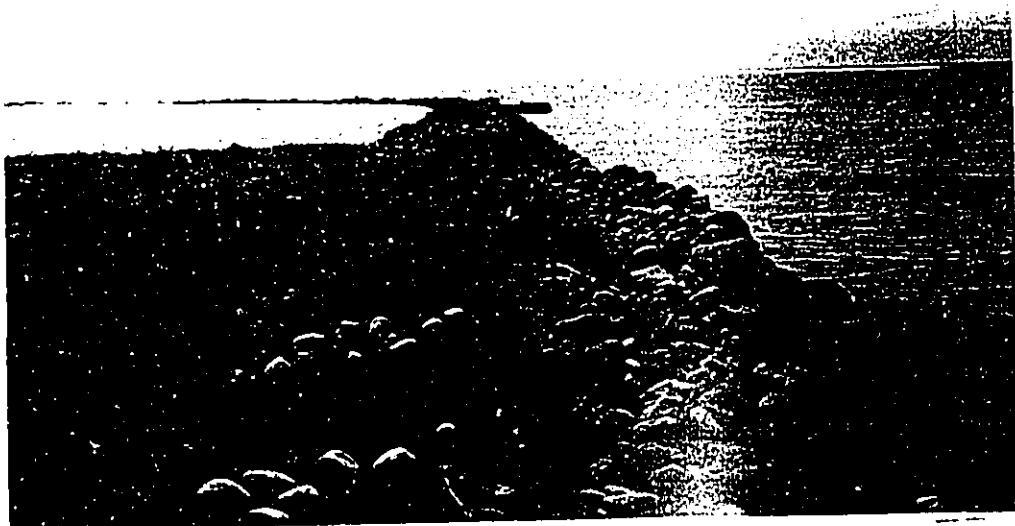
Photo 1: 8/27/92
Dunbar Seawall,
Looking Seaward
Wall Constructed
5/17/90 - 8/16/91

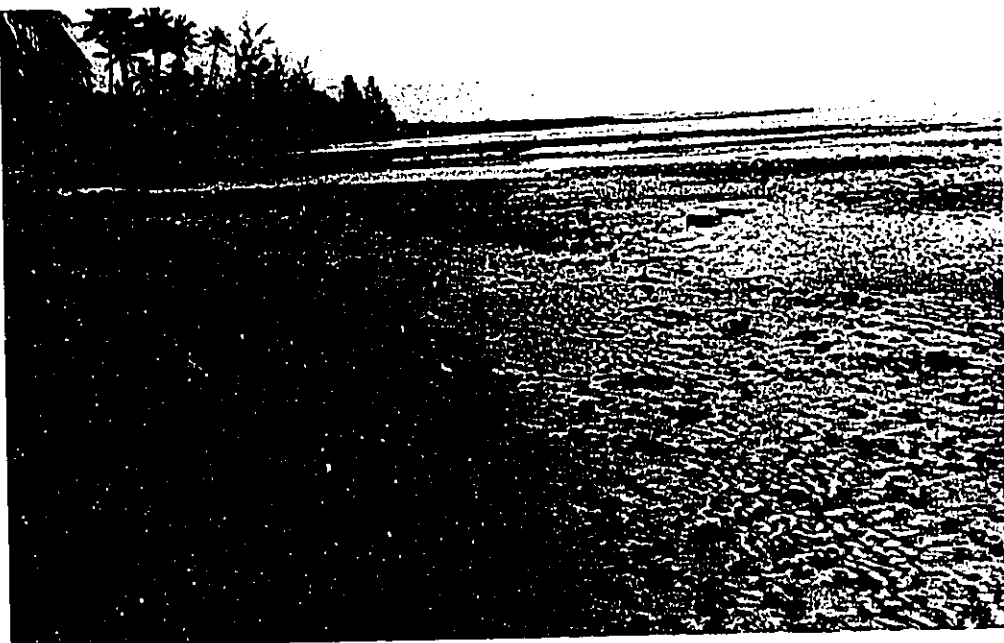
Photo 12: 8/27/92
Same Shoreline
After Construction
of Dunbar Seawall

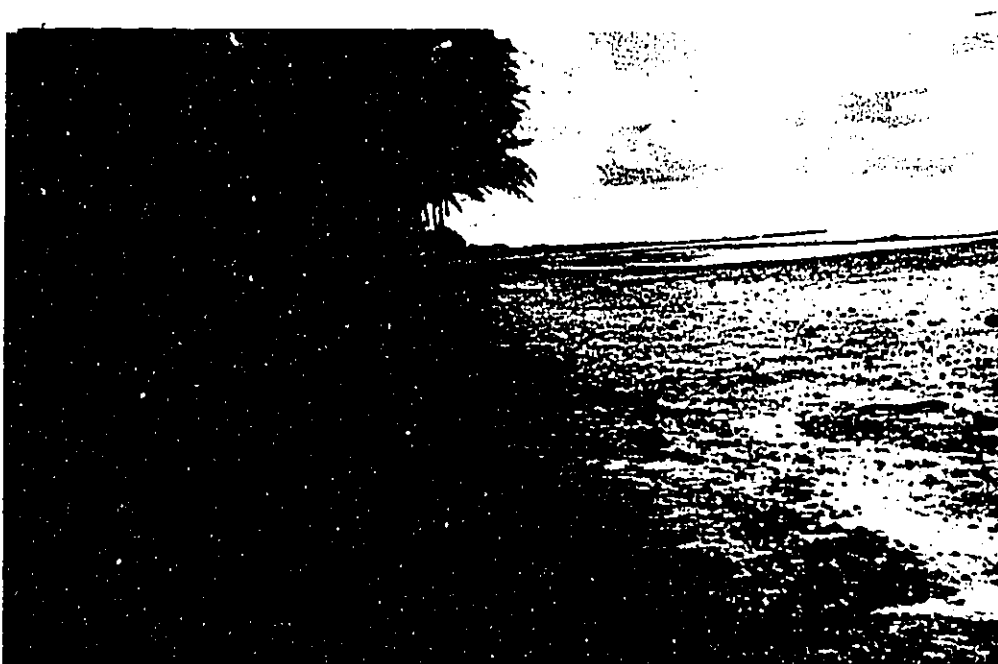
Photo 15: 8/27/92
Eastward View
of Same Shoreline
After Construction
of Dunbar Seawall
