*DRAFT ENVIRONMENTAL ASSESSMENT*

***Farrington Highway  
Replacement of Mākaha Bridges No. 3 and No. 3A***

District of Wai'anae, O'ahu, Hawai'i  
Federal Aid Project No. BR-093-1(20)

June 2009

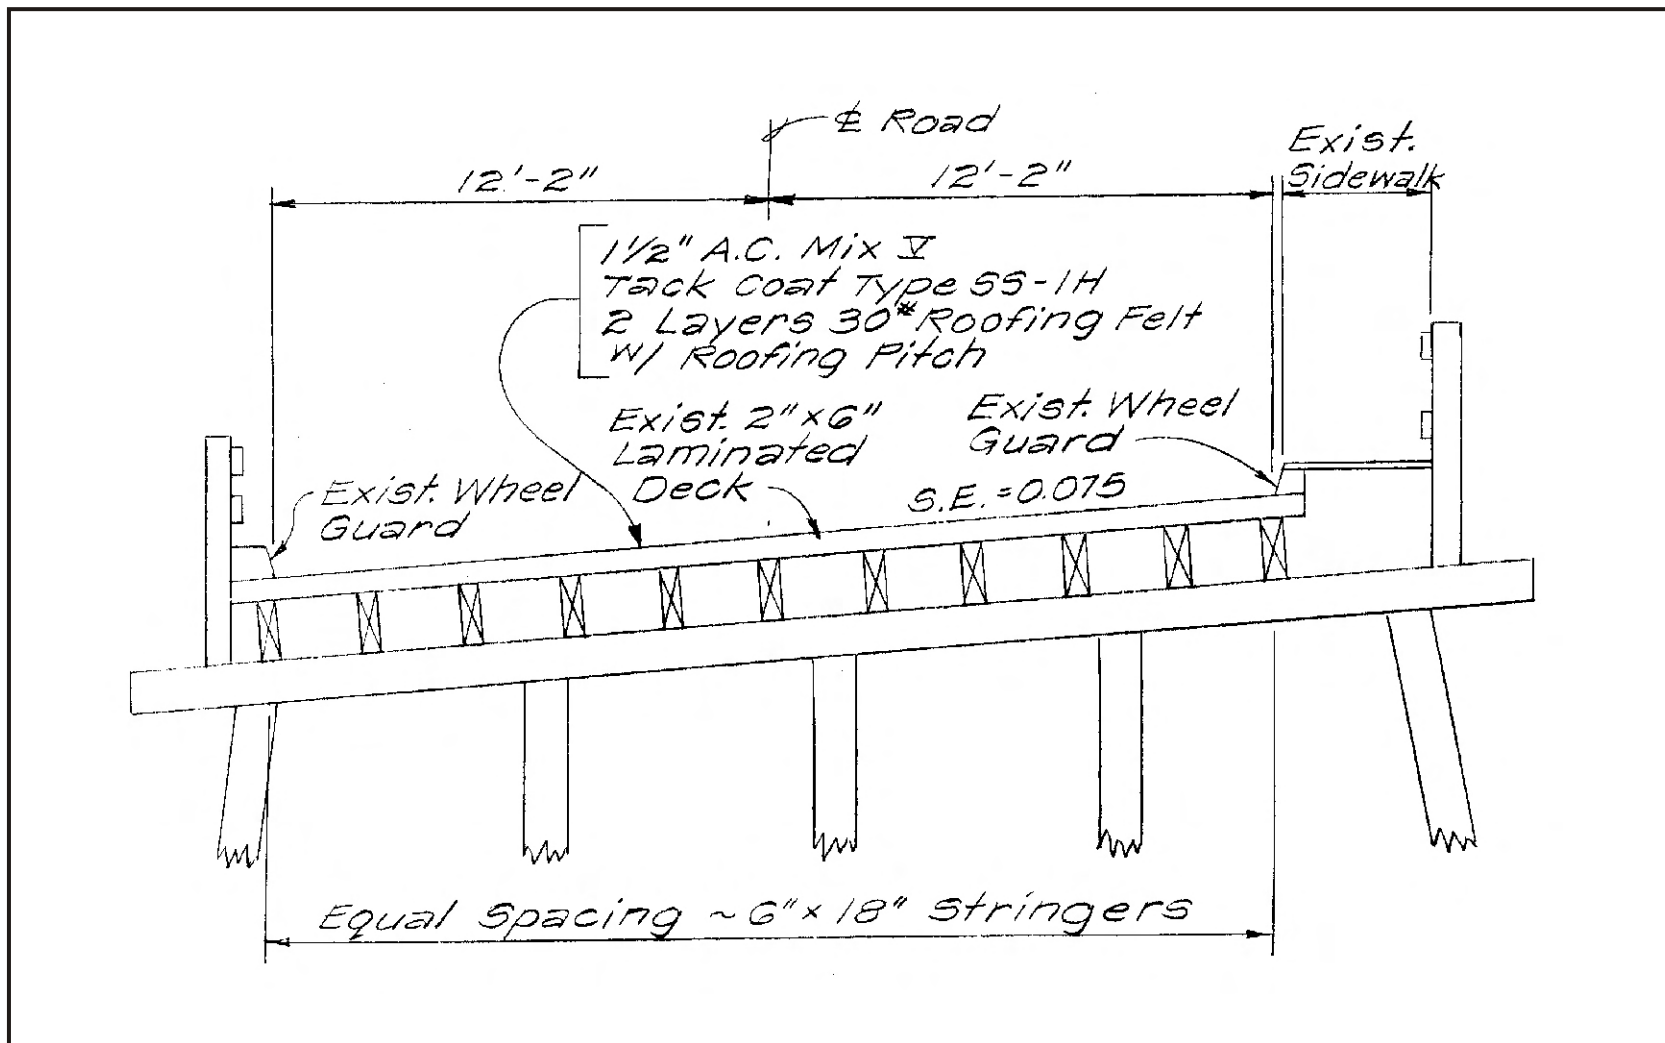
**Figure 2-1 Existing Typical Bridge Section**  
**Replacement of Mākaha Bridge No. 3 and 3A**  
 Farrington Highway, Wai'anae, O'ahu, Hawai'i  
 State Department of Transportation, Highways Division

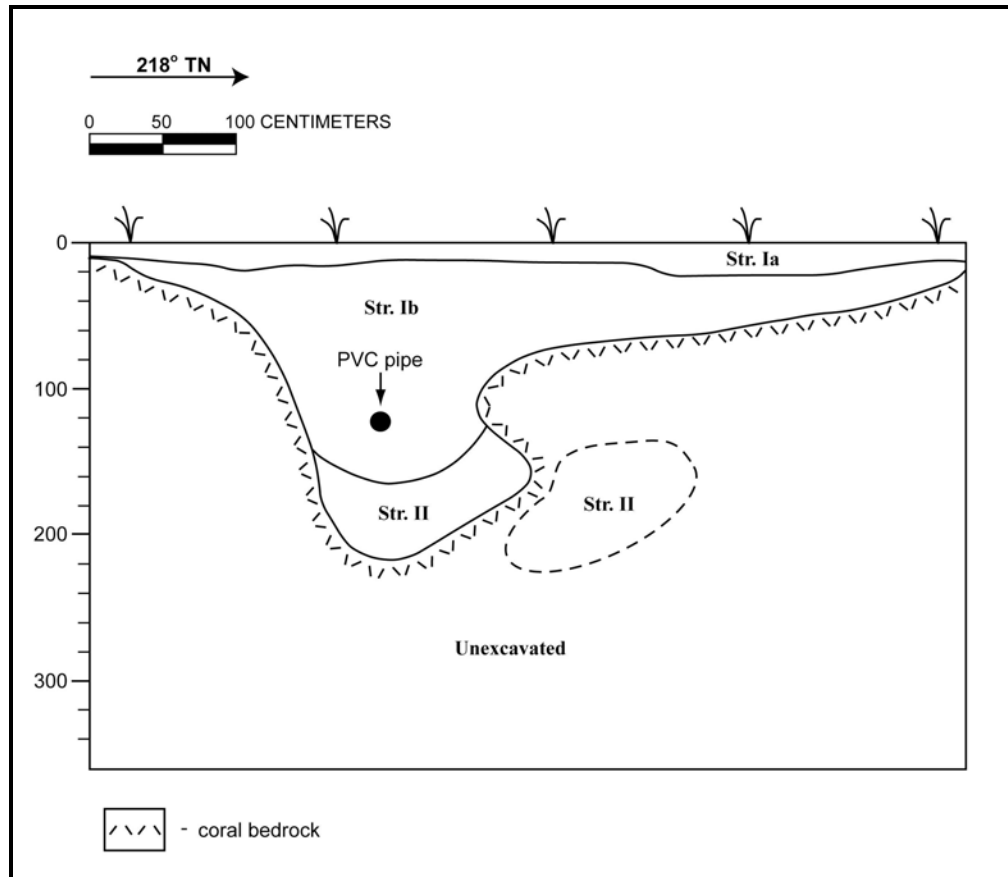
Figure 9. Trench 1, profile of east wall

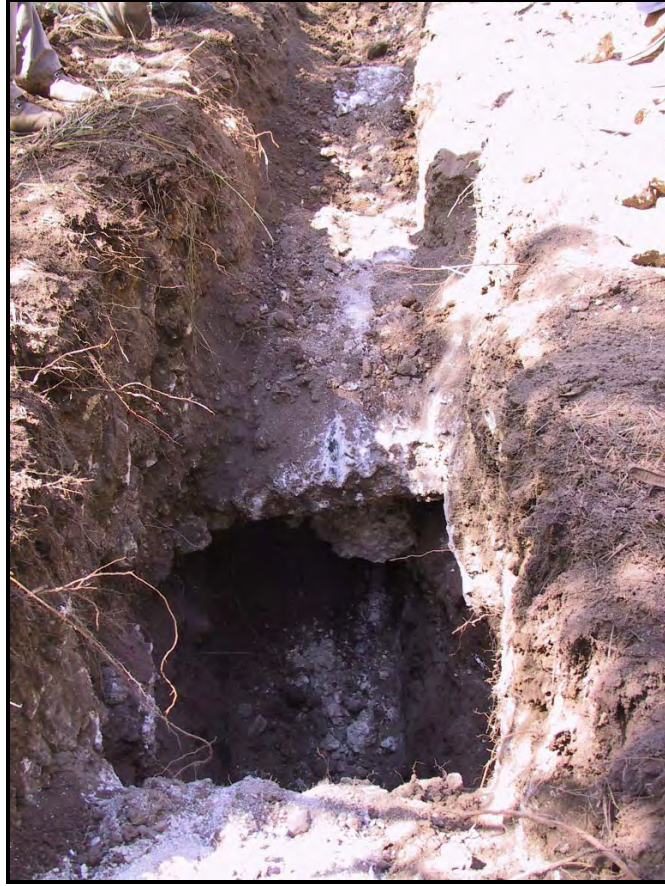
Figure 10. Photograph of Trench 1, view to the south, showing the uneven Pleistocene bedrock topography at the base of the excavation

Figure 8). Both Figure 9 and Figure 10 show the undulating topography of the Pleistocene coral bedrock at the base of the excavation. The PVC pipe fragment observed at 125 cmbs in Stratum Ib is evidence that that the sediments in this *mauka* portion of the project area have been disturbed by earth moving activity.

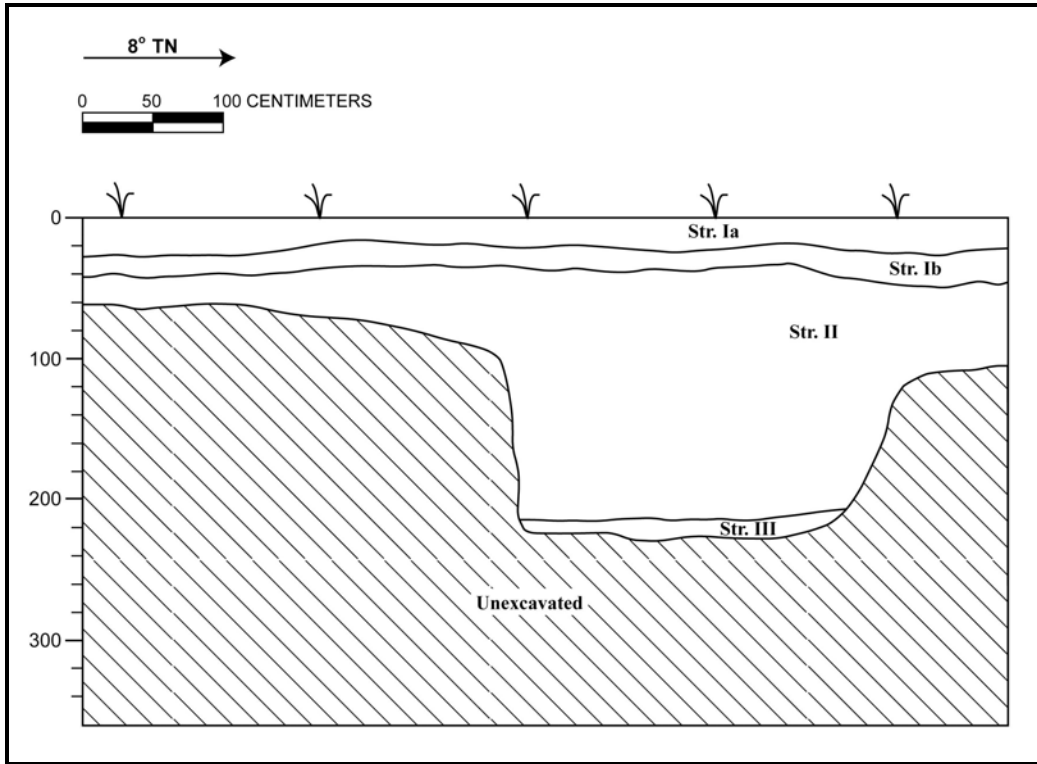
Figure 11. Trench 2, profile of west wall

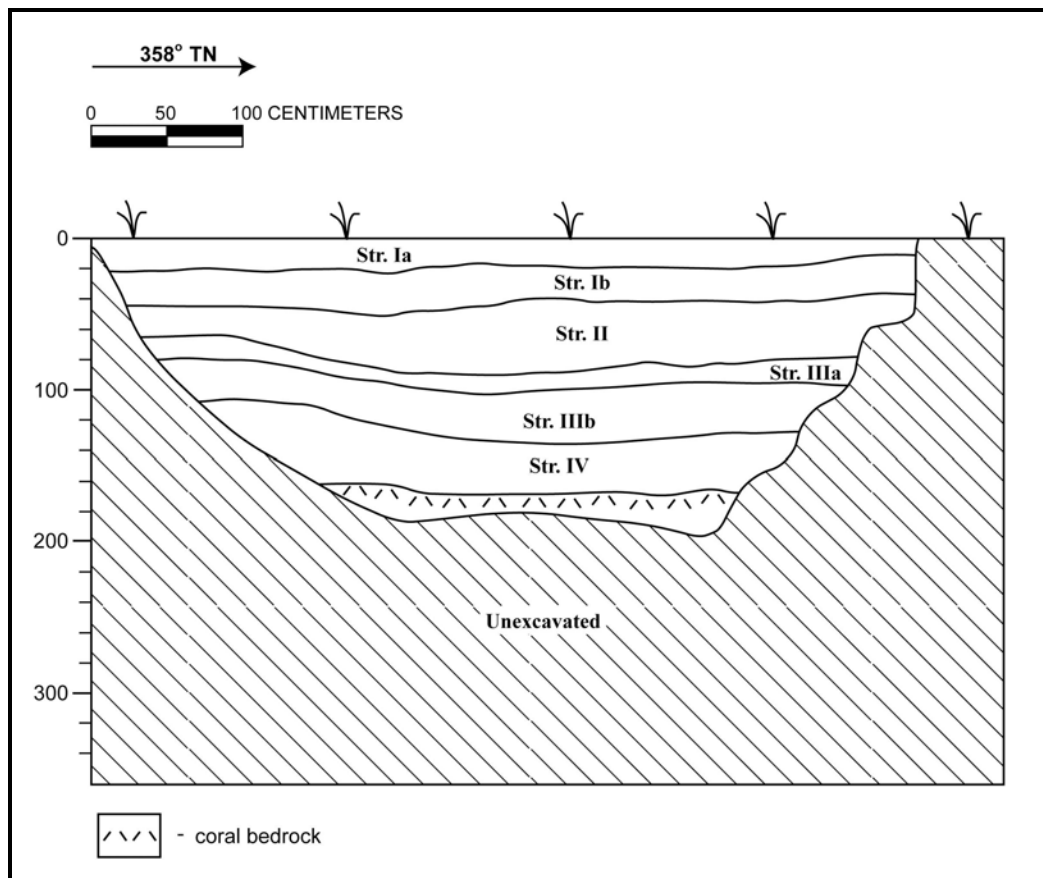
Figure 12. Trench 3, profile of west wall

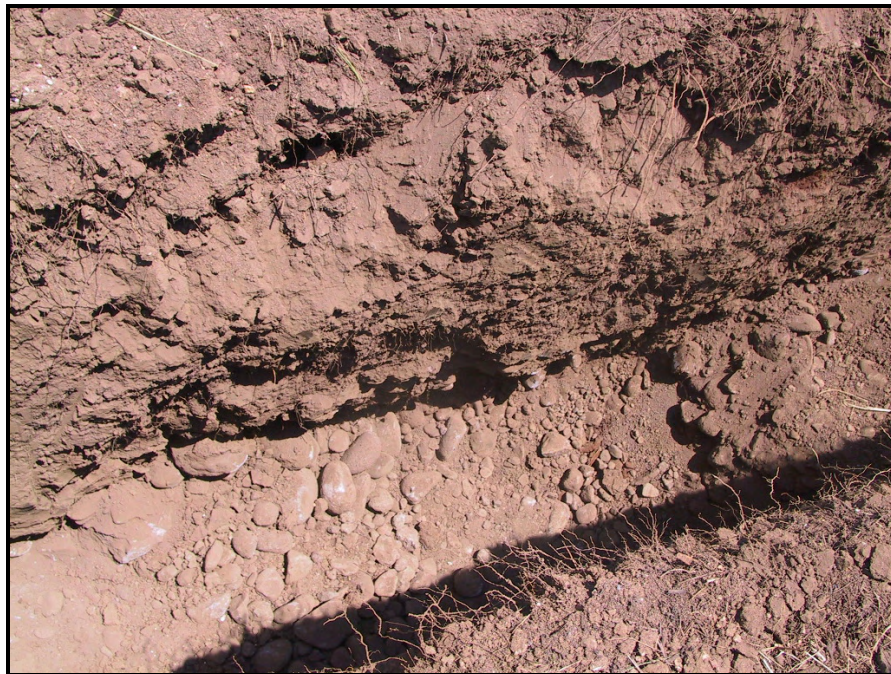
Figure 13. Photograph of the south end of Trench 4 showing the coarse bed load of a former Mākaha Stream alignment (Stratum III) at the base of the excavation

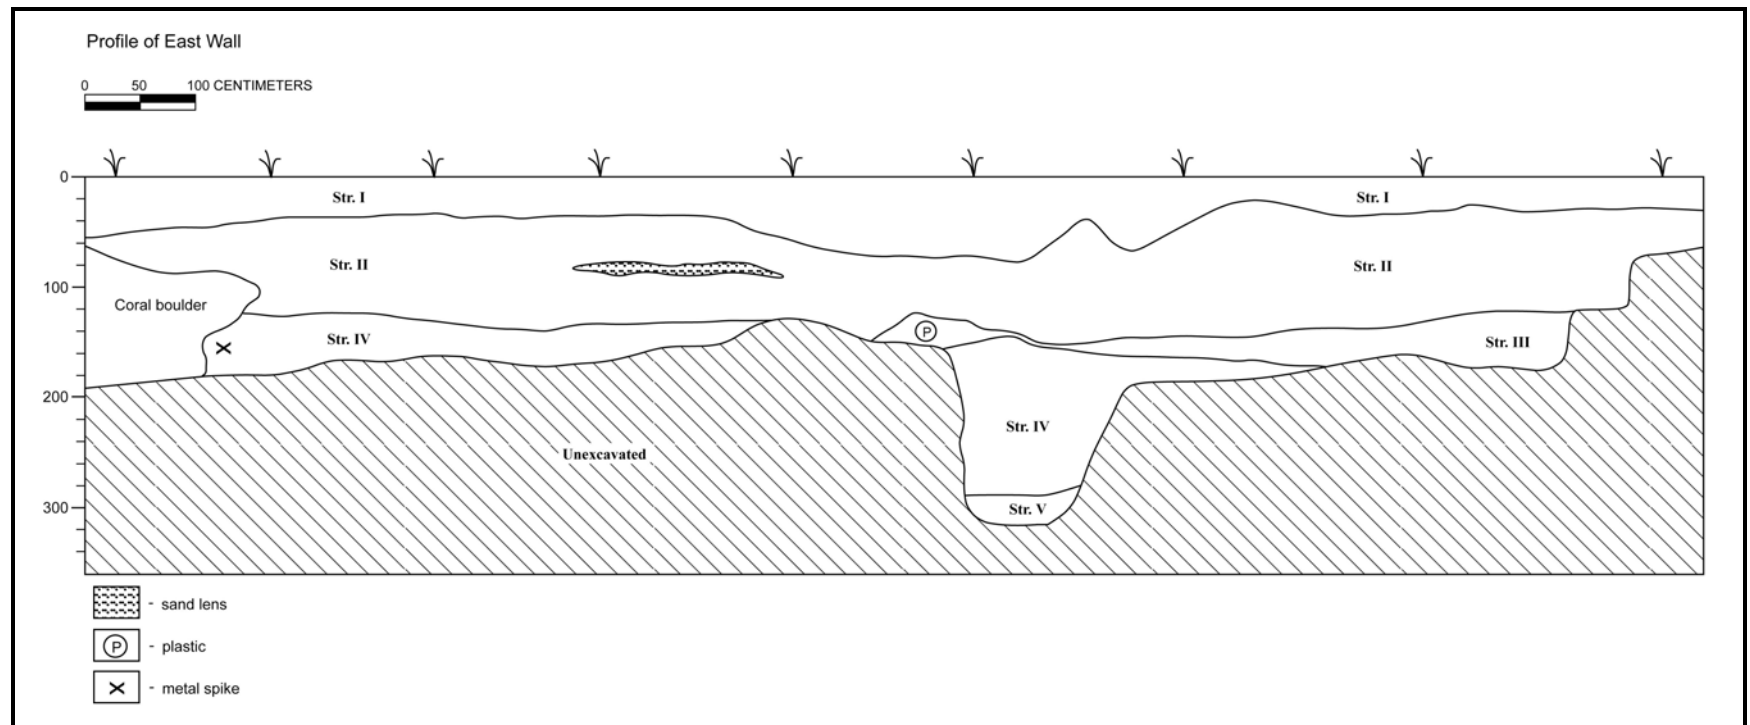
Figure 14. Trench 4, profile of east wall

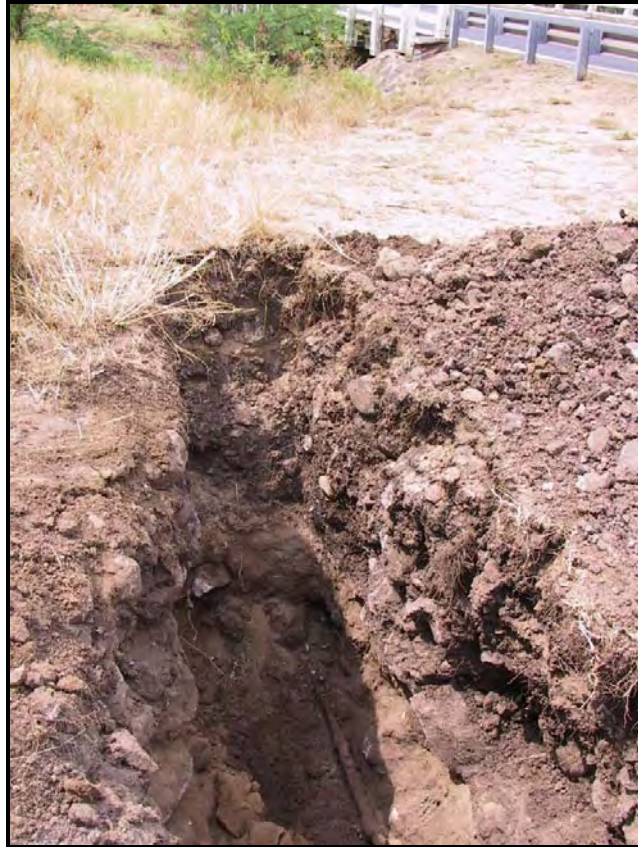
Figure 16. Photograph of Trench 5, shot north with Bridge 3A in the background, showing the two documented strata and a fragment of the defunct communication or electric cable at the base of the excavation

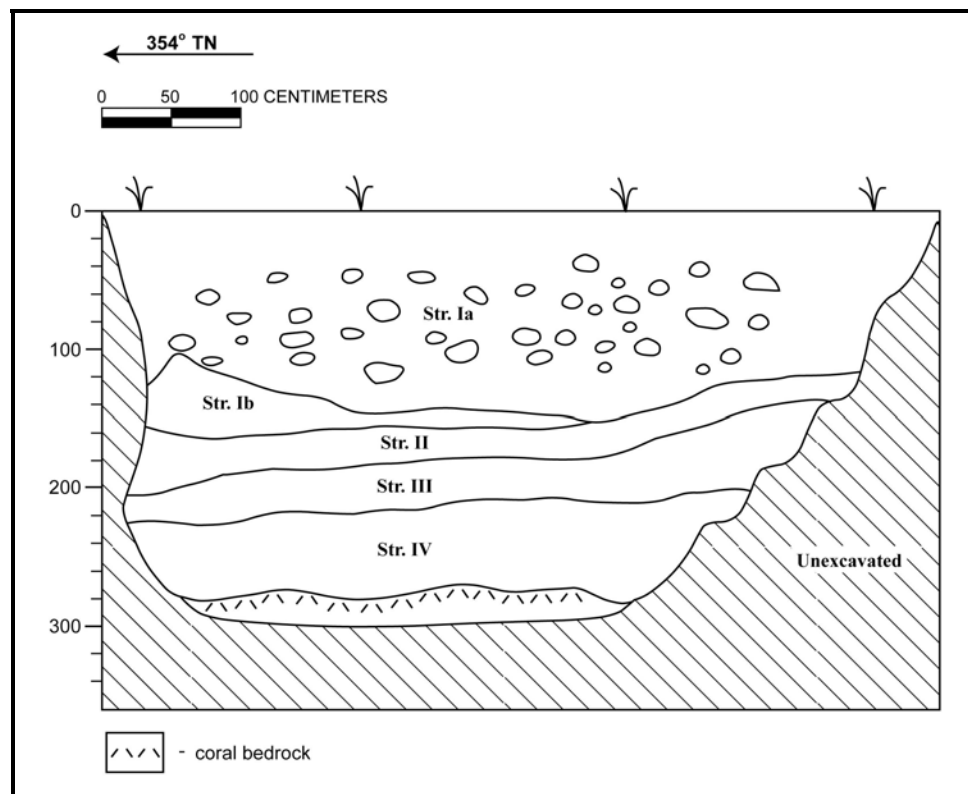
Figure 17. Trench 6, profile of east wall

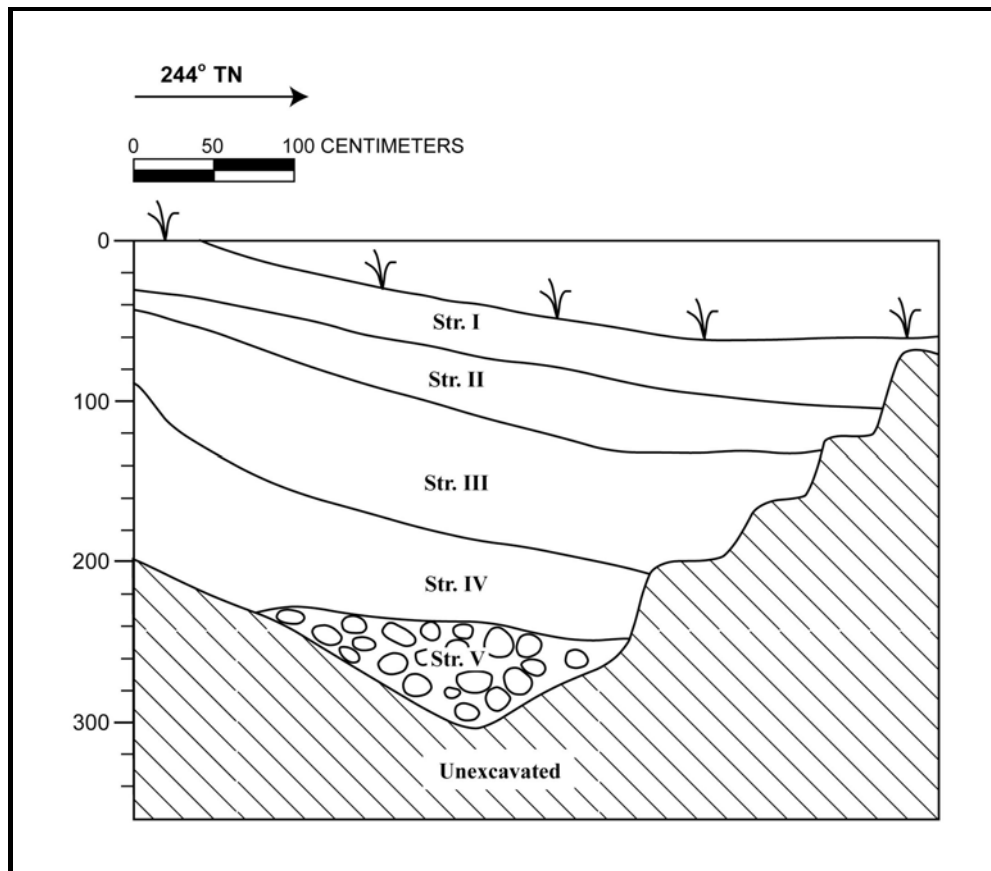
Figure 18. Trench 7, profile of south wall

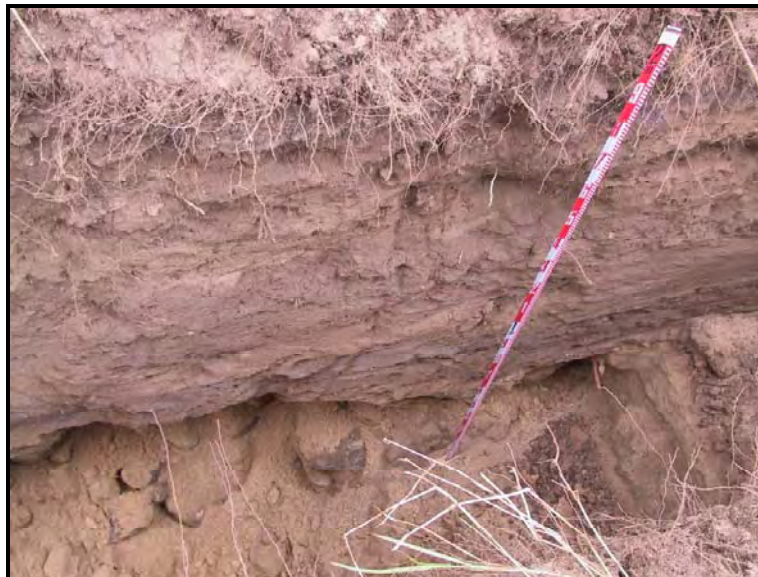
Figure 19. Photograph of the south profile of Trench 7 showing sand layers, note high energy sand and boulder layer at the base of the excavation

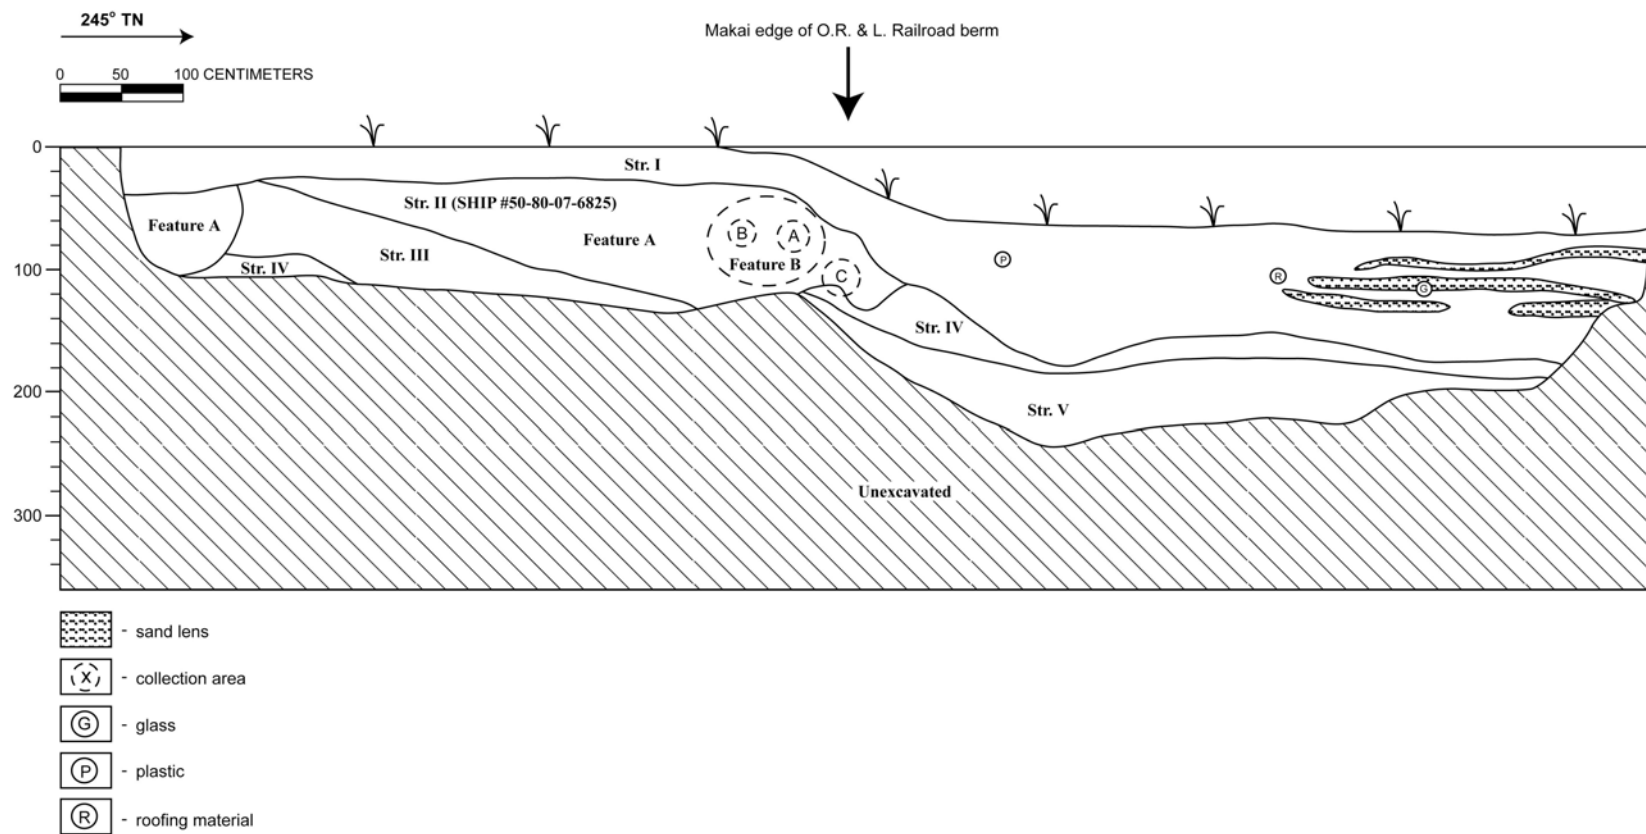
Figure 20. Trench 8, profile of south wall

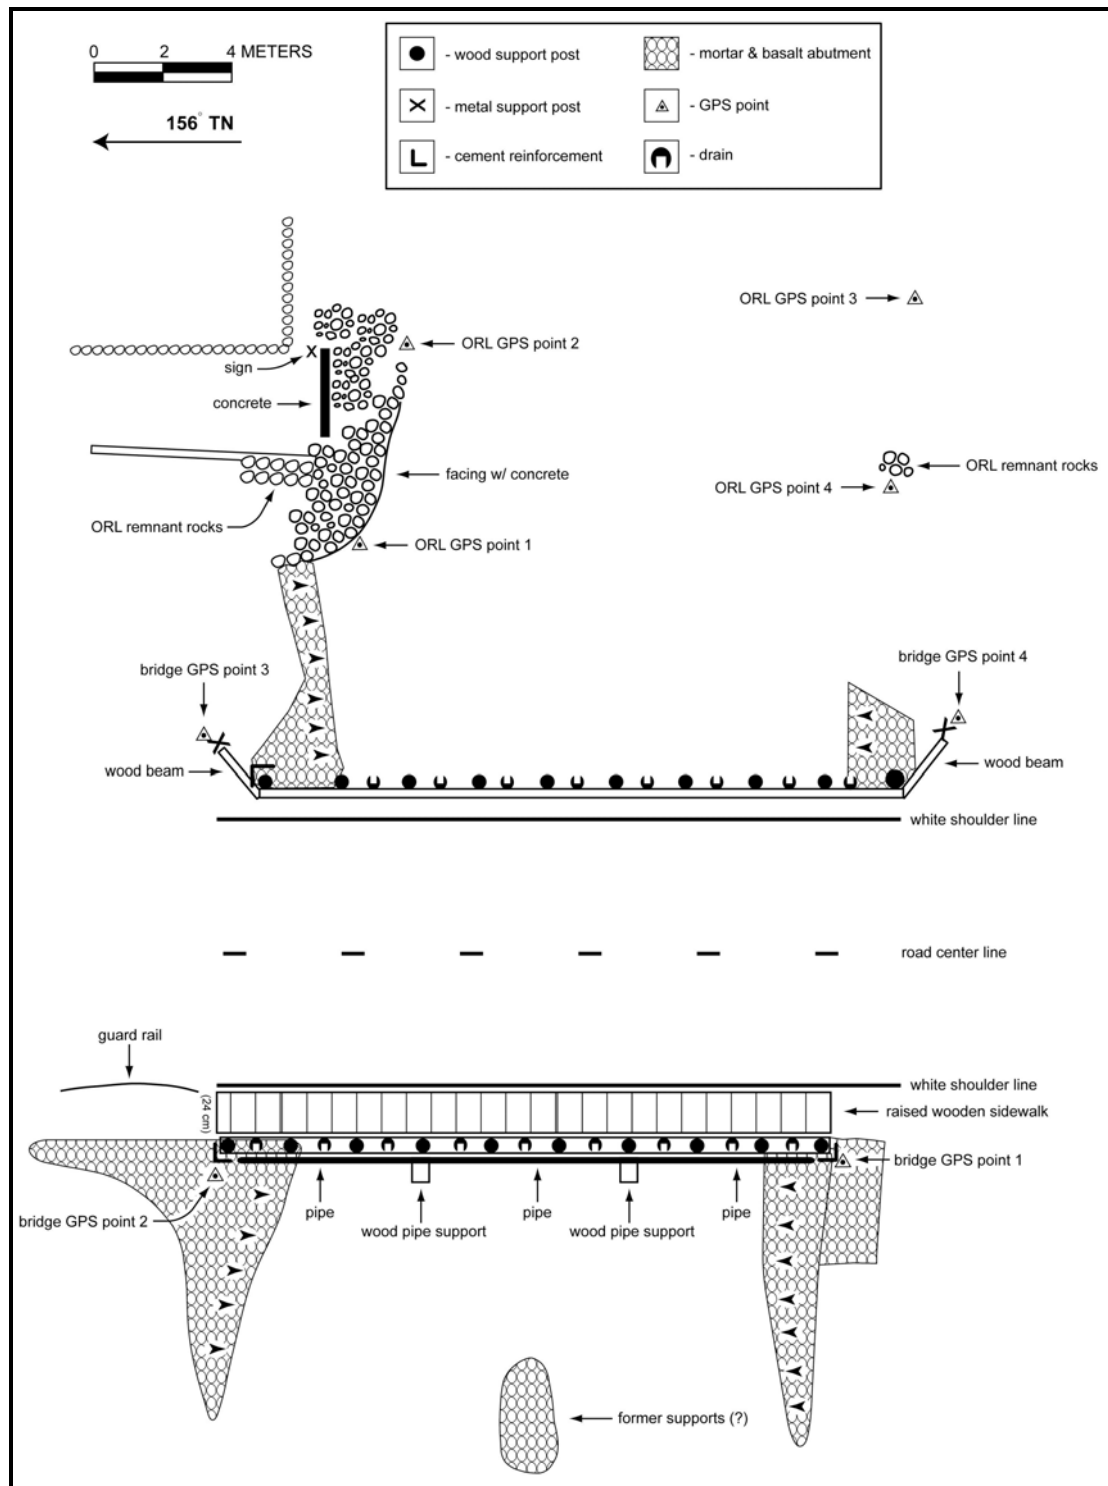
Figure 22. Plan view of SIHP # 50-80-07-6822 (a.k.a. Bridge 3) and Feature B, SIHP # 50-80-12-9714, remnant of a former O. R. and L. Railroad trestle

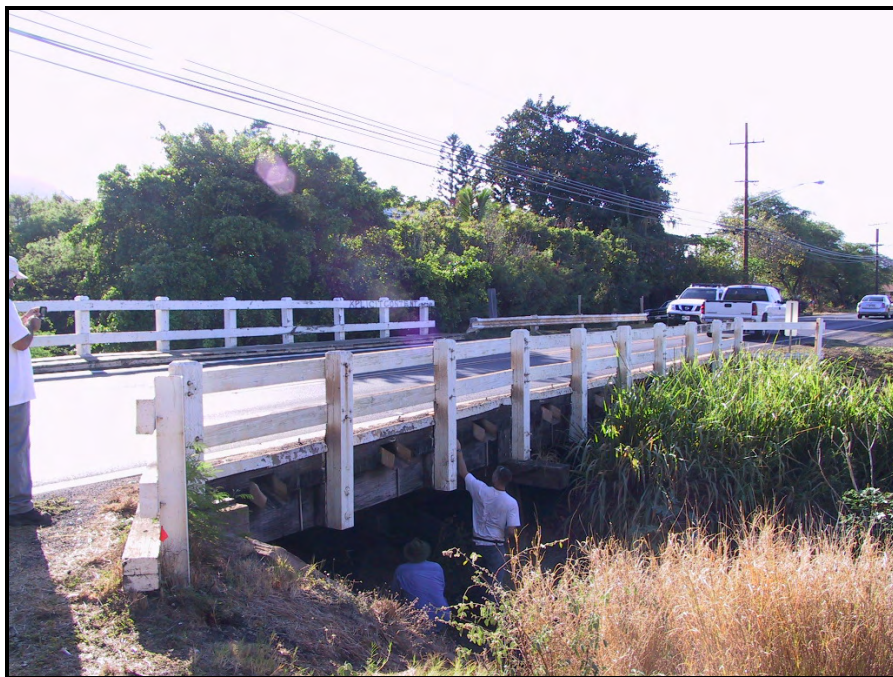
Figure 24. Photograph of SIHP # 50-80-07-6822, view to the southeast

During fieldwork, the streambed beneath Bridge 3 was sandy and dry. Mākaha Stream is an intermittent stream and Bridge 3 functions to maintain Farrington Highway's level road surface and provide protection against road flooding. The bridge measures 65 ft (20 m) long (SE/S-NW/N) by 50 ft (15 m) wide (E/NE-SW/W) and is 12 ft (3.5 m) high. The bridge is constructed primarily of massive, creosote-treated, wooden columns, beams, and planks of varying length and width (refer to Figure 25 and Figure 26), with blue rock (basalt) and mortar abutments and wing walls (Figure 27 and Figure 28). The wooden column, beams, and planks are held together by large steel nuts and bolts. Concrete reinforcements are visible at each of the bridge's four corners (Figure 23 and Figure 24).

Wooden guardrails, which are painted white and constructed along the *mauka* (east-northeast) and *makai* (west-southwest) sides of the bridge, run parallel with the road and run the entire length of the bridge (Figure 23, Figure 24, and Figure 29). A metal pipe also runs parallel to the *mauka* side of the bridge (Figure 29). It is supported by wooden beams behind the wooden guardrail, and is suspended above the dry streambed that leads to the ocean.

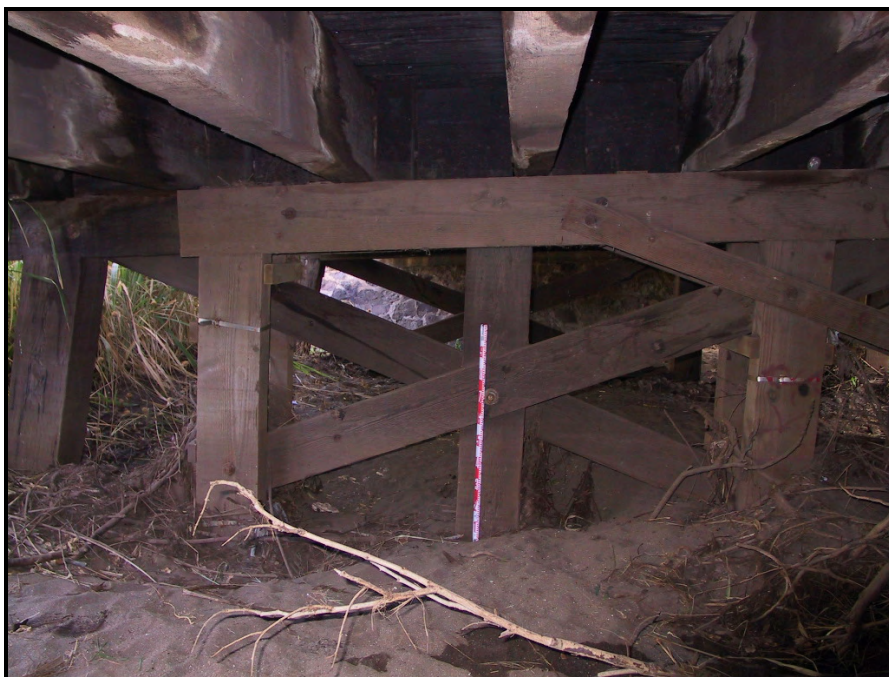
Figure 26. Photograph of SIHP # 50-80-07-6822, showing massive wooden beams, bents, and columns, and plank X-bracing, view to northwest/north

mortar (see description of Bridge 3A that follows). Over each of its two piers, the bridge's bents are wooden beams, while the bridge's end bents are concrete. The bridge deck is wooden planking set perpendicular to the bridge's alignment. The bridge is level with no significant elevation difference.

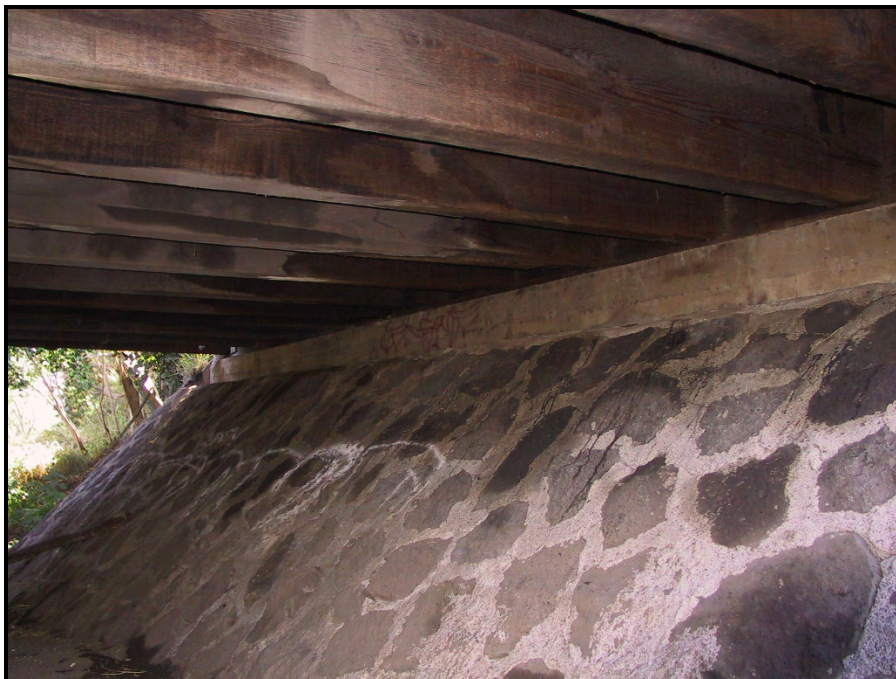
Figure 27. Photograph of SIHP # 50-80-07-6822, blue rock and mortar abutments, wooden beams and concrete end bent, view to north

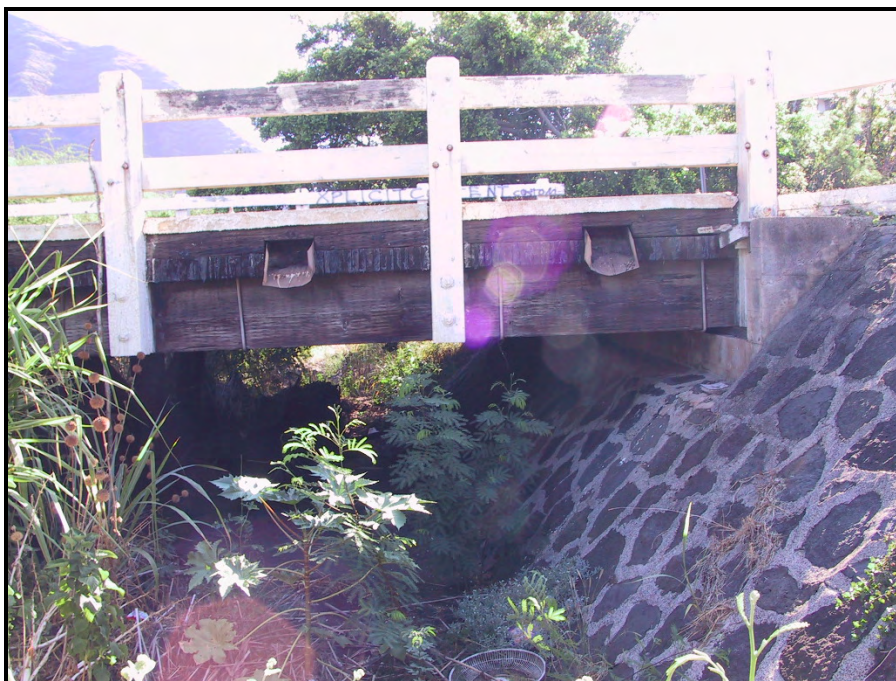
Figure 28. Photograph of SIHP # 50-80-07-6822, blue rock and mortar abutments with concrete reinforcement at corners, view to north

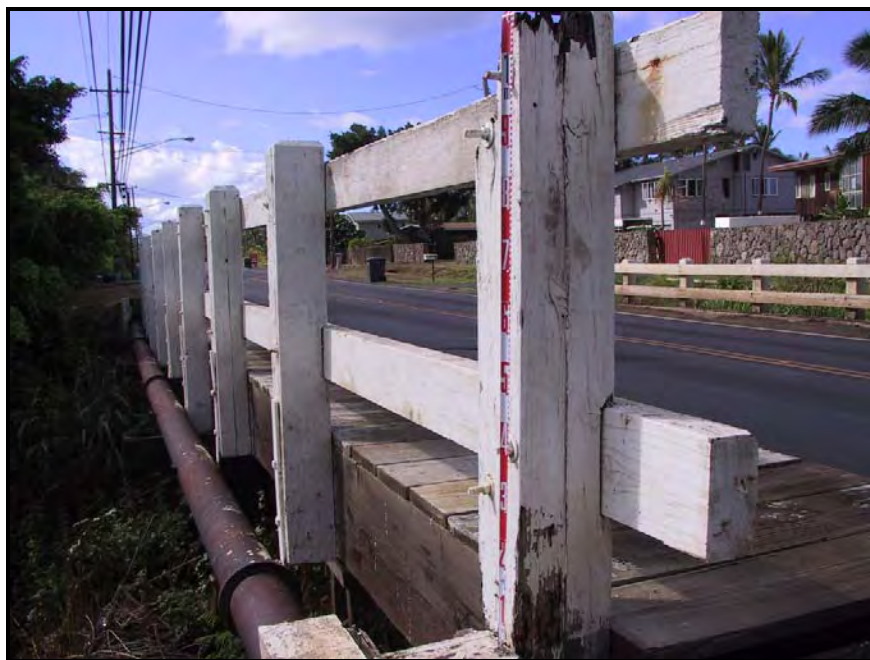
Figure 29. Photograph of SIHP # 50-80-07-6822, wooden guardrail and metal pipe, view to southeast/east

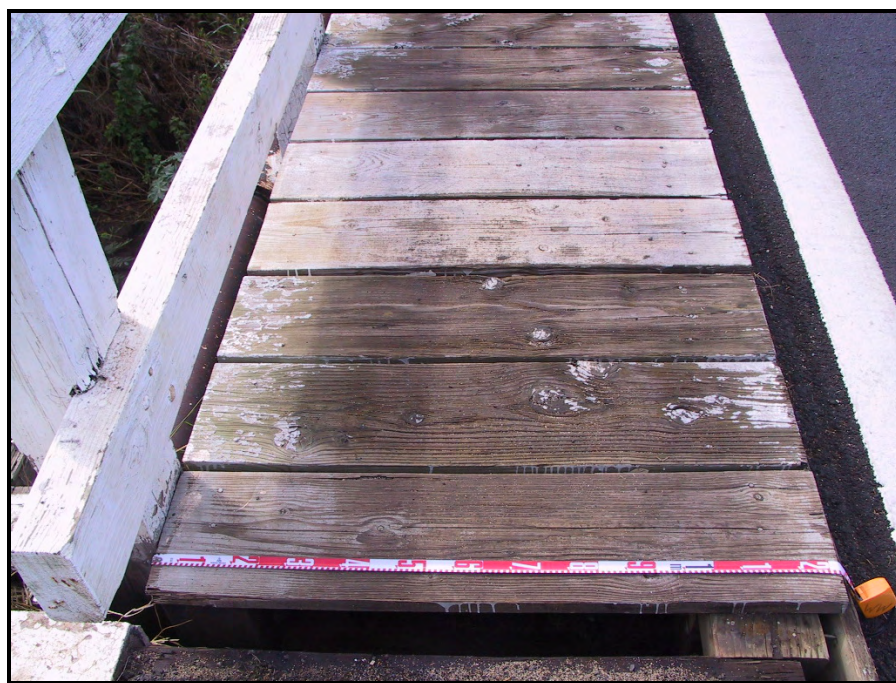
Figure 30. Photograph of SIHP # 50-80-07-6822, raised wooden sidewalk, view to southeast/east

A raised wooden sidewalk, located along the *mauka* (east-northeast) side of the bridge, is also incorporated into the bridge's construction (Figure 30). The sidewalk runs the entire length of the bridge, is raised 10 inches (25 cm) from the road surface and is 4 ft (120 cm) wide.

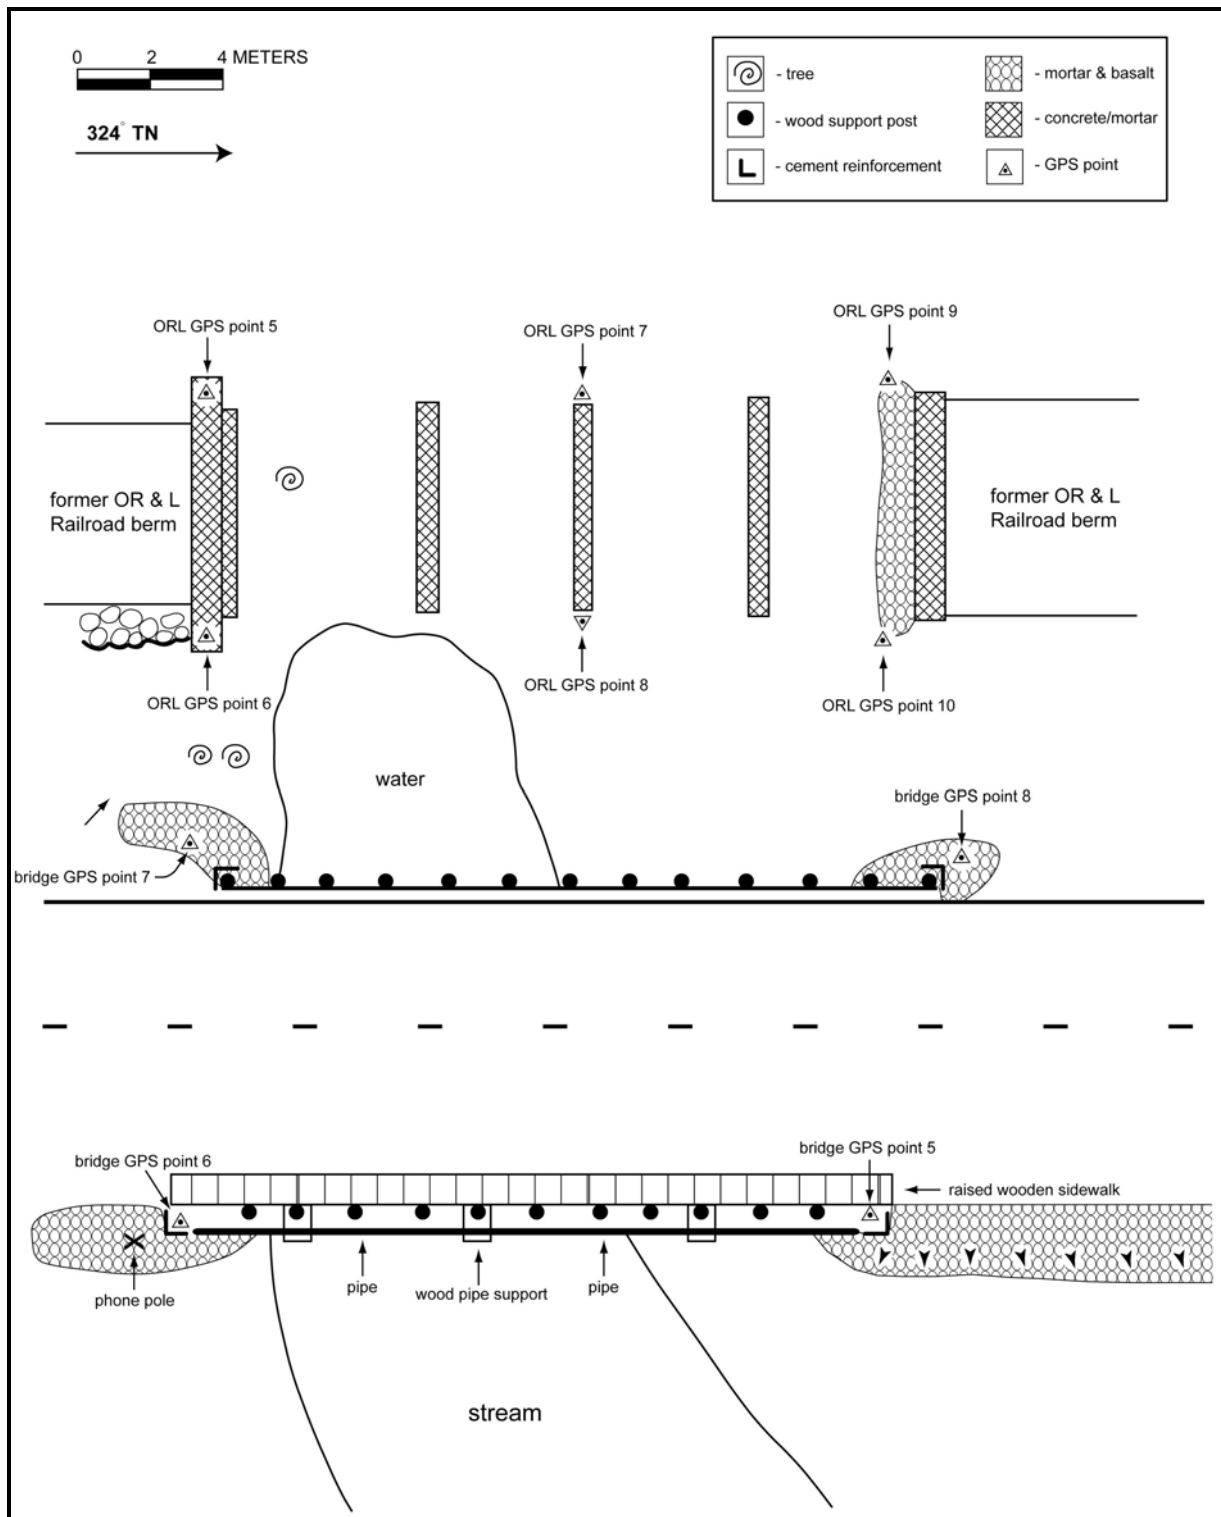
Figure 31. Plan view of SHIP # 50-80-07-6823 (a.k.a. Bridge 3A) and Feature C of SIHP # 50-80-12-9714, remnant of a former O. R. and L. Railroad trestle.

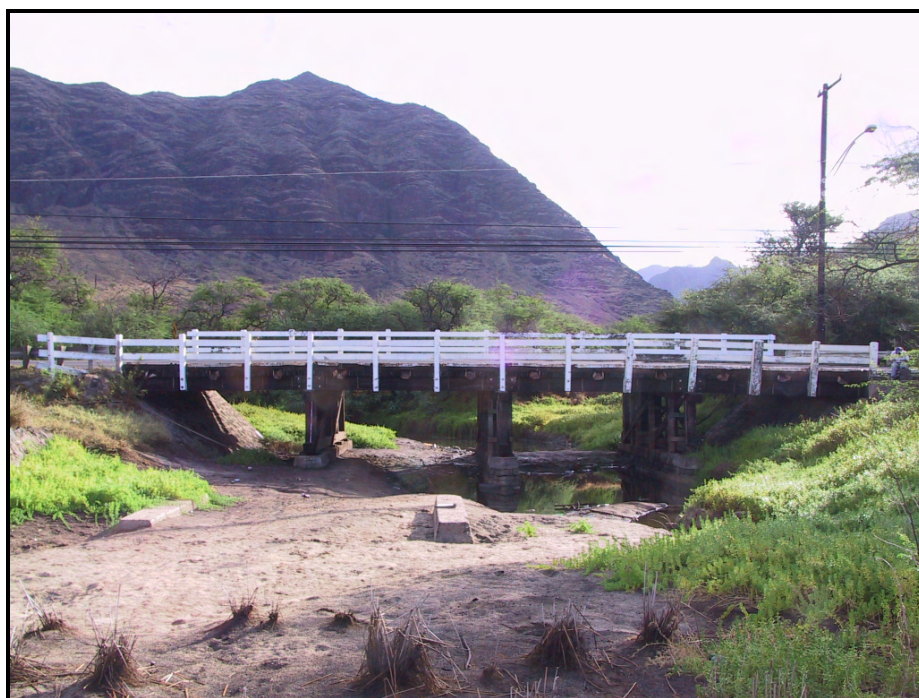
Figure 33. Photograph of SHIP # 50-80-07-6823, view to the northeast

Unlike Bridge 3, Bridge 3A's integrity of setting has not been diminished over the years with the encroachment of housing. The increased population in the vicinity of the bridge, with its associated increase in traffic volume, is less noticeable with Bridge 3A, and there is much more of a sense of the bridge's rural setting (refer to Figure 33).

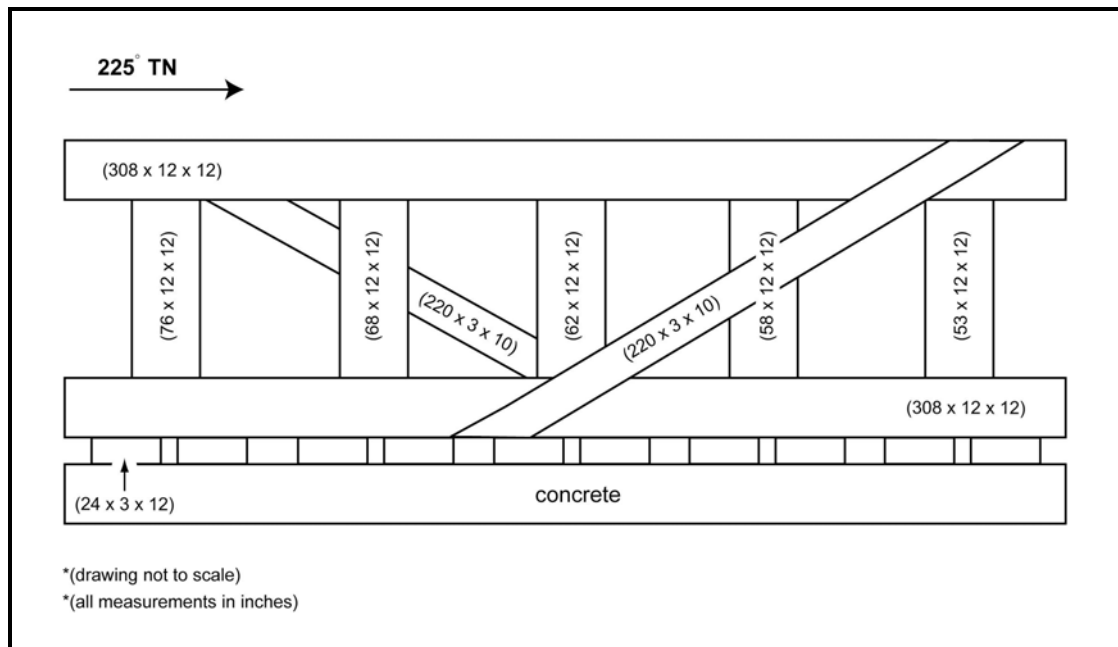
Figure 34. Schematic profile of SHIP # 50-80-07-6823, showing wooden column and bent supports, with wooden diagonal bracing, and the visible portion (concrete) of the bridge's pier

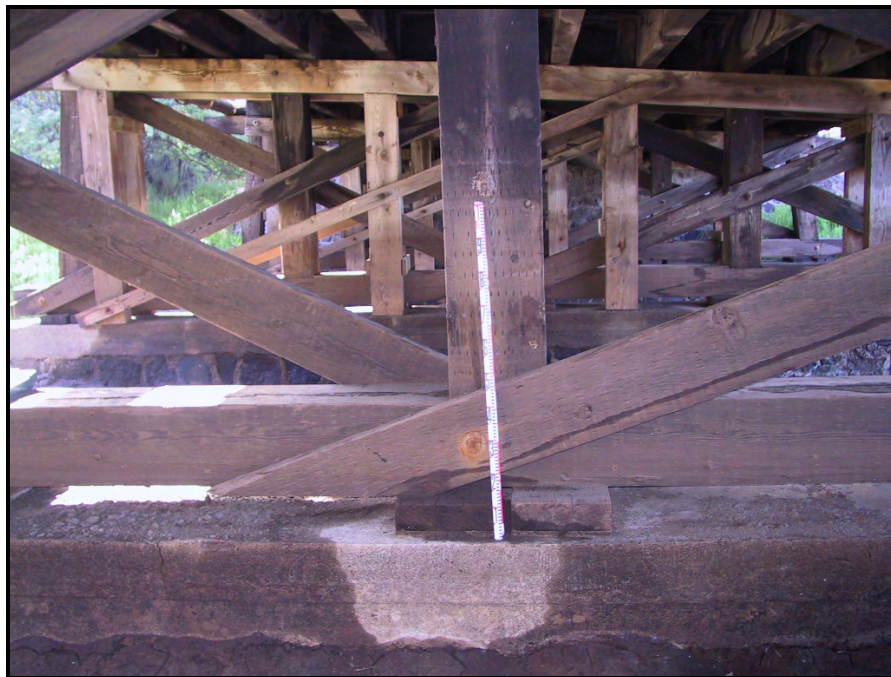
Figure 35. Photograph of SHIP # 50-80-07-6823 substructure, showing wooden columns, beams, planks, X-bracing, and the concrete and blue rock and mortar piers, view to south

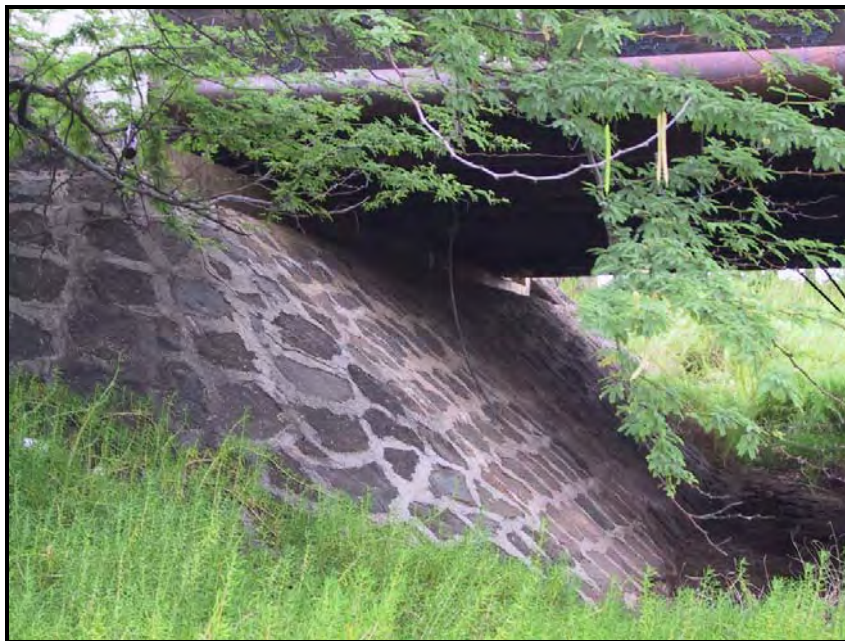
Figure 36. Photograph of SHIP # 50-80-07-6823, blue rock and mortar abutment, view to the west

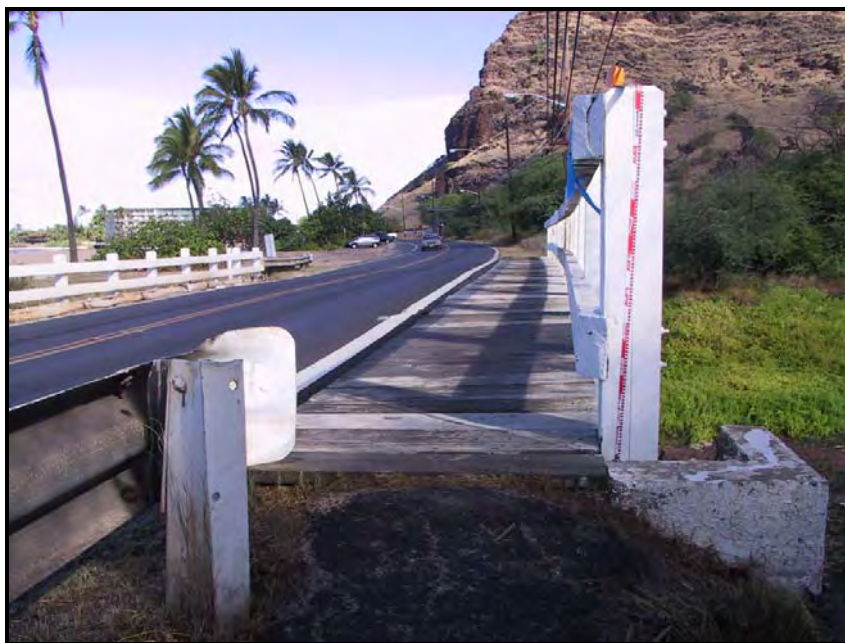
Figure 37. Photograph of SHIP # 50-80-07-6823, concrete corner reinforcement, wooden sidewalk and guardrail, view to northwest

Wooden guardrails, which are painted white and constructed along the *mauka* (northeast) and *makai* (southwest) sides of the bridge, run parallel with the road and run the entire length of the bridge (Figure 37 and Figure 38). A metal pipe also runs parallel to the *mauka* side of the bridge (Figure 38). It is supported by wooden beams behind the wooden guardrail, and is suspended above the dry streambed that leads to the ocean.
