*DRAFT ENVIRONMENTAL ASSESSMENT*

***Farrington Highway  
Replacement of Mākaha Bridges No. 3 and No. 3A***

District of Wai'anae, O'ahu, Hawai'i  
Federal Aid Project No. BR-093-1(20)

June 2009

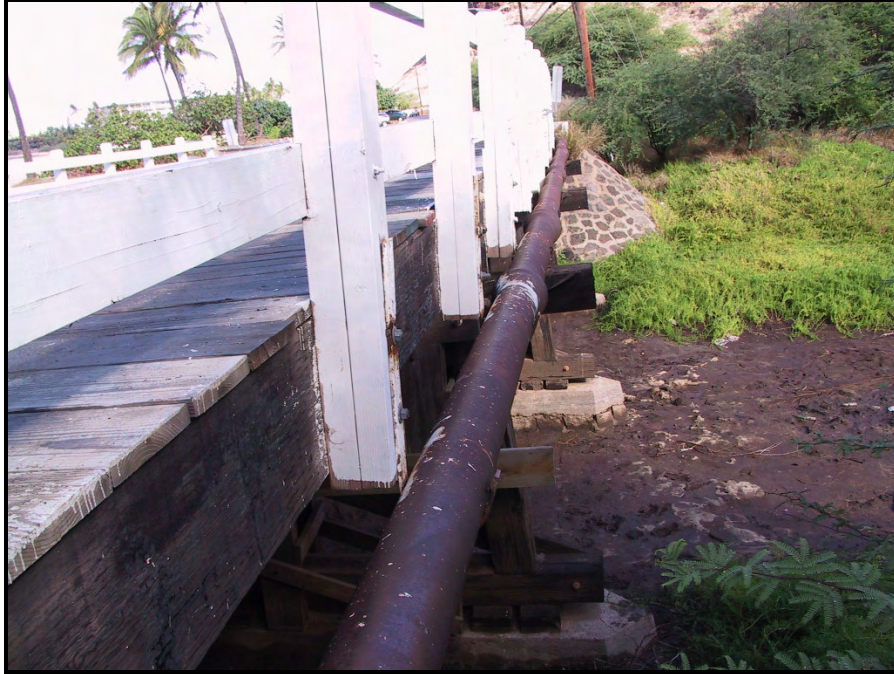
Figure 38. Photograph of SHIP # 50-80-07-6823, wooden guardrail and metal pipe, view to northwest

Wooden guardrails, which are painted white and constructed along the *mauka* (northeast) and *makai* (southwest) sides of the bridge, run parallel with the road and run the entire length of the bridge (Figure 37 and Figure 38). A metal pipe also runs parallel to the *mauka* side of the bridge (Figure 38). It is supported by wooden beams behind the wooden guardrail, and is suspended above the dry streambed that leads to the ocean.

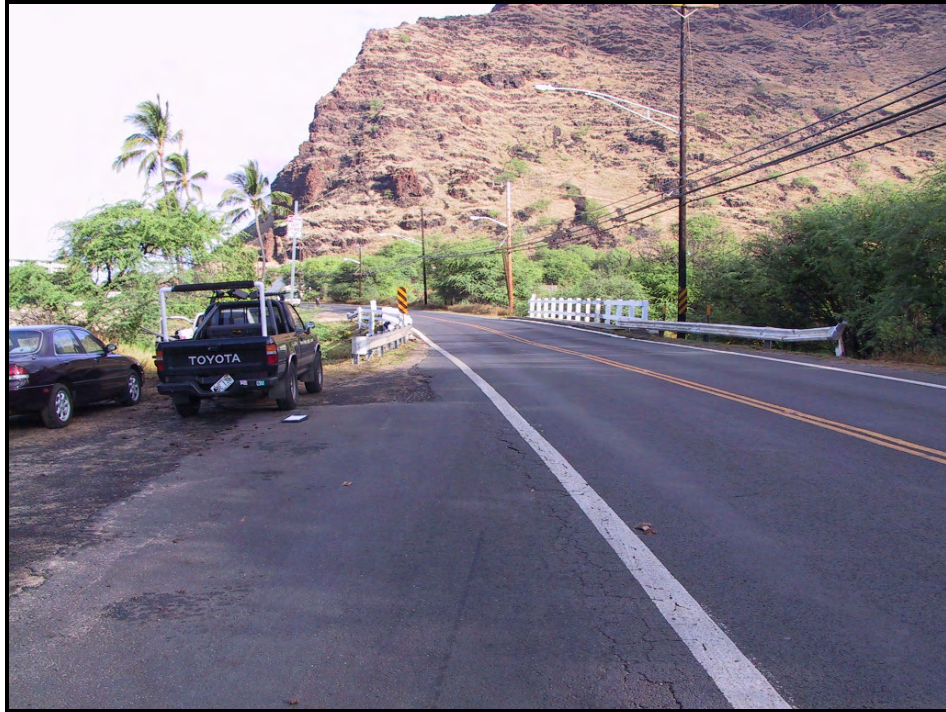
Figure 39. Photograph of SIHP #50-80-07-6824 (a.k.a. Farrington Highway), view to northwest

SIHP #50-80-07-6824 consists of Farrington Highway, which extends through the length of the project area, oriented roughly northwest by southeast, and continues outside the project area along the Mākaha Coast (Figure 39 and Figure 40). The portion of Farrington Highway within the project area measures approximately 340 m long (NW-SE) by 10 m wide, including shoulders (NE-SW). Construction of this portion of road included grading with subsequent asphalt paving. Painted upon the road surface are two solid white lines marking the roads' boundaries, while double-solid yellow lines divide the road into two lanes of opposing traffic. The road is asphalt paved. Two historic wooden bridges (SIHP #50-80-07-6822 & SIHP # 50-80-07-6823) have also been incorporated into this portion of Farrington Highway (see site descriptions above).

A large asphalt paved shoulder extends along the *makai* side of the Highway between Bridges 3 and 3A (Figure 39). This functions as a bus pull over for the City and County bus stop. There is a small bus stop shelter at the edge of this pull out area. Modern steel guardrails and steel safety signs have been installed along portions of the roadway adjacent to the approaches to Mākaha Bridges 3 and 3A. Overhead are utility lines strung between creosote-treated wooden utility poles. Based on background research, Farrington Highway is an important subsurface utilities corridor, with water, sewer, and fiber optic lines with the highway's right-of-way. The defunct electric or, more likely, communication cable observed in Trenches 5 and 6 is best considered another of the utility lines associated with the Farrington Highway utility and communication corridor.

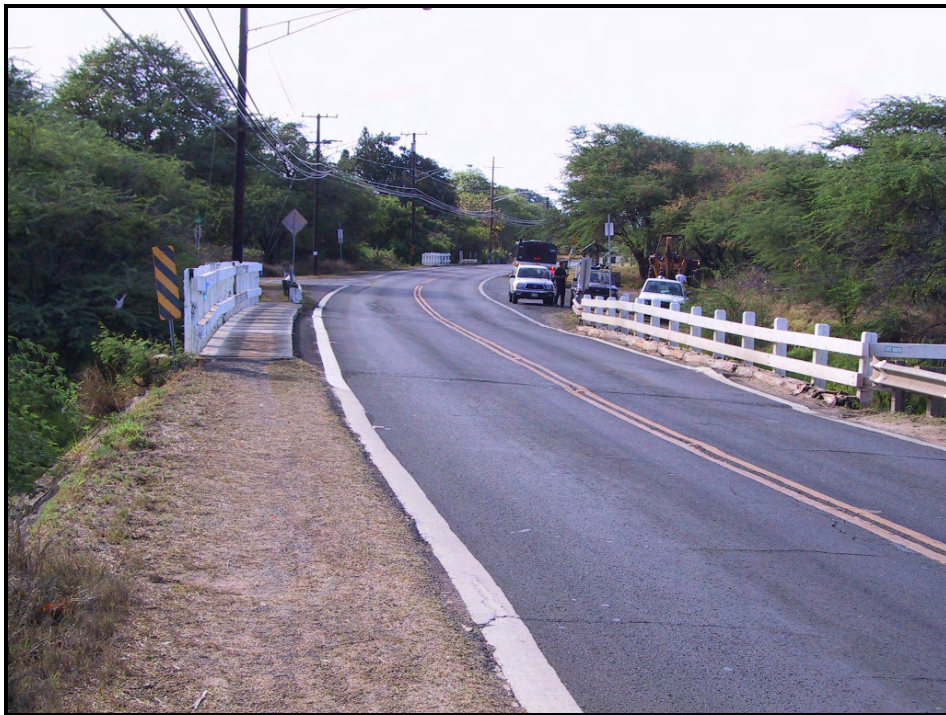
Figure 40. Photograph of SIHP #50-80-07-6824 (a.k.a. Farrington Highway), view to southeast

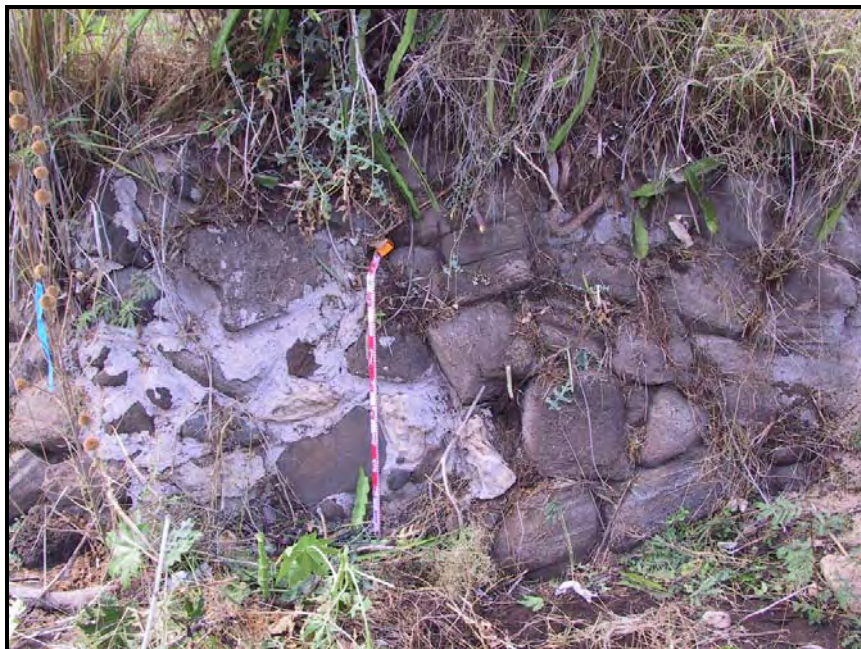
Figure 46. Photograph of the southern abutment of Feature B, SIHP # 50-80-12-9714, shot south, showing crude basalt boulder and mortar construction.

Feature B (Figures 46 and 47) is the railroad trestle remnant immediately *makai* of Mākaha Bridge 3. Based on the visible remnants, this former railroad bridge over Mākaha Stream's southern drainage would have been a single span beam structure supported by crudely constructed basalt rock and mortar abutments. The remnants are shown on Figure 22, the plan view of Bridge 3. Figure 46 is a photograph of the former railroad bridge's southern abutment,

showing the crude basalt boulder and mortar construction. The feature's southern abutment measures 8 m east/west, by 4 m north/south, by 1.5 m high. There is a narrow horizontal concrete form on the southern side of the abutment that is oriented perpendicular to the bridge's alignment. This likely served as an end bent for the railroad bridge. No similar concrete end bent was observed for the bridge's northern abutment (refer to Figure 22).

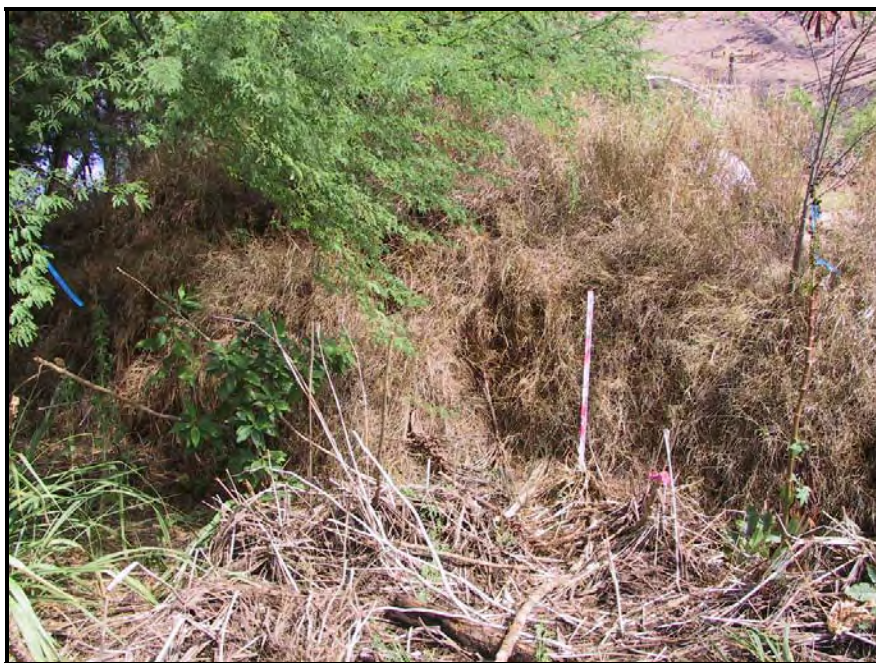
Figure 47. Photograph of the northern abutment of Feature B, SIHP # 50-80-12-9714, shot north, showing the lack of construction remnants

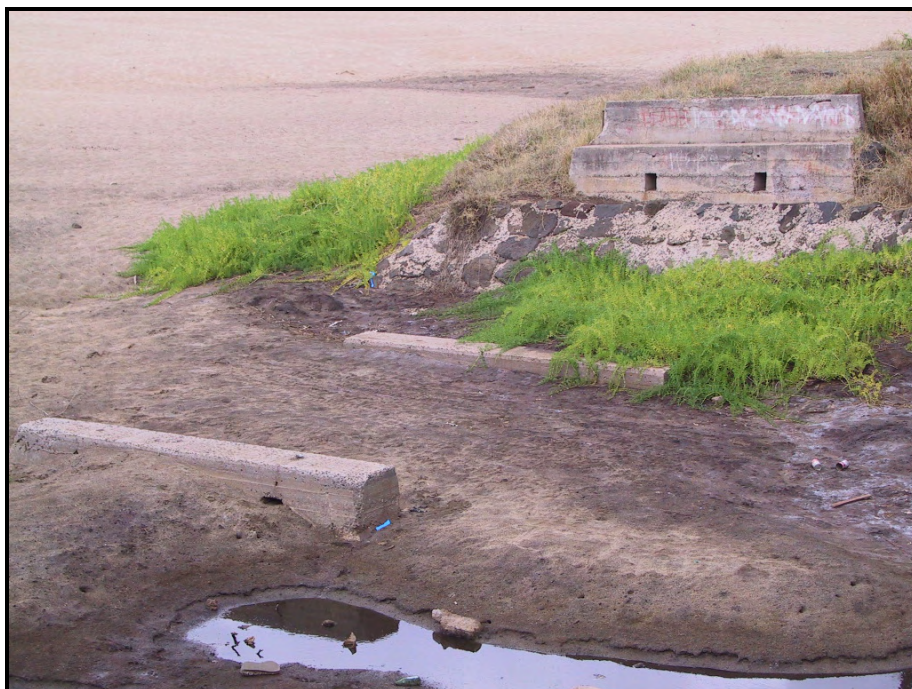
Figure 48. Photograph of the northern abutment and piers of Feature C, SIHP # 50-80-12-9714, shot northwest

Feature C, immediately *makai* of Mākaha Bridge 3A (refer to Figure 31) was much more formally constructed and/or is better preserved than Feature B. Feature C consists of the remains of a four span railroad trestle that once crossed the northern drainage of Mākaha Stream. Between the bridge's abutments are three piers that would have supported the bridge's substructure. These piers are 6 m long, 0.8 m wide, and 0.2 to 0.6 m high above the current drainage bottom surface. They are made of formed concrete, with visible seam scars from the wooden forms that were used when they were created (Figure 48). These piers likely supported the bridge's support columns.

The Feature C remnant abutments are tiered (Figures 48 and 49). The northern abutment (Figure 48) consists of three tiers, the lower of which is basalt rock and mortar, with the upper tiers made of formed concrete. The northern abutment measures 7.5 m long, by 2.0 m wide, by 2.0 m high. The southern abutment is two-tiered and made of formed concrete (Figure 49). Basalt boulders are piled along the abutment's northeastern (*mauka*) side. The southern abutment measures 8.0 m long, by 1.2 m wide, by 1.4 m high.

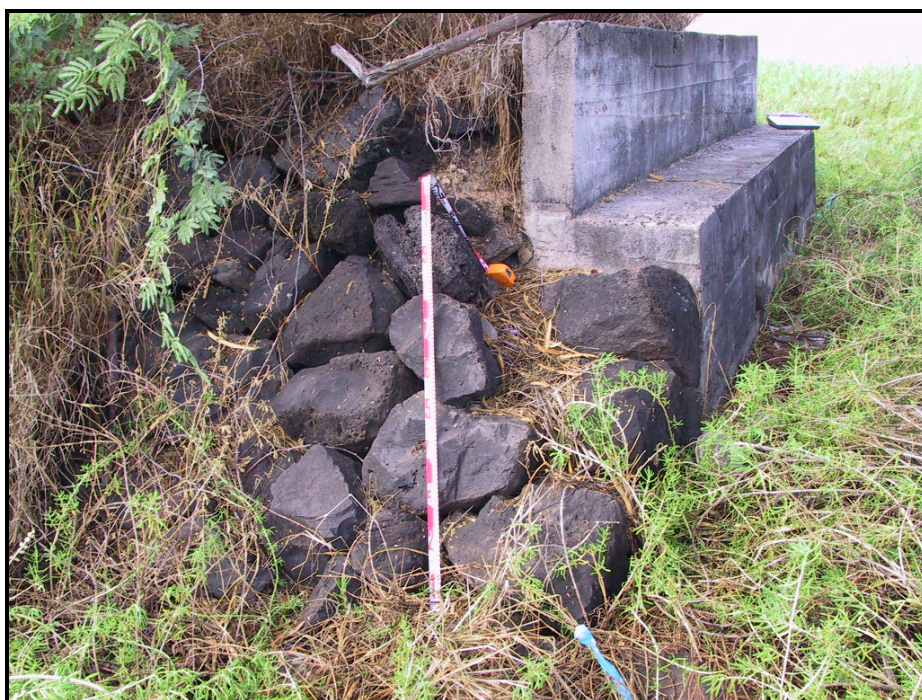
Figure 49. Photograph of the southern abutment of Feature C, SIHP # 50-80-12-9714, shot west
