FINAL ENVIRONMENTAL ASSESSMENT

University of Hawai‘i at Hilo Acquisition of Student Housing Complex

TMK: (3rd) 2-4-057:028 & 028
South Hilo District, Hawai‘i Island, State of Hawai‘i

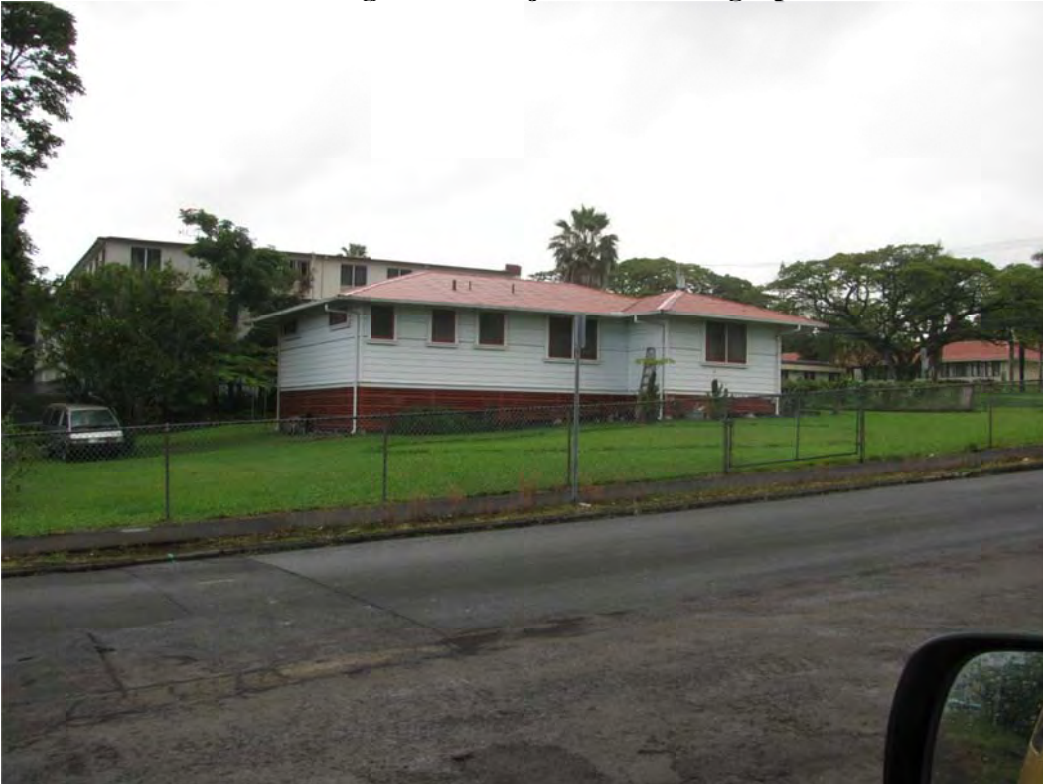
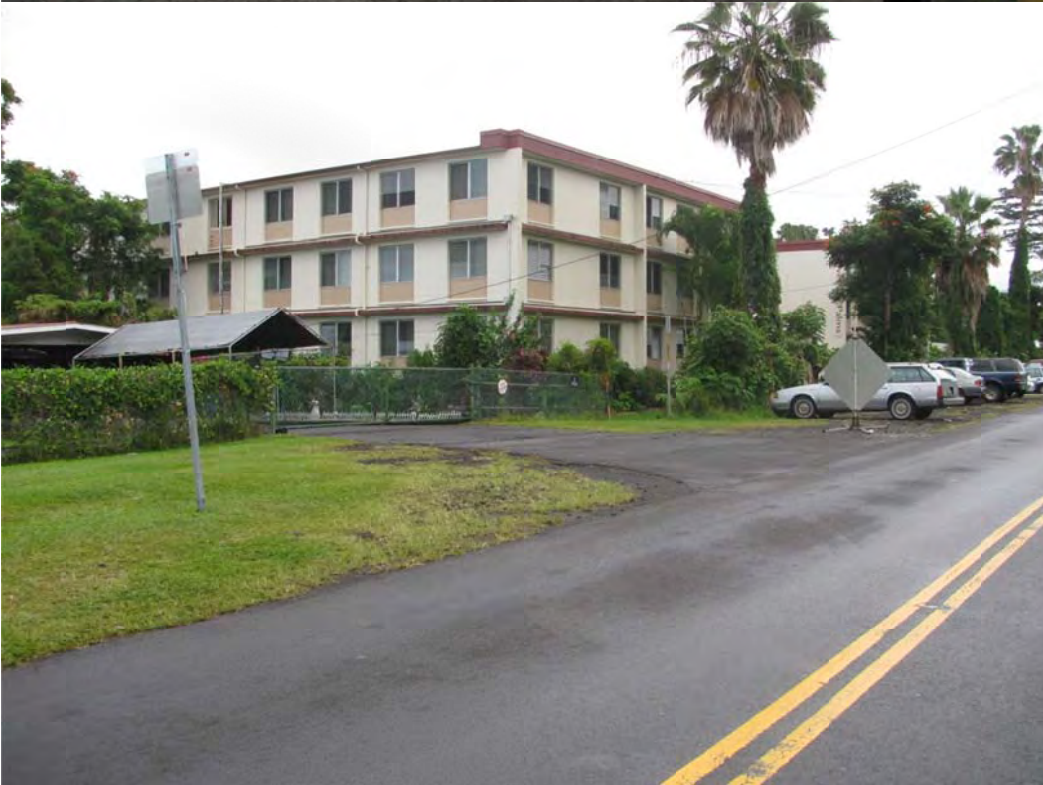
Figure 3 – Project Site Photographs

The University Palms Apartment complex is approximately 37 years old and appears to be in generally good condition (see Figure 3). The primary construction consists of concrete masonry units for the exterior walls and pre-stressed precast concrete planks for the ceiling/floor and ceiling/roof decks. Windows are aluminum frame jalousie units and exterior doors are painted solid-core wood. Some components including the roof, roof drainage, and exterior passage decks require repair. The interior of resident units is in fair to good condition but requires attention to paint, floors, and kitchen appliances and other

details. The acoustical spray-on ceiling material is in good condition but should be removed, as it has been identified as a Regulated Asbestos-Containing Material (RACM) (see Section 3.1.5 for discussion).

Drainage, parking and sidewalk/walkway improvements will also be required for the University Palms facility. In general, the interior plumbing and fixtures appear to be in fair condition, with water supply, water heaters, water pressure and drainage all appearing to be adequate. However, most of the mechanical ventilation systems are in poor condition and require repair or replacement. Electric and telephone services are provided via an underground infrastructure system from overhead public utilities along Kapiolani Street. CATV service is provided by overhead service drop. The entire building is powered through a single meter system from Hawaii Electric Light Co. (HELCO) with a service voltage of 240/120 volts, 1 phase, 3 wires, with a capacity estimated to be 300 amperes and with a measured use about 100 amperes. The lighting fixtures, wireless internet system and fire alarm system do not conform to current codes and standards. A Closed-Circuit-TV (CCTV) with cameras on roof and monitoring equipment in Manager's office was added in recent times. Landscaping infrastructure and plantings will require attention.

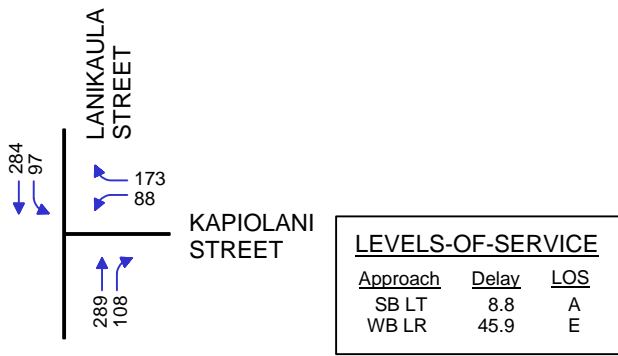
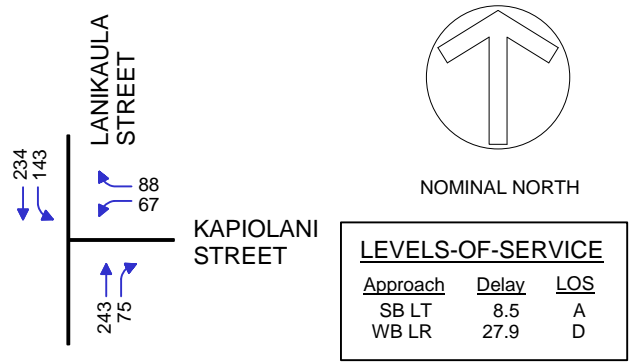
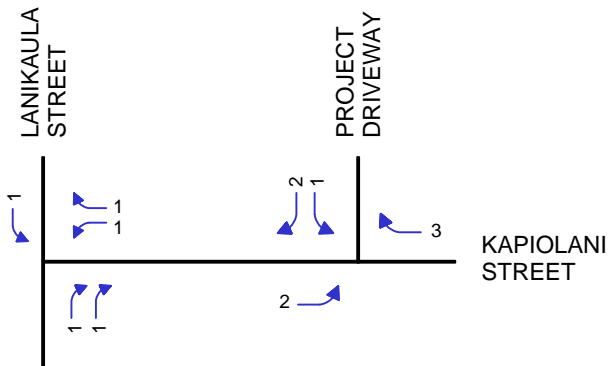
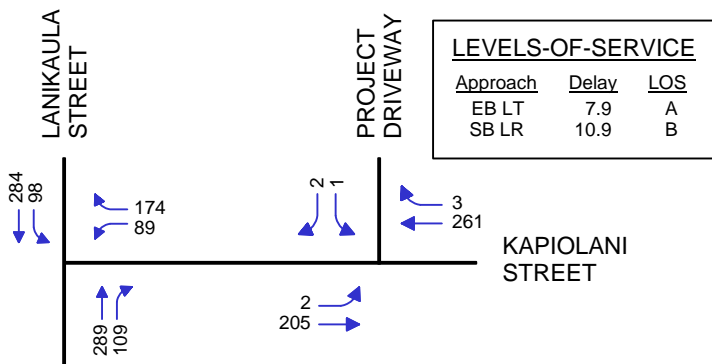
Attachment C
EXISTING VOLUMES, FUTURE TRAFFIC PROJECTIONS
AND LEVELS-OF-SERVICE

Approach	Delay	LOS
SB LT	8.8	A
WB LR	47.7	E

Approach	Delay	LOS
SB LT	8.5	A
WB LR	29.2	D

The results of the level-of-service analysis are summarized in [Tables 7 and 8](#). Shown are the average vehicle delays and the levels-of-service of the controlled lane groups. The analysis concluded that the major traffic movements along Lanikaula Street will operate at Level-of-Service A without and with project generated traffic. Level-of-Service A implies good operating conditions and minimal delays. The westbound approach of Kapiolani Street at Lanikaula Street will operate at Level-of-Service E during the morning peak hour and Level-of-Service D during the afternoon peak hour. There is no change in the level-of-service as a result of project generated traffic. Given that the delay of the westbound approach is 47.7 seconds during the morning peak hour, approach will operate at Level-of-Service E for a short time during the peak hour.

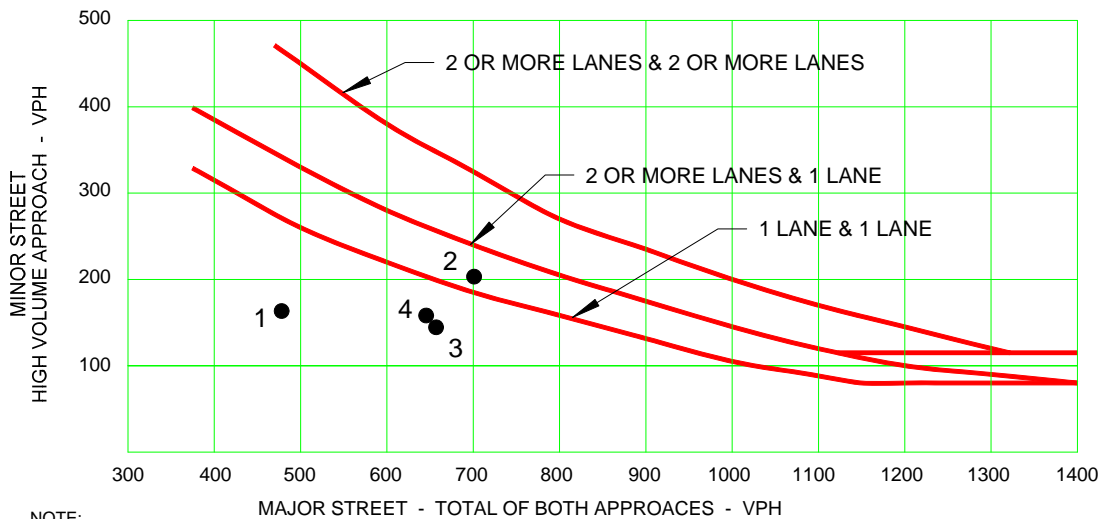
100% CONDITIONS

- 100% (URBAN) CONDITIONS APPLY.

The analysis is presented as [Attachment D](#). All four points should fall above the appropriate curve to satisfy the warrant. As shown, only one point falls above the curve for one lane approaches. The conclusion is that traffic signals are not warranted. It should be noted that other factors, such as the number of accidents that may be prevented if traffic signals are provided justify a traffic signal whether the warrants are satisfied or not. Since traffic accident data are not available, this warrant cannot be assessed.
