Final Environmental Assessment

Upper Kapahi Dam Replacement Project
Kapa'a, Kaua'i

Project Name: Upper Kapahi Reservoir Dam Replacement (DAGS Job Number 14-23-7591)

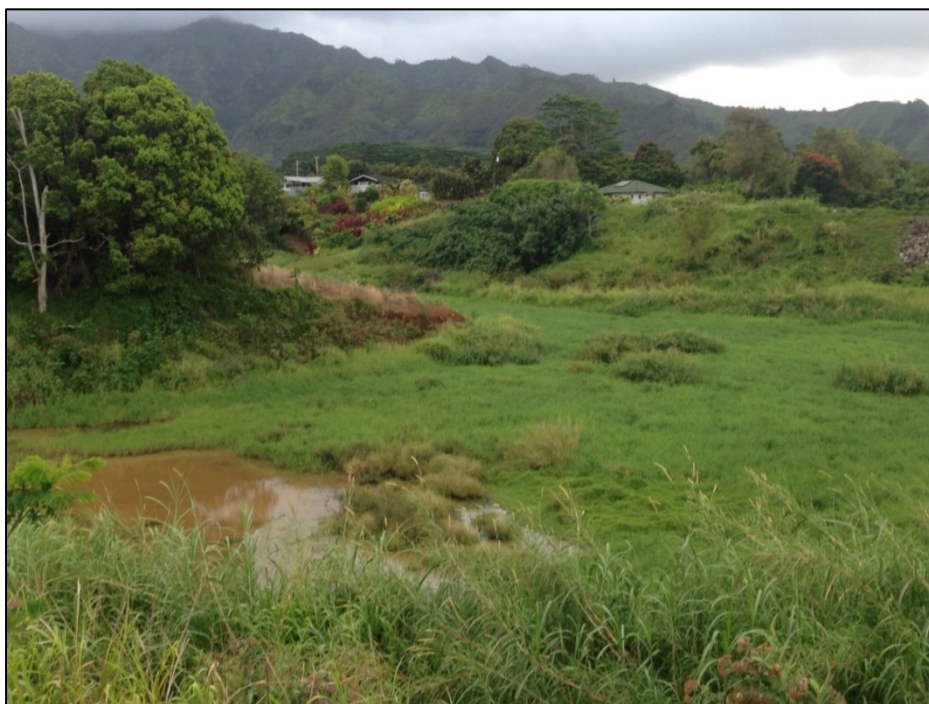
Photo 3-1: View of project site from Kainahola Road, March 2014. Photo taken after the reservoir was drained for public safety reasons.

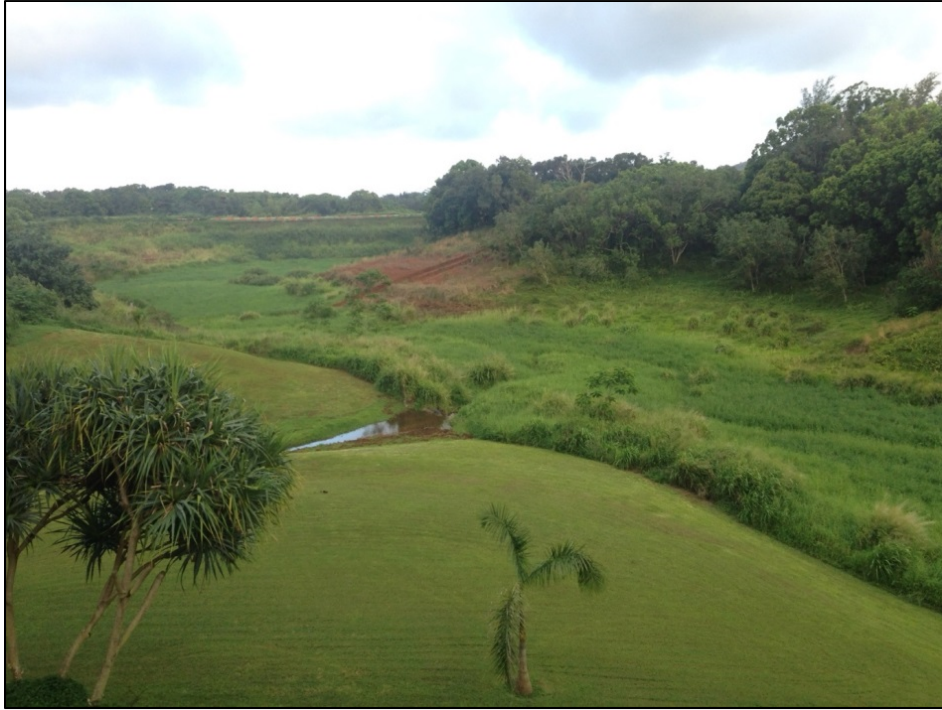
Photo 3-2: View of the project site from the residence on the west (*mauka*) side of the project, looking towards Kainahola Road, March 2014. Water in the center of the photo is from the diversion from Kapa'a Stream. The temporary pond feature of this water was made by the homeowner.

The visual characteristics of the project area could be described as agricultural and residential (Photos 3-1, through 3-4).

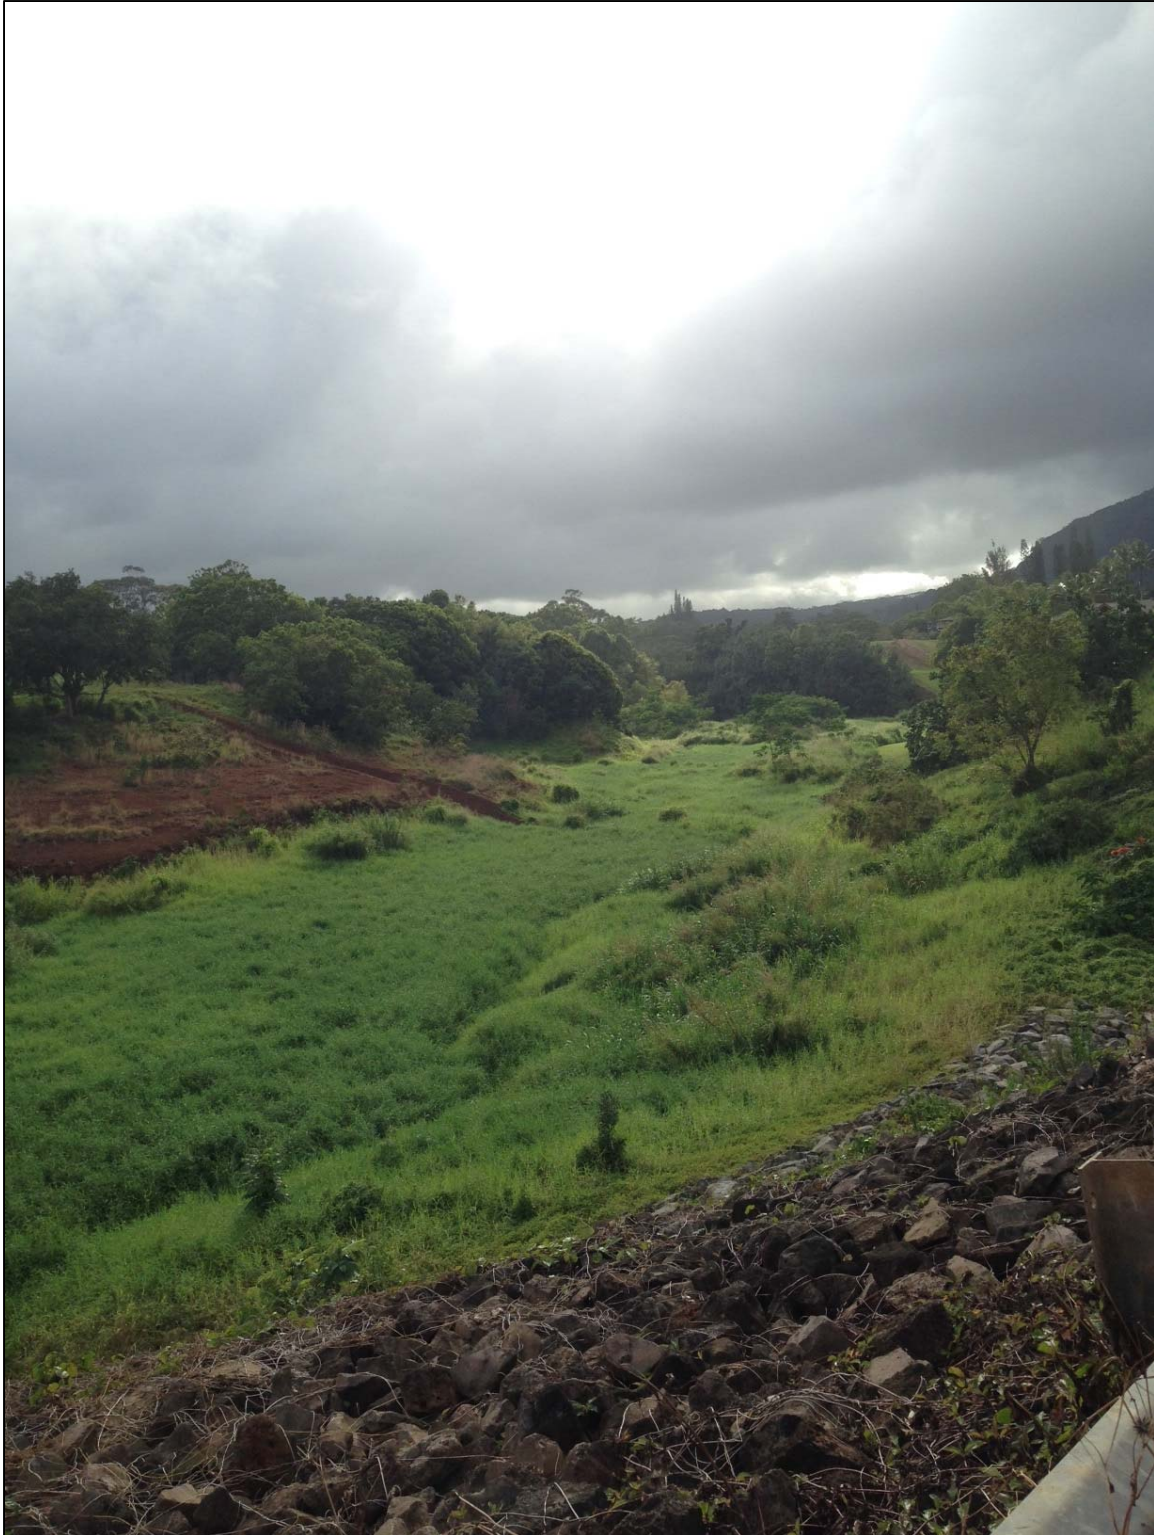
Photo 3-4: View from Kainahola Road looking upstream. Photo taken from near the reservoir outlet. Note rip rap in foreground. This rock was placed during the dam repair project. Road cut on the left mid-field of the photo is the approximate location of the south embankment of the replacement dam.

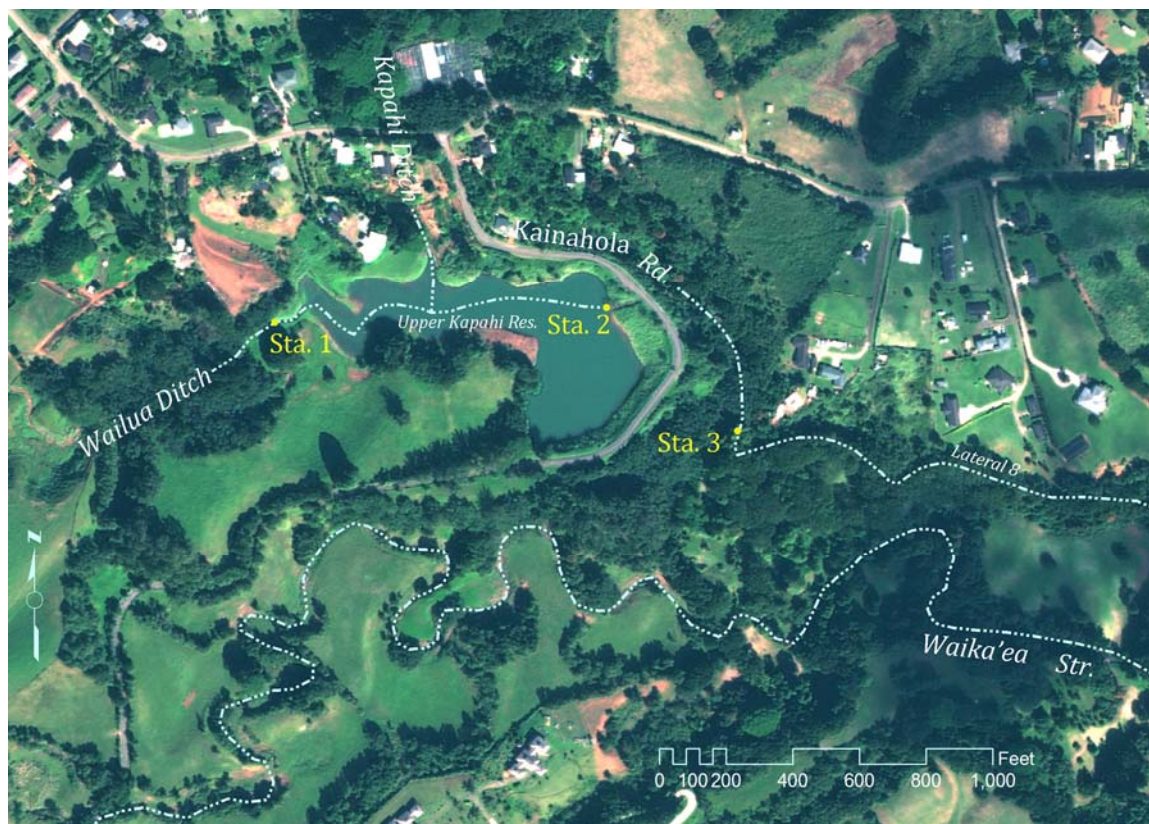
Figure 3. Location of water quality sampling stations sampled on January 29, 2014. The reservoir was mostly dry at the time of the sampling event and flow through from the *auwai* or irrigation system was sampled.

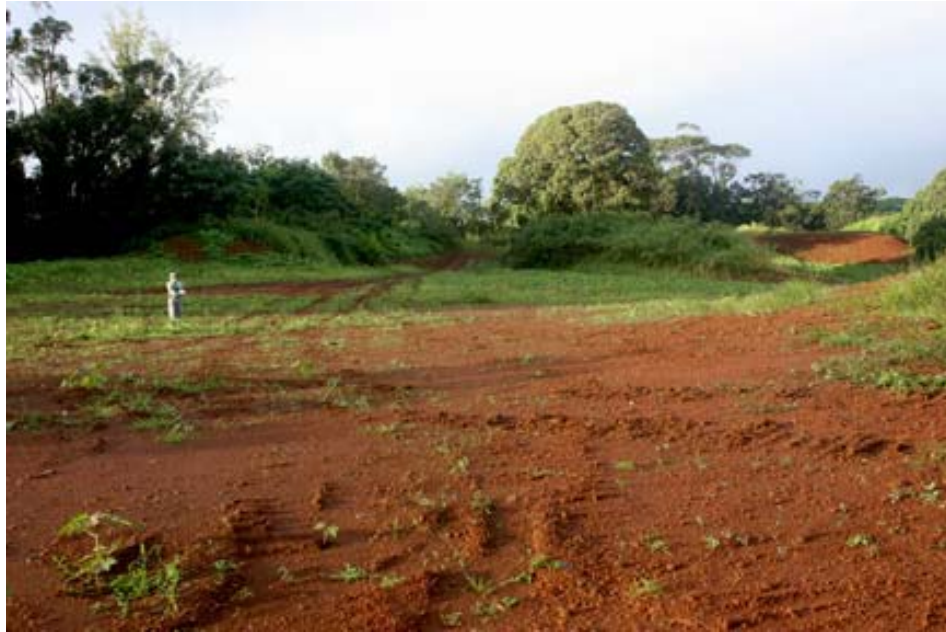
Figure 4. Graded area in vicinity of proposed new spillway.

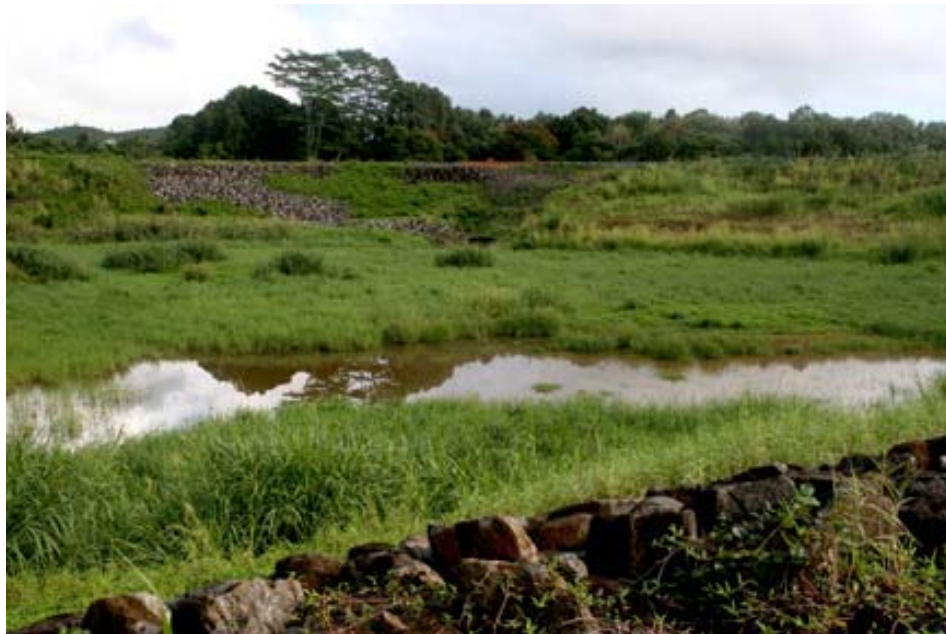
Figure 5. Lower end of Upper Kapahi Reservoir basin showing grass-covered bottom with a small remaining pond in the southeast corner. Water quality Sta. 2 is before a culvert at the base of the dam, center background.
