<b>Project Name:</b>	DEA for DHHL Wailua Well No. 1 Project Kuhio Highway
<b>Project Short Name:</b>	DEA for Wailua Well No. 1
<b>HRS §343-5 Trigger(s):</b>	Use of State of Hawaii lands and funds
<b>Island(s):</b>	Kauai
<b>Judicial District(s):</b>	Lihue
<b>TMK(s):</b>	(4) 3-902: 12 (portion)
<b>Permit(s)/Approval(s):</b>	Well Construction Permit 2
<b>Proposing/Determining Agency:</b>	Department of Hawaiian Home Lands
<b>Contact Name, Email, Telephone, Address</b>	Mr. Stewart Matsunaga, Master Planned Community Branch Manager; 91-5420 Kapolei Parkway, Kapolei, Hawaii 96707; Tel. (808) 620-9283; <a href="mailto:Stewart.t.matsunaga@hawaii.gov">Stewart.t.matsunaga@hawaii.gov</a>
<b>Accepting Authority:</b>	(for EIS submittals only)
<b>Contact Name, Email, Telephone, Address</b>	
<b>Consultant:</b>	Akinaka & Associates, Ltd.
<b>Contact Name, Email, Telephone, Address</b>	Scott A. Kunioka, P.E. ; <a href="mailto:sak@akinaka.com">sak@akinaka.com</a> ; (808) 836-1900 x 684 1100 Alakea Street Suite 1800, Honolulu, HI. 96813

**DHHL Wailua Well No. 1 Project Kuhio Highway  
Wailua, Kaua‘i, Hawai‘i  
TMK No. (4) 3-9-02, portion of Parcel 12**

May 2017

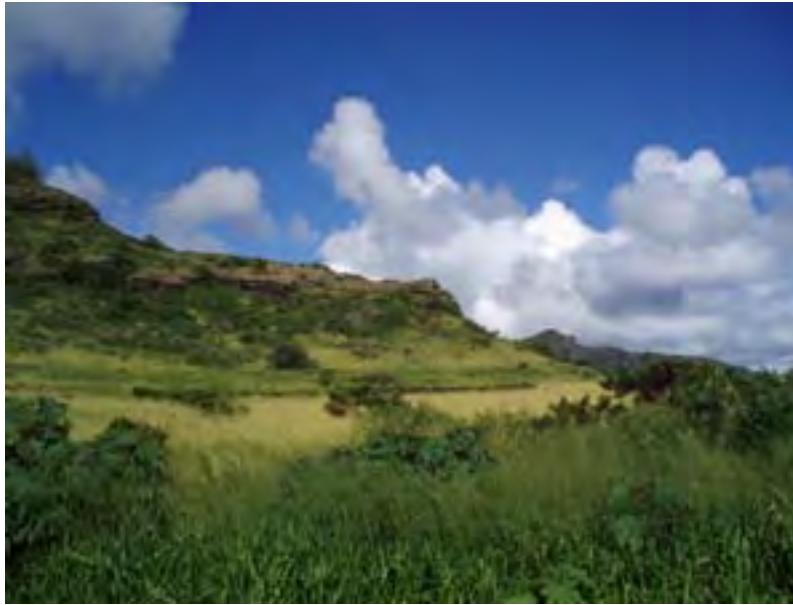
View from bottom of Kalepa Ridge looking northwest.  
Source: Waimea Water Services, Inc. 2009

The bore hole site is located at approximately 200 feet above mean sea level in the southern sector of the parcel near the eastern flank of Kalepa Ridge. The site is approximately 2,600 feet (0.25 mile) west (*mauka*) of Kūhiō Highway and 4,000 feet (0.75 mile) mauka of the coast. See Figure 1. The vacant project site is flat, measures 100 ft x 40 ft and is accessible via an existing cane haul road that connects with Kūhiō Highway. The drill rig and water testing equipment would occupy the 4,000 sf site with sufficient turnaround area for the vehicles to enter and exit the site. Photos below are of the east facing slope of Kalepa Ridge and surface conditions of the site.

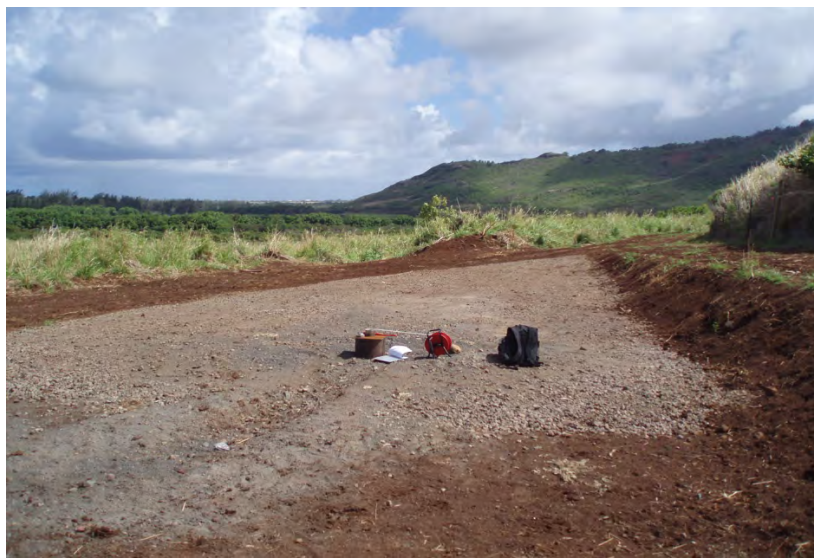
Well no. 1 ground level looking south.

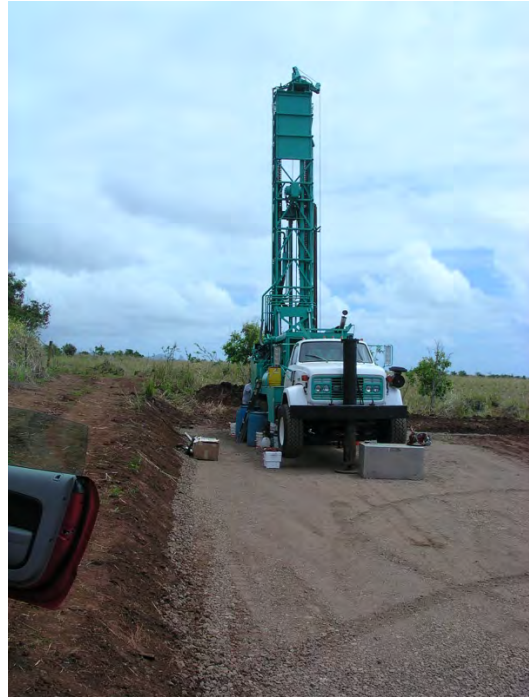
Drill rig on well #1 site. Looking north.  
Source: Waimea Water Services, Inc. 2009

Wa'alani Enterprises, LLC. was contracted by Waimea Water Services, Inc. to prepare the pad for exploratory drilling. Ground was broken June 22, 2009 and drilling of the 9 inch pilot hole began the following day by Derrick's Well Drilling and Pump Services, LLC. After water was encountered, drilling was stopped and a test pump was set at a depth of 114 feet. The first test resulted in a severe drawdown and pumping was stabilized at 85 gpm with a chloride salinity of 280 mg/L (milligrams/liter). A decision was made to deepen the well an extra 20 ft to attain improved water quality as well as increasing gpm potential. The well was drilled to a final depth

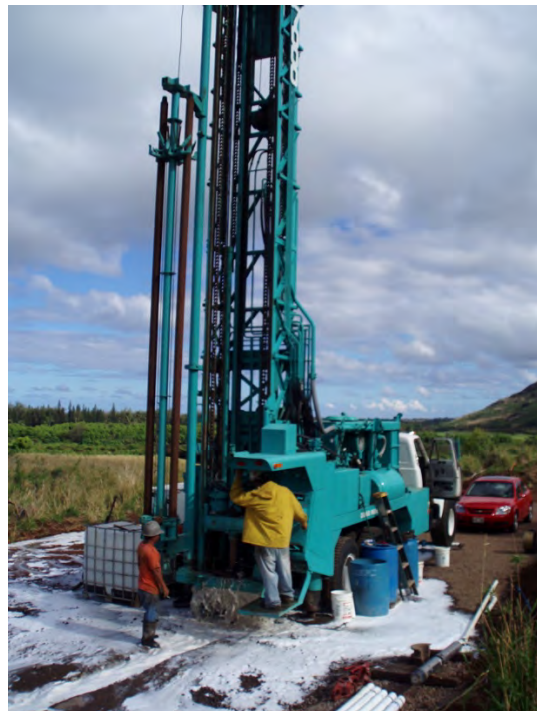
Close up of drill rig operation, testing.  
Source: Waimea Water Services, Inc. 2009

With the pump set at a depth of 129 ft, the second pump test was performed on July 2, 2009. This test ran for 400 minutes at 150 gpm and stabilization of water level was observed. Additional water samples were taken during the test and showed a drop in chlorides to 180 mg/L. After the water level had stabilized, the pump was turned off and water level was tracked and recorded until full recovery of the aquifer was observed. Tables 1 and 2 provide drawdown verses recovery test data below. Photos of Well No. 1 site follow.

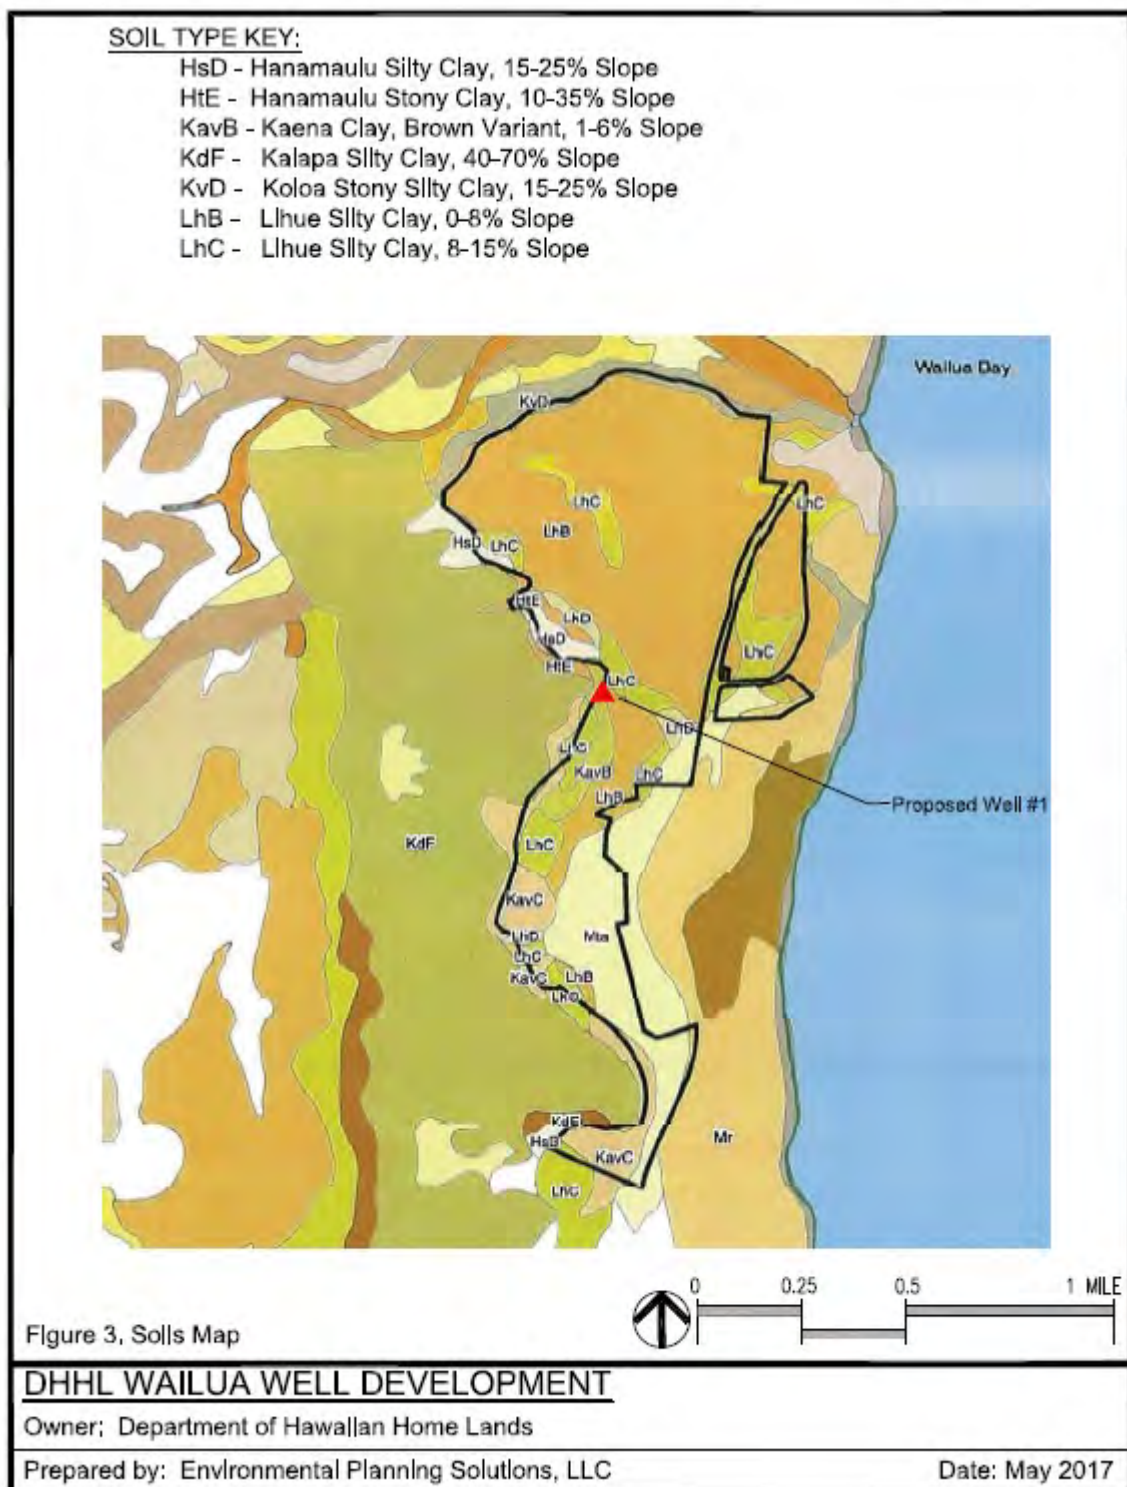
Figure 3 Soils Map

The project site is located on a coastal plain extending up to one mile inland from the shore that was formed from recent alluvial and beach deposits. Major soils in the project area include those in the Lihue, Kaena, Hanamaulu, Koloa, and Mokuleia Series. The surface soil within the project site consists of the following soil type: Līhuʻe silty clay, 8 to 15 percent slopes (LhC). Figure 3 illustrates the soil types also found in the vicinity of the project site area, based on soil maps from the Natural Resource Conservation Service (NRCS). See Figure 3 Soils.

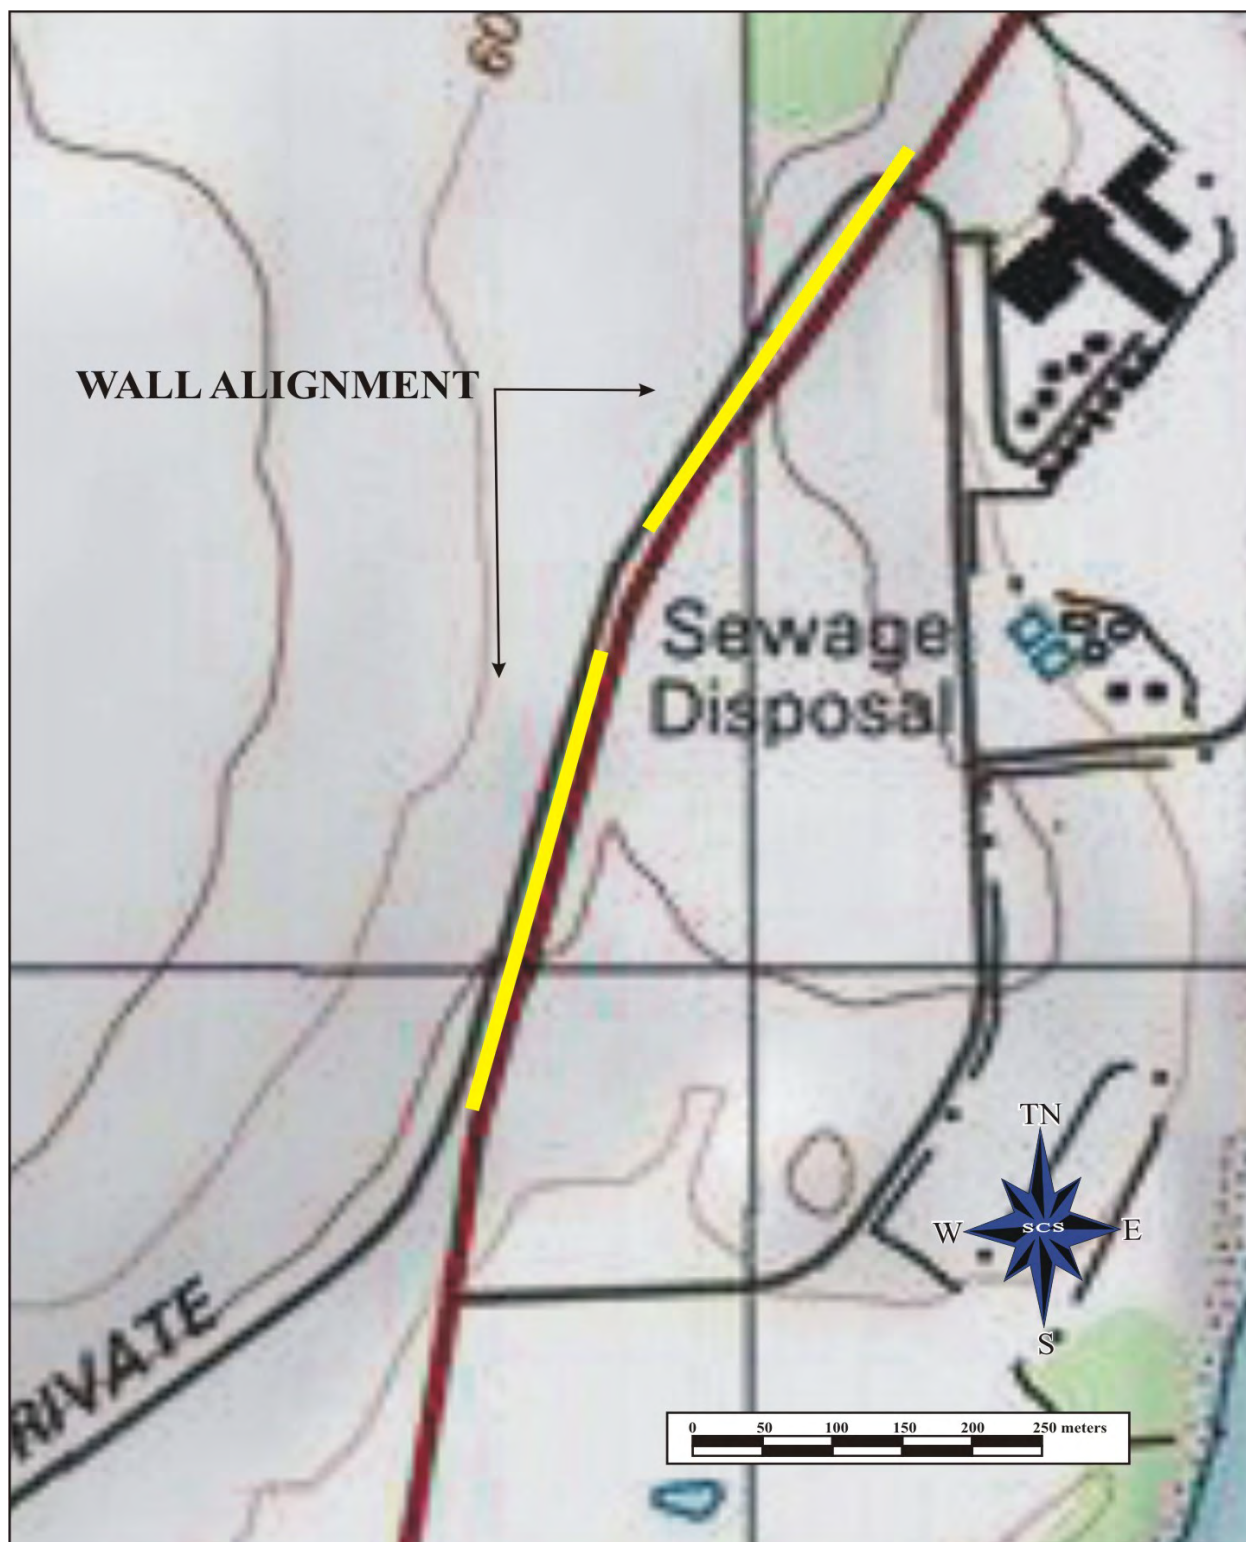
**Figure 5: USGS Wailua Quadrangle Map Showing Probable Location of Historic Rock Wall.**

was later verified on the ground as an earthen berm after the conclusion of the field portion of the survey (Figure 5). Twenty-eight backhoe trenches (ST-1 through ST-28) were excavated at two locations during field survey (e.g. Site TS-2 (Test Area 1) at the northeastern boundary of the project area, and Test Area 2 at the southeastern corner of the project area) (Figure 6).

Nine features were identified at three sites. An historic 1933 map provides the location of an historic rock wall which lies between the Lihue Plantation leased land on its western boundary, and the abandoned Government Rd. property and Kauai Belt Road on its eastern side (Kaua'i Historical Society) (see Figure 4). Twenty-three stratigraphic trench (ST) units were excavated in the southeastern portion of the project area adjacent to the golf course and closest to the shoreline (see Figure 6). The results for trench excavations again produced negative results.

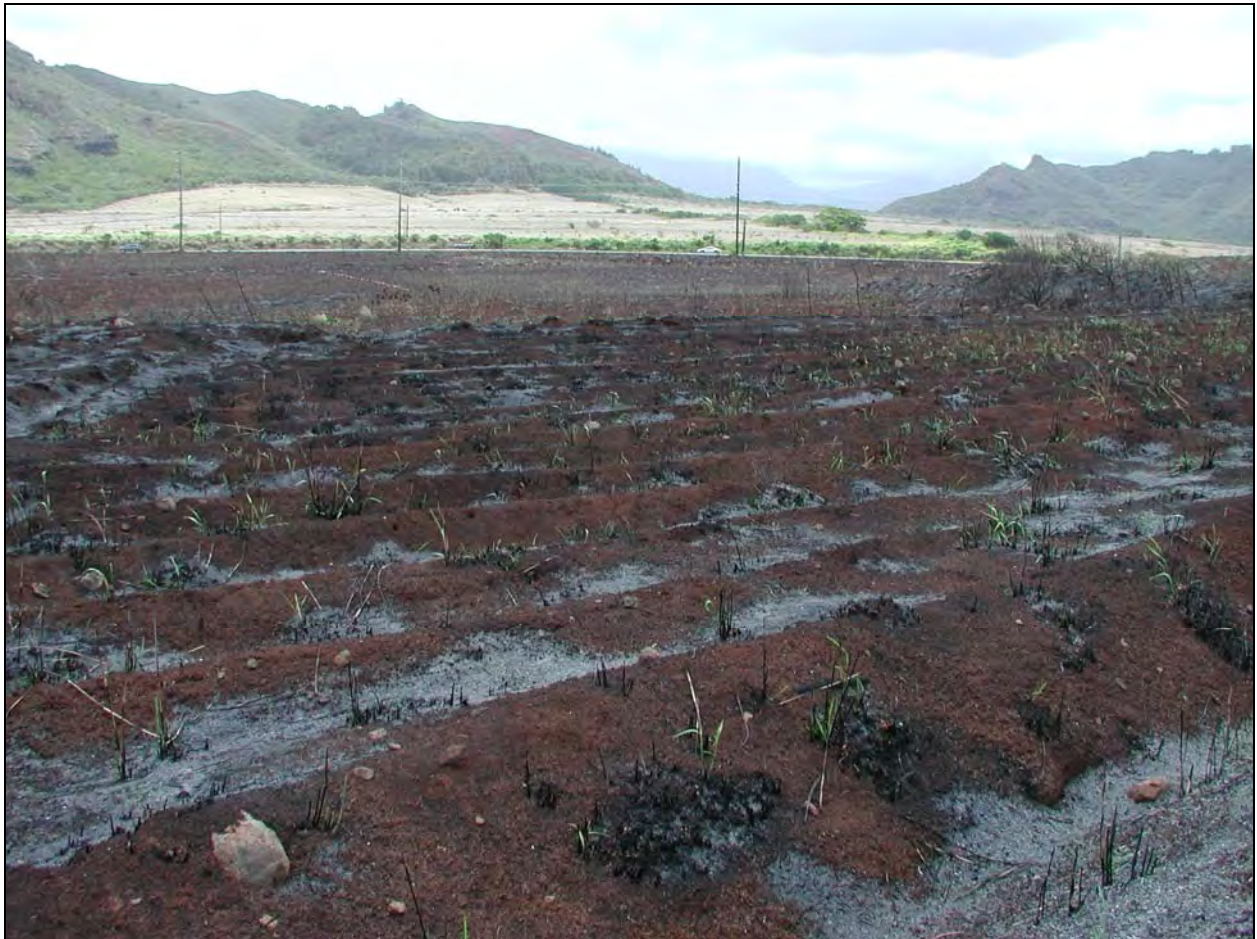
**Figure 9: TS-1, Overview of DHHL Lands. View to West.**

Three significant sites were identified during the Inventory Survey at Wailuā-DHHL (see Table 1) (Figure 9). Site TS-1 is an historic site (agricultural water diversion and irrigation features) associated with the Plantation Era on Kauaʻi. Site TS-2 consists of a prehistoric surface lithic (stone tool) scatter. TS-3 is composed of two rock terrace remnants (TS-3, Features 2 and 3), one rock wall (TS-3, Feature 1), with traditional construction, and one multi-tiered enclosure (Feature 4). An historic map (ca. 1933) provided by Randy Wickman of the Kauaʻi Historical Society, revealed an historic rock wall existed along the eastern border of the project area (see Figure 4). Following the field portion of the inventory survey, a SCS archaeologist revisited the location as exemplified by the historic map and located an earthen berm extensively covered with vegetation. Further investigation and testing will be required to ascertain the berm's form, function and temporal association.

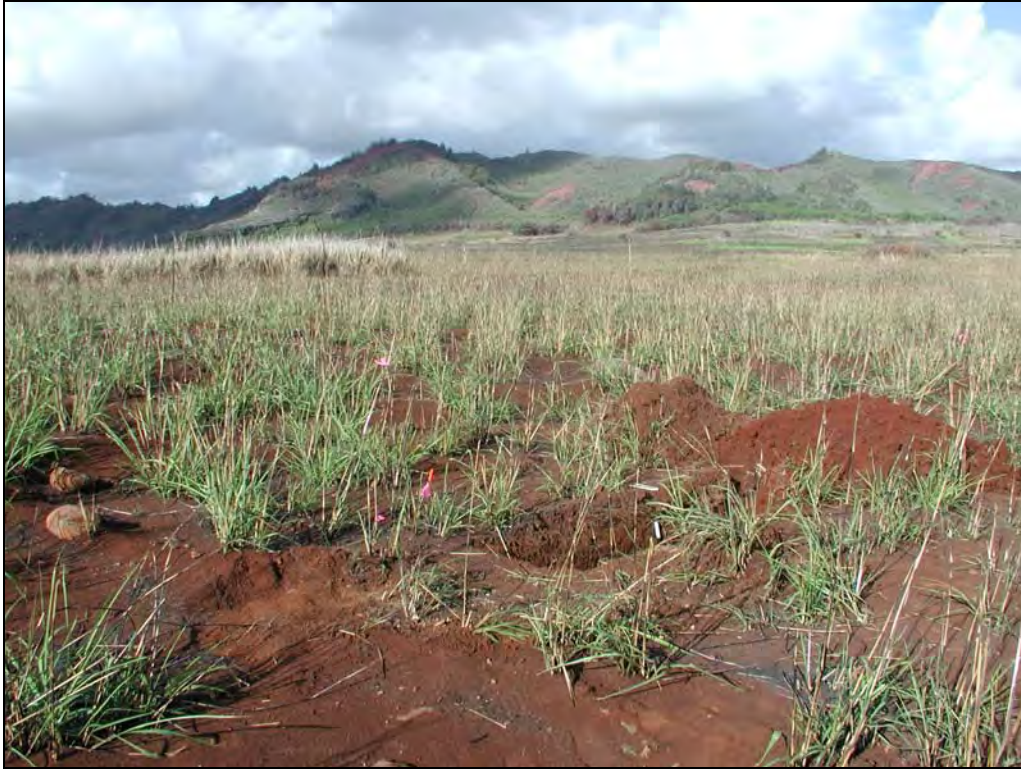
Figure 14: TS-2, Overview. View to West.

Site TS-2 consisted of a pre-Contact surface lithic (stone tool) scatter (Figure 14). The artifacts occurred within four main locations and one outlier (see Figure 6). Locus A contained the highest concentration of lithics (N=111); the remaining loci consisted of a total 25 artifacts (Appendix A). Locus A was located on level terrain; the closest observable artifact was noted 48.0 m west of Malae Heiau (Site 104); this places the eastern edge of the Locus within the 100-foot buffer zone of the site’s western boundary (see Figure 3). Locus A measured 313.0 m long by 242.0 m wide; its longitudinal axis was oriented northwest-southeast. Locus B was situated 249.0 m south of Malae Heiau. The artifact spread was oriented in an east-west direction and measured approximately 200.0 m in length. Loci C and D were situated along the southern banks of Wailuā River. Locus C was located 658.0 m northwest of the Heiau; its artifact spread measured approximately 200.0 m in length. Locus D was situated between Malae Heiau (1.02 km west) and Poliʻahu Heiau (528 m southeast) on the southern banks of Wailuā River; the artifact spread measured 44.0 m in length. The artifacts were associated with pre-Contact times. Five backhoe trenches were placed in Locus A (Test Area 2 [TA-2]), which produced negative results for cultural material (Figure 15) (see STRATIGRAPHIC TEST EXCAVATION).

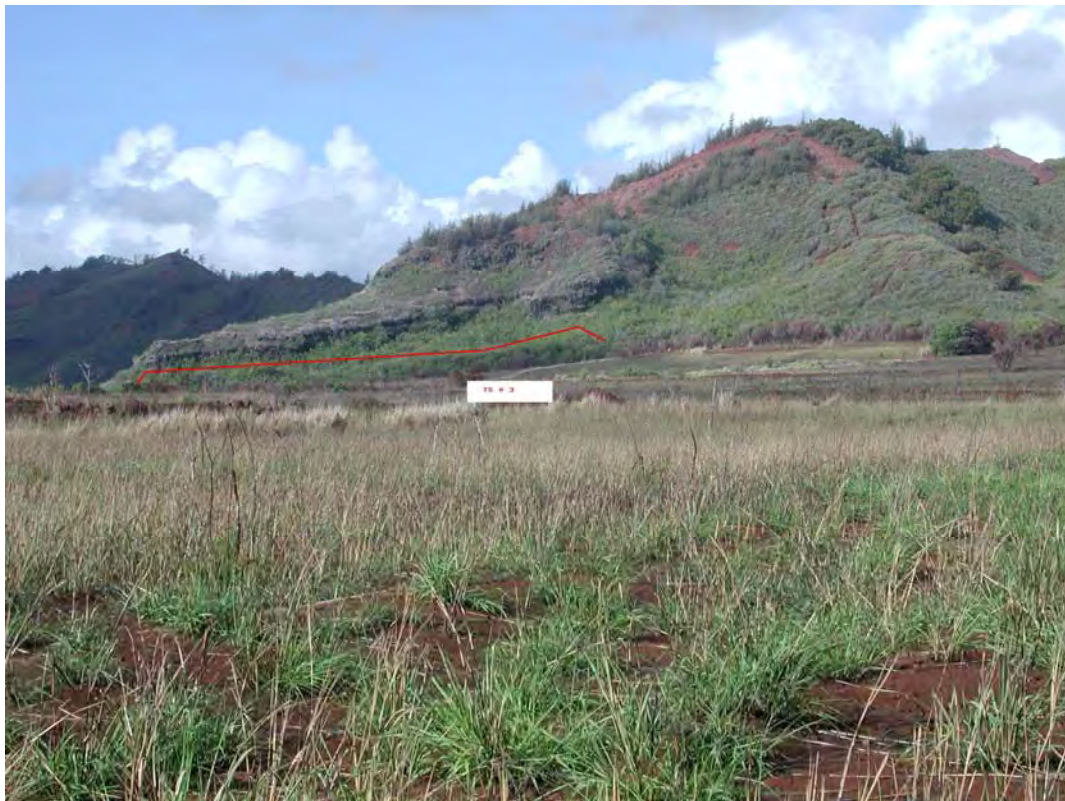
**Figure 16: DHHL Lands. View to West Overlooking TS-3.**

Site TS-3 contains four features situated along a narrow contour line of a moderately steep northeastern-facing slope of Nailiakauea Ridge between the mountain and the lower plain (Figure 16). Site TS-3, Feature 4 was located just outside the project boundary, but was also recorded due to its significance and possible relation to the other three features. Features 2 and 3 were composed of two rock terrace remnants and one rock wall (TS-3, Feature 1). The site vegetation consisted of umbrella tree (*Brassaia actinophylla*), Christmas berry (*schinus terebinthifolius*), common guava (*Psidium guajava* L.), Java plum (*Eugenia jambolana* Lam.), and *lantana* (*Lantana camara*). No archaeological test units were placed in Site TS-3.

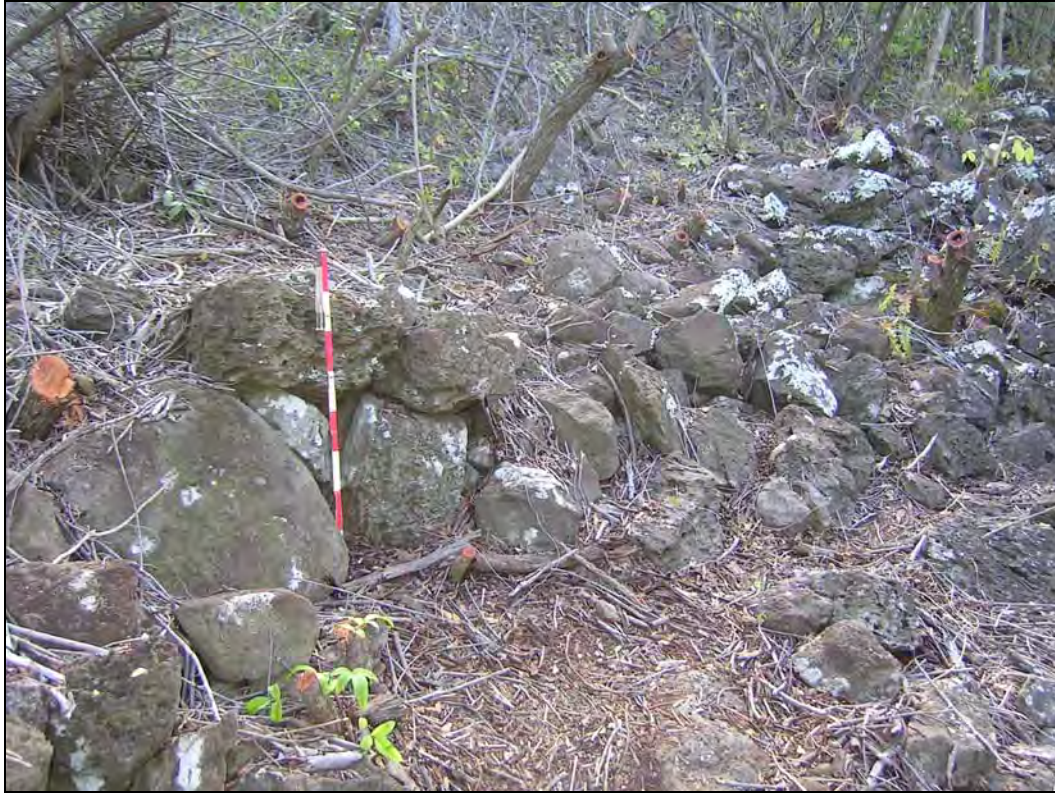
**Figure 17: Site TS-3, Feature 1. View to Southwest.**

Feature 1 was a linear rock wall located at the base of Nailiakauea Ridge, along the southwestern boundary of the project area (Figure 17). The length of the wall (Feature 1) stretched 119.0 m in length, which suggested an historic temporal affiliation; however, the feature was traditionally constructed. The feature was constructed of piled sub-rounded basalt boulders, with intermittently placed cobbles and pebbles. There was some evidence of facing where the boulders were piled two to three courses high (Figure 18). Some large boulders were used in wall segments. The wall measured 119.0 m long and 2.0 to 6.0 m wide with wall

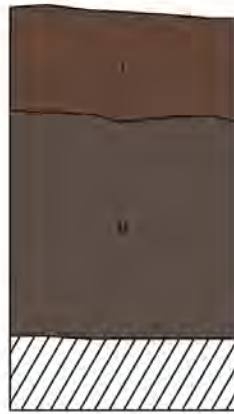
ST-21 NORTH EAST WALL PROFILE

- I** - LAYER I: DARK BROWN (7.5 YR 3/4) SILTY CLAY LOAM, WEAK VERY FINE SUB-BLOCKY, FEW MICRO TO CORSE ROOTLET, FEW BASALT COBBLE GRAVEL PEBBLE ROCKS, SMOOTH CLEAR BOUNDARY, NO CULTURAL REMAINS.
- II** - LAYER II: DARK BROWN (7.5 YR 3/2) SILTY CLAY, WEAK VERY FINE SUB-BLOCKY, VERY FEW MICRO TO MEDIUM ROOTLET, VERY FEW BASALT COBBLE PEBBLE ROCKS, NO CULTURAL REMAINS.

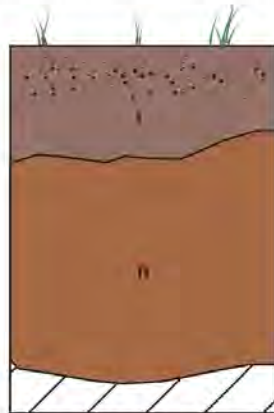
TYPICAL PROFILE TO ST-24 THROUGH ST-27

- I - LAYER I: REDISH BROWN (2.5 YR 5/4) PLOW ZONE, CLAY/ ROOTS. NO CULTURAL MATERIAL.
- II - LAYER II: YELLOWISH RED (5 YR 5/8) COMPACT CLAY/ NO ROOTS. NO CULTURAL MATERIAL.

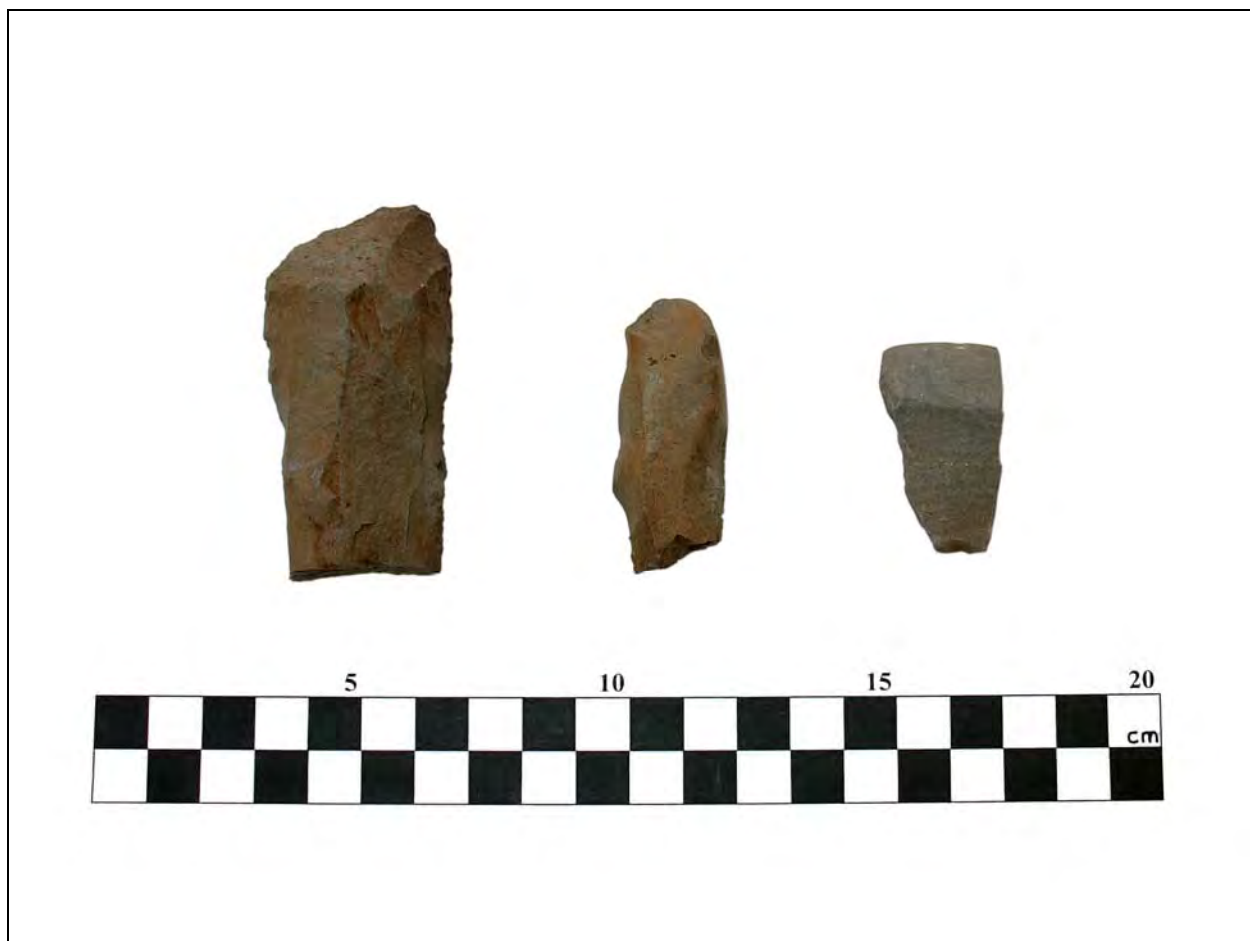
DSC03206\_REV: Field Bag 96-Basalt Adze Preform (left), Field Bag 7-Basalt Chisel (middle), Field Bag 49-Basalt Adze (right).

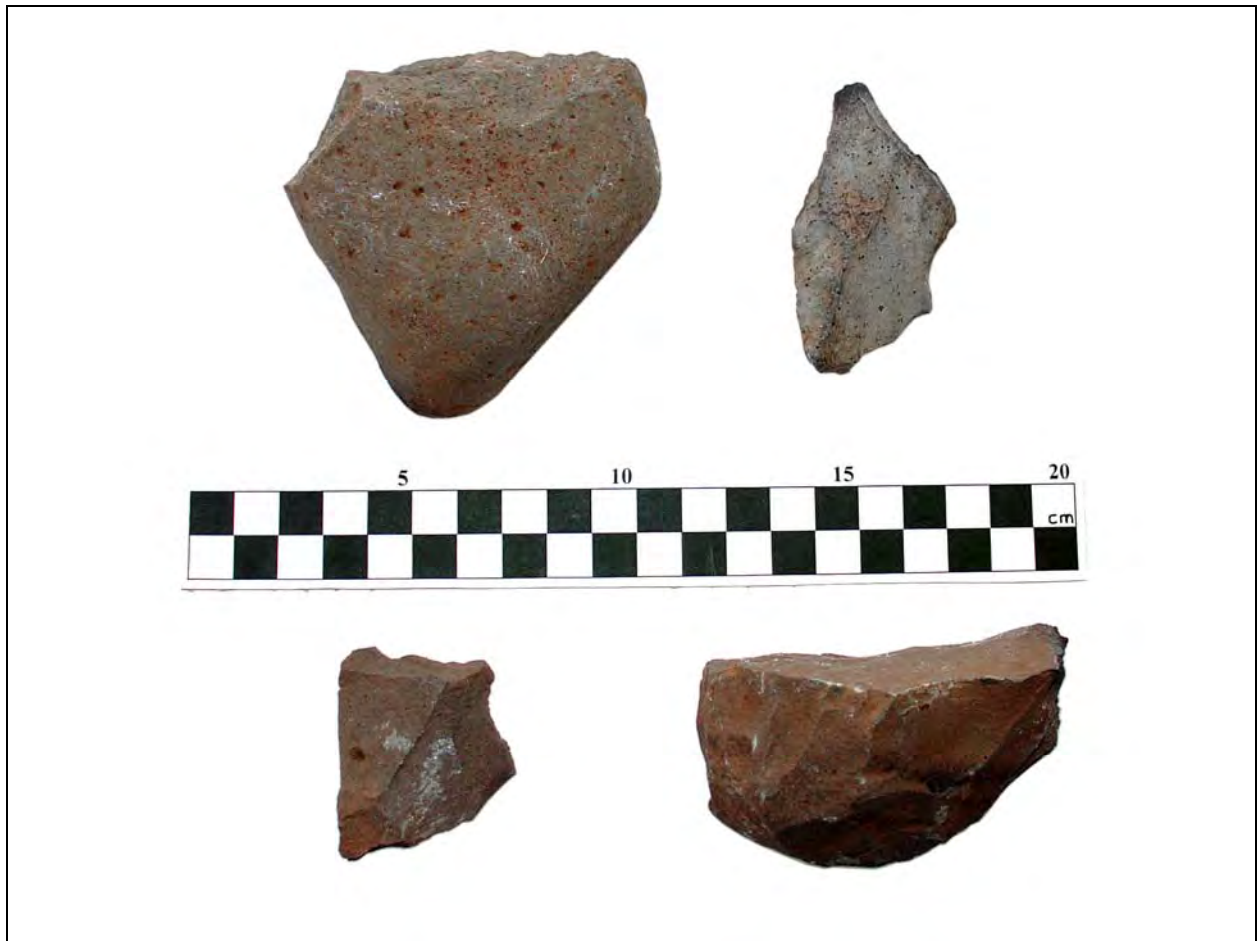
DSC03208\_REV: Field Bag 73-Basalt Cobble Uniface (upper left), Field Bag 79-Basalt Graver (upper right), Field Bag 70-Edge Altered Basalt Flake (lower left), Field Bag 14-Basalt Core (lower right).
