Subject: Final Environmental Assessment and Finding of
No Significant Impact for the Salt Lake Debris Basins Project
Salt Lake, Oahu, Hawaii
Tax Map Key (TMK): (1) 1-1-063:018

The City and County of Honolulu (City), Department of Facility Maintenance (DFM) proposes the implementation of stormwater pollution control structures within the City-owned lot, a part of Hoaloha Salt Lake Regional Park in Salt Lake on the Island of O‘ahu, Hawai‘i. The project location is at the upper reaches of an existing concrete drainage channel along Likini Street, at the base of the southern-facing exterior slopes of Āliamanu Crater. Maps depicting the project vicinity and location are presented in Figure 1-1 & Figure 1-2, respectively.

The proposed action is to construct physical improvements that would intercept sediment and debris from the hillside. Specifically, two debris basins (Basin “A” & Basin “B”) at the upstream end of the existing concrete drainage channel are proposed. These basins would intercept and capture rocks, coarse sediment, trash and debris before it reaches Salt Lake. An added benefit of the installation of debris basins is that they will help protect the storm drainage system

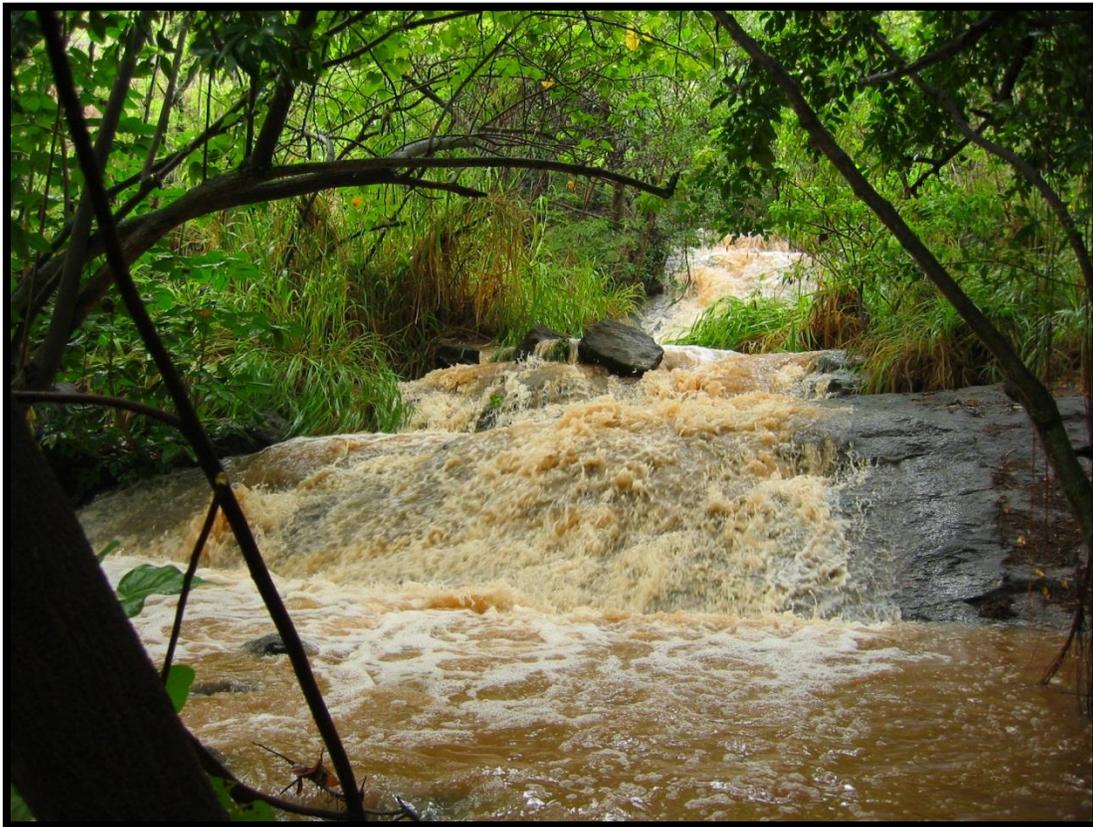
Figure 2-1. Sediment and Debris Impact upon Salt Lake

The no action alternative would mean nothing is done to capture the rocks, coarse sediment, trash and debris that is transported via stormwater from the outer wall of Āliamanu Crater into Salt Lake. Without the installation of debris basins or other structural stormwater BMPs to capture the pollutants before they are deposited into Salt Lake, the water quality of the water body will remain at the current degraded level. Additionally, there will be no protection of the storm drainage channel from blockages and surface wear caused by debris in the stormwater flows. The siltation will continue and more frequent dredging will be needed to maintain Salt Lake.

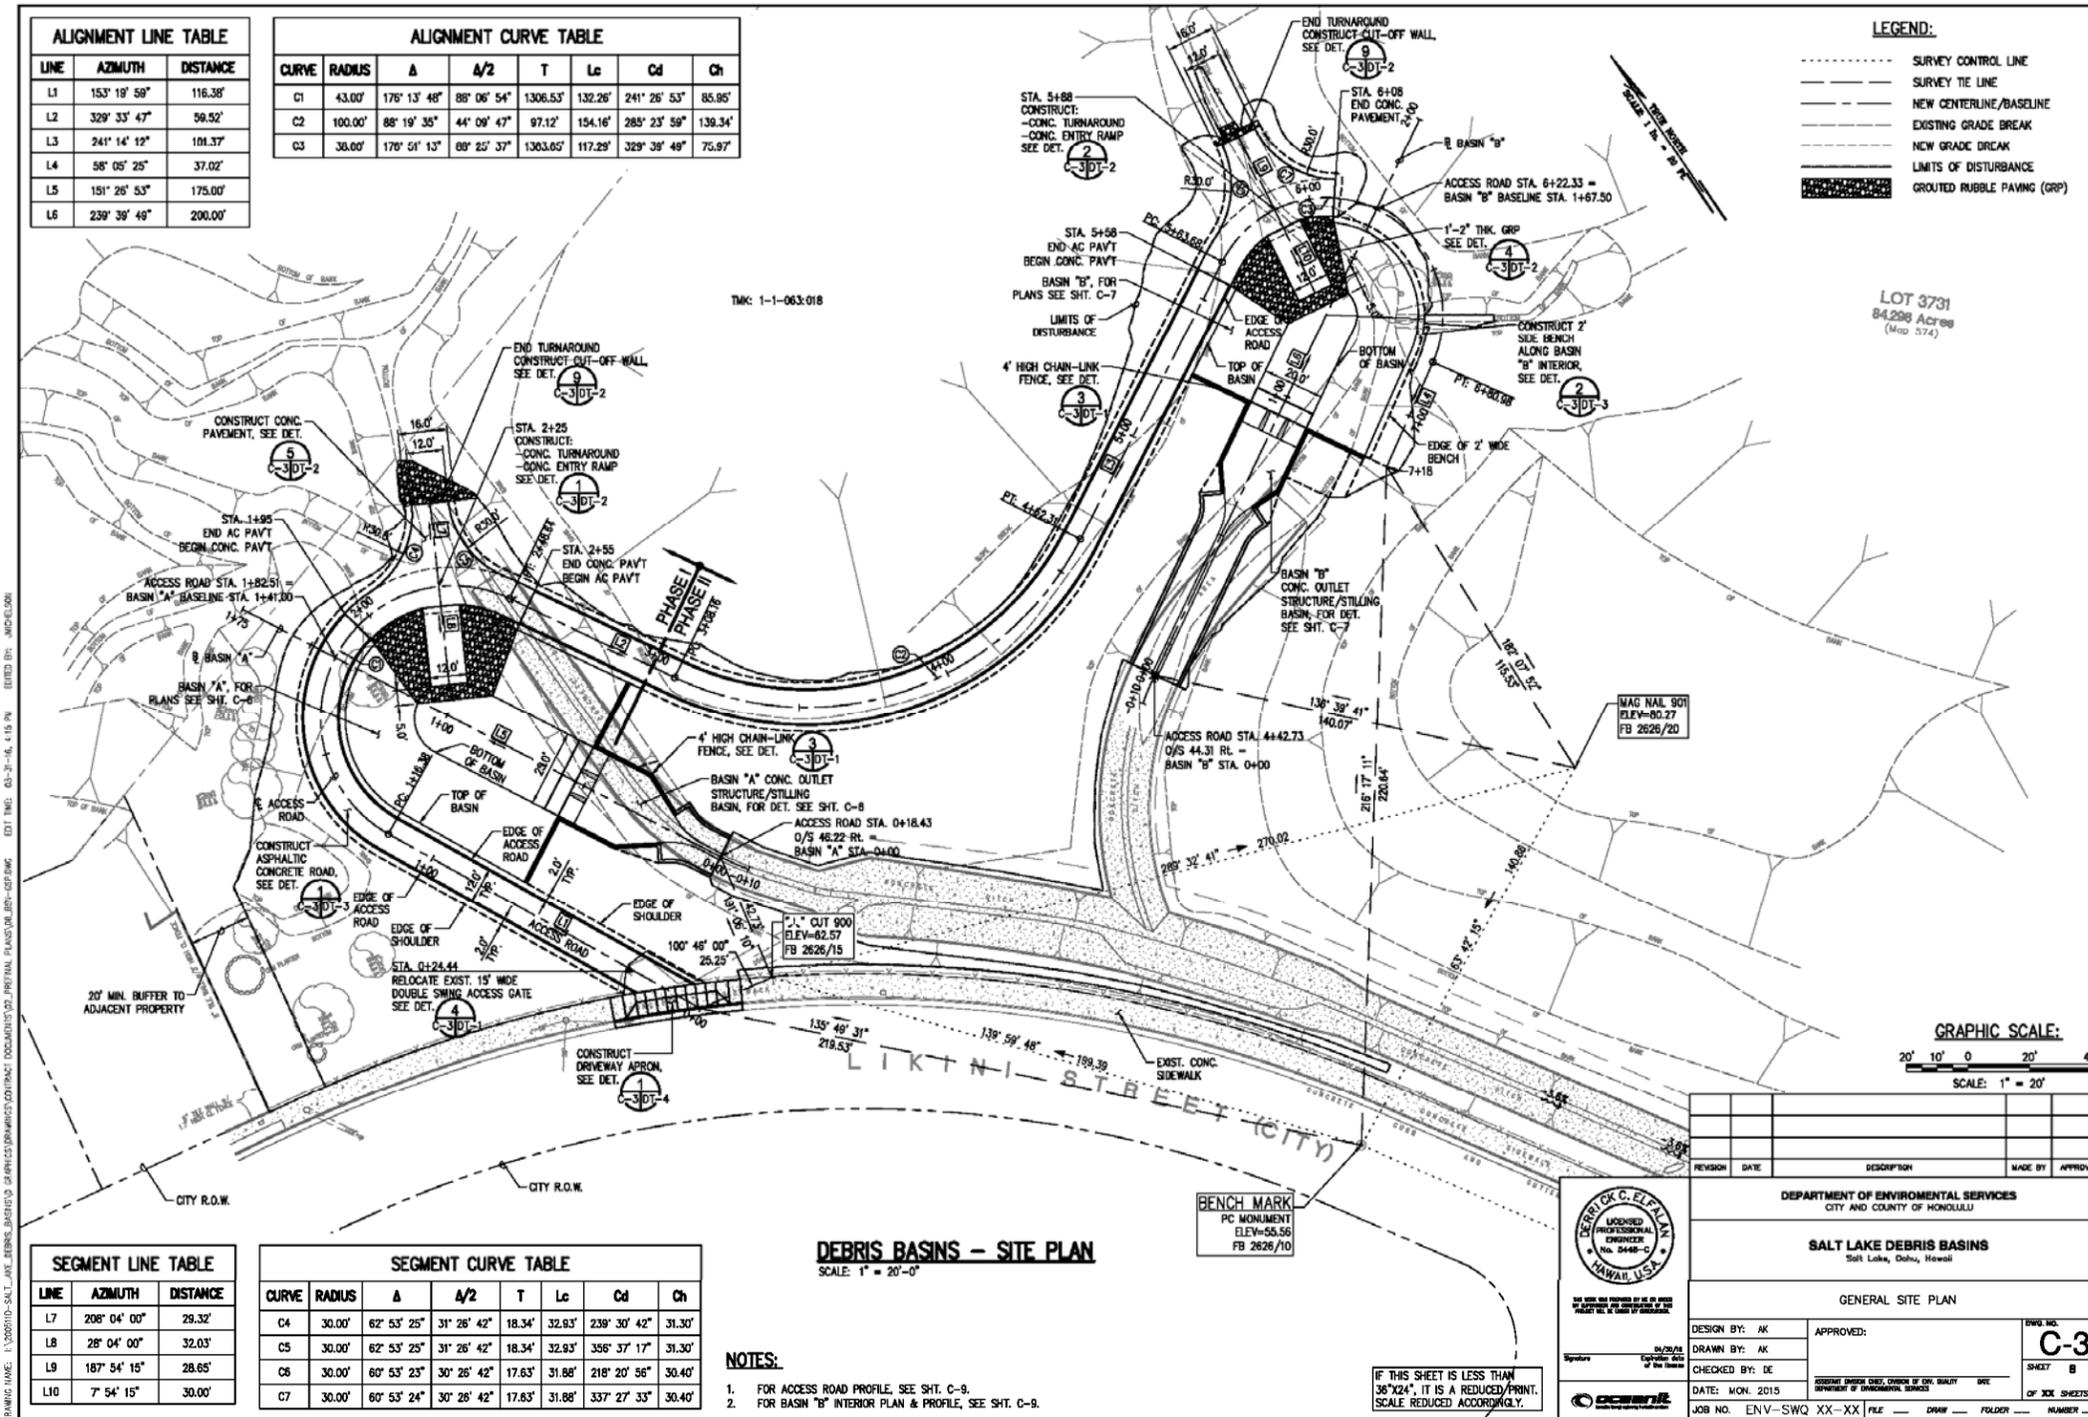
Figure 3-1. Basin Site Plan

The storm drain pollution control devices are debris basins to be installed in the upper reaches of the existing drainage channel. The basins are sized for a target water quality design volume based on associated drainage area and runoff characteristics. Calculations are provided in Appendix B. The basins are generally constructed of a grassed earth bottom and side slopes

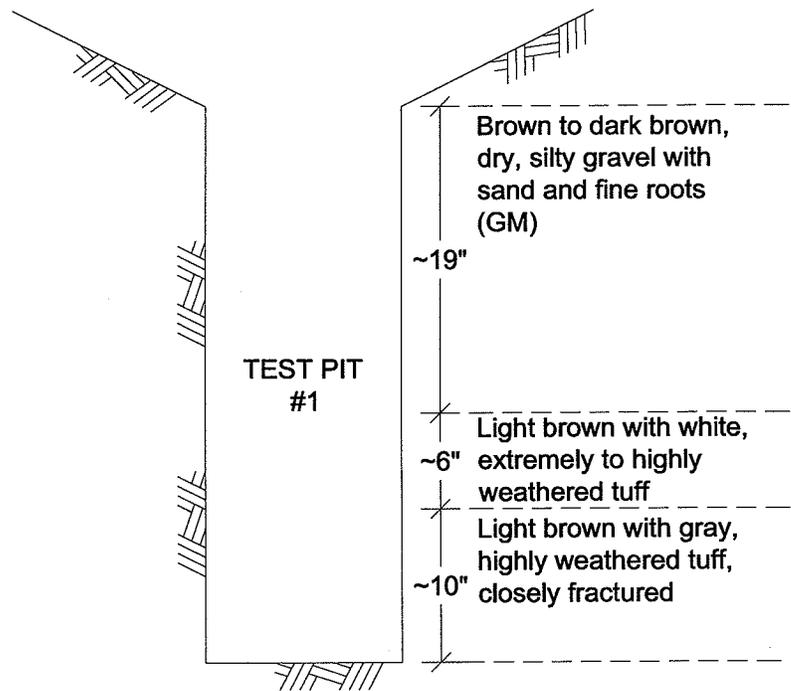
Test pit terminated at approximately 2.9 feet below existing ground surface

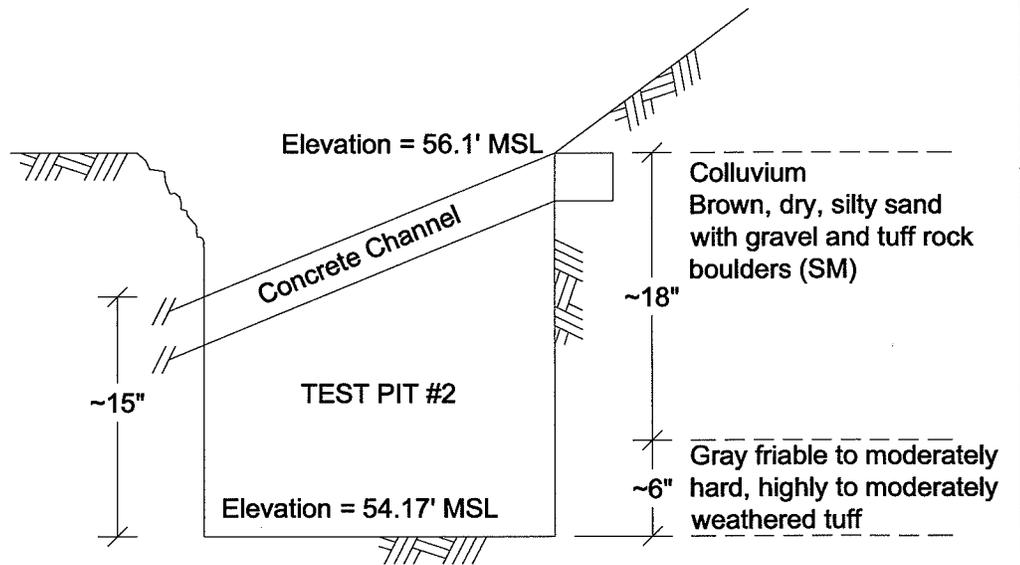
PROFILE VIEW WITH ENCOUNTERED SOIL CONDITIONS
 NOT TO SCALE

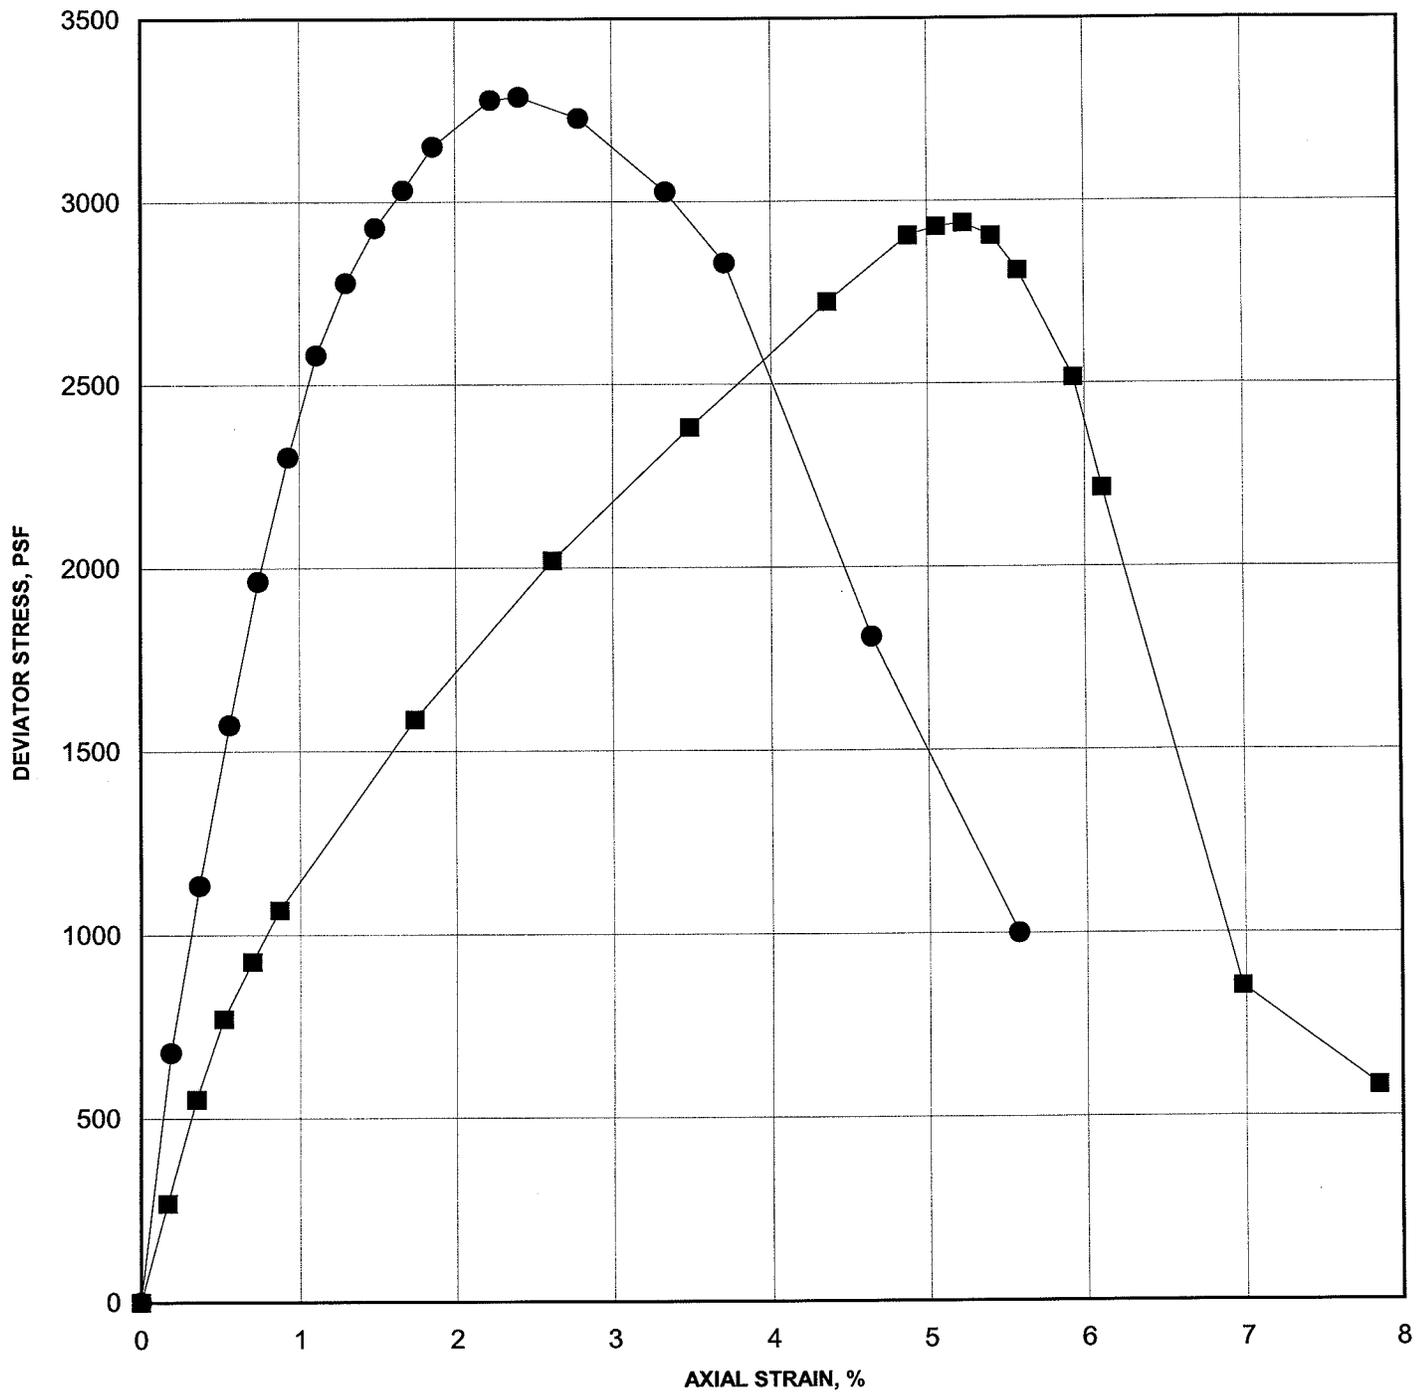
Boring	Depth (ft)	Classification	UCS (psf)	w _o (%)	γ _d (pcf)	
●	B-1	11.0	Very stiff, brown, fat clay with some sand (CH), alluvium	3286	40.0	79.9
■	B-1	35.0	Very stiff, brown, fat clay with rounded gravel (CH), lacustrine	2939	61.0	65.2
▲						
◆

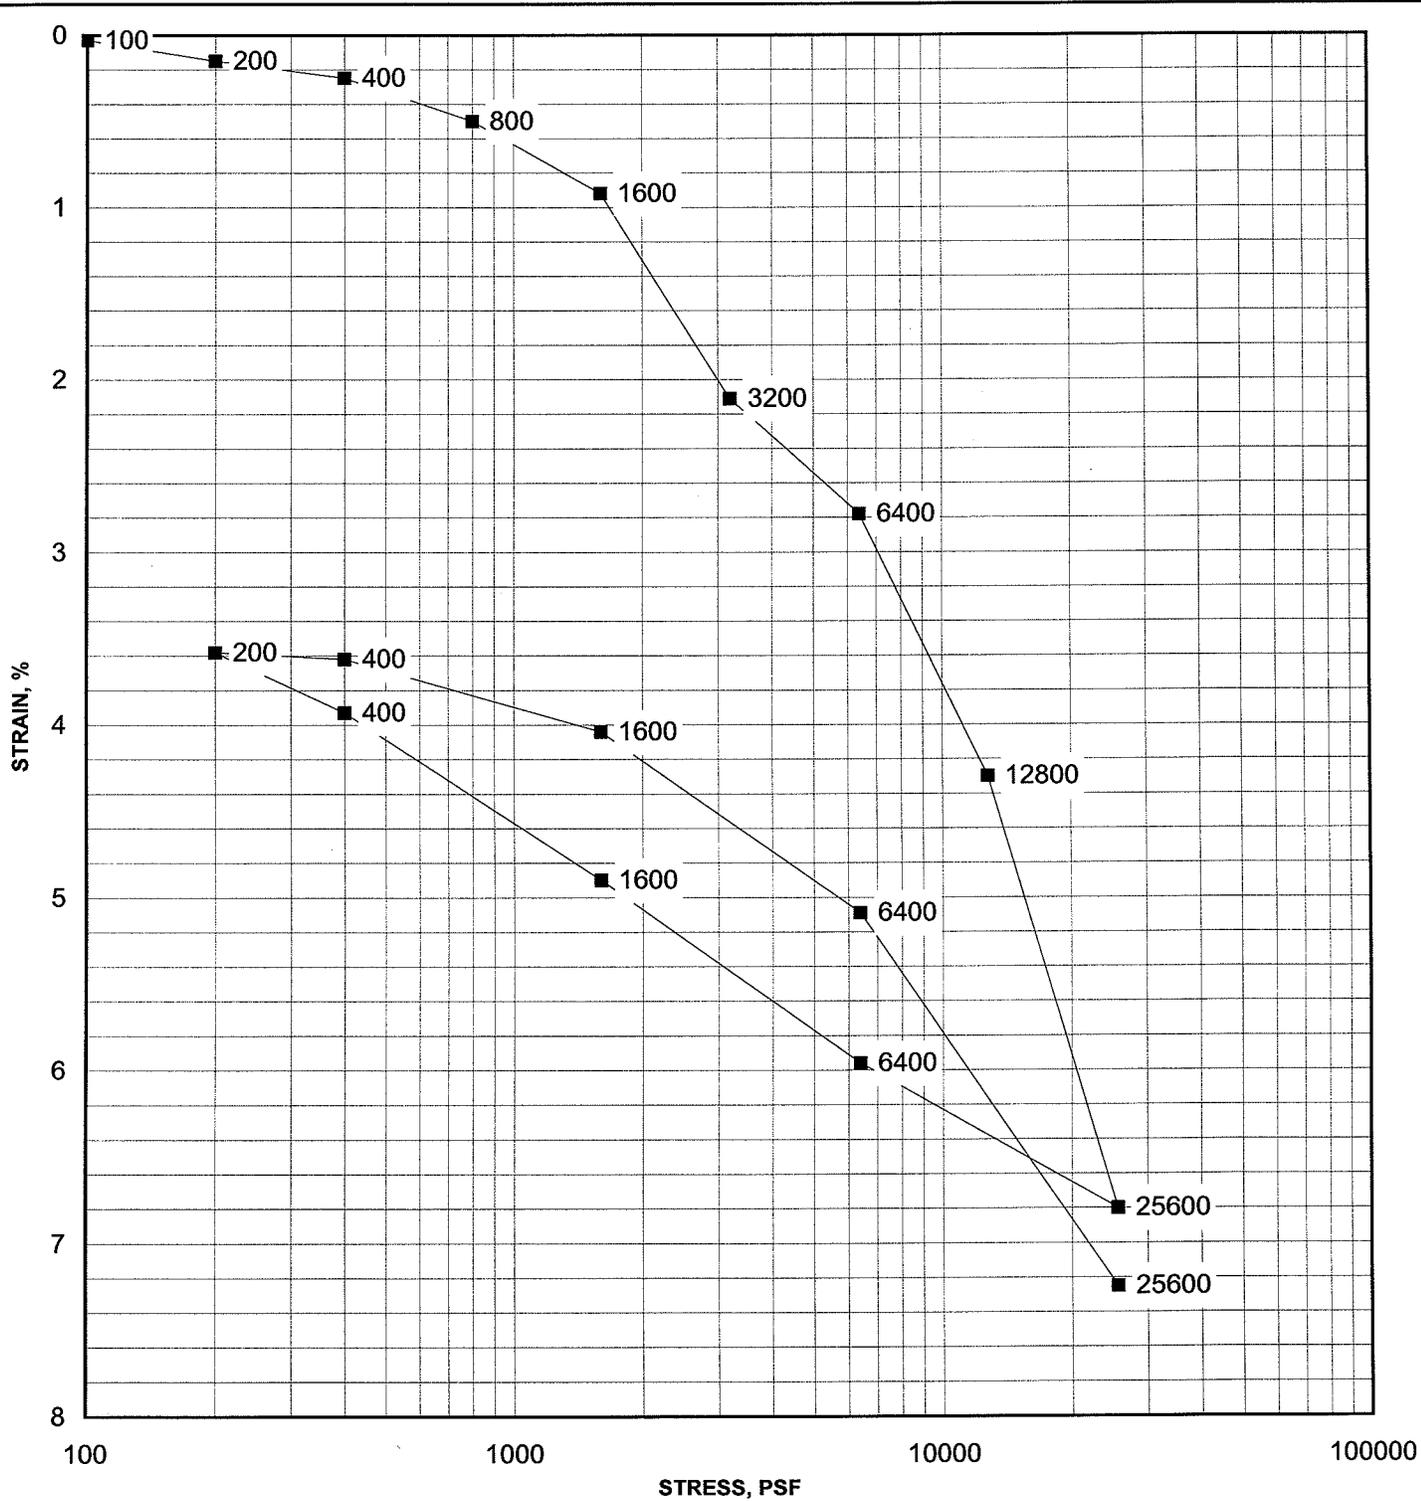
Boring	Depth (ft)	Description	P_o (psf)	C_{ec}	C_{er}	t_{50} (min)	t_{90} (min)	C_v (in ² /min)	w_o (%)	γ_d (pcf)
B-1	35.0	V. stiff fat clay (CH)	5000	12.56	11.56	<0.1	0.49	1.73	54.7	69.4

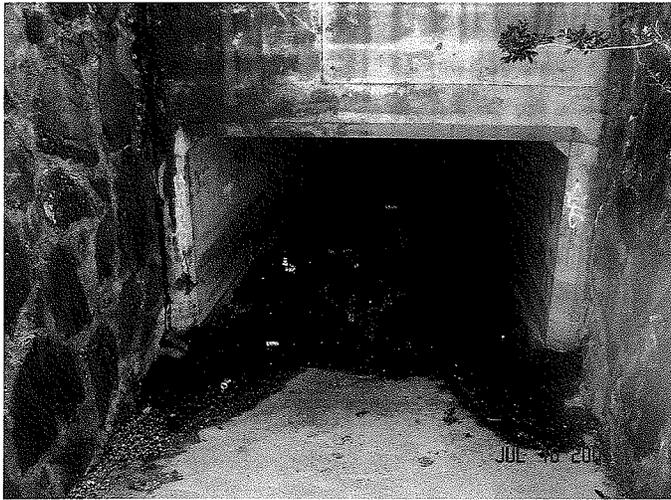
Water infiltration seen at entrance to culvert

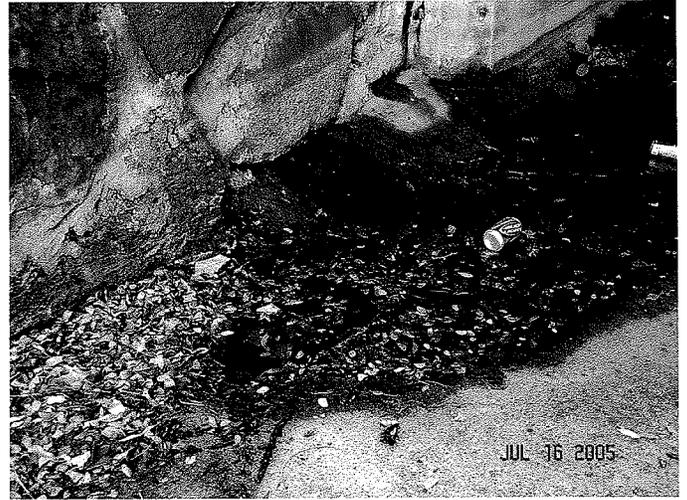
Water infiltration seen at entrance to culvert

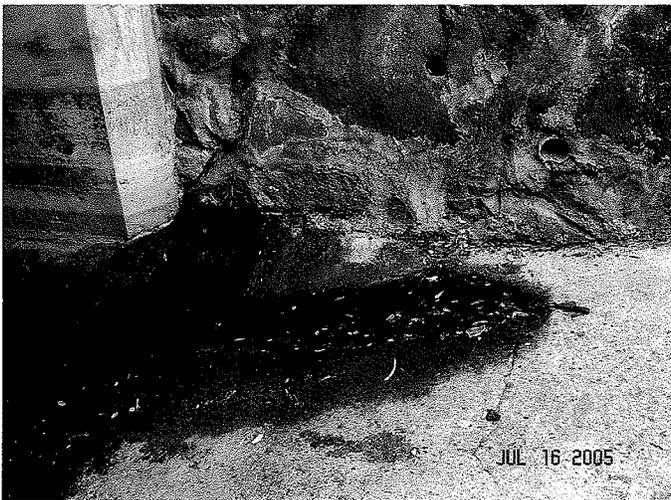
Water infiltration seen at entrance to culvert

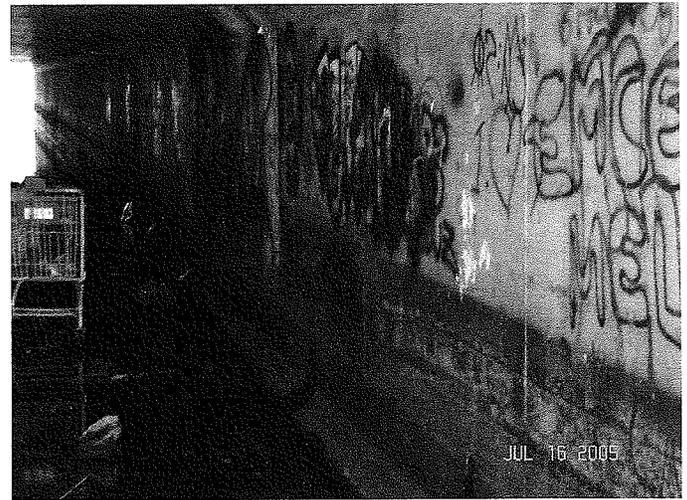
High water line mark in culvert

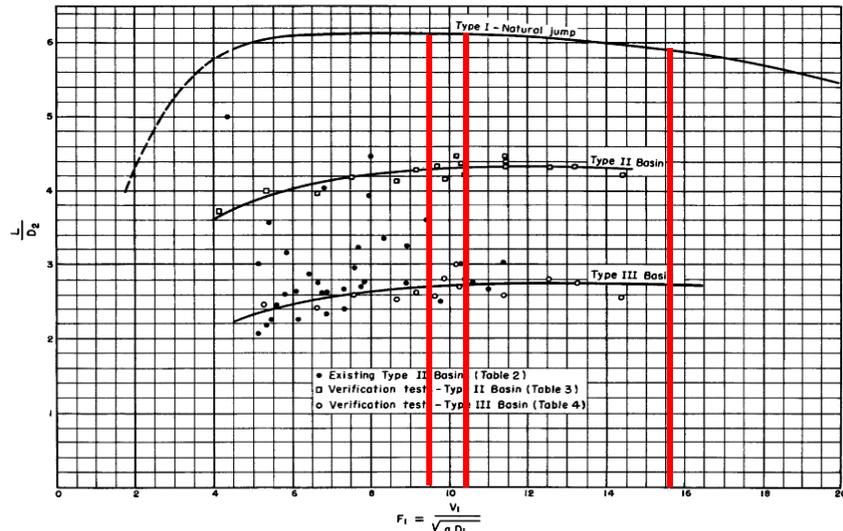
FIGURE 12.—Length of jump on horizontal floor (Basins I, II, and III).

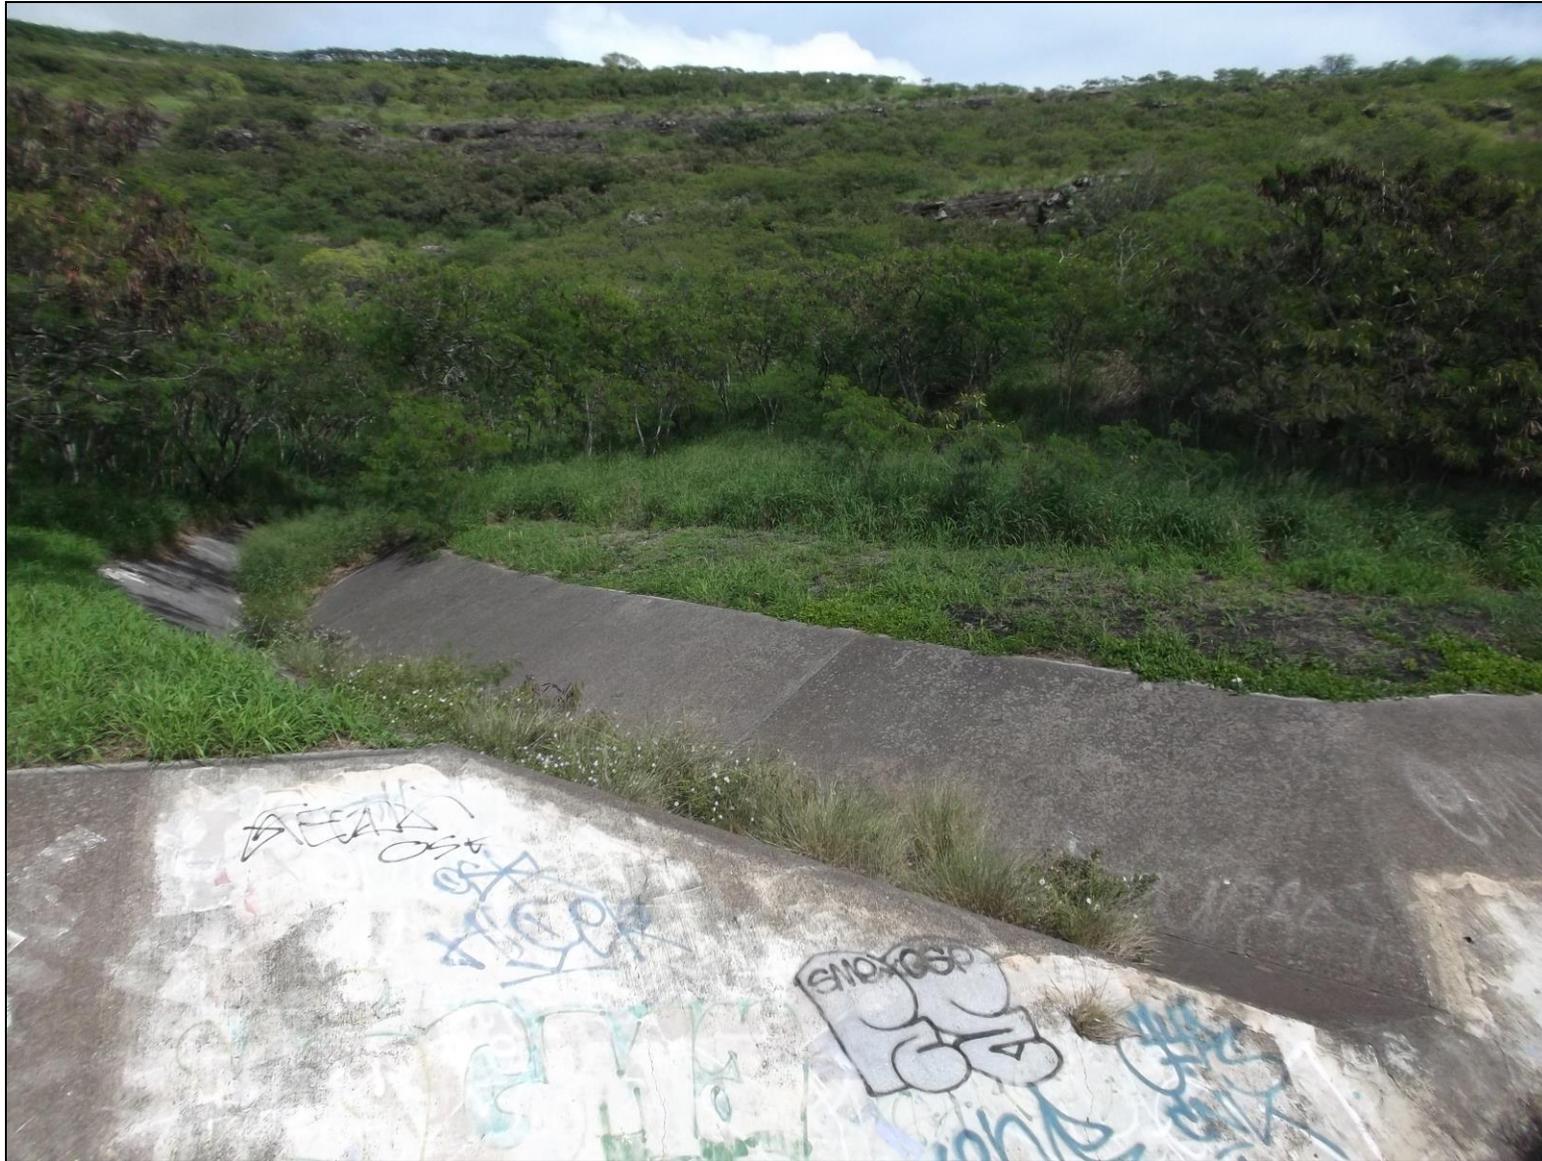
Figure 9: Photographic View of Southeast Lateral Concrete Drainage. View to Northeast.

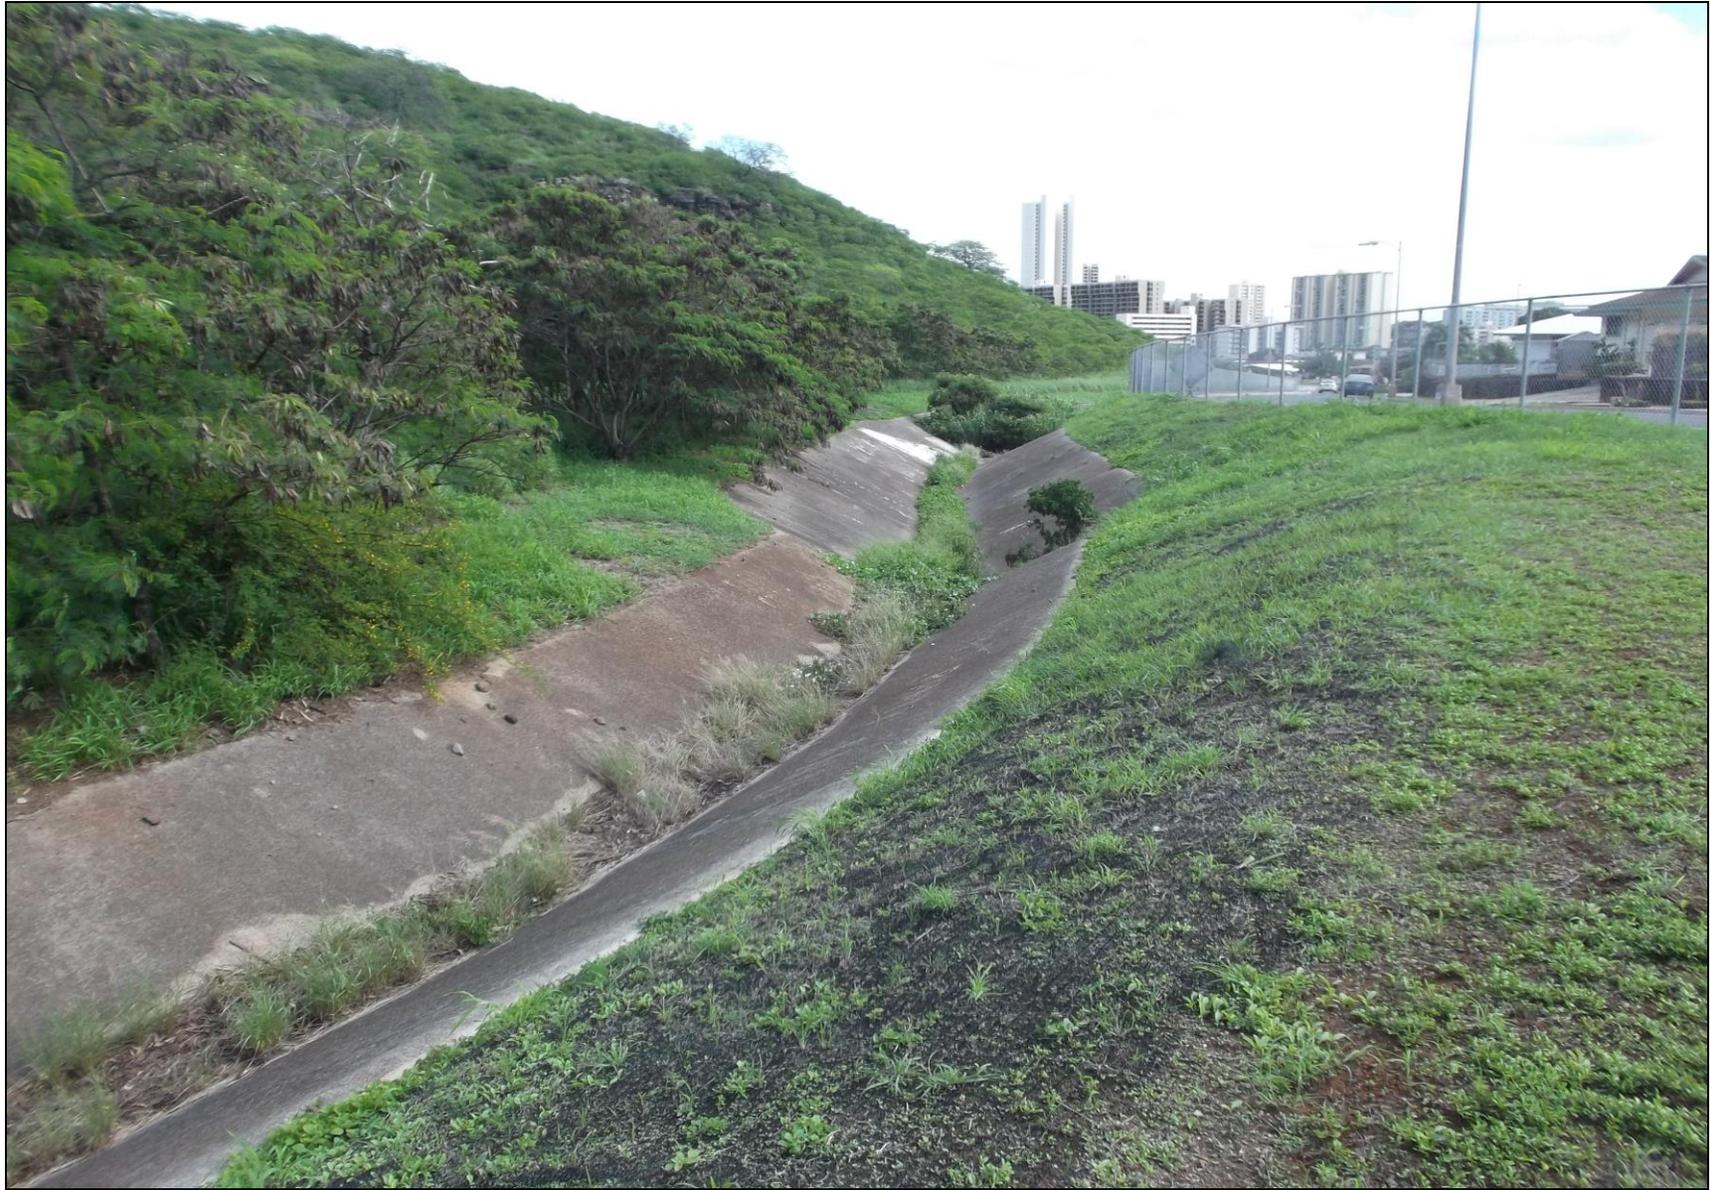
Figure 11: Photographic View of Main Concrete Drainage. View to Southeast.

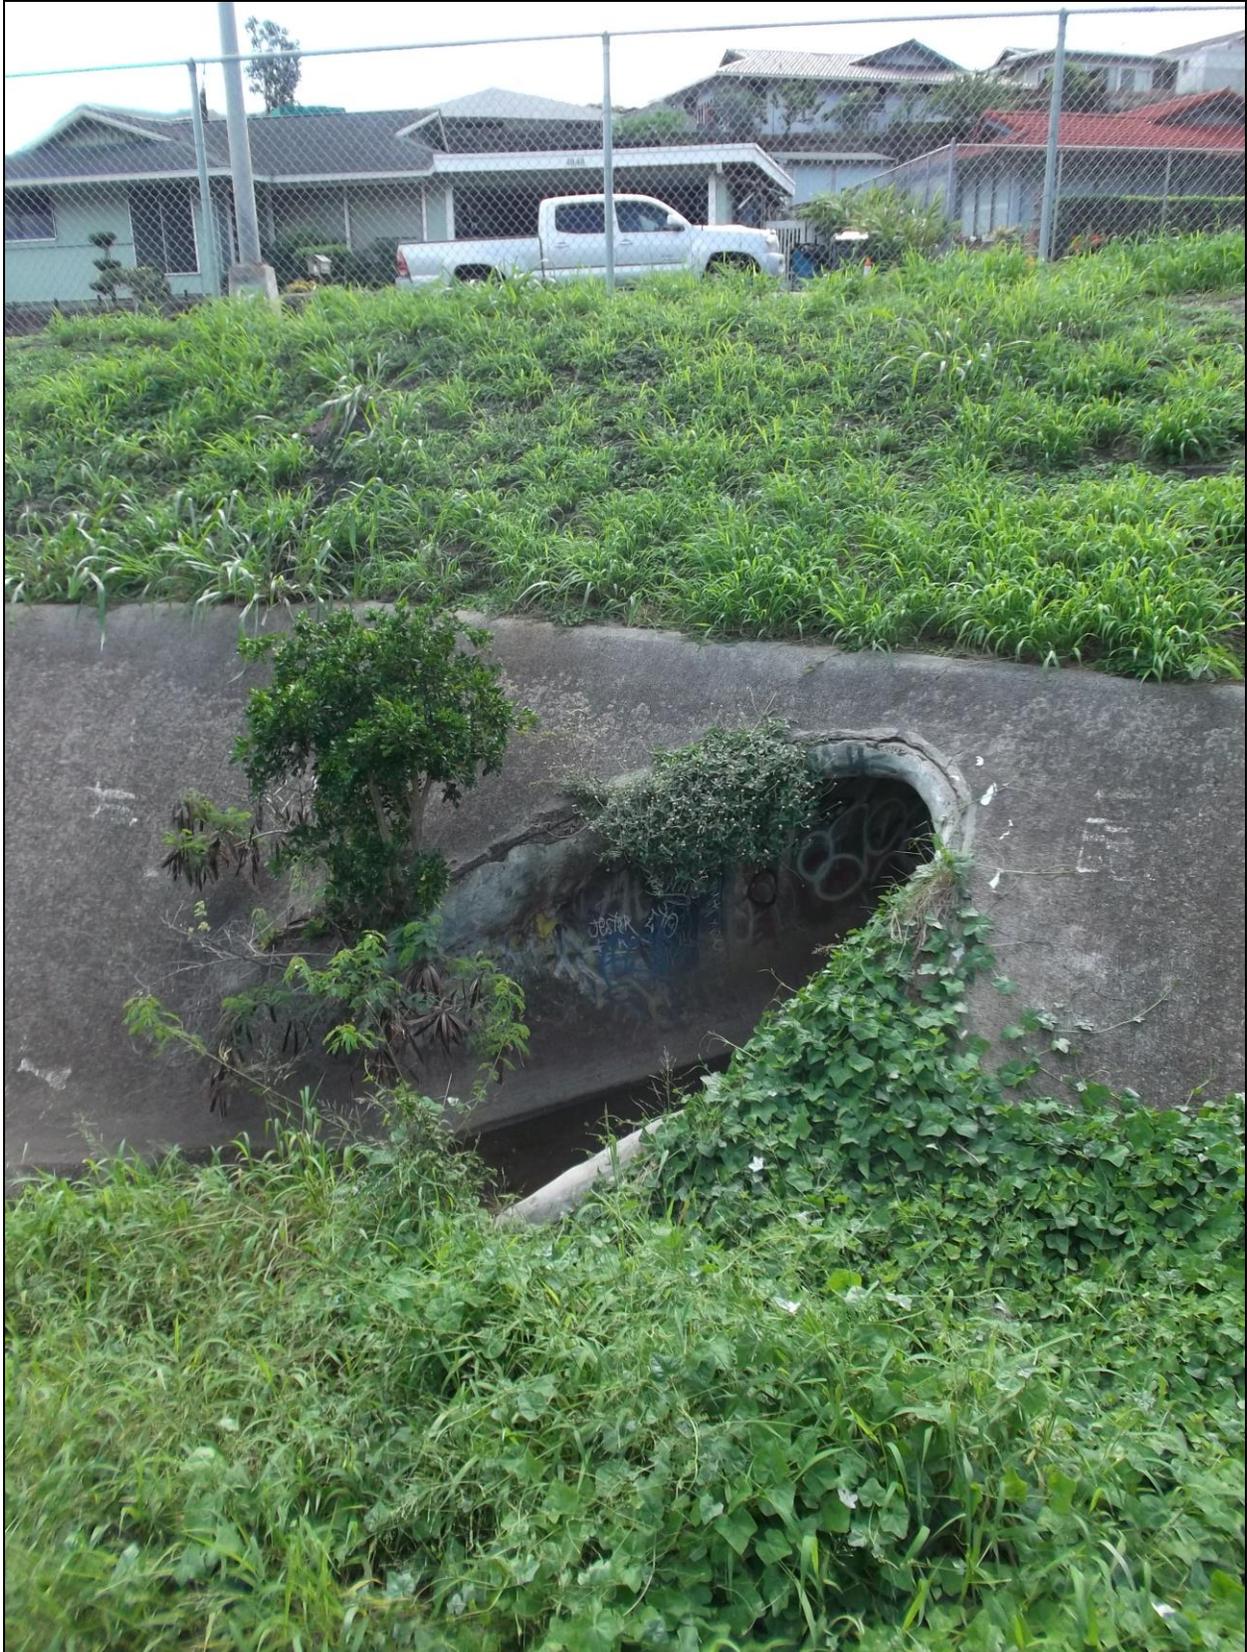
Figure 12: Photographic View of Concrete Pipe. View to Southwest.

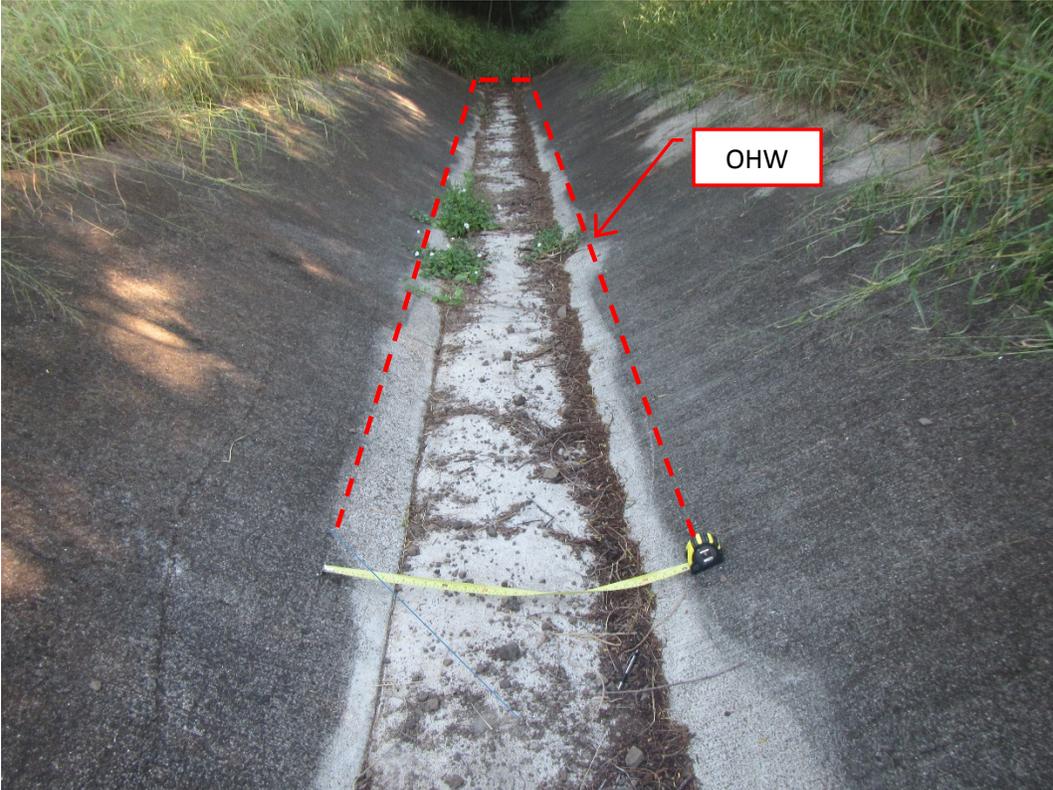
Figure 2. West Branch channel OWM stains indicate flow width of 36" and depth of 3".

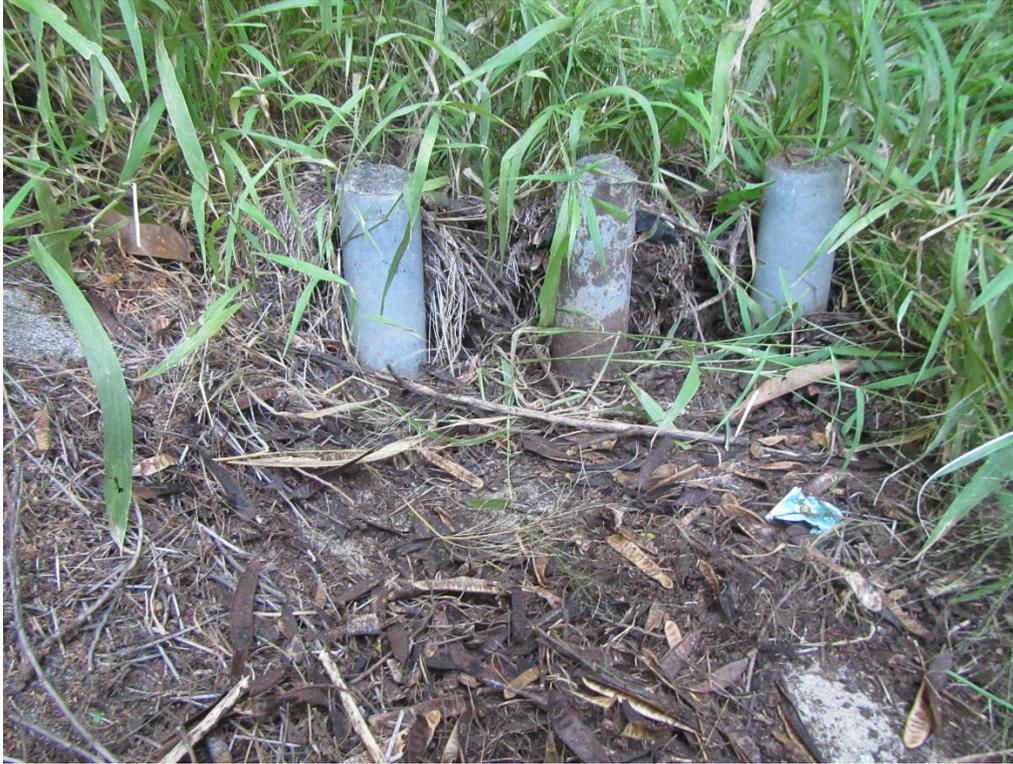
Figure 3. Top of West Branch channel has three 4-inch metal posts that inhibit the flow of debris into the concrete channel.

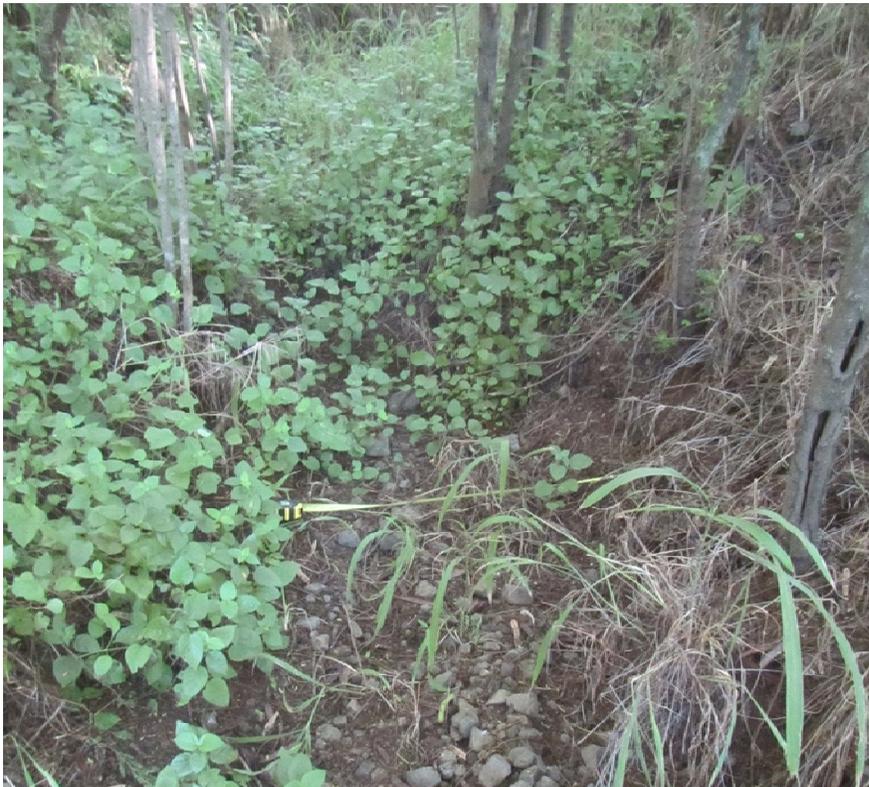
Figure 4. Swale immediately above top of West Branch concrete channel contains a small discontinuous rill with loose gravel and leaves in the bottom.

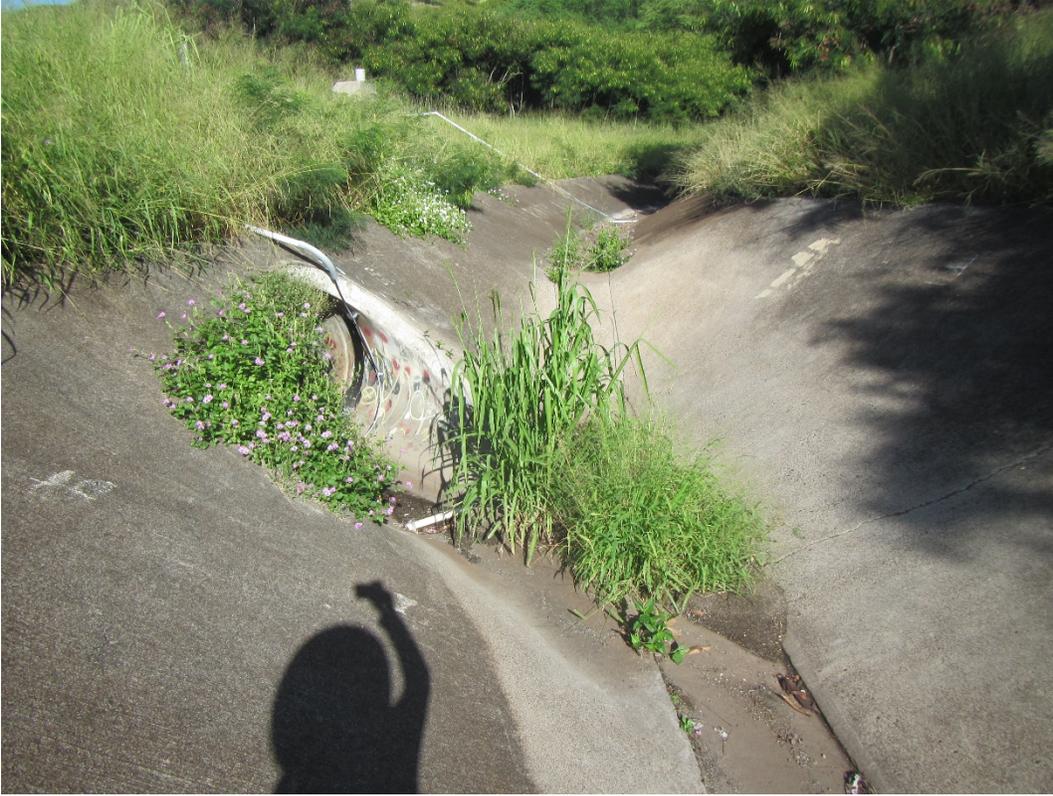
Figure 5. West Branch channel at junction with 54-inch drain pipe.
