SUBJECT: Chapter 25, Revised Ordinances of Honolulu
Final Environmental Assessment (EA)
Project: Wailehua I Single-Family Residences
Applicant: Wailehua I, LLC
Agent: GK Environmental, LLC (Graham Knopp, Principal)
Location: Wailehua Road - Kaalaea
Tax Map Key: 4-7-014: 051; 4-7-014: 052 and 4-7-014: 055
Determination: Finding of No Significant Impact (FONSI)

Project Name: Wailehua I Single-Family Residences

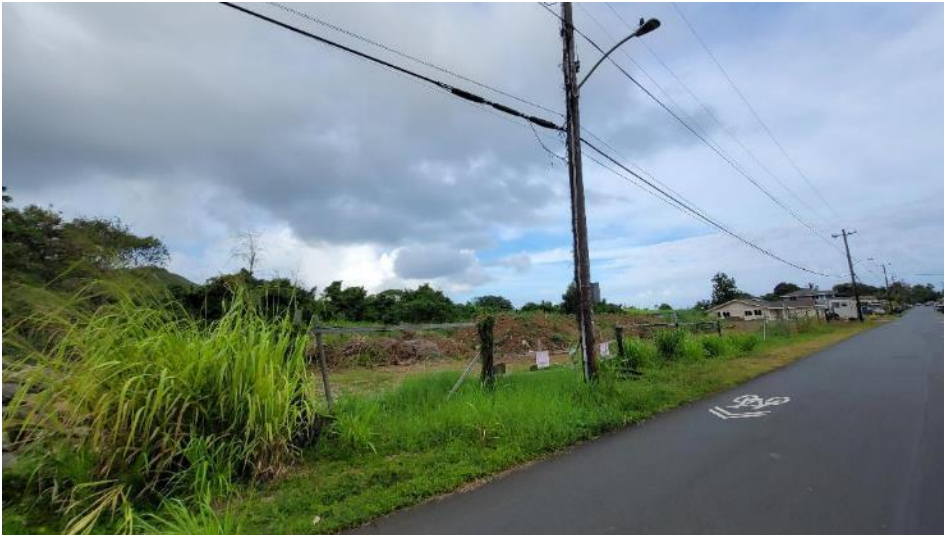
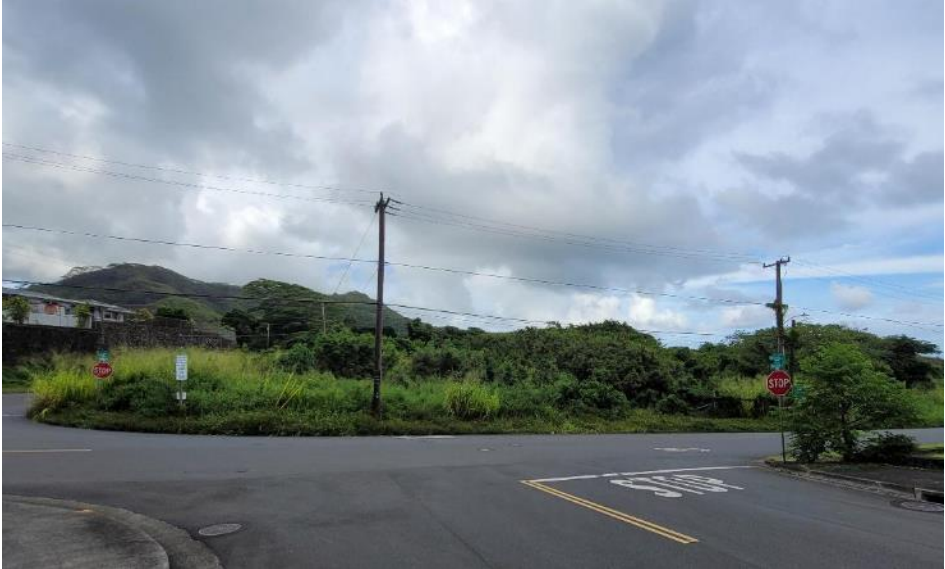
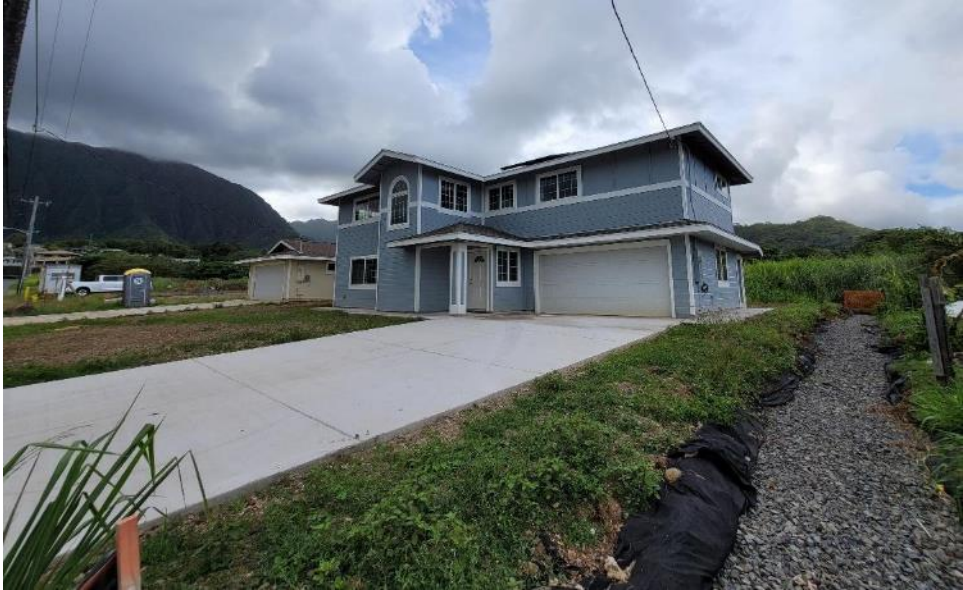
Figure 5. Site Photographs of Existing Site Conditions

Figure 1 shows a site location map, Figure 2 a vicinity map, Figure 3 a TMK map, Figure 4 a subdivision map, and Figure 5 photographs of existing site conditions taken November 11, 2021. Figure 6 through Figure 10 show project drawings of the proposed single-family dwellings.

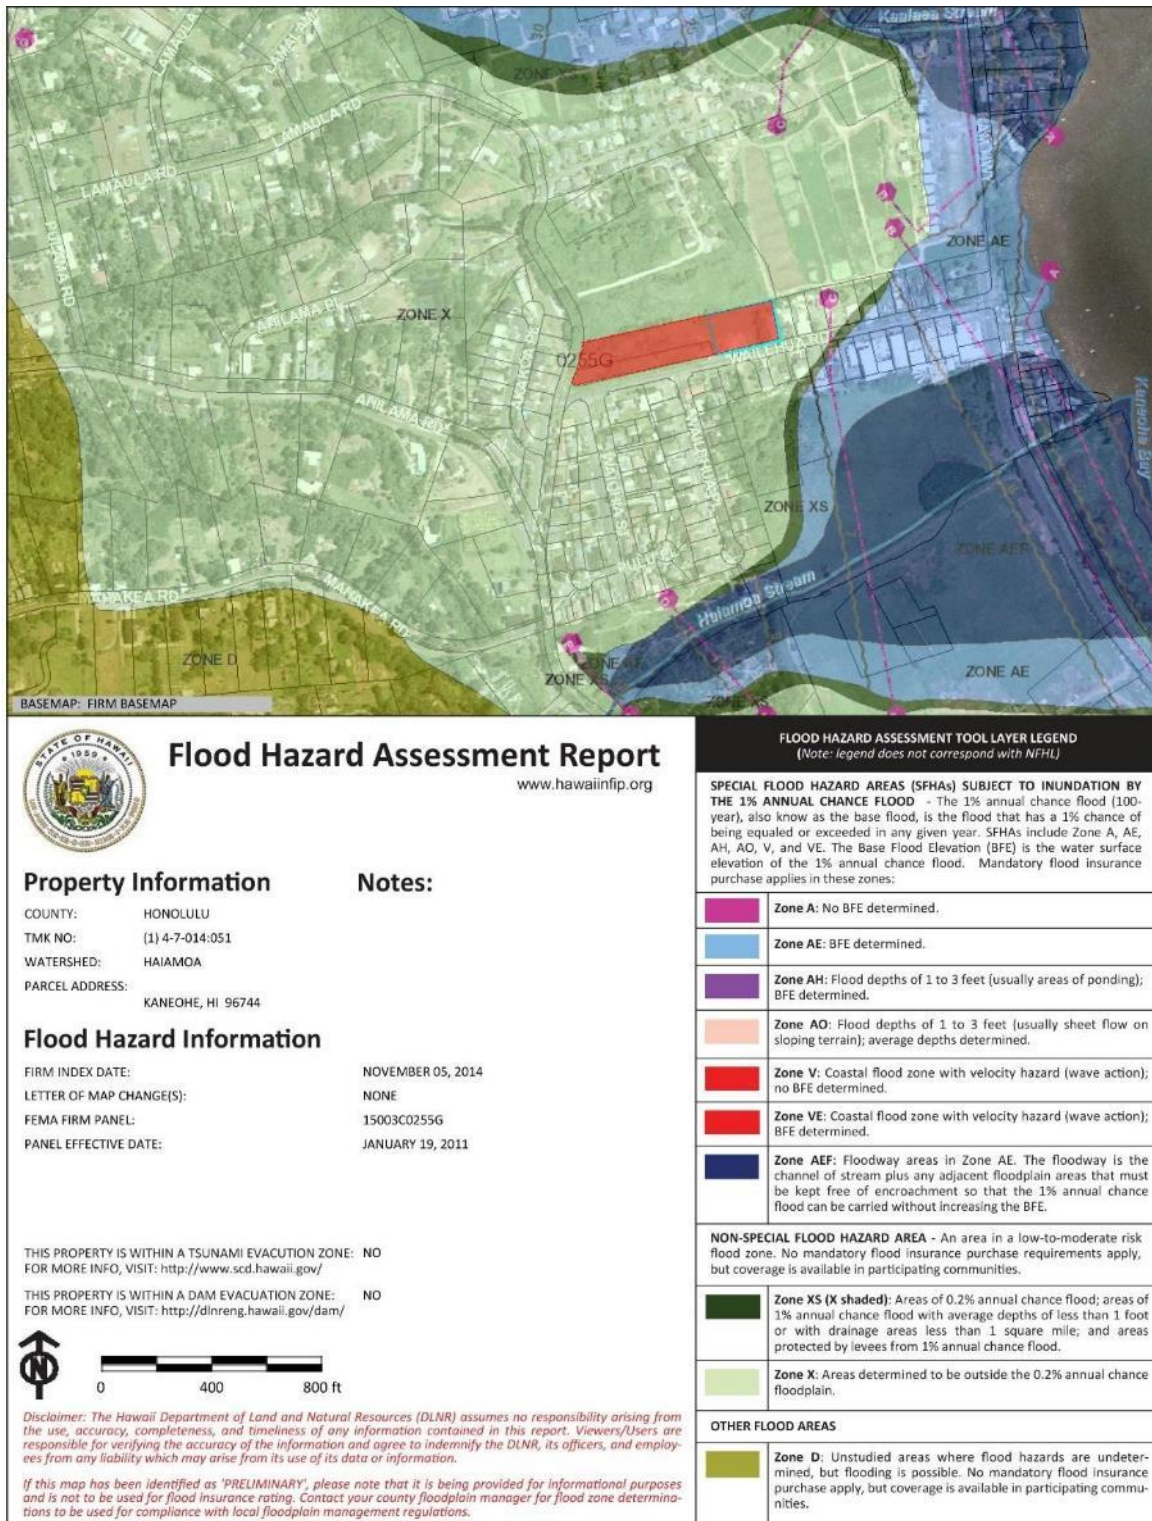
Figure 13. Flood Zone Map

The FEMA National Flood Hazard Layer (NFHL) viewer (FEMA 2021) shows that the proposed project site is entirely located in Flood Zone X, areas determined to be outside the 0.2% annual chance floodplain, as mapped on FEMA FIRM panel 15003CO255G (Figure 13). The proposed project site is not located within the tsunami evacuation zone but is located within the extreme tsunami evacuation zone (State of Hawaii, 2021).

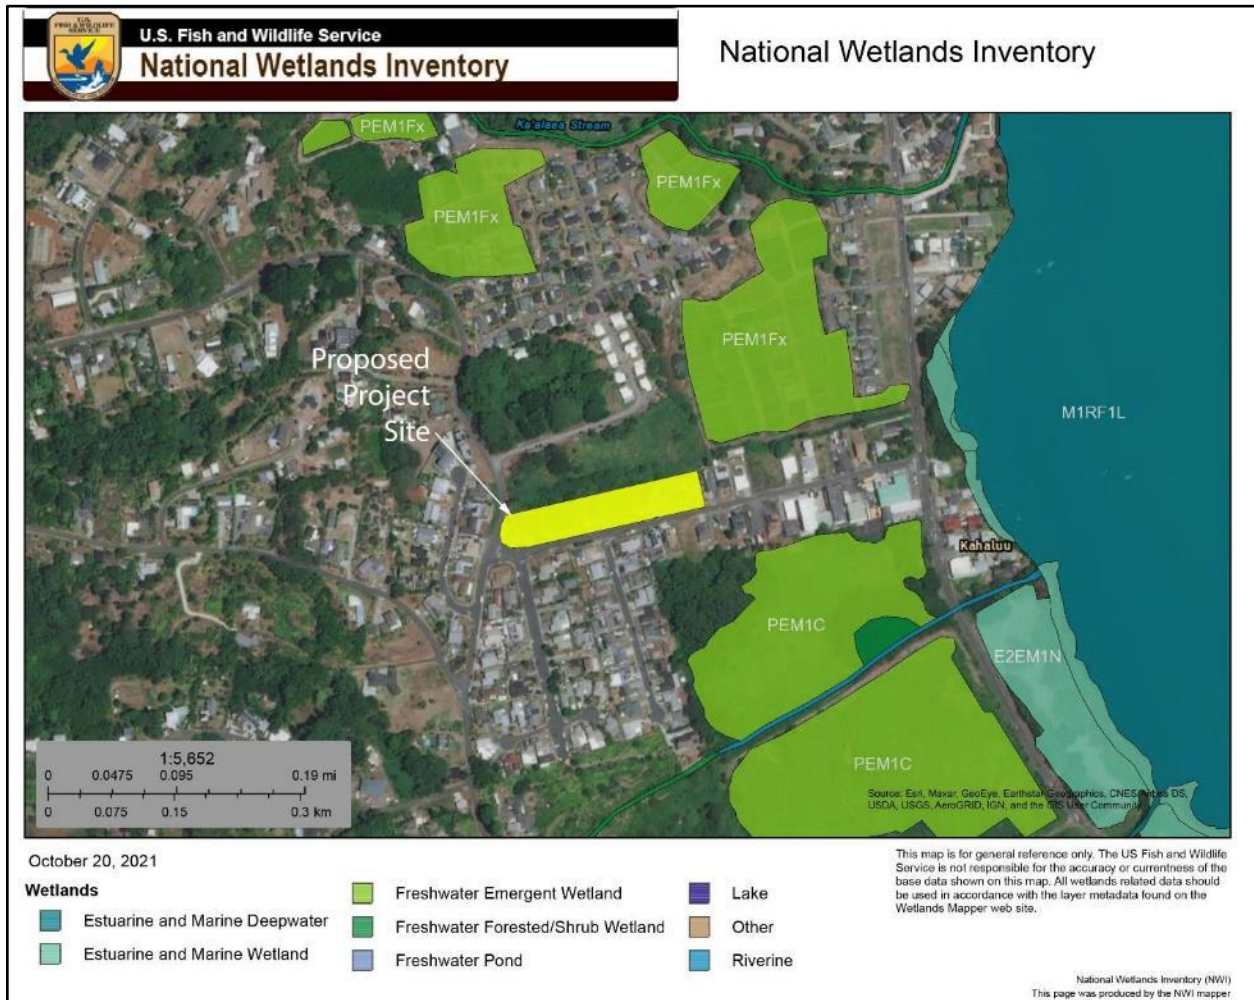
Figure 14. FWS Wetlands Map

There are no potential wetlands impacts from the proposed project as determined by the U.S. Army Corps of Engineers in a jurisdictional determination on December 21, 2020 (Appendix B). Figure 14 shows the U.S. Fish and Wildlife Service National Wetlands Inventory for the proposed project site and vicinity. This finding was issued after wetlands were delineated on the proposed project site under a previous study in 2015 (Paahana 2015) and was associated with a notice of violation dated February 14, 2017 for placement of fill in waters of the U.S. by the Applicant on a portion of the proposed project site. The change in jurisdictional determination is due to the halting of implementation of the Navigable Waters Protection Rule, which essentially rolled back interpretation of the definition of “waters of the United States” to the pre-2015 regulatory status. In the December 21, 2021 jurisdictional determination, the U.S. Army Corps of Engineers determined that the “Wailehua 1 drainage feature” was created by excavation for the purpose of drainage of stormwater and, furthermore, conveys flow only ephemerally, and is therefore not a water of the United States as per 33 CFR Section 328(b)(10). This determination is fixed for a period of five years, meaning that another rule change would not affect the determination for this term.

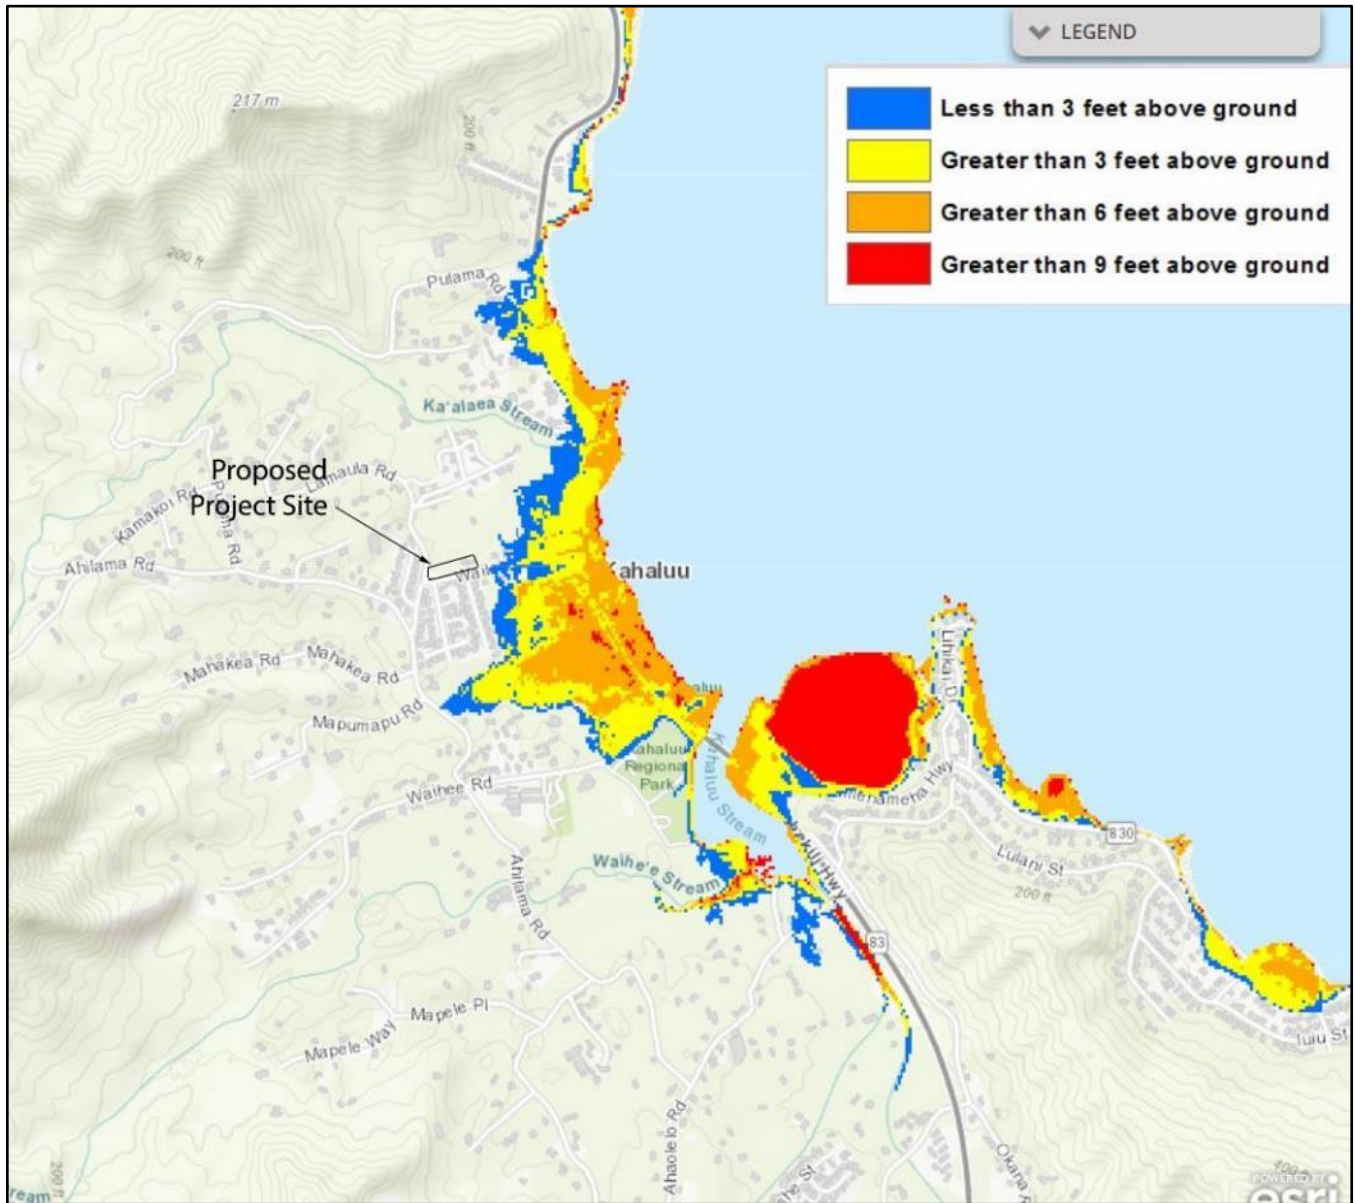
Figure 17. The SLOSH Model for Storm Surge from a Category 4 Hurricane.

The National Atmospheric Administration (NOAA) produces national storm surge hazard maps to depict storm surge flooding vulnerability for areas vulnerable to tropical storms and hurricanes. The maps depict the SLOSH (Sea, Lake, and Overland Surges from Hurricanes) numerical model for hurricane strength categories 1-4. The predicted storm surge for a Category 4 hurricane is shown in Figure 17 and shows no storm surge inundation on the proposed project site.

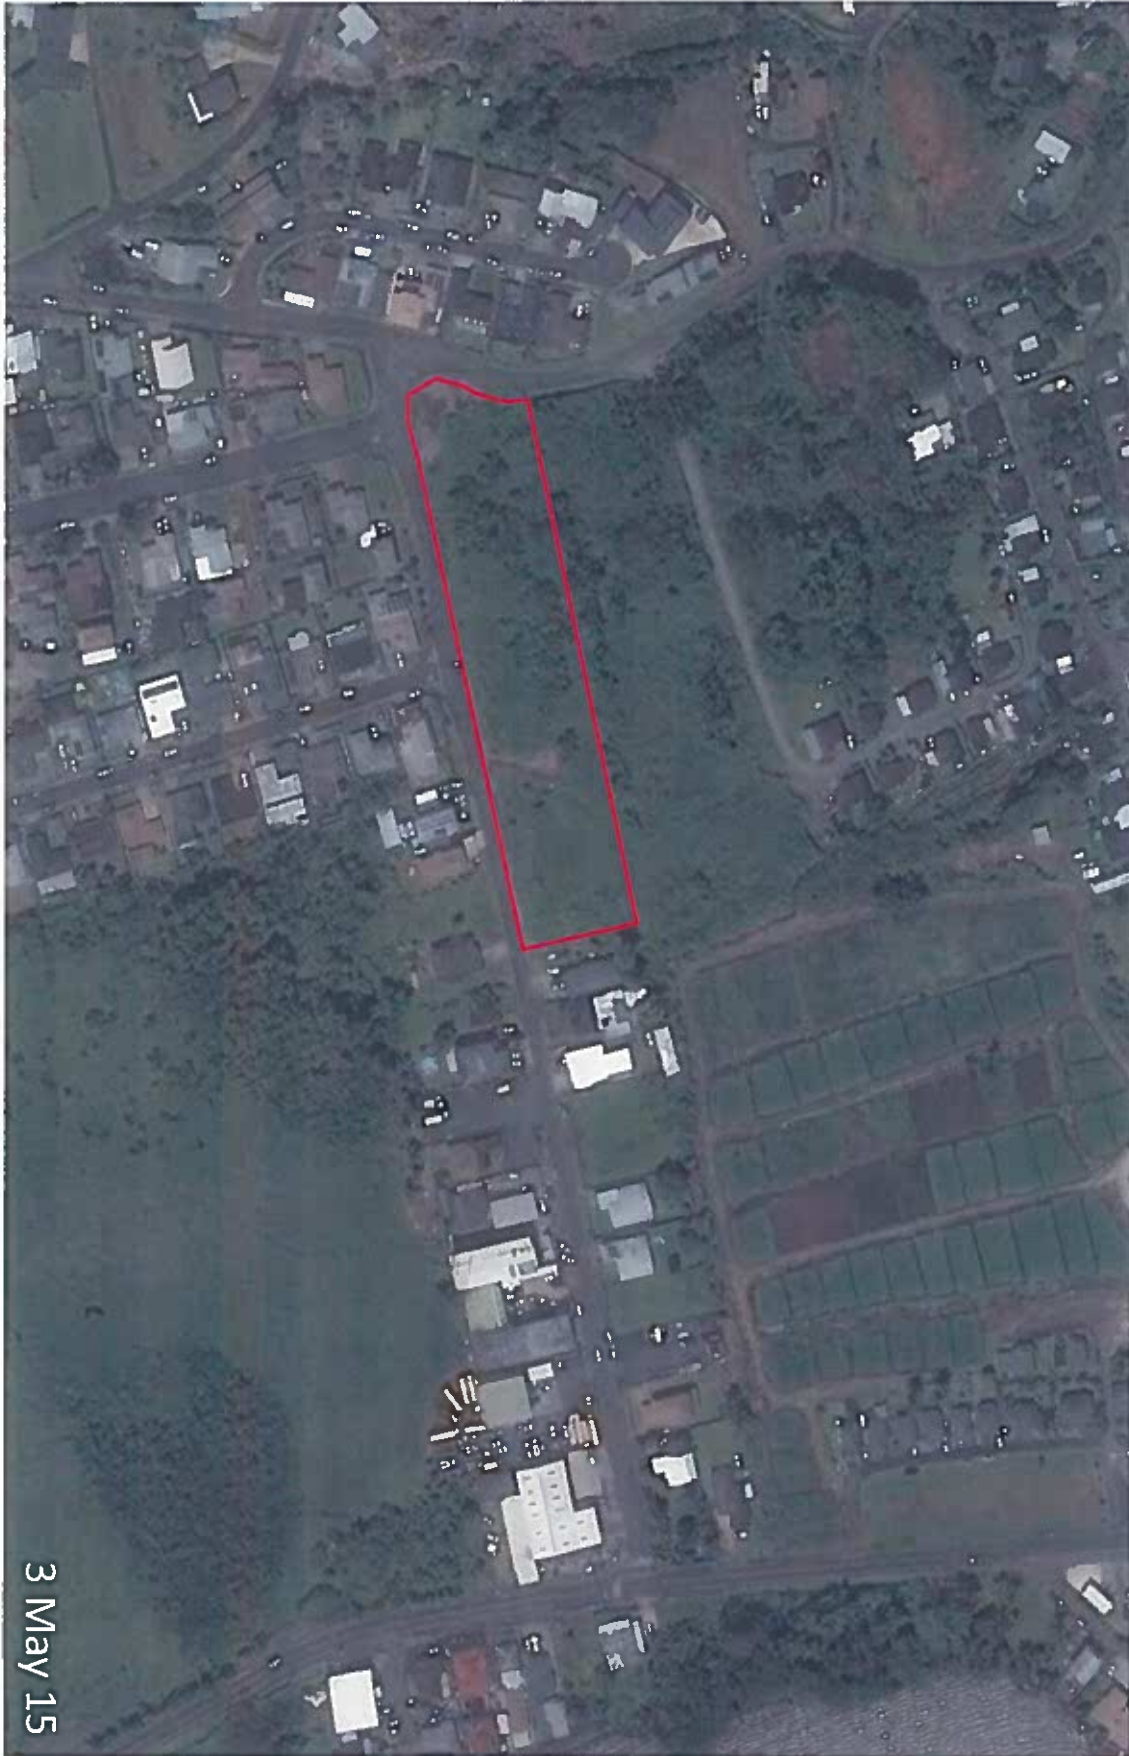
Figure 5. Pre-Disturbance Aerial, 3 May 15
(Source: Digital Globe)
Appendix A

Plant species at each sample plot were identified, percent cover for each dominant species was visually estimated and the indicator status as established in the Hawaii 2014 Regional Wetland Plant List (Lichvar, et. al, 2014) recorded on the data sheet. Plot size was primarily dependent on the encroaching adjacent fill boundary and secondarily in relation to changes in composition of the plant community. Where significant changes to the composition of the plant community were observed, such as introduction of a different species of a different indicator status, a separate sample point was established and evaluated. Sample points ranged from a 100-square foot rectangular plot to a 30-foot diameter circular plot. The subject property primarily featured an herb stratum, lacked both sapling/shrub and woody vine strata and only within the remnant plant community featured a tree stratum. If a plant was not immediately identifiable in the field, a representative sample was collected and identified in the office using resources available to the Corps. Hydrophytic vegetation indicators used were the Dominance Test and the Prevalence Test. All observed vegetation, with the exception of the remnant plant community west of the center of the property, represents regrowth since the site was mechanically grubbed in May 2015 (Figure 5, Appendix A).

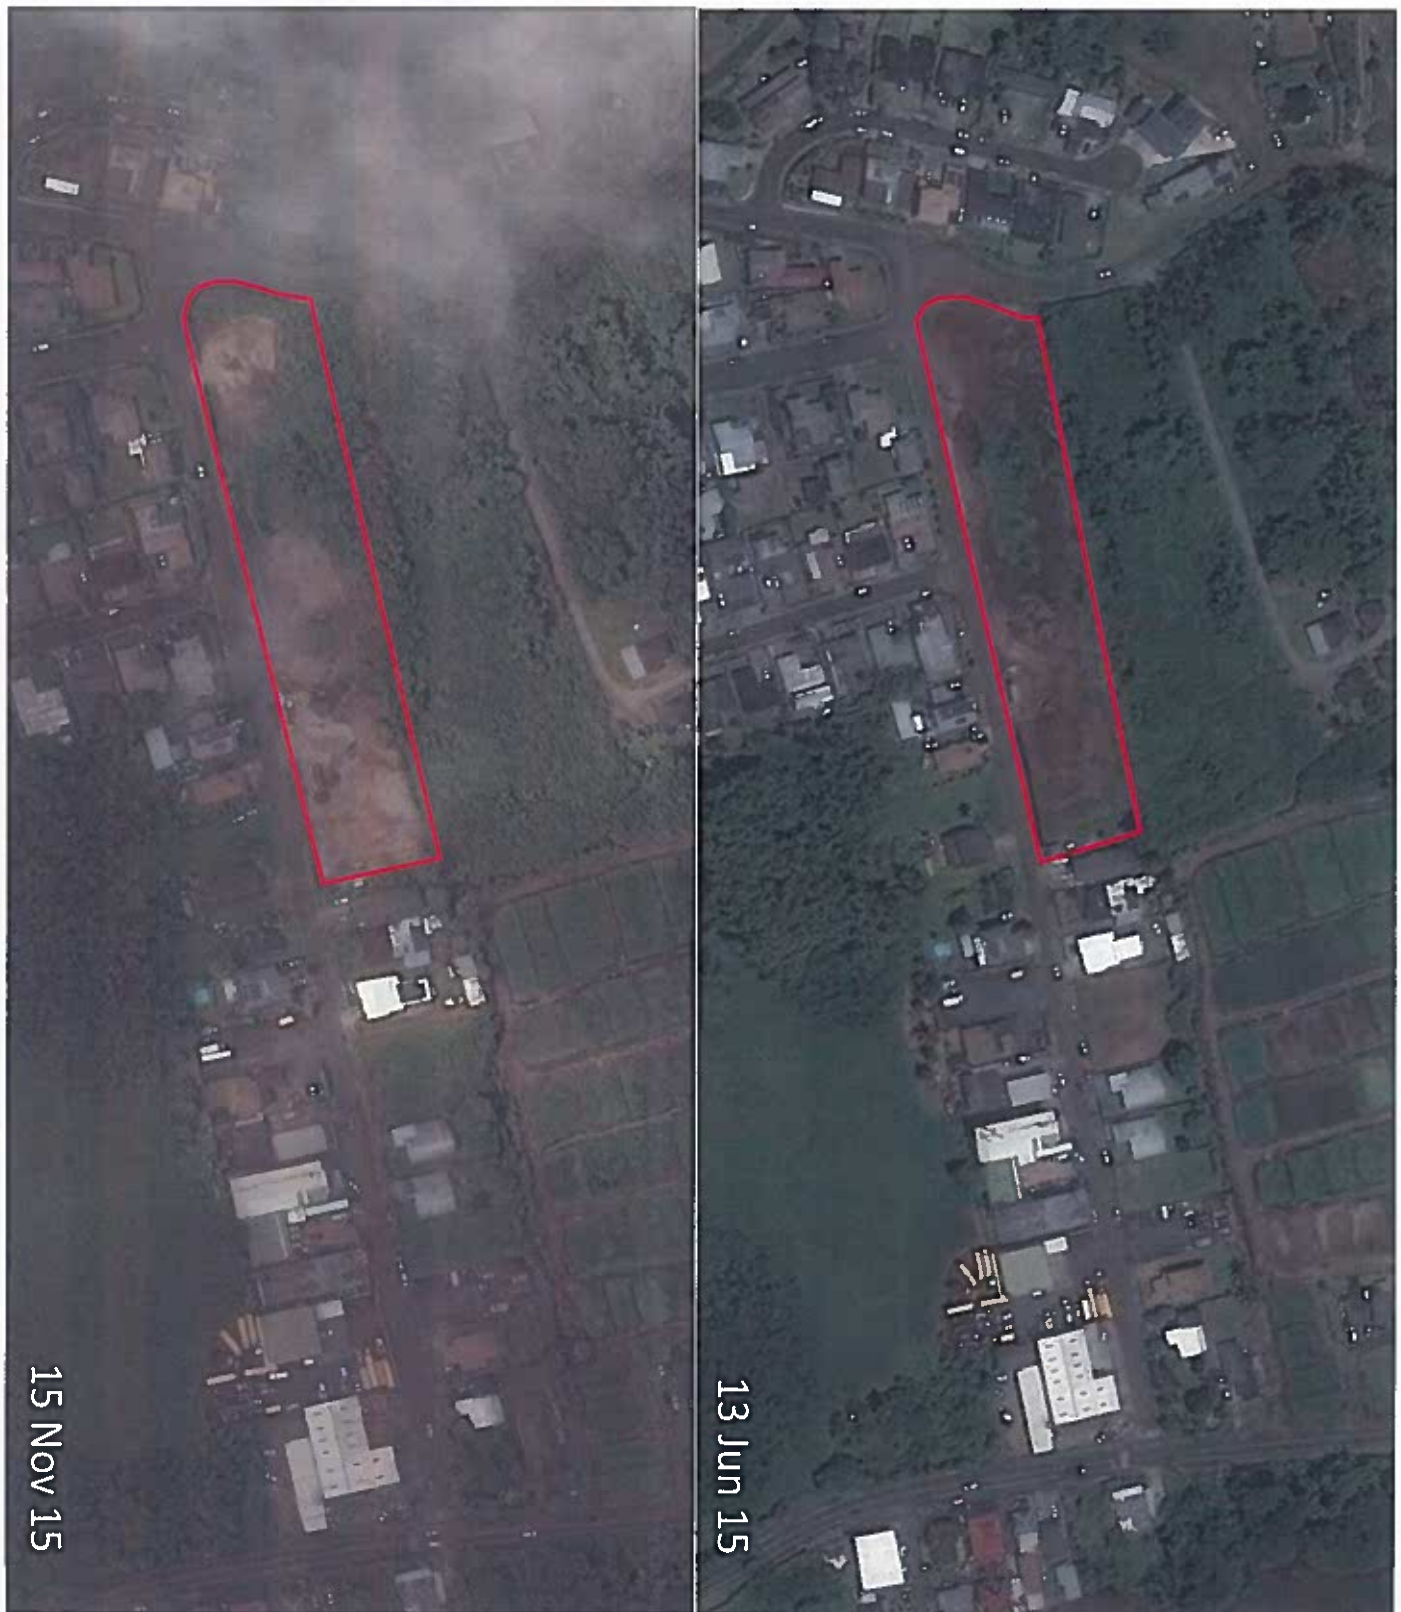
Soil Survey Staff, Natural Resources Conservation Service, United States Department of Agriculture. Web Soil Survey. Available online at the following link: <http://websoilsurvey.sc.egov.usda.gov/>. Accessed October 15, 2021.

Figure 6. Post-Disturbance Aerials, 3 Jun 15 & 15 Nov 15
(Source: Digital Globe)
Appendix A

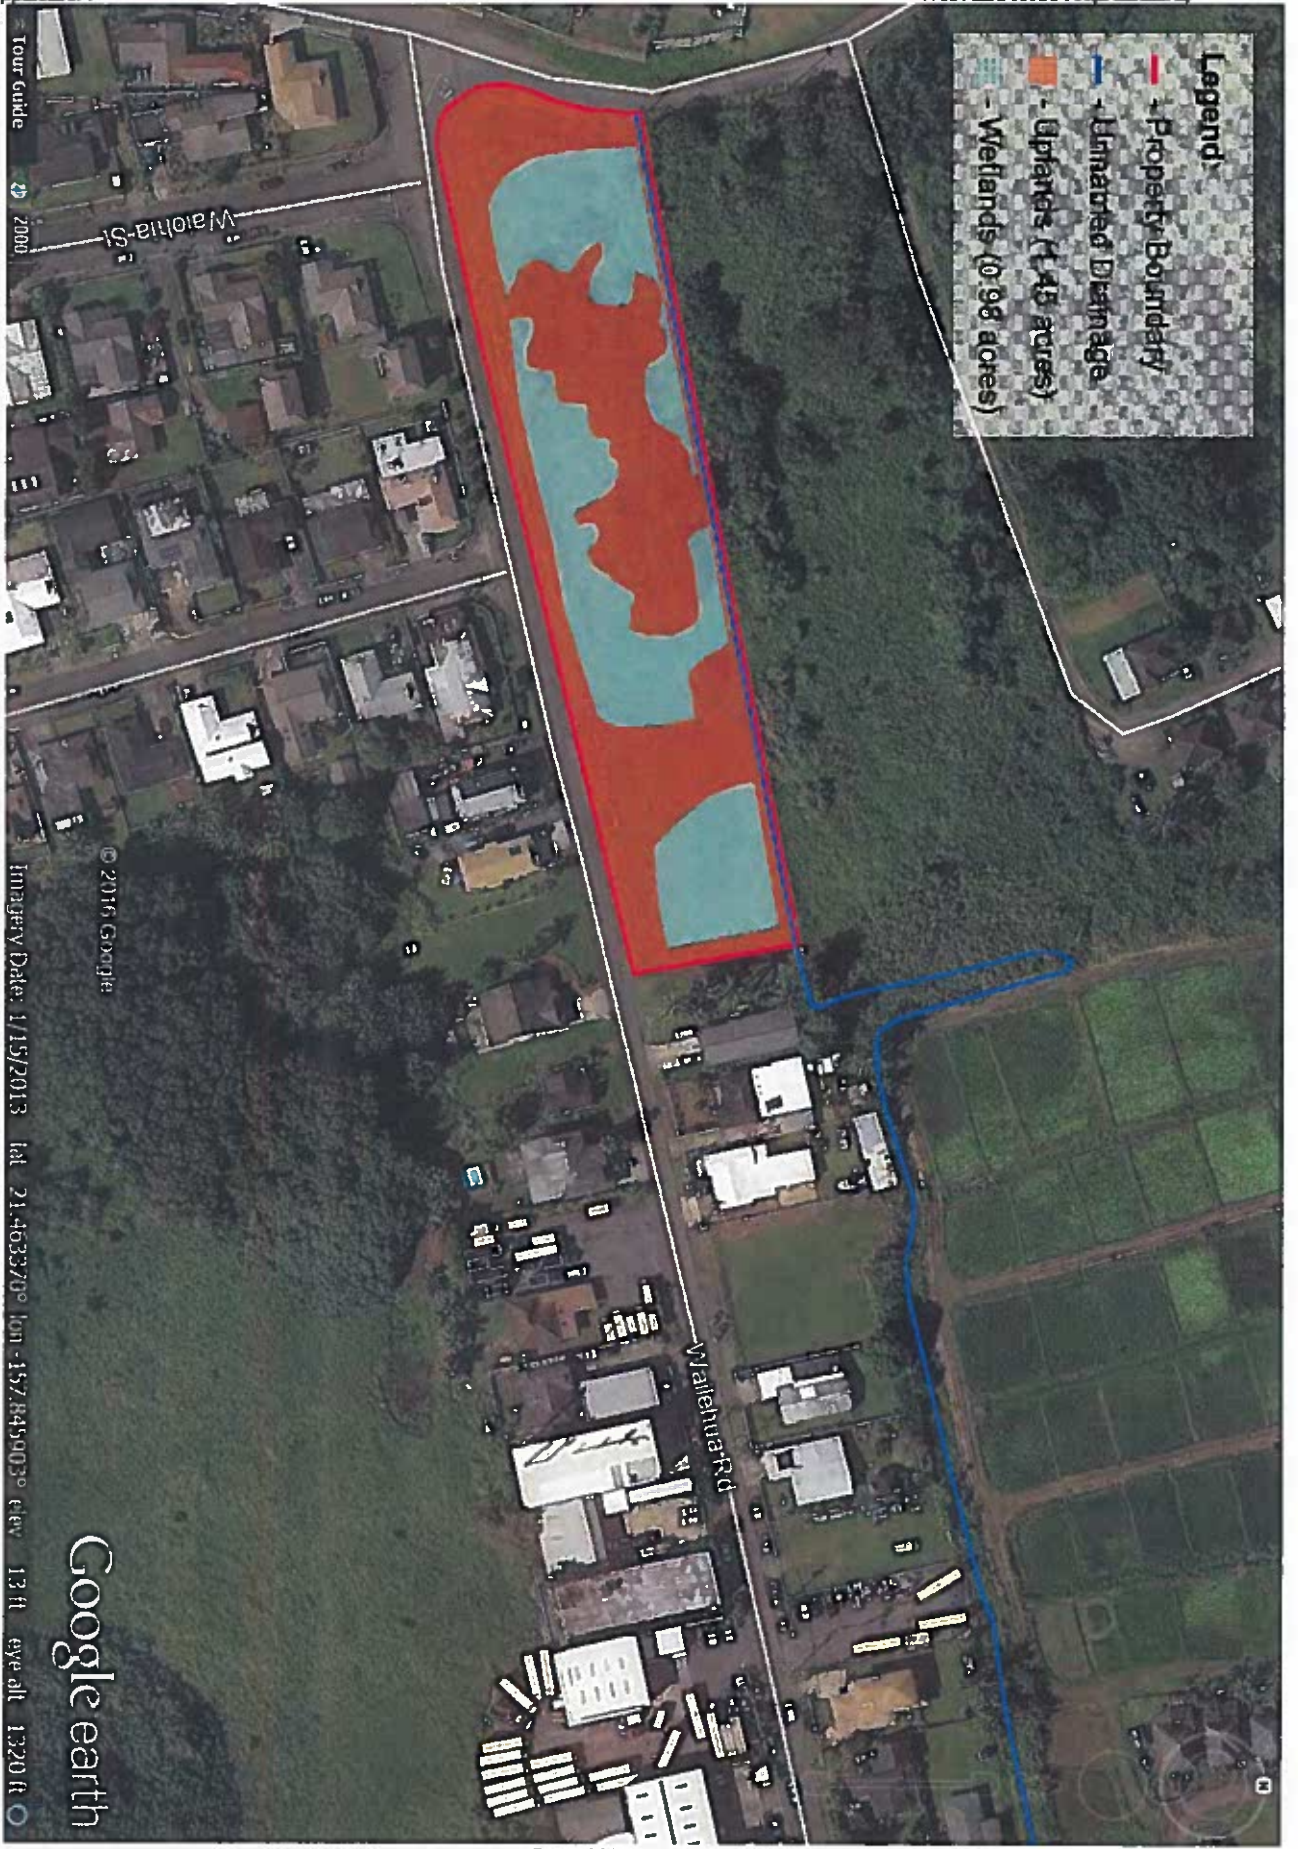
Figure 7: Pre-Fill conditions and resources based on in-office assessment as overlain and quantified in Google Earth

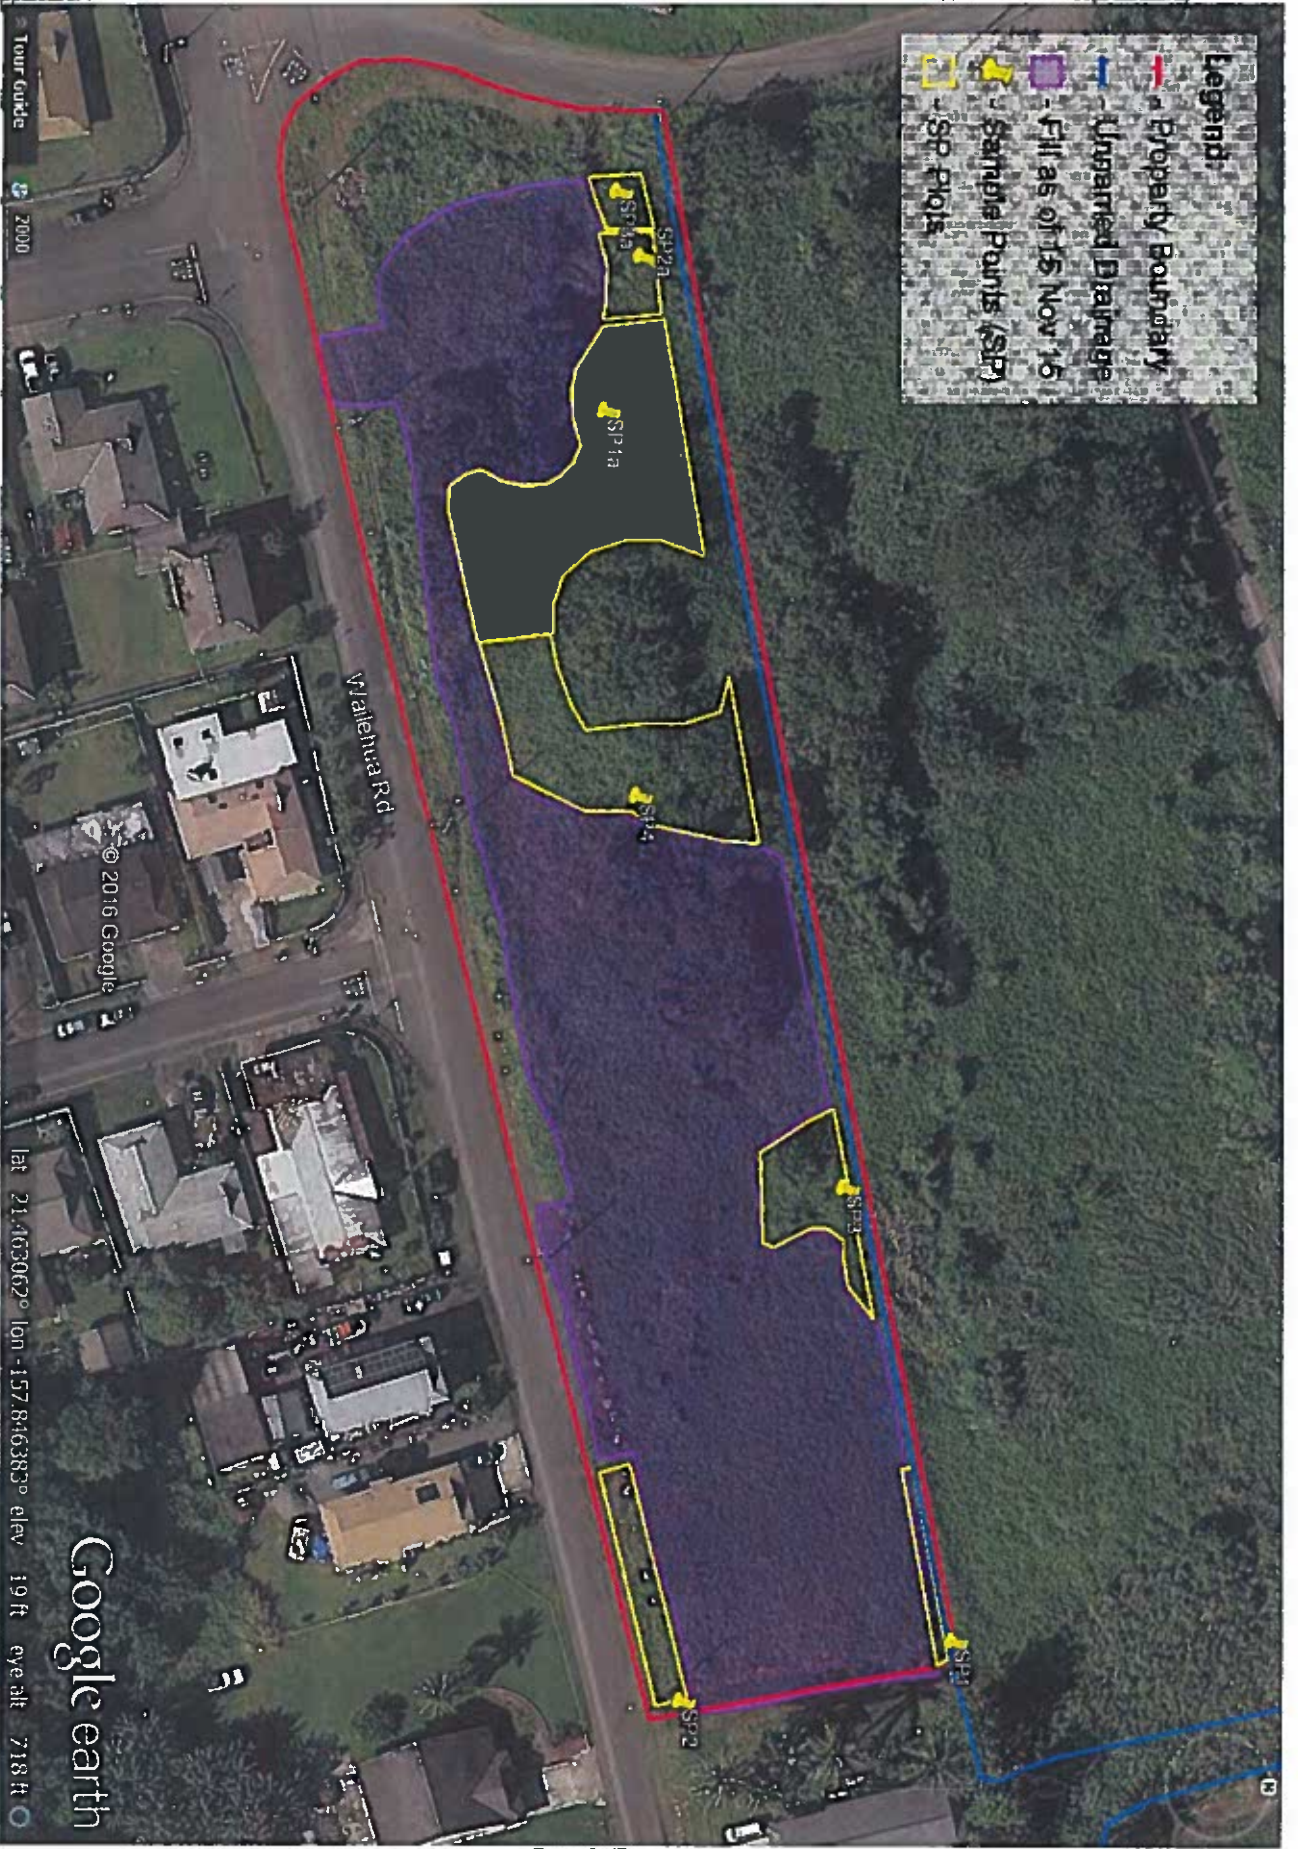
Figure 8: Fill as of 15 Nov 15. Corps wetland delineation sample point selection and corresponding plots based on fill at time of site visit as overlain and quantified in Google Earth

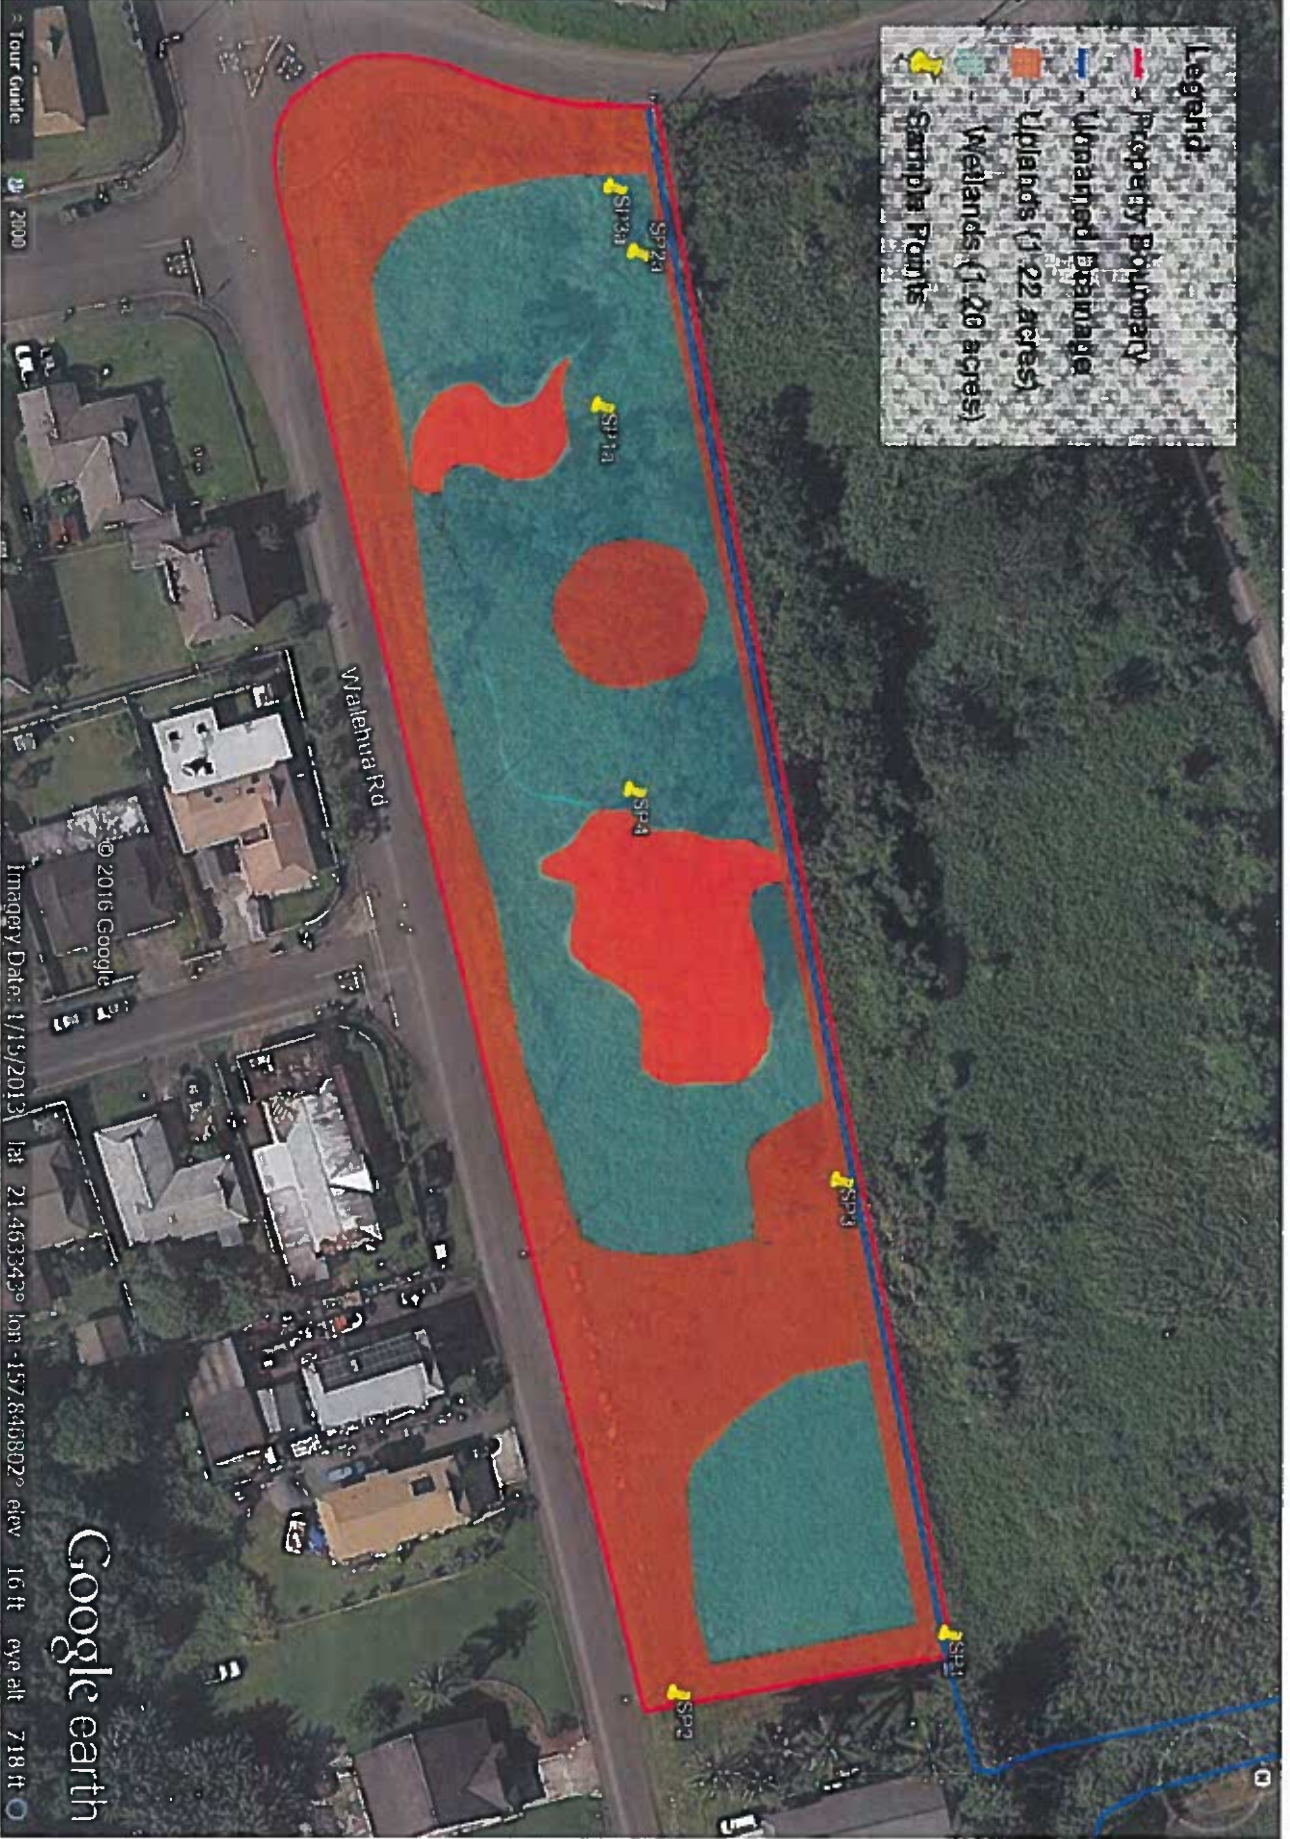
Figure 9: Final results based on existing, post-fill conditions and in-office assessment as overlain and quantified in Google Earth

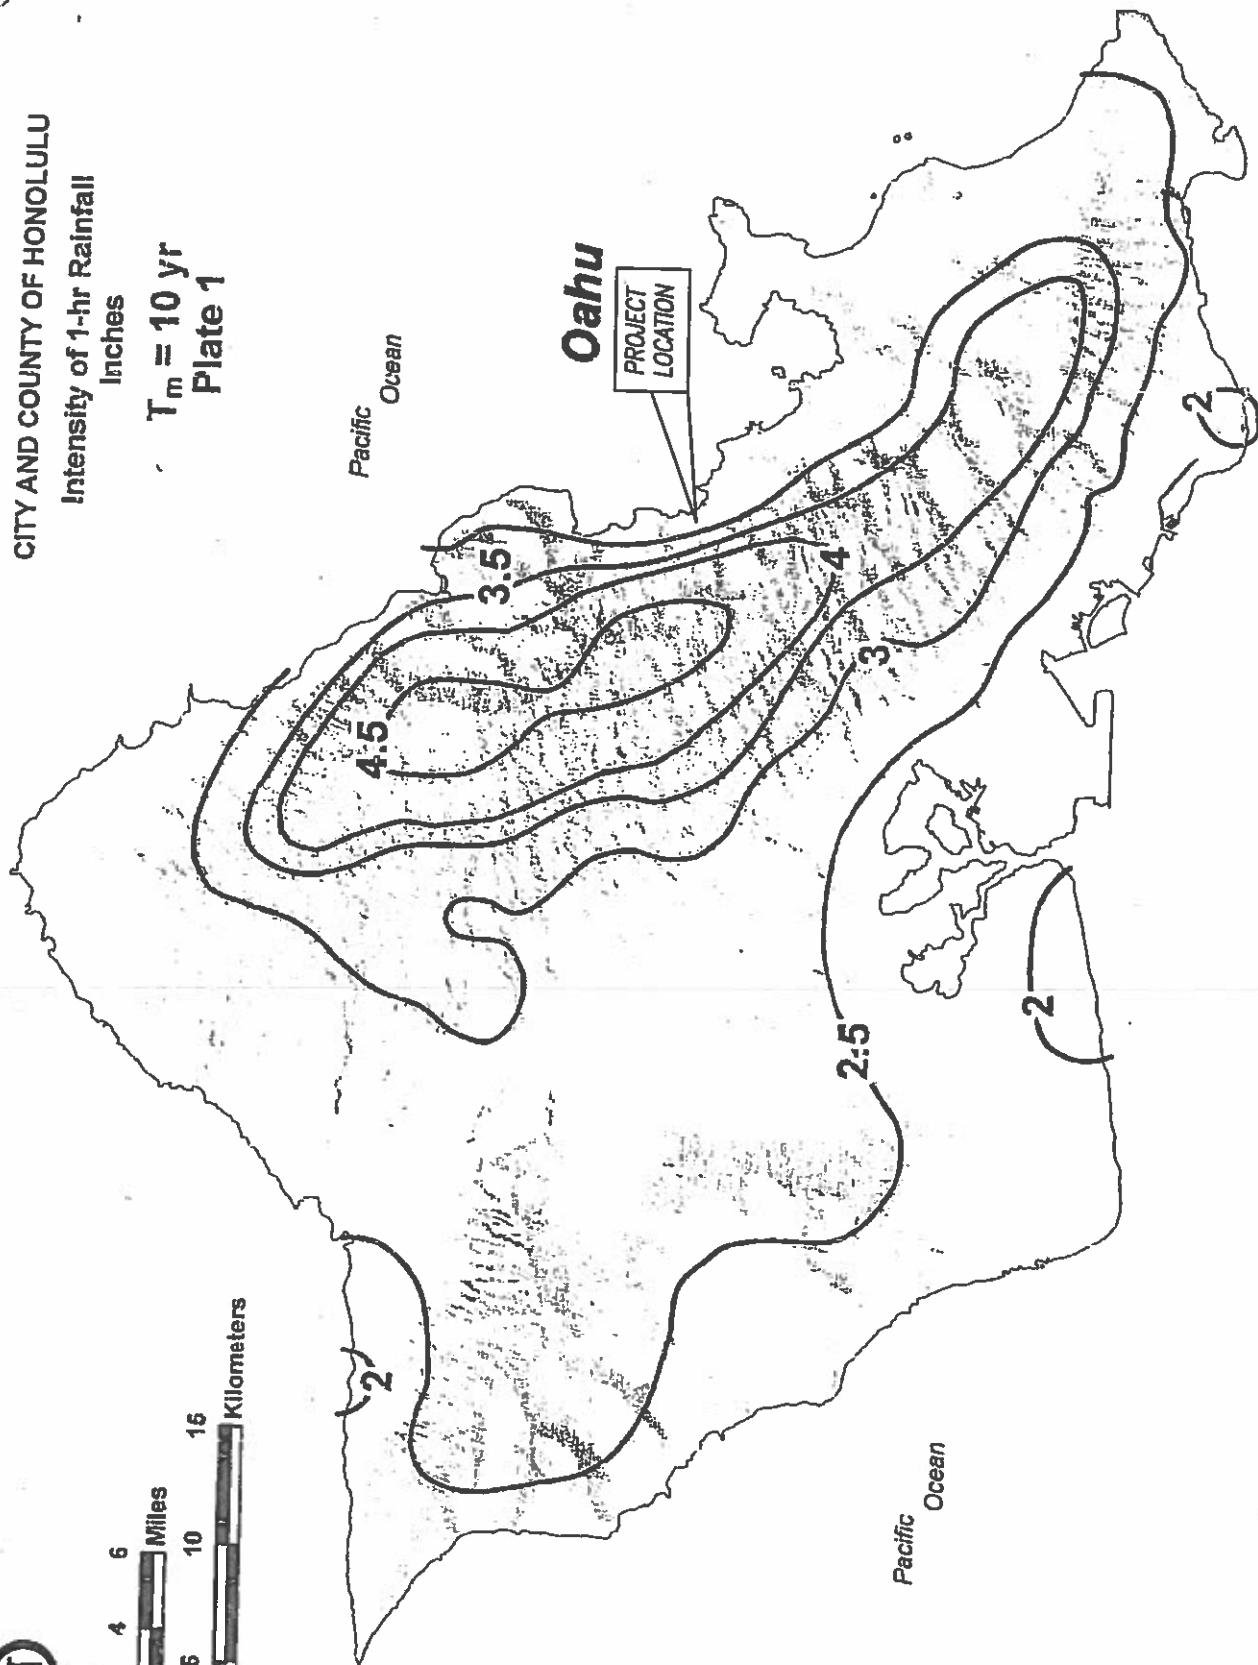
$T_m = 10$ yr
Plate 1

Intensity of 1-hr Rainfall
Inches

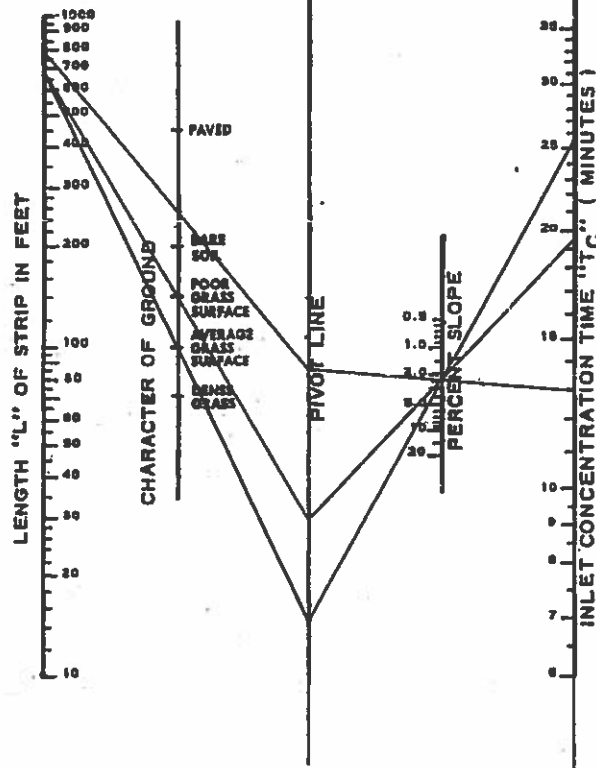
Plate 3

Overland Flow Chart

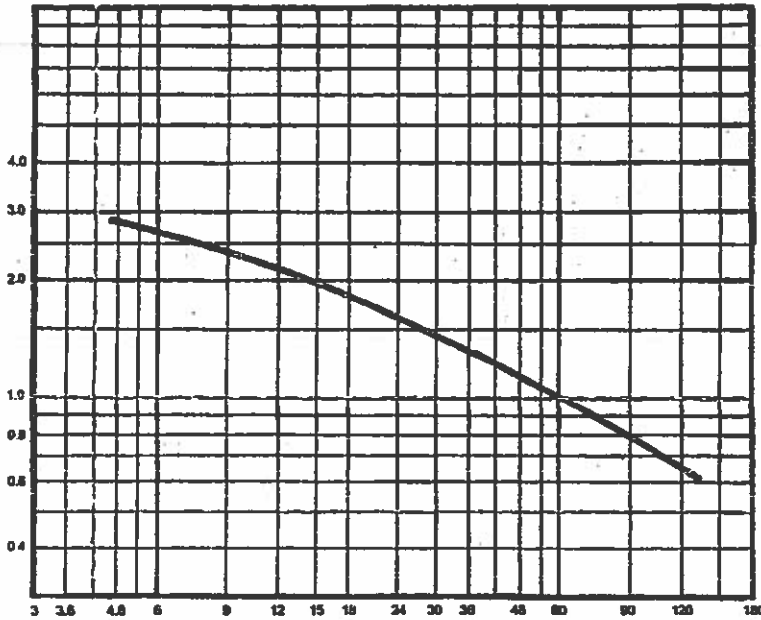
Plate 4

CORRECTION FACTOR APPLIED TO ONE HOUR RAINFALL IN INCHES
TO OBTAIN RAINFALL INTENSITY OF GIVEN DURATION

DURATION OF RAINFALL INTENSITY IN MINUTES
(ENTER "t_c" FROM PLATE 3 OR 5)
