STATE OF HAWAII
DEPARTMENT OF LAND AND NATURAL RESOURCES
COMMISSION ON WATER RESOURCE MANAGEMENT
P.O. BOX 621
HONOLULU, HAWAII 96809

STAFF SUBMITTAL

November 20, 2019
Lahaina, Maui

Request to Address the Waste Complaint Filed by Ka Malu O Kahalawai and West Maui Preservation Association Against Maui Land and Pineapple Company Alleging Water Diverted from Honokōhau Stream Overflows the Honokōhau Ditch, Pursuant to Hawai‘i Revised Statutes §174C-13, and to Amend the Interim Instream Flow Standards for the Surface Water Hydrologic Units of Honolua (6013) and Honokōhau (6014), West Maui

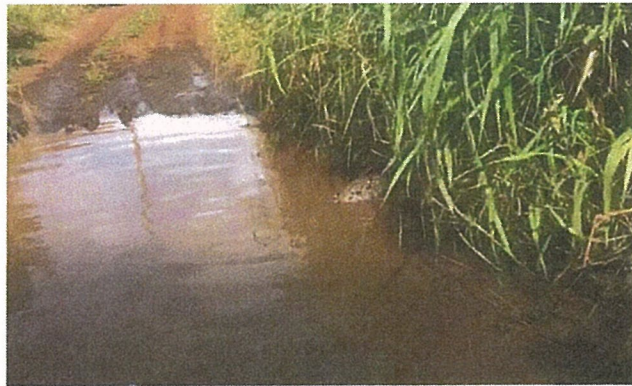
Fig. 4 (right) Water from Wahikuli flume crossing cane haul road. Screenshot of video taken by Wili Wood on Dec. 4, 2018.

On December 4, 2018, Petitioners observed water from Honokōhau ditch freely exiting the Honokōhau ditch through a gate and spilling into the fields and entering the Wahikuli Gulch at the northern end of the Wahikuli Flume. From there, the water spilled into agricultural fields and over cane haul roads into Wahikuli gulch. Also around this time, Petitioners observed water constantly flowing from Hahakea gulch (into which merges Wahikuli stream) into the ocean by Hanakao‘o (Canoes beach). West Maui skies were clear and sunny when these wasted water flows were observed. *See Fig. 2-6.*

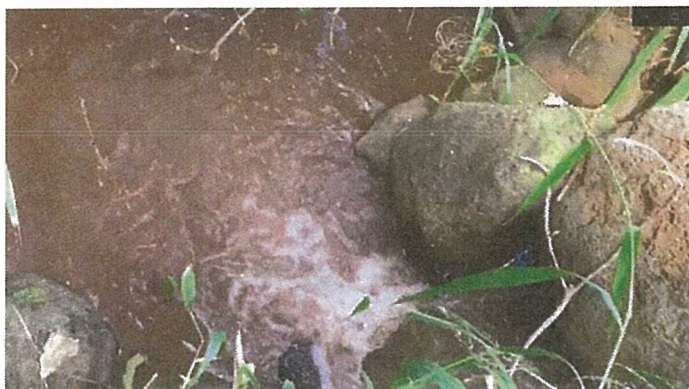
Fig. 5 (left) Water from fields makai of cane haul road flowing into Wahikuli gulch. Screenshot of video taken by Wili Wood on Dec. 4, 2018.
