PREPARED BY
ERSKINE ARCHITECTS, INC.
540 Lagoon Drive, Suite 4
Honolulu, HI 96819
808-833-8891

Preliminary Findings & Recommendations Report for
MALAEKAHANA STATE RECREATION AREA
KAHUKU SECTION
Laie, HI
15 January 2014

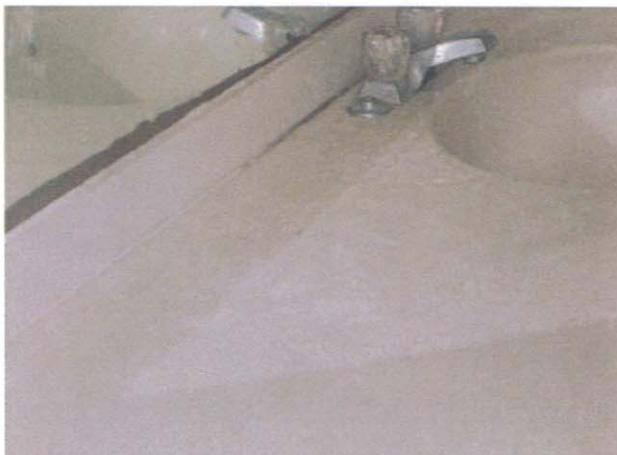
Photograph 5: Black Asphaltic Built-up Roofing Material.

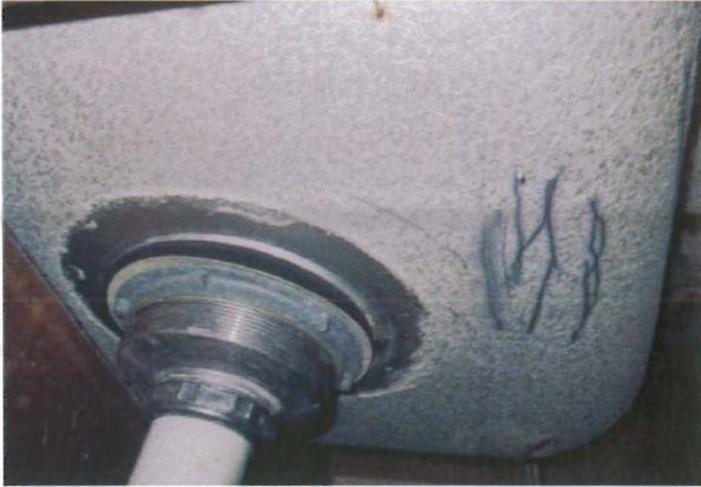
Photograph 20: Security House (Aaron Tufaga Residence)
Black Sink Undercoat

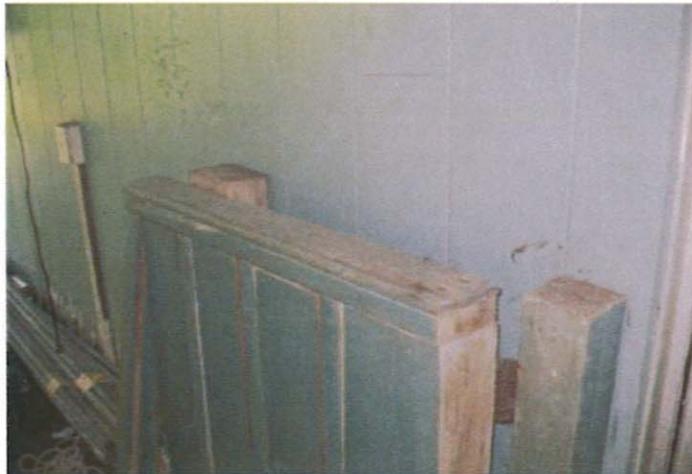
Per the Hazardous Materials Survey Report, Category I non-friable ACM was detected in the sliding door caulking. Category I friable ACM was found in the white kitchen sink undercoating. Lead containing paint was found within the Cabin at several locations including the white paint throughout the interior walls, door frames, wood and drywall ceilings, door and window frames. Lead containing paint was also found at the exterior dark blue paint throughout the walls, window frames, and beams. Mercury containing lamps were found within the Cabin.

Photograph 21:
Security Residence (Game Warden Residence)
White Sink Undercoat

Due to the overall damaged condition of the Cabin, presence of hazardous materials, and non-compliance with ADA requirements, the lease of the Security Residence should be terminated and the building should be boarded up to prevent public entry. The Security Residence should not be occupied.

The DLNR should proceed with the proper removal of the hazardous material, which is required to be by a licensed contractor(s) approved to perform such work in the State of Hawaii. Following the cleaning of hazardous materials, the Cabin should be demolished.
