Assessment Report

State of Hawai'i, Department of Land & Natural Resources, Land Division

Assess Banyan Drive Properties

Prepared by Erskine Architects, Inc.

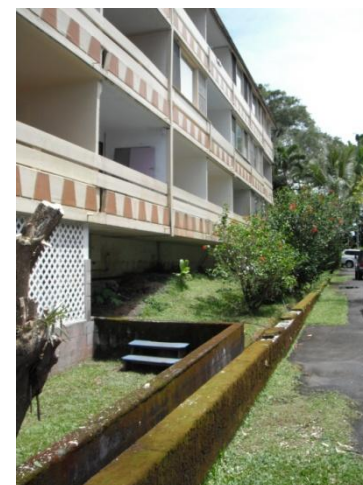
Finding No.	Date of Finding	Floor	Location	Description	Solution	Discipline						Opinion of Probable Cost	
						ARCH	CIV	STRUCT	PLBG	MECH	ELEC		
RB.A-15	June 17, 2015	Typical	Hotel Wing - Stair Towers	Mauka Stair Tower - Guardrails needed. Picket spacing exceeds code regulation. Spacing at landing concrete/wood guardrail exceeds code regulation. Stair Tower is open. Carpet; Makai Stair Tower - Guardrails needed. Picket spacing exceeds code regulation. Stair Tower is open. Ponding. Non-slip nosing paint worn.	Provide code compliant stair towers.	●							\$150,000.00
RB.OA-01	June 17, 2015	0	Exterior	Northwest site retaining wall needs repair.	Repair retaining wall.	●	●	●					\$30,000.00
RB.OA-02	June 17, 2015	0	Hotel Wing	Electrical equipment to be enclosed in protected room.	Construct enclosure for electrical equipment.	●		●		●	●		\$2,500.00
RB.OA-03	June 17, 2015	0	Hotel Wing	Exterior curved stair (near pool) requires railings. Riser height at 3", may be too short.	Add railings. Modify/reconstruct stair for code compliant riser height.	●		●					\$5,000.00

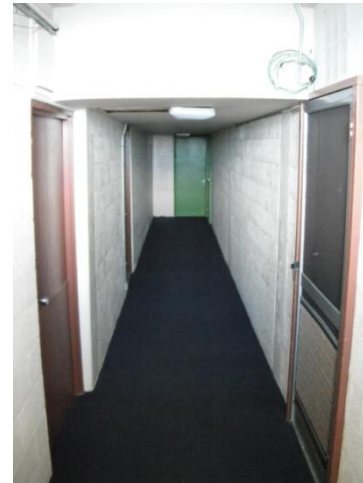
RB.0A-04

RB.OA-04	June 17, 2015	0	Hotel Wing	Lanais enclosed with unrated construction-combustible materials.	Demolish lanai enclosures.	●		●					\$1,500.00
RB.OA-05	June 17, 2015	0	Hotel Wing	Dead end corridor. Screen doors open into corridor.	Modify layout to eliminate dead end corridor, add sprinklers or add alternate exit.	●					●		\$25,000.00
RB.OA-06	June 17, 2015	1	Annex	Entire basement in poor condition.	Install new floor finish, drywall, paint, ceilings, lights, etc.	●				●	●		\$250,000.00
RB.1A-01	June 17, 2015	1	Exterior - Pool	Retaining wall needs to be repaired. Wall is leaning.	Repair retaining wall.	●		●					\$15,000.00
RB.1A-02	June 17, 2015	1	Lobby Wing	Laundry Area is unenclosed and not protected by rated construction. Windows in wall adjacent to Laundry Area.	Reconstruct Laundry Area with rated construction to comply with code.	●		●			●		\$75,000.00
RB.1A-03	June 17, 2015	1	Annex	Access to unsafe burnt roof deck.	Cordoned off stair to burnt roof deck or remove stair access completely.	●							\$1,000.00

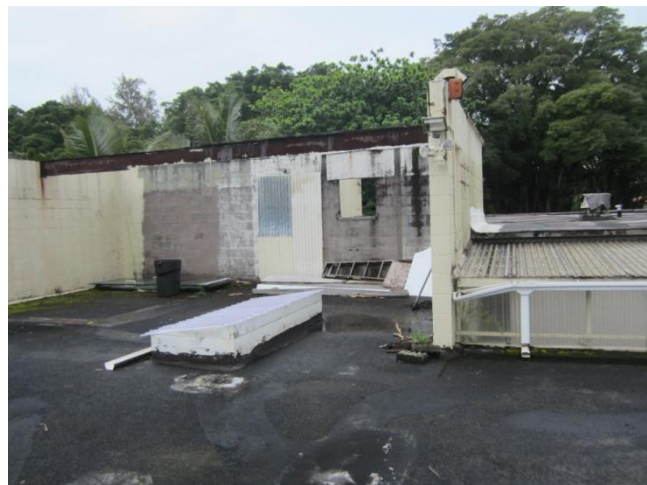
RB.1A-04	June 17, 2015	1	Annex	Stair down to "Owners Only" basement old exercise room in poor condition.	Repair stair.	●							\$3,000.00
RB.1A-05	NOT USED												
RB.1A-06	June 17, 2015	1	Annex	Roof above exercise room needs to be replaced so that occupiable spaces below will be protected in the future and to maintain integrity of the structure.	Install new roofing and gutters/downspouts.	●		●					\$75,000.00
RB.RA-01	June 17, 2015	Roof	Roof	Need scuttle access to roof. Current access a life safety issue.	Provide new scuttle and ladder access, or external ladder access at exterior of building.	●							\$25,000.00
RB.RA-02	June 17, 2015	Roof	Roof	Half of roof is moss covered. Spongy roof in spots, water beneath - no secondary drainage off roof - only internal downspouts provided.	Remove moss and roofing material. Provide secondary drainage method off roof.	●							\$150,000.00
RB.RA-03	June 17, 2015	Roof	Roof	Parapet liner is peeling. Copper coping is good, but fasteners deteriorated. Mansard roof rusted.	Replace deteriorated fasteners. Replace mansard roof.	●							\$75,000.00

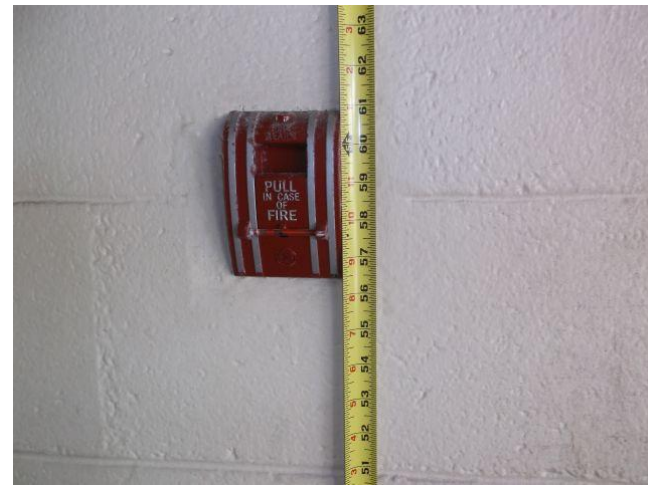
RD.D-01	June 24-25, 2015	Typical	Hotel Wing - Guest rooms	Non-compliant identification sign; Non-compliant entrance door and doorway.	Provide compliant permanent room signs that are tactile and brailed. Widen entrance and interior doors and doorways.	●		●					\$60,000.00
RD.D-02	June 24-25, 2015	Typical	Hotel Wing - Corridors	Fire Alarm System - Pull Stations	Replace with accessible pull stations and locate at accessible locations.						●		\$8,000.00

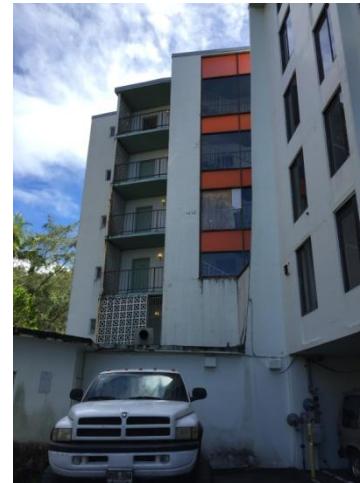
Finding No.	Date of Finding	Floor	Location	Description	Solution	Discipline						Opinion of Probable Cost	
						ARCH	CIV	STRUCT	PLBG	MECH	ELEC		
CC.1C-01	June 17, 2015	1	Exterior - West driveway and parking area; Northeast driveway and parking area; Southeast driveway and parking area	Worn AC pavement, minor to moderate ponding, AC cracks, potholes.	Complete AC pavement reconstruction (approximately 31,800 sf), new pavement markings, replace speed bumps.		●						\$375,000.00
CC.1C-02	June 17, 2015	1	Exterior - North end of property, near shoreline	Chain link fence on east side of pool is in poor condition, missing curb at grade, erosion problem.	Replace fence with 80-ft of aluminum chain link fence, repair erosion area by AC pavement, install 80-ft of concrete curb at grade.		●						Included elsewhere
CC.A-01	June 17, 2015	Typical	Typical	Paint in poor condition.	Paint building complete.	●							\$750,000.00

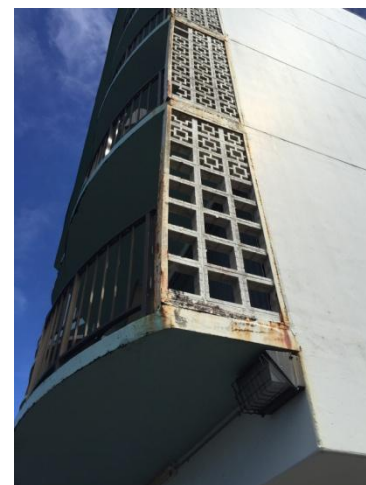
Finding No.	Date of Finding	Floor	Location	Description	Solution	Discipline						Opinion of Probable Cost
						ARCH	CIV	STRUCT	PLBG	MECH	ELEC	
CC.S-01	June 17, 2015	Typical	Makai Wing - Entry to Stairwell. Exterior - Makai concrete wall, makai corridor concrete column, parking areas, interior corridor. Mauka Wing - Left and right end and exterior walls; Mauka concrete wall near elevator.	Concrete spalls and cracks at lanai slab edges; window sills; top and edges of concrete slab; exterior concrete walls; base of concrete walls; base of concrete columns. Cracks and spalls, with exposed rebar, at fire sprinkler riser penetrations; Cracks & paint delamination on underside of concrete stair framing and on concrete walls; Diagonal cracks in concrete stair wall; Horizontal cracks at header in concrete stair wall; Corrosion of embedded corner angles at exposed concrete columns & concrete spalling; Concrete cracks and spalling at top of concrete wall below landing/corridor	Repair spalls and cracks. Repair / replace corner angles.			●				\$225,000.00

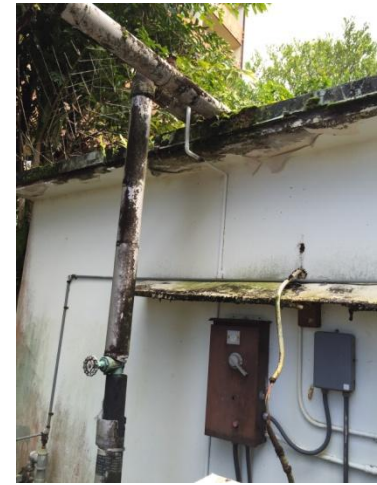
CC.1S-04	June 17, 2015	2	Makai Wing - Parking area below residential units	Bubbling of paint at concrete floor slab soffit	Prepare and repaint.	●						Included elsewhere
CC.1S-05	June 17, 2015	2	Mauka Wing - Mechanical Room Roof Framing	Moisture damage & paint delaminating at roof slab edges	Prepare and repaint.	●						Included elsewhere
CC.3S-01	June 17, 2015	3	Mauka Wing - Near Elevator	Differential slab elevations marked by yellow indications on floor covering	Repair/add topping			●				\$10,000.00
CC.1P-01	June 17, 2015	1	Exterior - Parking Area	Soil pipe rusting	Clean rust from pipe and repaint				●			\$5,000.00
CC.1P-02	June 17, 2015	1	Exterior - Parking Area	Fire hose cabinet rusty	Replace cabinet				●			\$1,500.00
CC.1M-01	June 17, 2015	1	Exterior - Mauka Wing	Grilles installed in soffit are rusted.	Replace existing soffit grilles with aluminum coated grilles					●		\$2,500.00
CC.1M-02	June 17, 2015	1	Exterior - Mauka Wing	Abandoned mechanical equipment at exterior.	Remove all abandoned equipment.					●		\$1,500.00

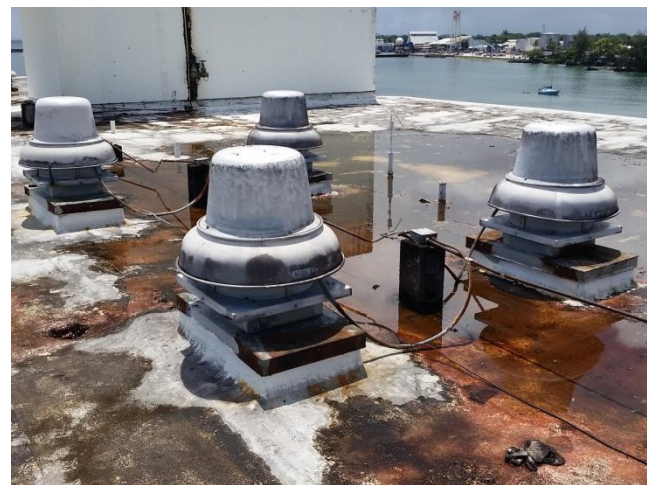
CC.1M-03	June 17, 2015	1	Makai Wing - Laundry Area	Dryer vent discharges into bucket.	Extend dryer vent to exterior of building.					●		\$1,000.00
CC.RM-01	June 17, 2015	Roof	Roof	Noticeable vibration/noise originating from exhaust fans on roof; corrosion on roof curb	Replace exhaust fans and curbs (approx 9)					●		\$27,000.00
CC.RM-02	June 17, 2015	Roof	Roof	Air cooled chiller in poor condition - corrosion noted on frame and cooling coils.	Replace air cooled chiller and other air conditioning upgrades.					●		\$500,000.00
CC.E-01	June 17, 2015	Typical	Typical	Exit sign does not indicate direction of exit. Exit sign not illuminated, pointing in wrong direction, mounted low, etc.	Provide new illuminated exit signs and proper signage to indicate direction of exit						●	\$50.00
CC.E-02	June 17, 2015	Typical	Makai Wing	All floors, many of the halls lights are not properly secured to the ceiling	Provide proper supports for all light fixtures.							\$5,000.00

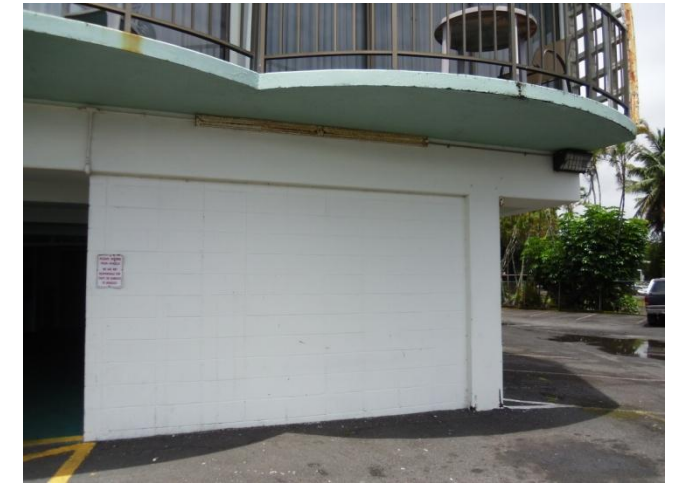
Finding No.	Date of Finding	Floor	Location	Description	Solution	Discipline						Opinion of Probable Cost	
						ARCH	CIV	STRUCT	PLBG	MECH	ELEC		
CC.1E-01	June 17, 2015	1	Makai Wing	Parking garage lights showing signs of rust.	Replace with fixtures rated for wet locations.							●	\$3,000.00
CC.1E-02	June 17, 2015	1	Makai Wing	Outdoor fixtures under overhangs are rusted and some don't have bulbs. Fixtures may be abandoned.	If fixtures are abandoned, they should be removed. If they are intended to be used, they should be replaced with wet location rated fixtures and bulbs should be provided.							●	\$3,000.00
CC.1E-03	June 17, 2015	1	Makai Wing	Light fixture and conduit installed in front of grill.	Relocate fixture away from front of grill.							●	\$1,000.00
CC.1E-04	June 17, 2015	1	Makai Wing	Fluorescent fixtures installed under balconies do not appear to be wet location rated.	Replace with fixtures rated for wet locations.							●	\$1,000.00

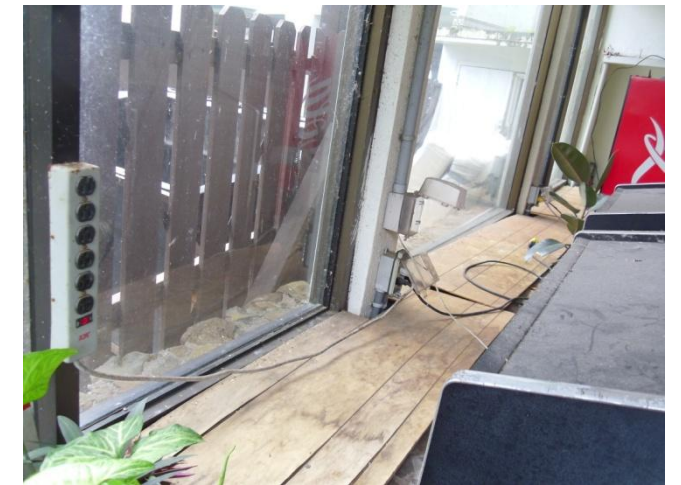
CC.1E-05	June 17, 2015	1	Makai Wing	Equipment in parking lot is turned off and appears to be abandoned. It is in poor condition and some panels are rusted through. Broken conduits and exposed electrical wires are also present.	Remove unused equipment, conduit and wires. If equipment is still intended to be used, it should be replaced prior to use.							●	\$5,000.00
CC.1E-06	June 17, 2015	1	Mauka Wing	Switch missing from device box.	Replace switch or replace cover if the switch is not required.							●	\$50.00
CC.2E-01	June 17, 2015	2	Mauka Wing	Equipment on second floor roof is in poor condition. Conduits are rusted and not properly secured to the structure.	Repair or replace equipment and replace conduit and wiring.							●	\$3,000.00
CC.3E-01	June 17, 2015	3	Makai Wing	Hallway lighting levels seem low.	Evaluate lighting levels and install new light fixtures.							●	\$125,000.00
CC.4E-01	June 17, 2015	4	Mauka Wing	Globe missing from light fixture and bulb not installed.	Replace globe and bulb to provide lighting							●	\$50.00

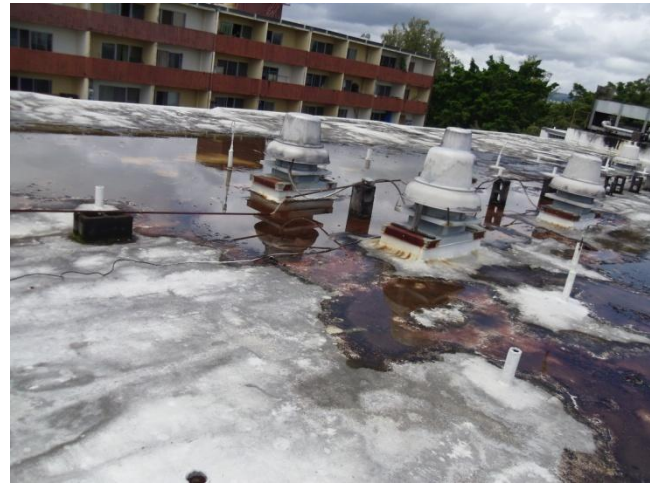
CC.RE-01	June 17, 2015	Roof	Makai Wing	Conduits disconnected from junction box. Junction box is not supported properly. Conduits are in poor condition	Remove existing conduit and junction box and replace with new.							●	\$1,000.00
CC.RE-02	June 17, 2015	Roof	Makai Wing	Conduits severely rusted and supported from cinder block, not properly secured. Conduits completely rusted through and separated at some points.	Remove existing conduits and replace with new conduits, properly secure.							●	\$1,000.00
CC.RE-03	June 17, 2015	Roof	Makai Wing	Receptacle damaged and completely rusted through. Conduits run along ground are tripping hazard.	Remove receptacle, patch and fill conduit penetrations. Relocate conduit run along ground or provide platform to eliminate tripping hazard.							●	\$1,000.00
CC.RE-04	June 17, 2015	Roof	Makai Wing	Ventilation duct resting on conduit.	Provide separation between duct and conduit.							●	\$100.00

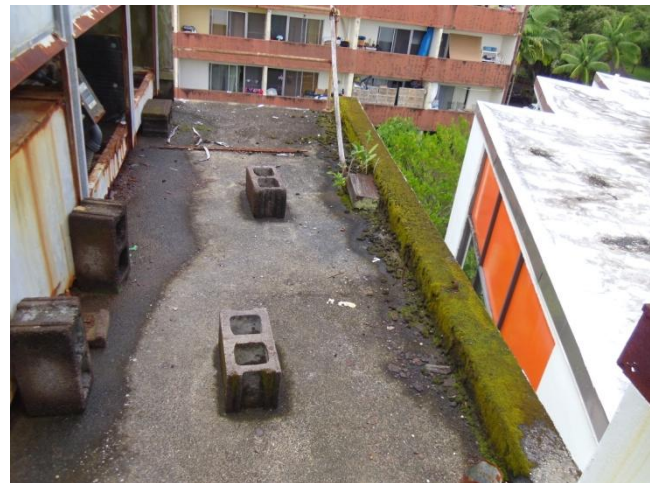
CC.RE-05	June 17, 2015	Roof	Makai Wing	Equipment not adequately protected from rain and is extremely rusted.	Repair and protect equipment or remove if not in use.							●	\$1,000.00
CC.RE-06	June 17, 2015	Roof	Makai Wing	No guard rail around equipment. This is an extreme safety hazard for personnel servicing equipment. Could not determine if this equipment is still in use.	Provide guard rail if equipment is to remain in service.							●	\$2,000.00
CC.RE-07	June 17, 2015	Roof	Makai Wing	Wireway and conduits rusted through.	Remove equipment if not in service. Replace equipment if is still in service.							●	\$3,000.00
CC.RE-08	June 17, 2015	Roof	Makai Wing	Conduit knockout at disconnect not plugged.	Provide plug for knockout							●	\$100.00
CC.RE-09	June 17, 2015	Roof	Makai Wing	Unterminated cables at weatherhead.	Remove unused cables.							●	\$200.00
TOTAL												\$6,108,250.00

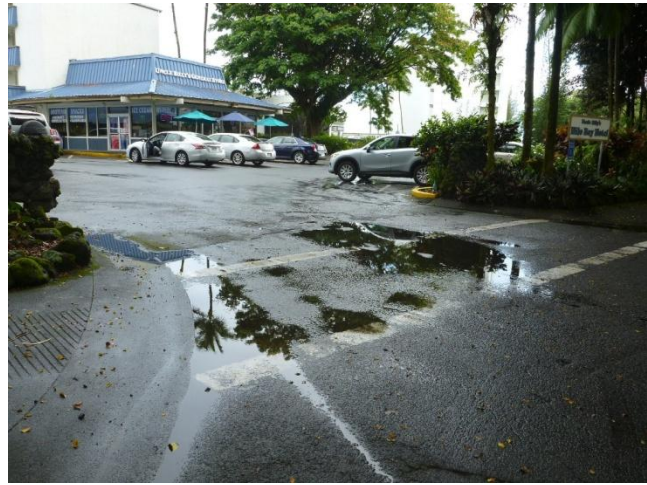
Finding No.	Date of Finding	Floor	Location	Description	Solution	Discipline						Opinion of Probable Cost
						ARCH	CIV	STRUCT	PLBG	MECH	ELEC	
UB.1C-01	June 17, 2015	1	Exterior - East driveway, covered driveway	Minor ponding at two locations	Monitor and seal when cracks appear.		●					N/A
UB.1C-02	June 17, 2015	1	Exterior - Covered driveway	Minor AC cracks on both sides of covered driveway/reception area.	Crack sealing.		●					\$4,800.00
UB.A-01	June 17, 2015	Typical	Typical	Paint in poor condition.	Paint complete.	●						\$1,250,000.00
UB.A-02	June 17, 2015	Typical	Typical	Carpet in poor condition.	Replace carpet complete.	●						\$240,000.00
UB.A-03				No wayfinding signage.	Provide wayfinding signage.							\$47,000.00
UB.A-04	June 17, 2015	Typical	Typical	Obstruction at exit door: Fire hydrant at North Wing Basement, fire extinguisher at North Wing 3rd floor makai stair, counter at East Wing 3rd floor	Remove obstruction.	●						\$750.00

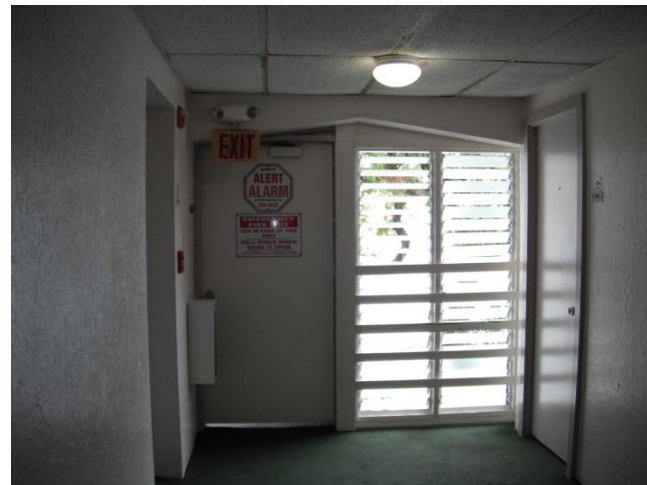
UB.A-16	June 17, 2015	Typical	North Wing - Makai Stair	Corridor has broken windows at end. Jalousie windows extended to floor with no guardrail.	Replace window and add code compliant guardrail.	●						\$2,500.00
UB.A-17	June 17, 2015	Typical	North Wing	Dead-end corridor at elevator. Jalousie windows in elevator lobby (if considered lobby).	Modify layout to remove dead end corridor by constructing elevator lobby. Remove jalousie window and make fire rated.	●						\$150,000.00
UB.OA-01	June 17, 2015	0	Exterior	All wood lean-to sheds built in non-compliant with wood and badly damaged.	Demolish or reconstruct wood lean-to sheds.	●						\$20,000.00
UB.OA-02	June 17, 2015	0	Exterior	Guardrails needed at exterior walking paths and bridges over ponds.	Provide code compliant guardrails at new code compliant paths/bridges.	●						\$65,000.00

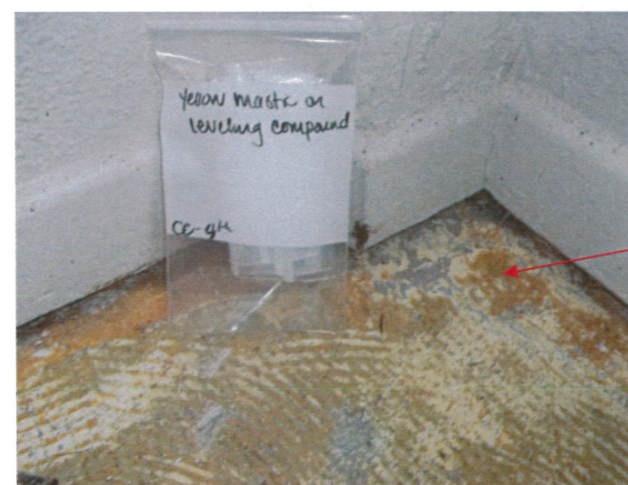
Photograph 3: Floors, - 2, 4, 5 & 6 Yellow Carpet Mastic on Leveling Compound

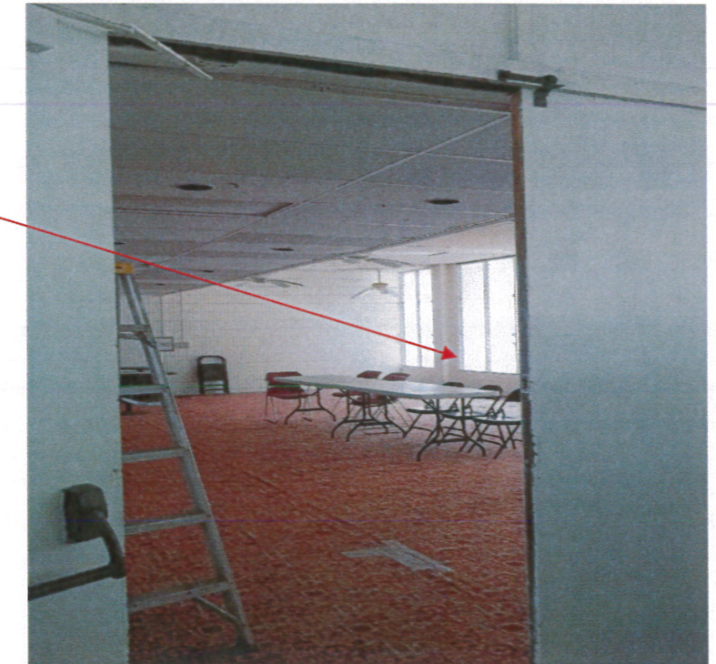
Photograph 7: Halau Room- Window Caulking

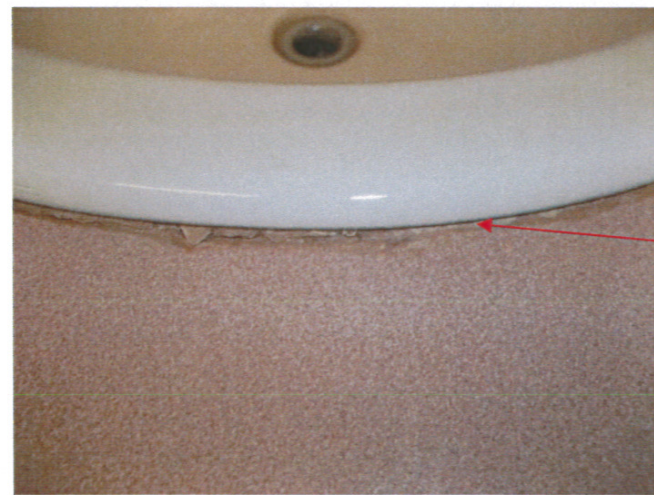
Photograph 16: Lobby Men's Restroom, Sink Caulking

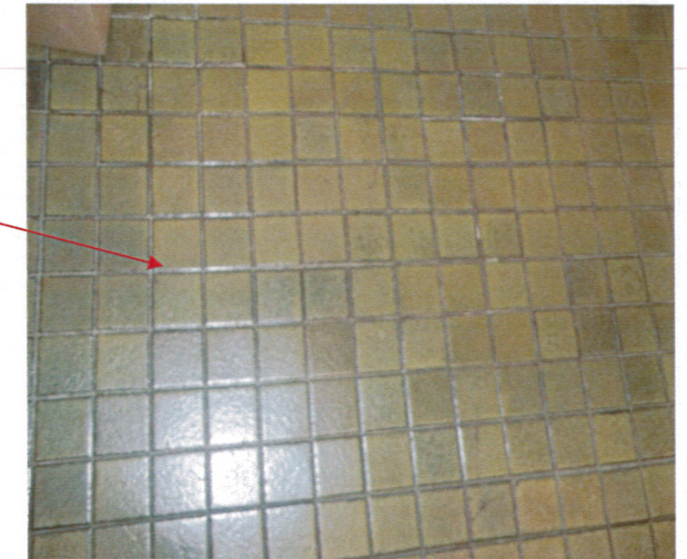
Photograph 18: 2"x 2" Green Ceramic Floor Tile

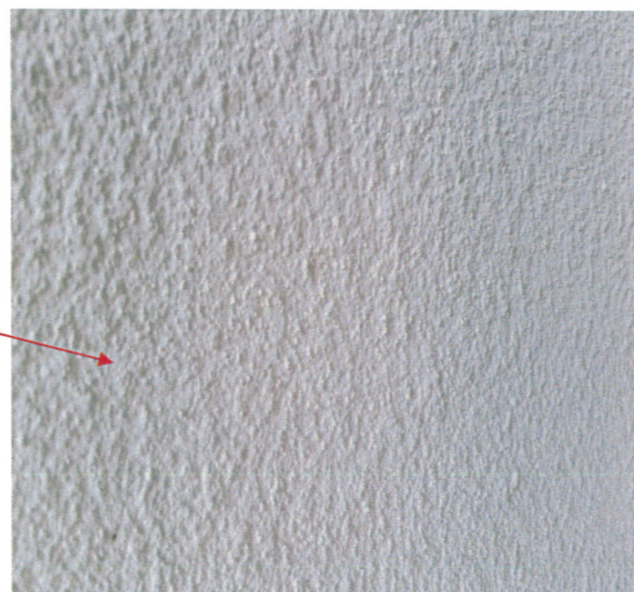
Photograph 20: Spray on Ceiling Material
